ELITE GROUP

INSPECTION PROFESSIONALS

1625 Van Horne Ln, Redondo Beach, CA 90278
Inspection prepared for: Robert Abeyta
Real Estate Agent: -

Date of Inspection: 2/24/2021 Time: 12:00 PM
Age of Home: 1961 Size: 1064
Weather: Sunny and warm
Order ID: 234133

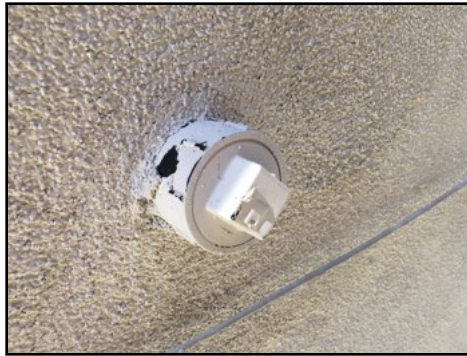
Clean out cap has normal wear for age with no major visible defects at the time of the inspection

Clean out used for inspection

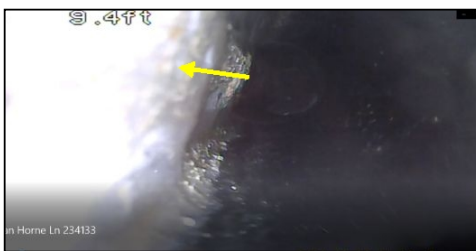
Heavy sewer line sludge observed in portions of the sewer line - cleaning recommended

Sewer line sludge observed at 9.4 feet

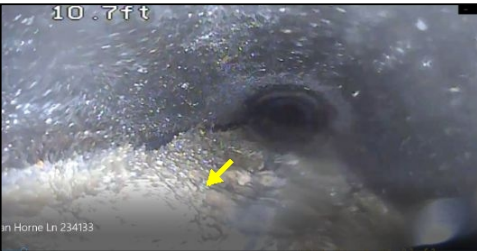
Sewer line sludge observed at 10.7 feet

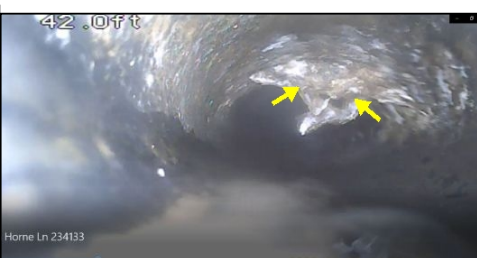
Debris material found in drain line at approximate distance of: 42 feet (see pictures)

Sewer line sludge build up present at 42.0 feet

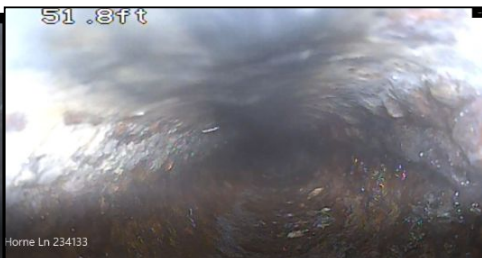
Condition of sewer line at 51.8 feet (cast iron piping)

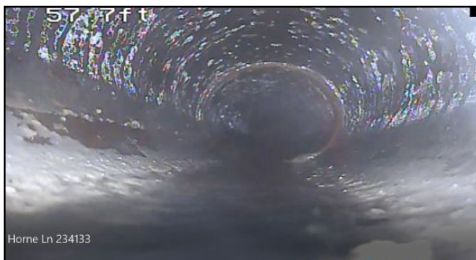
Condition of sewer line at 57.7 feet (abs piping)

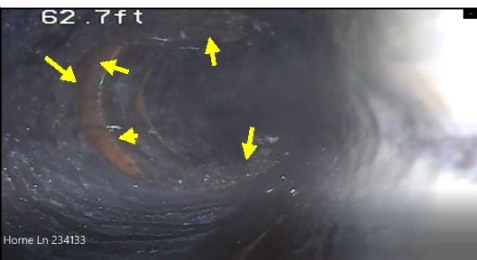
Offset found in sewer line at approximate distance of: 62 & 67 feet

Separations/steps/offsets observed in sewer line (this is a common condition at many pipe connections) - consult a licensed plumbing contractor for service options)

Offset & root intrusion present at 62.7 feet

We recommend that you consult with a licensed plumber for further evaluation, cleaning and any repairs needed

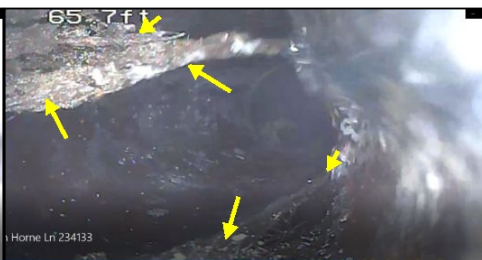
Root intrusion found in various areas of the sewer line, see pictures for more details

Root intrusion present at 65.7 feet

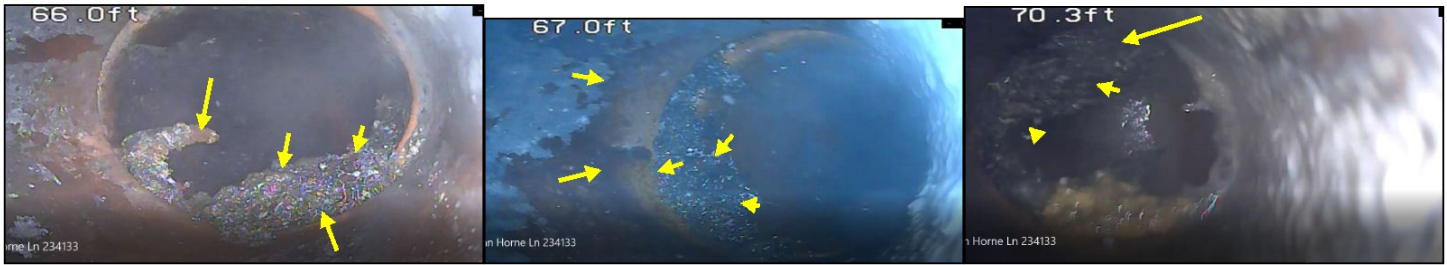
Root intrusion present at 66.0 feet Offset and root intrusion present at 67.0 feet Root intrusion present at 70.3 feet

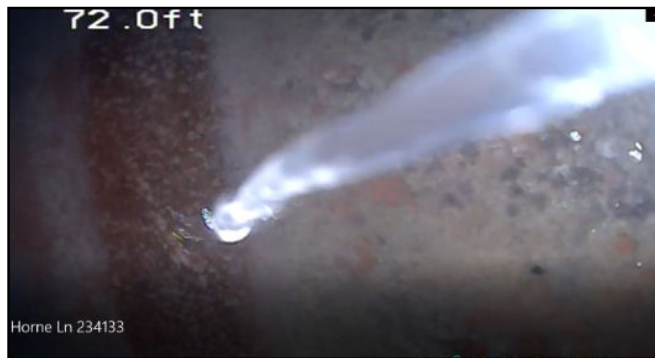
Believe to have reached main city sewer line at 72.0 feet
