INSPECTION REPORT

For the Property at:
1067 PALOS VERDES BOULEVARD
REDONDO BEACH, CA 90277

Prepared for: RUTH RODGERS
Inspection Date: Friday, April 3, 2020
Prepared by: Robert Gaudreault

Report No. 1101

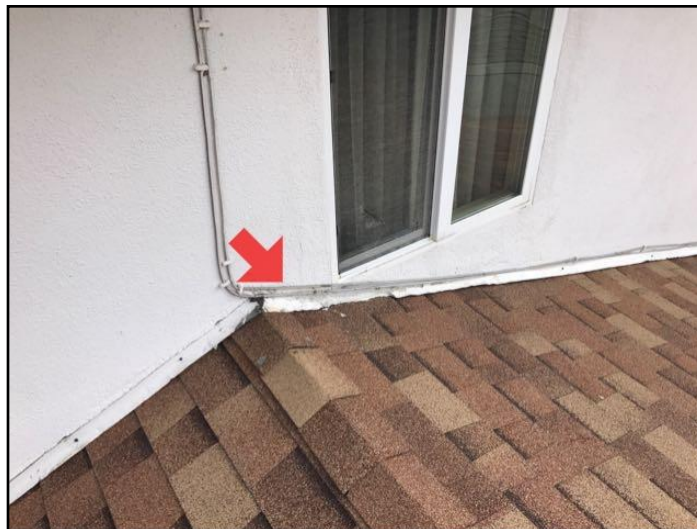
3. **Condition:** • [Damage, loose, open seams, patched](#)

Implication(s): Chance of water damage to contents, finishes and/or structure

Location: Lower front side

3. *Damage, loose, open seams, patched*

Task: Maintenance

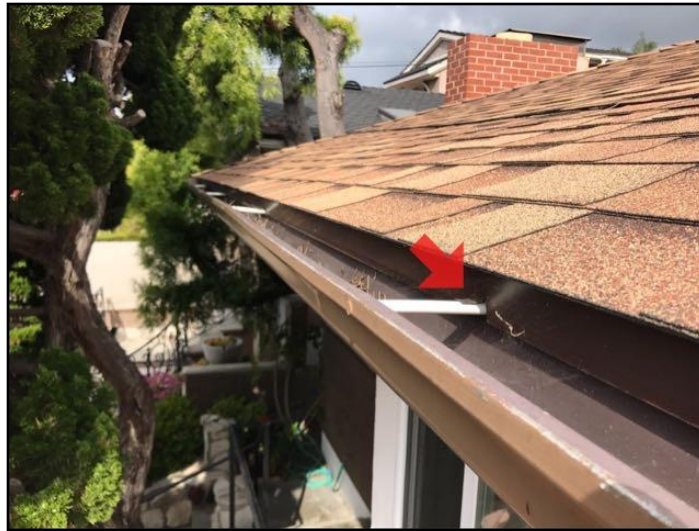
4.

5. **Condition:** • Drip edge flashing had been cut in sections to allow for the nailing of gutters to the wood fascia. This does compromise the original intention of the flashing, which is to shed water away from wood fascia trim to prevent possible water damage in the future.

Task: Further evaluation

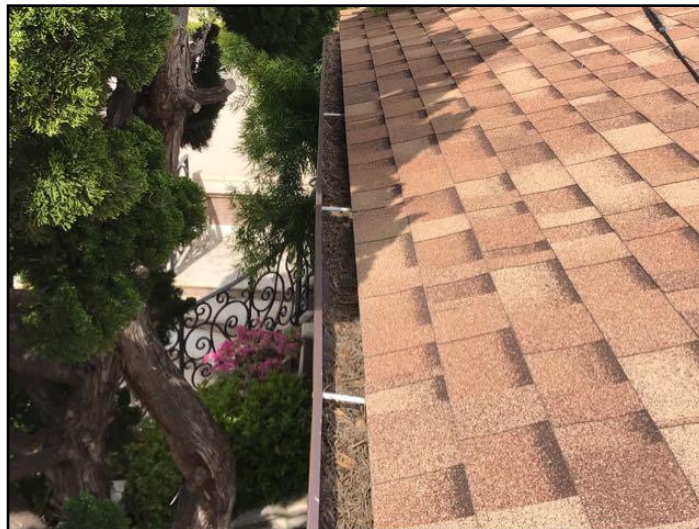
8. Condition: • Dirty/debris

5. Dirty/debris

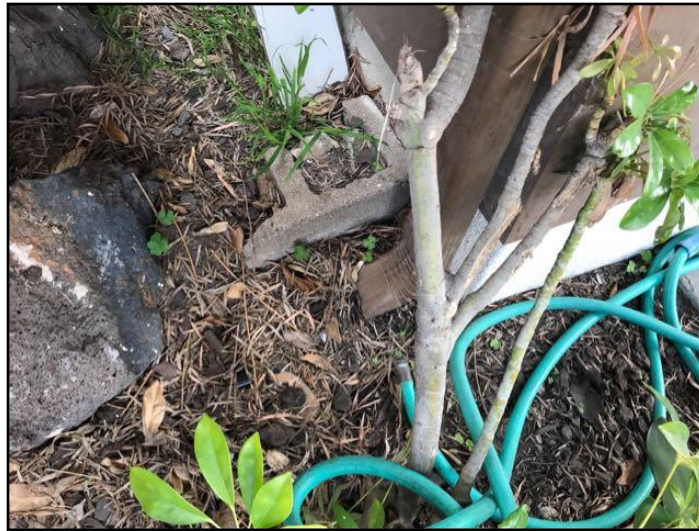
9. Condition: • [Discharge too close to building](#)

Implication(s): Chance of water damage to contents, finishes and/or structure

Location: Front left

6. Discharge too close to building

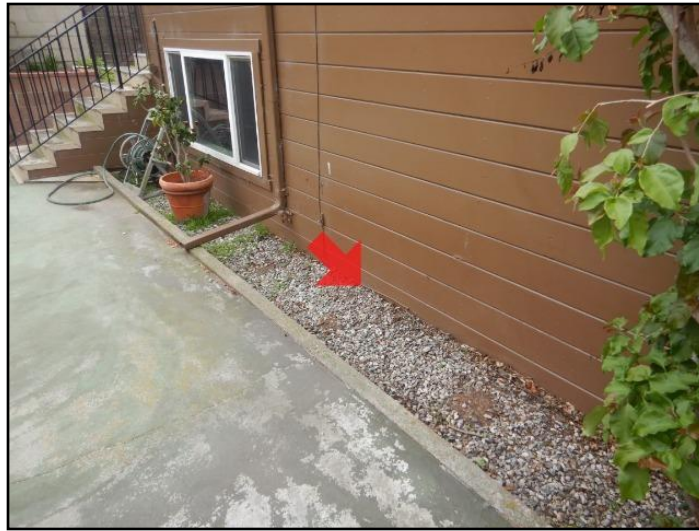
11. Condition: • [Too close to grade](#)

Implication(s): Chance of water damage to contents, finishes and/or structure | Material deterioration | Rot | Insect damage

Location: Along back side

7. Too close to grade

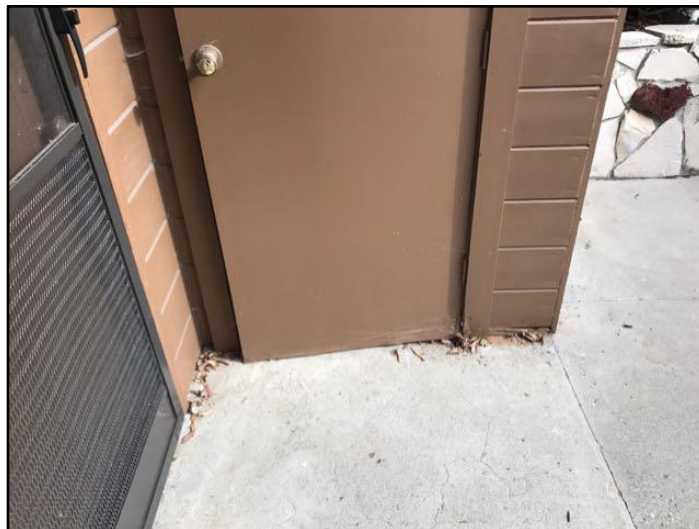
14. Condition: • [Damage](#)

Water related damage

Location: Back under stairs access door

8. Damage

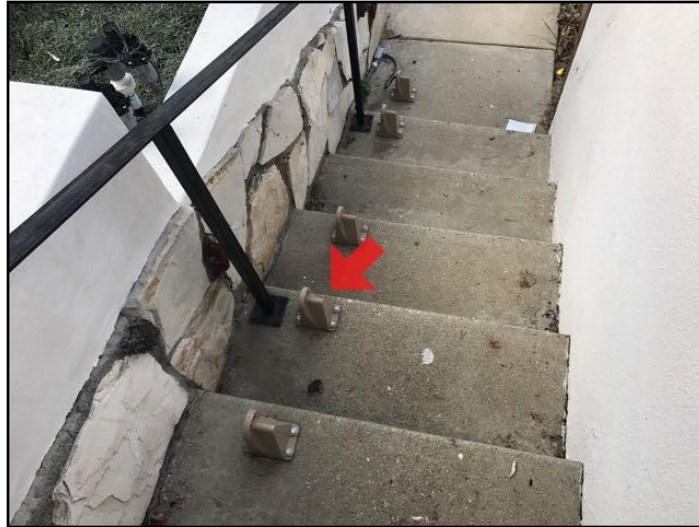
9.

15. Condition: • Remove items that can pose a potential trip hazard

Location: front

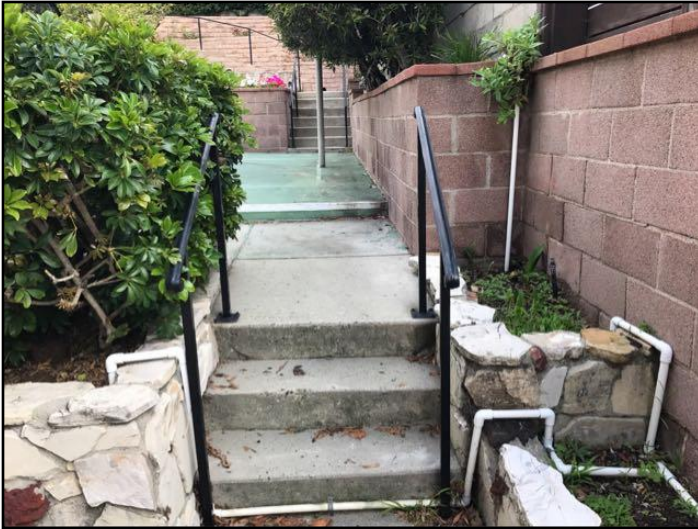
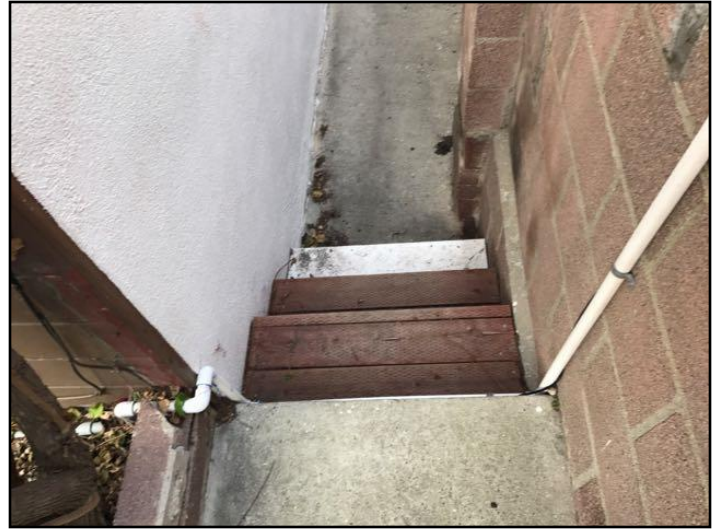
16. Condition: • [Stair run too small or not uniform](#)

Implication(s): Trip or fall hazard

Location: All back stairs

10. Stair run too small or not uniform

11. Stair run too small or not uniform

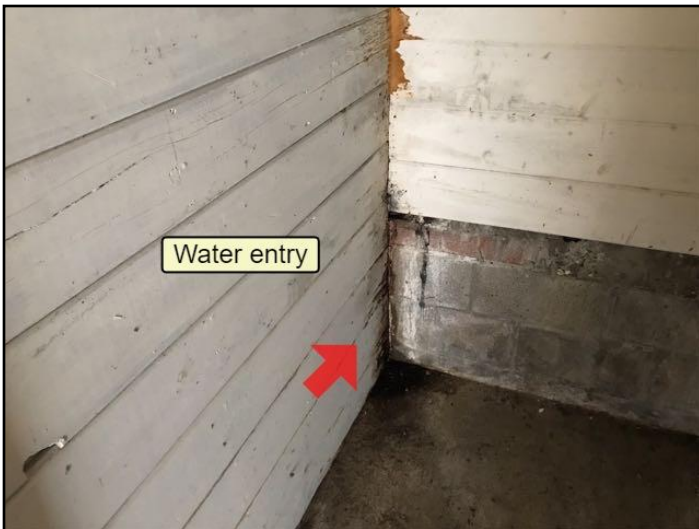
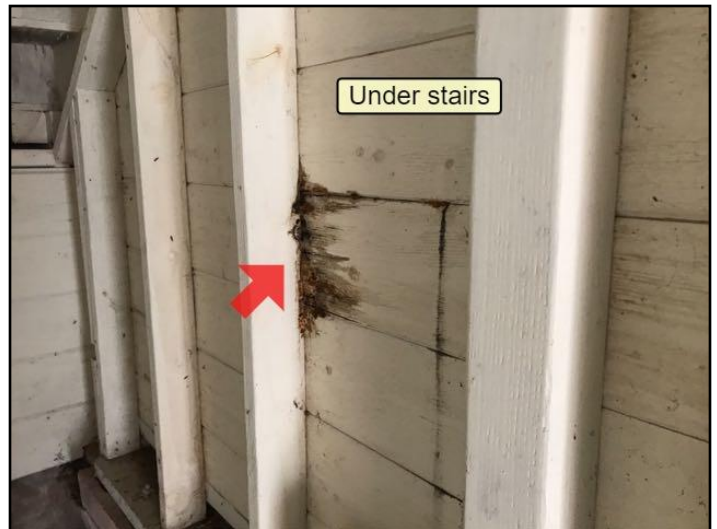
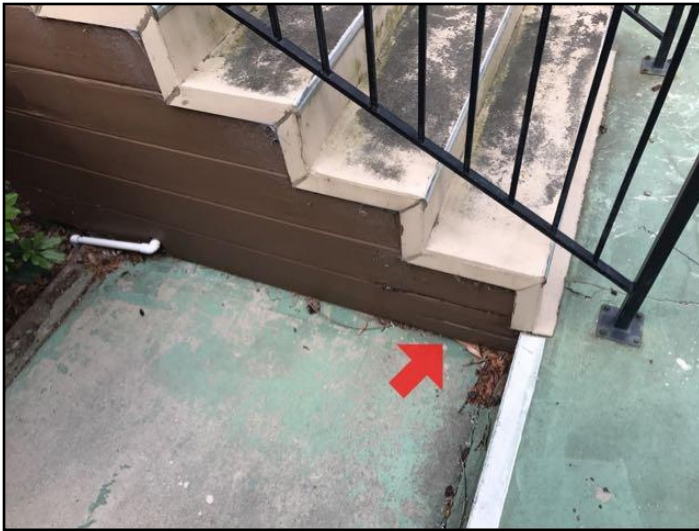
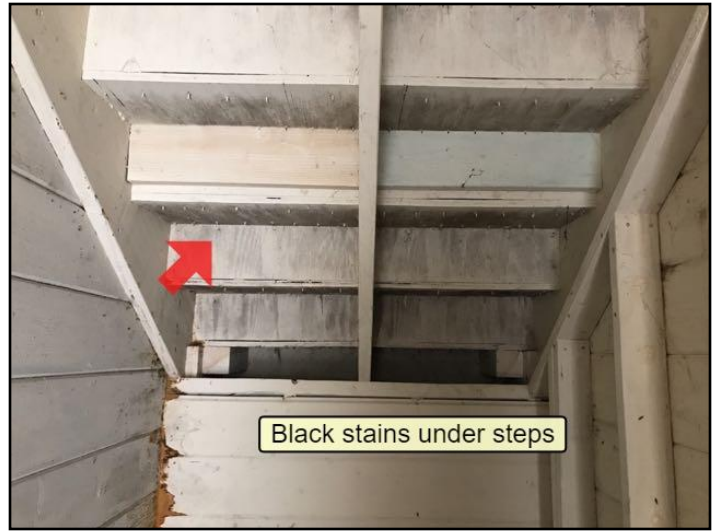
17. Condition: • [Rot](#)

Implication(s): Weakened structure | Material deterioration

Location: At back second story exit stairs.

12. Rot

13. Rot

14. Rot

15. Rot

Task: Further evaluation

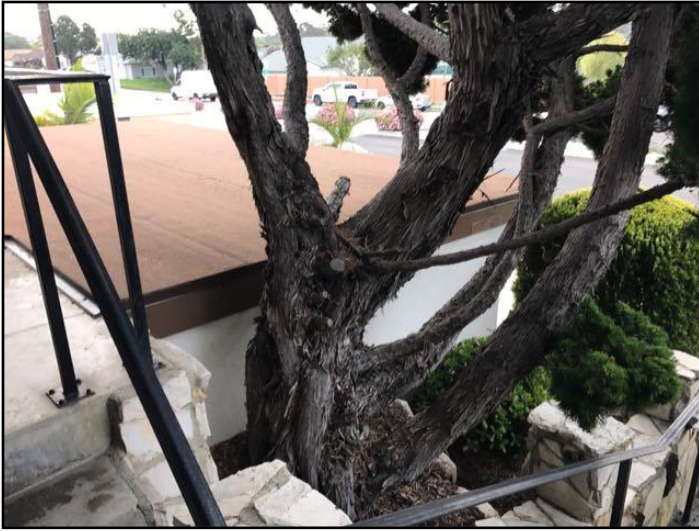
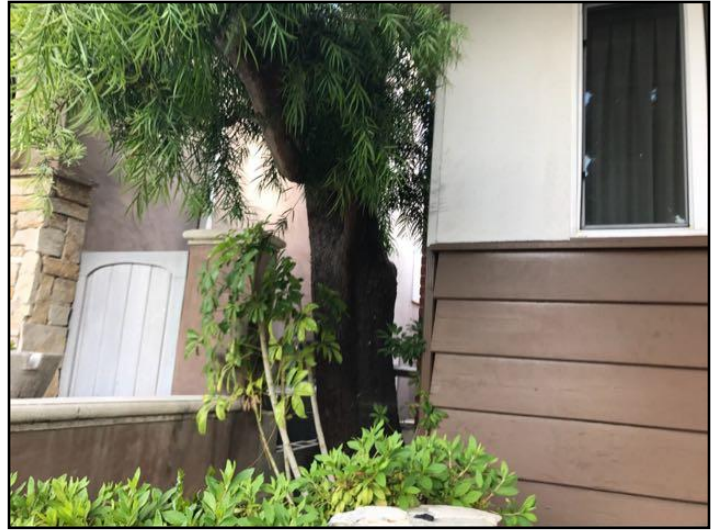
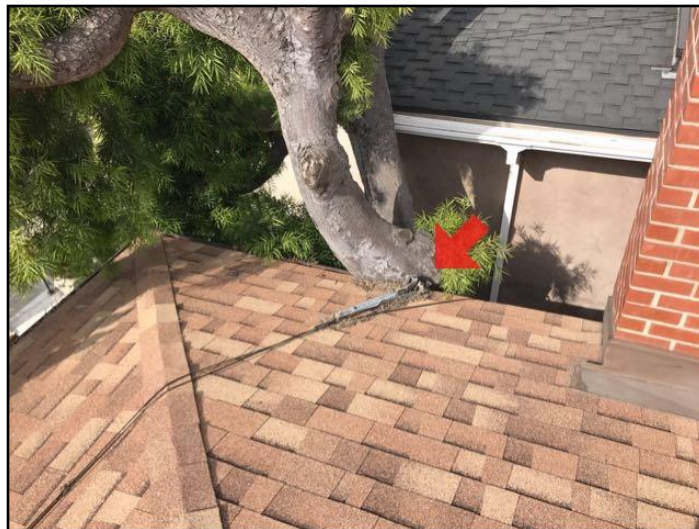
18. Condition: • [Planters and gardens against walls](#)

Implication(s): Chance of water entering building | Chance of damage to structure | Chance of structural movement

Location: To the left of garage

16. Trees or shrubs too close to building

17. Trees or shrubs too close to building

18. Trees or shrubs too close to building

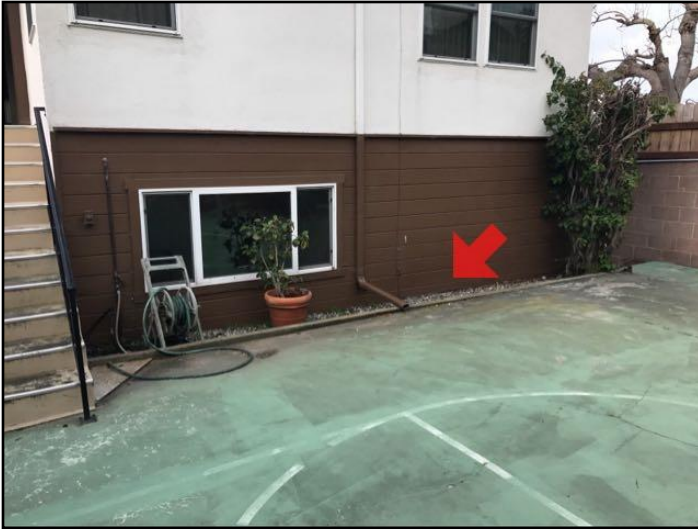
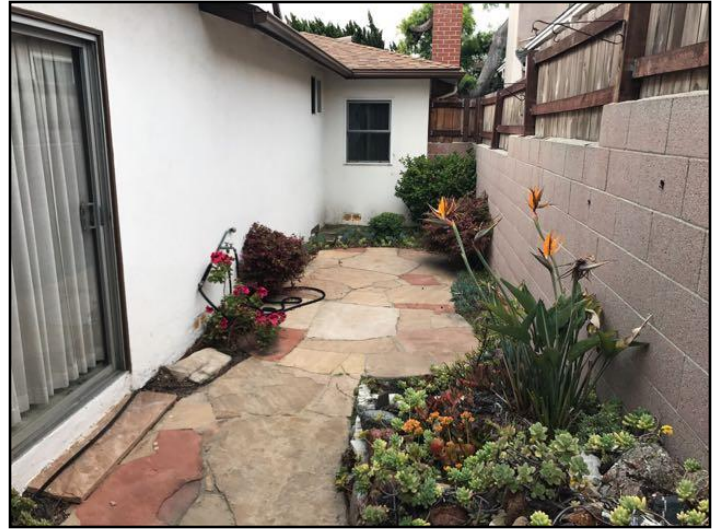
19. Condition: • [Improper slope or drainage](#)

Implication(s): Chance of water damage to contents, finishes and/or structure

19. Improper slope or drainage

20. Improper slope or drainage

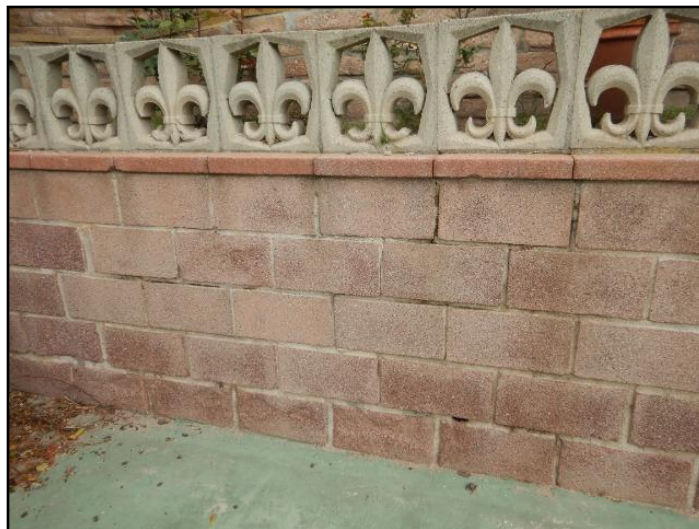
22. Condition: • [Mortar - deteriorated, missing](#)

Implication(s): Weakened structure | Chance of movement

Location: Various

21. Mortar - deteriorated, missing

Task: Repair Further evaluation

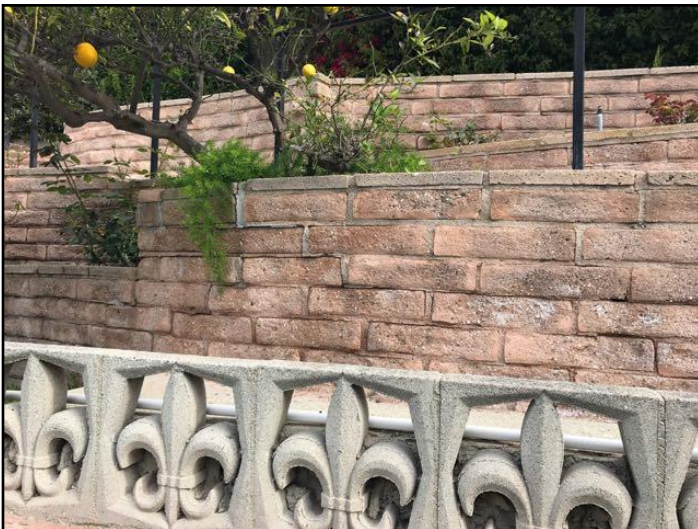
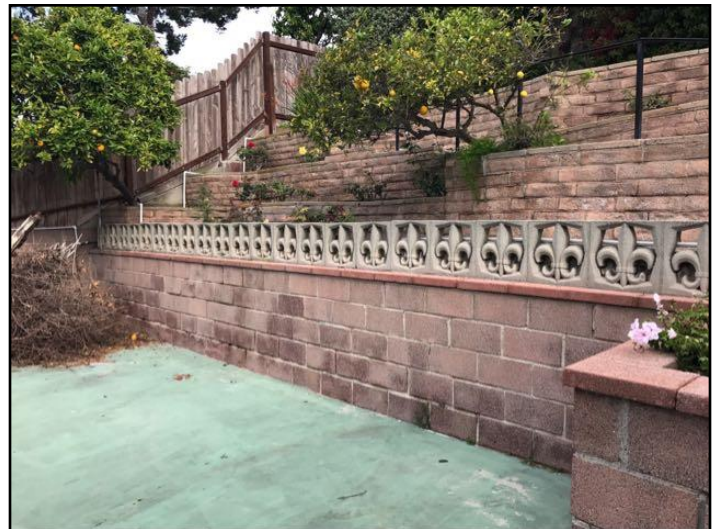
23. Condition: • [Drainage system missing](#)

Some fractures also noted

Implication(s): Weakened structure | Chance of movement

Location: Various areas

22. Drainage system missing

23. Drainage system missing

Task: Further evaluation be licensed mason

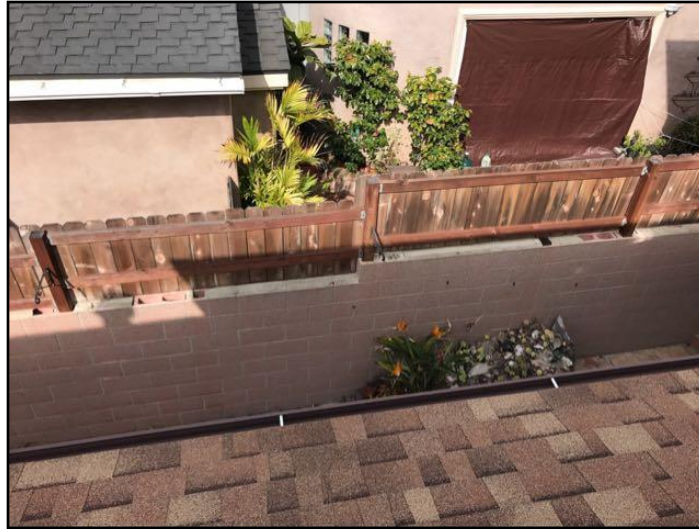
24. Condition: • Portions of cement cap missing

Location: General locations

Task: Maintenance. Install cap

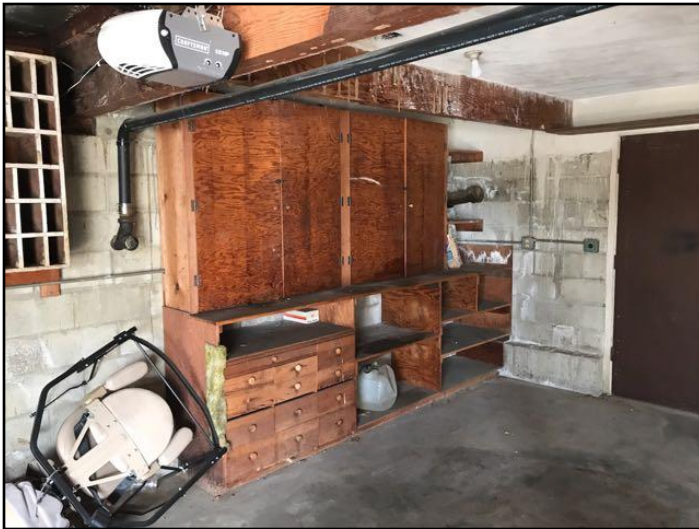
25. Condition: • Evidence of water and soil entry

Location: Throughout

Task: Correct adjacent grade

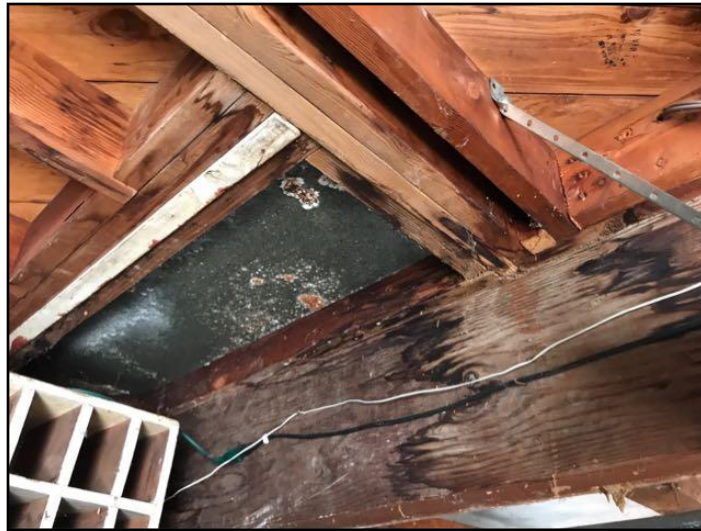
27. Condition: • Water stains at ceiling under kitchen from prior leak

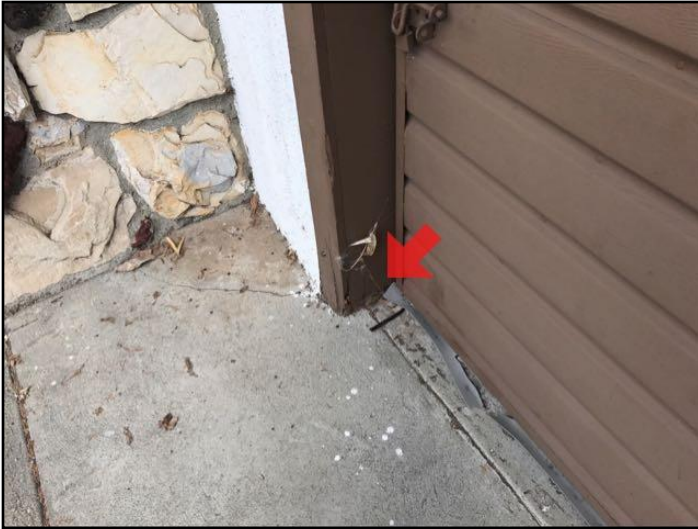
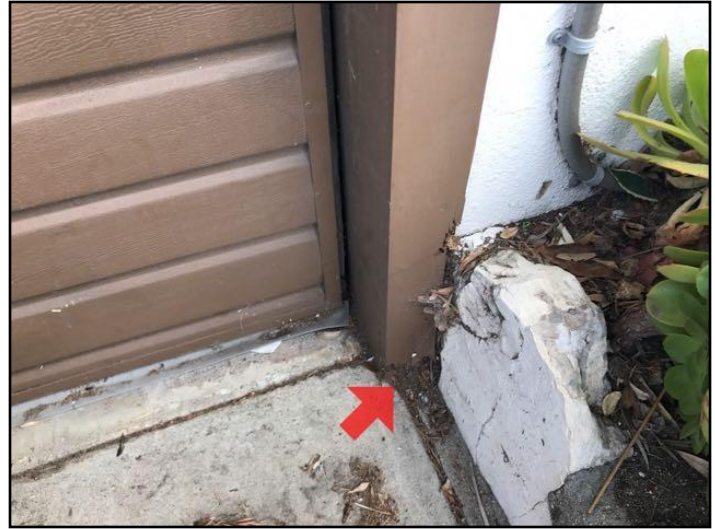
29. Condition: • Water damage

29. Water damage

30. Water damage

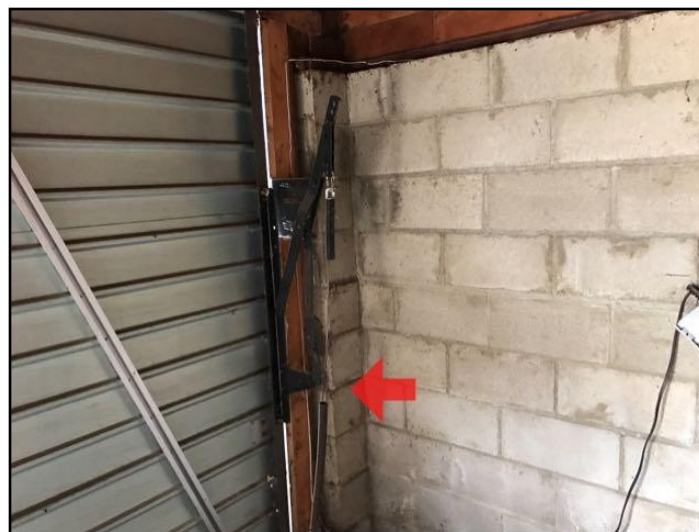
30. Condition: • Overhead door springs or hardware needs some repair or replacement parts. Garage door comes down too freely. This could be of safety concern and should be addressed at this time.

Left door spring damaged

31. Overhead door springs or hardware needs som...

Task: Replace

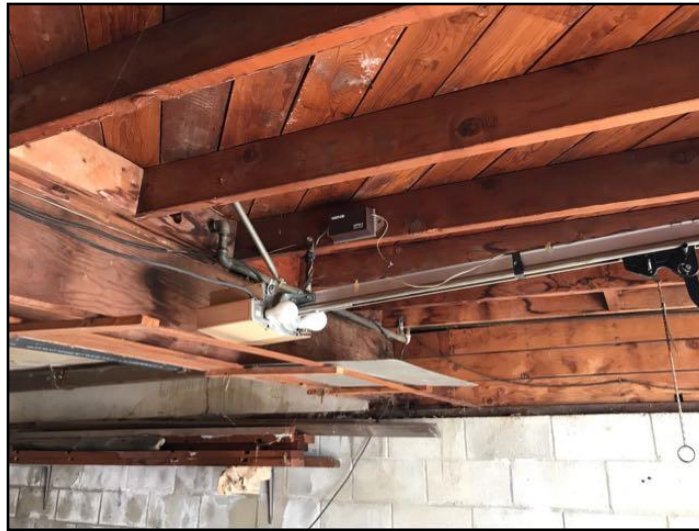
31. Condition: • [Inoperative](#)

Implication(s): System inoperative

32. Inoperative

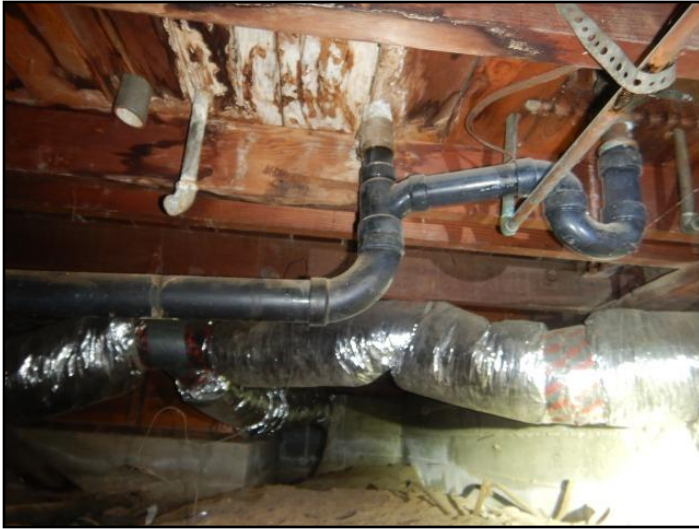
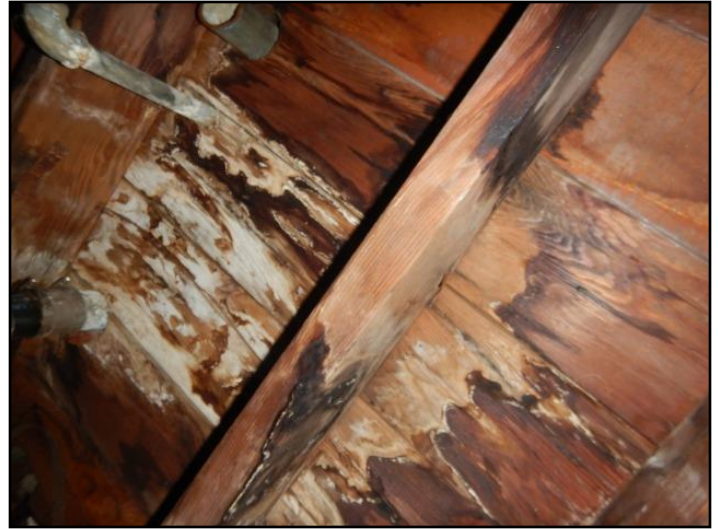
36. Condition: • Water stains

Implication(s): Material deterioration

33. Water stains

34. Water stains

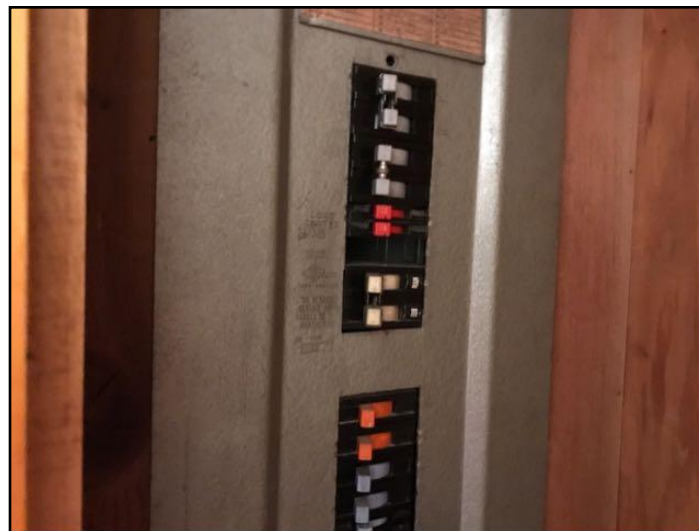
43. Condition: • [Unprotected openings](#)

Implication(s): Electric shock

Location: Sub panel

38. Unprotected openings

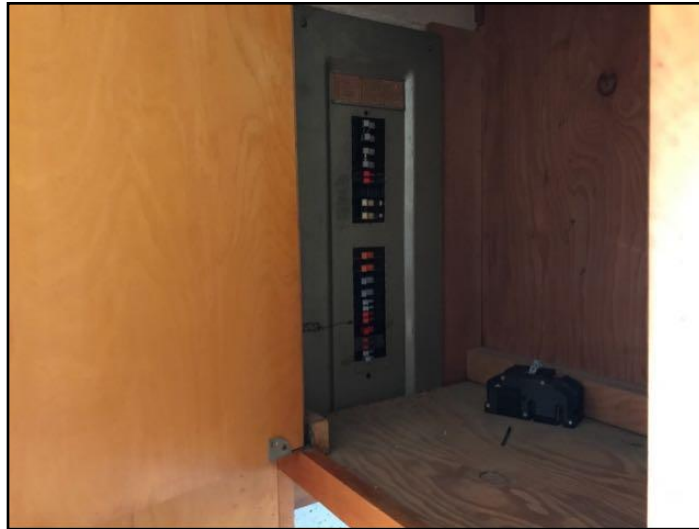
39.

46. Condition: • NOTE: Many electricians and home inspectors have discovered that certain "Zinsco" panels often can fail to operate properly and prone to some adverse conditions. These panels can work fine for years, but as homes have increased energy demands, these panels may overheat and portions of it melt.

Location: Cabinet off of kitchen

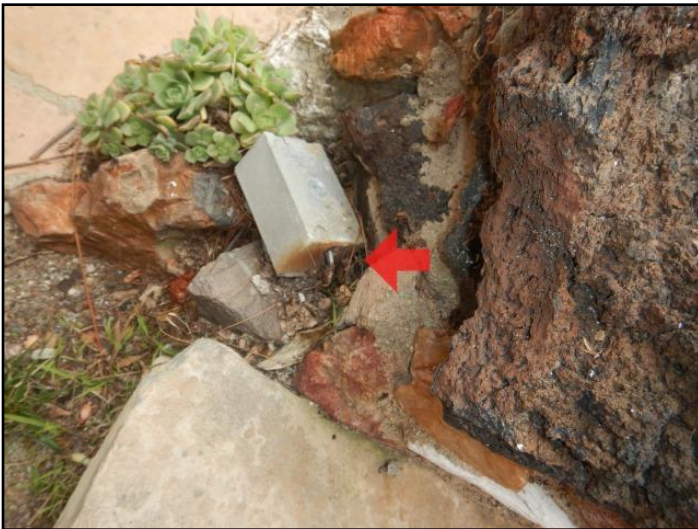
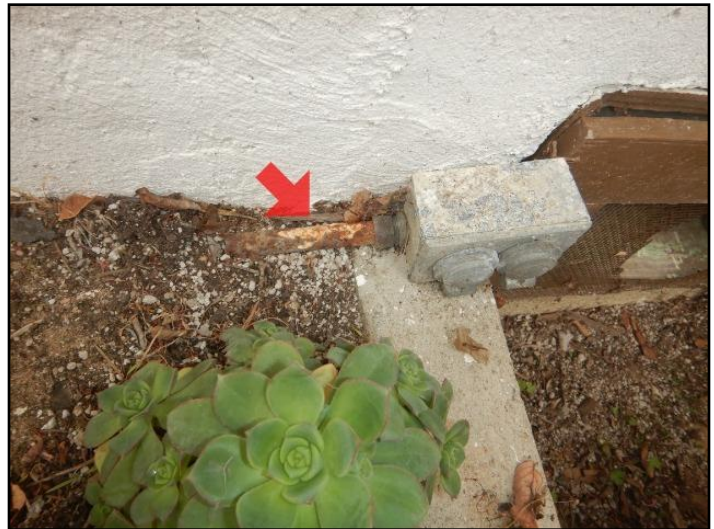
47. Condition: • Unsafe conditions. Damaged boxes and exposed electrical wires.

Implication(s): Shock hazard.

Location: Exterior left side

Task: Remove or replace

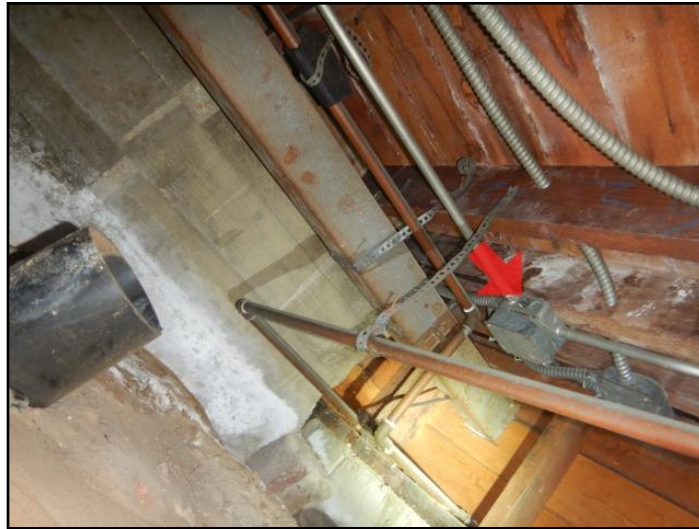
42.

48. Condition: • Not sealed. Knock out cover missing.

Location: Crawl space

Task: Repair.

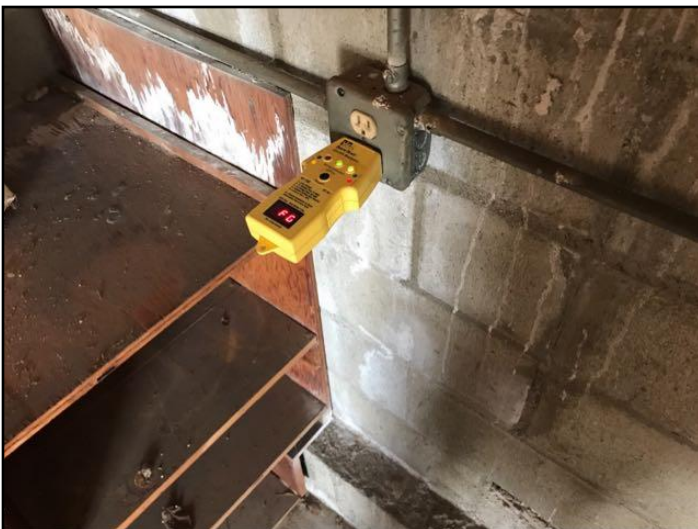
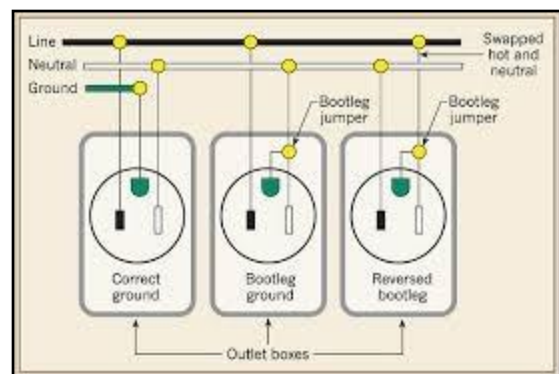
49. Condition: • False or bootlegged ground

Implication(s): Shock hazard potential

Location: Garage

Task: Further evaluation by licensed electrician

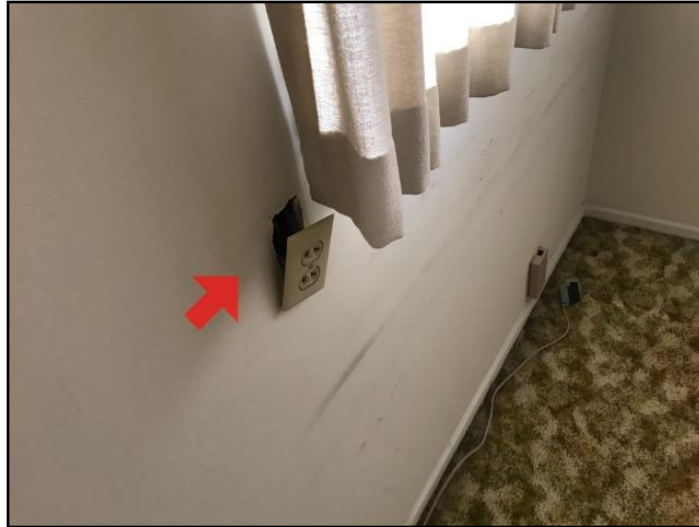
50. Condition: • [Damage](#)

Loose or displaced receptacle

Implication(s): Electric shock | Fire hazard

Location: Upper floor

45. Damage

Task: Repair

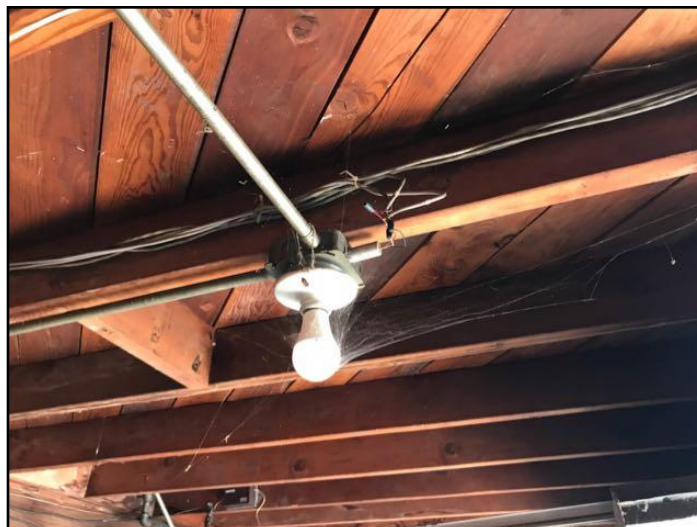
46.

55. Condition: • Low voltage operating wires exposed

Location: Garage

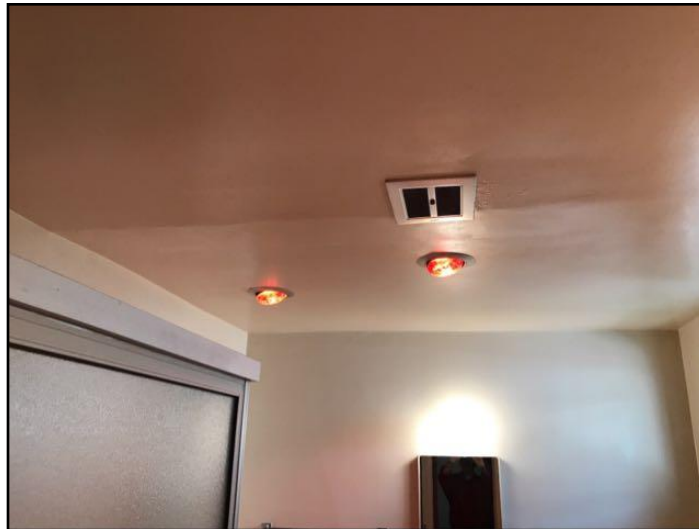
47.

56. Condition: • Displaced or askew. Missing fixtures at some locations
