# HEATING

1067 Palos Verdes Boulevard, Redondo Beach, CA April 3, 2020

Report No. 1101

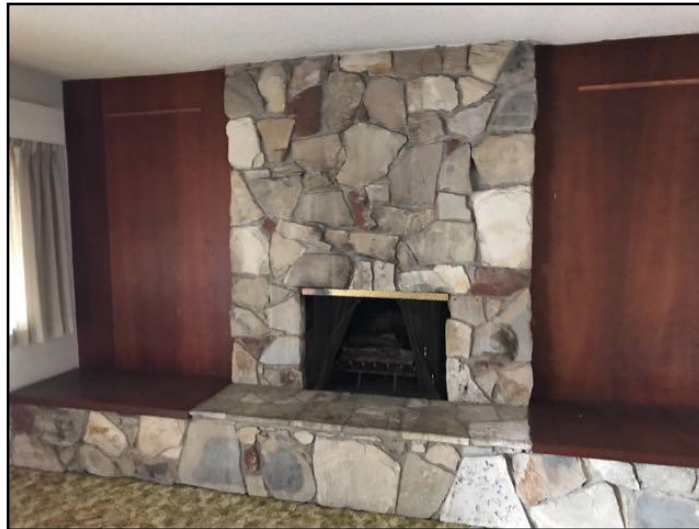
51. Wood-burning fireplace

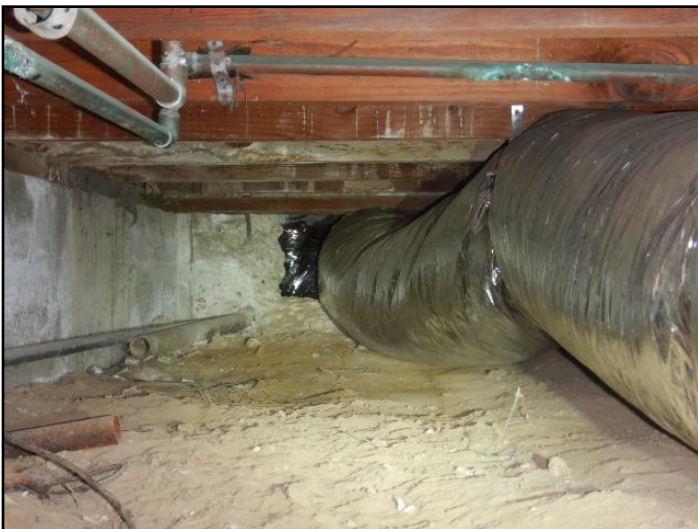
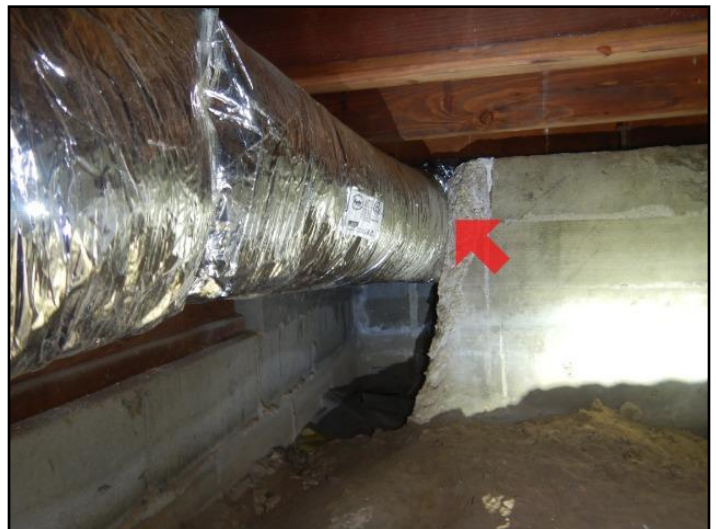
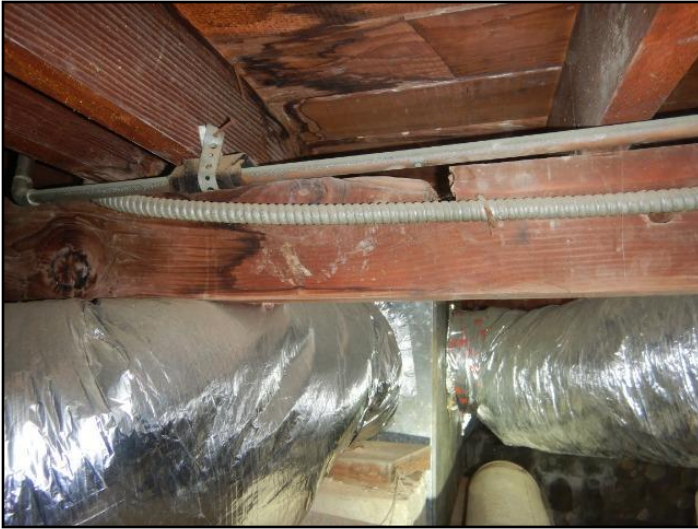
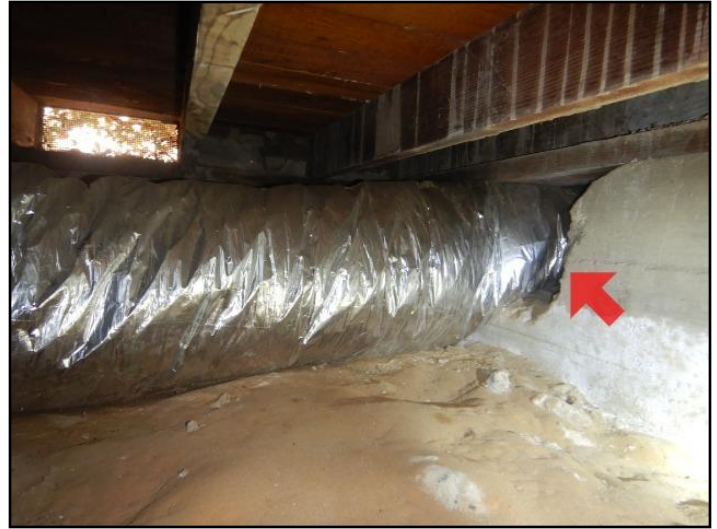
## 60. Condition: • [Collapsed](#)

Sections of visible duct are kinked or pinched. Only a small percentage of the duct work is visible. Due to the age of this structure there is always a possibility that duct work within the walls is insulated with asbestos fiber insulation.

53. Collapsed

54. Collapsed

55. Collapsed

56. Collapsed

**Task:** Repair

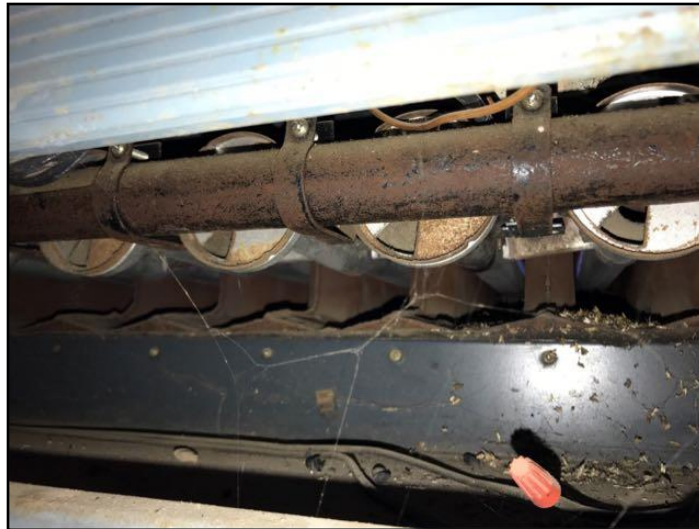
61. Condition: • [Rust](#)

Implication(s): Shortened life expectancy of material | Material deterioration

57. Rust

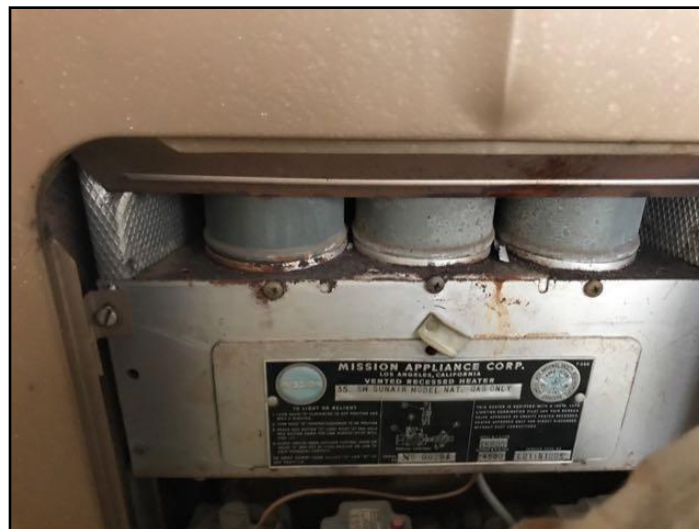
62. Condition: • [Draft hood spillage or backdraft](#)

Implication(s): Equipment not operating properly | Hazardous combustion products entering home

58. Draft hood spillage or backdraft

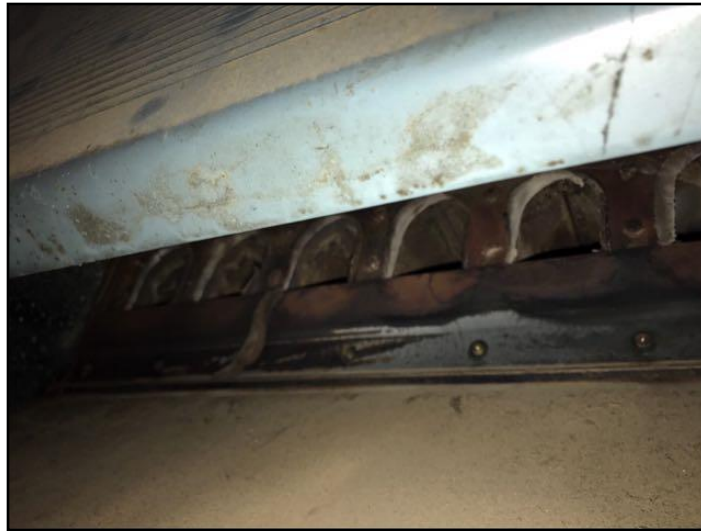
63. Condition: • [Draft hood spillage or backdraft](#)

Implication(s): Equipment not operating properly | Hazardous combustion products entering home

Location: Garage furnace

59. Draft hood spillage or backdraft

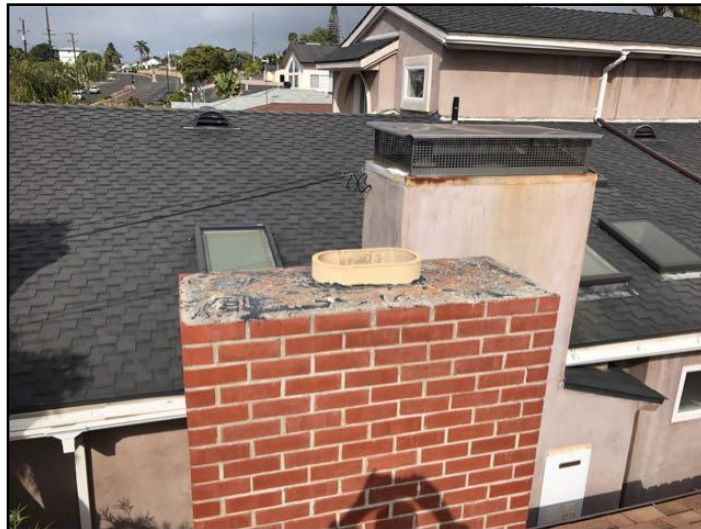
64. Condition: • [Screen missing or damaged](#)

Implication(s): Chance of pests entering building | Fire hazard

60. Screen missing or damaged

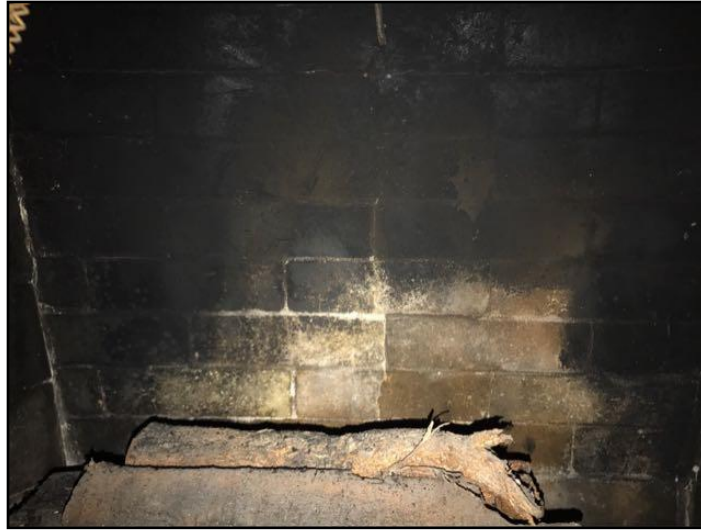
65. Condition: • [Cracked masonry or refractory](#)

Implication(s): Hazardous combustion products entering home | Fire hazard

61. Cracked masonry or refractory

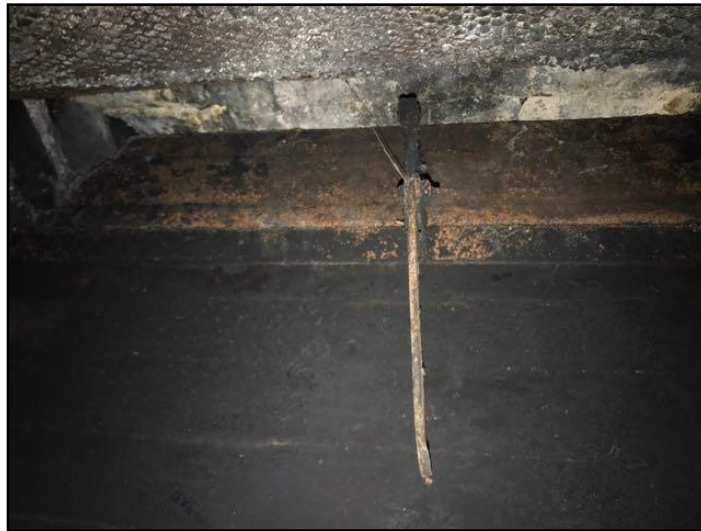
66. Condition: • [Damper or frame rusted](#)

Implication(s): Hazardous combustion products entering home | Increased heating costs | Reduced comfort

62. Damper or frame rusted

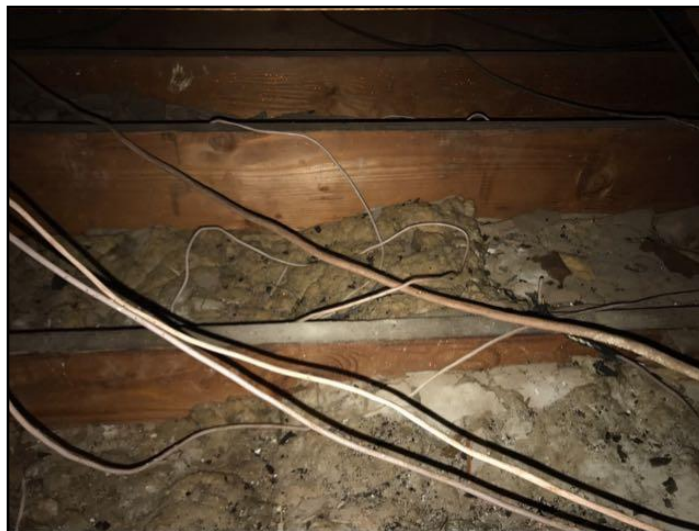
63.

67. **Condition:** • Aged worn and deteriorated

**Location:** Throughout attic

**Task:** Replace

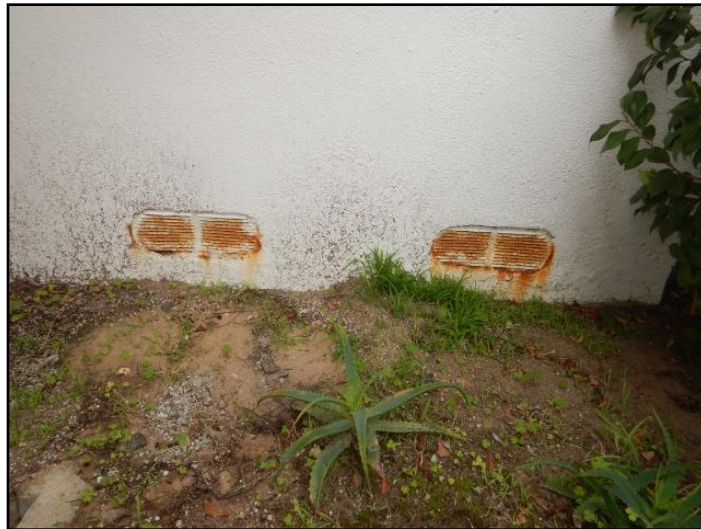
65.

**69. Condition:** • Rusty from prior moisture.

**Location:** Left side

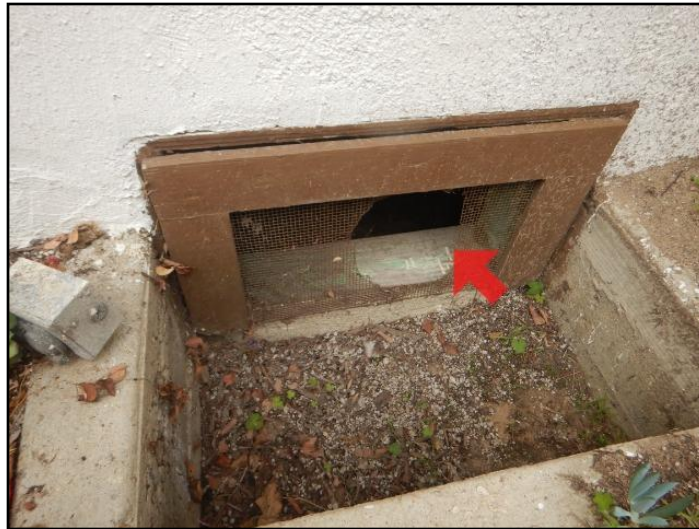
**70. Condition:** • Damaged

Potential for animal entry as result.

66. *Damaged*

**Task:** Repair

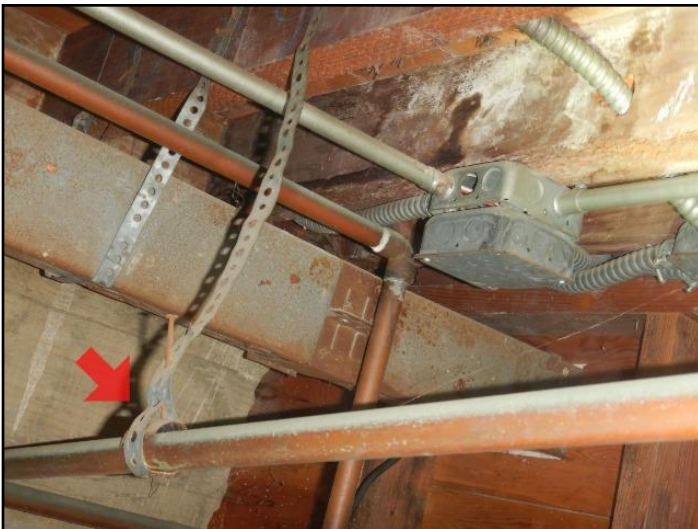
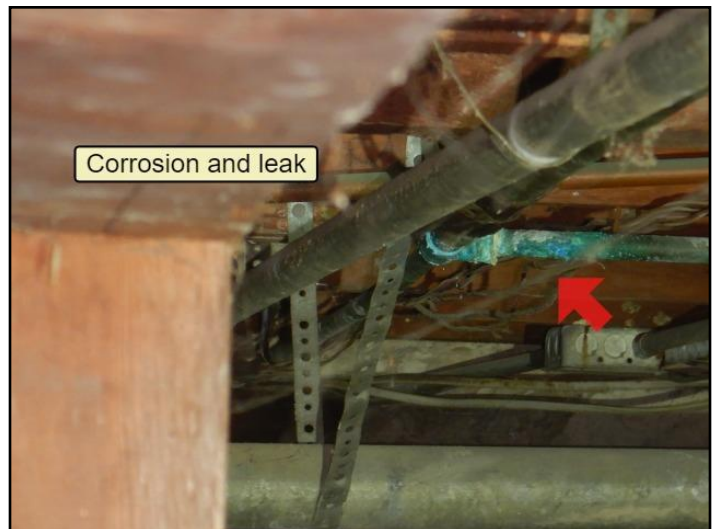
#### **71. Condition:** • Corrosion

Galvanized straps or plumbing tape is used to support copper pipe. Suggest that a buffer be placed between the two metals or that straps be changed to plastic or copper. Using galvanized straps is not to industry standards as it promotes corrosion.

**Implication(s):** Chance of water damage to contents, finishes and/or structure | Leakage | Reduced system life expectancy | Equipment failure

76. Corrosion

77. Corrosion

**Task:** Repair

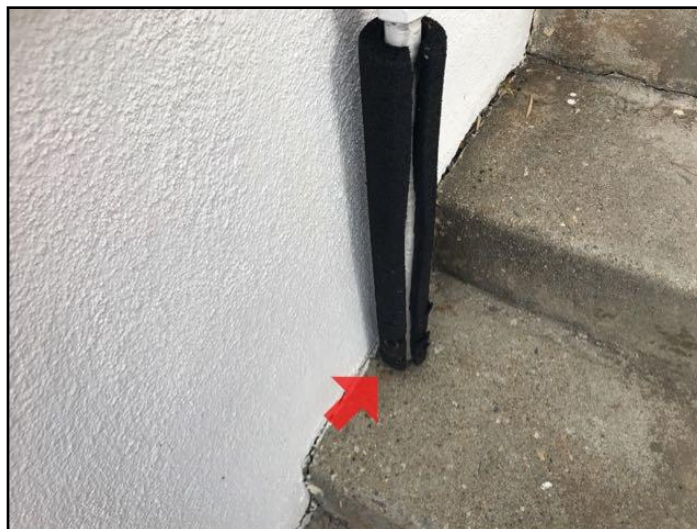
78.

**73. Condition:** • A section of gas line noted that passes through concrete without an appropriate sleeve. Gas lines should not be embedded into concrete as this could pose damage and future leaks. Contact a licensed plumber for further evaluation

**Implication(s):** Potential for gas leak

**Task:** Further evaluation needed by licensed plumber

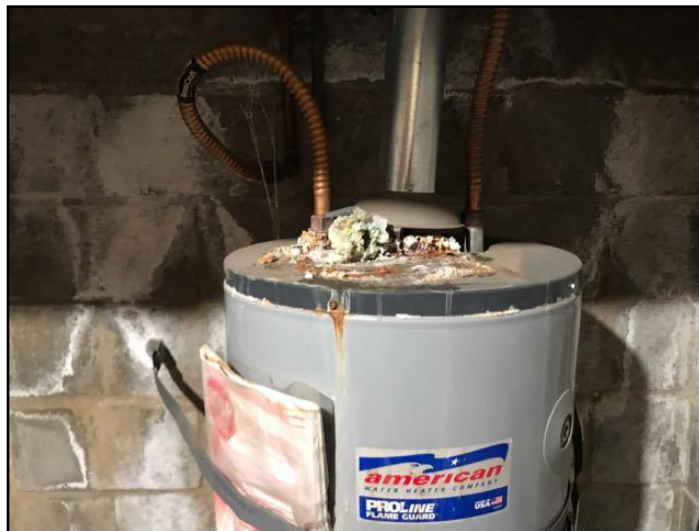
**76. Condition:** • [Rust](#)

**Implication(s):** System inoperative | No hot water

79. Rust

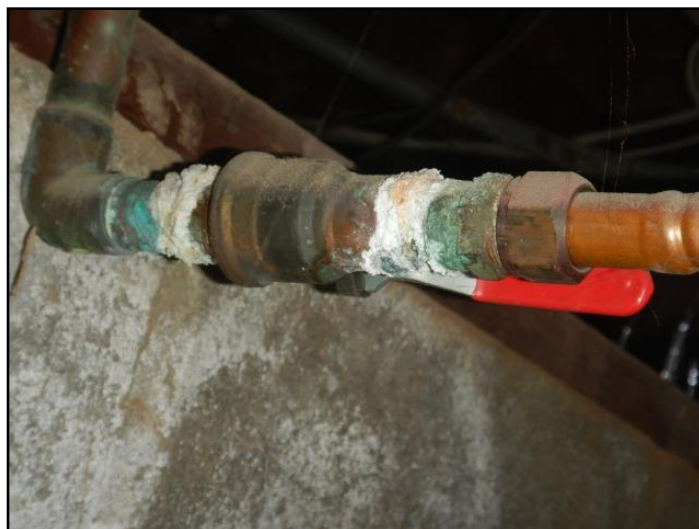
80.

**78. Condition:** • Corrosion seen.

**Implication(s):** Leak Potential

**Task:** Replace

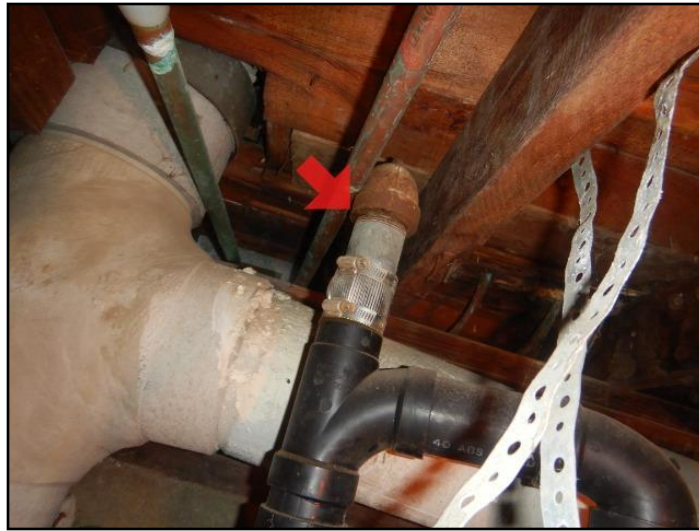
**82. Condition:** • Predominant waste line material is cast iron. Also some galvanized piping installed. Client should be aware that the normal life span of cast iron or galvanized waste pipe is generally 55 to 65 years. This older pipe tends to corrode from the inside restricting waste flow and back ups become more and more frequent. Upgrades should be anticipated.

81. Predominant waste line material is cast...

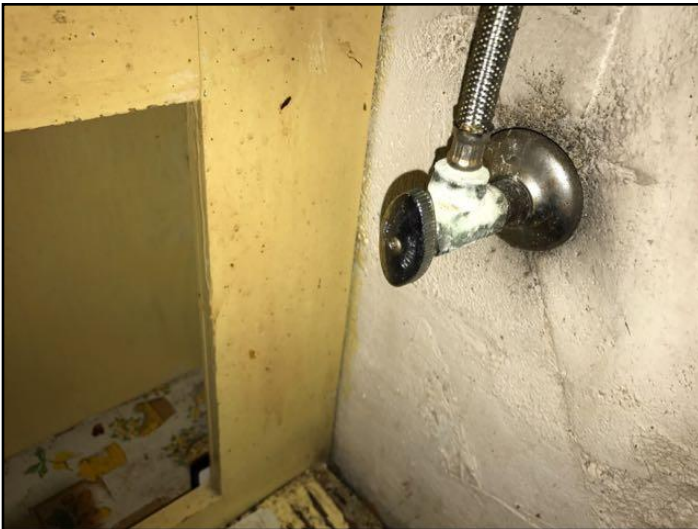
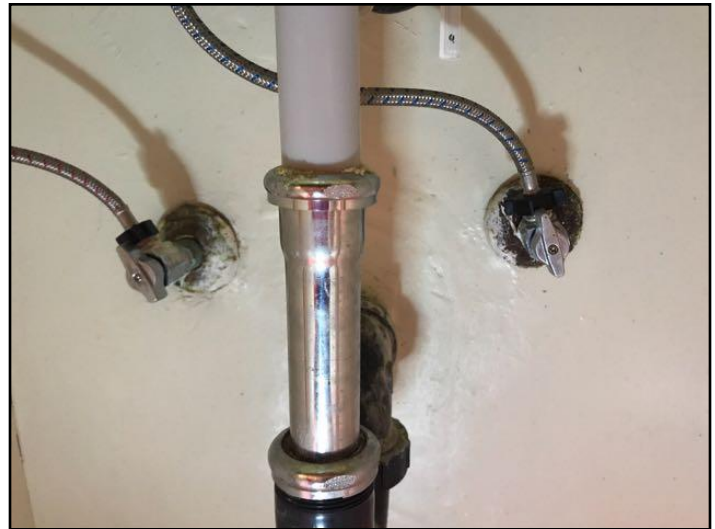
86. Condition: • Angle stops show corrosion

Location: all sink fixtures

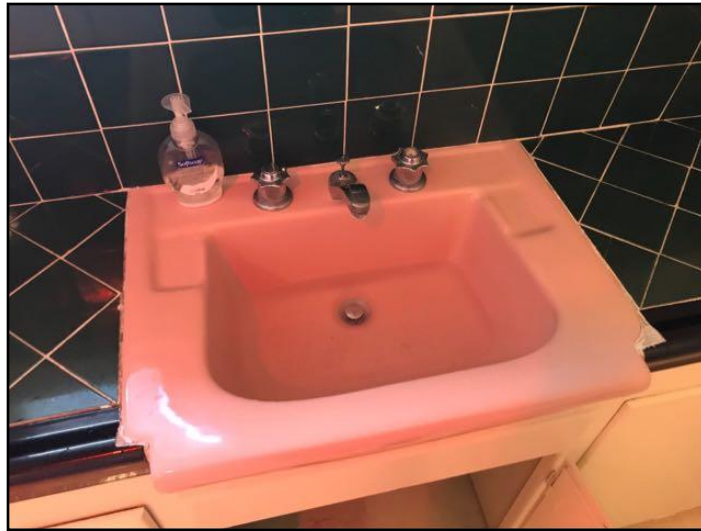
87. Condition: • [Slow drains](#)

Implication(s): Chance of water damage to contents, finishes and/or structure

84. Slow drains

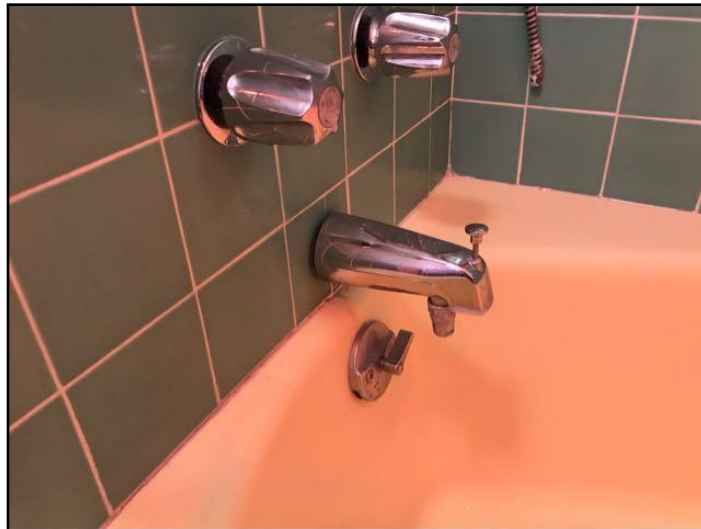
85.

88. Condition: • Spout not sealed

Location: Lower hall bath

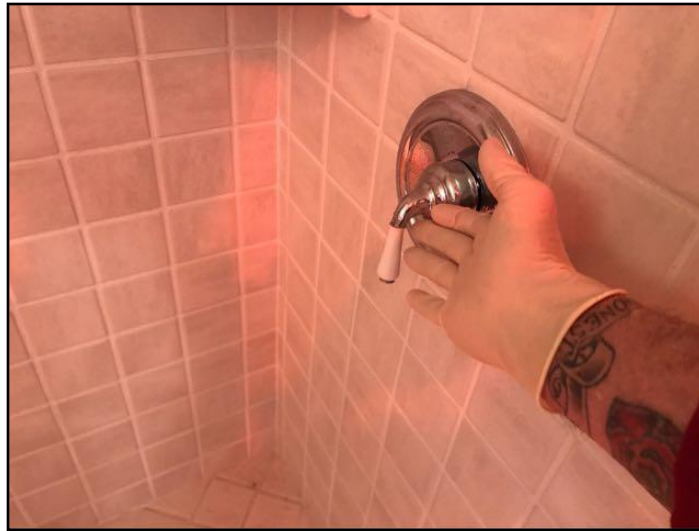
86.

89. Condition: • Loose fixture

Location: Lower hall bath

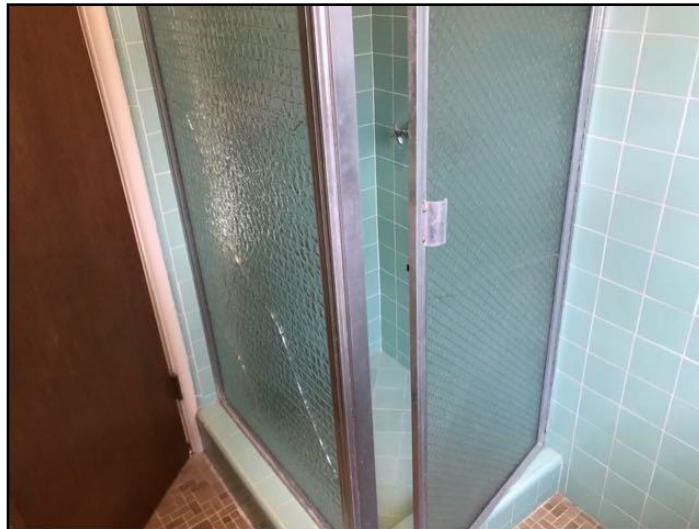
87.

**90. Condition:** • Older nine tempered enclosure cracked

**Location:** Master bath

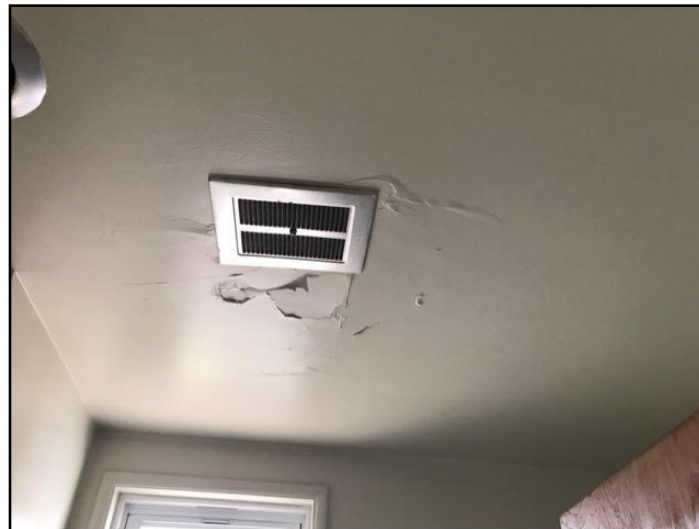
**94. Condition:** • [Water damage](#)

**Implication(s):** Chance of movement | Rot | Leakage

88. Water damage

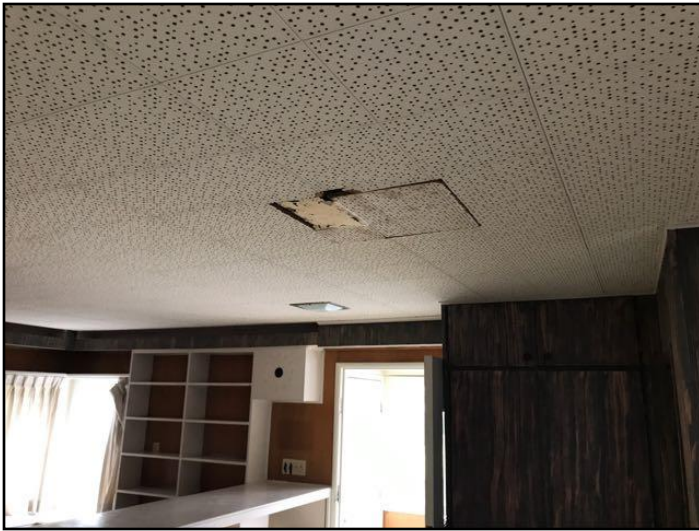
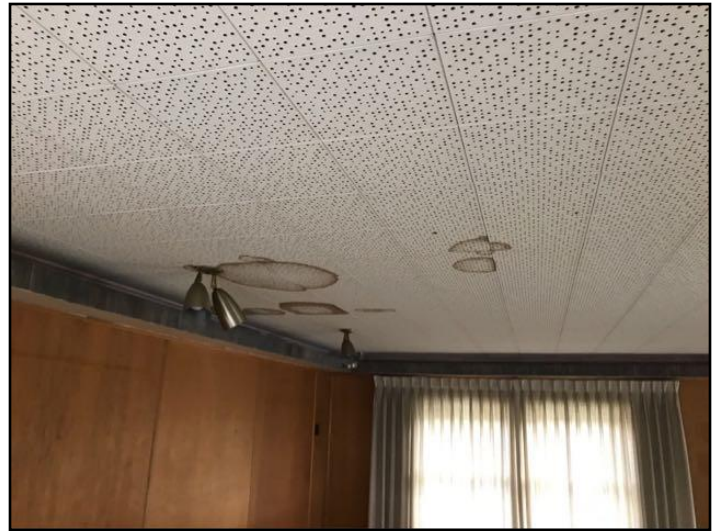
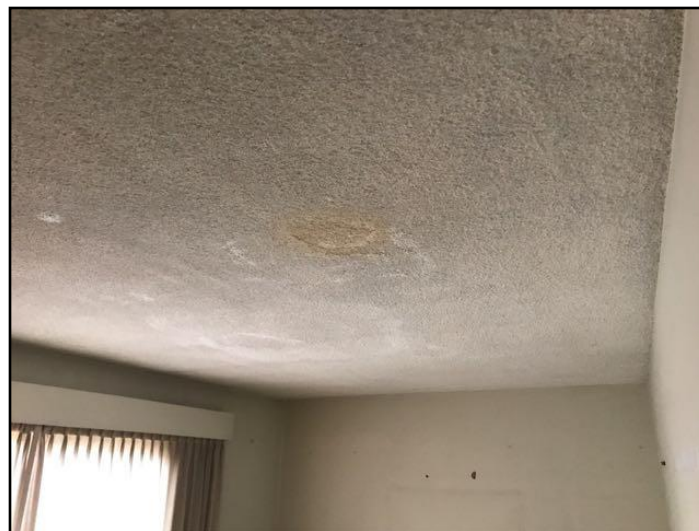
95. Condition: • Water stains

Implication(s): Chance of water damage to contents, finishes and/or structure

89. Water stains

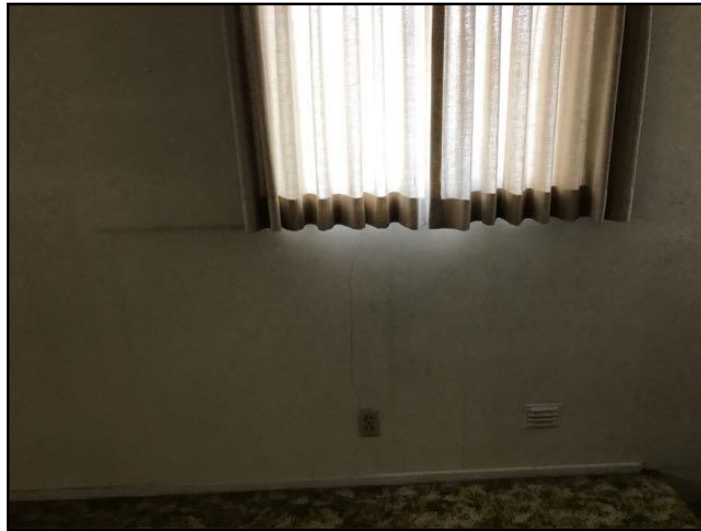
**96. Condition:** • Cracks

**Implication(s):** Chance of structural movement | Damage or physical injury due to falling materials

92. Cracks

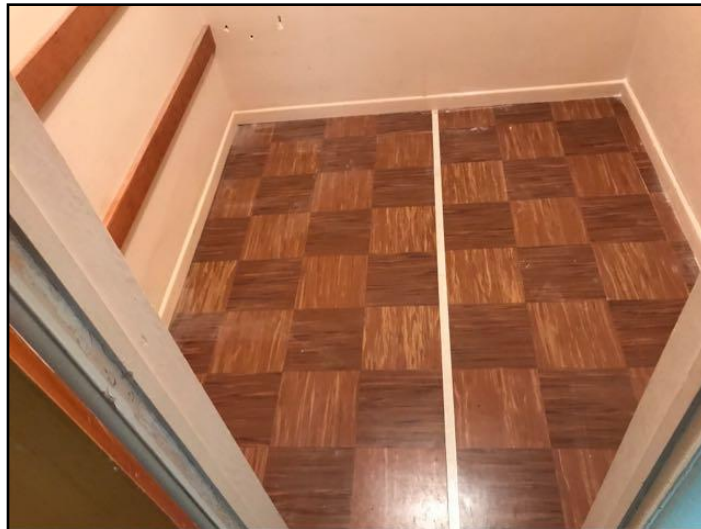
93.

**97. Condition:** • Possible asbestos tile

**Location:** Throughout. possibly under carpets

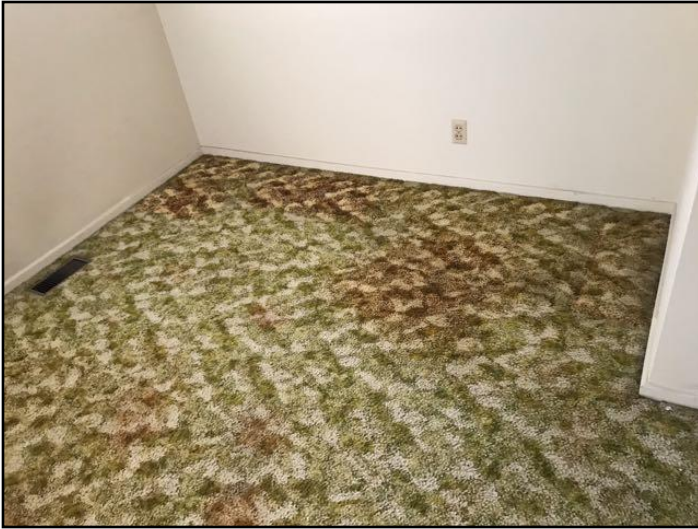
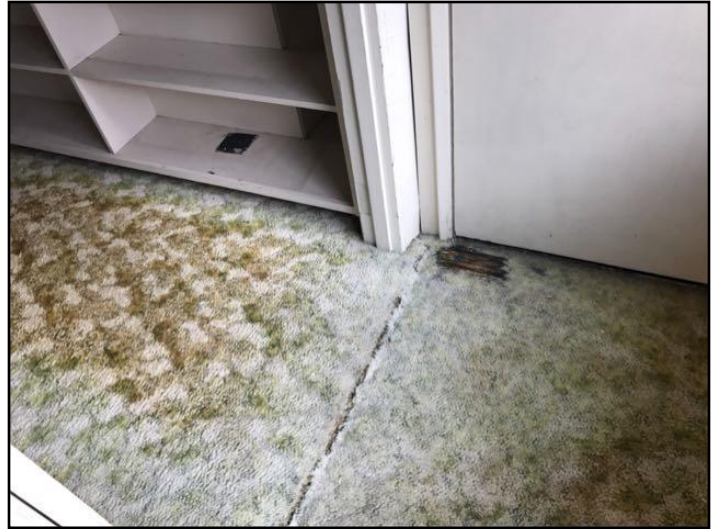
**98. Condition:** • Carpet is generally worn and stained. Anticipate upgrades

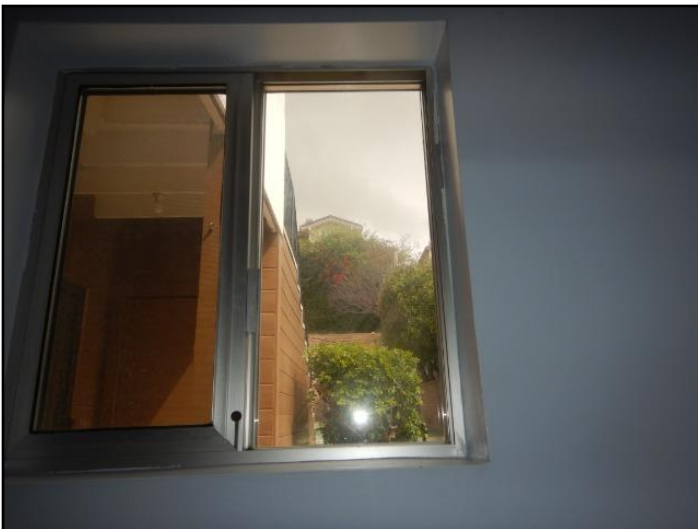
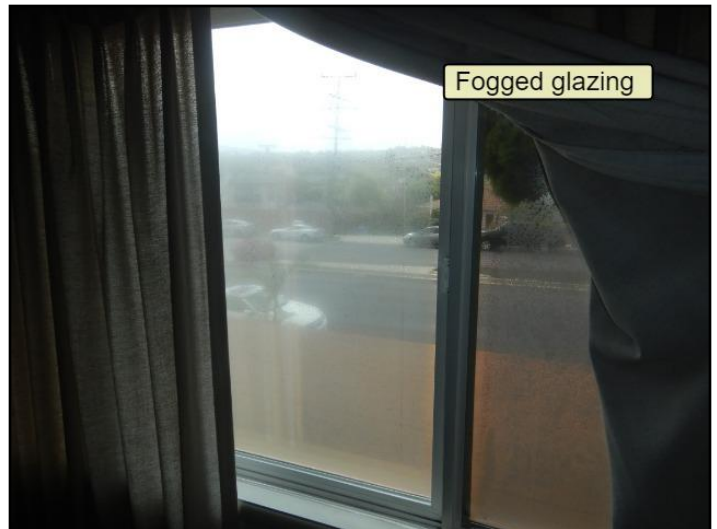
99. Condition: • [Lost seal on double or triple glazing](#)

Location: At least two windows. Such as front facing living room window and at back bath window

96. Lost seal on double or triple glazing

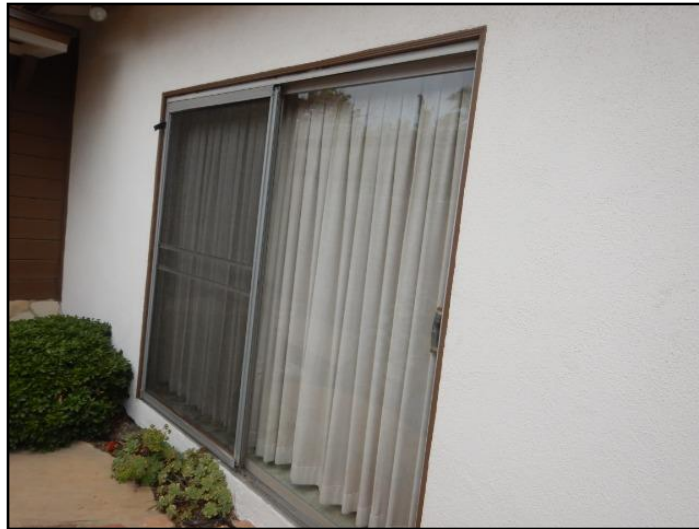
100. Condition: • Safety glass not installed

Implication(s): Physical injury

98. Safety glass not installed

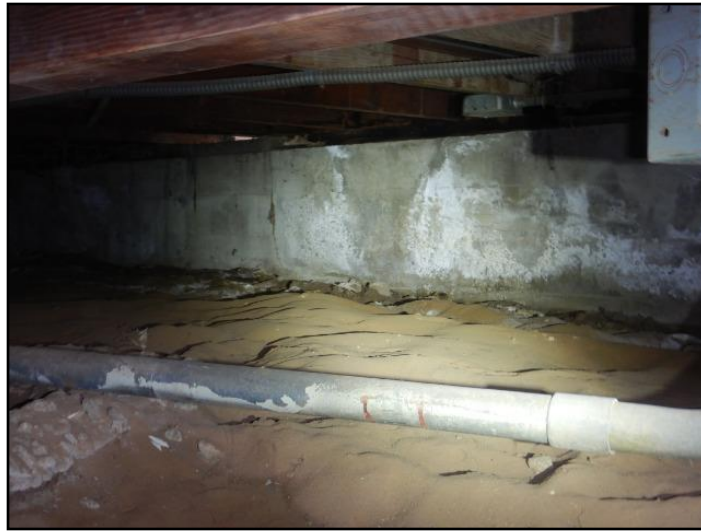
106. Condition: • [Dampness on floor or walls](#)

Evidence of water entry from right side.

99. Dampness on floor or walls

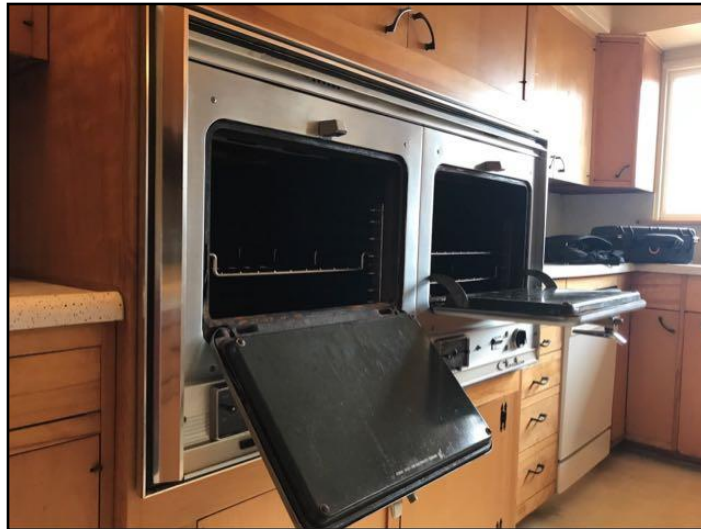
107. Condition: • Old

Implication(s): Reduced system life expectancy

100. Old

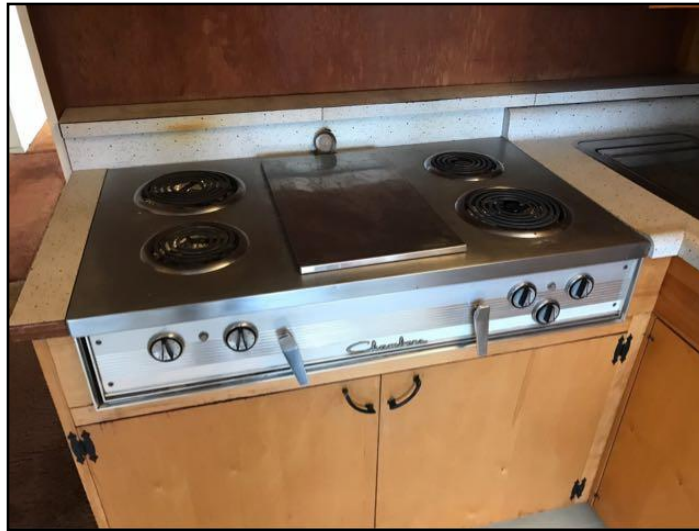
108. Condition: • Old

Implication(s): Reduced system life expectancy

101. Old

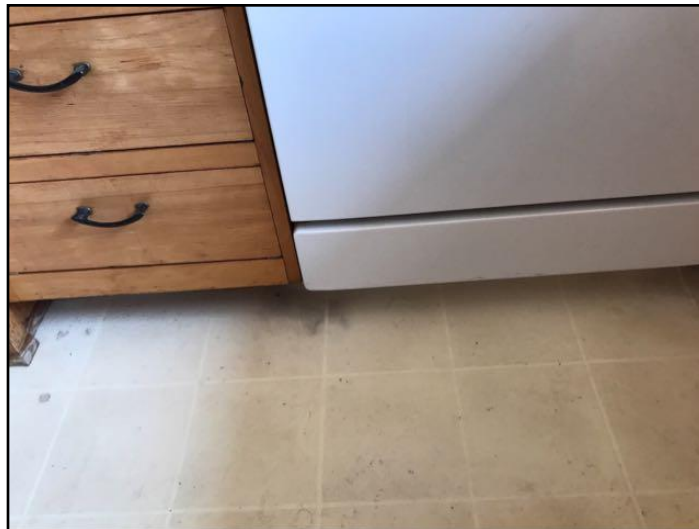
102.

109. Condition: • Signs of prior leak

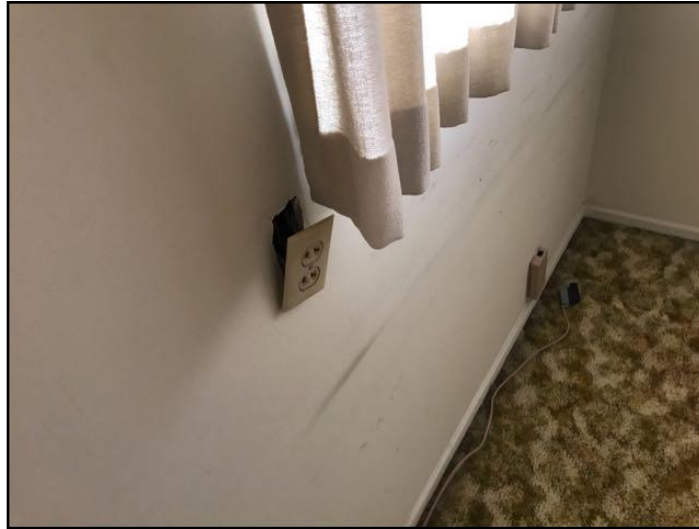
**103.**

**113. Condition:** • At least one loose or displaced

**Location:** Upper center room
