## **Inspection Report**

**Property Address:**  
12 Sussex Ct  
Rancho Mirage CA 92270

**Livingston Home Inspections**

<b>Date:</b> 4/27/2020	<b>Time:</b> 09:30 AM	<b>Report ID:</b> 20200427-12-Sussex-Ct
<b>Property:</b> 12 Sussex Ct Rancho Mirage CA 92270	<b>Customer:</b> Pro-Com Products Inc Johnny Zhu James Park	<b>Real Estate Professional:</b> Joe Chung Compass

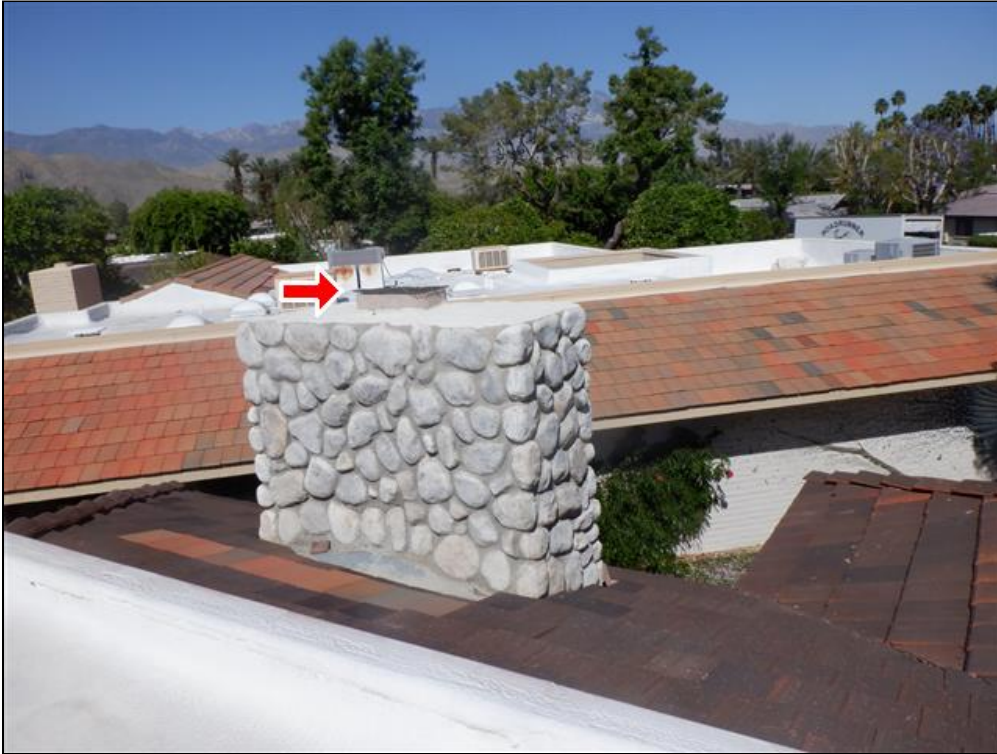
**1.2 (1)** We noted that this chimney has no rain cap. It is recommended that a rain cap be in place to protect the liner and brick from water damage. Water that can get in behind the flue liner can damage the liner itself the brick and interior walls. Recommend installation of rain cap as needed by a specialist.

1.2 Item 1(Picture) Chimney Missing Rain Cap

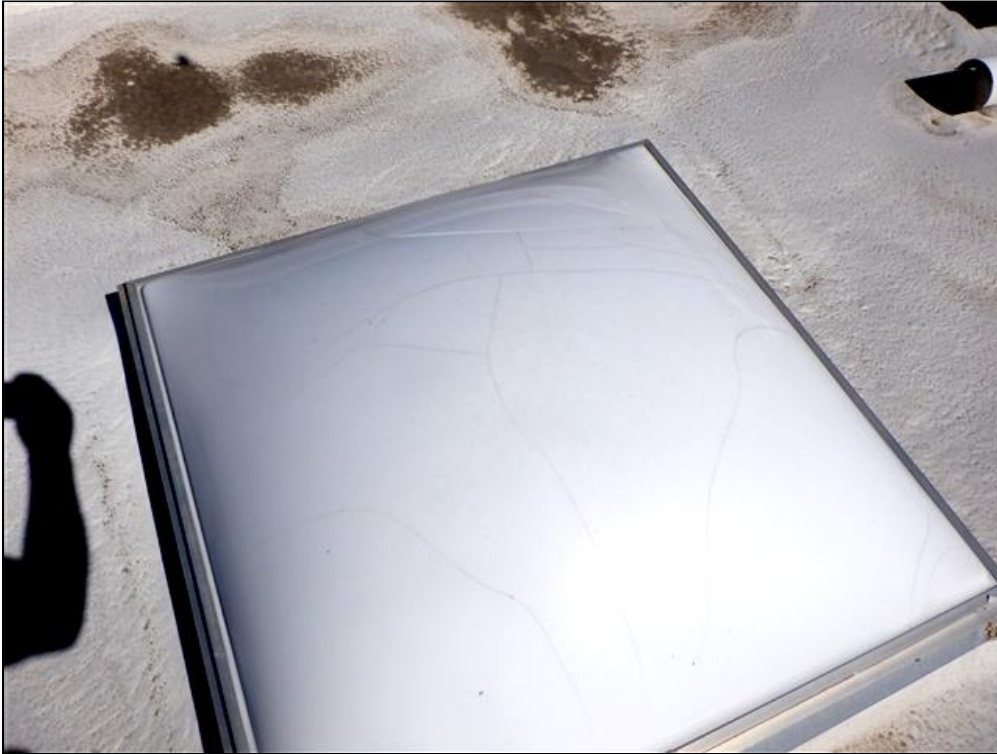
**1.2 (2)** Skylights are prone to leakage. We noted several of these skylights appeared to have cracks in the outer panes, ten skylights total and at least four of those were cracked. Damaged skylights will eventually lead to leakage. Recommend evaluation and replacement by a licensed roofing contractor.

1.2 Item 2(Picture) Skylight 1 Cracked

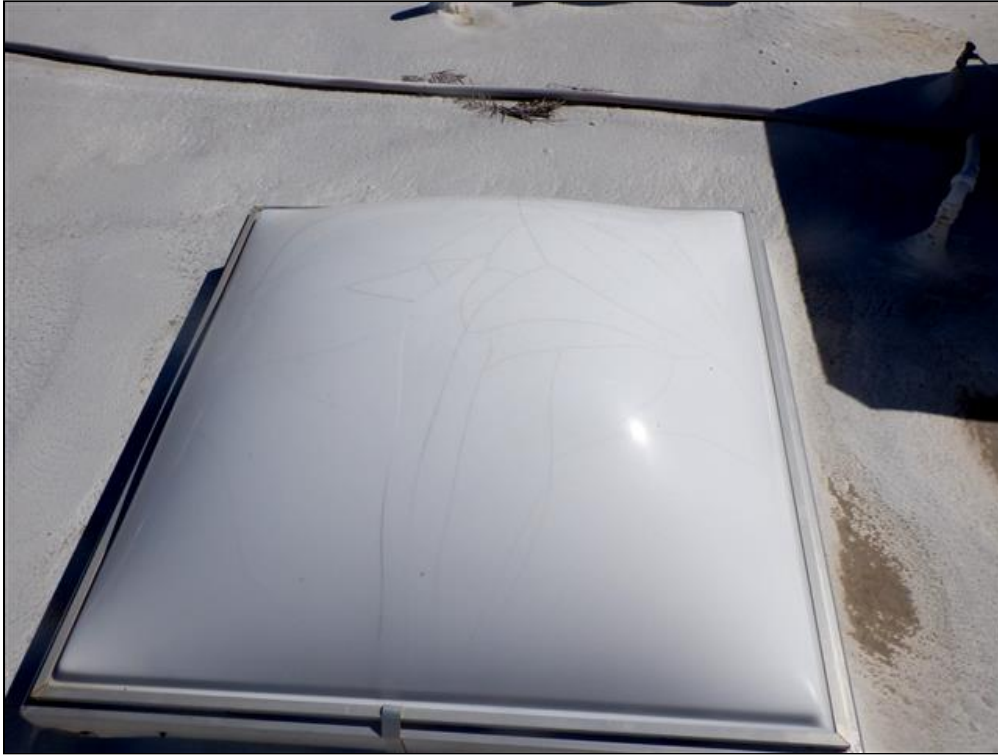
1.2 Item 6(Picture) Skylight 5 Cracked

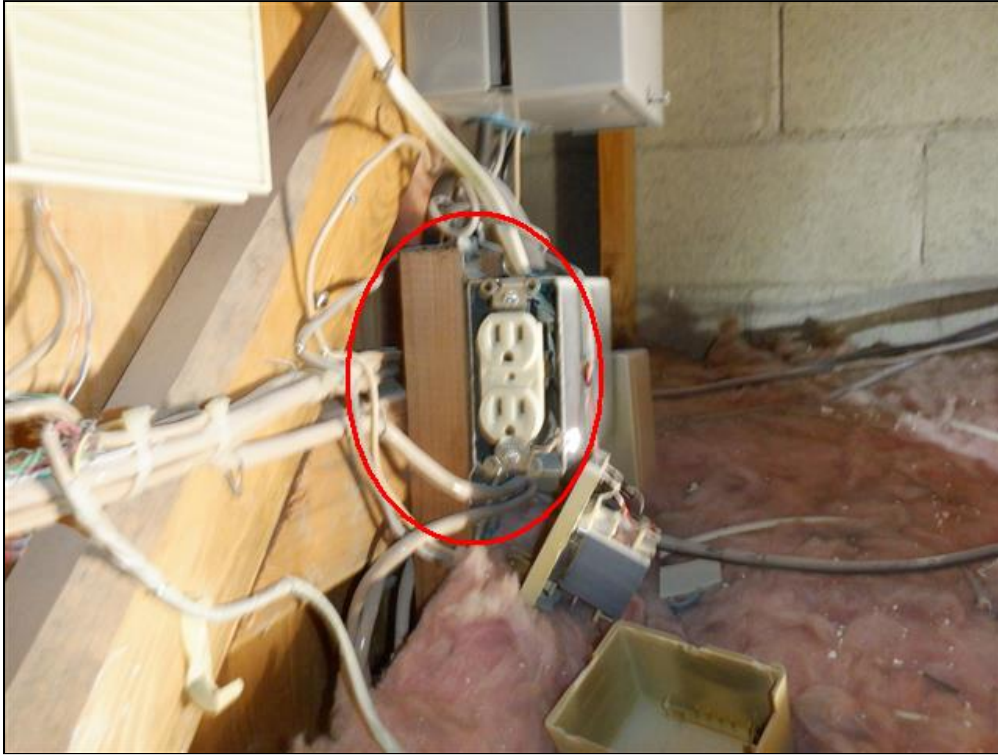
1.7 We noted at least one electrical outlet in the attic that was missing its cover plate. Recommend insulation of cover plate to avoid any future safety issues.

1.7 Item 1(Picture) Attic Electrical Outlet Missing Cover Plate

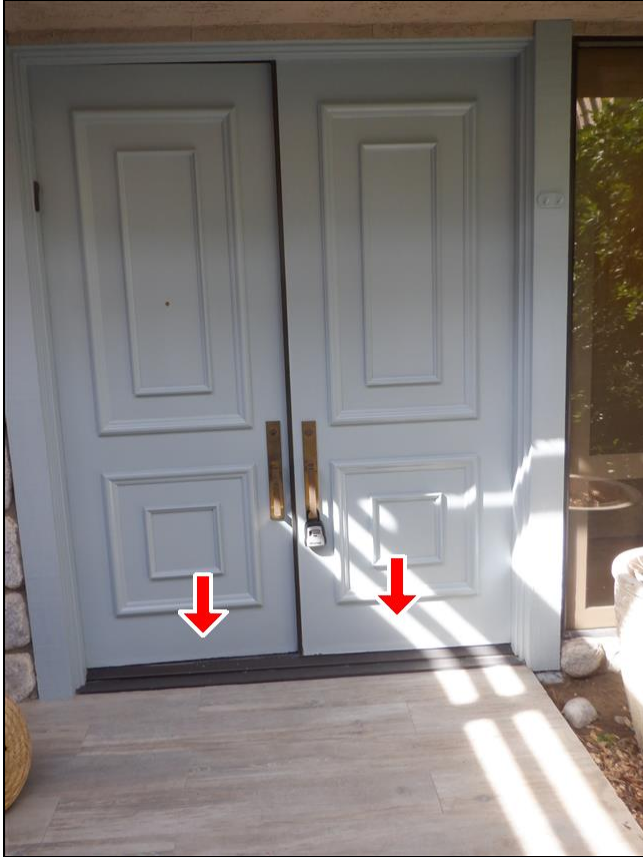
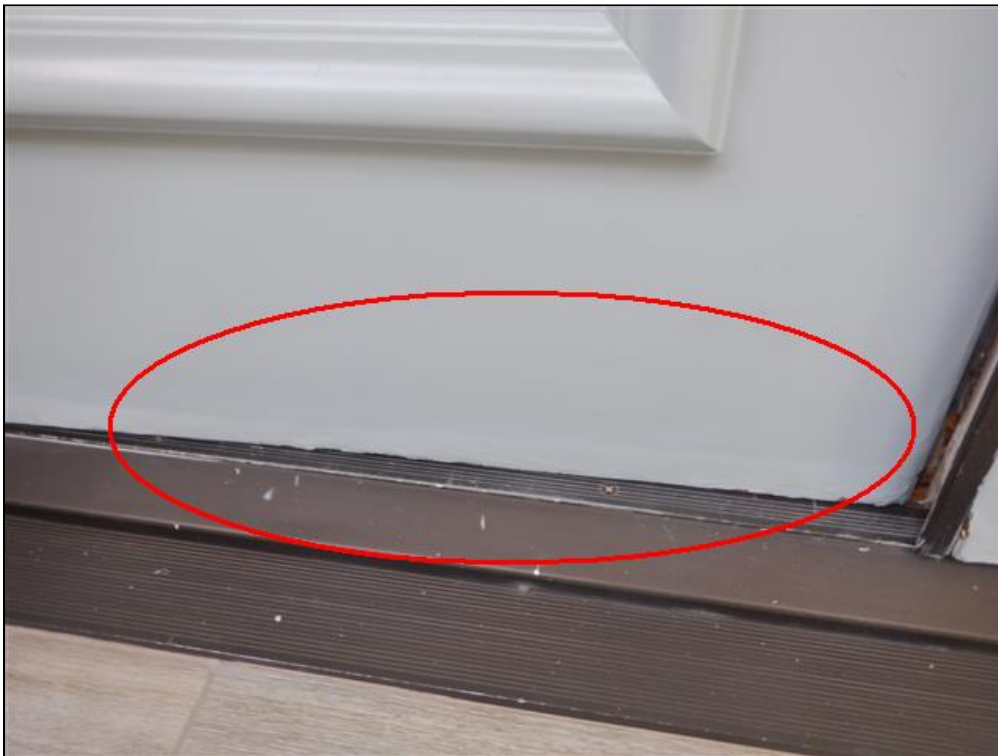
**2.1** We noted that the front door appeared weathered at the bottom. Recommend evaluation by a licensed contractor repair replace as needed.

2.1 Item 1(Picture) Front Doors Weathered

2.1 Item 3(Picture) Front Doors Weathered

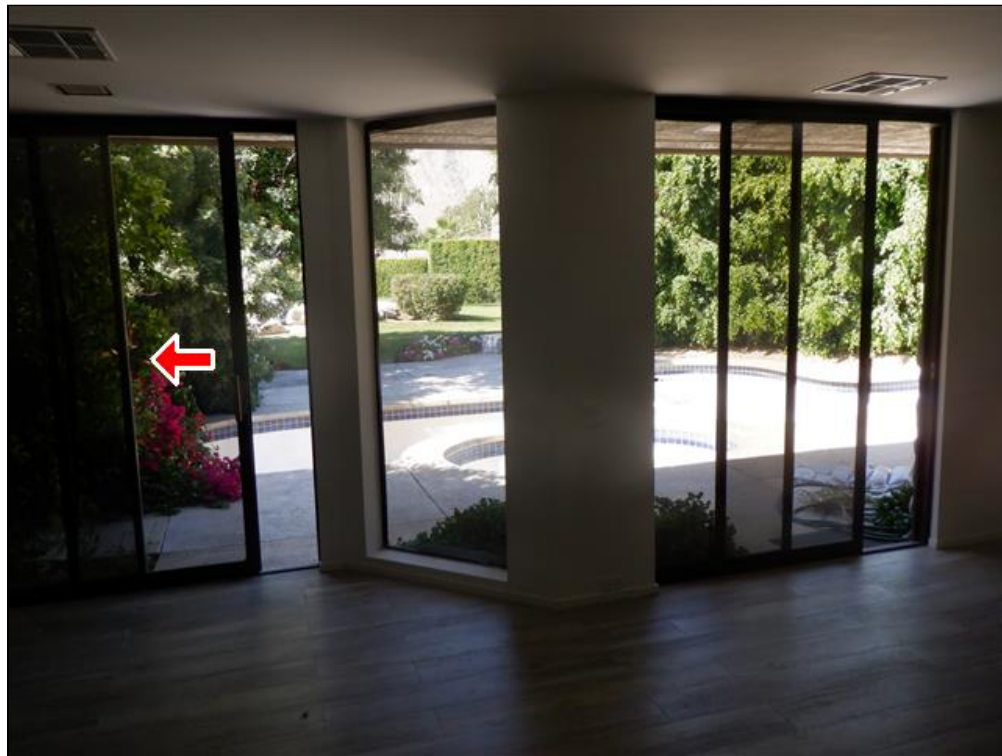
**2.2 (2)** We noted at least one of the sliding glass doors (master bedroom) appeared to have a bad seal, we also noted that at least two of the living room sliding glass doors were either hard to operate or were inoperable and at least one of them failed to lock. Recommend evaluation by a licensed sliding glass door specialist to repair or replace as needed for proper operation.

2.2 Item 1(Picture) Master Bedroom Slider Bad Seal

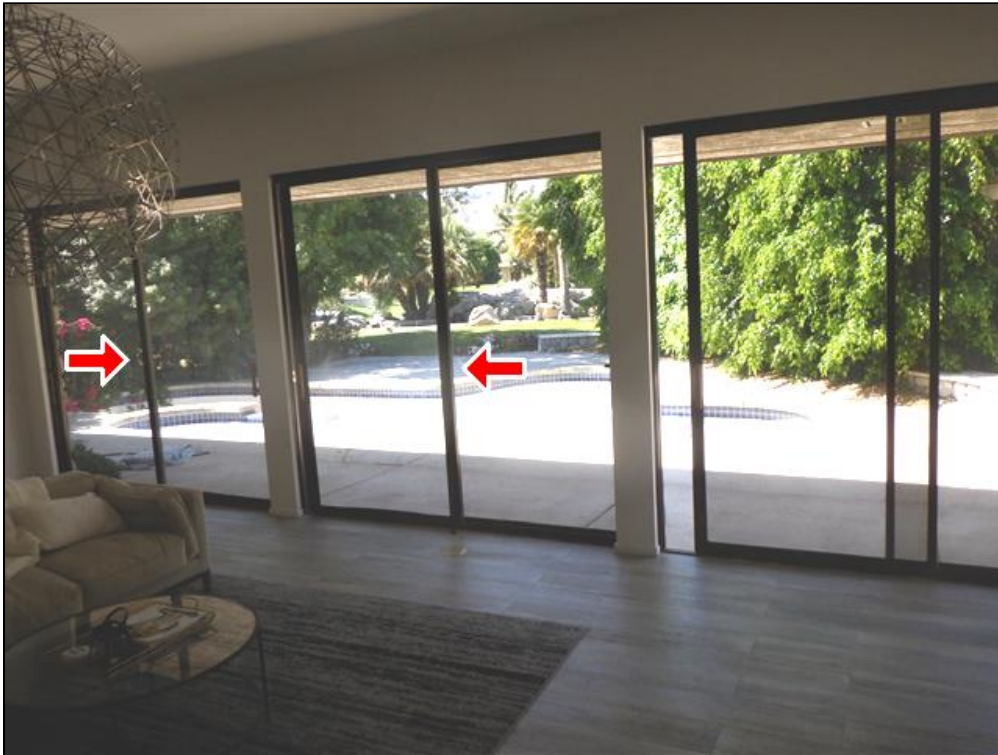
2.2 Item 3(Picture) Living Room Sliders Hard To Operate/Inoperable

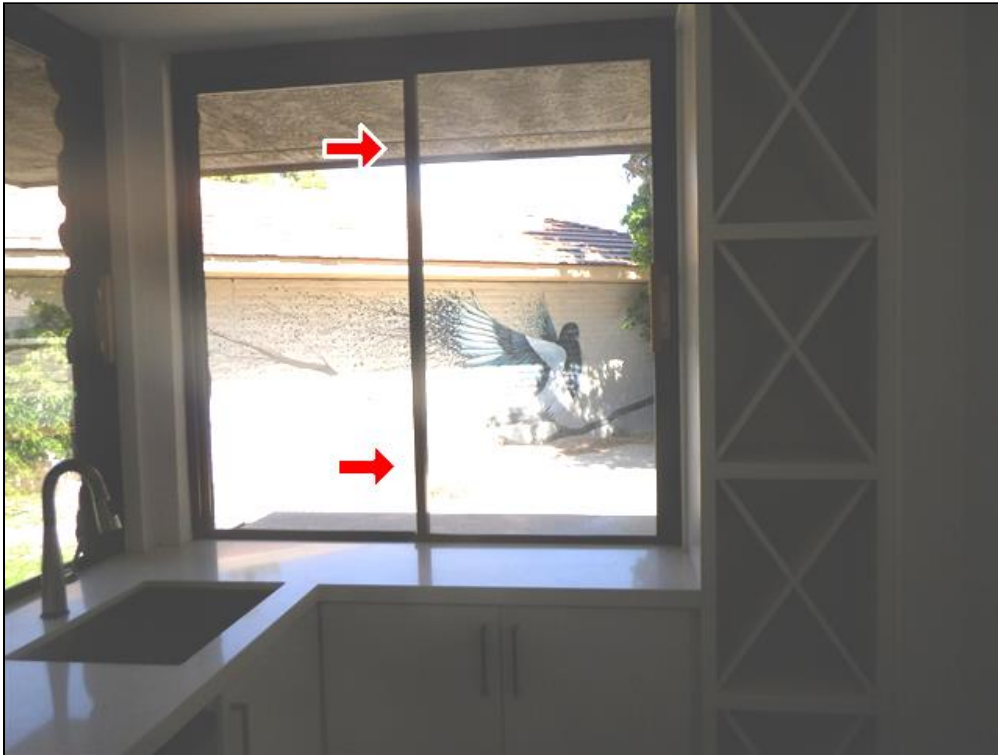
2.2 (3) We noted that at least one of the bar windows was inoperable at time of inspection, this window was stuck shut. Recommend evaluation by a licensed window specialist to repair or replace as needed for proper operation.

2.2 Item 5(Picture) Bar Window Inoperative

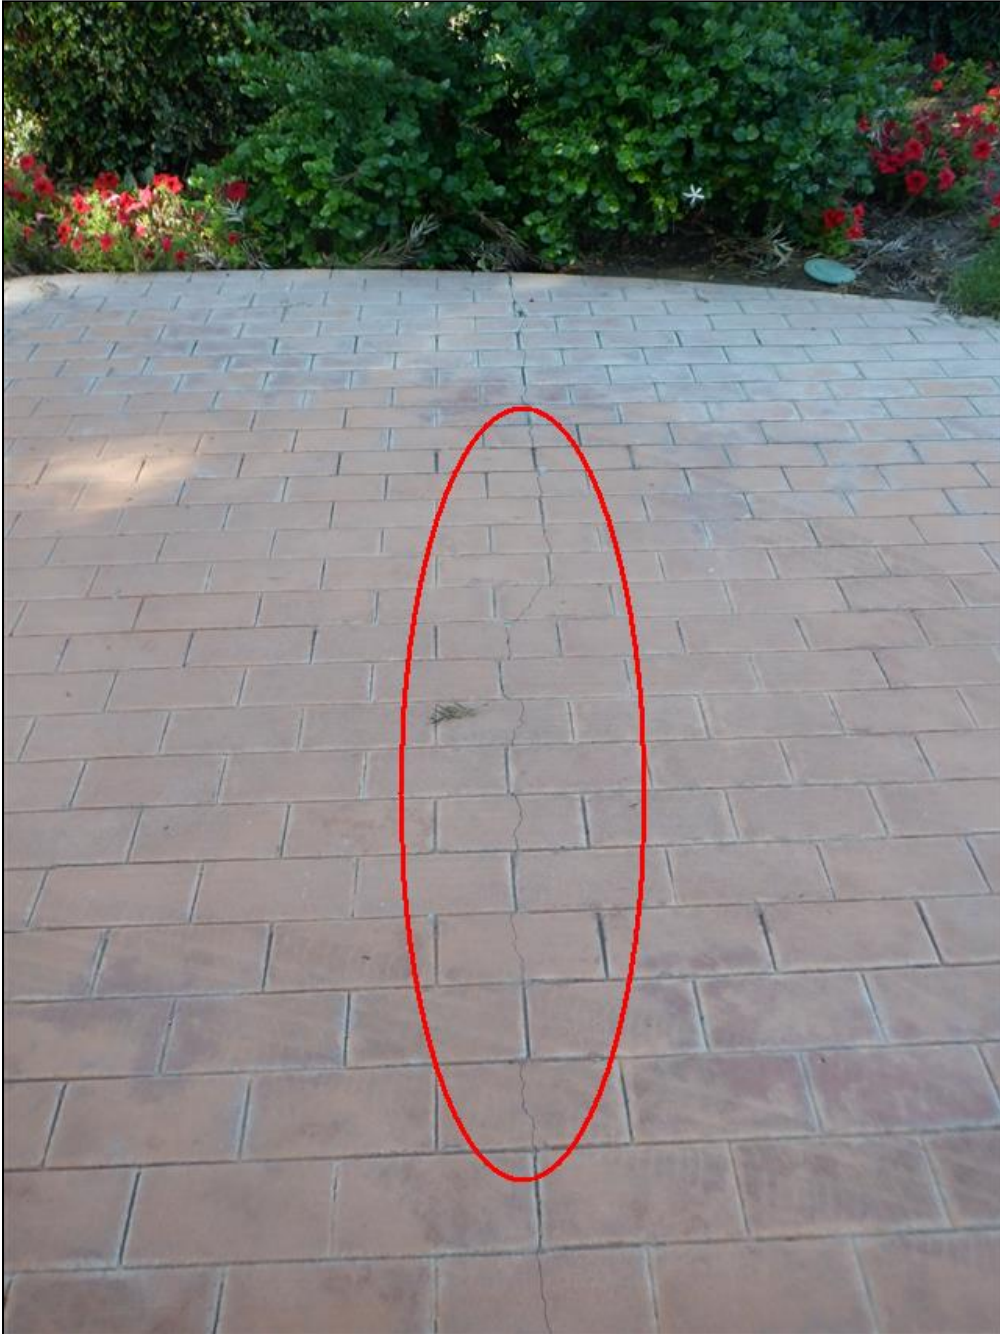
**2.4 (1)** We noted that several of the bricks in the driveway were cracked. These cracks are normal shrinkage cracks for this climate, none of which exceeded 1/8 inch in size. Recommend replace as needed.

2.4 Item 2(Picture) Driveway Cracked Bricks

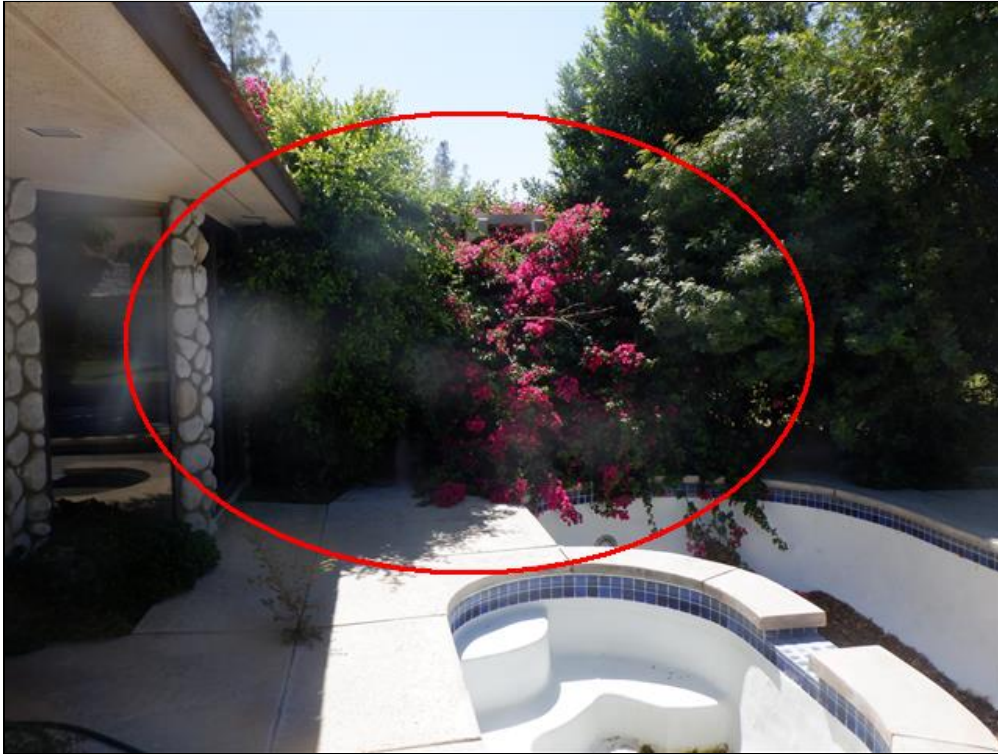
**2.4 (2)** We noted a bush or vine plant growing up the wall and into the eaves in the backyard and we also noted that this plant is growing into the pool. This plant should if nothing else be cut back away from eaves and pool. It is possible that damage to the eaves and pool liner will occur if this plant is allowed to grow any further. Recommend trimming bush (Vine) away from eaves and pool.

2.4 Item 6(Picture) Plant Growing Wild

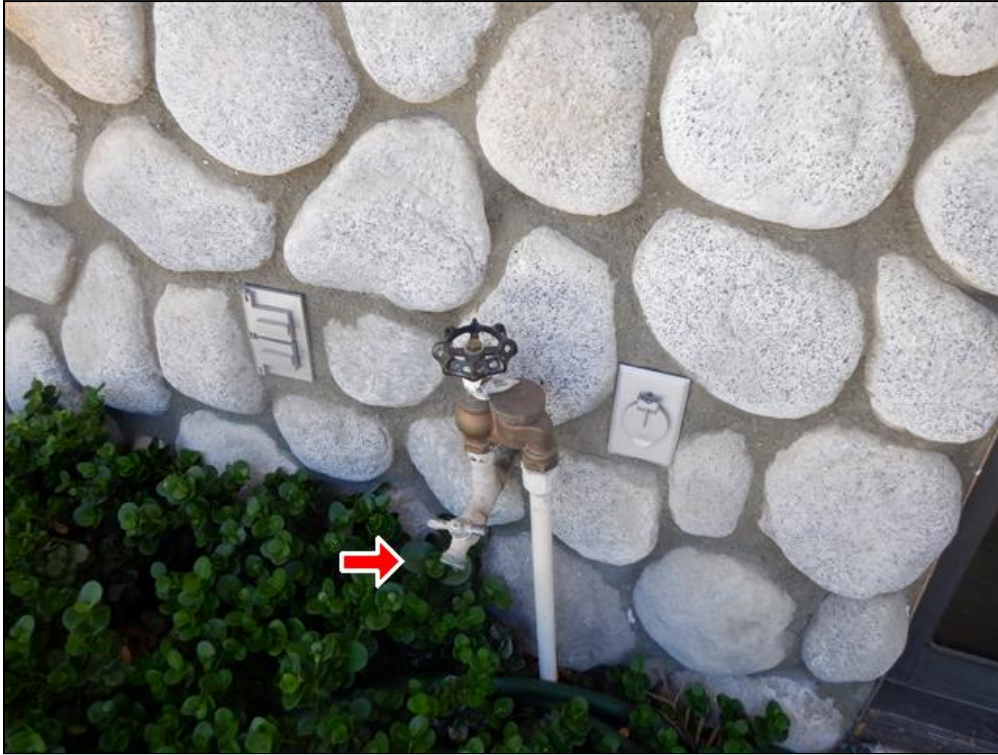
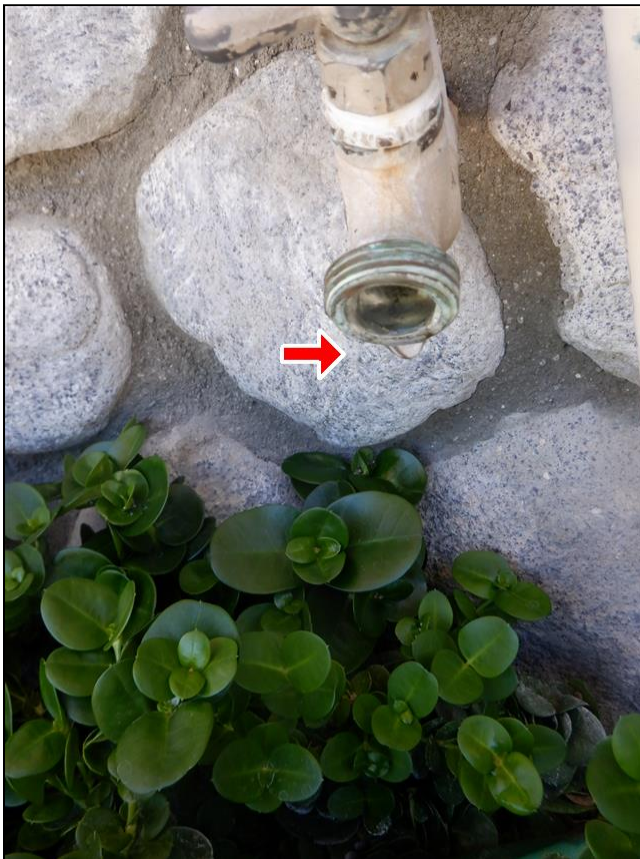
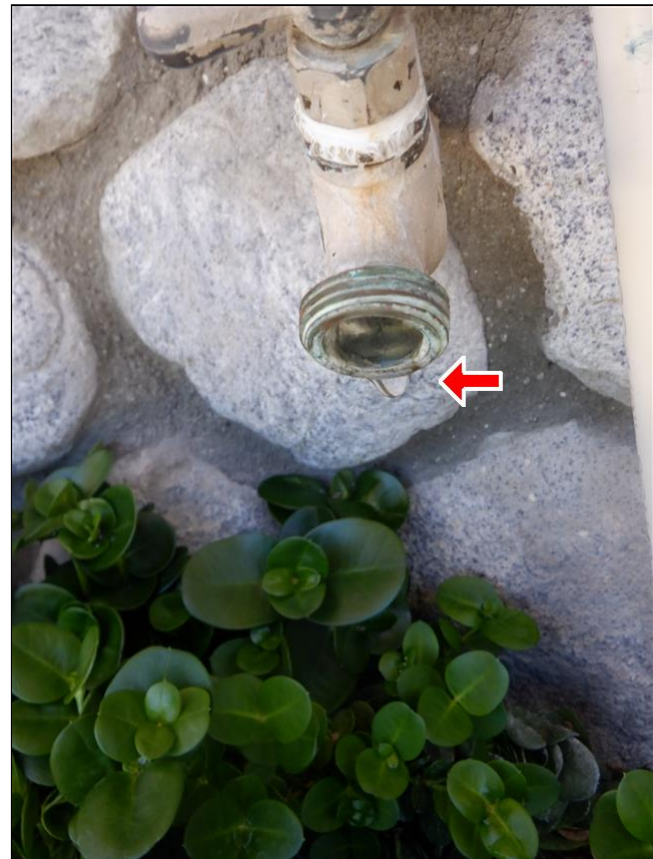
2.6 We noted that the hose bib in the backyard has a constant drip. We believe that this hose bib has a small leak. Recommend evaluation repair replace as needed by a licensed plumbing contractor.

2.6 Item 1(Picture) Hose Bib Leak

2.6 Item 2(Picture) Hose Bib Leak

2.6 Item 3(Picture) Hose Bib Leak

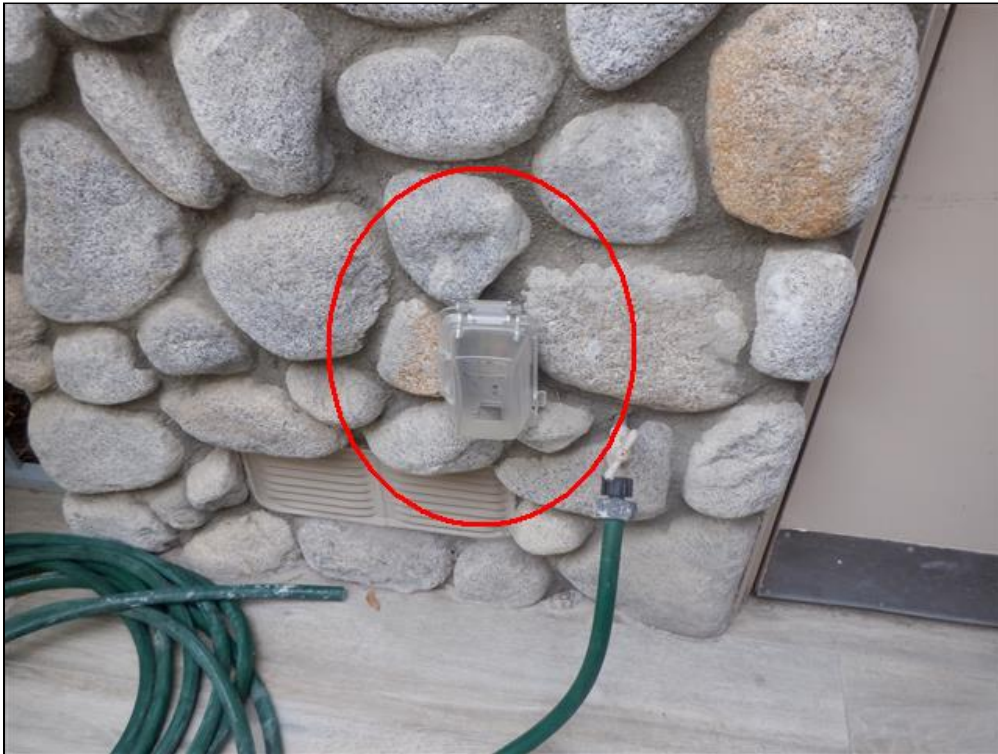
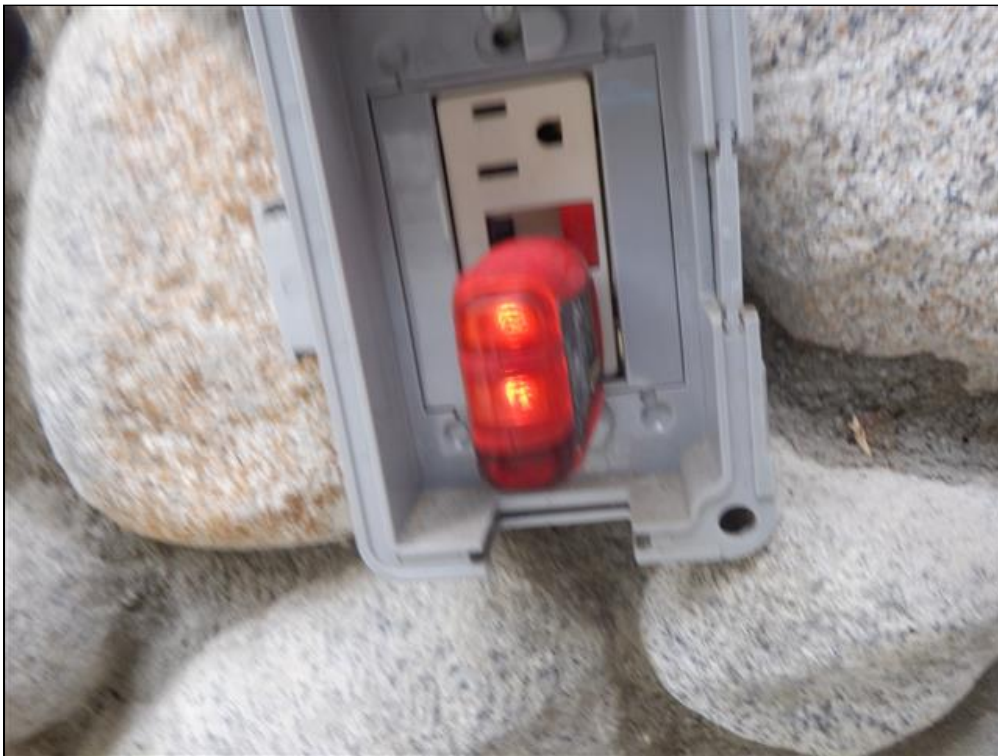
2.7 (1) We noted that the GFCI outlet in courtyard failed to trip upon testing. Any GFCI outlet that is not functioning as intended will be considered a safety issue that should be corrected. Recommend replacing GFCI outlet as needed by a licensed electrical contractor.

2.7 Item 1(Picture) GFCI Outlet Failed To Trip

2.7 Item 2(Picture) GFCI Outlet Failed To Trip

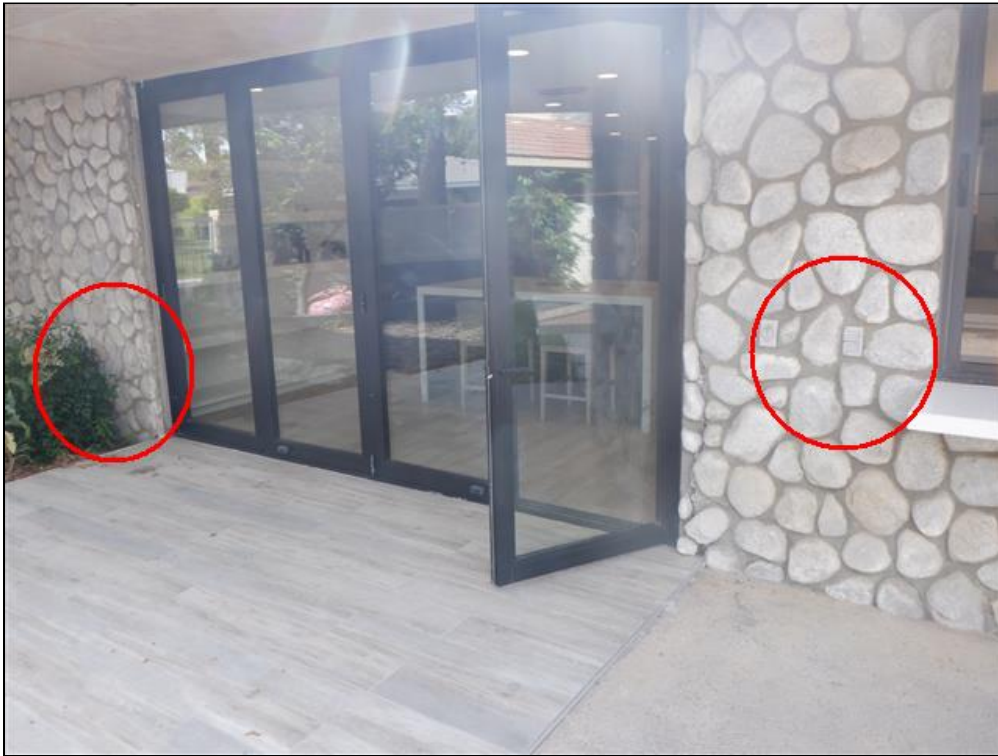
2.7 (2) We noted several exterior outlets that had no power, 2 on the north patio and 1 on the west patio, we also cannot confirm if these outlets are GFCI protected. Recommend evaluation by a licensed electrical contractor to restore power and confirm GFCI protection repair replace as needed.

2.7 Item 3(Picture) North Patio Outlet No Power

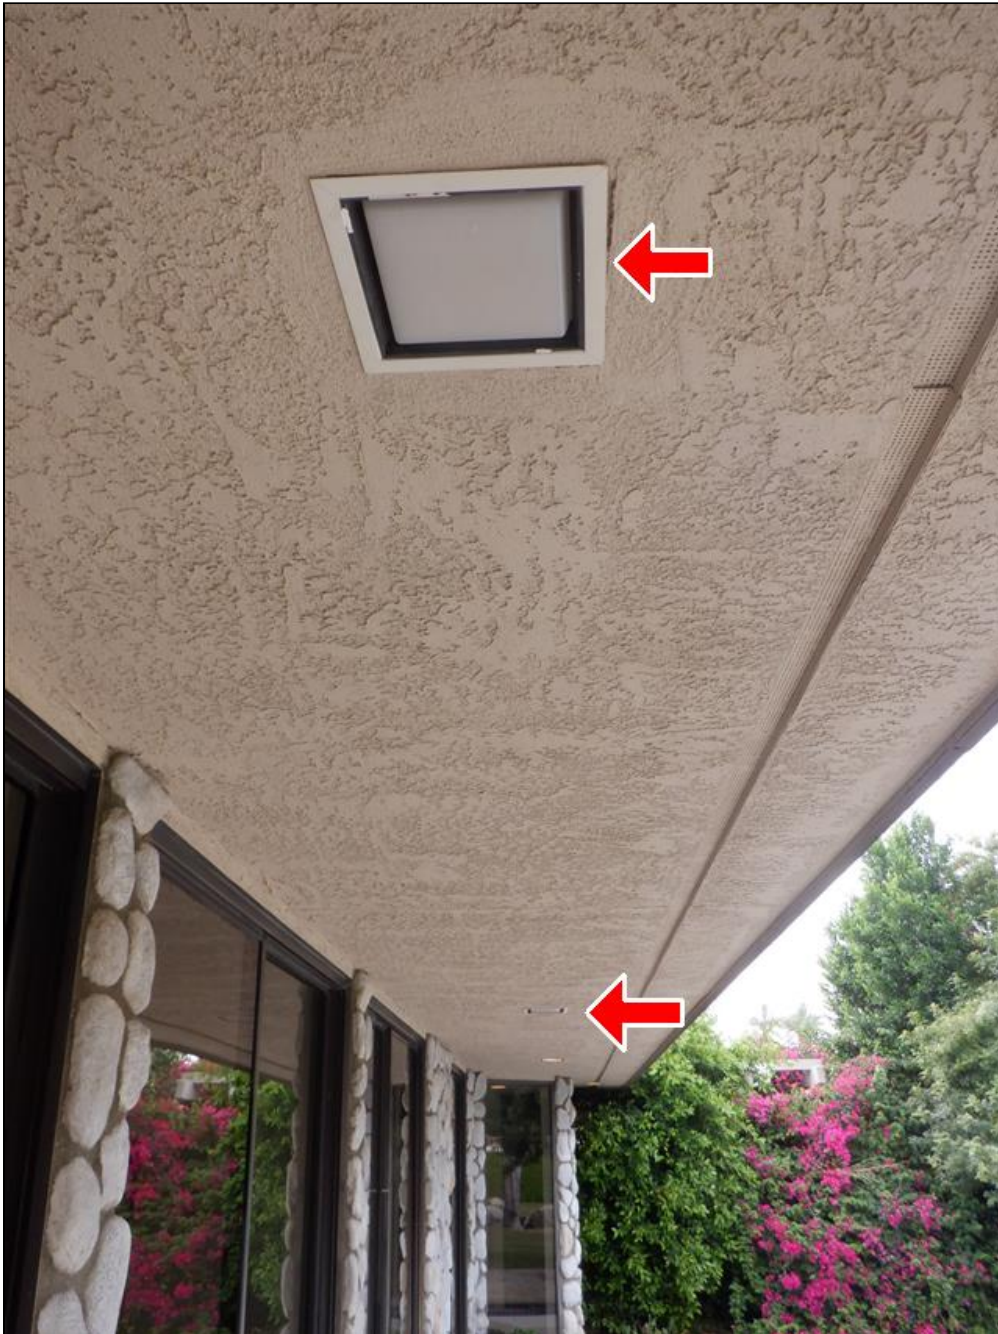
**2.8** We noted several exterior light fixtures that were not functioning. These lights are in the courtyard and back patio. Recommend bulb replacement and further evaluation if needed.

2.8 Item 2(Picture) Patio Light Fixtures Not Functioning

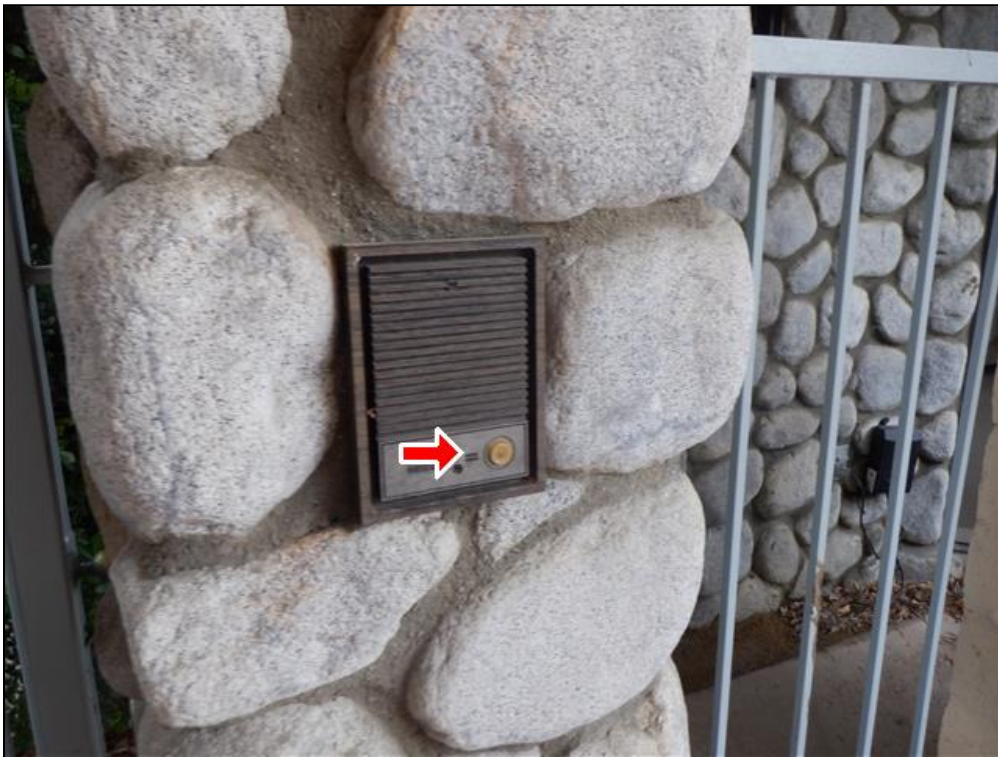
2.9 We noted that the door bells were inoperative at time of inspection. Recommend evaluation/repair/replace as needed.

2.9 Item 2(Picture) Door Bell Not Functioning

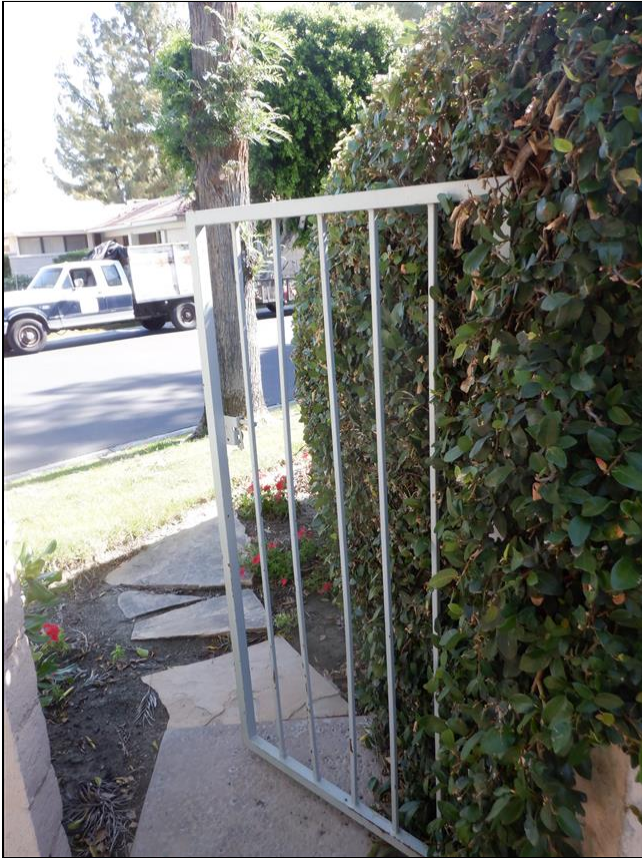
**2.10** We noted the gate to the backyard on the north side of house has no self closing or self latching hardware. Anytime there is a gate that allows access to a pool in the backyard from the street the gate must have self closing hardware and must be self latching. This is a safety issue that should be corrected. Recommend repair/replace as needed for proper operation.

2.10 Item 1(Picture) Gate To Backyard

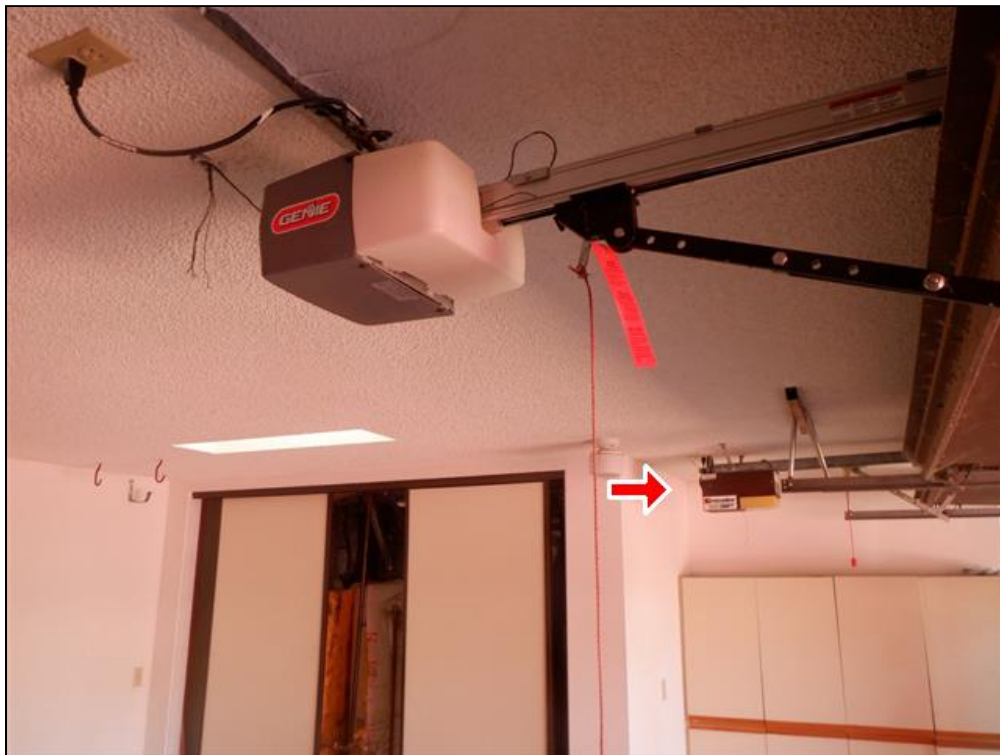
**3.4 (1)** Although this garage door opener was functioning we believe that it is too old to have any of the safety features of a newer opener. This garage door opener does not have electronic eyes (Sensors) and we do not believe that this garage door opener will reverse when met with resistance. At this point we believe that the only way to get these safety features would be to replace the existing opener with a new one. Recommend installation of new opener as desired. FYI single garage door opener only.

3.4 Item 1(Picture) Single Garage Door Opener Very Old

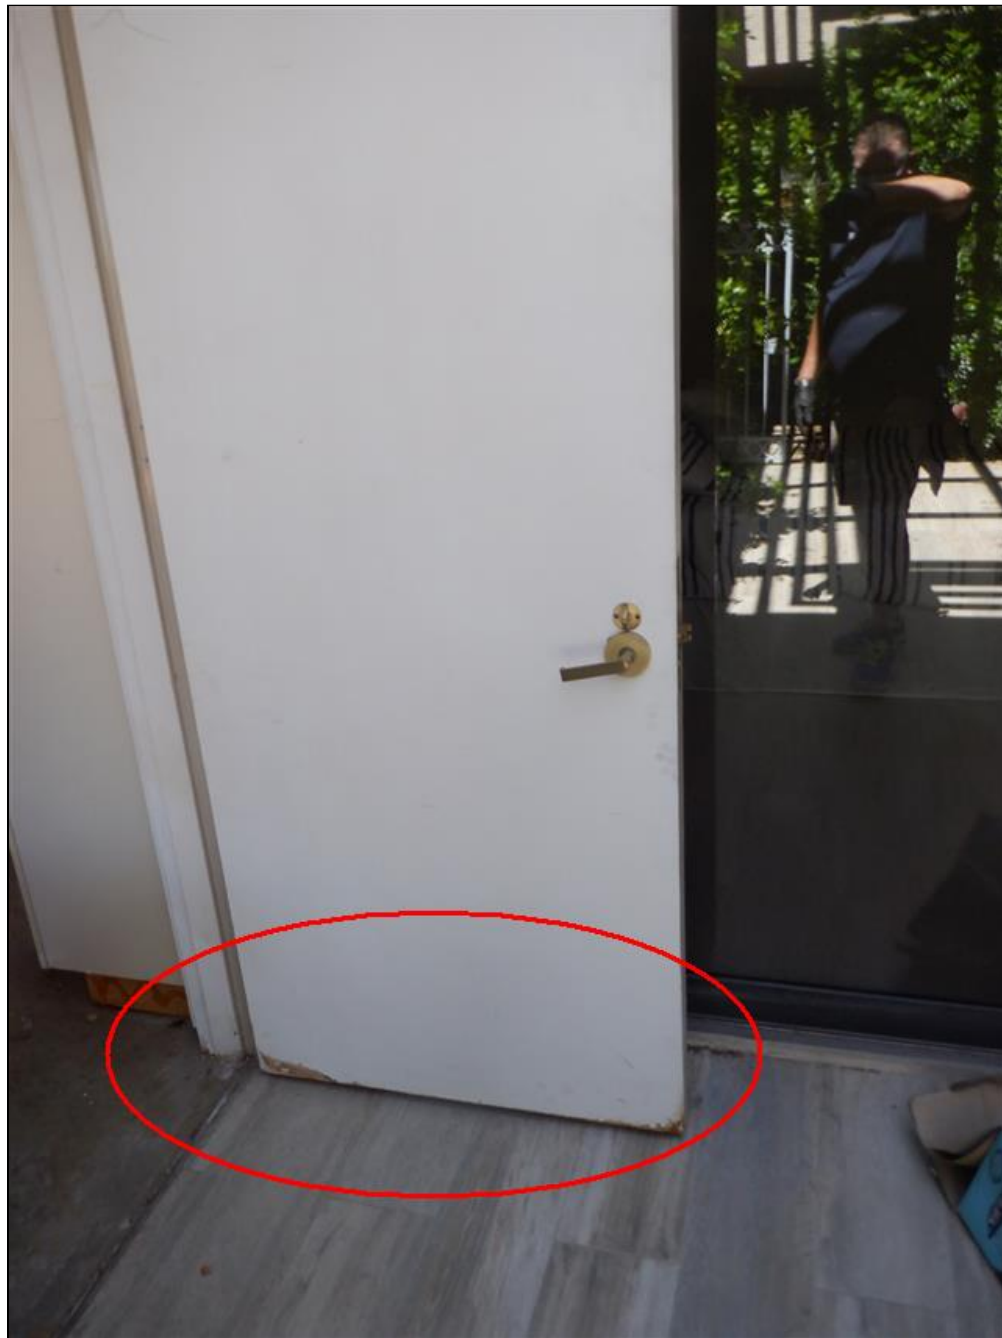
**3.7** We noted that the interior of the garage man door is stained and weathered. Recommend repair replace as needed.

3.7 Item 1(Picture) Garage Man Door Stained/Weathered

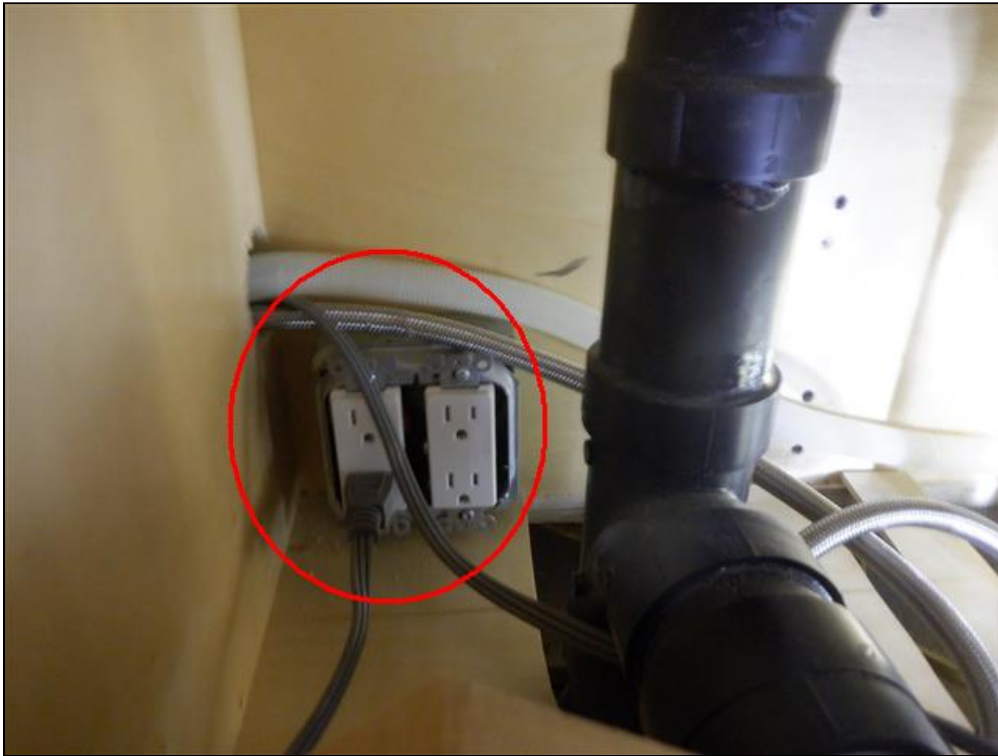
**4.7 (1)** We noted a missing outlet cover plate under the sink. Recommend installation of cover plate to avoid any future safety issues.

4.7 Item 1(Picture) Missing Outlet Cover Plate

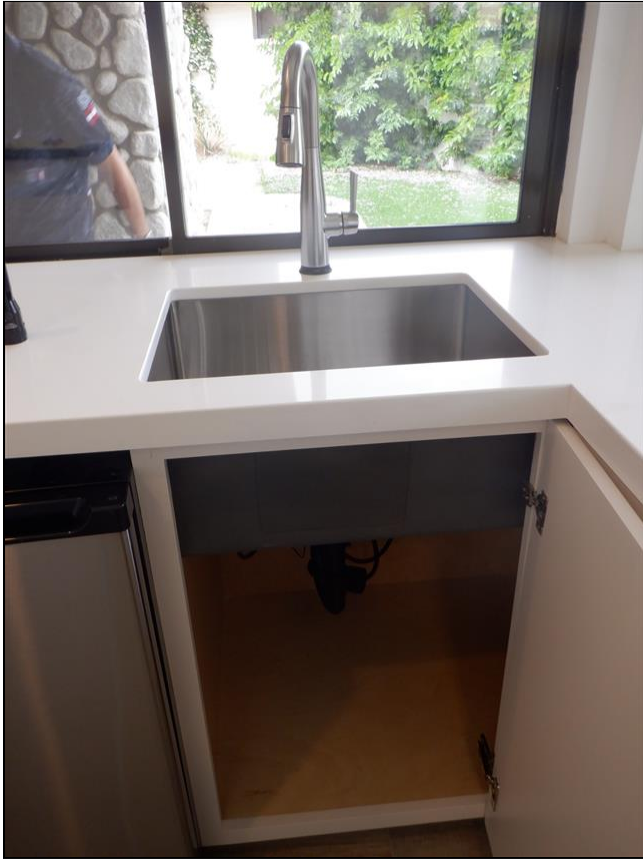
**4.15** We noted that the bar sink faucet was not supplying water at time of inspection. It appeared that the supply lines were off and upon activation the faucet still did not supply any water. Recommend evaluation by a licensed plumbing contractor repair replace as needed for proper operation. .

4.15 Item 1(Picture) Bar Sink Faucet

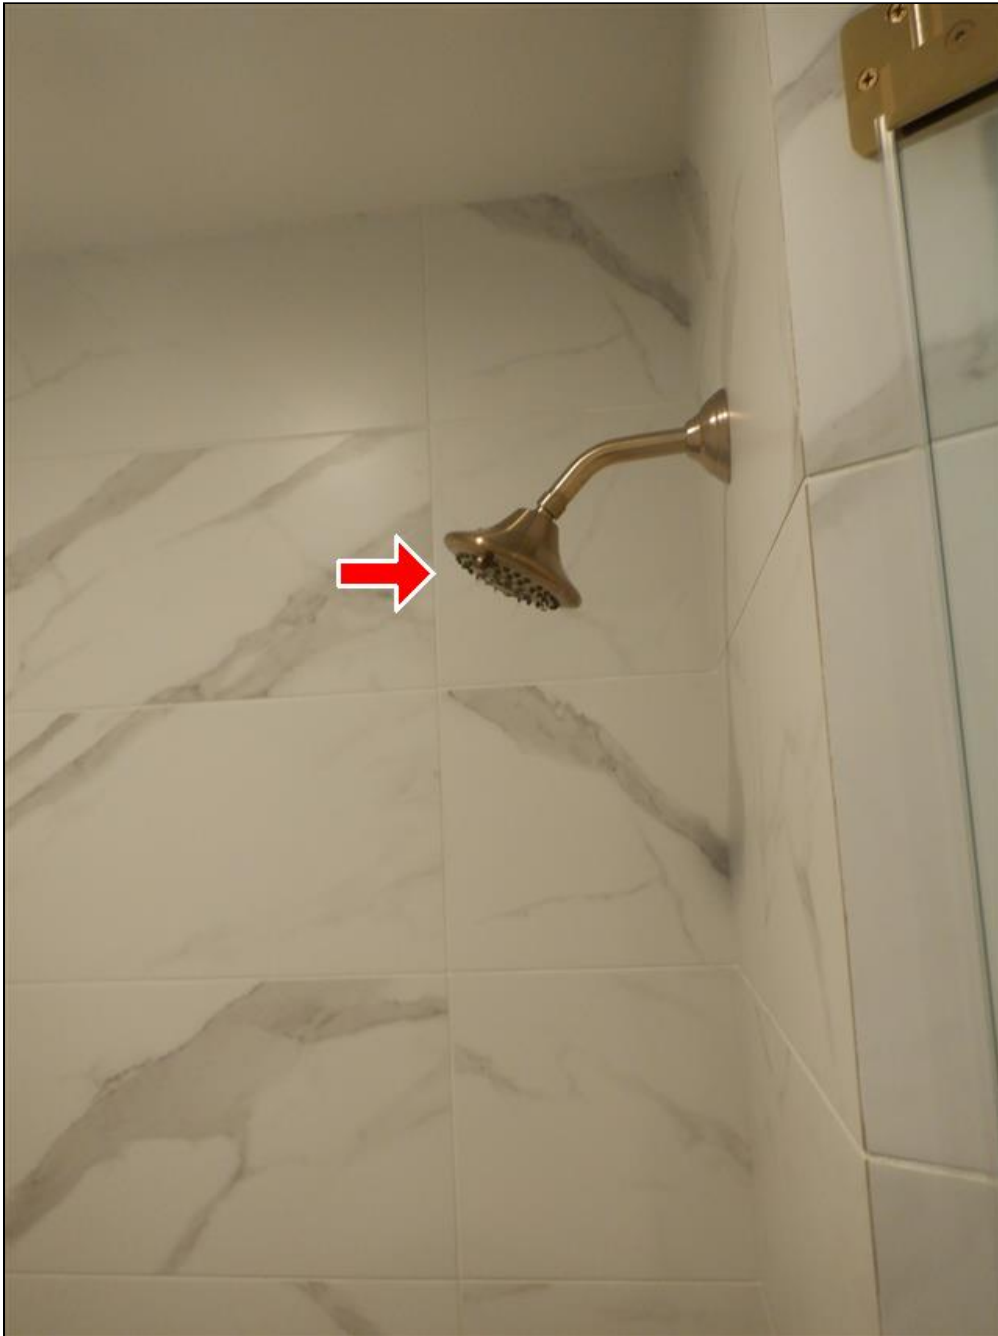
**6.4.B** We noted that the water supply to the shower head was low. This issue is isolated to this shower fixture only and its possible that the aerator is clogged. Recommend cleaning of aerator and further evaluation as needed by a licensed plumbing contractor.

6.4.B Item 1(Picture) Shower Head Low Flow

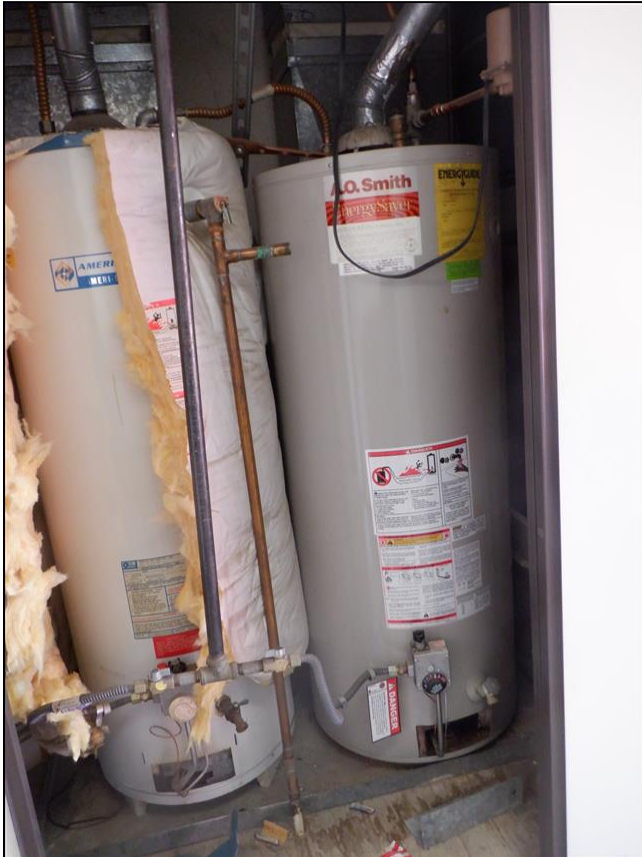
**8.2 (1)** This property has two water heaters. We noted that the main water heater is 20 years old it has a 50 gallon tank, we also noted that the secondary water heater is 36 years old and it also has a 50 gallon tank, this water heater is being used as a storage tank only, this is an outdated old school set up although function its not very efficient. FYI these water heater are older and upon replacement the new water heater should be installed with a fuel line sediment trap and a catch pan.

8.2 Item 1(Picture) Water Heaters
