## **Inspection Report**

**Property Address:**  
12 Sussex Ct  
Rancho Mirage CA 92270

**Livingston Home Inspections**

<b>Date:</b> 4/27/2020	<b>Time:</b> 09:30 AM	<b>Report ID:</b> 20200427-12-Sussex-Ct
<b>Property:</b> 12 Sussex Ct Rancho Mirage CA 92270	<b>Customer:</b> Pro-Com Products Inc Johnny Zhu James Park	<b>Real Estate Professional:</b> Joe Chung Compass

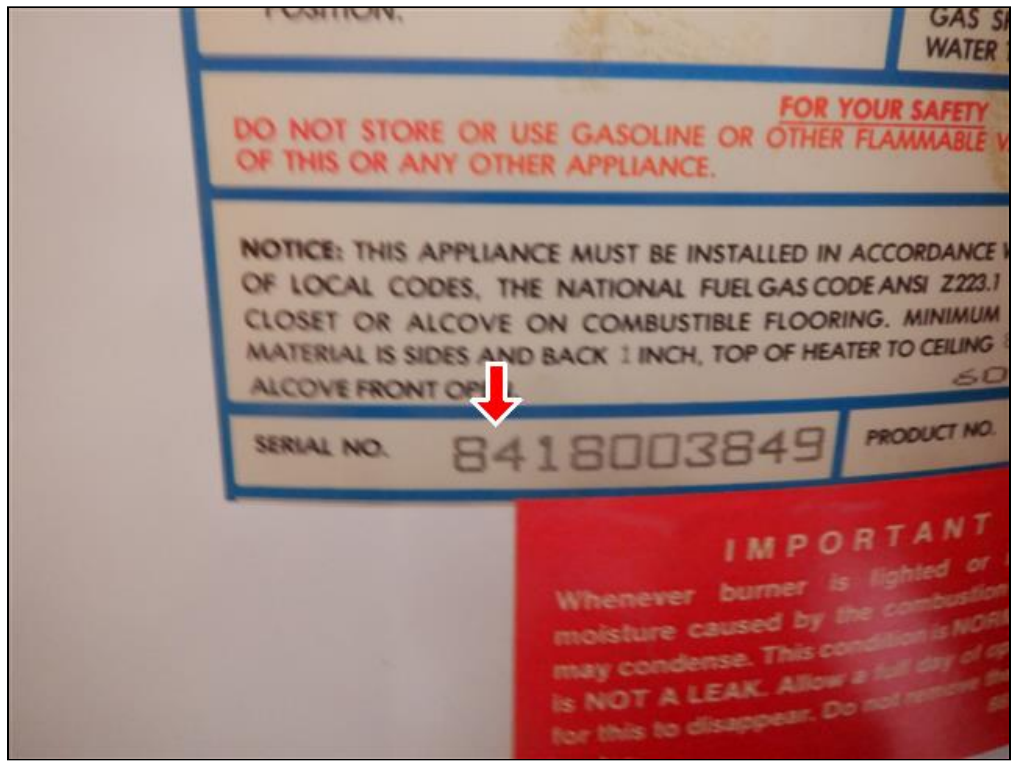
**8.2 (1)** This property has two water heaters. We noted that the main water heater is 20 years old it has a 50 gallon tank, we also noted that the secondary water heater is 36 years old and it also has a 50 gallon tank, this water heater is being used as a storage tank only, this is an outdated old school set up although function its not very efficient. FYI these water heater are older and upon replacement the new water heater should be installed with a fuel line sediment trap and a catch pan.

8.2 Item 4(Picture) Secondary Water Heater MFG Date

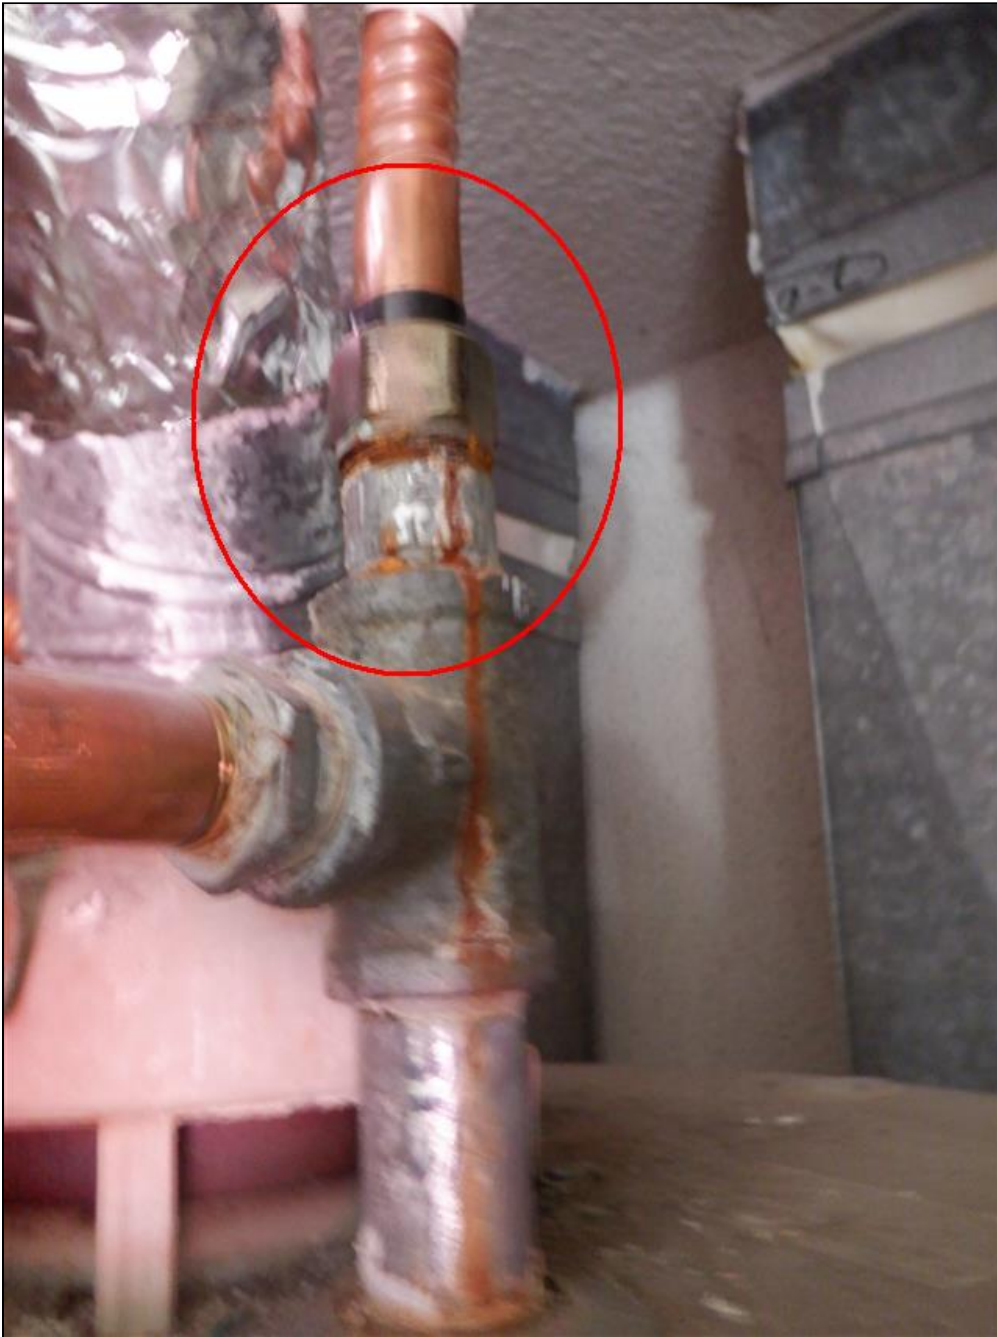
**8.2 (2)** We noted at least one galvanized fitting for the cold water supply that is connected directly to copper pipe (main water heater). This is a improper installation. Galvanized and copper pipe should be separated by at least a 4 inches of brass nipple or a dielectric fitting to avoid electrolysis from dissimilar materials. In this situation we can already see this electrolysis process taking affect. Recommend evaluation and repair by a licensed plumbing contractor.

8.2 Item 5(Picture) Copper/Galvanized Pipe

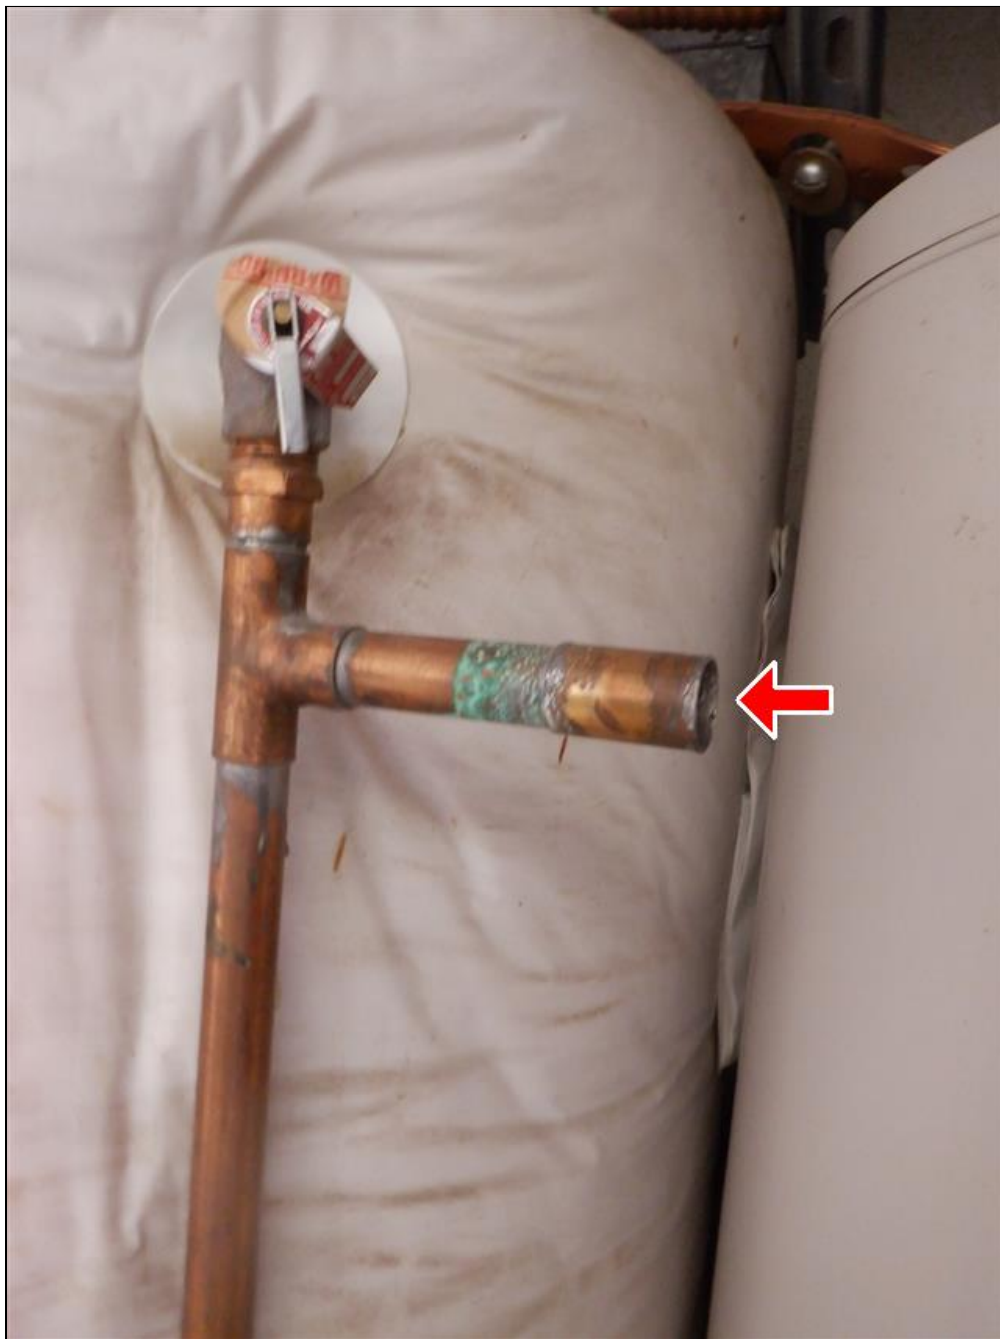
**8.3** We noted that the main water heater it was missing its TPR valve piping, we also noted that the secondary water heaters TPRV valve piping is missing its cap. This is a safety issue that should be corrected. Recommend evaluation of all TPRV piping for both water heaters by a licensed plumbing contractor repair replace as needed to avoid any future safety issues.

8.3 Item 1(Picture) Secondary Water Heater TPRV Valve Piping Open

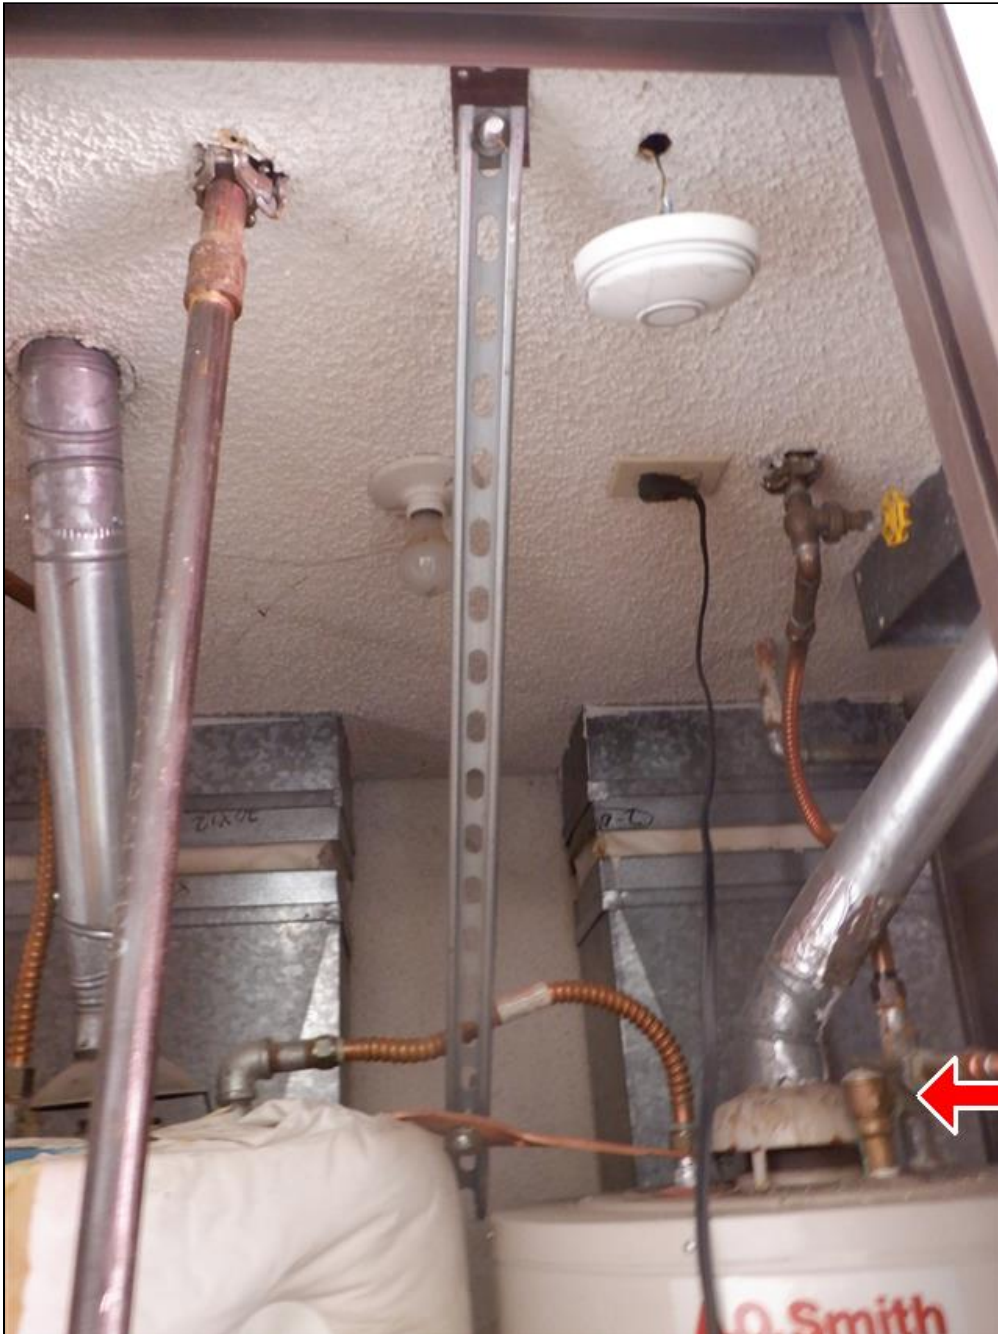
8.3 Item 2(Picture) Main Water Heater Missing TPRV Valve Piping

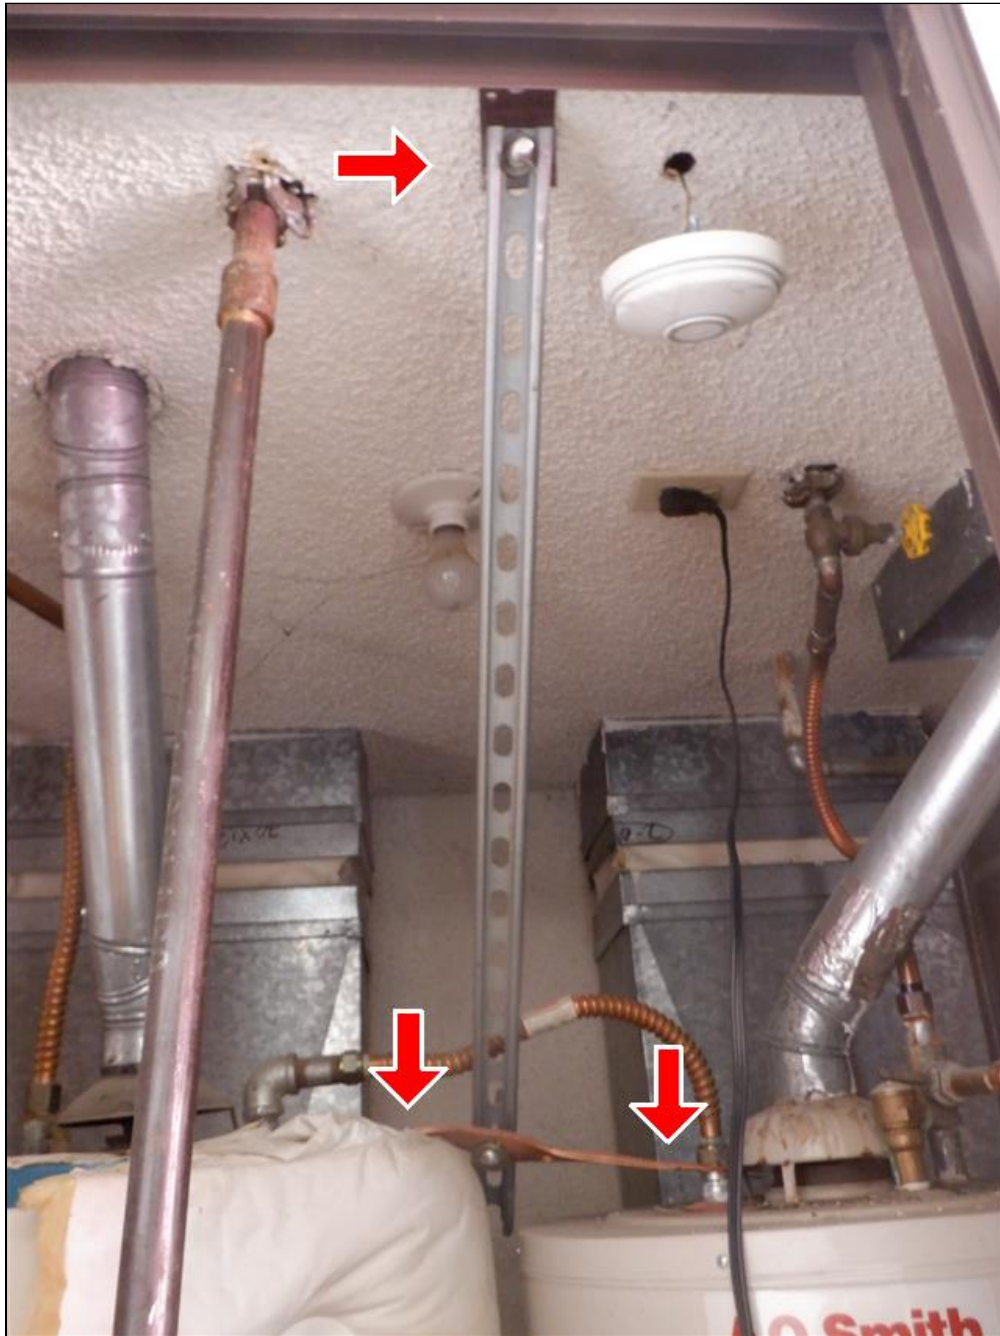
**8.4** We noted the use of improper material for the seismic restraints on these water heaters, the seismic restraint for these water heaters is in the form of a bracket that's connected to the ceiling and then strapped to the units. This existing installation is not approved for water heater seismic straps. The approved seismic straps must be installed in the upper 1/3 and the lower 1/3 of the units and they must be connected to the wall studs. This is a safety issue that should be corrected. Recommend evaluation and installation of proper strapping materials as needed by a licensed plumbing contractor.

8.4 Item 1(Picture) Existing Seismic Bracing Not Approved

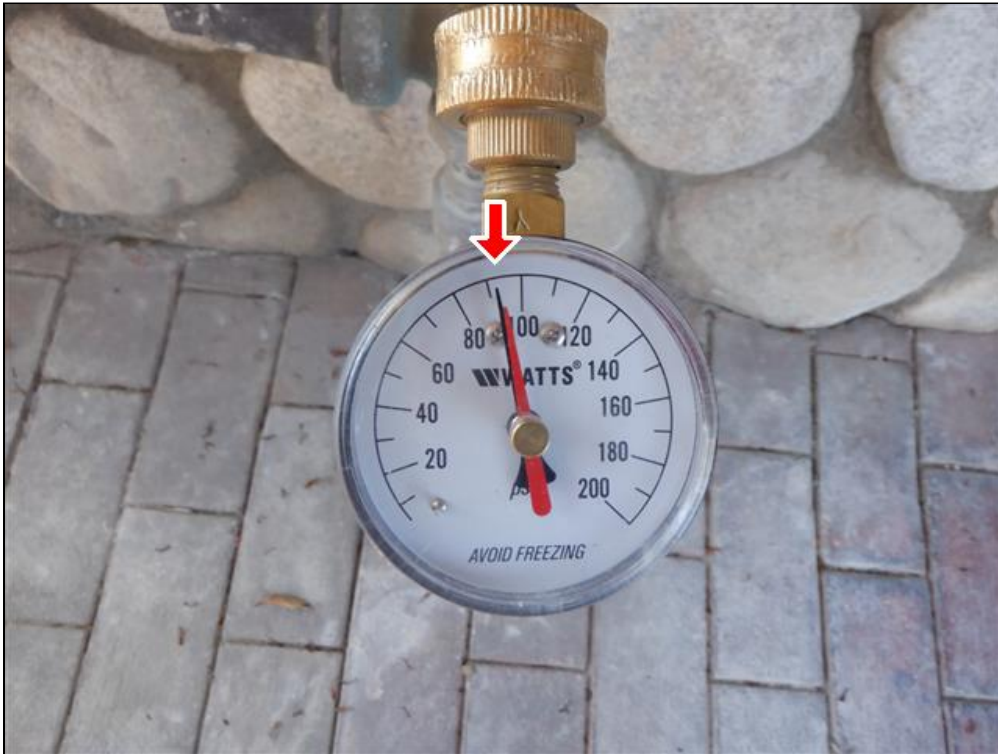
**8.5 (1)** At the time of inspection water pressure tested beyond normal limits of 40-80 psi. At the time of inspection water pressure was 92 psi. We recommend adjustment of the regulator to reduce pressure to within the normal range. Excessive water pressure above 80 psi can cause the water supply lines to fail.

8.5 Item 1(Picture) Water Pressure 92 psi

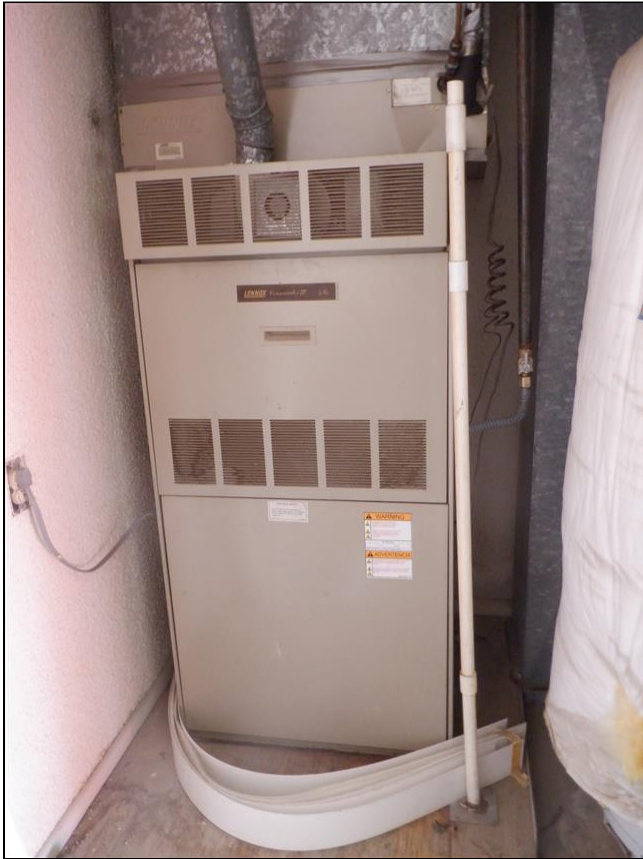
**10.0.A** Although these heater were functioning properly at time of inspection we noted the Installation of a flex hose for the fuel line through the cabinet wall and without some kind of protection this is considered dangerous. Although possibly not a requirement at the time of construction a solid pipe should be installed through the cabinet wall where the flex hose can be used or some kind of impact resistant none flammable protective sleeve should be installed over this flex hose. This safety concern should be corrected one way or another. Recommend evaluation/repair/replace by an licensed HVAC contractor. FYI these units are older at 36 years.

10.0.A Item 1(Picture) Heating Unit 1

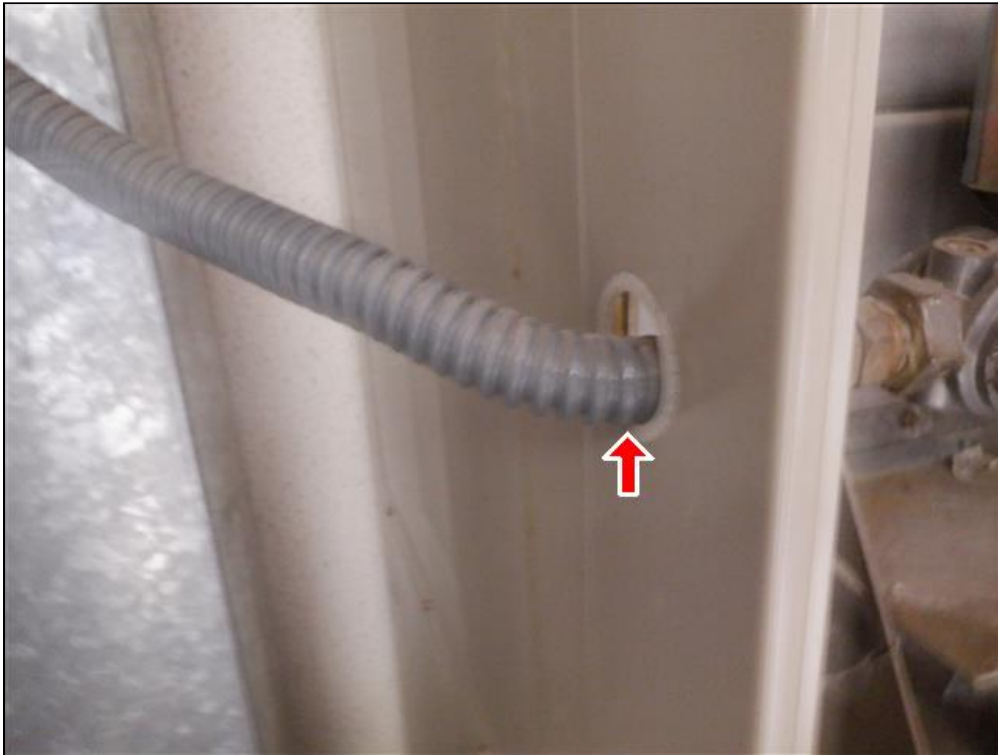
10.0.A Item 6(Picture) Heating Unit 2 Flex Fuel Line

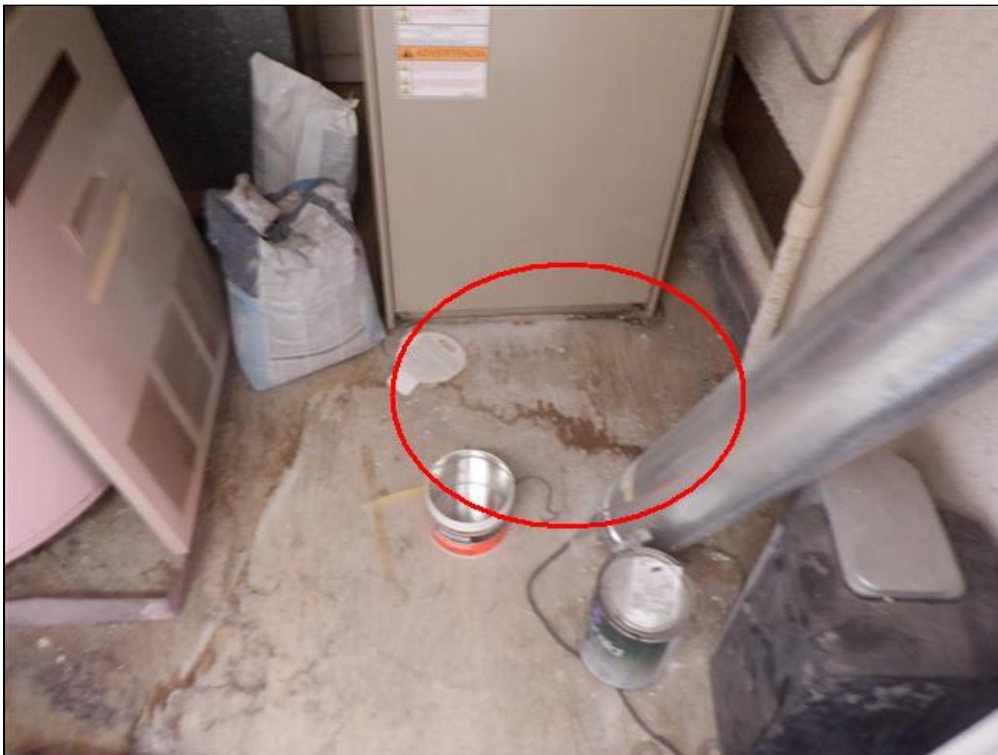
**10.3.A** We noted moisture staining on the furnace landing around both of the heating units. We believe that these units have been leaking condensate. Recommend evaluation and servicing by a licensed HVAC contractor to confirm that condensate lines are clear of debris and draining properly.

10.3.A Item 1(Picture) Moisture Stains Furnace Landing

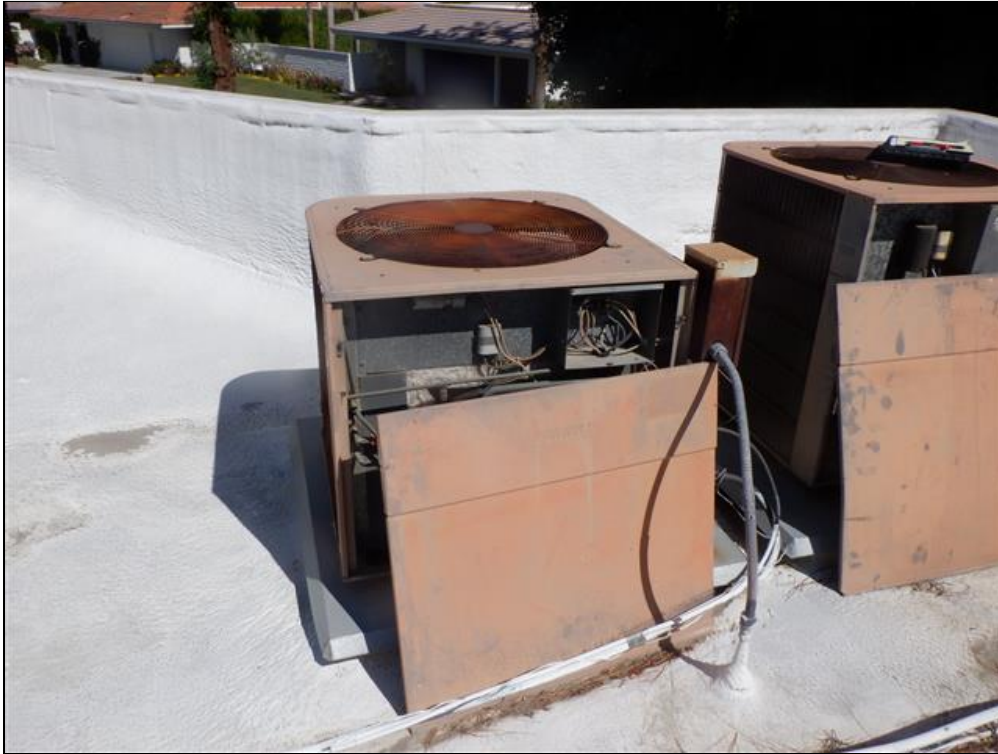
**10.8.A** These AC units are both extremely old at 36 years and although these units were producing cold air we do not believe that they were operating at peak performance. Recommend evaluation and servicing by a licensed HVAC contractor. FYI the refrigerant in these units is R-22. This refrigerant will be phased out in a few years. We also noted that both of the front covers on these units were detached, these covers should be re-installed.

10.8.A Item 1(Picture) Cooling Units

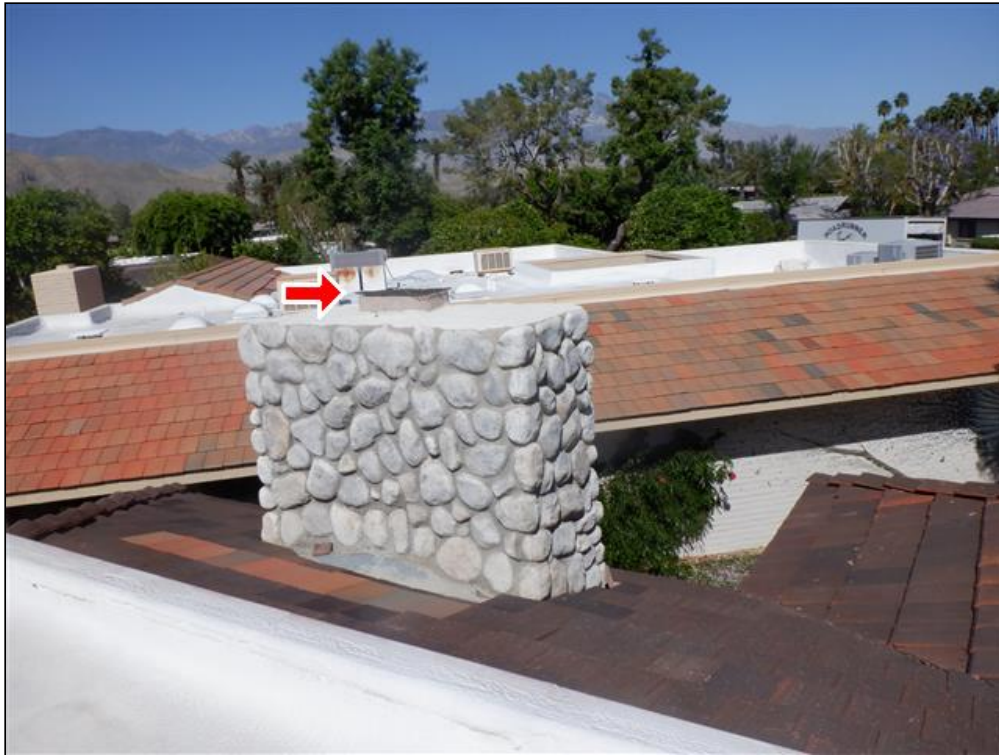
(1) We noted that this chimney has no rain cap. It is recommended that a rain cap be in place to protect the liner and brick from water damage. Water that can get in behind the flue liner can damage the liner itself the brick and interior walls. Recommend installation of rain cap as needed by a specialist.

1.2 Item 1(Picture) Chimney Missing Rain Cap

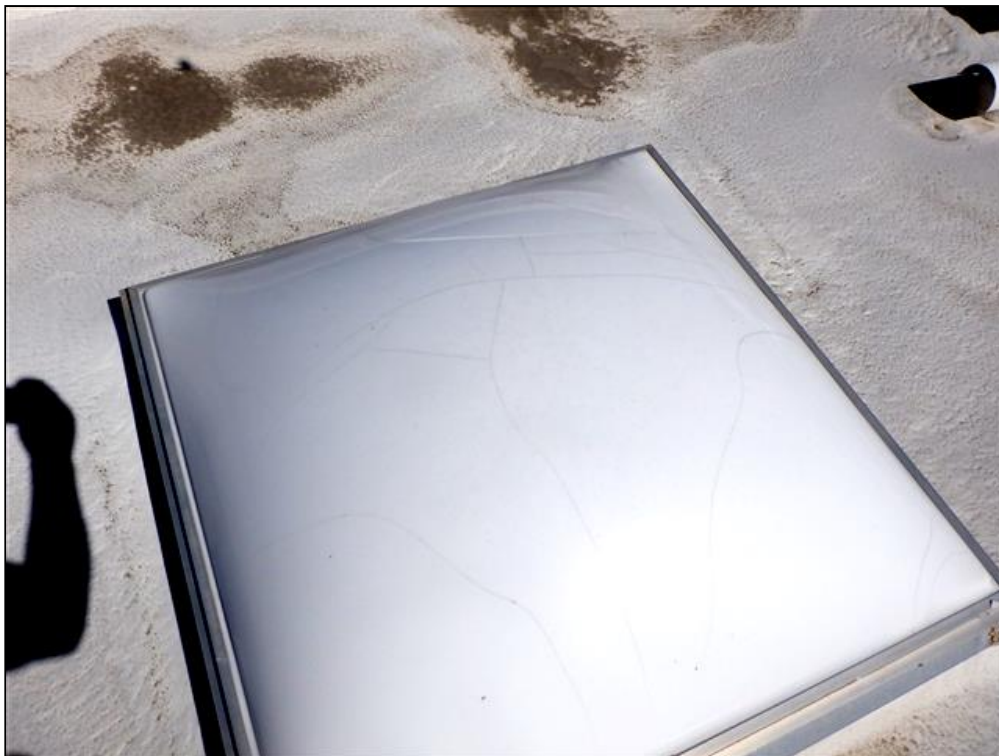
(2) Skylights are prone to leakage. We noted several of these skylights appeared to have cracks in the outer panes, ten skylights total and at least four of those were cracked. Damaged skylights will eventually lead to leakage. Recommend evaluation and replacement by a licensed roofing contractor.

1.2 Item 2(Picture) Skylight 1 Cracked

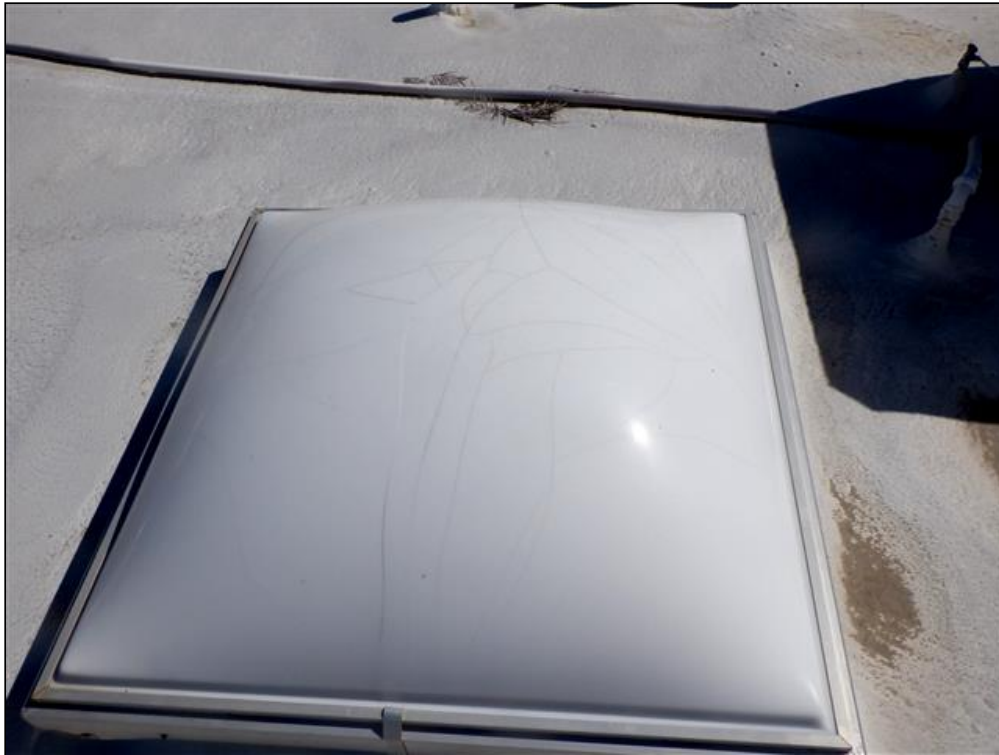
1.2 Item 6(Picture) Skylight 5 Cracked

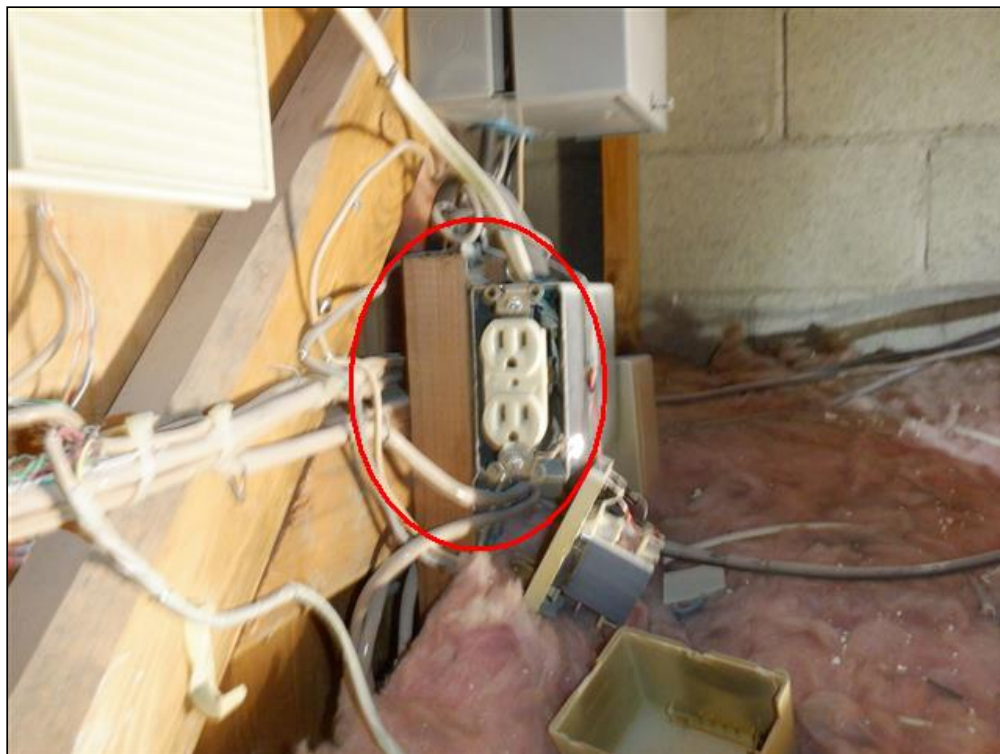
We noted at least one electrical outlet in the attic that was missing its cover plate. Recommend insulation of cover plate to avoid any future safety issues.

1.7 Item 1(Picture) Attic Electrical Outlet Missing Cover Plate

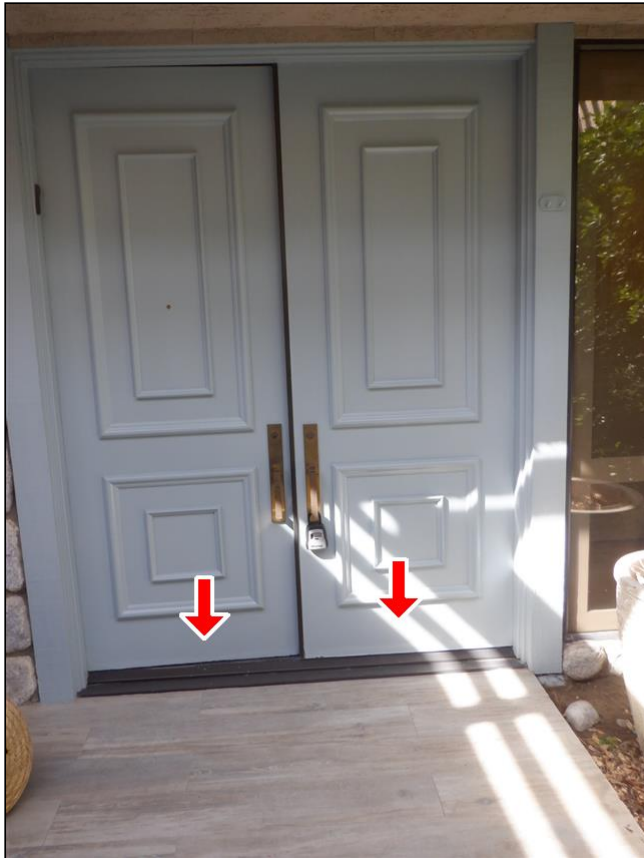
We noted that the front door appeared weathered at the bottom. Recommend evaluation by a licensed contractor repair replace as needed.

2.1 Item 1(Picture) Front Doors Weathered

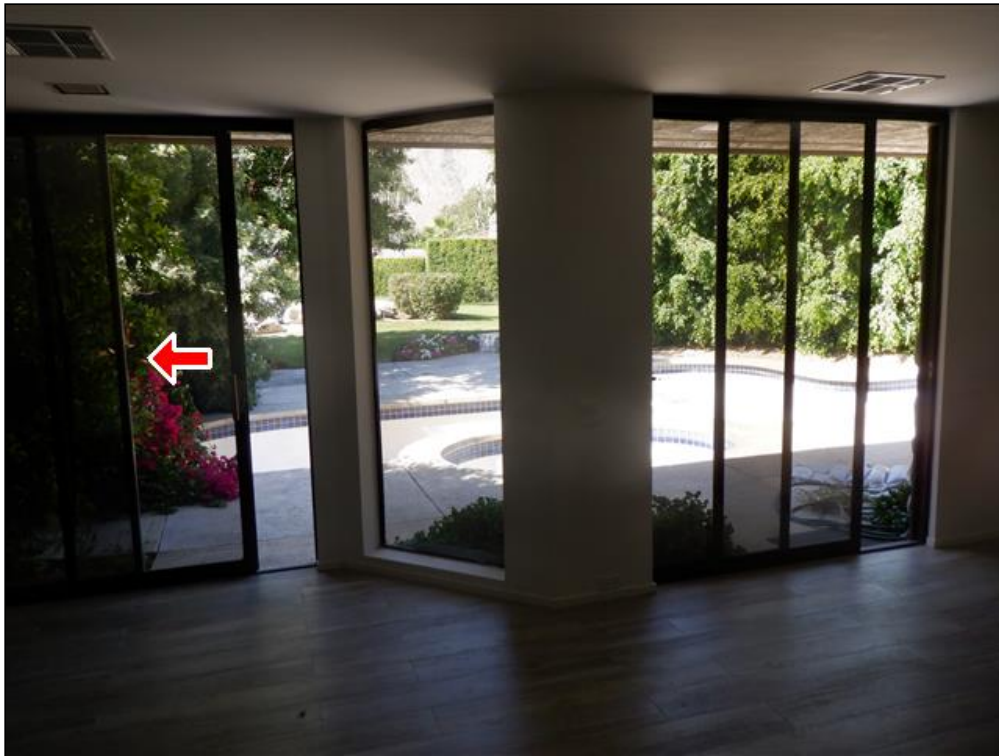
one of them failed to lock. Recommend evaluation by a licensed sliding glass door specialist to repair or replace as needed for proper operation.

2.2 Item 1(Picture) Master Bedroom Slider Bad Seal

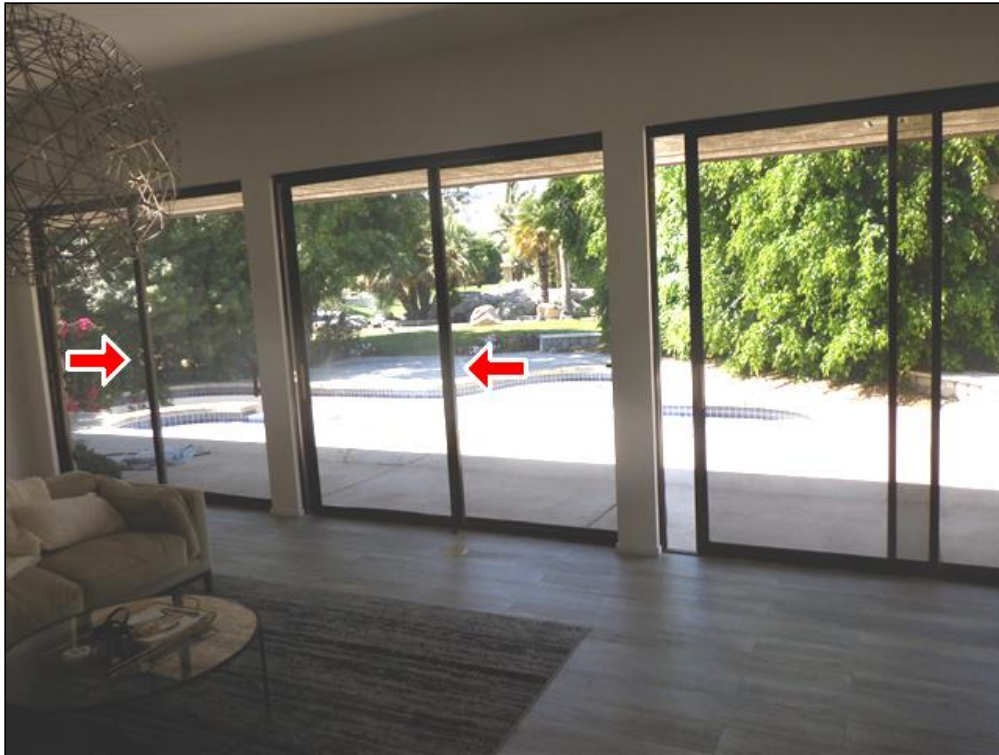
2.2 Item 3(Picture) Living Room Sliders Hard To Operate/Inoperable

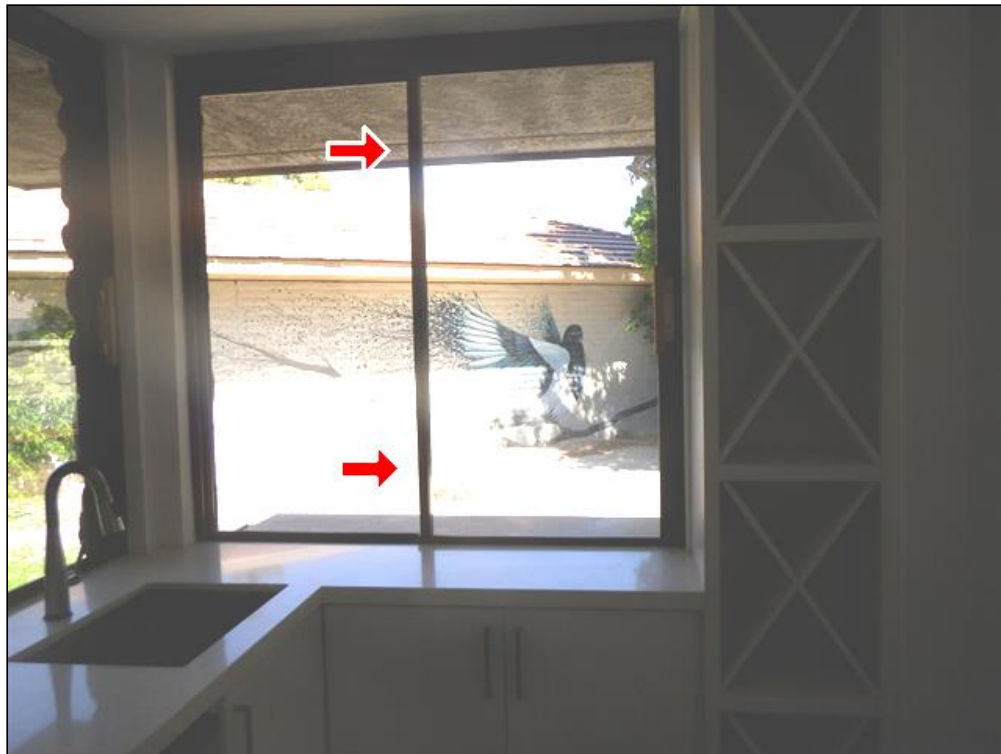
2.2 Item 5(Picture) Bar Window Inoperative

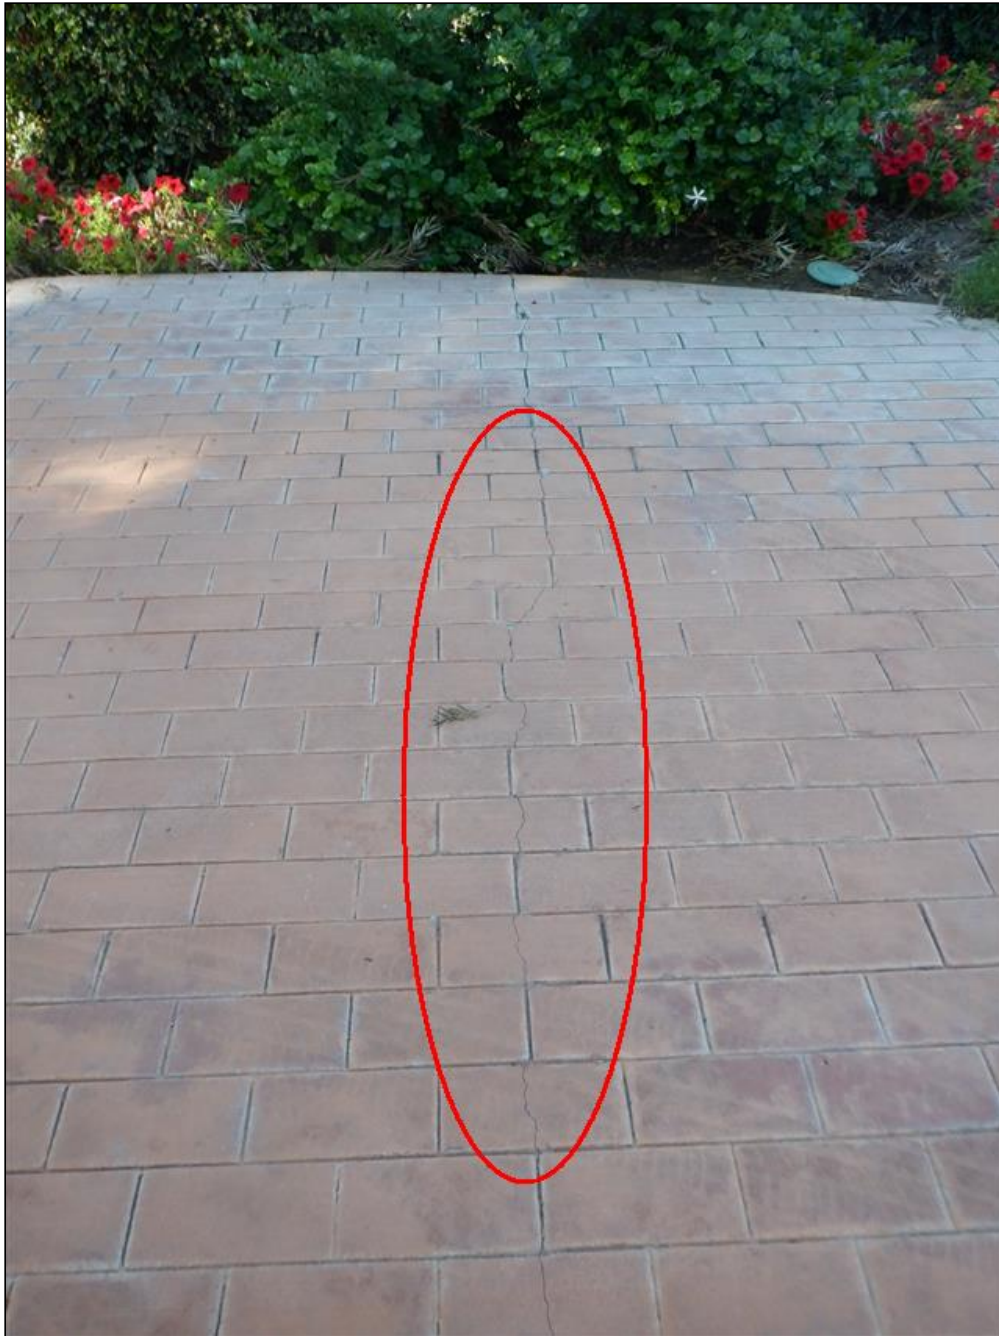
2.4 Item 2(Picture) Driveway Cracked Bricks

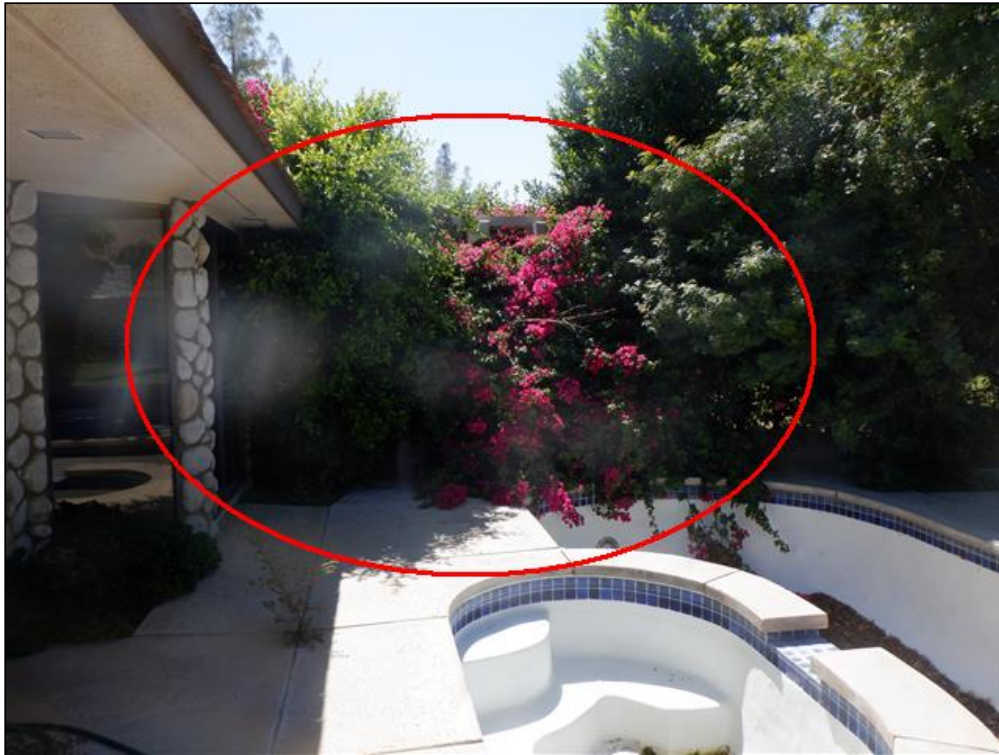
(2) We noted a bush or vine plant growing up the wall and into the eaves in the backyard and we also noted that this plant is growing into the pool. This plant should if nothing else be cut back away from eaves and pool. It is possible that damage to the eaves and pool liner will occur if this plant is allowed to grow any further. Recommend trimming bush (Vine) away from eaves and pool.

2.4 Item 6(Picture) Plant Growing Wild

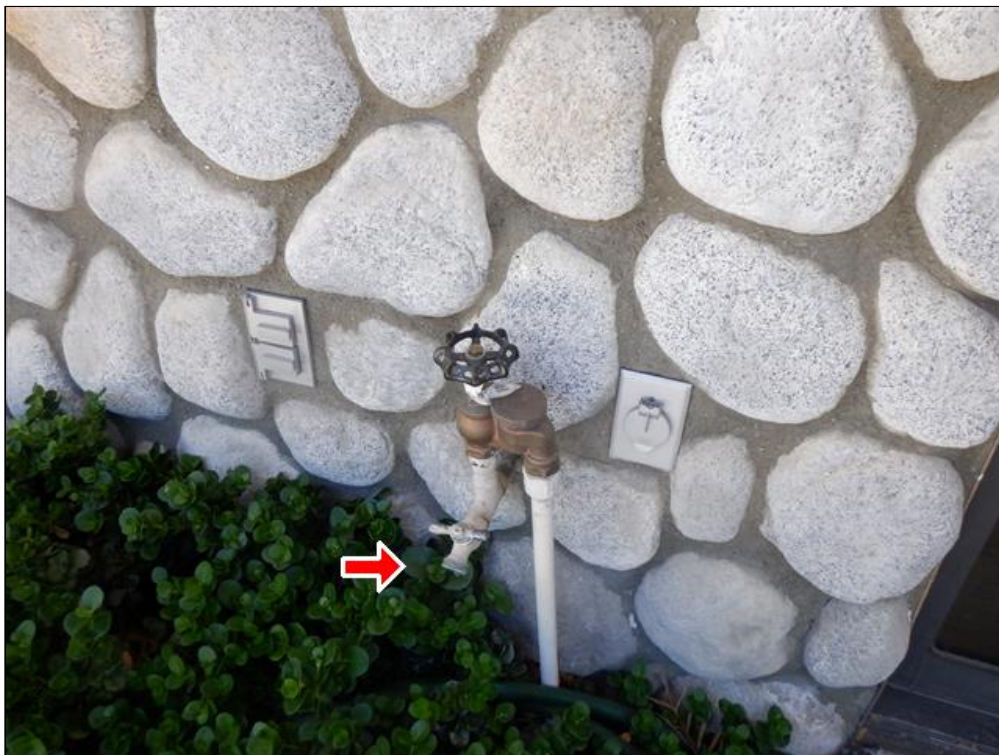
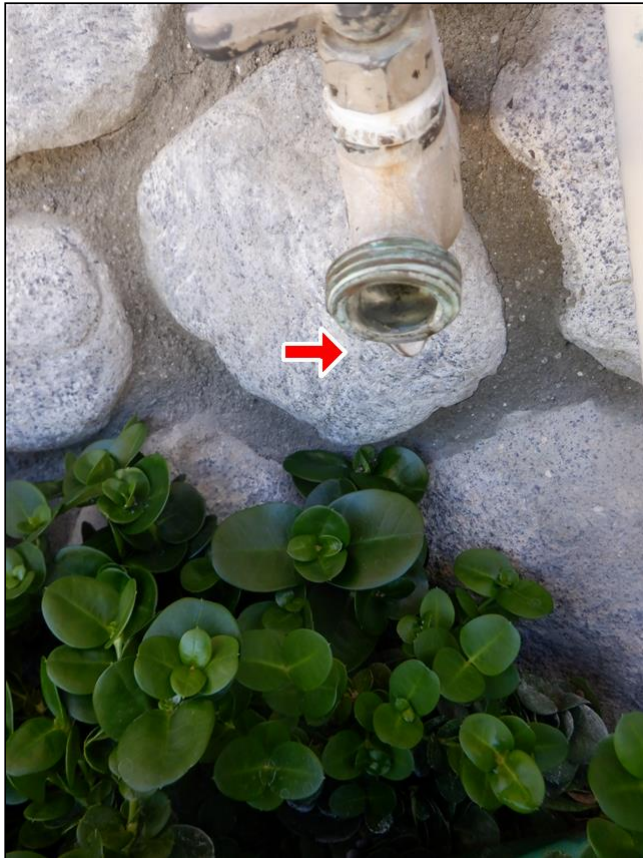
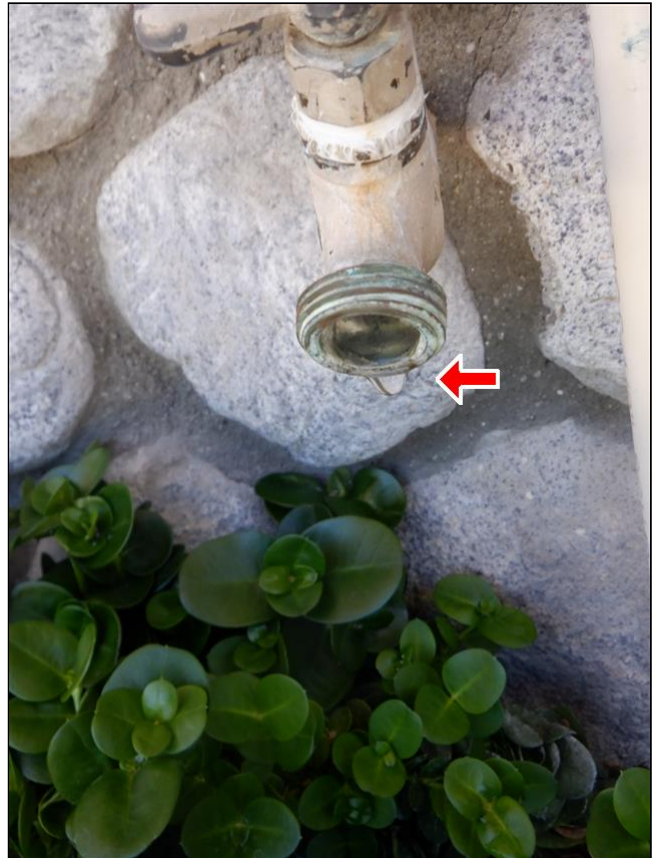
We noted that the hose bib in the backyard has a constant drip. We believe that this hose bib has a small leak. Recommend evaluation repair replace as needed by a licensed plumbing contractor.

2.6 Item 1(Picture) Hose Bib Leak

2.6 Item 2(Picture) Hose Bib Leak

2.6 Item 3(Picture) Hose Bib Leak

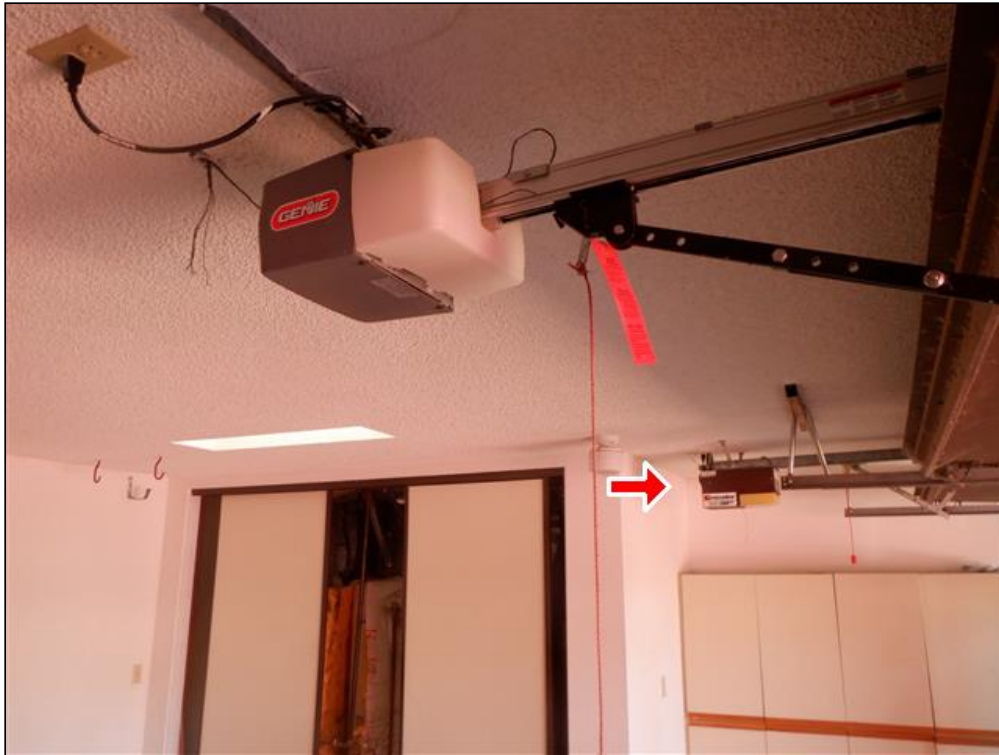
(1) Although this garage door opener was functioning we believe that it is too old to have any of the safety features of a newer opener. This garage door opener does not have electronic eyes (Sensors) and we do not believe that this garage door opener will reverse when met with resistance. At this point we believe that the only way to get these safety features would be to replace the existing opener with a new one. Recommend installation of new opener as desired. FYI single garage door opener only.

3.4 Item 1(Picture) Single Garage Door Opener Very Old
