## **Inspection Report**

**Property Address:**  
12 Sussex Ct  
Rancho Mirage CA 92270

**Livingston Home Inspections**

<b>Date:</b> 4/27/2020	<b>Time:</b> 09:30 AM	<b>Report ID:</b> 20200427-12-Sussex-Ct
<b>Property:</b> 12 Sussex Ct Rancho Mirage CA 92270	<b>Customer:</b> Pro-Com Products Inc Johnny Zhu James Park	<b>Real Estate Professional:</b> Joe Chung Compass

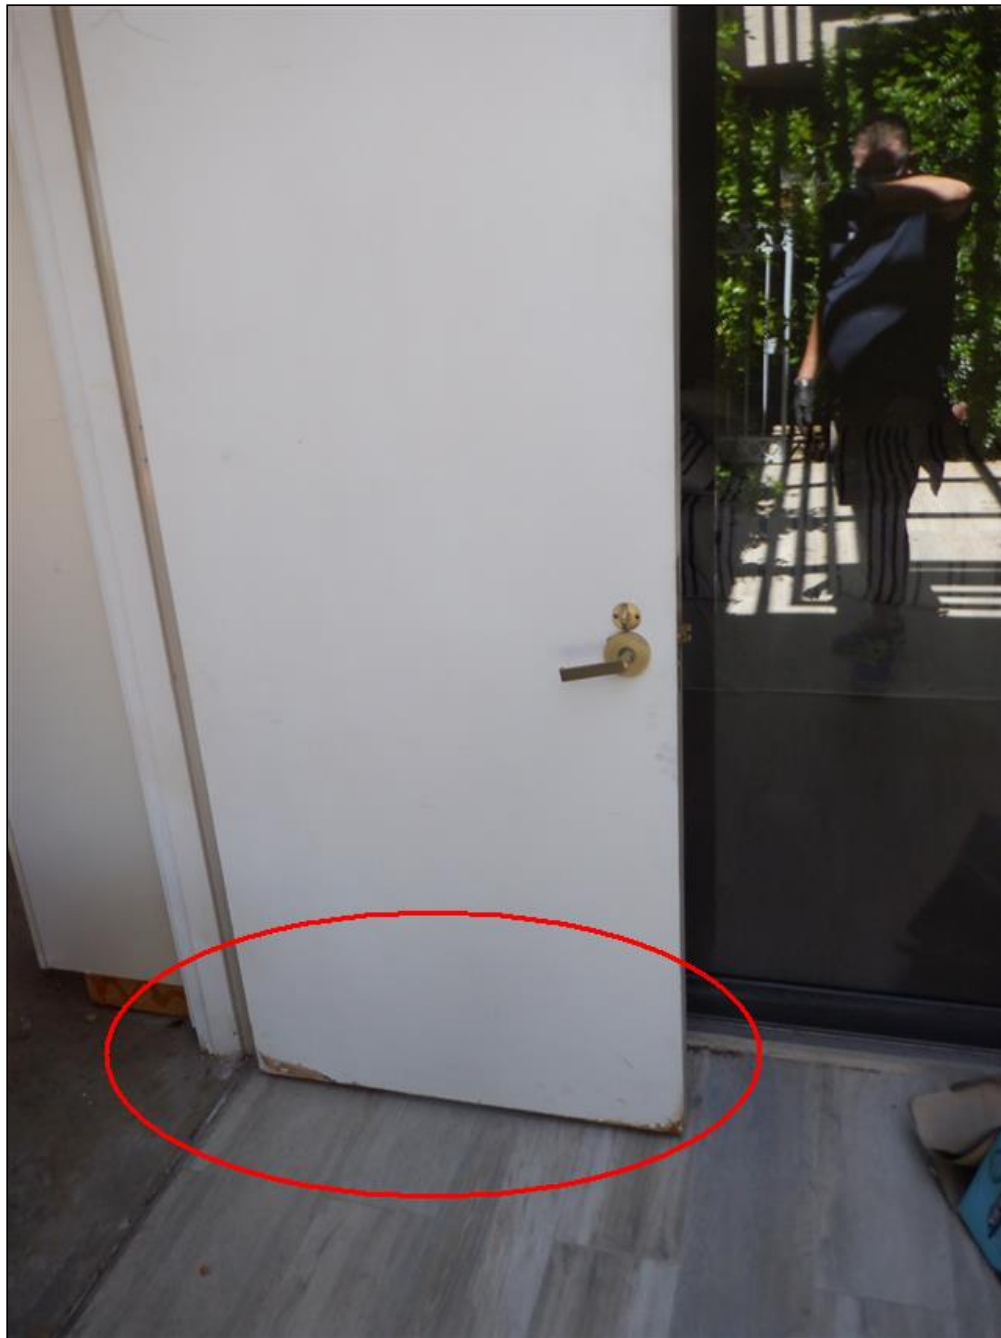
3.7 Item 1(Picture) Garage Man Door Stained/Weathered

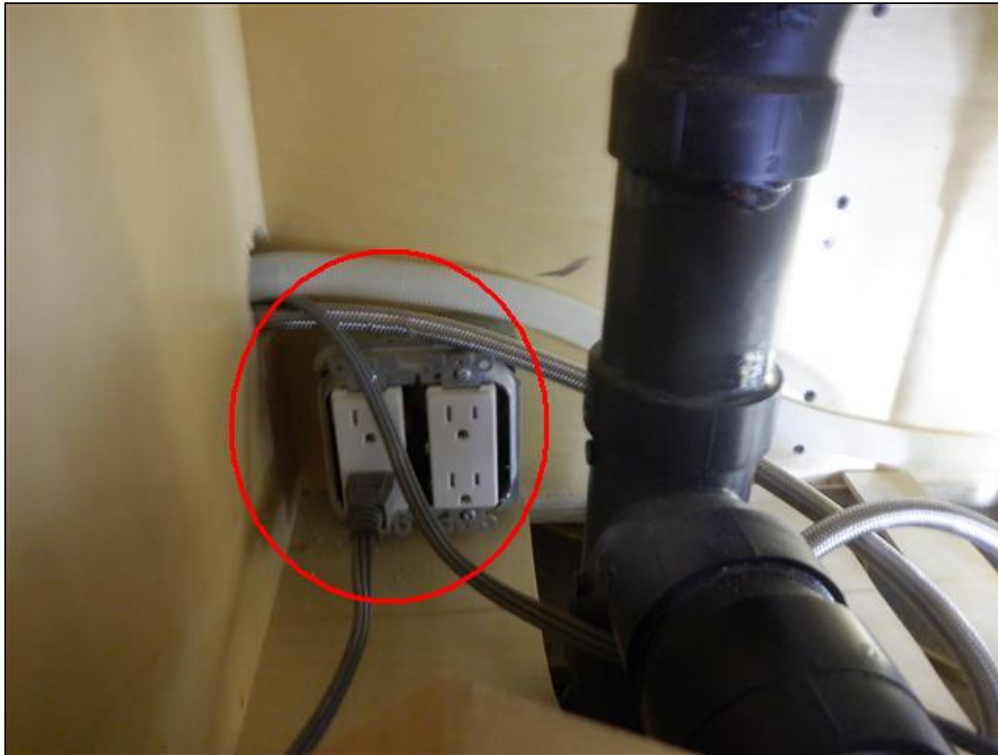
4.7 Item 1(Picture) Missing Outlet Cover Plate

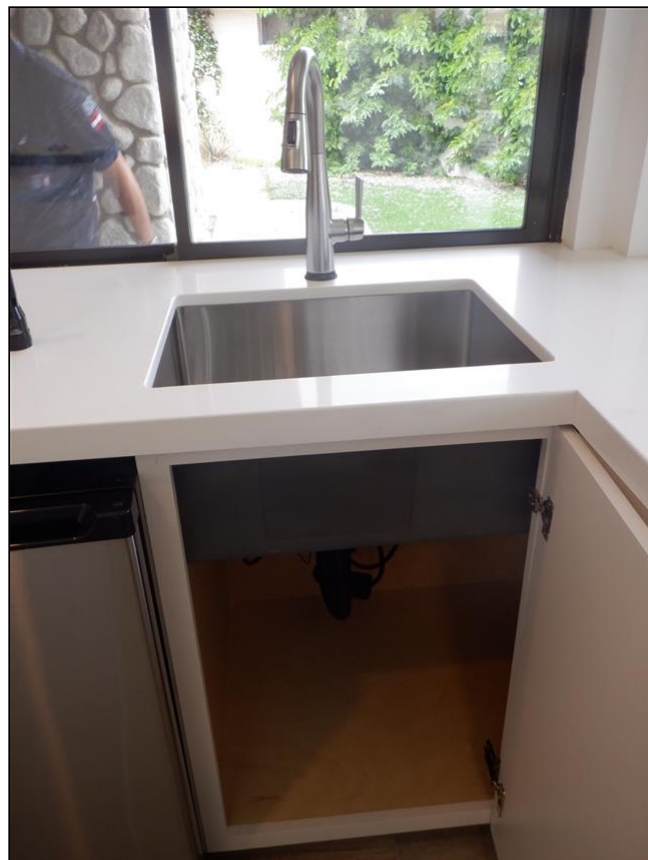
4.15 Item 1(Picture) Bar Sink Faucet

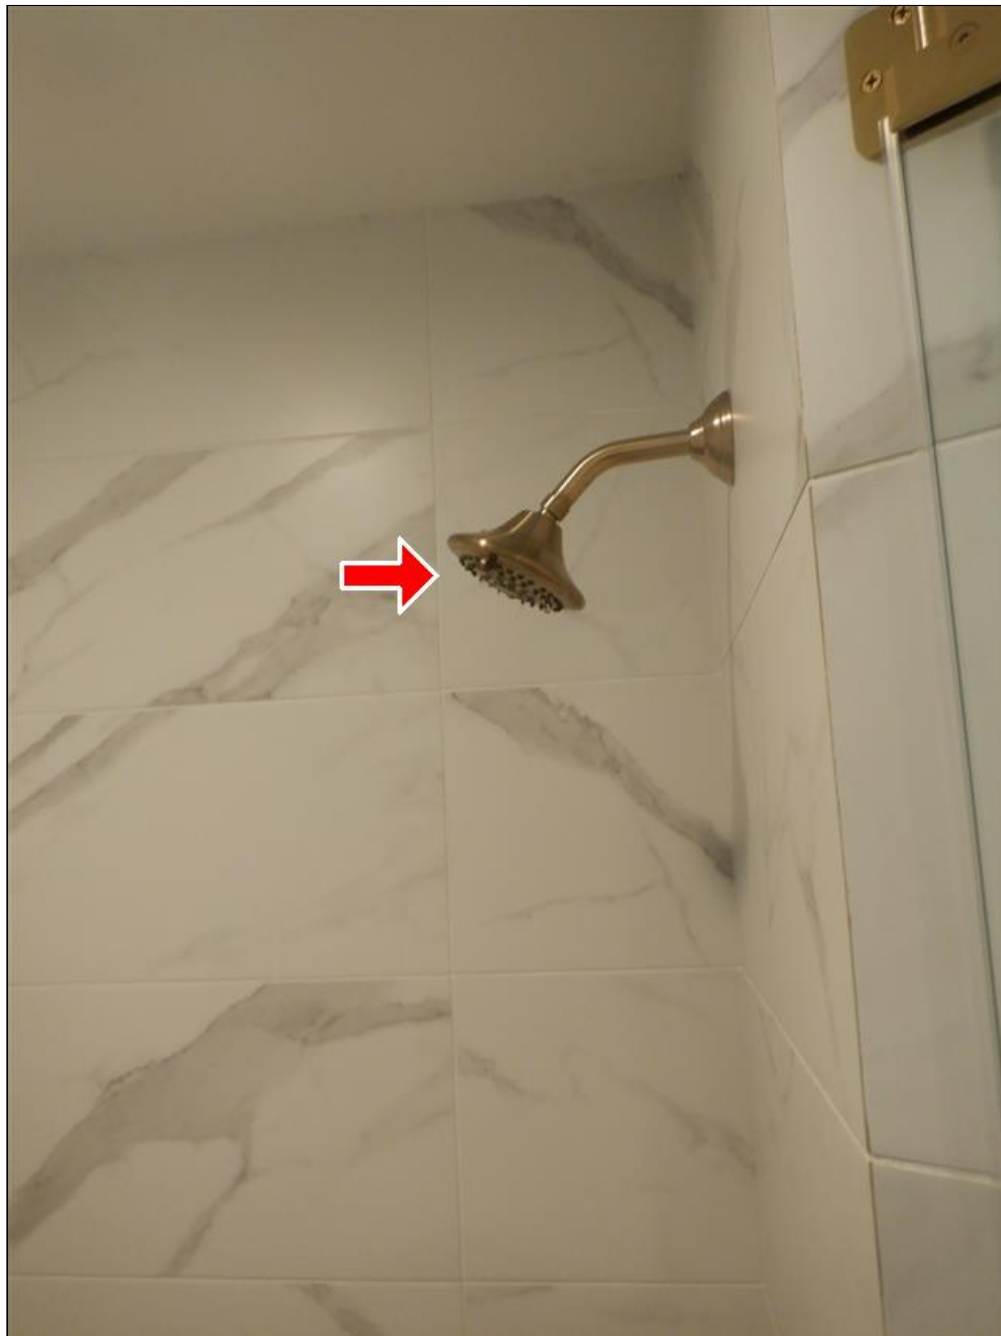
6.4.B Item 1(Picture) Shower Head Low Flow

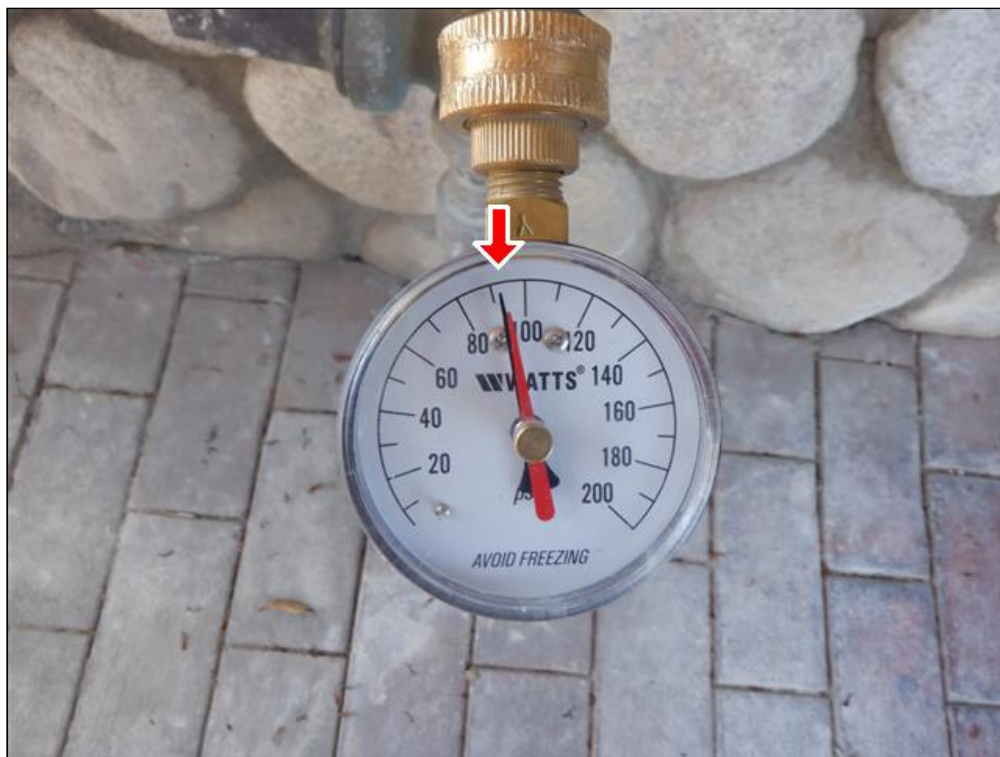
8.5 Item 1(Picture) Water Pressure 92 psi

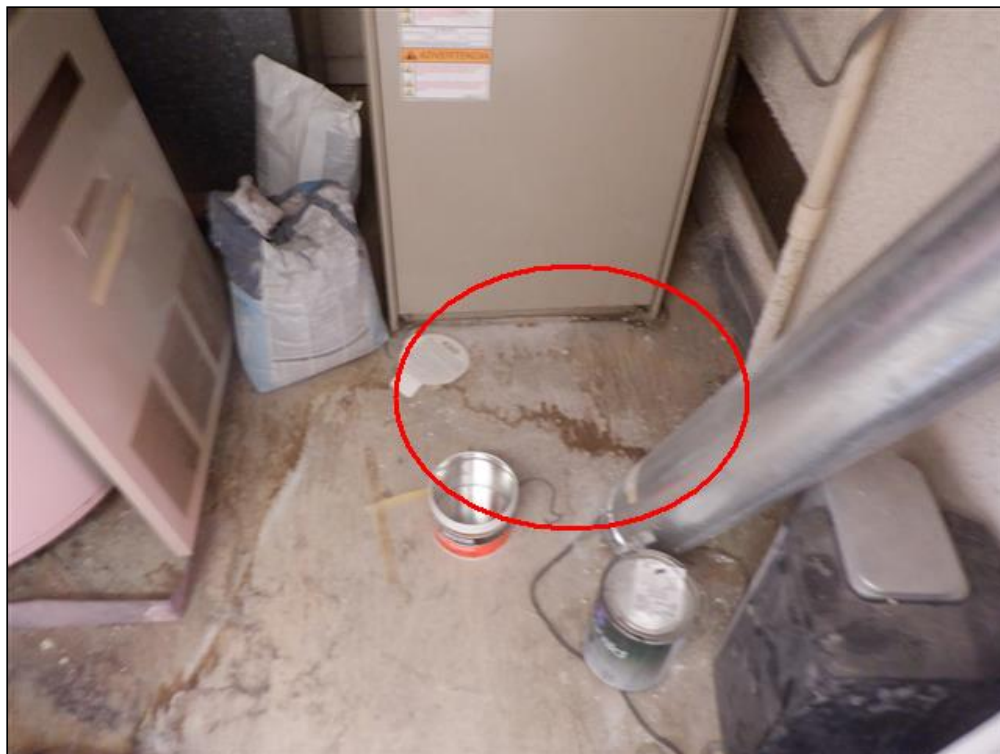
10.3.A Item 1(Picture) Moisture Stains Furnace Landing

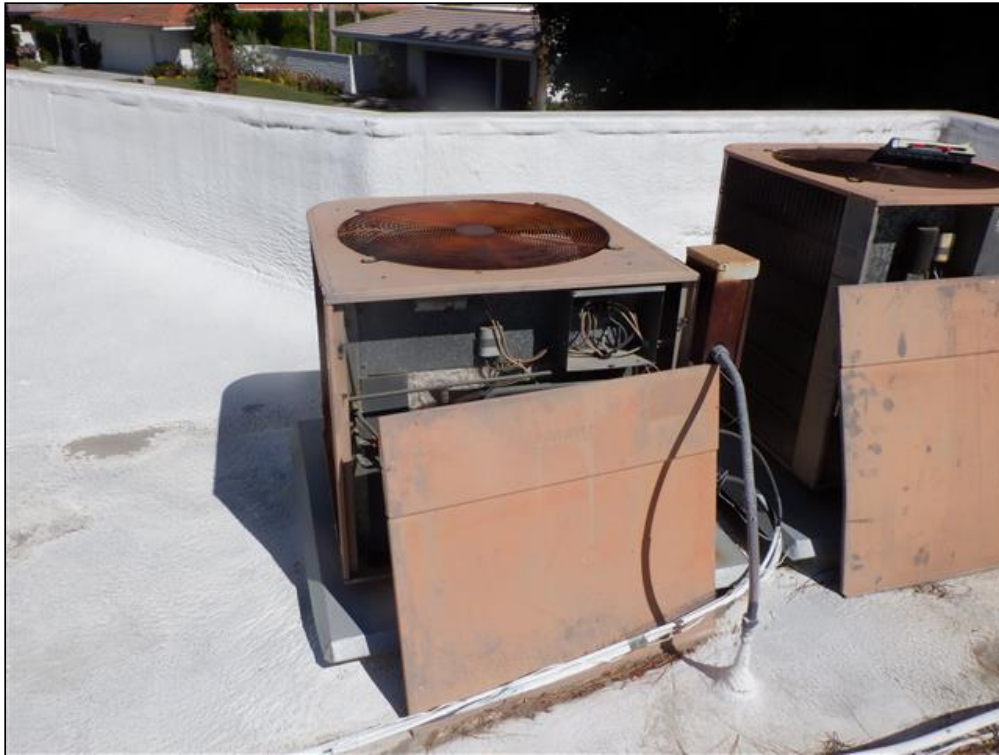
10.8.A Item 1(Picture) Cooling Units

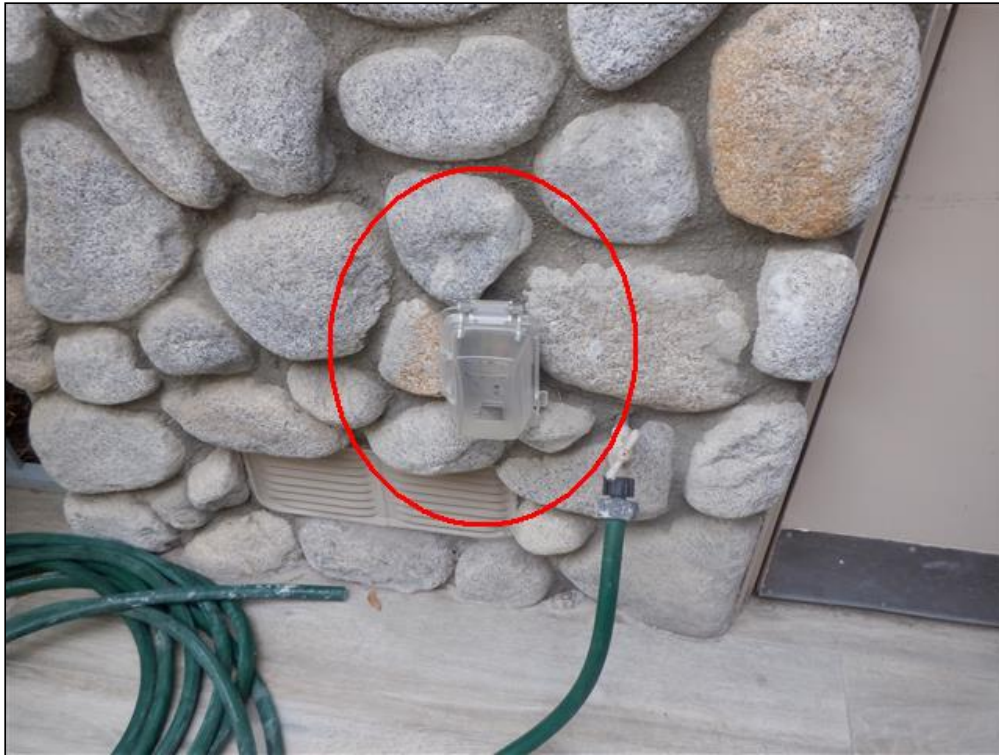
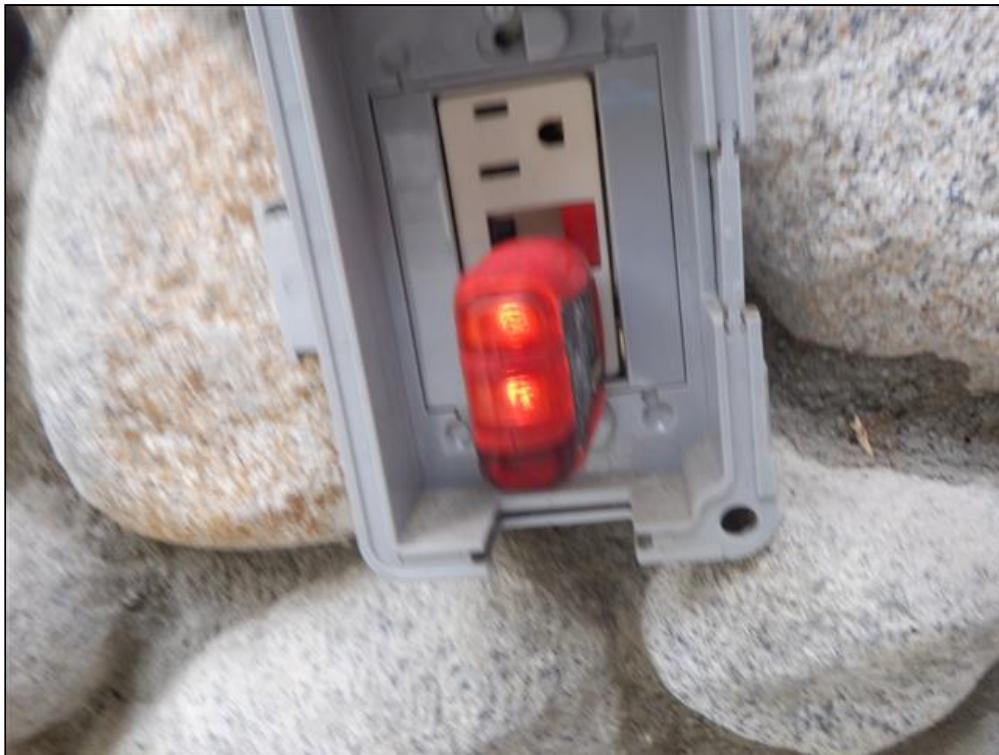
2.7 Item 1(Picture) GFCI Outlet Failed To Trip

2.7 Item 2(Picture) GFCI Outlet Failed To Trip

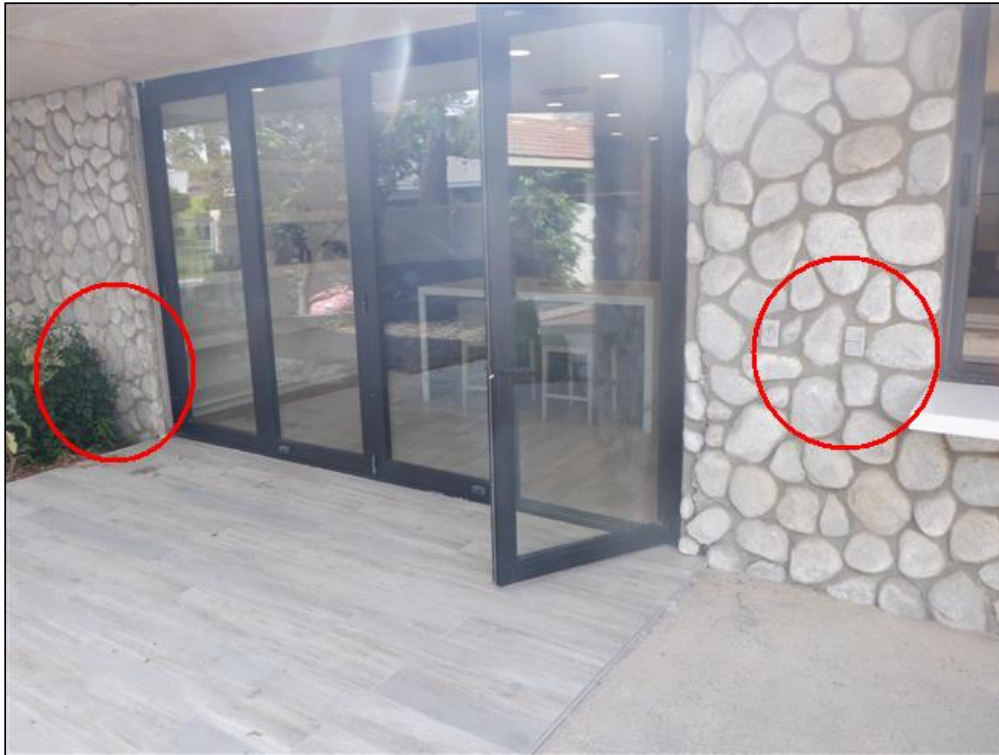
2.7 Item 3(Picture) North Patio Outlet No Power

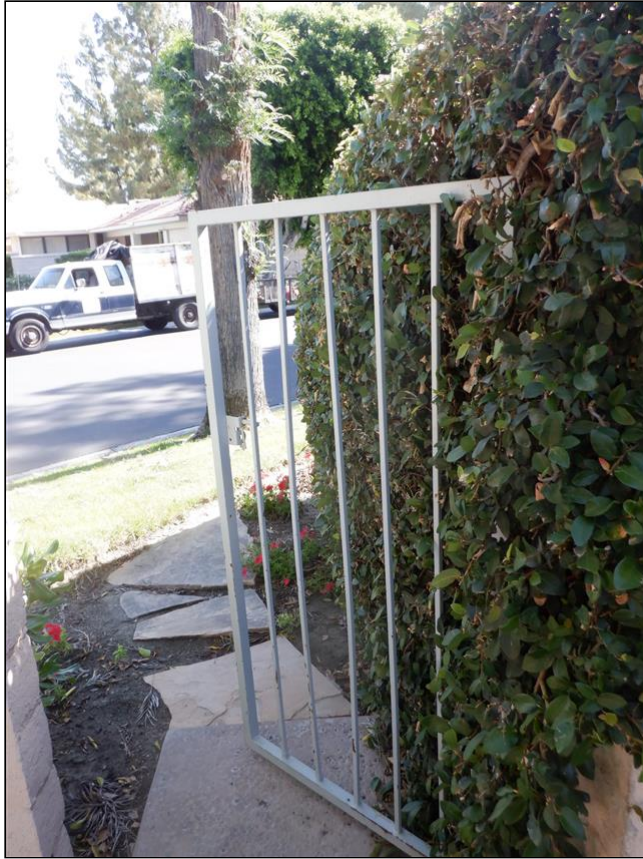
2.10 Item 1(Picture) Gate To Backyard

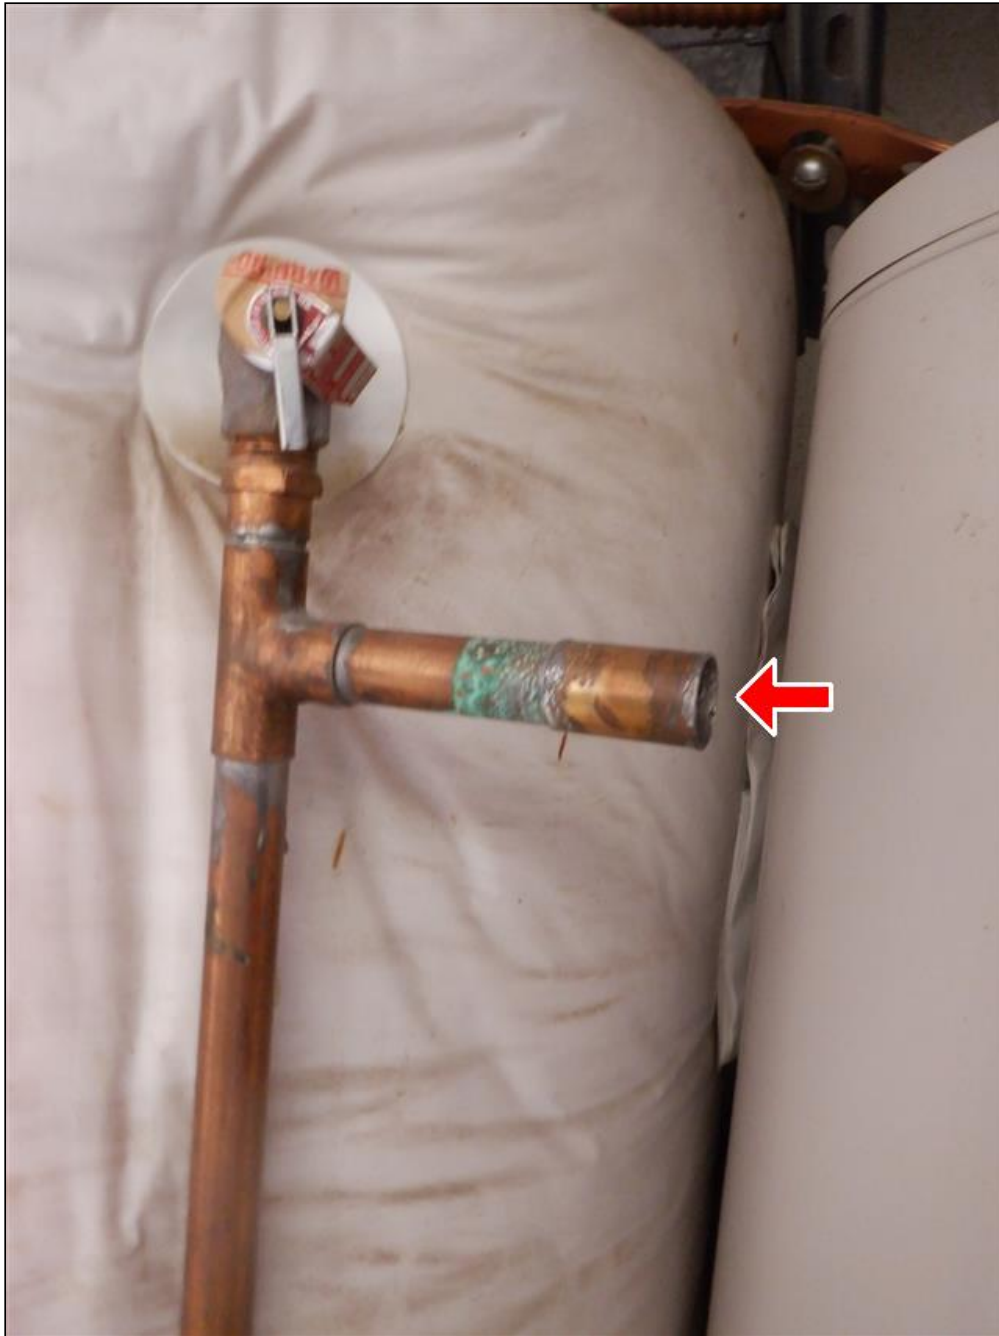
8.3 Item 1(Picture) Secondary Water Heater TPRV Valve Piping Open

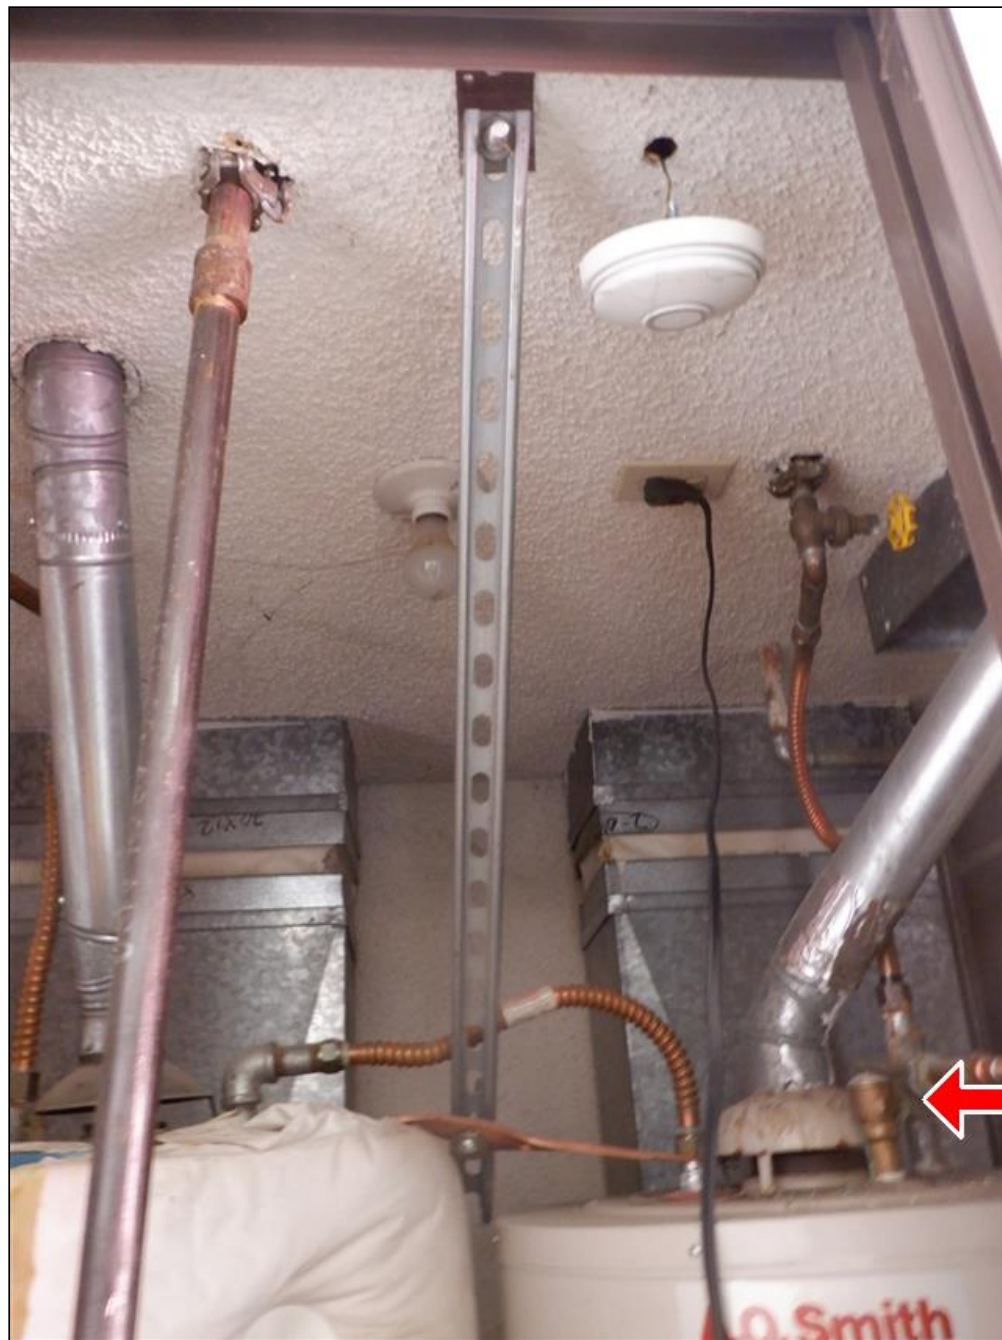
8.3 Item 2(Picture) Main Water Heater Missing TPRV Valve Piping

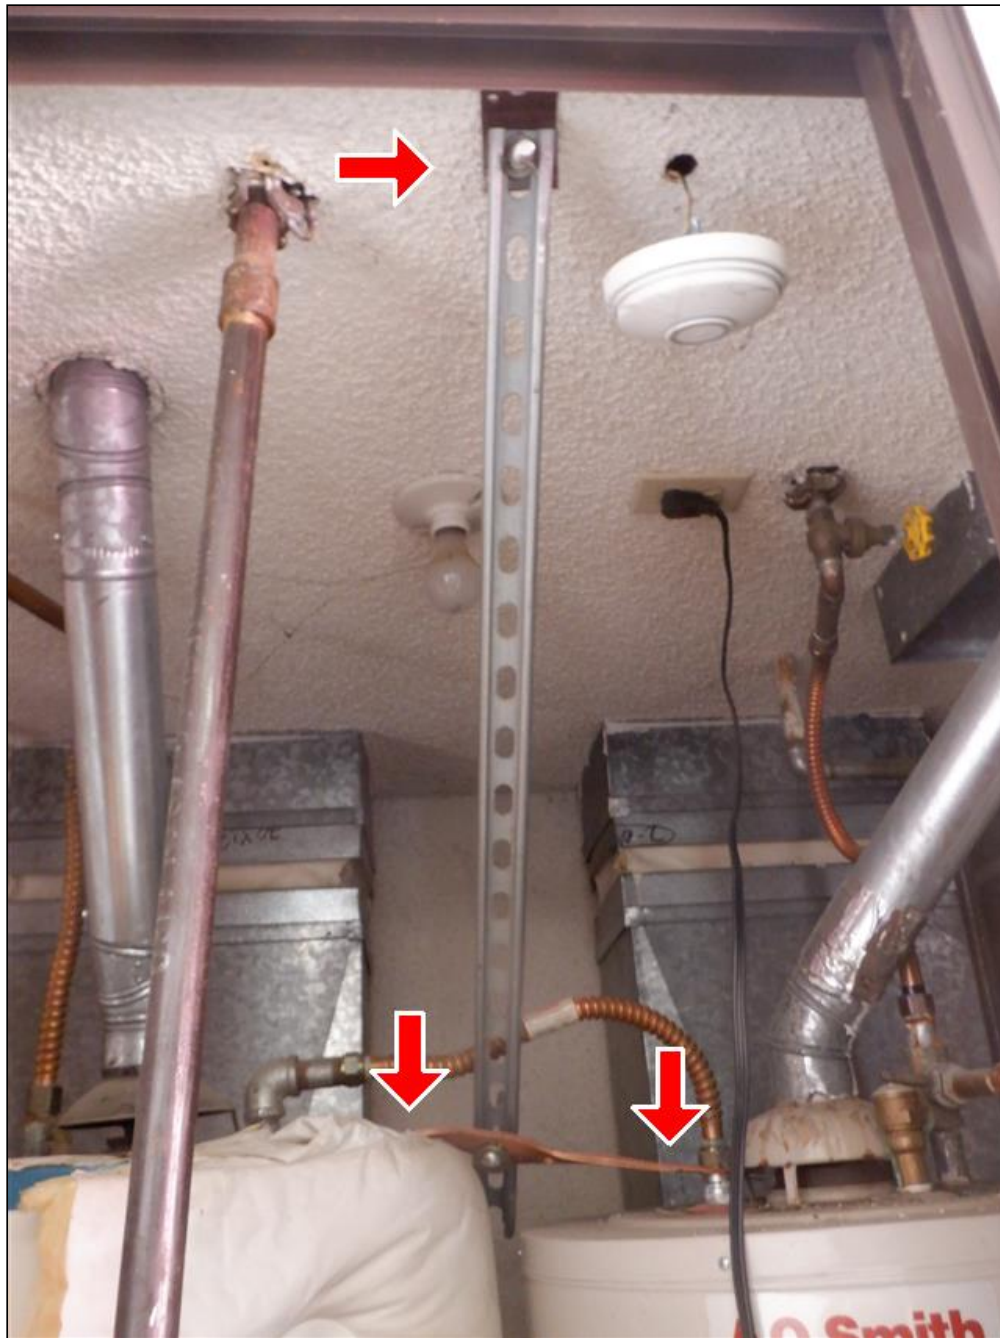
8.4 Item 1(Picture) Existing Seismic Bracing Not Approved
