# Inspection Report

**Jeff Boles**  
**111 Flag Way**  
**Paso Robles, CA 93446**

*Inspected by:* **Benjamin P. Terry**

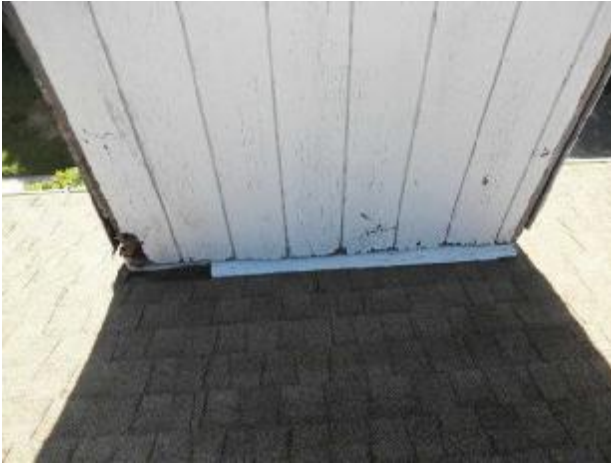
**Maintenance Note:** There is no "cricket" flashing behind the chimney enclosure. This is installed so water can drain around the chimney. Without a proper cricket the flashing area may be prone to leaks.

No cricket flashing behind the chimney enclosure.

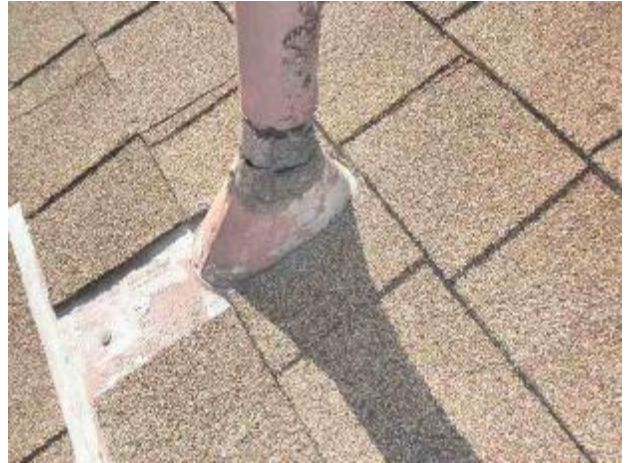
**Maintenance Note:** The sealant at the flashings has become cracked and deteriorated from exposure to the sun. Recommend resealing the flashings to prevent water intrusion.

The flashings need to be resealed.

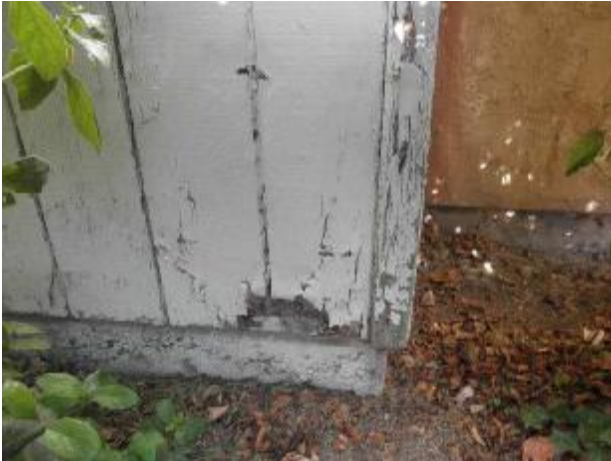
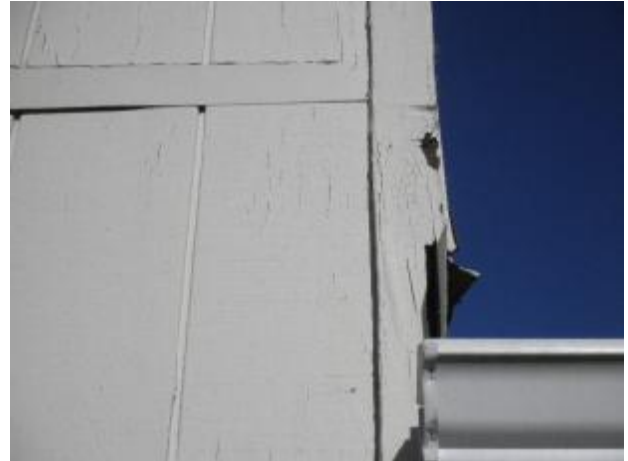
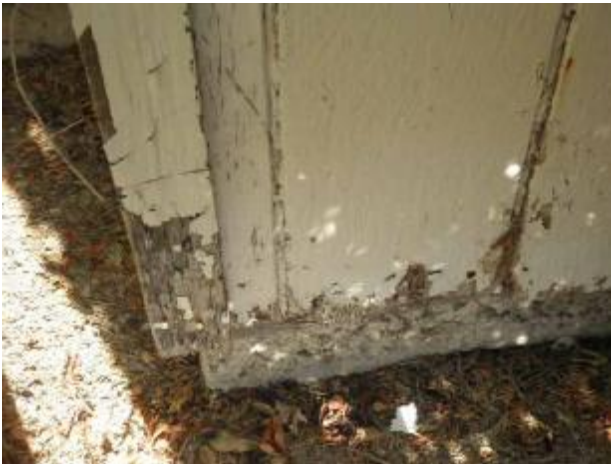
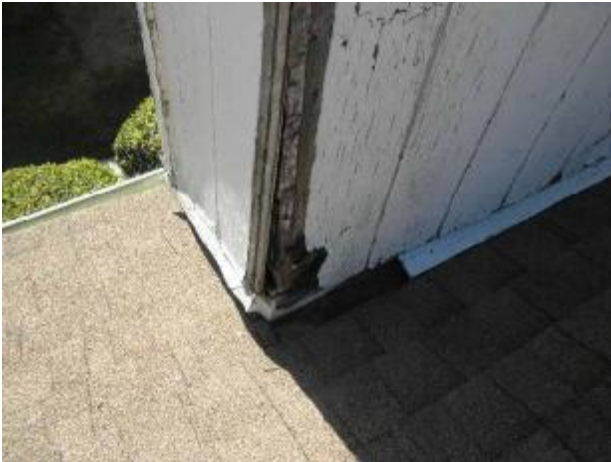
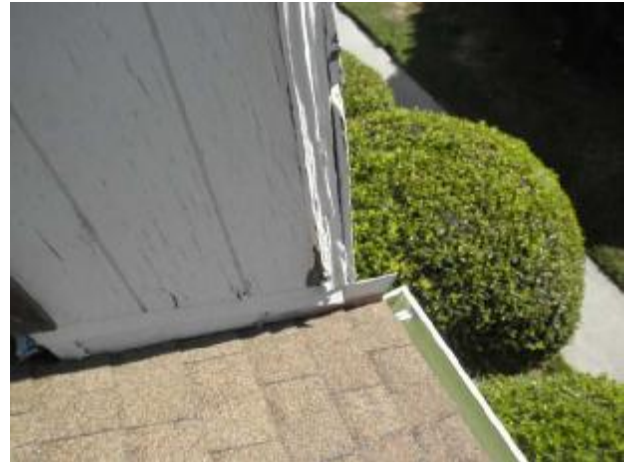
- 16 1.) There is moisture damage to several areas of the chimney enclosure and trim.  
2.) There are holes/damaged to the base metal track at the dining room slider.

Moisture damage to the wood siding and trim at the chimney enclosure.

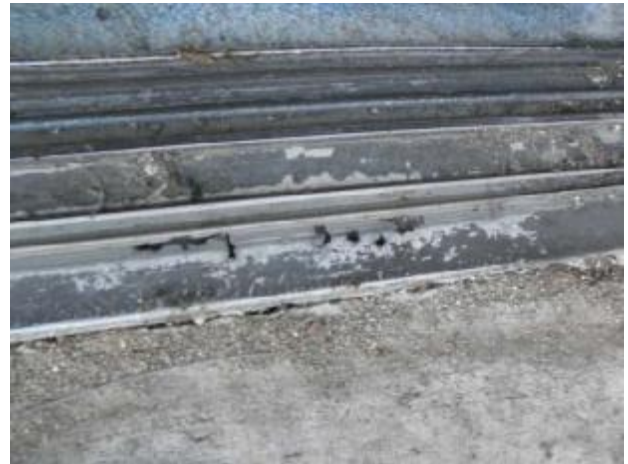
Damage/holes to the metal track for the sliding glass door.

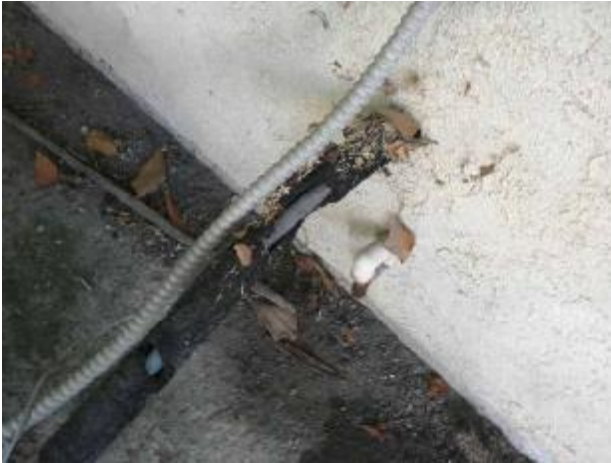
- 1.) The insulation at the low pressure refrigerant lines for the condenser unit are damaged and need to be replaced.

Damage to the insulation at the low pressure refrigerant lines.

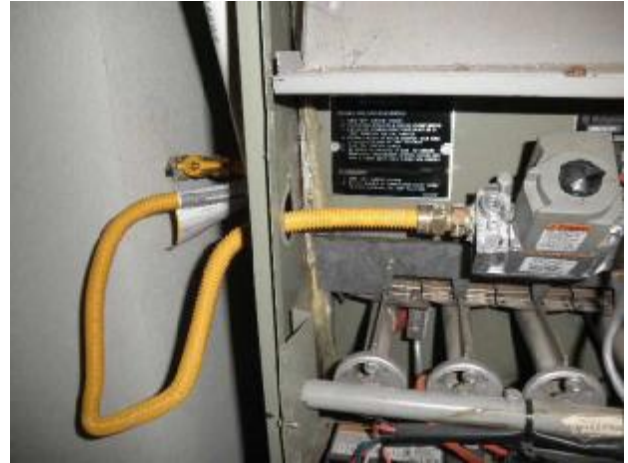
Flexible gas line penetrates the housing at the furnace.

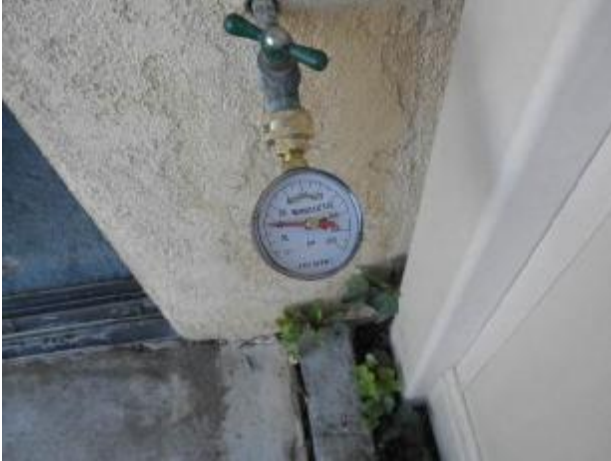
Water pressure is 40 psi.

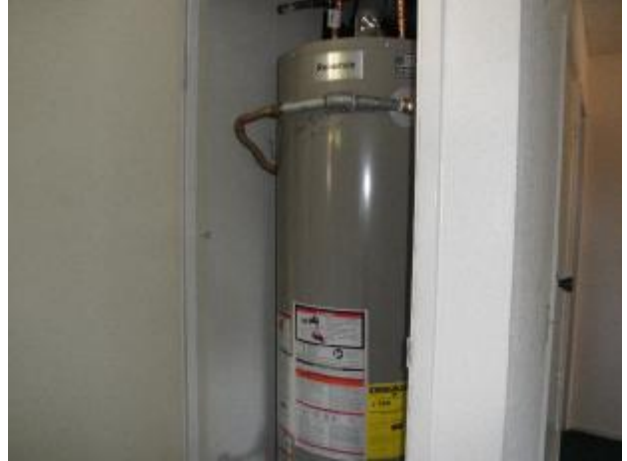
Safety Hazard Note: The water heater is inadequately braced. Recommend installing a State approved earthquake restraint strapping system.

Improper straps at the water heater.

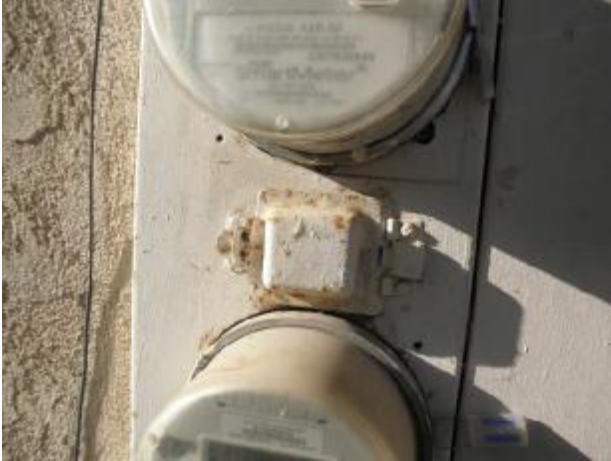
Main electrical shut off should be labeled.

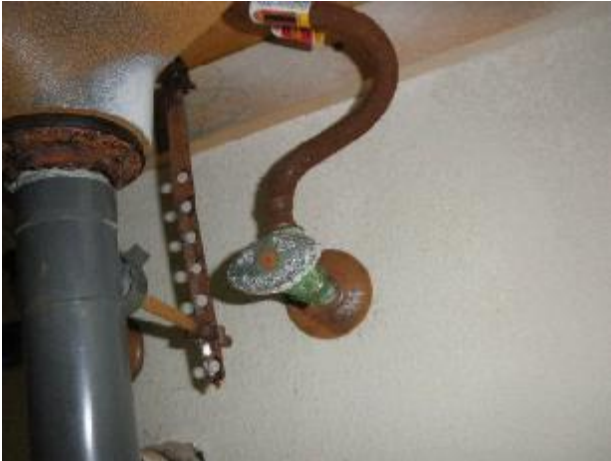
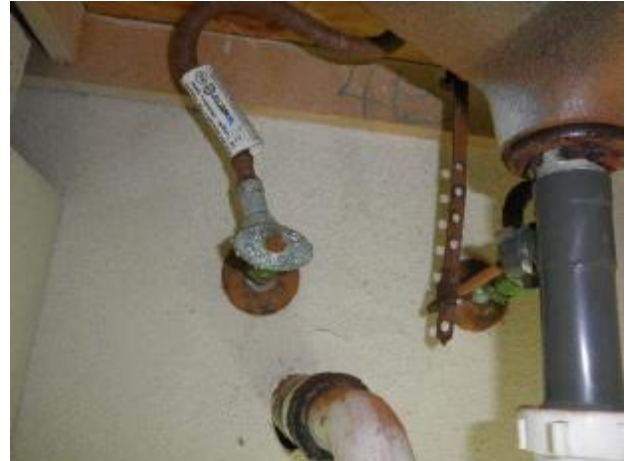
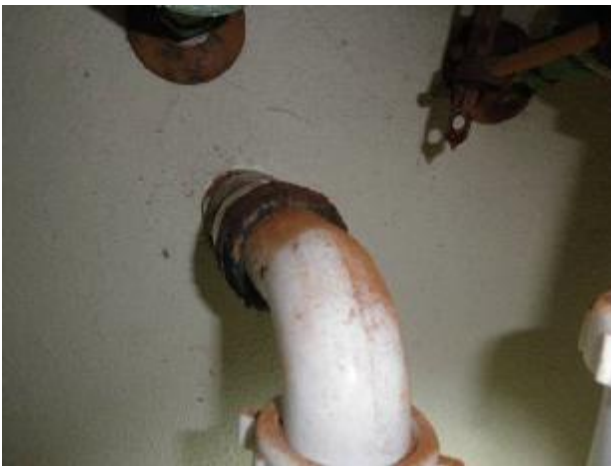
Rust damage to the angle stop valves and drain line connection at the hall bathroom sink.

1.) There is heavy rust and hard water damaged to the angle stop valves and drain line at the hall bathroom sink.

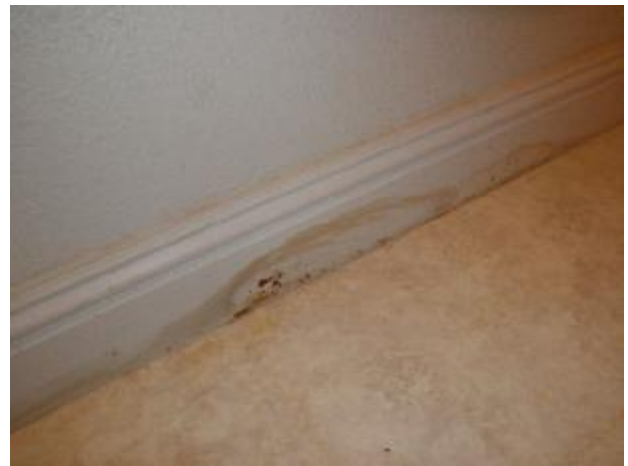
Water stain at the base of the hall bathroom wall behind the shower.

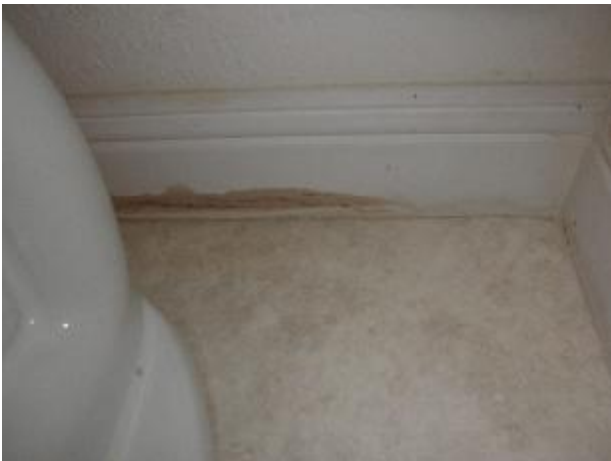
Water stain at the baseboard behind the toilet.

3.) There is a water stain behind the toilet at the baseboard in the hall bathroom.

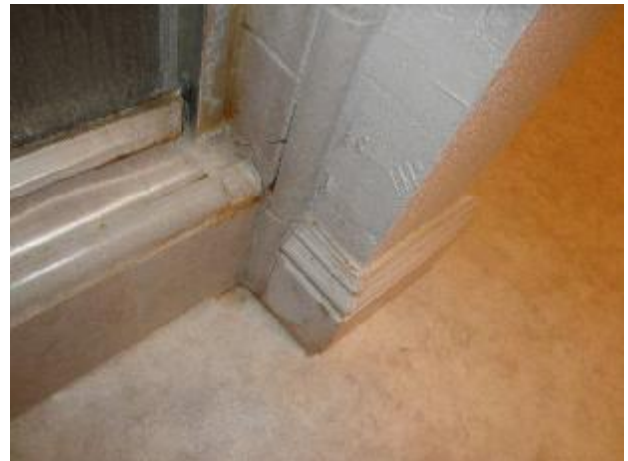
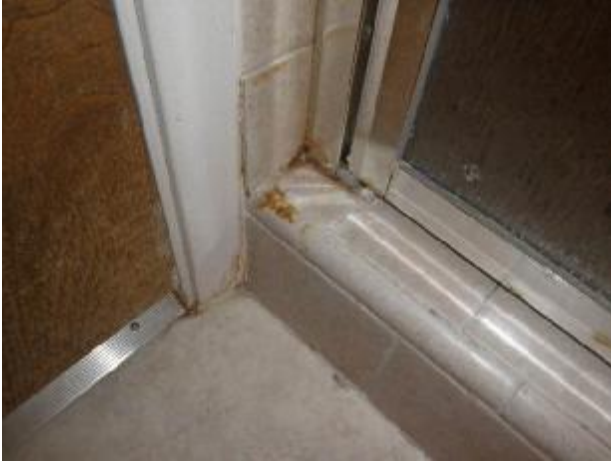
Evidence of leaks at both sides of the shower door in the hall bathroom.

2.) There are water stains at the base of the wall behind the hall bathroom shower, Also, there are damaged tiles are evidence of leaks at both sides of the shower door.

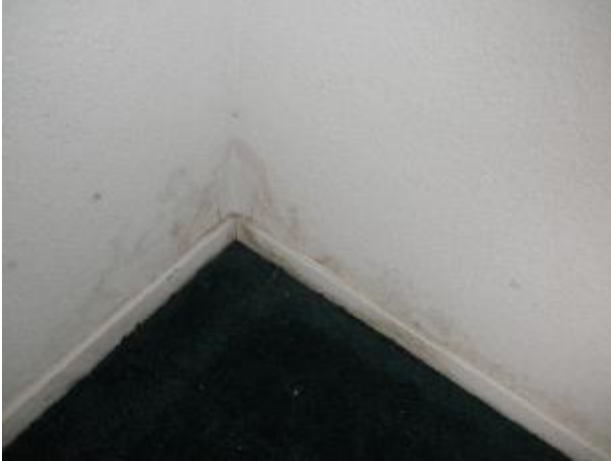
2.) There is a water stain at the base of the SE bedroom closet. Also, there is a black mildew like substance. (See notes on the Deficiency Summary page at the end of the report regarding the potential for microbial contamination.)

Water stain at the base of the wall in the SE bedroom closet.

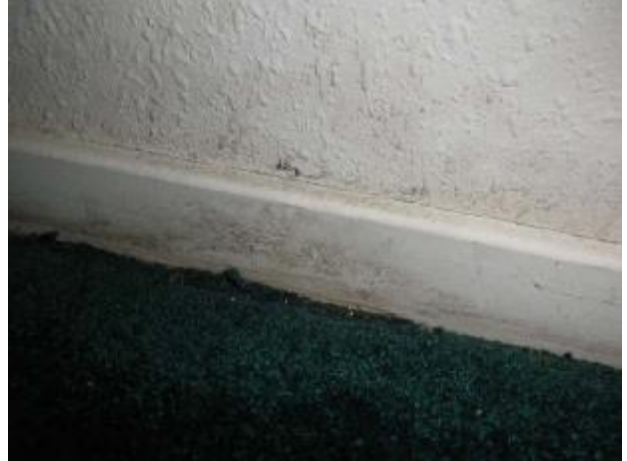
Black mildew like substance at the base of the wall in the SE bedroom closet.

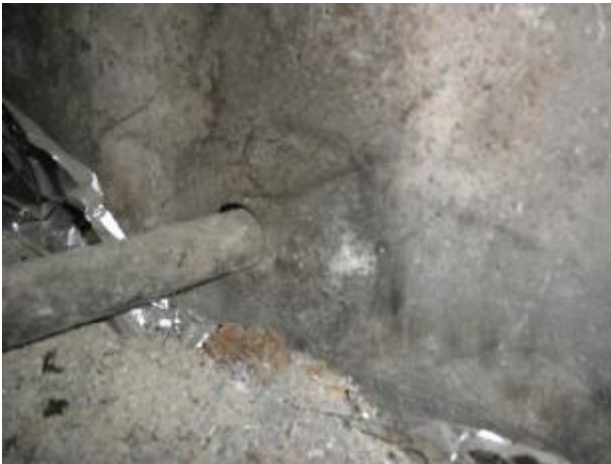
Fire Safety Hazard Note: Noncombustible caulking is needed in the gaps where the gas lighter log for the fireplace penetrates the side wall refractory plate.

Caulking needed at the gas starter pipe inside the firebox.

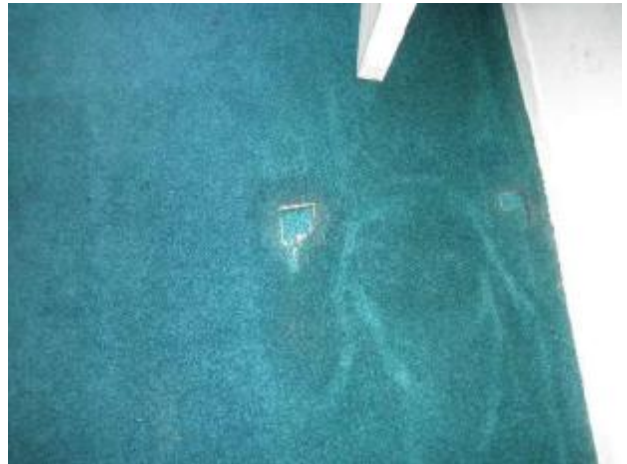
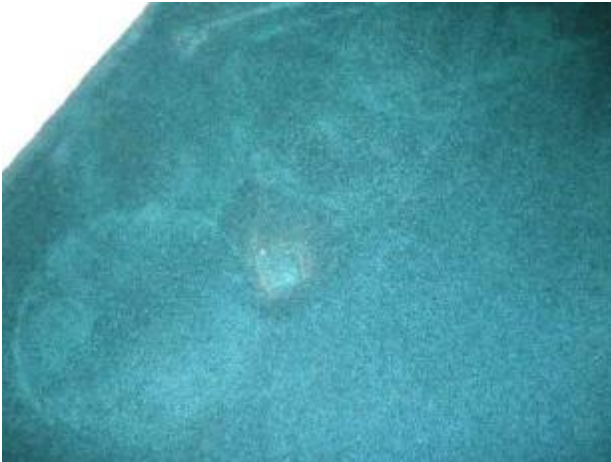
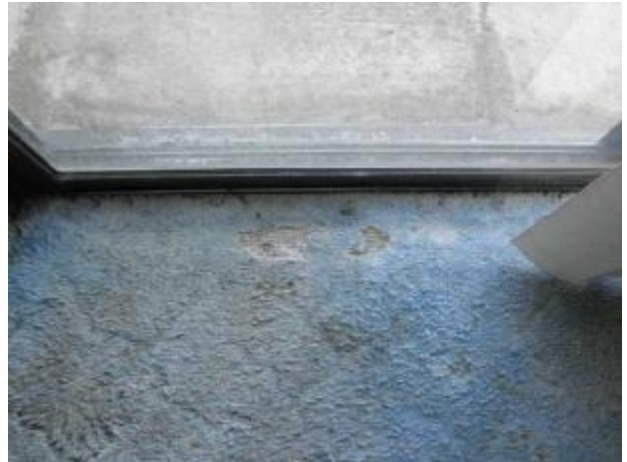
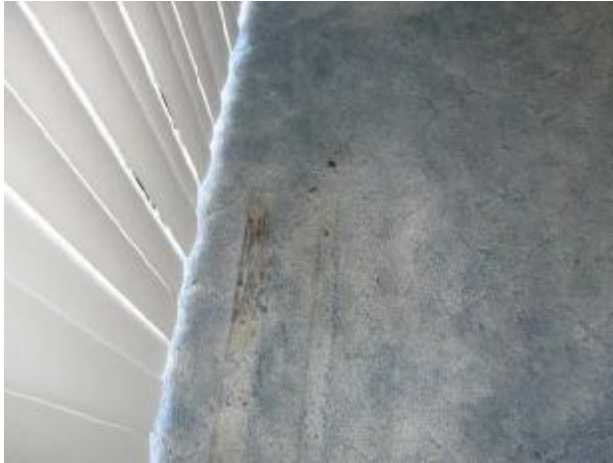
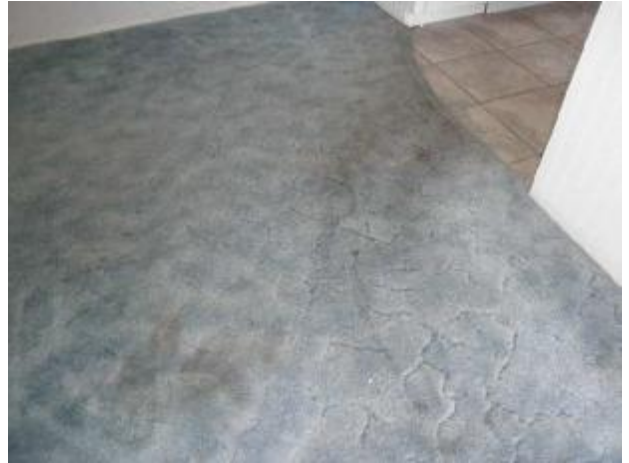
1.) There is damage and stains in the carpeting throughout the home.

Example of damage and stains to the carpeting.
