Inspection Report

Property Address: 3304 Gibson Pl Redondo Beach CA 90278

Ferguson Home Inspections

Date: 12/7/2023	Time: 02:30 PM	Report ID: 12072023Gibson
Property: 3304 Gibson Pl Redondo Beach CA 90278	Customer: Ed Frazier	Real Estate Professional: Julie DeCoste

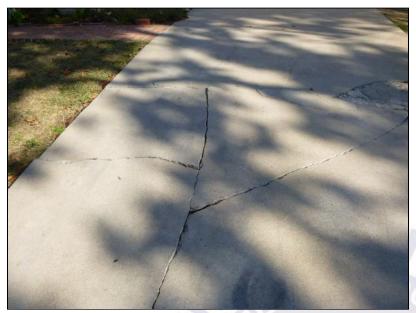
1.0 Item 1(Picture)

1.0 Settling, expansion cracks and heaving noted at various areas, this is a potential trip hazard. Suggest review with a licensed contractor for repair/replacement costs as needed.

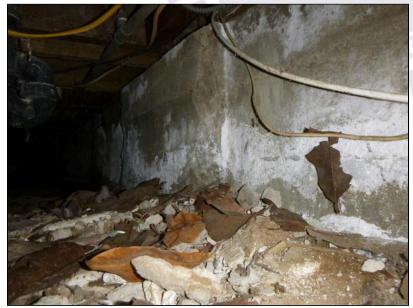
3.0 Item 1(Picture)

3.0 (1) White efflorescence (powder substance) on foundation footings indicates prior, and possibly ongoing, excessive moisture build up at the exterior of the foundation. Ongoing water intrusion at the foundations can, in some cases, cause the steel in the foundations to rust, called spawling, which can lead to horizontal cracking of the foundation (currently there are no major cracks visible at the foundation). Any future cracking/damaged can be an expensive repair as the foundation is now structurally weak and susceptible to horizontal movement. Suggest review of the Lot/Grade and drainage systems, including rain gutters, to reduce and prevent further and future water buildup at the exterior of the dwellings foundations.

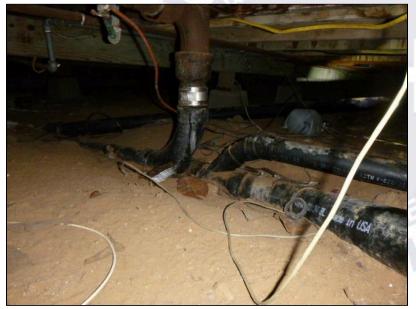
4.4 Item 1(Picture)

4.4 (1) Rust and corrosion noted at various cast iron drain lines within the crawl space, common for the age, active leaking visible at the hallway toilet drain at the time of the inspection. Suggest review by a licensed plumbing contractor for repair/replacement costs as needed.

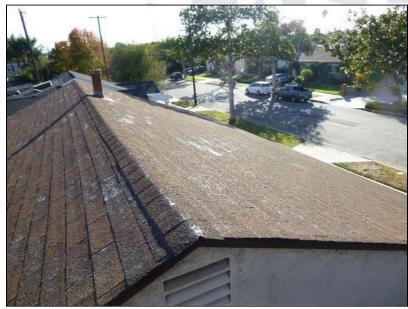
5.0 Item 1(Picture)

5.0 The roof covering is old and deteriorated. It is nearing the end of its useful life and the covering will need to be replaced. While it could last a year or so, some areas may need patching/repairs as leaks develop. Please review with a licensed roofer to determine the remaining life expectancy and for costs to repair/remove and replace the existing roofing material as needed.

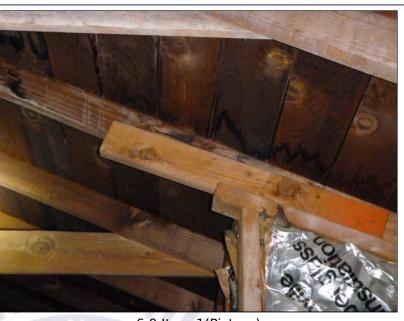
6.0 Item 1(Picture)

6.0 Moisture stains noted at various areas of the attic sheathing/ framing, see roof comments and repair as needed.

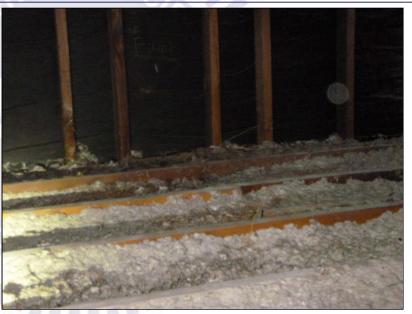
6.1 Item 1(Picture)

6.1 Minimal insulation installed in the attic, common for the age of the dwelling. Suggest review by a licensed contractor for additional insulation installation costs as an upgrade.

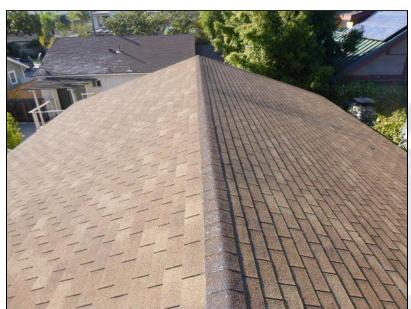
7.1 Item 1(Picture)

7.1 (1) The roof shows normal wear for its age and type, suggest periodic review with a licensed roofer for maintenance as needed.

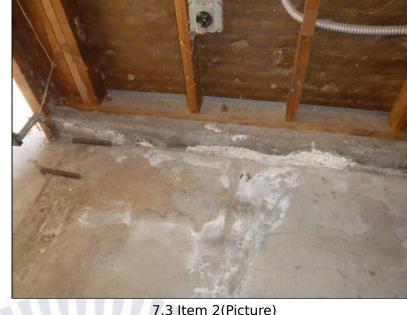
7.3 Item 2(Picture)

7.3 (2) White efflorescence (powder substance) on foundation footings indicates prior, and possibly ongoing, excessive moisture build up at the exterior of the foundation. Ongoing water intrusion at the foundations can, in some cases, cause the steel in the foundations to rust, called spawling, which can lead to horizontal cracking of the foundation (currently there are no major cracks visible at the foundation). Any future cracking/damaged can be an expensive repair as the foundation is now structurally weak and susceptible to horizontal movement. Suggest review of the Lot/Grade and drainage systems, including rain gutters, to reduce and prevent further and future water buildup at the exterior of the dwellings foundations.

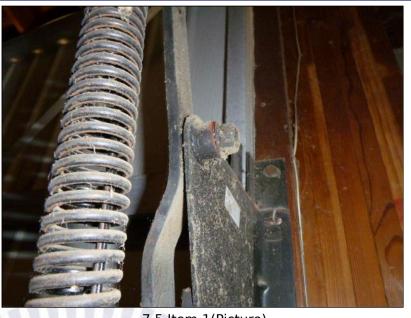
7.5 Item 1(Picture)

7.5 Bent and damaged hinge hardware was noted, this is a potential safety hazard. Suggest review with a licensed contractor for repair/replacement costs as needed.

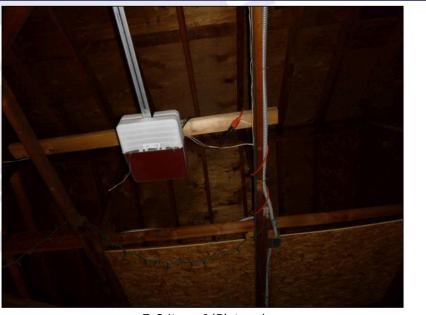
7.6 Item 1(Picture)

7.6 (1) Unreasonable resistance was required to stop the main garage door(s) in motion, this is a safety concern. Suggest adjusting door opener(s) so the safety reverse operates as required. The US Product Safety Commission recommends these devises be checked monthly.

7.6 (2) The garage door opener is improperly wired with an extension cord. Suggest review with a licensed electrician for costs to hard wire a receptacle adjacent to the garage door opening unit for electrical service and remove the extension cord.

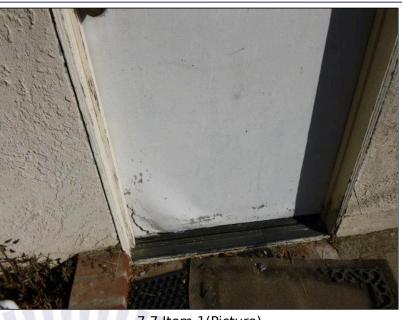
7.7 Item 1(Picture)

7.7 (1) Excessive wood deterioration/delaminating noted at the garage access door. Suggest review by a licensed contractor for repair/replacement costs as needed.

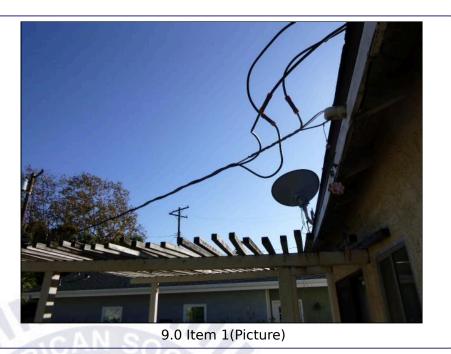
9.0 Potential safety hazard due to the electrical service conductors clearance (outside) from the ground is lower than 12 feet. Suggest review with a licensed contractor and/or the utility company for repair/replacement/relocation costs as required for safety.

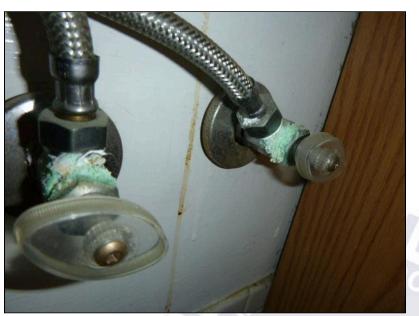
10.0 Item 1(Picture)

10.0 (1) Corroded plumbing and fittings noted at various areas within the dwelling. Suggest further review by a licensed plumber for repair/replacement costs as needed to prevent future leakage, pin hole leaks and possible stains/damage to the interior of the dwelling.

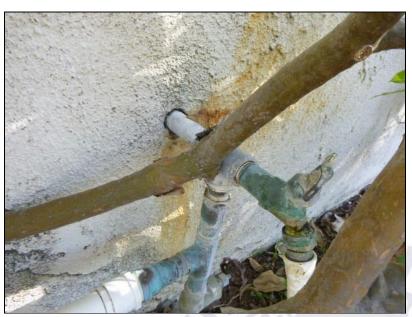
10.0 Item 5(Picture)

10.0 (4) Water flow fluctuation noted at water supply lines due to galvanized piping and restrictions when flow tested. Suggest review by a licensed plumber for costs to replace the galvanized plumbing as needed.

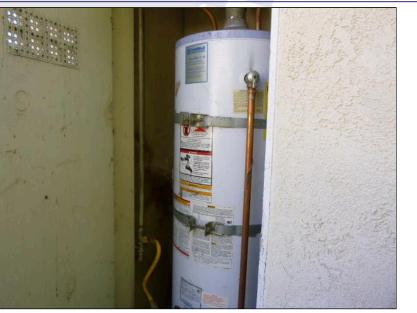
12.0 Item 1(Picture)

12.0 (1) Due to the age of this unit, suggest review with a licensed plumber for replacement costs as it has exceeded it's intended life span (12-15 years).

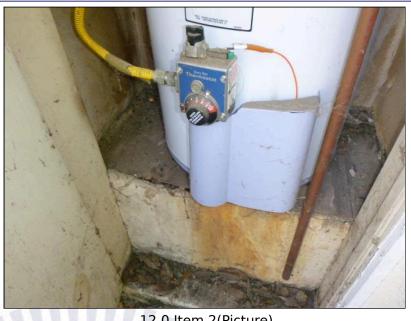
12.0 Item 2(Picture)

12.0 (2) No spill pan or drain line installed at the time of inspection. Suggest installation of a spill pan with a drain line to the exterior of the dwelling as required as leakage would cause damage to the stand and surrounding area.

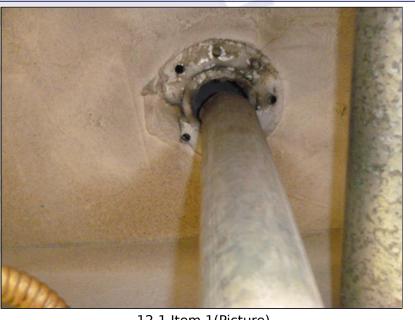
12.1 Item 1(Picture)

12.1 (1) A poor fitting/ disconnected vent pipe was noted, this is a safety hazard requiring immediate attention. Suggest review by a licensed plumbing contractor for repair/replacement costs as required for safety.

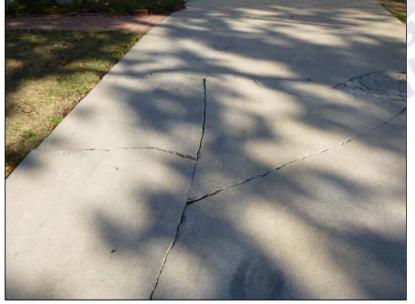
1.0 Item 1(Picture)

Settling, expansion cracks and heaving noted at various areas, this is a potential trip hazard. Suggest review with a licensed contractor for repair/replacement costs as needed.

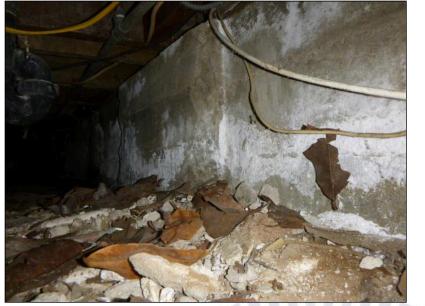
3.0 Item 1(Picture)

(1) White efflorescence (powder substance) on foundation footings indicates prior, and possibly ongoing, excessive moisture build up at the exterior of the foundation. Ongoing water intrusion at the foundations can, in some cases, cause the steel in the foundations to rust, called spawling, which can lead to horizontal cracking of the foundation (currently there are no major cracks visible at the foundation). Any future cracking/damaged can be an expensive repair as the foundation is now structurally weak and susceptible to horizontal movement. Suggest review of the Lot/Grade and drainage systems, including rain gutters, to reduce and prevent further and future water buildup at the exterior of the dwellings foundations.

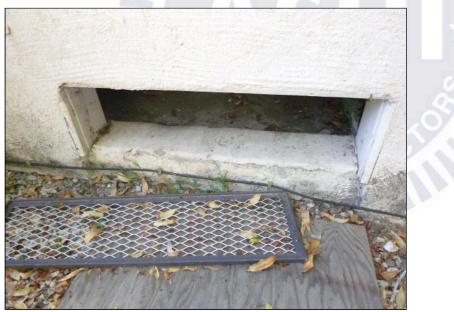
4.0 Item 1(Picture)

(1) Suggest review with a licensed contractor for costs to install a crawl access port door/screen as required.

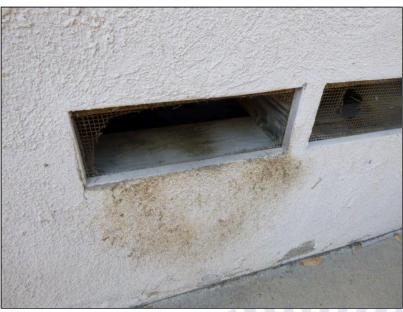
4.2 Item 1(Picture)

Loose, missing or deteriorated vent screens noted. Suggest re-screening missing and/or deteriorated vent screens as needed to prevent rodent and insect intrusion .

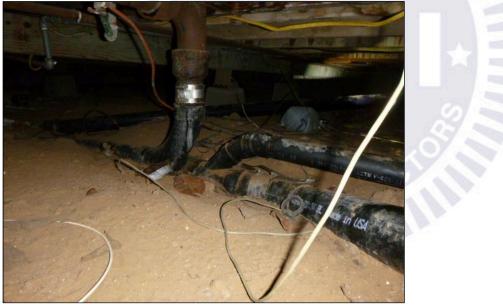
4.4 Item 1(Picture)

(1) Rust and corrosion noted at various cast iron drain lines within the crawl space, common for the age, active leaking visible at the hallway toilet drain at the time of the inspection. Suggest review by a licensed plumbing contractor for repair/replacement costs as needed.

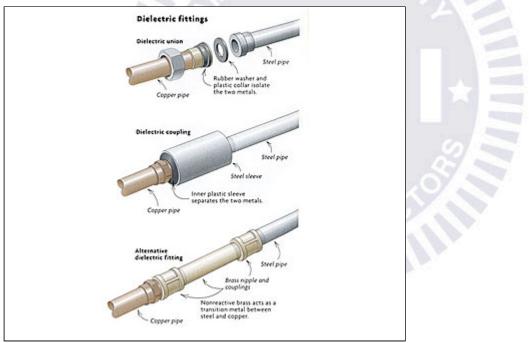
4.4 Item 3(Picture) Dielectric fitting

(3) No dielectric connections installed between the different types of plumbing. Suggest review by licensed plumber and repair as necessary.

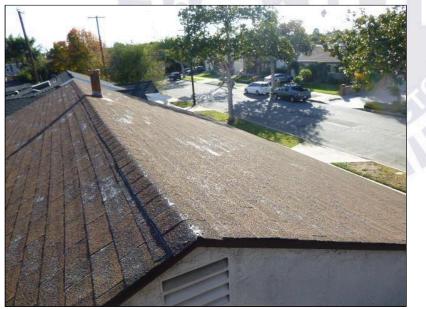
5.0 Item 1(Picture)

The roof covering is old and deteriorated. It is nearing the end of its useful life and the covering will need to be replaced. While it could last a year or so, some areas may need patching/repairs as leaks develop. Please review with a licensed roofer to determine the remaining life expectancy and for costs to repair/remove and replace the existing roofing material as needed.

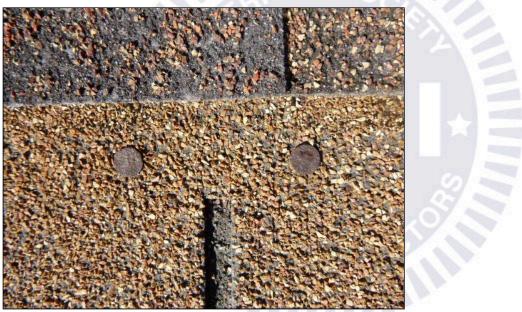
7.1 Item 4(Picture)

(3) Exposed nail heads noted at various areas of the roof, suggest review with a licensed roofer for repairs as needed.

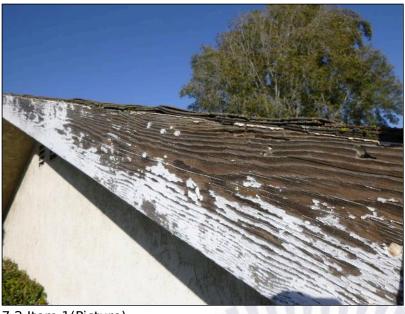
7.2 Item 1(Picture)

No eave drip flashings installed, suggest review with a licensed roofer for installation costs as needed.

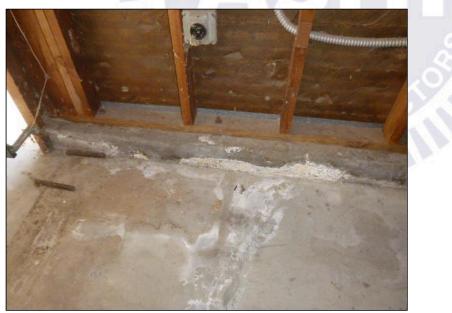
7.3 Item 2(Picture)

(2) White efflorescence (powder substance) on foundation footings indicates prior, and possibly ongoing, excessive moisture build up at the exterior of the foundation. Ongoing water intrusion at the foundations can, in some cases, cause the steel in the foundations to rust, called spawling, which can lead to horizontal cracking of the foundation (currently there are no major cracks visible at the foundation). Any future cracking/damaged can be an expensive repair as the foundation is now structurally weak and susceptible to horizontal movement. Suggest review of the Lot/Grade and drainage systems, including rain gutters, to reduce and prevent further and future water buildup at the exterior of the dwellings foundations.

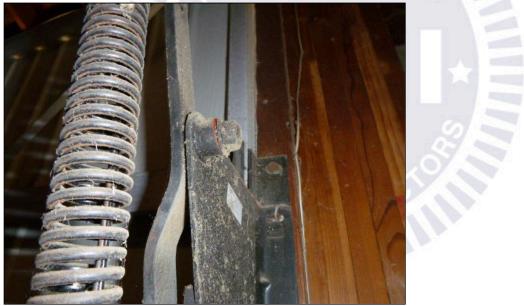
7.5 Item 1(Picture)

Bent and damaged hinge hardware was noted, this is a potential safety hazard. Suggest review with a licensed contractor for repair/replacement costs as needed.

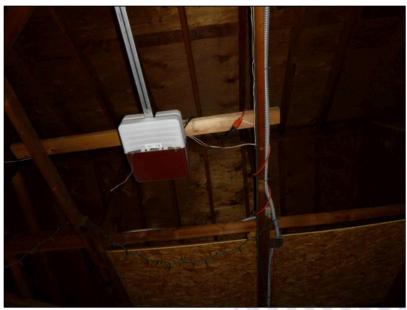
7.6 Item 1(Picture)

(2) The garage door opener is improperly wired with an extension cord. Suggest review with a licensed electrician for costs to hard wire a receptacle adjacent to the garage door opening unit for electrical service and remove the extension cord.

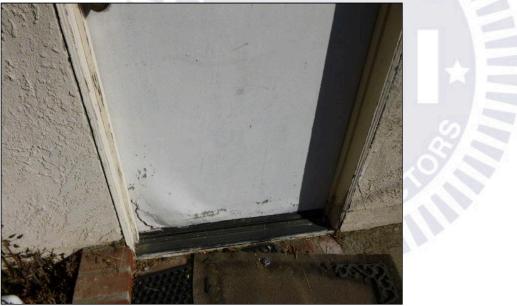
7.7 Item 1(Picture)

(1) Excessive wood deterioration/delaminating noted at the garage access door. Suggest review by a licensed contractor for repair/replacement costs as needed.

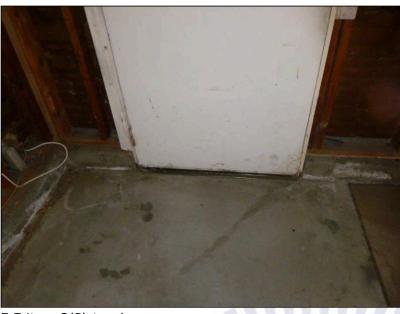
7.7 Item 2(Picture)

(2) Evidence of previous and possible ongoing water intrusion at the garage access door. Suggest review with a licensed contractor for repair/replacement costs as needed.

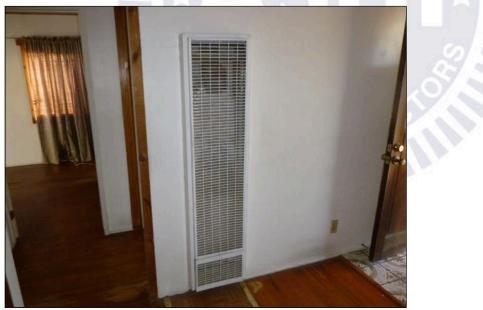
8.0 Item 1(Picture)

(1) Unable to test the heating system as the gas was turned off to the unit at the time of the inspection. Suggest review by the Gas Company or a licensed heating company for further review to determine if the unit is operational/usable, the remaining life of the unit and/or any repair/ replacement costs as needed.

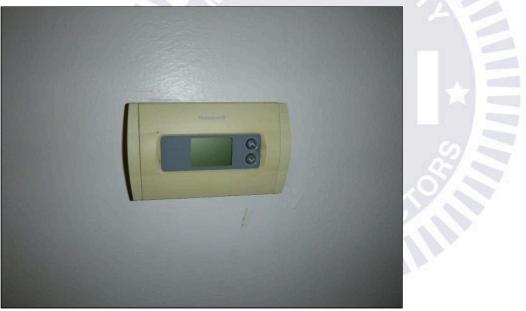
8.0 Item 3(Picture)

(2) The inspector was unable to test the heating system as the thermostat was inoperable at the time of the inspection. Suggest review by the Gas Company and/or a licensed heating company for review to determine if the unit is operational, any repair/replacement costs and confirm correct operation as needed.

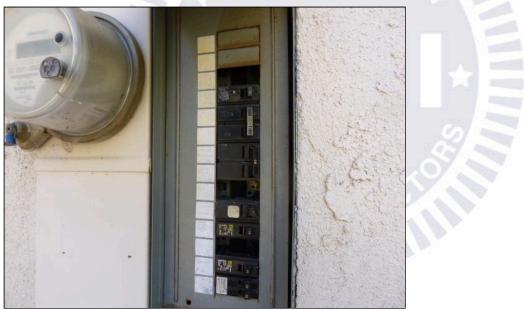
9.1 Item 1(Picture)

(1) Suggest adding correct/complete indexing/labelling to all breakers for indentification of each circuit for safety.

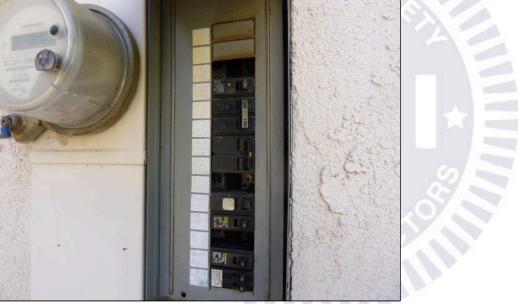
9.1 Item 3(Picture)

(2) Potential safety hazard due open areas of the electrical panel cover plate. Suggest installing future plugs in the cover plate where the blanks have been removed as required for safety.

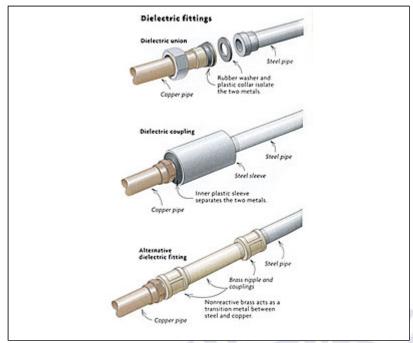
10.0 Item 3(Picture) Dielectric fitting

(3) No dielectric connections installed between the different types of plumbing. Suggest review by licensed plumber and repair as necessary.
