# WOOD DESTROYING PESTS AND ORGANISMS INSPECTION REPORT

| BUILDING NO.<br>3144 | STREET<br>MARWICK | CITY<br>LONG BEACH | ZIP<br>90808 | Date of Inspection<br>07/28/2025 | NUMBER OF PAGES<br>1 of 11 |
| GENERAL DESCRIPTION:<br>This is a one story stucco and wood single family residence with an attached metal patio. It has a detached 2 car garage/two story guest house. It has a composition roof and was vacant at the time of inspection. | | | | Inspection Tag Posted:<br>Attic.<br>Other Tags Posted: | |

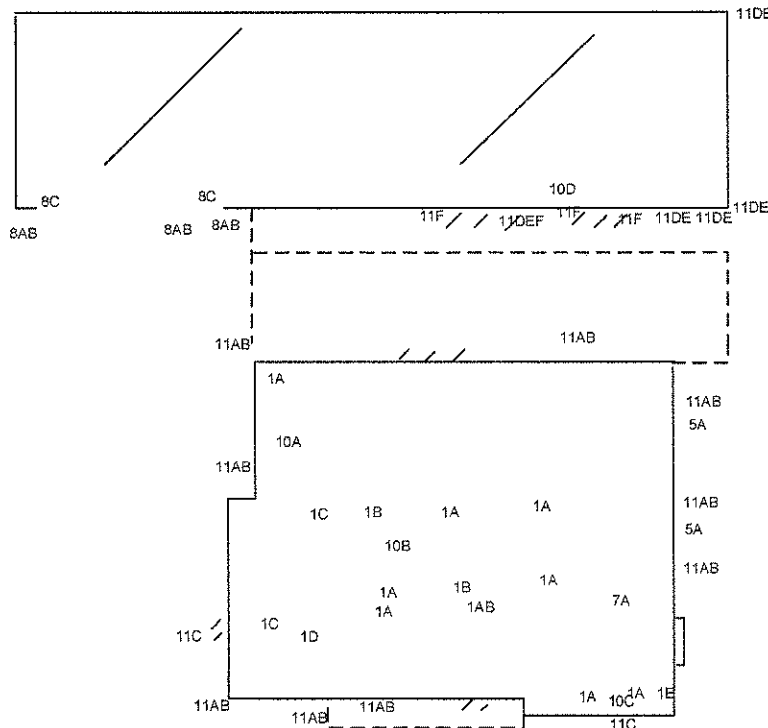
Subterranean termites found as 1A as indicated on the diagram near or at subarea .

Form boards/stakes were noted embedded in the subarea soil as 1B as indicated on the diagram.

Scrap wood and cellulose debris was noted in the subarea as 1C as indicated on the diagram.

Earth to wood contact noted below additional support blocks where marked as 1D.

Evidence of DRYWOOD TERMITES as indicated by 1E on the diagram. Evidence noted in or near: subarea from inaccessible wall void above.

Missing or damaged subvents were noted as 5A as indicated on the diagram.

Evidence of DRYWOOD TERMITES as indicated by 7A on the diagram. Evidence noted in or near: attic rafter.

Evidence of DRYWOOD TERMITES as indicated by 8A on the diagram. Evidence noted in or near: garage rafter tails and trim.

Evidence of drywood termite damage was noted as 8B as indicated on the diagram near or at garage rafter tails and trim.

Rot damage noted as 8C on diagram. The damage was in or near: garage door jambs and trim.

The toilet was found to be loose indicated on the diagram as 10A.

Evidence of Subterranean damage noted as 10B as indicated on the diagram near or at hardwood flooring in hall.

Rot damage noted as 10C on diagram. The damage was in or near: living room windowstool.

Rot damage noted as 10D on diagram. The damage was in or near: plank flooring near sliding door.

Evidence of DRYWOOD TERMITES as indicated by 11A on the diagram. Evidence noted in or near: eave enclosure, post, post railing, and trim.

Evidence of drywood termite damage was noted as 11B as indicated on the diagram near or at eave enclosure, post, post railing, and trim.

Rot damage noted as 11C on diagram. The damage was in or near: doorsill, windowsill, and trim.

Evidence of DRYWOOD TERMITES as indicated by 11D on the diagram. Evidence noted in or near: guest house gable facia, rafter tails, and trim.

Evidence of drywood termite damage was noted as 11E as indicated on the diagram near or at guest house gable facia, rafter tails, and trim.

Rot damage noted as 11F on diagram. The damage was in or near: guest house trim.

RECOMMENDATION Remove sub tubes that are visible and accessible, Treat subterranean termites with Termidor chemical.

RECOMMENDATION: Remove the form boards/stakes from the subarea where possible and dispose of them. If it is found to be impractical to remove the form boards/stakes, we will treat the embedded wood with Termidor, an EPA registered termiticide, in accordance with the manufacturers labe.

RECOMMENDATION: Clean out debris and remove from premises.

RECOMMENDATION: Remove blocks and install new support girder(s) and piers as deemed necessary by this company.

Fumigate the structure with a fumigant lethal to DRYWOOD TERMITES. See the occupants fumigation notice for further details. This company is not responsible for delays or schedule changes due to inclement weather or other agencies, nor is it responsible for damage to roof or plants as a result of the fumigation. Refer to the occupant's fumigation notice/preparation sheet (sent separately) for additional information.

RECOMMENDATION: Screen or repair missing subvents.

RECOMMENDATION: Repair and/or replace damage as deemed necessary by this company. If during the course of repair damage is found to extend beyond visible area a supplemental report with additional costs and findings will be issued. Exposed lumber repaired or replaced by this company will be painted with one coat of primer only. If requested prior to start of work a color matched finish coat of paint can be applied to for an additional charge. Due to varying rates of aging and fading around a property an exact match with existing paint may not be made.

RECOMMENDATION Cut out rotted timbers. Repair and/or replace damage as deemed necessary by this company. If during the course of repair damage is found to extend beyond visible area a supplemental report with additional costs and findings will be issued. Exposed lumber repaired or replaced by this company will be painted with one coat of primer only. If requested prior to start of work a color matched finish coat of paint can be applied to for an additional charge. Due to varying rates of aging and fading around a property an exact match with existing paint may not be made.

RECOMMENDATION: Remove the toilet for further inspection. If no damage is exposed, reset the toilet on a new wax ring.

RECOMMENDATION: Repair and or replace damage as deemed necessary by this company. If damage is found to extend beyond visible area during the course of our repairs a supplemental report with findings will be issued.

Fumigate the structure with a fumigant lethal to DRYWOOD TERMITES. See the occupants fumigation notice for further details. This company is not responsible for

**RECOMMENDATION:** Repair and/or replace damage as deemed necessary by this company. If during the course of repair damage is found to extend beyond visible area a supplemental report with additional costs and findings will be issued. Exposed lumber repaired or replaced by this company will be painted with one coat of primer only. If requested prior to start of work a color matched finish coat of paint can be applied to for an additional charge. Due to varying rates of aging and fading around a property an exact match with existing paint may not be made.

**RECOMMENDATION** Cut out rotted timbers. Repair and/or replace damage as deemed necessary by this company. If during the course of repair damage is found to extend beyond visible area a supplemental report with additional costs and findings will be issued. Exposed lumber repaired or replaced by this company will be painted with one coat of primer only. If requested prior to start of work a color matched finish coat of paint can be applied to for an additional charge. Due to varying rates of aging and fading around a property an exact match with existing paint may not be made.
