Address: 447 E Hullett St, Long Beach

Date of Inspection: 3-22-24

Main Sewer Line Inspection Report

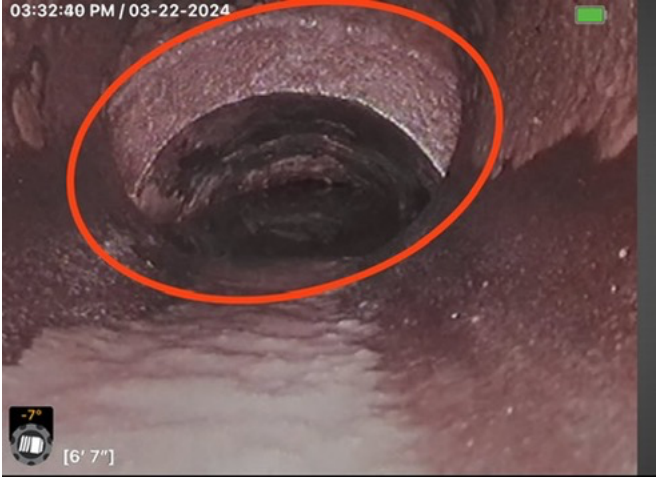
Areas Needing Attention: A portion of the clay pipe sewer line underneath the rear patio area has a very large offset/shift. The shifting of the pipe is more extensive than could be considered acceptable and it is failed to the degree that some sewer will likely be able to escape the system into the surrounding soil. The most effective and cost-efficient method of repairing the line can best be determined with the assistance of your sewer contractor of choice who will be performing the work.

Location of offset/shifted clay pipe 3.2' deep.

Estimated Costs for Repairs: To repair the offset/shifted clay pipe it might cost \$3,200 - \$3,500.

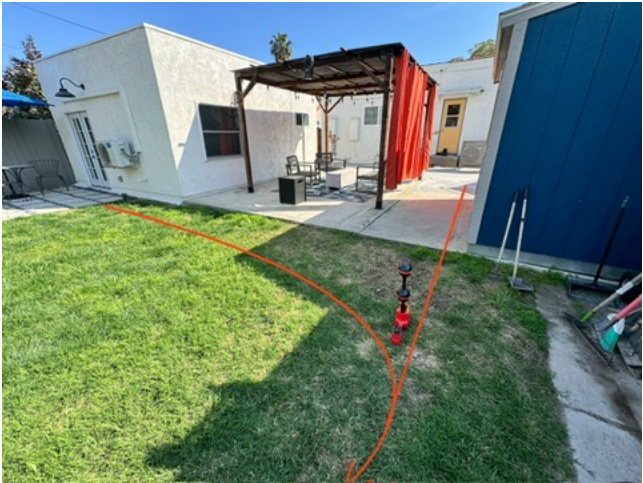
Location where front house and ADU sewer lines tie in together.

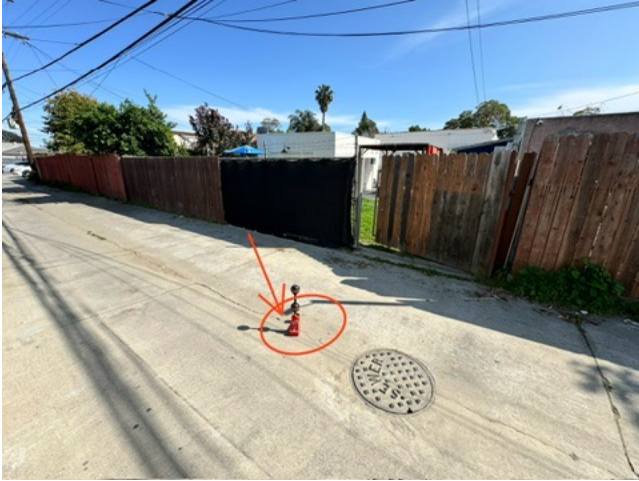
There is a moderate crack in the pipe located at the connection to the city sewer. When this represents a breach of the system there are certain definite indicators which are not being demonstrated here. While this portion of the line is not perfect it does appear to be functional at this time. In a few years a second inspection can determine if the pipe is in motion at all or if it has settled in place. If it is desired to proactively repair this defect in the line, it may be possible to have a specifically designed robotic repair done on the line known as a "top hat" liner. This is a method of repairing a connection to the city sewer without the need to dig. Not all sewer systems qualify for this repair and if it is desired then a contractor which specializes in robotic sewer repair should be contacted to ensure the pipe can be helped with that method of repair.

Connection to city sewer under tool.

To install a top hat liner, it might cost \$3,800 - \$4,000.
