# **Cornerstone Inspection**

## **Property Inspection Report**

**1556 Gulf St, San Luis Obispo, CA 93405**

**Date of Inspection: 10/7/2025 Time: 1:00 PM**

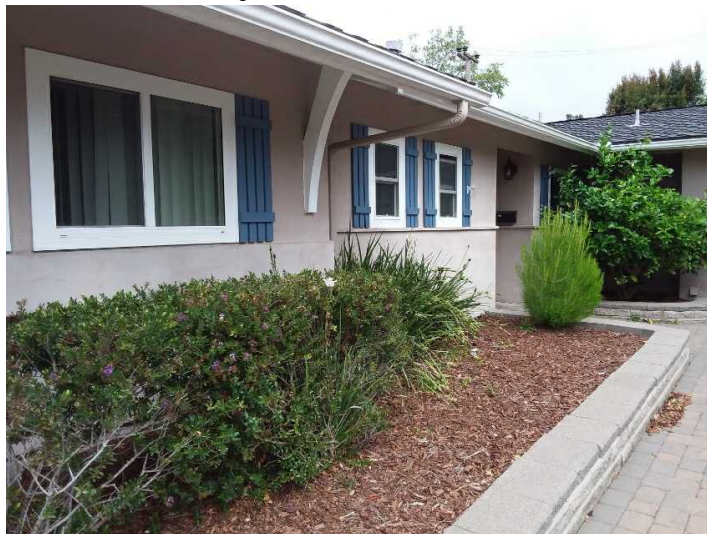
3.2. Vines, shrubs or bushes are growing on the house walls and although they are attractive they can introduce pests and rodents and accelerate deterioration. Therefore, you may wish to consider having them removed or cut back to 12 inches away from the home.

Vines, shrubs or bushes are growing on the house walls and although they are attractive they can introduce pests and rodents and accelerate deterioration. Therefore, you may wish to consider having them removed or cut back to 12 inches away from the home.

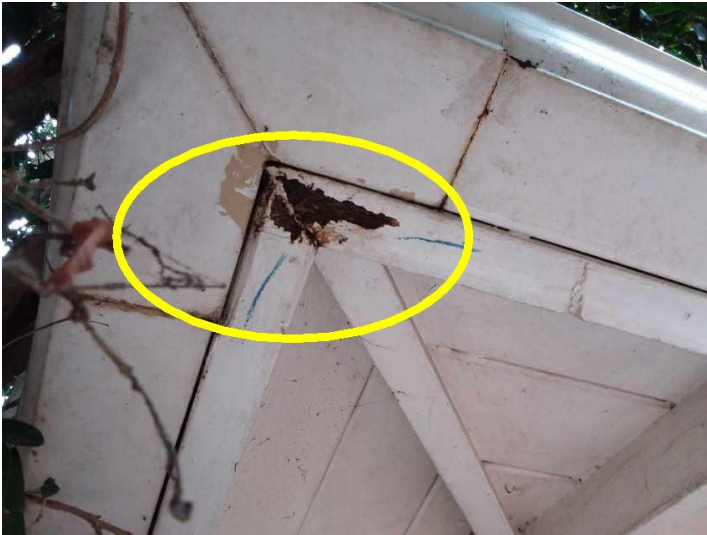
There is damage to the wood trim that should be evaluated by a termite inspector.

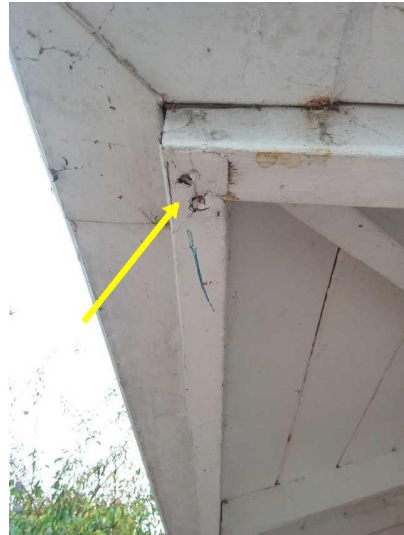
There is damage to the wood trim that should be evaluated by a termite inspector.

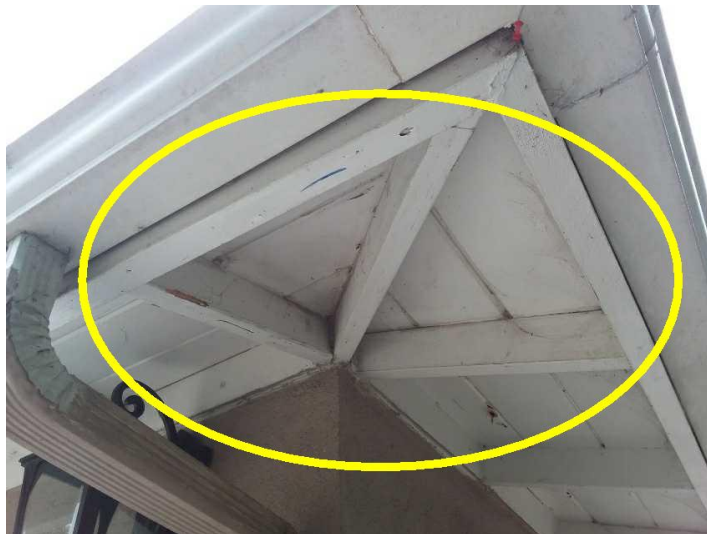
There is damage to the wood trim that should be evaluated by a termite inspector.

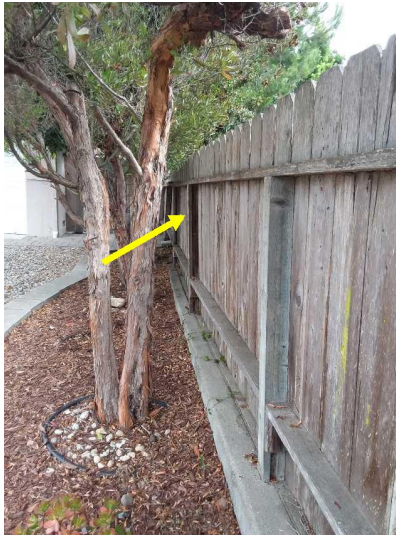
9.3. Sections of the fence are leaning or missing which you may wish to have repaired or replaced.

Sections of the fence are leaning or missing which you may wish to have repaired or replaced.

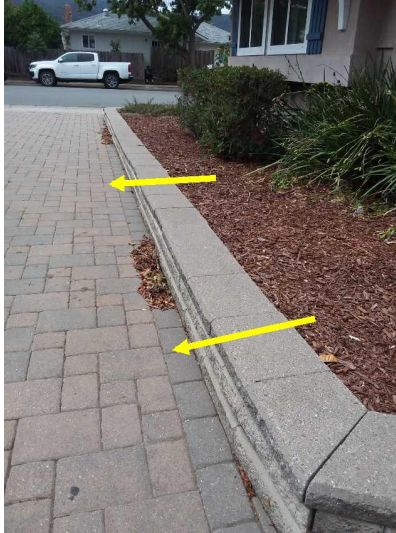
12.2. There are areas of this property that do not have guardrails, which are required for walk-offs greater than thirty inches. While there are walk off's less than 30 inches, appropriate precautions should be taken to safeguard children and the elderly.

There are areas of this property that do not have guardrails, which are required for walk-offs greater than thirty inches. While there are walk off's less than 30 inches, appropriate precautions should be taken to safeguard children and the elderly.

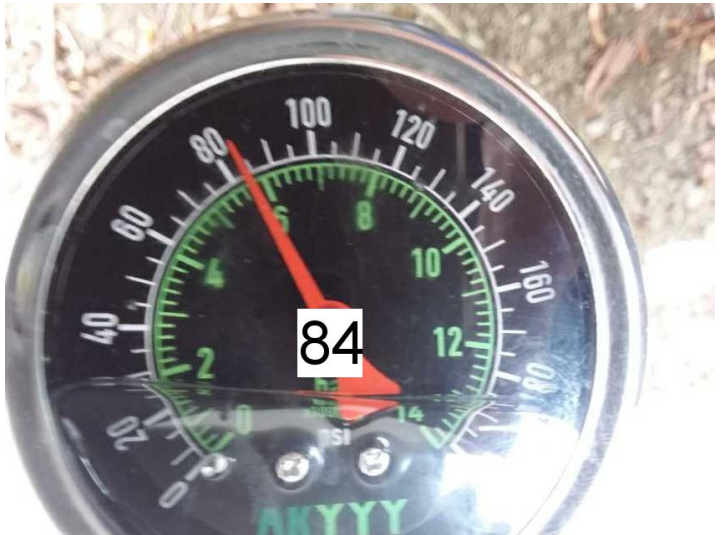
1.7. The pressure inside the residence exceeds 80psi, which is too strong and will stress components of the system, and a regulator should be installed. Most regulators come factory pre-set at 60psi.

The pressure inside the residence exceeds 80psi, which is too strong and will stress components of the system, and a regulator should be installed. Most regulators come factory pre-set at 60psi.

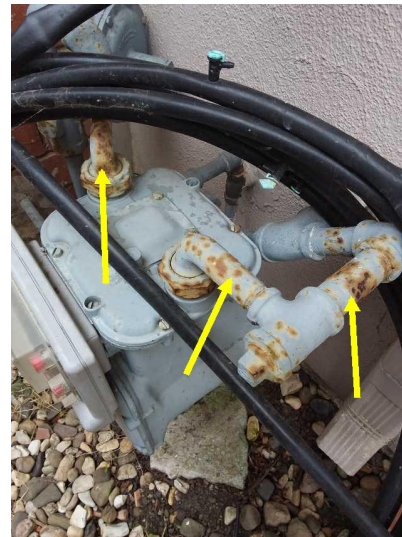
2.4. Some of the gas lines at the meter are rusted and should be painted to prevent further corrosion.

Some of the gas lines at the meter are rusted and should be painted to prevent further corrosion.

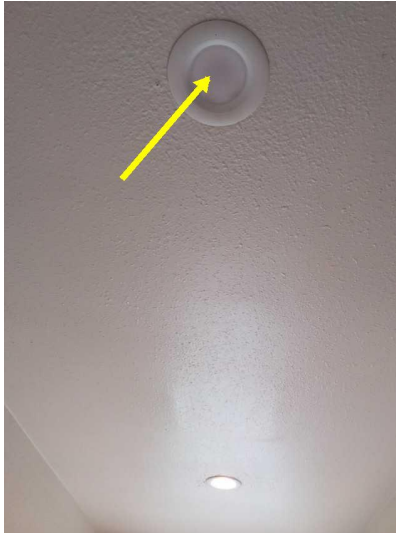
A ceiling light does not respond, and should be serviced.

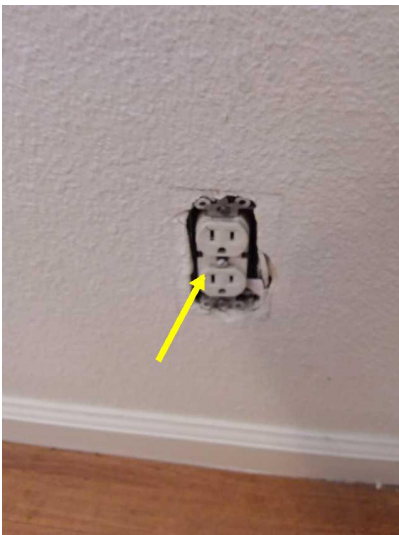
| Page 30 Item: 1 | Master Bedroom Observations | 1.6. There are outlet or switch covers that are missing and should be replaced. |

There are outlet or switch covers that are missing and should be replaced.

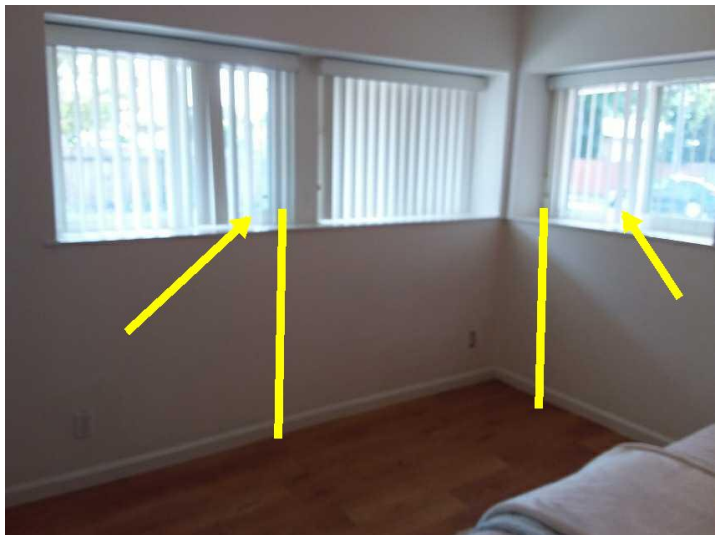
A window is too high or too small to facilitate an emergency exit or egress. Bedroom windows should measure 24" high by 20" wide, with an optimum sill height of 44", to facilitate an emergency exit by the occupant and an emergency egress for a fire person wearing breathing apparatus.

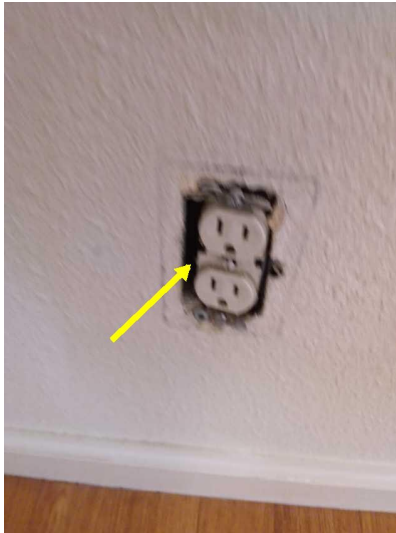
| Page 31 Item: 3 | Bedroom 3 | 3.4. There are outlet or switch covers that are missing and should be replaced. |

There are outlet or switch covers that are missing and should be replaced.

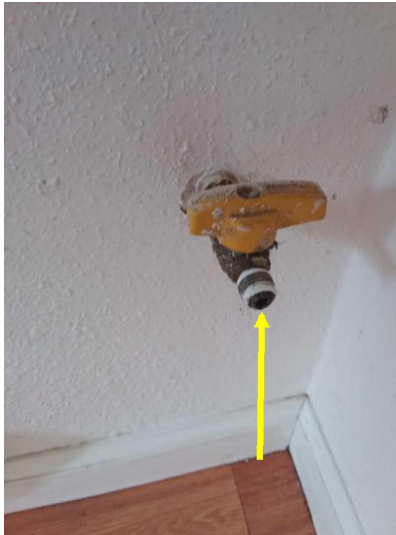
There is no cap on the gas valve. The gas valve should be capped when not in use.

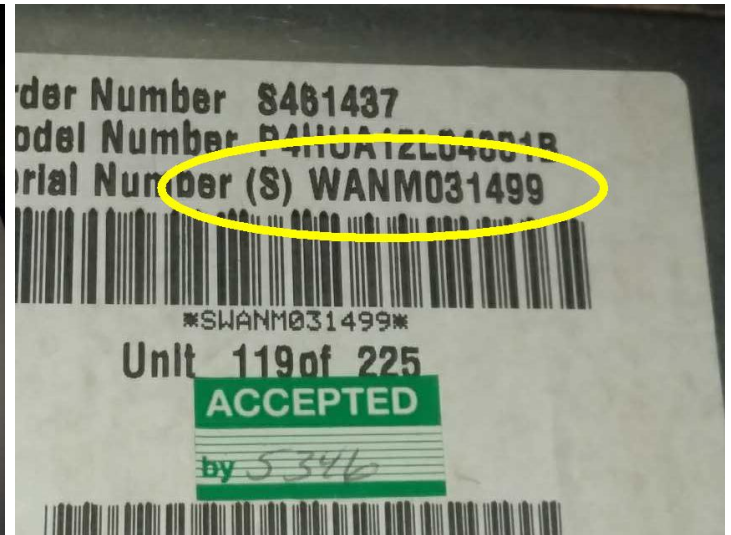
| Page 38 Item: 1 | Forced Air Furnace | 1.14. The furnace is functional. However, it is beyond the commonly accepted design life of twenty years, and will need to be monitored more closely for evidence of metal fatigue. We recommend that you have it serviced and evaluated by an HVAC contractor prior to the close of the inspection period. |

Serial number WANM031499 - manufactured 2004

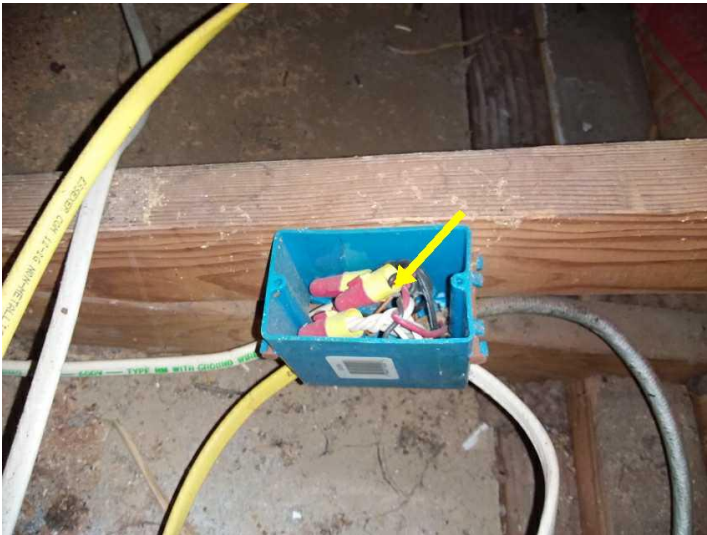
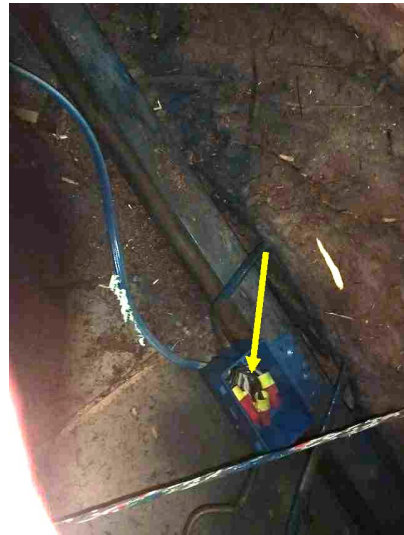
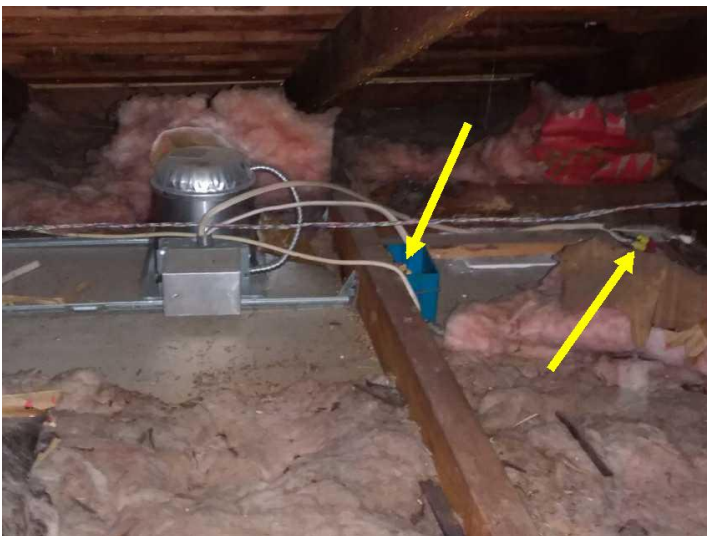
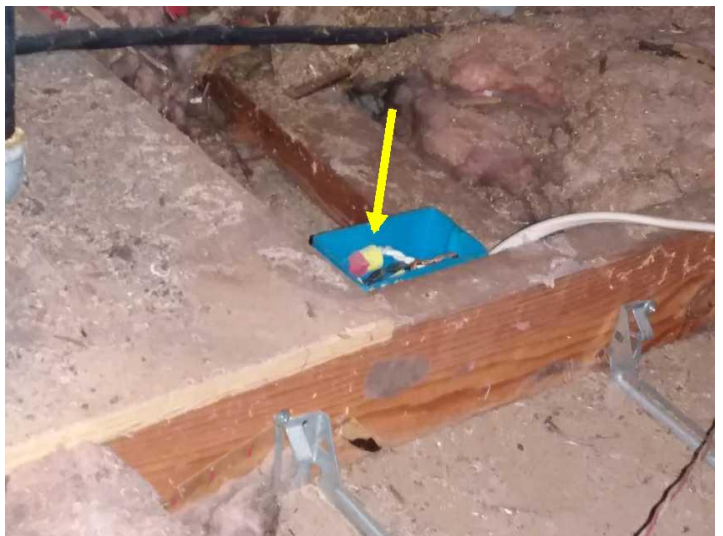
1.17. There are open electrical junction boxes, which should be sealed to contain any arcing or sparking that might occur.

There are open electrical junction boxes, which should be sealed to contain any arcing or sparking that might occur.

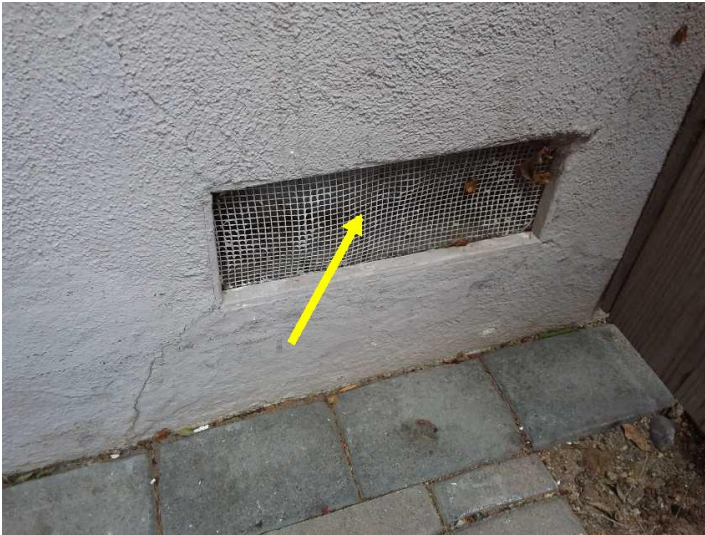
The ventilation ports in the wall have been blocked or covered. If they are not uncovered, vehicle engines and combustion appliances could produce noxious by-products, including deadly, carbon monoxide.

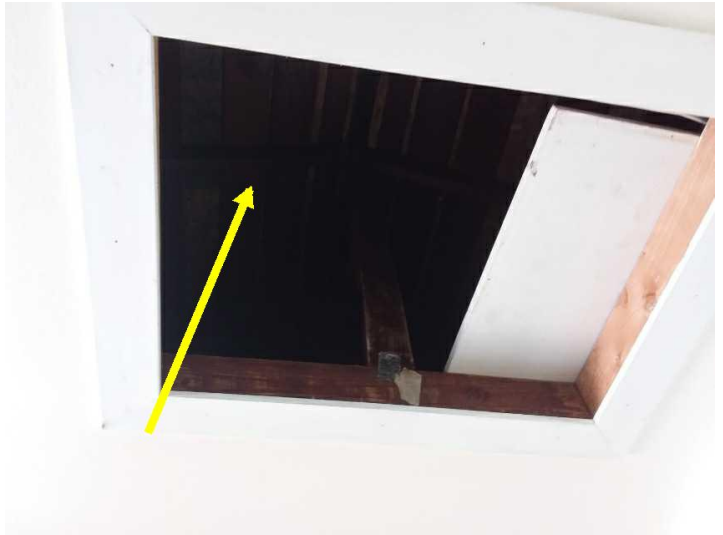
The wooden hatch cover to the attic area should be sheathed with metal or drywall, and made to self close and latch in order to provide a firewall separation between the garage and the residence.

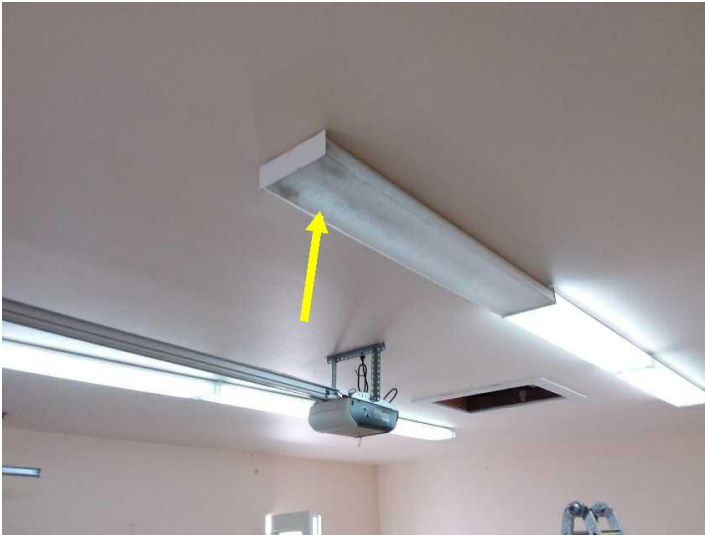
A ceiling light does not respond, and should be serviced.

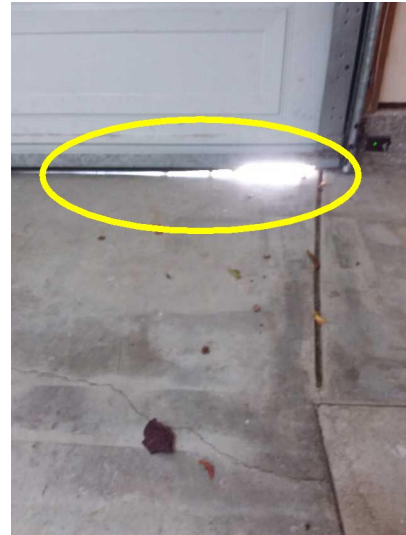
The seal at the base of the garage door is deteriorated and you may wish to have it replaced.
