The Chaufee Report

616 24th Place

Prepared Exclusively For: Mr. Chaufee

9/24/2018

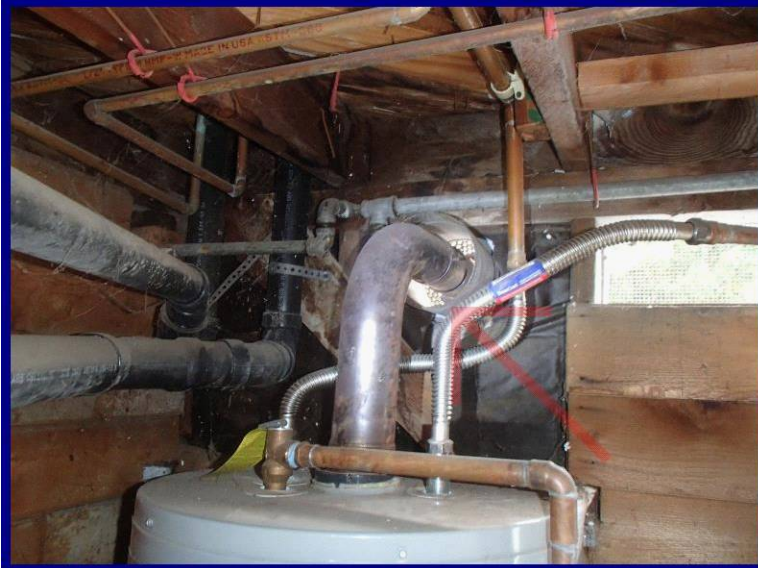
6.7 VENT CONDITIONS:

1. [SC] The flue vent pipe is installed with a material that was not rated for this application. We recommend replacing this material with an approved product, using approved methods for safety reasons. **NOTE: The combustion air vent for the direct vented furnace is missing. Generally the vent is required to allow for venting and combustion from the exterior of the structure. They do not make these types of water heaters any longer so the missing part may not be found. When the unit is replaced we recommend a power vented unit. Other wise the vent will have to discharge two feet above the roof line on the exterior of the structure.**

MISSING COMBUSTION AIR DUCT

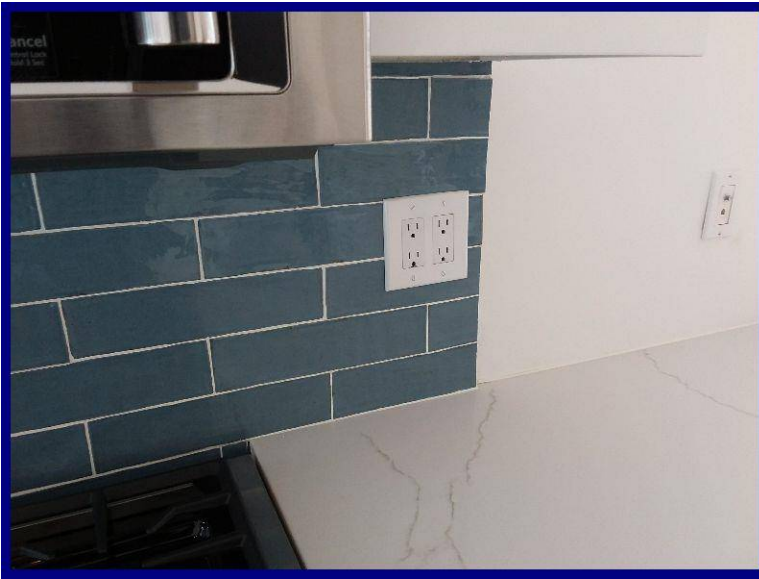
8.27 KITCHEN CONDITIONS:

3. [SC] The accessible receptacles are not GFCI protected, GFCI protected outlets should have been installed at the time the building was remodeled. This is an electrical Safety Hazard. We recommend providing GFCI protection at the required locations for safety reasons.

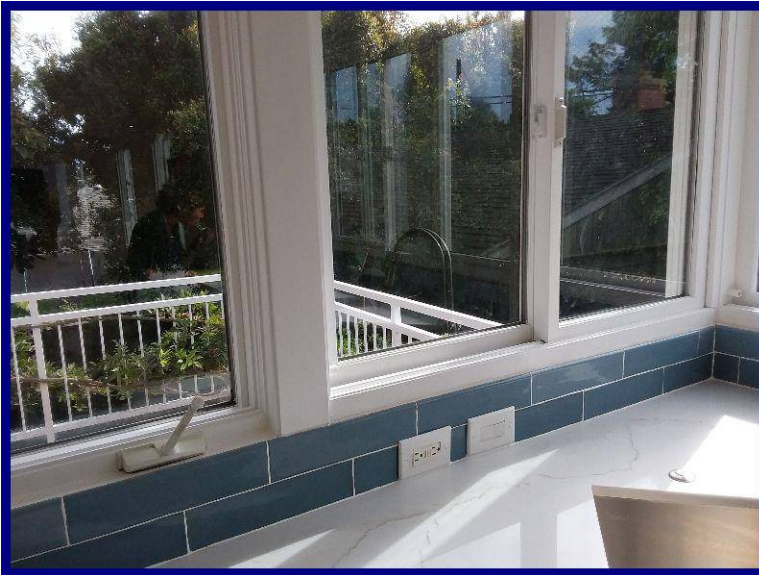
12.3 WINDOWS:

4. [CR] Moisture and/or stains were observed between the glass panes of the double-paned window(s), this condition usually indicates a defective seal. We recommend having all of the thermal windows and doors evaluated by a glazing specialist and replaced as needed.

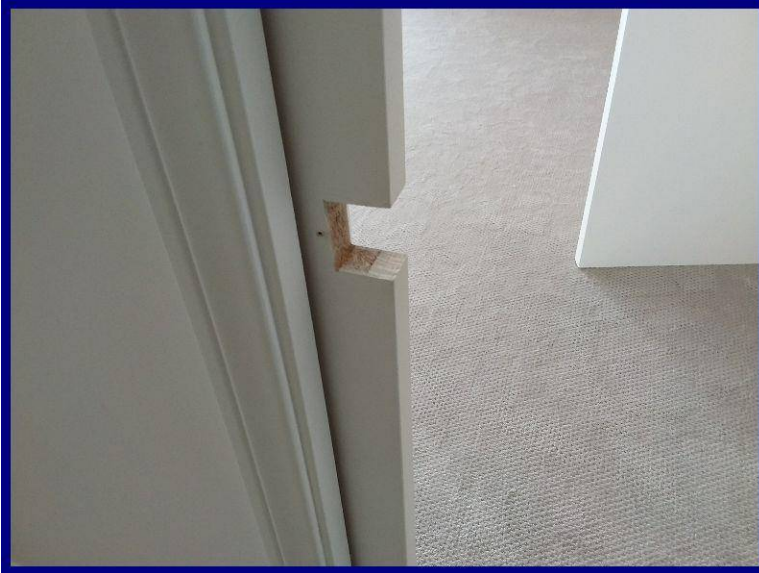
MASTER BATHROOM**13.26 INT DOORS:**

7. [CR] The door knob-set is missing parts. We recommend replacing the knob or parts as needed.

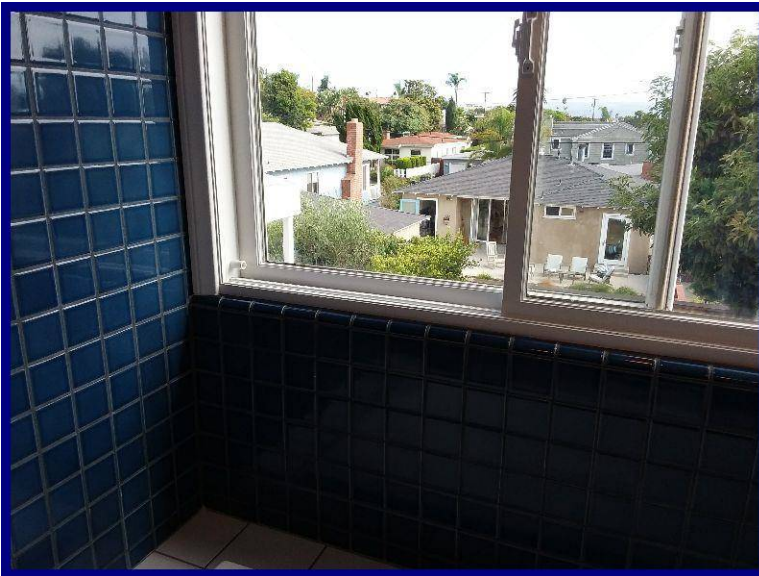
**13.27 WINDOWS:**

8. [CR] Moisture and/or stains were observed between the glass panes of the double-paned window(s), this condition usually indicates a defective seal. We recommend having all of the thermal windows and doors evaluated by a glazing specialist and replaced as needed. [SC] There are no visible safety glass markings on the glass in the window(s) within 60 inches above the walking surface of the tub or floor

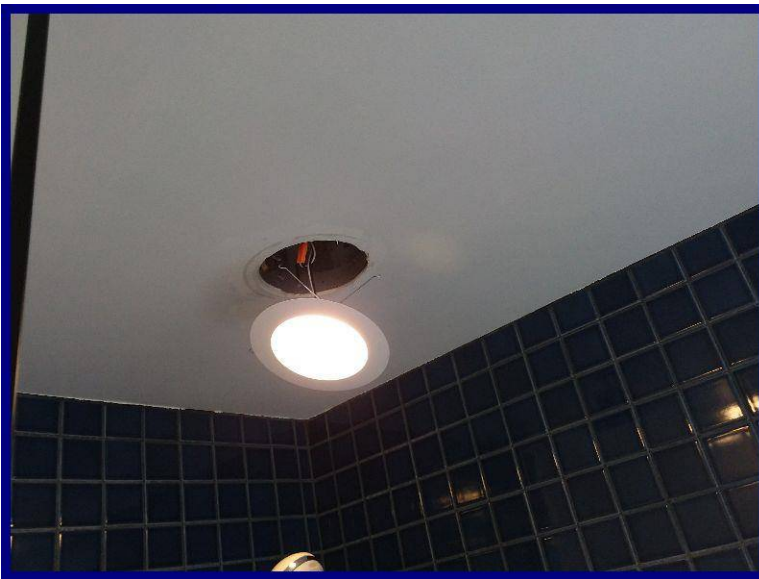
**13.28 LIGHTS:**

9. [CR] One or more of the light lenses are missing. We recommend replacing all missing parts as needed.

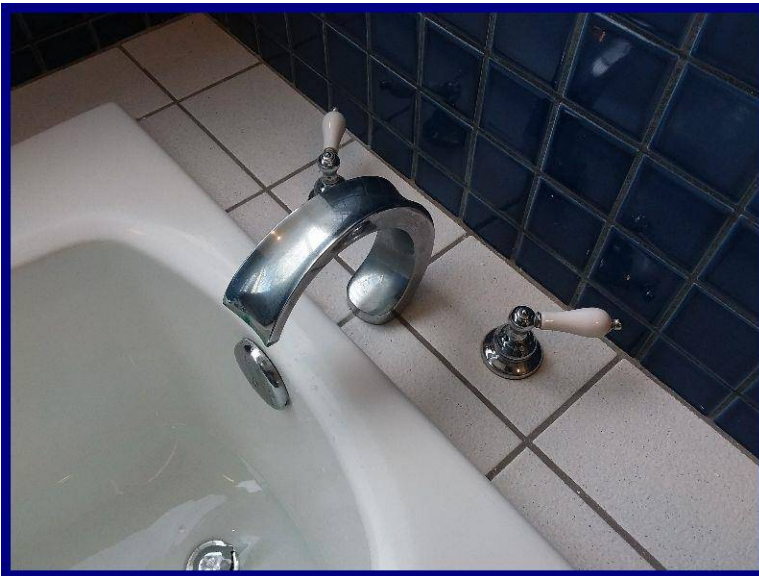
13.31 BATH/SHOWER FAUCETS:

10. [CR] The bathtub faucet and/or spout is loose on the deck or wall. We recommend the faucet be tightened to prevent moisture from getting behind the faucet.

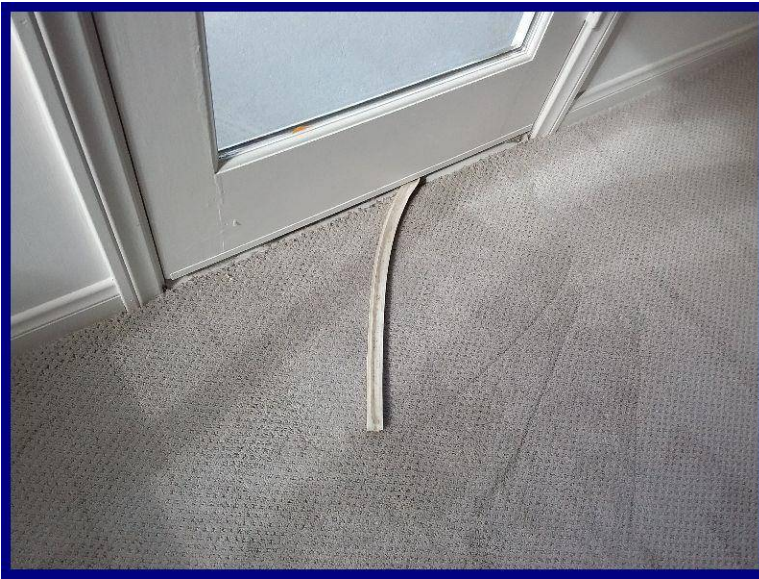
11. [CR] There is evidence of moisture intrusion at the base and threshold of the exterior exit door(s). We recommend locating and repairing the source and any damaged materials.

NOTE: Strip seal should be replaced.

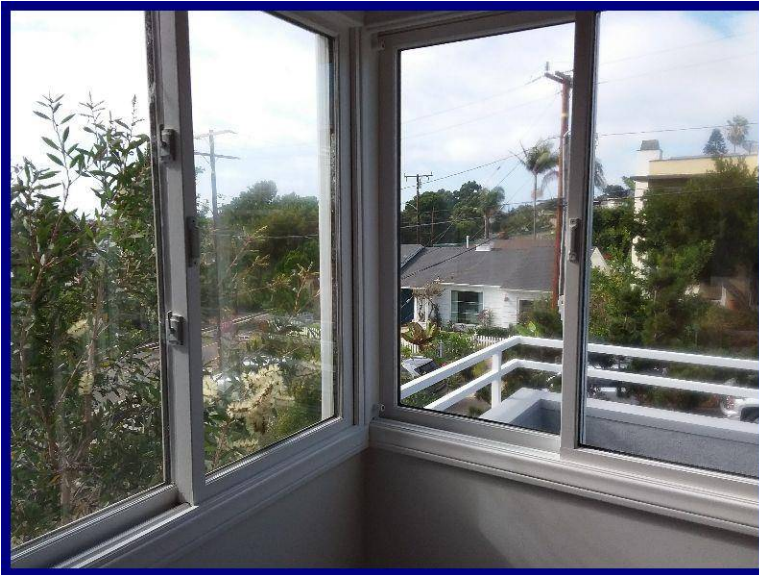
14.16 UPSTAIRS FRONT BEDROOM WINDOWS:

12. [CR] Moisture and/or stains were observed between the glass panes of the double-paned window(s), this condition usually indicates a defective seal. We recommend having all of the thermal windows and doors evaluated by a glazing specialist and replaced as needed.

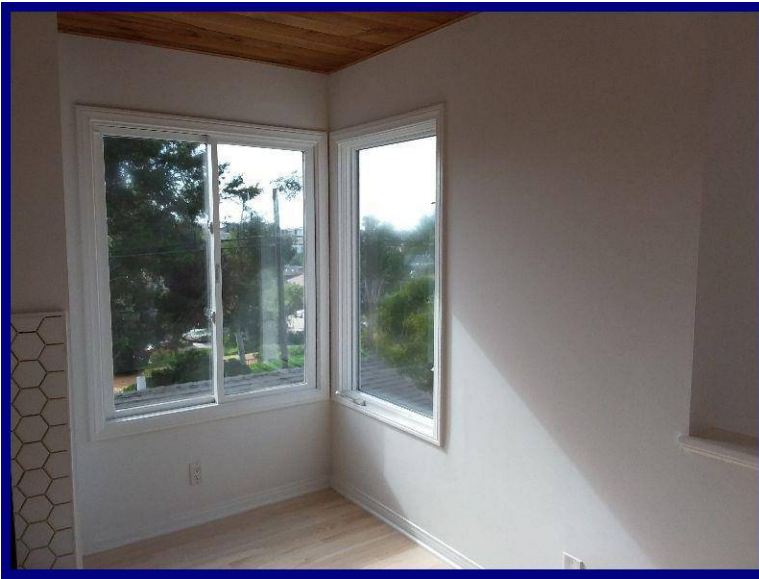
14.17 UPSTAIRS WINDOWS:

13. [CR] Moisture and/or stains were observed between the glass panes of the double-paned window(s), this condition usually indicates a defective seal. We recommend having all of the thermal windows and doors evaluated by a glazing specialist and replaced as needed.

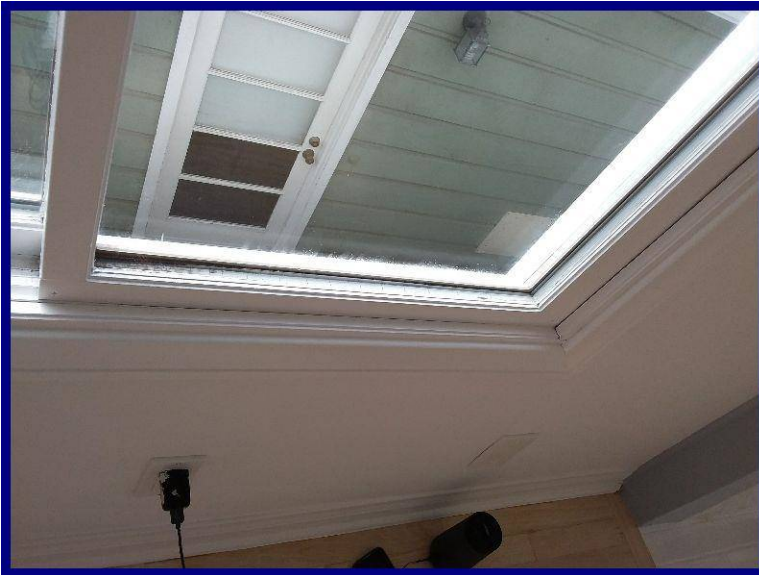
14.18 DINING AREA WINDOWS:

14. [CR] Moisture and/or stains were observed between the glass panes of the double-paned window(s), this condition usually indicates a defective seal. We recommend having all of the thermal windows and doors evaluated by a glazing specialist and replaced as needed.

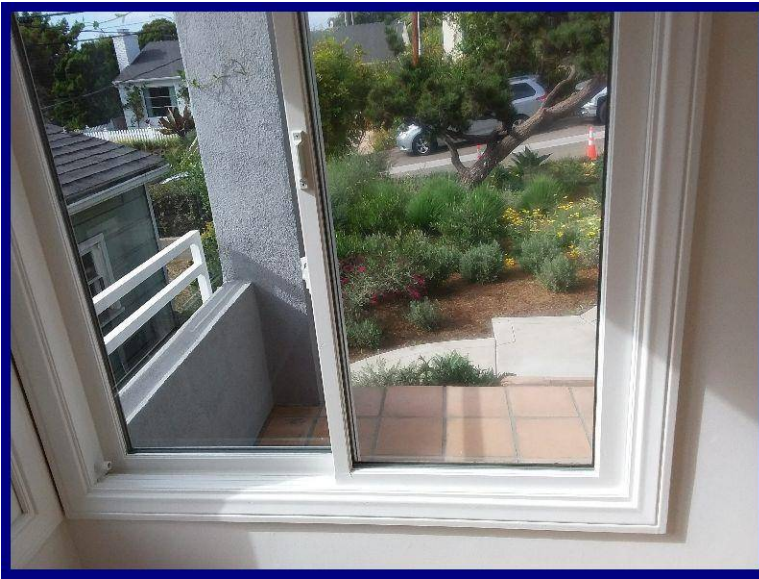
14.19 LIVING ROOM WINDOWS:

15. [CR] Moisture and/or stains were observed between the glass panes of the double-paned window(s), this condition usually indicates a defective seal. We recommend having all of the thermal windows and doors evaluated by a glazing specialist and replaced as needed.

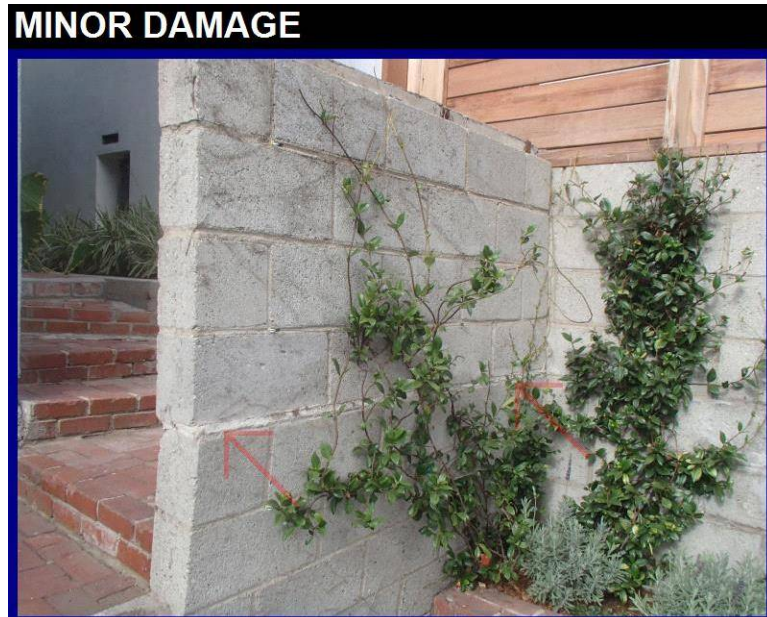
3.19 FENCING:

[CR] The concrete block fencing had common settlement or movement cracks. We recommend it be monitored and repaired if further damage develops

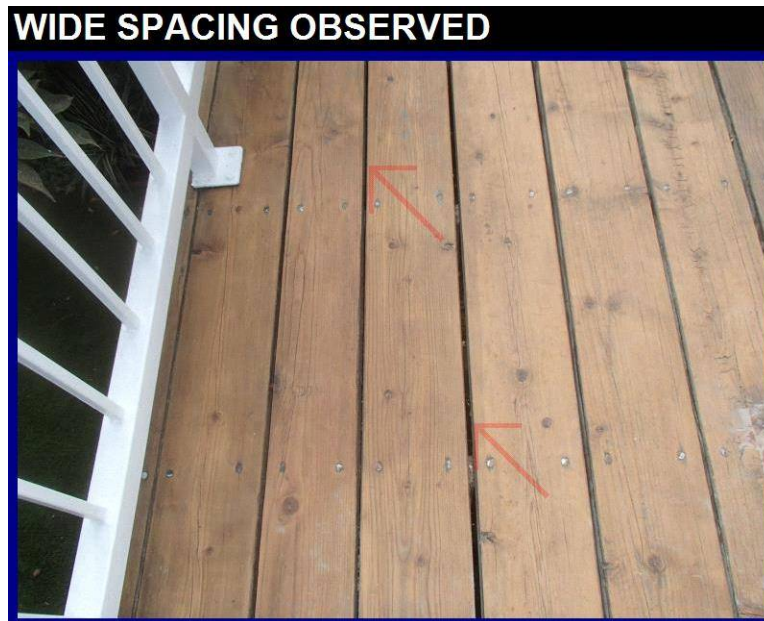
3.20 WOOD DECKS:

[SC] The spacing between the deck boards is installed with large gaps between the boards. This is a safety concern especially for woman with high heels. Generally industry standards dictate a gap of 1/8th of an inch between boards for the expansion and contraction of the boards as well as to vent the moisture. The current installation is a safety concern. We recommend the boards be installed with no more than an 1/8th of an inch gap for a safe walking surface.

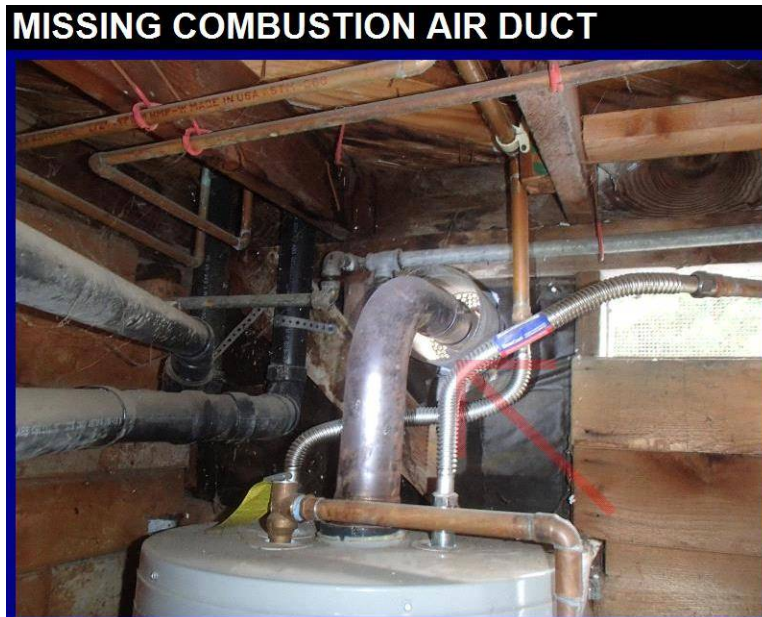
6.7 VENT CONDITIONS:

[SC] The flue vent pipe is installed with a material that was not rated for this application. We recommend replacing this material with an approved product, using approved methods for safety reasons.

NOTE: The combustion air vent for the direct vented furnace is missing. Generally the vent is required to allow for venting and combustion from the exterior of the structure. They do not make these types of water heaters any longer so the missing part may not be found. When the unit is replaced we recommend a power vented unit. Other wise the vent will have to discharge two feet above the roof line on the exterior of the structure.

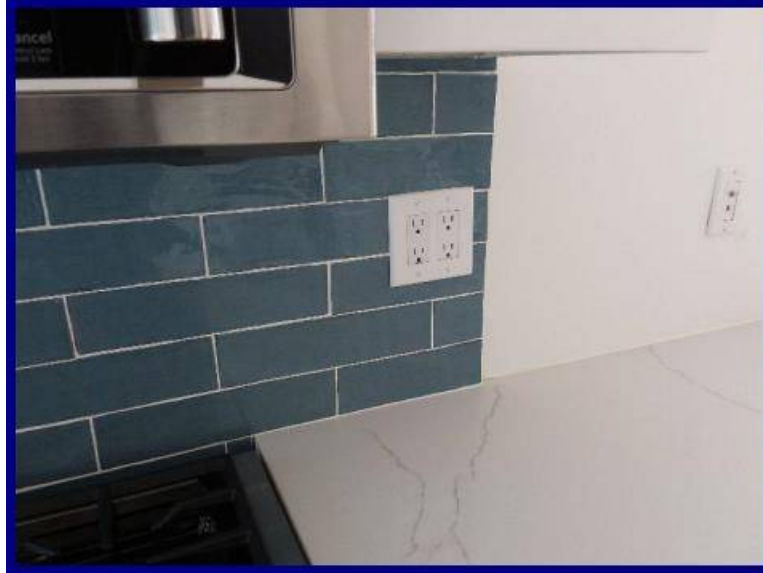
8.27 KITCHEN CONDITIONS:

[SC] The accessible receptacles are not GFCI protected, GFCI protected outlets should have been installed at the time the building was remodeled. This is an electrical Safety Hazard. We recommend providing GFCI protection at the required locations for safety reasons.

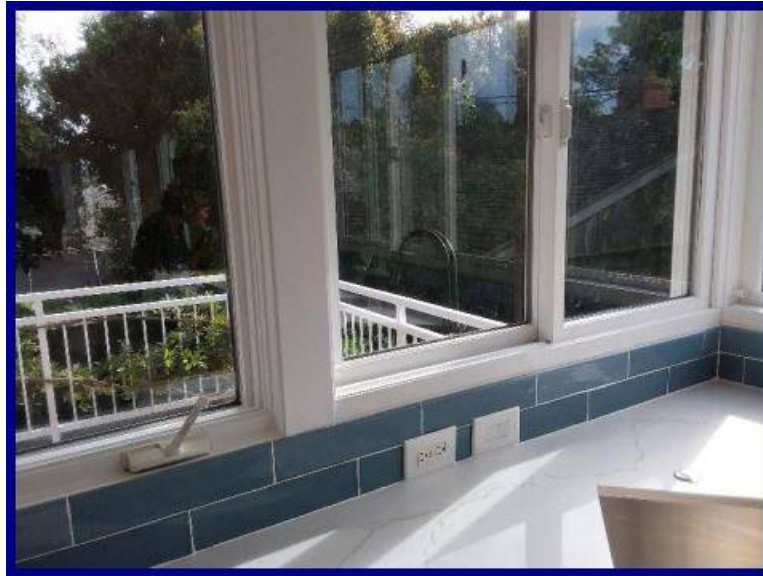
12.3 WINDOWS:

[CR] Moisture and/or stains were observed between the glass panes of the double-paned window(s), this condition usually indicates a defective seal. We recommend having all of the thermal windows and doors evaluated by a glazing specialist and replaced as needed.

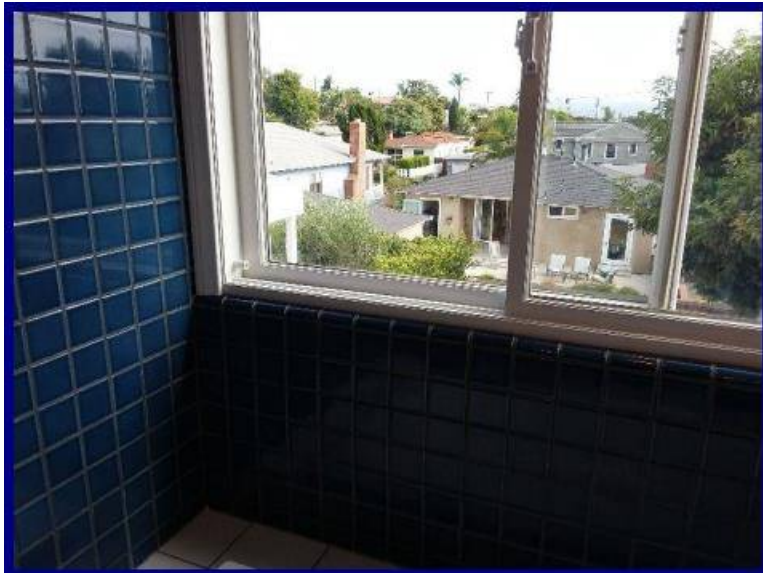
13.27 WINDOWS:

[CR] Moisture and/or stains were observed between the glass panes of the double-paned window(s), this condition usually indicates a defective seal. We recommend having all of the thermal windows and doors evaluated by a glazing specialist and replaced as needed. [SC] There are no visible safety glass markings on the glass in the window(s) within 60 inches above the walking surface of the tub or floor

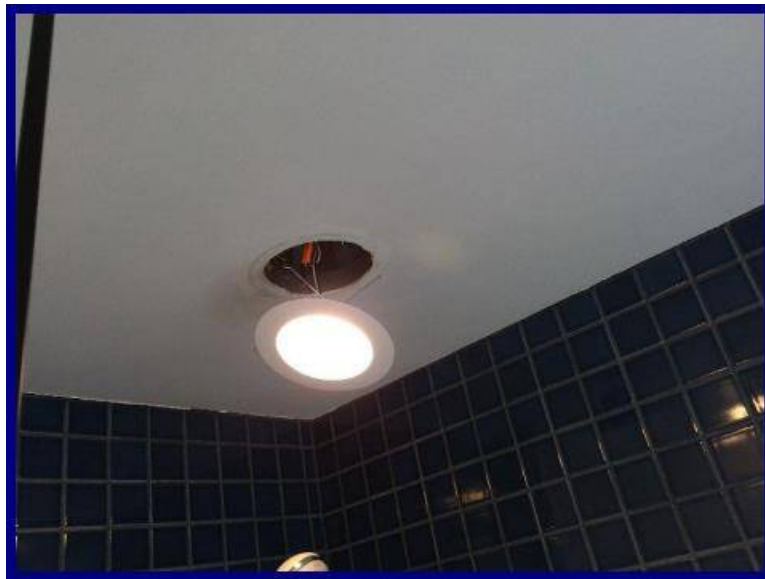
13.28 LIGHTS:

[CR] One or more of the light lenses are missing. We recommend replacing all missing parts as needed.

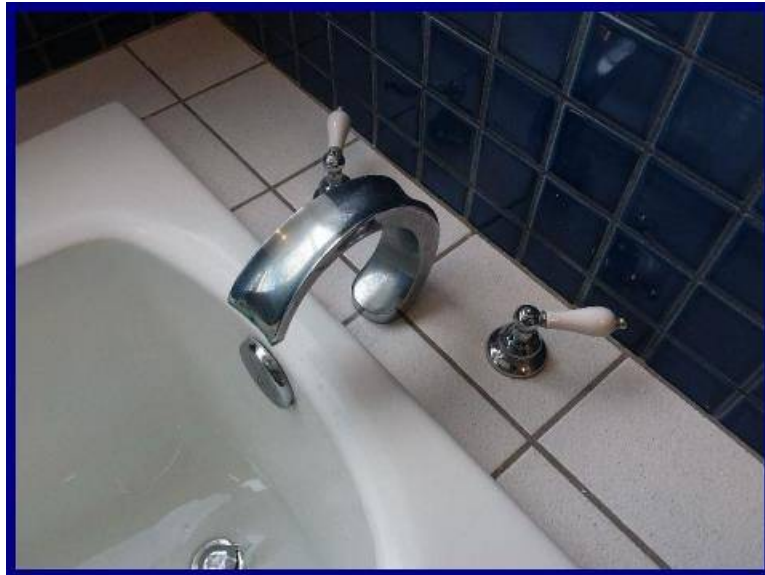
**13.31 BATH/SHOWER
FAUCETS:**

[CR] The bathtub faucet and/or spout is loose on the deck or wall. We recommend the faucet be tightened to prevent moisture from getting behind the faucet.

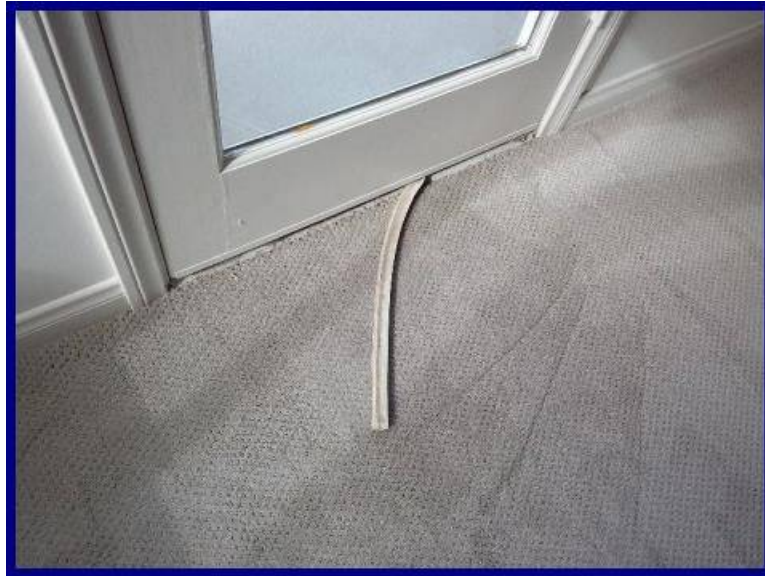
14.15 UPSTAIRS FRONT BED EXT DOORS:

[CR] There is evidence of moisture intrusion at the base and threshold of the exterior exit door(s). We recommend locating and repairing the source and any damaged materials.

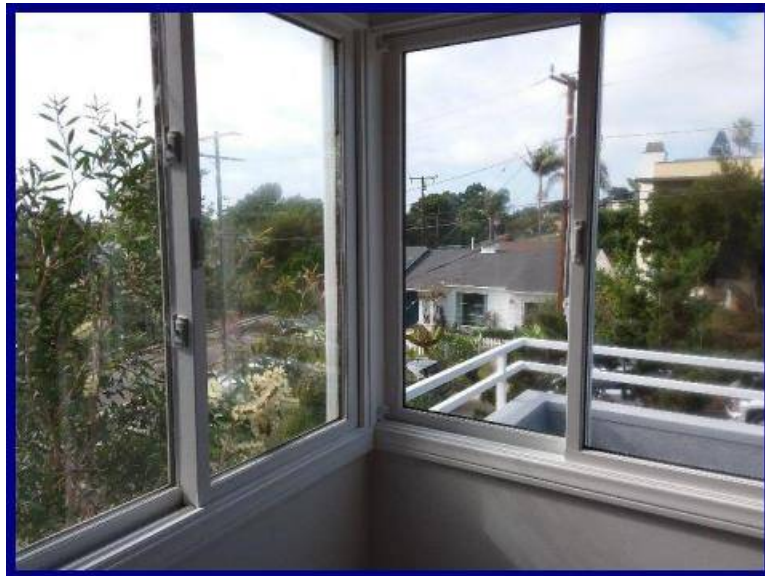
*14.16 UPSTAIRS FRONT
BEDROOM WINDOWS:*

[CR] Moisture and/or stains were observed between the glass panes of the double-paned window(s), this condition usually indicates a defective seal. We recommend having all of the thermal windows and doors evaluated by a glazing specialist and replaced as needed.

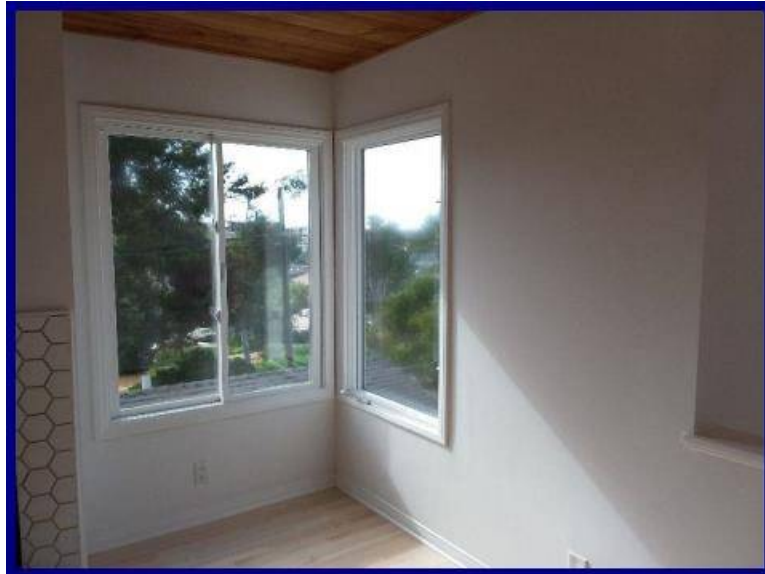
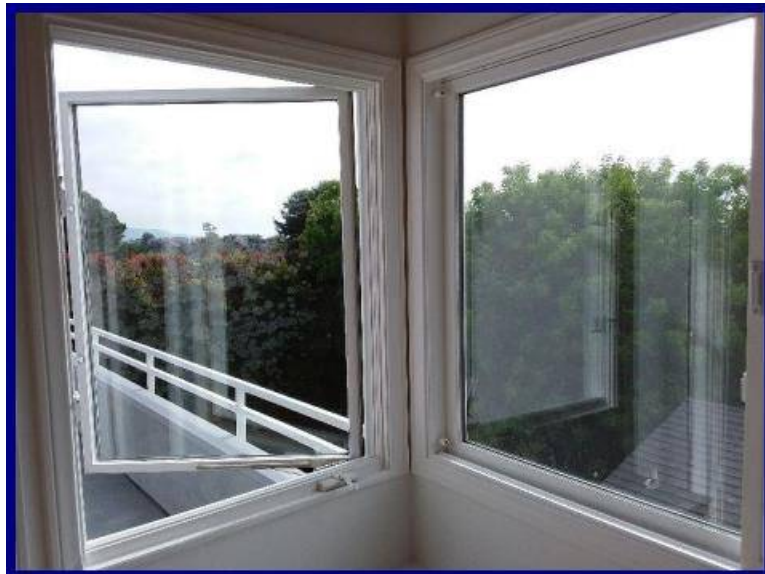
14.17 UPSTAIRS WINDOWS:

[CR] Moisture and/or stains were observed between the glass panes of the double-paned window(s), this condition usually indicates a defective seal. We recommend having all of the thermal windows and doors evaluated by a glazing specialist and replaced as needed.

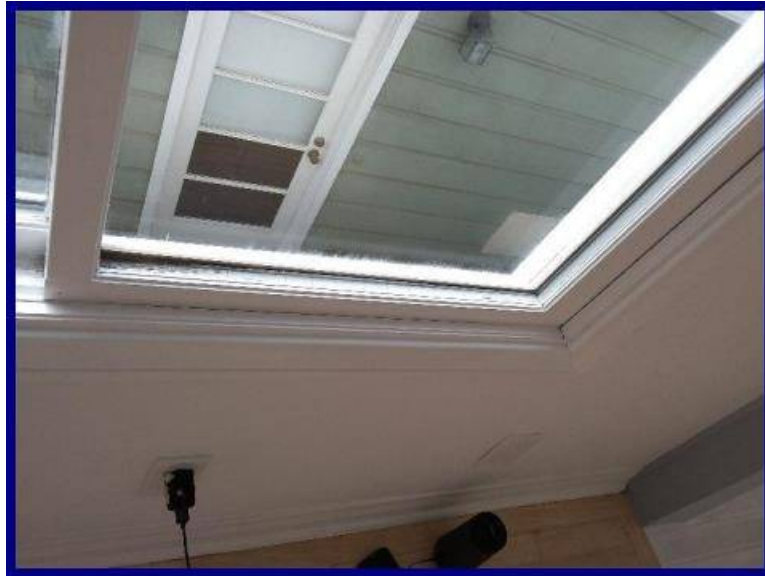
**14.18 DINING AREA
WINDOWS:**

[CR] Moisture and/or stains were observed between the glass panes of the double-paned window(s), this condition usually indicates a defective seal. We recommend having all of the thermal windows and doors evaluated by a glazing specialist and replaced as needed.

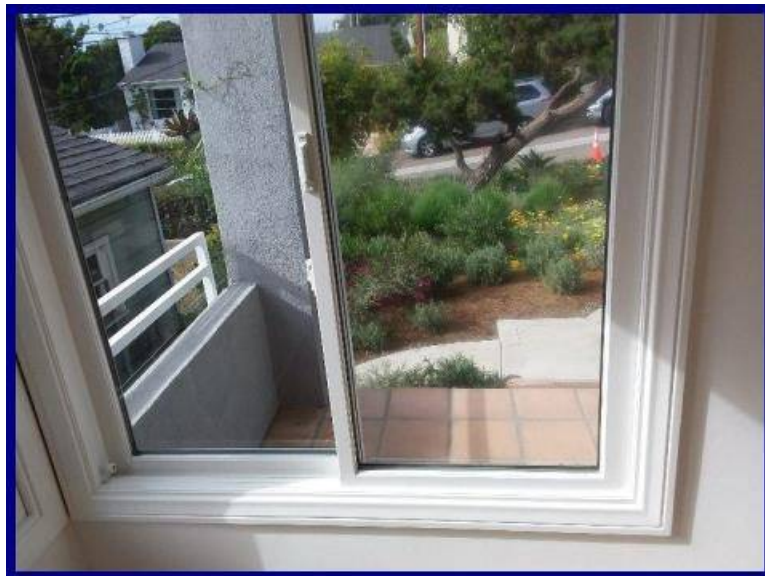
*14.19 LIVING ROOM
WINDOWS:*

[CR] Moisture and/or stains were observed between the glass panes of the double-paned window(s), this condition usually indicates a defective seal. We recommend having all of the thermal windows and doors evaluated by a glazing specialist and replaced as needed.

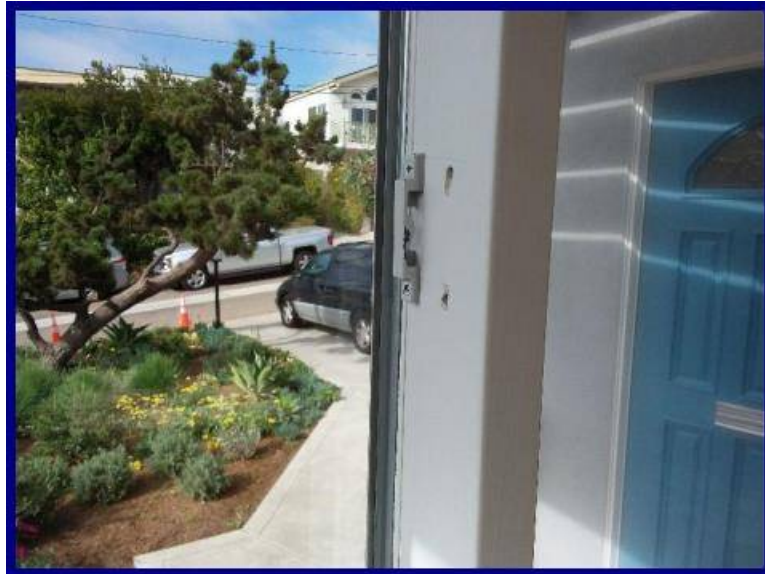
*14.20 LIVING ROOM
WINDOW FUNCTION:*

[CR] The window lock is missing. We recommend replacing the missing lock(s) for security reasons.
