### *Inspection Report*

Address: 3437 Shearer Ave Cayucos, CA 93430

02/12/2026

Inspector: Taylor Vreeken, CCI  
P.O. Box 415 Templeton, CA 93465 | O: 805.462.1978 C: 805.441.9727

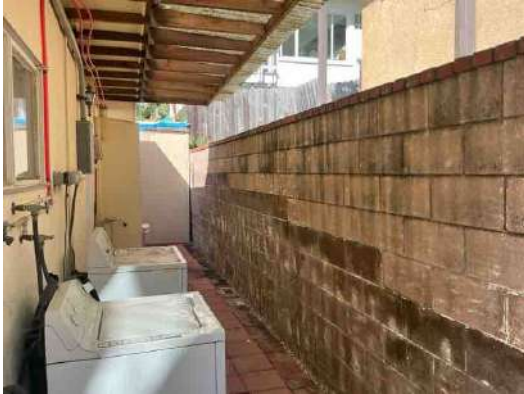
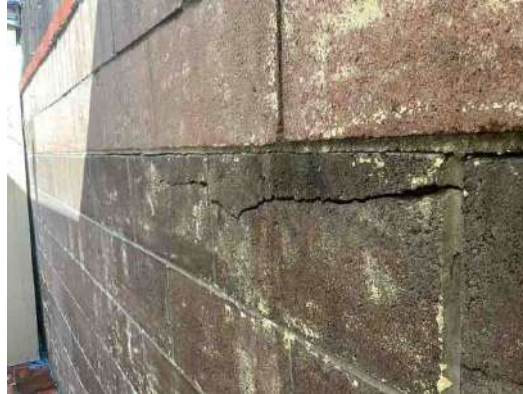
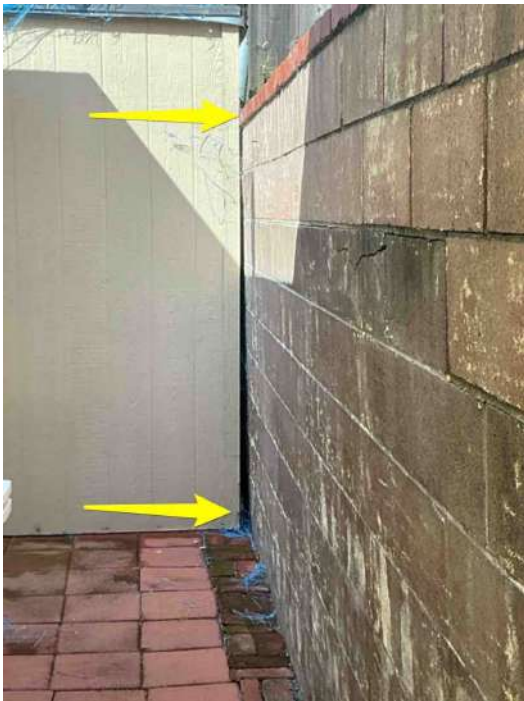
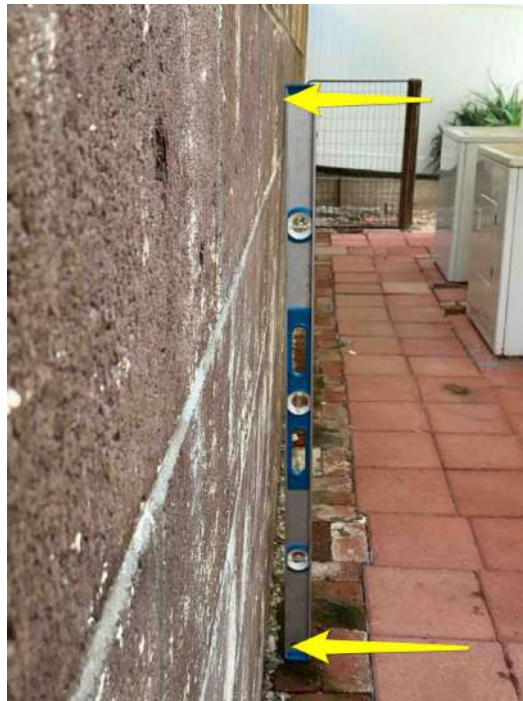
**FI DS** s-39: The masonry wall was observed to be leaning approximately 3% (roughly 3 inches out of plumb over 8 feet). This exceeds typical construction tolerances for masonry walls and may indicate structural movement or lateral pressure. Further evaluation by a qualified structural engineer is recommended to determine cause and corrective measures.

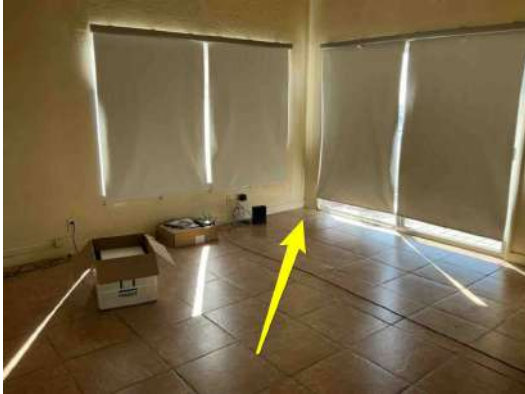
**E&C FI s-41:** Some sloping of the interior slab noted (2.5 inch drop at the living room Southwest corner). Suspected foundation/ slab settlement.

The measured slope calculates to approximately  $\frac{1}{8}$  inch per foot, which is below  $\frac{1}{4}$  inch per foot, the total cumulative drop of  $2\frac{1}{2}$  inches across the span is significant and may indicate settlement or differential movement.

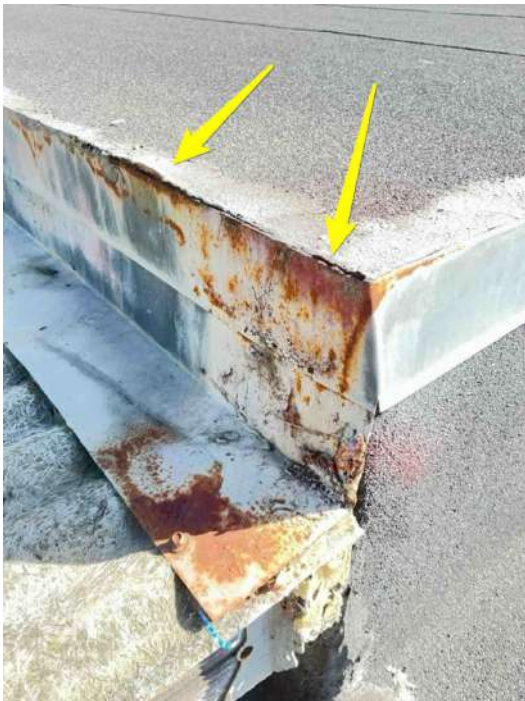
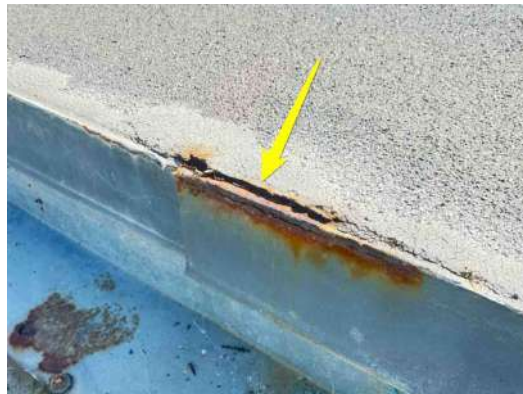
**E&C MR s-50:** Some roof flashings found rusted and deteriorated. Further evaluation and potential upgrades needed by a licensed roofer.

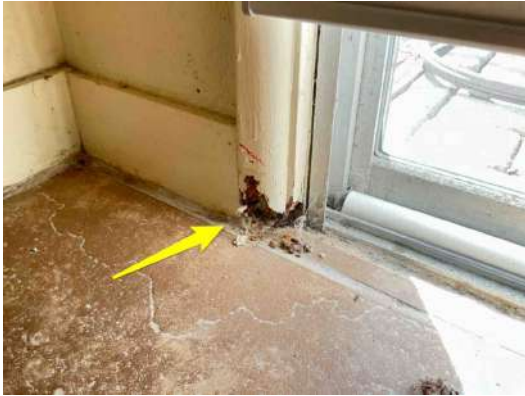
**s-114:** Evidence of past water intrusion from around threshold area from exterior sliding glass door with stains and/or damage: LIVING ROOM

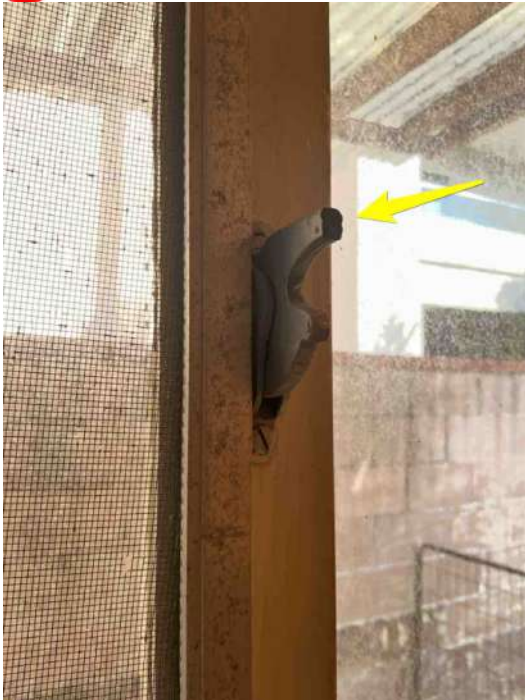
**SC s-120:** Window lock found damaged/ non-operational. Safety hazard: BEDROOM-2 EAST WALL

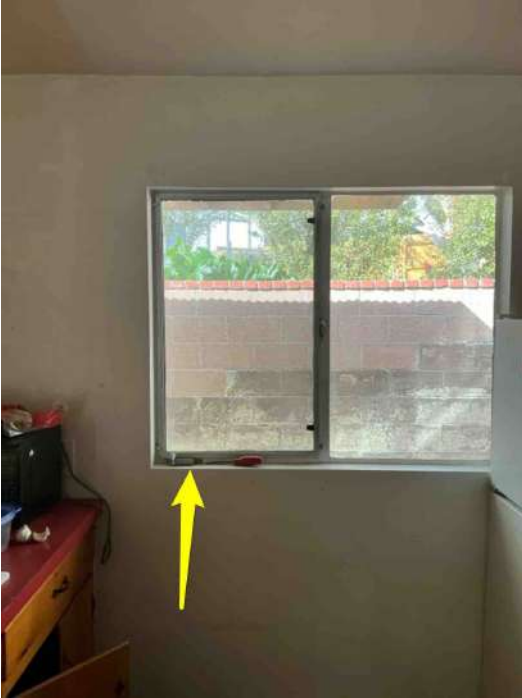
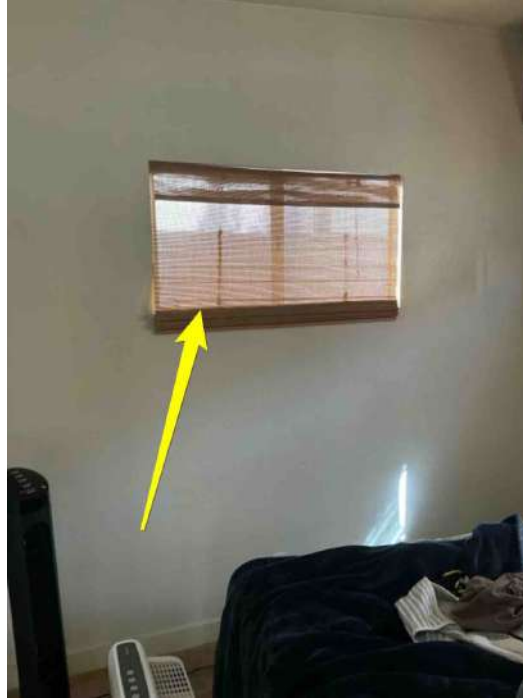
**s-123:** The crank handle/ window in the KITCHEN and BEDROOM -2 (east wall) found non-operational. Contact a qualified window, professional for evaluation and repairs or replacement.

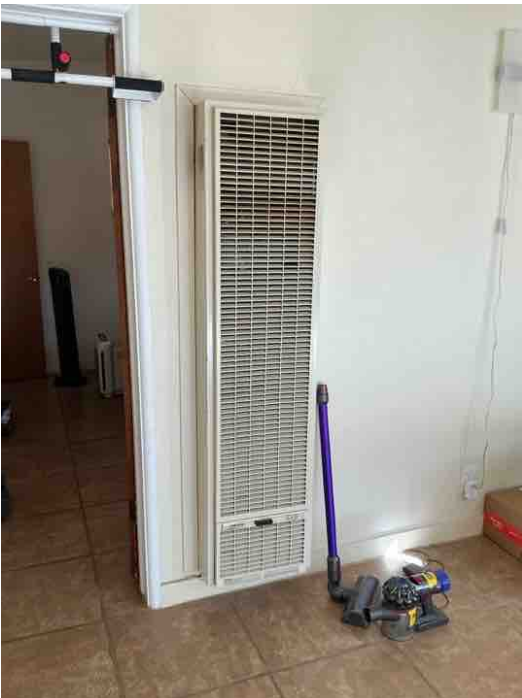
**s-132:** Disclosure- This type of heating unit has an anticipated 20-30 year life span and is currently 54 years old. The heating unit operated today but is past anticipated life expectancy. Continuous maintenance and inspection recommended.

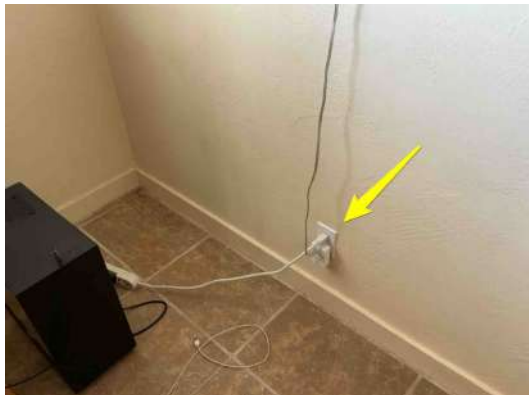
**SC s-147:** Miswired electrical outlet (Reverse polarity) found TWO IN BEDROOM-1. Have electrician check all outlets and correct as needed.

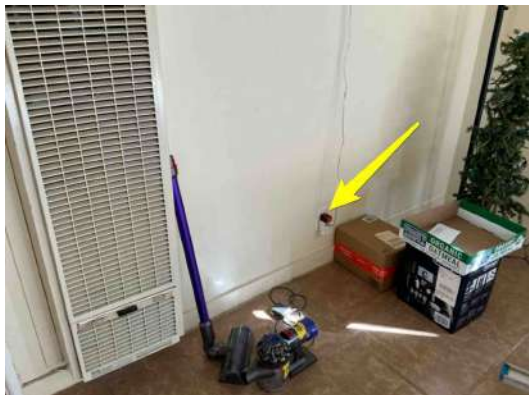
**SC s-148:** Three-prong electrical outlets did not test properly grounded: LIVING ROOM EAST WALL. Contact a licensed electrical contractor for evaluation and repairs.

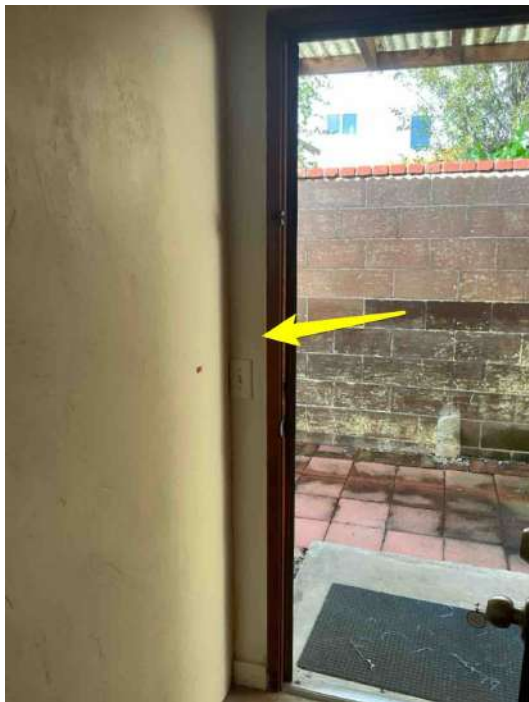
**s-151:** Missing the required light switches for interior lighting off the ENTRY DOOR, BEDROOM-1, and BEDROOM-2 BACK DOOR. Upgrades recommended per minimum standards.

Exterior light switch only

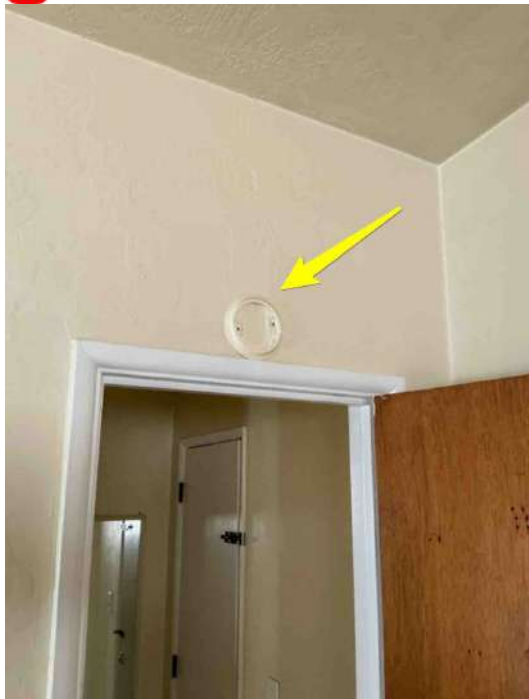
**SC s-155: Smoke detector missing at required location: BEDROOM-2**

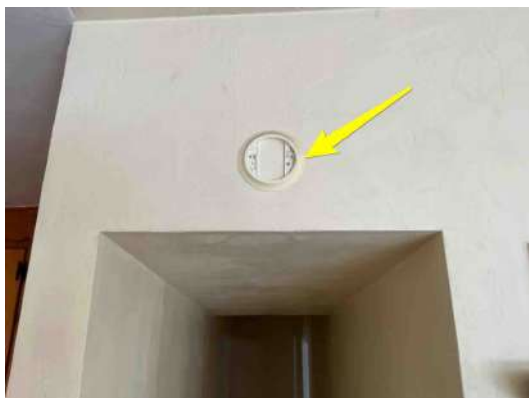
**SC s-156: Smoke detector AND Carbon Monoxide detector are missing at required location: BEDROOM HALLWAY**

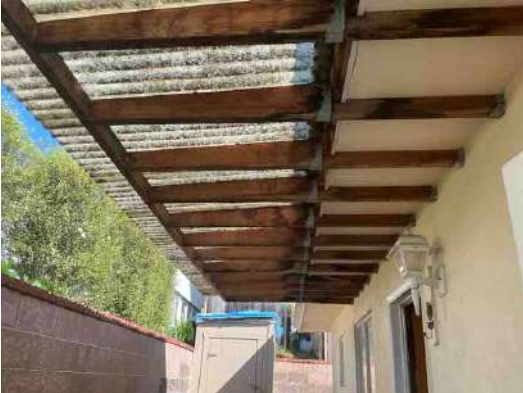
**E&C SU 22:** Areas of the wood framed FRONT PORCH COVER do not meet minimum construction or engineering standards. Further evaluation with upgrades or repairs by a licensed contractor familiar with minimum construction and engineering standards is recommended.

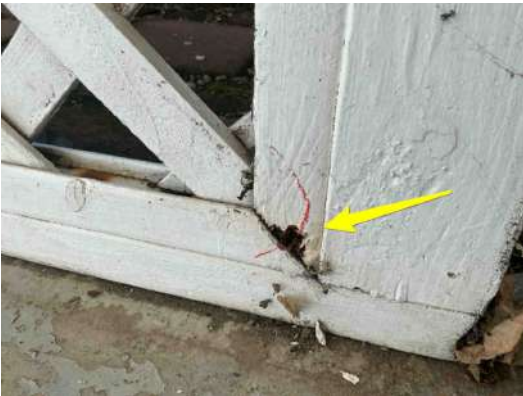
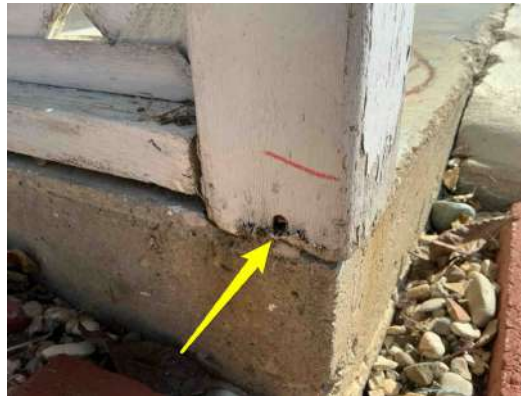
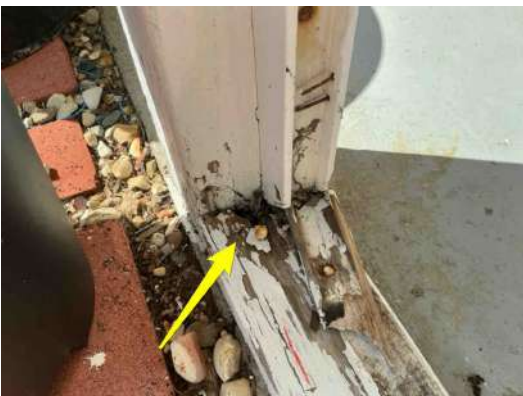
**E&C 24:** Some moisture type damage found at areas of the wood framed carport. Refer to the Termite Report for additional comments and recommendations.

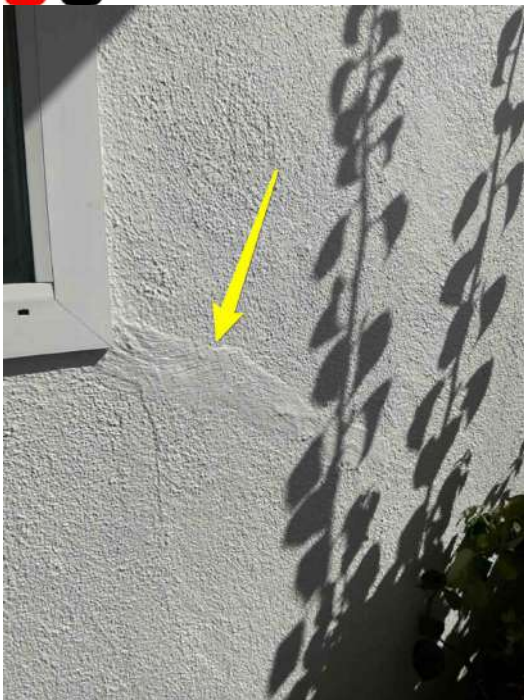
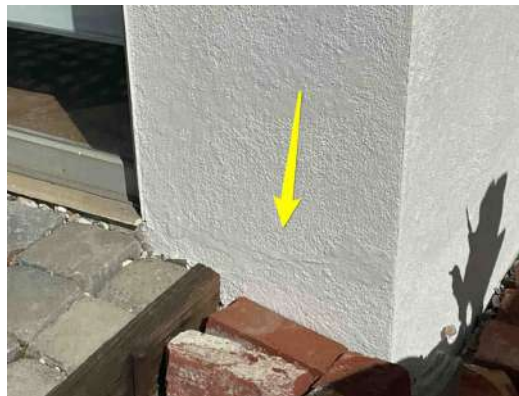
**FI DS 31:** Multiple past stucco crack repairs noted throughout. Ask seller for details.

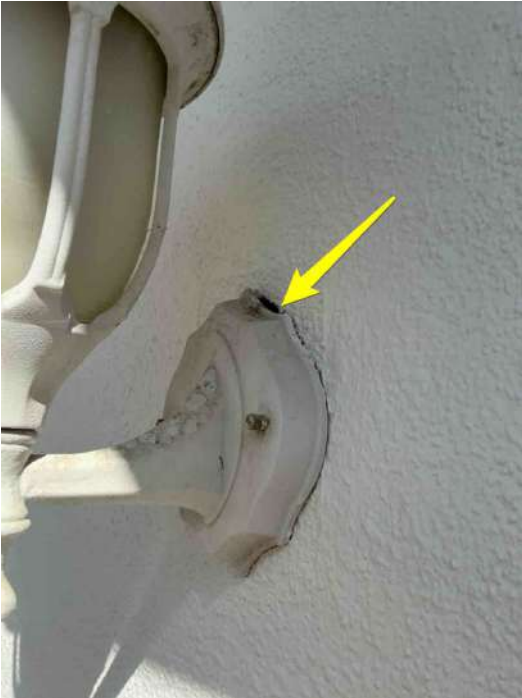
**MR 32:** Recommend sealing holes in exterior walls to prevent water intrusion around areas such as unused open holes in the exterior siding and trim, exterior light fixtures, around exterior electrical boxes and covers, and where utility pipes and/or wires pass through the exterior walls. Have a qualified painter or licensed professional evaluate the entire exterior and seal where needed.

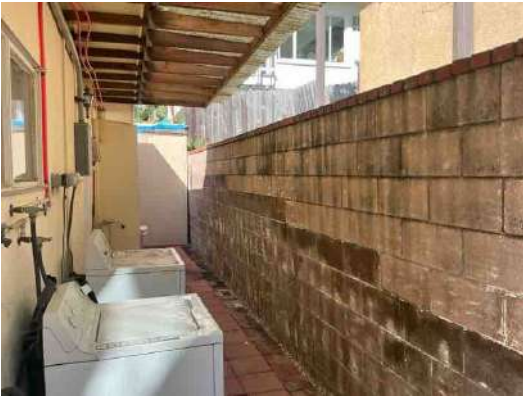
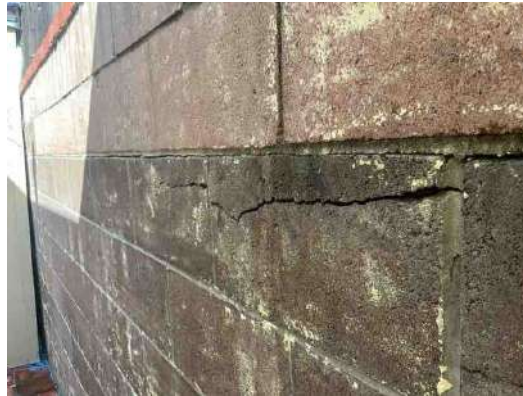
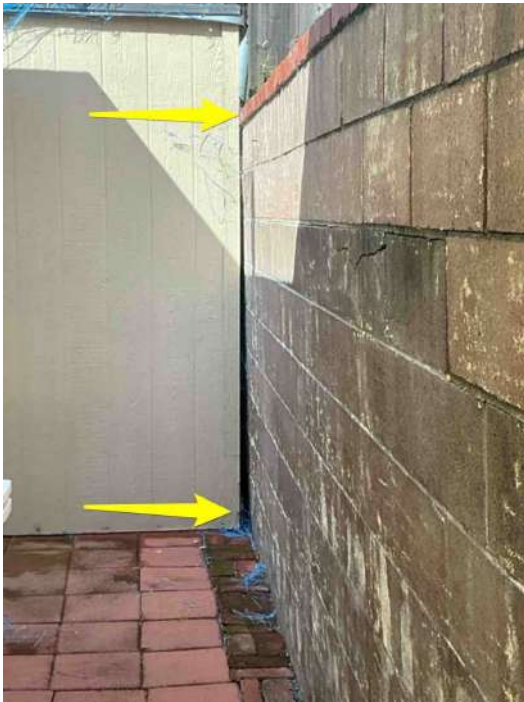
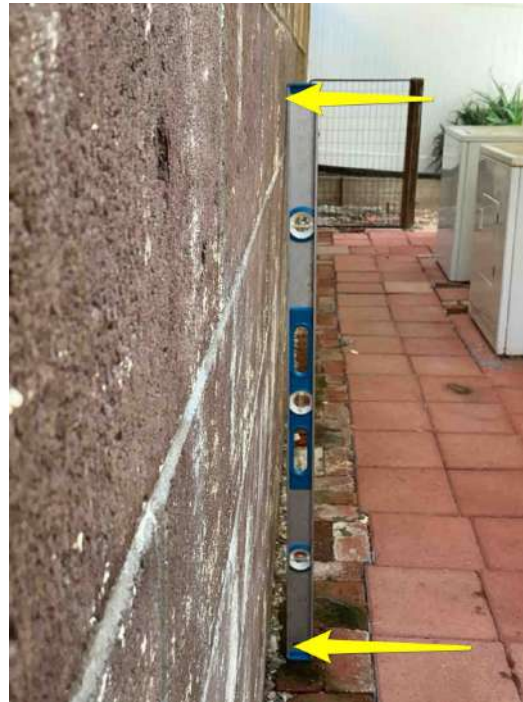
**FI DS 39:** The masonry wall was observed to be leaning approximately 3% (roughly 3 inches out of plumb over 8 feet). This exceeds typical construction tolerances for masonry walls and may indicate structural movement or lateral pressure. Further evaluation by a qualified structural engineer is recommended to determine cause and corrective measures.

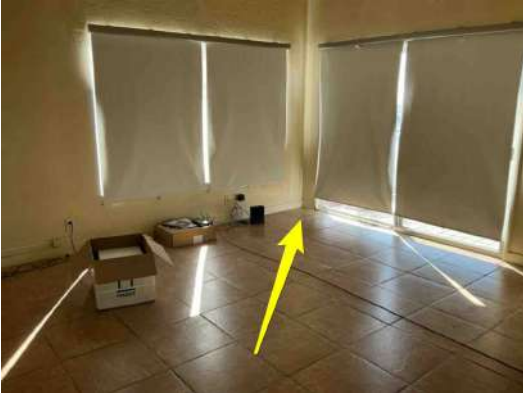
**E&C** **FI** **41:** Some sloping of the interior slab noted (2.5 inch drop at the living room Southwest corner). Suspected foundation/ slab settlement.

The measured slope calculates to approximately  $\frac{1}{8}$  inch per foot, which is below  $\frac{1}{4}$  inch per foot, the total cumulative drop of  $2\frac{1}{2}$  inches across the span is significant and may indicate settlement or differential movement.

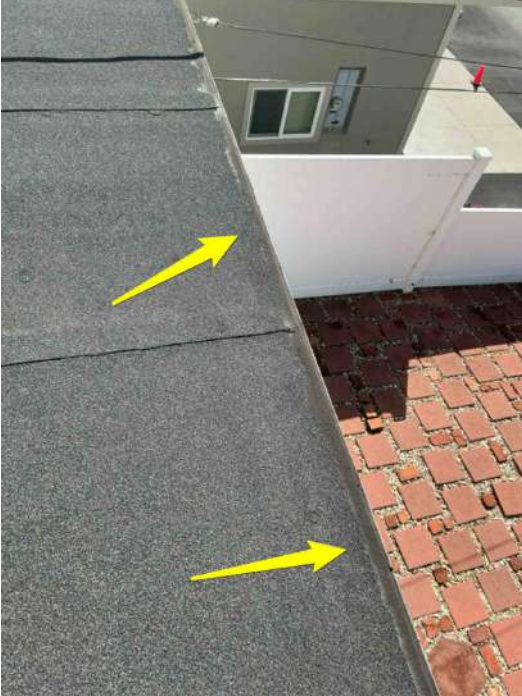
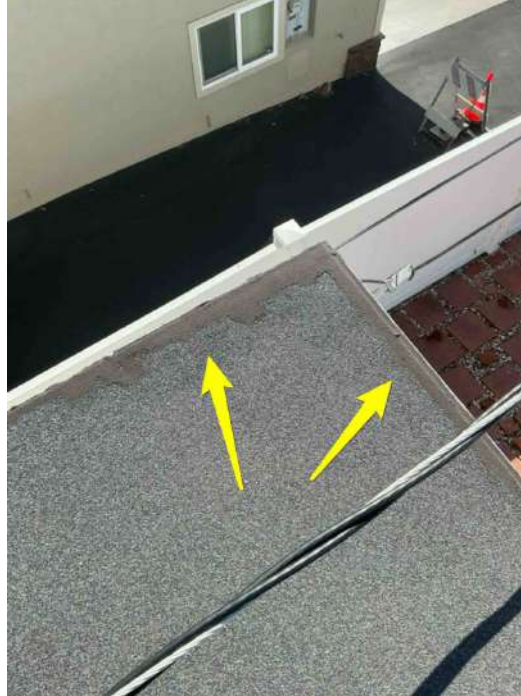
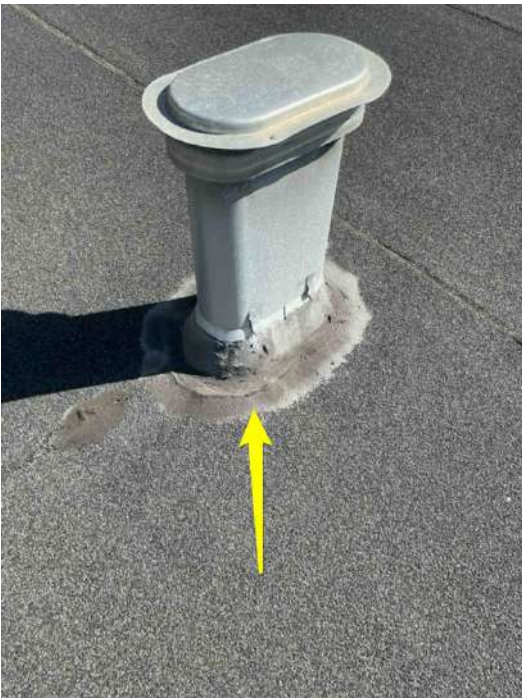
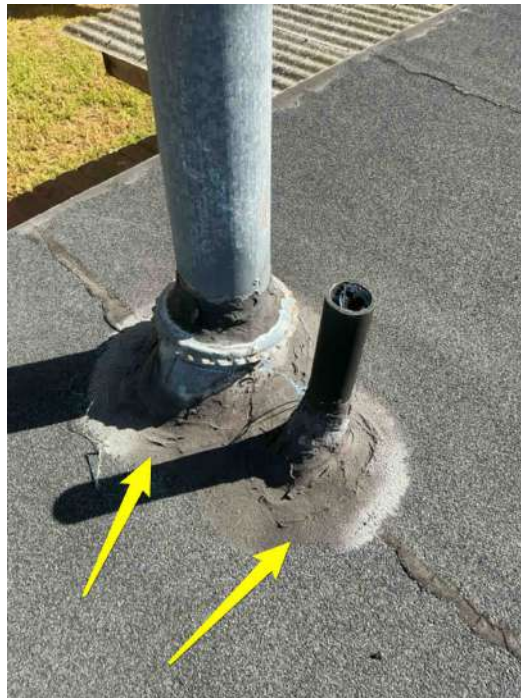
**MR 47:** Areas of past improper or incomplete past repairs found at areas of the ROLLED COMPOSITION ROOFING. Areas of exposed mastic found not covered by aggregate found deteriorated.

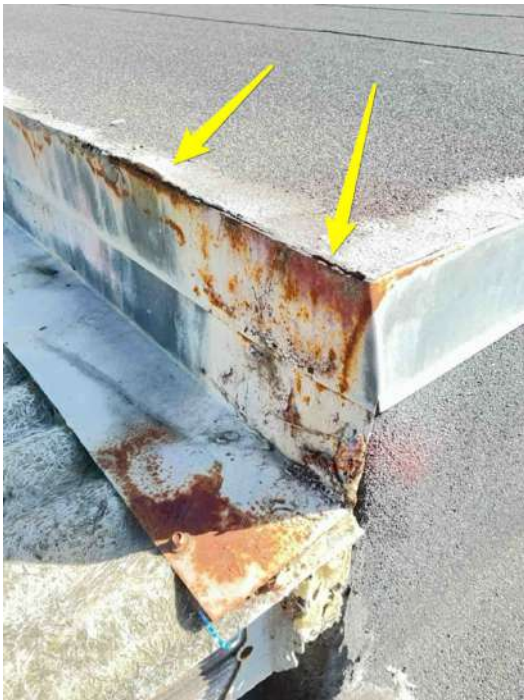
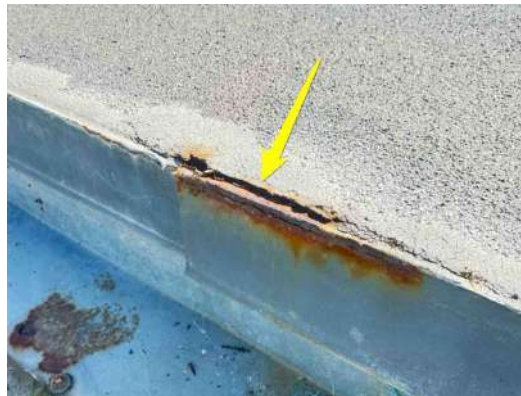
**E&C MR 50:** Some roof flashings found rusted and deteriorated. Further evaluation and potential upgrades needed by a licensed roofer.

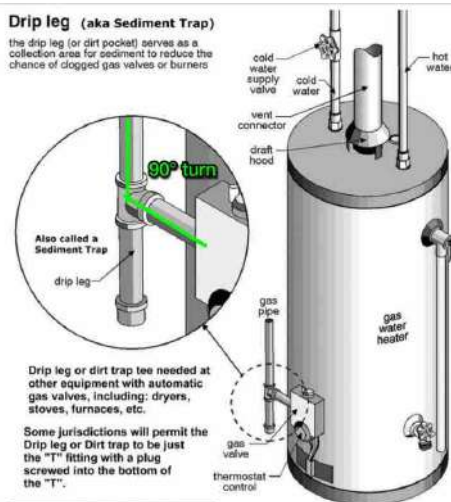
**SU 77:** Recommend the installation of the missing sediment trap / drip leg at the WATER HEATER gas piping at flex connection by a certified or licensed plumbing professional familiar with minimum requirements. [CPC 1212.8]

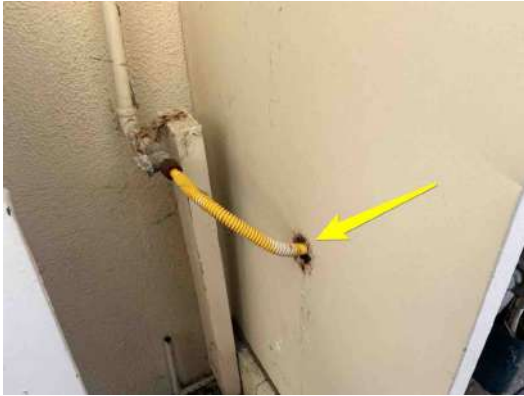
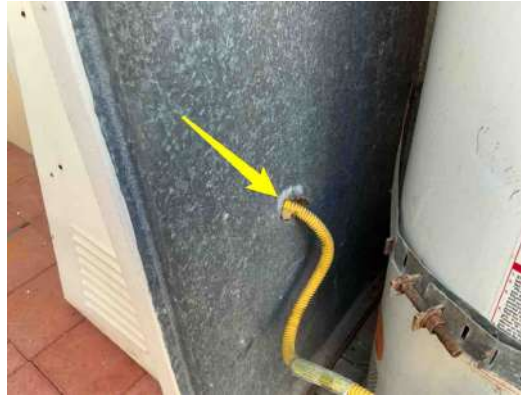
**78:** Improper installation of the water heater gas flex connector through the metal water heater enclosure. Contact qualified plumbing professional for evaluation and repairs.

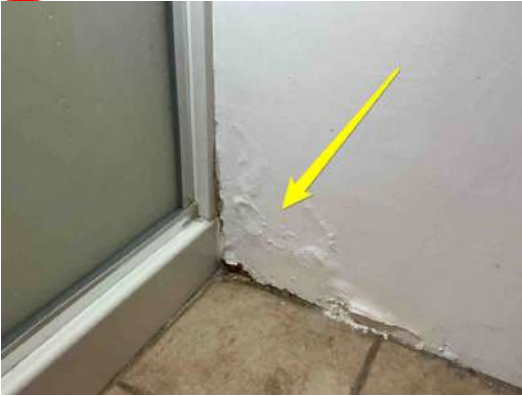
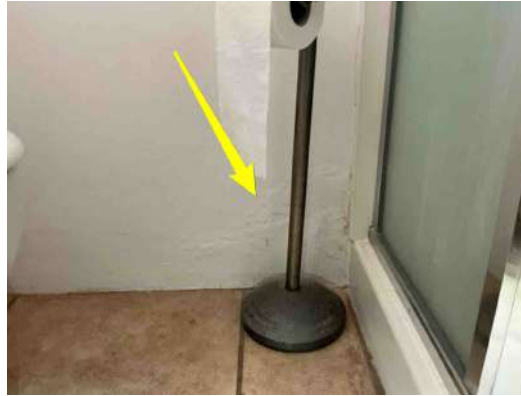
**FI 108: Moisture stains & damage to walls outside shower: HALLWAY BATHROOM**

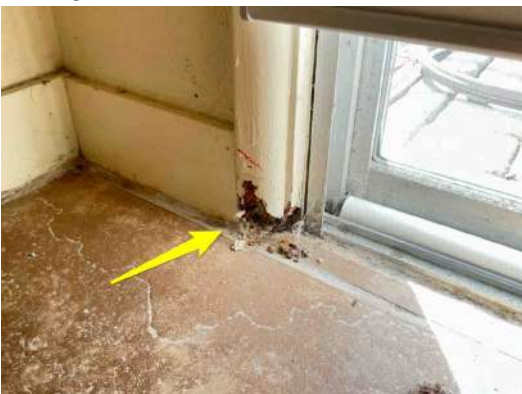
**114:** Evidence of past water intrusion from around threshold area from exterior sliding glass door with stains and/or damage: LIVING ROOM

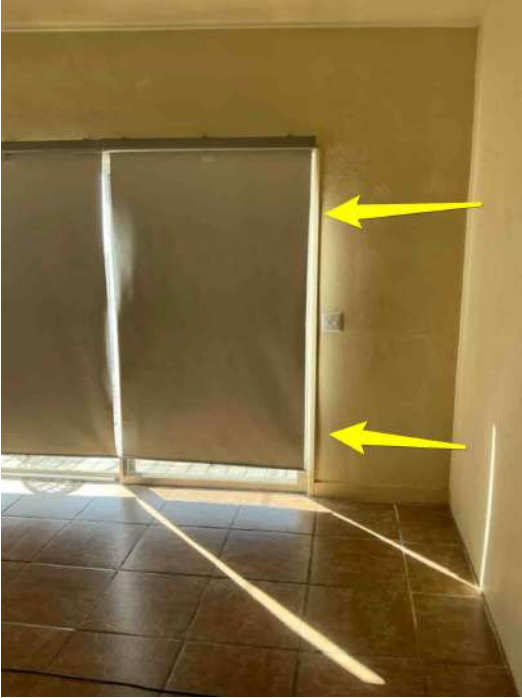
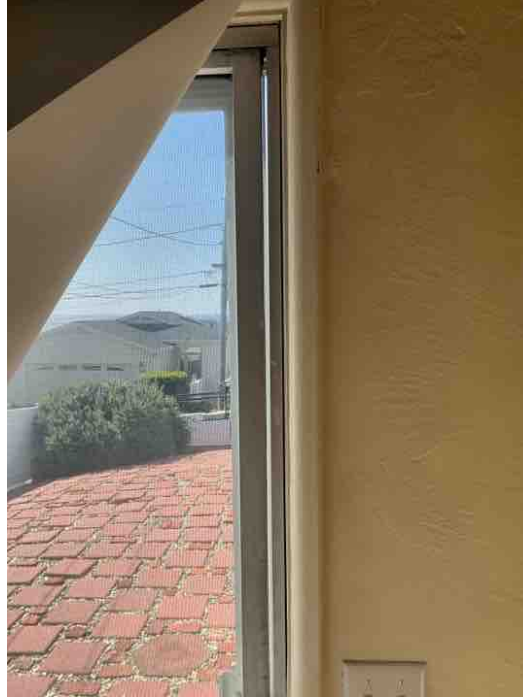
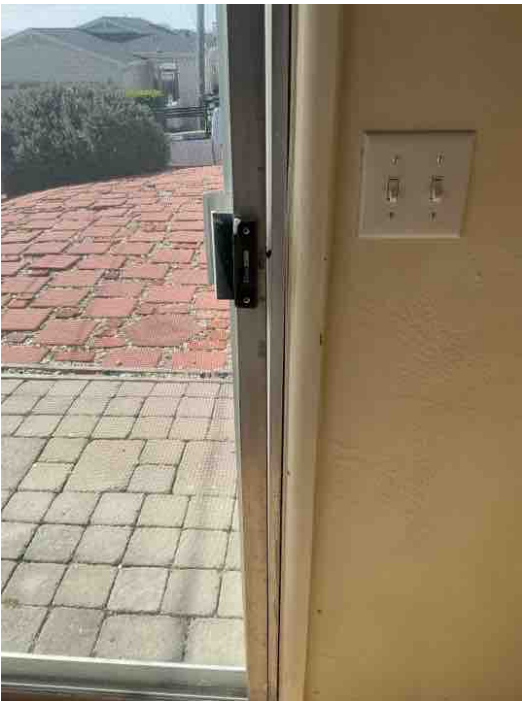
**E&C 115:** The sliding glass door found out of alignment and not plum with the jamb. Contact a qualified professional for evaluation and maintenance or repairs.

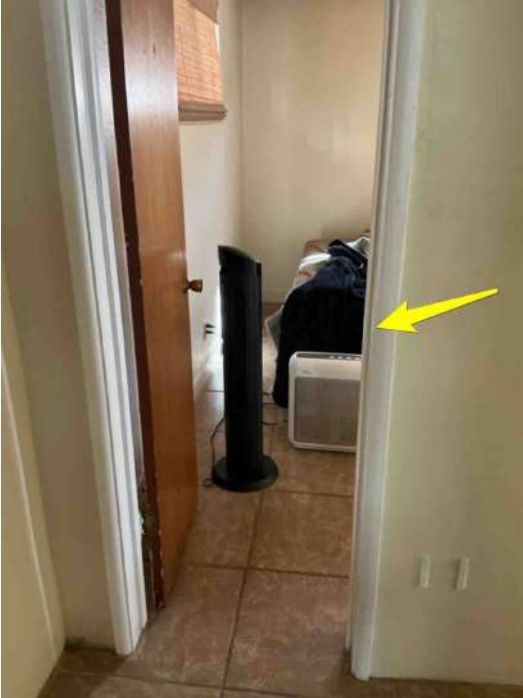
**MR 117:** Interior door does not latch. Recommend adjustment of the strike plate: BEDROOM-2 BACK DOOR

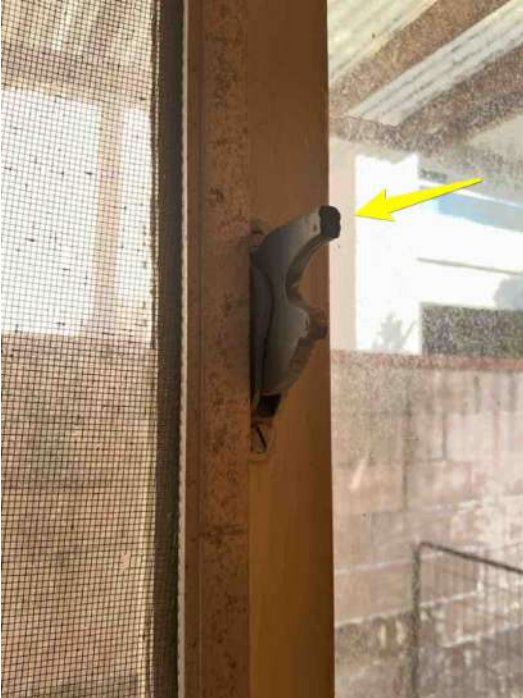
**SC 120:** Window lock found damaged/ non-operational. Safety hazard: BEDROOM-2 EAST WALL

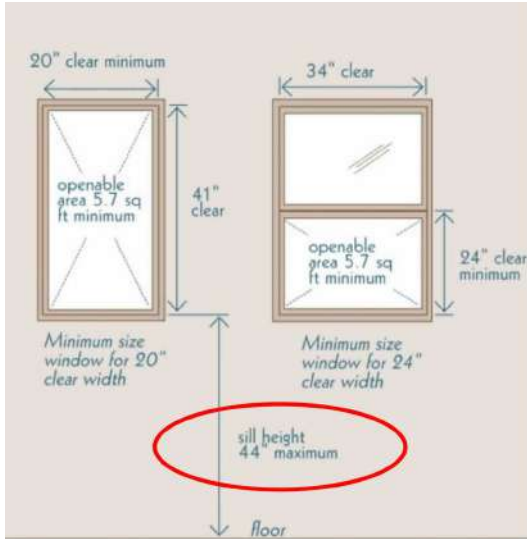
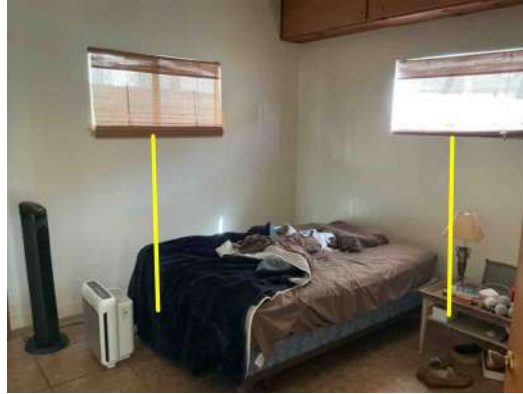
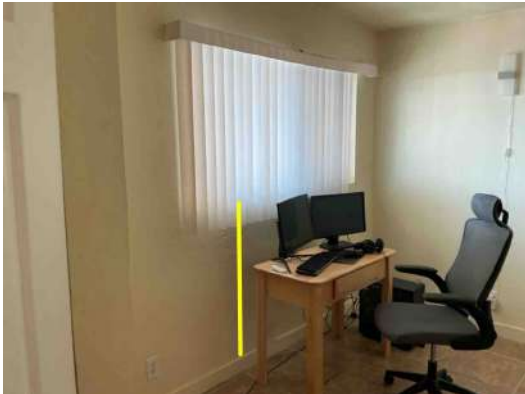
**SC 122:** Windows in BOTH bedrooms are a too high off the floor and do not meet the current minimum fire egress standards. Standards for fire egress windows are no more than 44 inches off the floor.

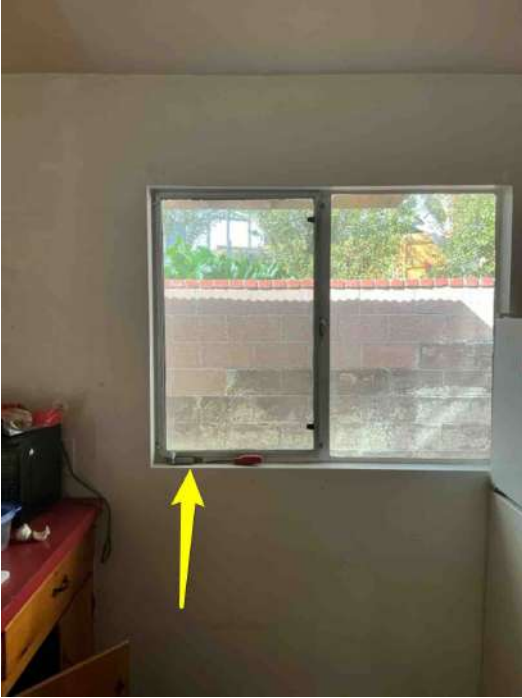
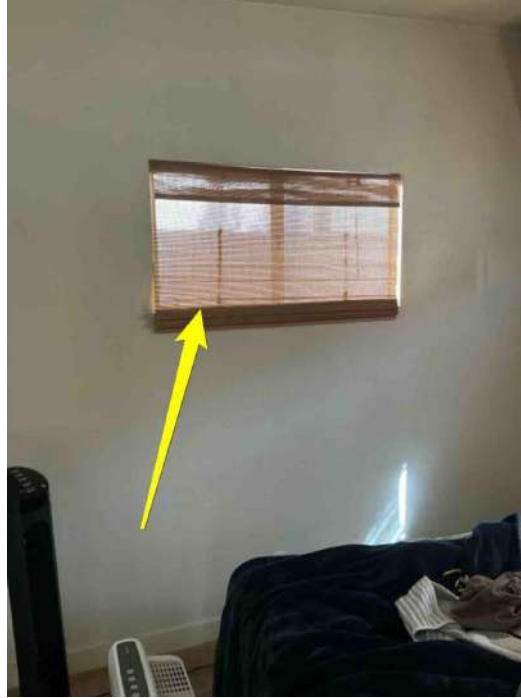
**E&C 123:** The crank handle/ window in the KITCHEN and BEDROOM -2 (east wall) found non-operational. Contact a qualified window, professional for evaluation and repairs or replacement.

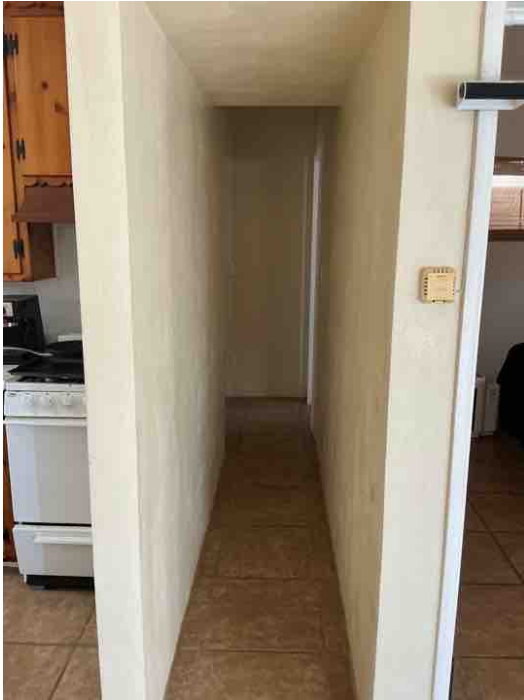
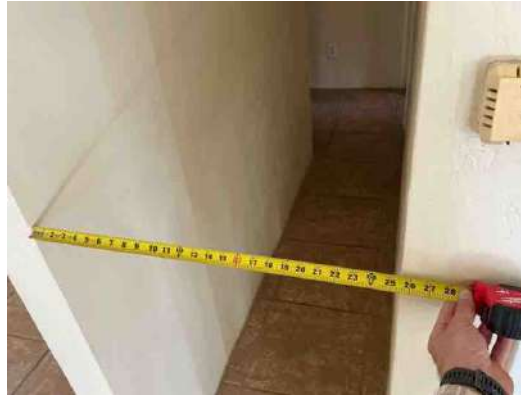
**DS 129:** The hallway measured approximately 25½ inches in width. Current residential construction standards require a minimum hallway width of 36 inches; however, this home was built in 1959 and the hallway appears to be original construction. While likely acceptable at the time of construction, the narrow width does not meet modern standards and may limit accessibility.

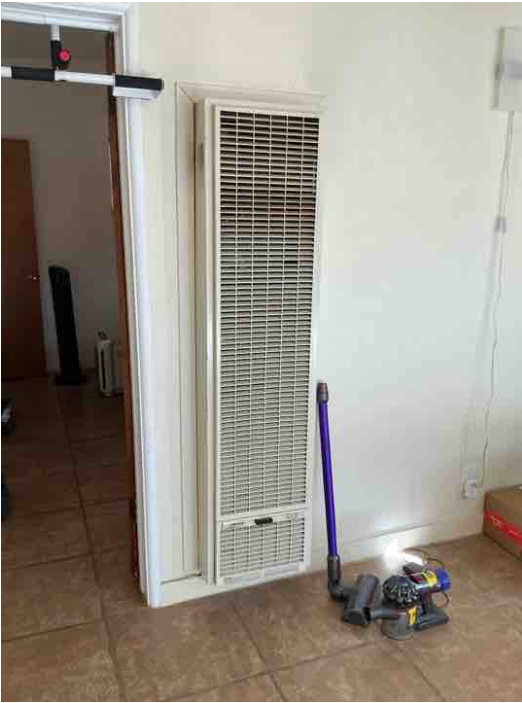
**SU DS 132:** Disclosure- This type of heating unit has an anticipated 20-30 year life span and is currently 54 years old. The heating unit operated today but is past anticipated life expectancy. Continuous maintenance and inspection recommended.

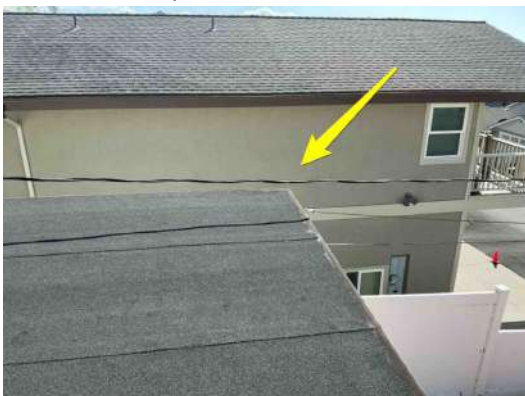
**SC 143:** The overhead electrical service wires found to be improperly installed and are considered unsafe as the wires are hanging too close to the ROOF. A minimum of (18 inches.) needed above a roof for safety per standards. Recommend further review and repair by a qualified and licensed professional familiar with the minimum installation requirements.

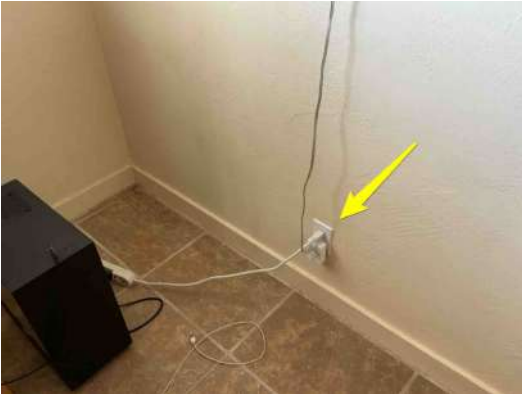
**SC 147:** Miswired electrical outlet (Reverse polarity) found TWO IN BEDROOM-1. Have electrician check all outlets and correct as needed.

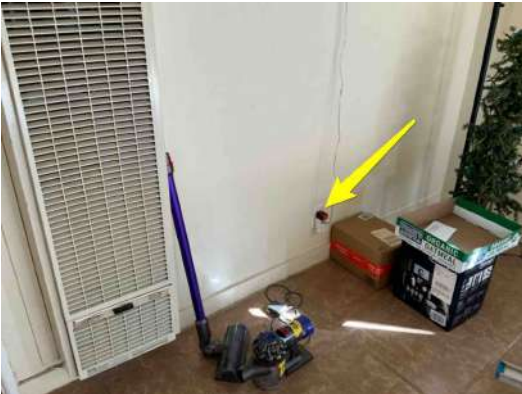
**SC 148:** Three-prong electrical outlets did not test properly grounded: LIVING ROOM EAST WALL. Contact a licensed electrical contractor for evaluation and repairs.

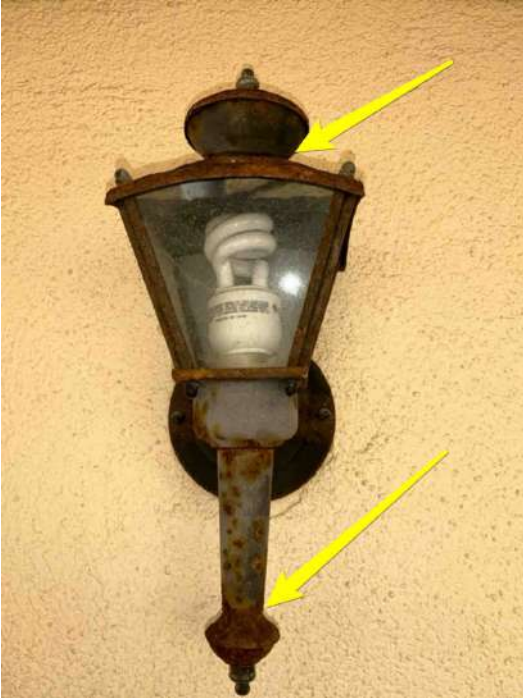
**MR DS** 150: **Disclosure:** Some exterior light fixtures found corroded and/or deteriorated.

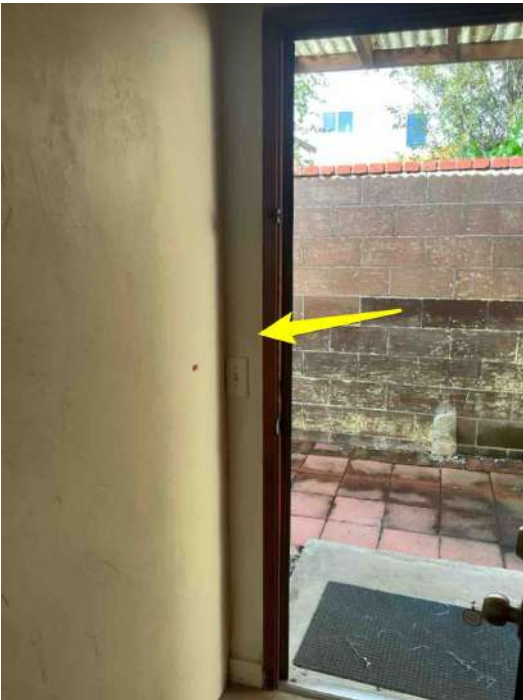
**151:** Missing the required light switches for interior lighting off the ENTRY DOOR, BEDROOM-1, and BEDROOM-2 BACK DOOR. Upgrades recommended per minimum standards.

Exterior light switch only

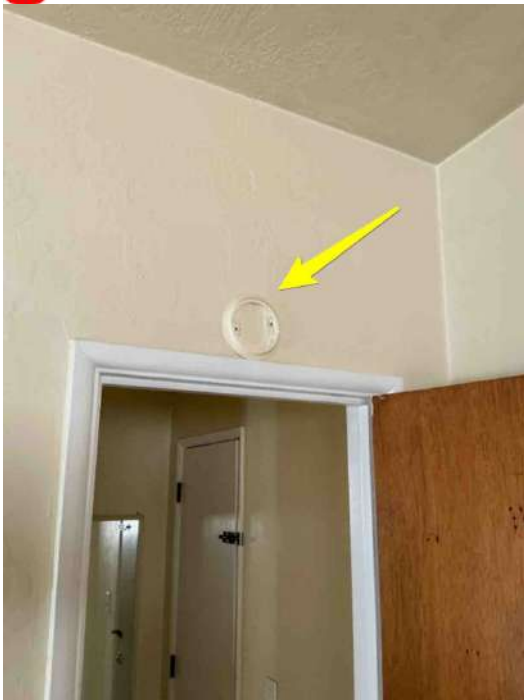
**SC 155:** Smoke detector missing at required location: BEDROOM-2
