## WOOD DESTROYING PESTS AND ORGANISMS INSPECTION REPORT #: 20230092

BUILDING NO. 1798	STREET ALRITA STREET	CITY SAN LUIS OBISPO	ZIP 93401	Date of Inspection 03/30/2023	NUMBER OF PAGES 1 of 8
<b>Central Coast Termite, Inc.</b> P.O. Box 1614 Nipomo, CA 93444 PH# (805) 929-8500 FAX (805) 929-5487 PR7147					
Ordered by: JESSICA FITZPATRICK CHRISTA LOWRY REAL ESTATE TEAM JESSICA@CHRISTALOWRYREALESTATE.CO PH.# 562-899-0935		Property Owner and/or Party of Interest MOSES GASTELUM-SELLER 1798 ALRITA STREET MGASTELUM1@GMAIL.COM SAN LUIS OBISPO, CA 93401 PH.# 510-688-0444		Report sent to:	
COMPLETE REPORT <input checked="" type="checkbox"/> LIMITED REPORT <input type="checkbox"/> SUPPLEMENTAL REPORT <input type="checkbox"/> REINSPECTION REPORT <input type="checkbox"/>					
GENERAL DESCRIPTION: This is a one story, stucco, single family residence. It has a detached carport and an attached patio. It was occupied and furnished at the time of inspection.				Inspection Tag Posted: Water Heater Closet Other Tags Posted:

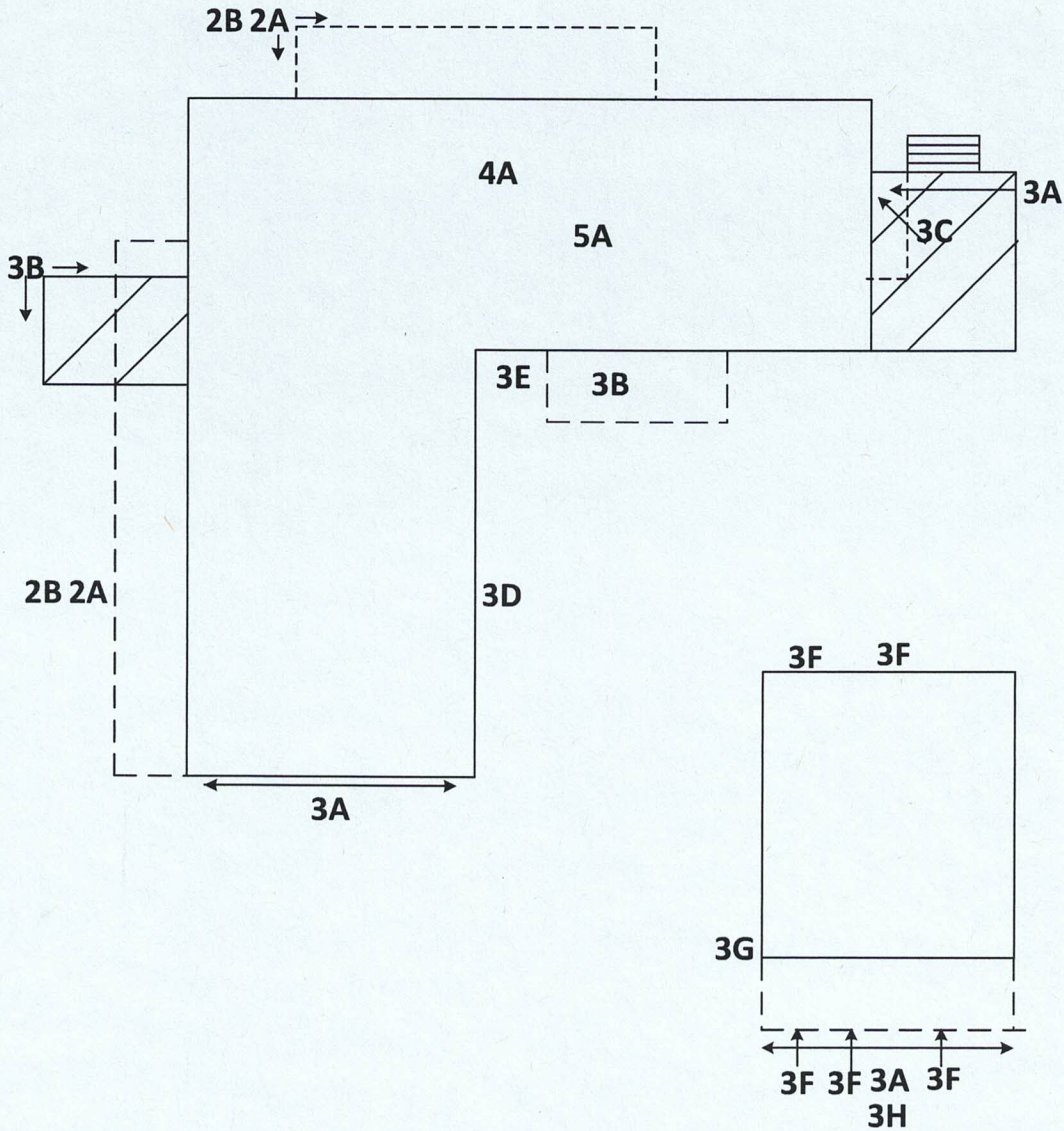
**Diagram of Area Inspected:**

Drywood termite infestation was found in wood members at the eaves and appears to extend into inaccessible areas.

Drywood termite damage was found at the roof sheathing

Fungus damage was noted at the wood siding, and it appears to be caused by weather.

Earth to wood contact and fungus damaged was noted at the deck fascia.

Fungus growth and damage was found at the side entry door door and jamb.

Fungus damage was found at the threshold , due to exposure to weather.

Fungus damage was found at the exterior window sill , due to exposure to weather.

Fungus damage was found at the 2x10 support post at the carport , due to exposure to weather.

Fungus damage was found at the trim boards , due to exposure to weather.

Fungus damage was found at the 2x2 picket at the carport , due to exposure to weather.
