# Inspection Report

1730 Morgan Ln  
Redondo Beach, CA 90278

Friday, April 15, 2022

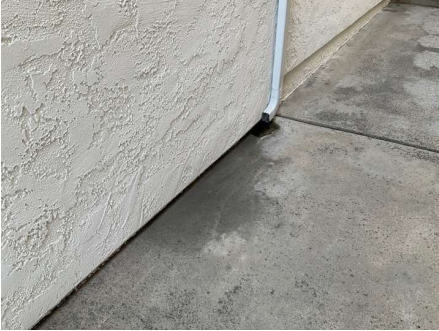
**SC s-22:** Evidence of ponding water was observed on the walkway. This condition poses a slip and fall hazard. We recommend correcting the condition(s) noted for safety reasons.

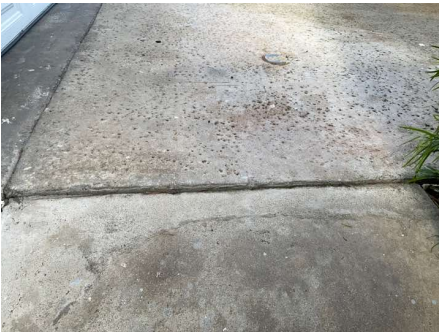
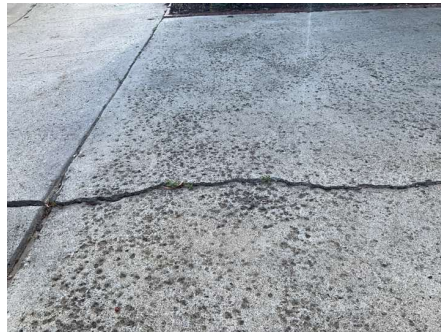
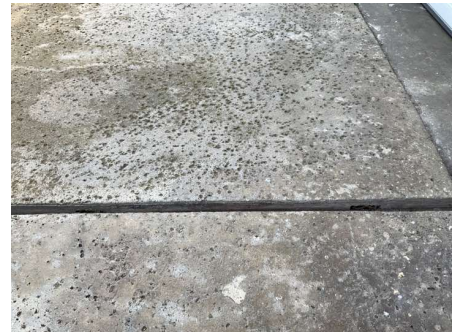
**SC s-23:** Uneven sections were observed in the driveway surface. This condition poses a trip hazard. We recommend correcting the condition(s) noted for safety reasons.

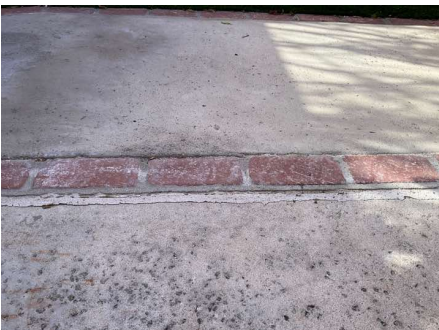
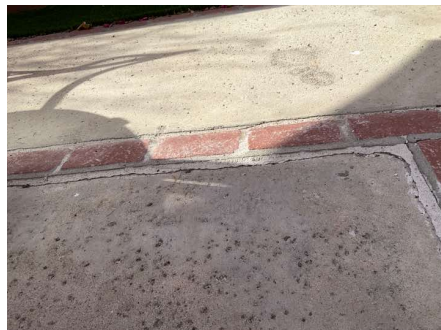
**SC s-24:** Uneven sections were observed in the patio surface. This condition is a trip hazard. We recommend correcting the condition(s) for safety reasons.

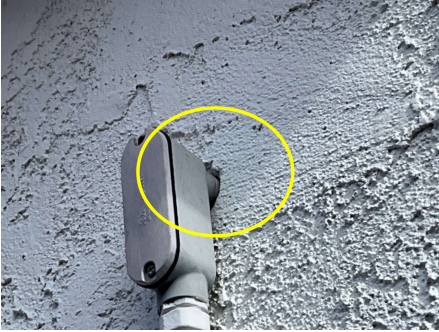
**FE CR s-29:** There is a gap(s) in the exterior cladding at joints with dissimilar materials, a utility, pipe or vent penetration. This can permit water entry and result in damage to the cladding and underlying building elements. We suggest that open joints or gaps in the siding should be caulked and sealed.

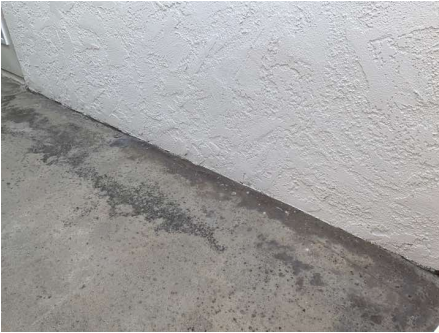
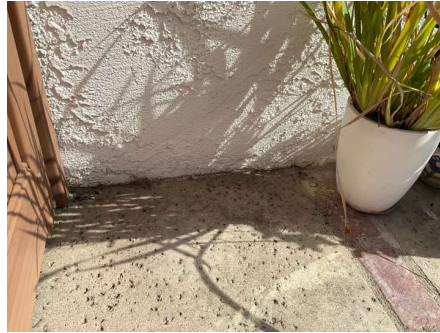
**FE s-30:** The patio/walkway surface on several sides of the building had been installed above the metal stucco weep screed material along the bottom edge of the stucco wall. This condition is conducive to moisture intrusion and deterioration. We recommend further evaluation and corrections by a specialist in the appropriate trade.

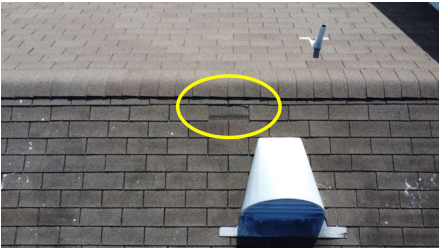
**CR s-38:** Shingles are loose or missing on one or more sides of this roof. This may be a result of wind and weather, or it may indicate improper installation. We suggest a qualified technician could make repairs or modifications as necessary.

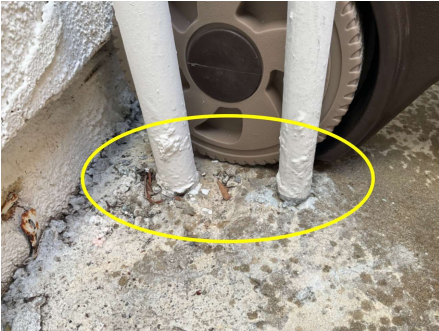
**CR s-63:** The copper supply piping at the left front of the building does not appear to have proper protection where it penetrates and/or is embedded in the concrete walkway. This will hasten corrosion and deterioration of the piping, which could lead to leaks. We suggest a qualified plumber should evaluate this condition and make repairs or modifications as necessary.

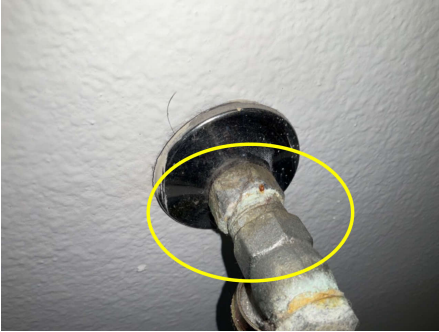
Laundry washer hook-ups

**CR s-68:** In the area(s) listed below the water supply shutoff valves are noticeably corroded, but are not leaking at this time. We recommend replacing any corroded valve before leaks are discovered.

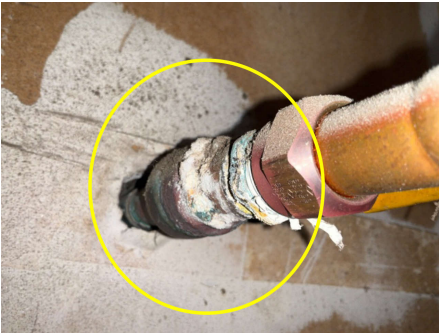
**CR s-74:** The water connections are heavily corroded and leaks may occur. We suggest a qualified plumber should replace the corroded connections.

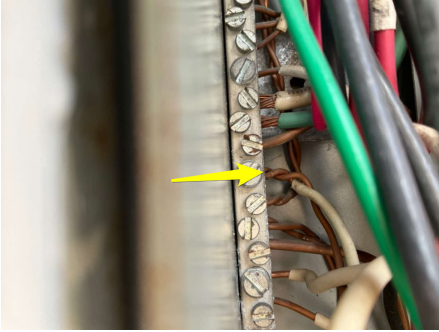
**CR s-93:** Multiple neutral wires are installed on the bus bar under one screw. The connectors may not have proper connection which would lead to arcing and overheating. We suggest a licensed electrician should correct all improper double taps.

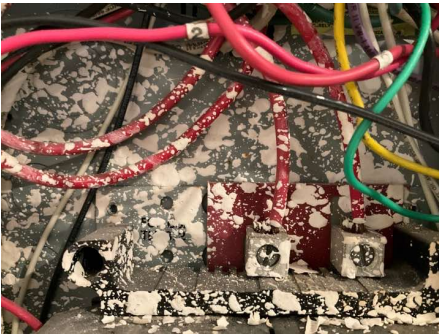
**FE s-97:** Most of the interior components of the electrical sub panel have been painted over. This is contrary to industry standards and may affect the performance of the panel. We suggest a qualified electrician should evaluate the panel and determine if the affected internal components and/or entire panel should be replaced.

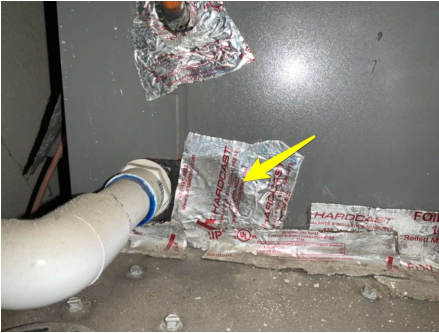
**CR s-133:** The secondary condensate drain from the evaporator coil is capped. If the primary drain line clogs, there is no effective backup drain and this could lead to water damage to the adjacent surfaces. We suggest a qualified HVAC technician should install a float switch cutoff, which shuts off the A/C unit if it detects water in the secondary condensate drain.

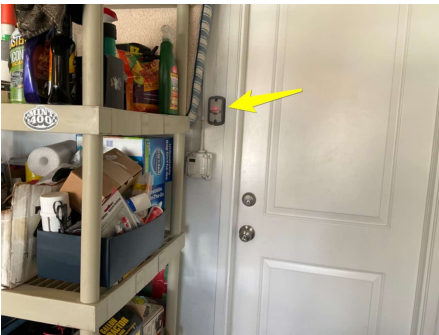
**CR s-148:** The control knob for the garage door opener is installed at an incorrect height. This could allow children to activate the garage door opener. This is a safety concern. We suggest the knob should be installed at least five feet above the floor in accordance with the manufacturer's specifications.

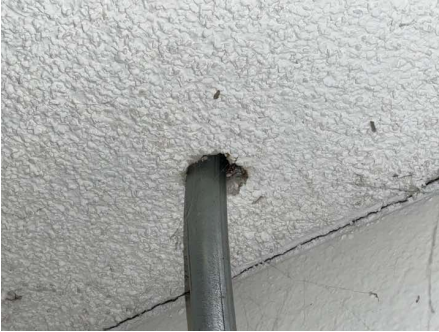
**CR s-151:** There are holes/damage in the fire-resistive barrier between the garage and interior or attic. This condition can allow more rapid spread of smoke and flames in the event of a fire. We suggest all voids should be repaired per current industry standards.

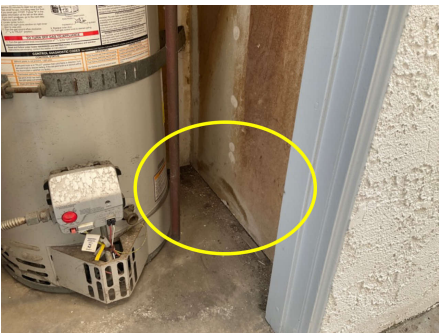
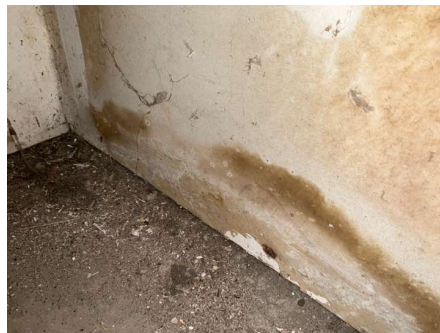
Water heater closet

**FE CR s-162:** In the area(s) listed below there are water stains and/or minor surface damage to the wall and ceiling. We suggest the source of the moisture should be identified and eliminated. The surface could be refinished as necessary.

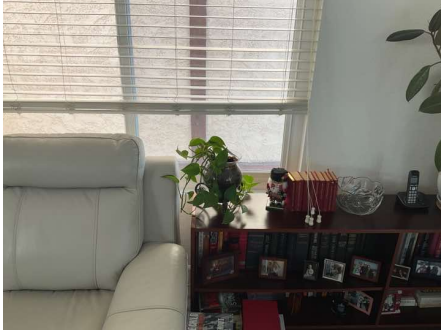
Living room

**SC** **RU** **s-164:** In the area(s) listed below openable window(s) is/are too close to the floor given their height above the ground outside. This is a potential fall hazard for children. As an upgrade we suggest installing window guards that adults and older children can easily open in case of a fire. A qualified technician should do the work in accordance with current industry standards.

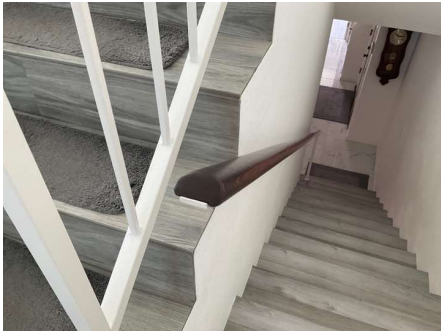
**SC** **s-166:** The end of the stairway handrails do not return to the wall. This can be a fall hazard if someone carrying a purse or bag catches the strap on the end of the handrail as they pass. We suggest the end of all stairway handrails should return to the wall. A qualified technician should do the work.

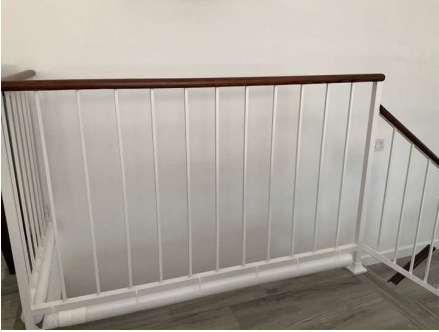
**SC RU s-167:** The baluster spacing on the stairs or landing is improper. The balusters are spaced too far apart, climbable and/or are too low. This is a hazard for small children. This installation may have been acceptable at the time of construction. We suggest the railings could be upgraded or modified to meet modern standards.

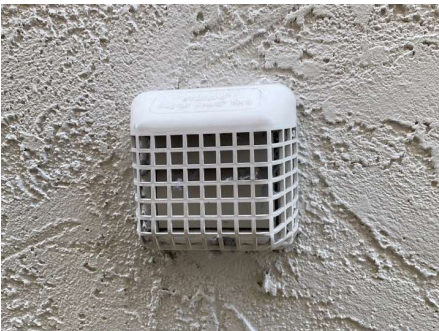
**SC s-198:** The clothes dryer vent exterior termination is screened and can clog with lint, dirt or debris. This is a fire hazard, and reduces dryer efficiency. We suggest a damper hood terminal should be installed.

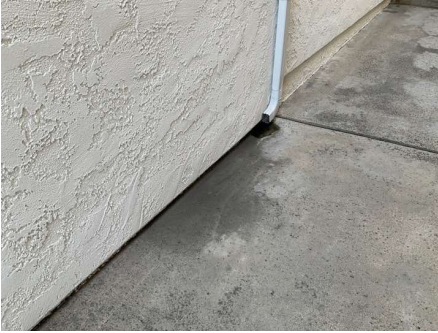
**SC 22:** Evidence of ponding water was observed on the walkway. This condition poses a slip and fall hazard. We recommend correcting the condition(s) noted for safety reasons.

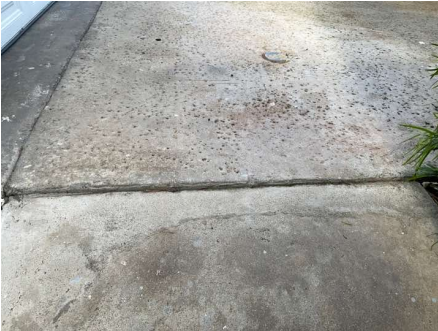
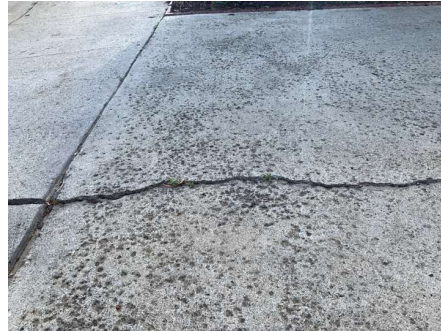
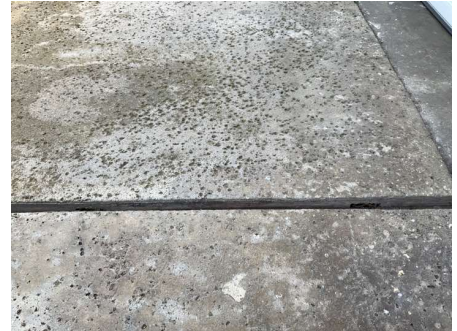
**SC 23:** Uneven sections were observed in the driveway surface. This condition poses a trip hazard. We recommend correcting the condition(s) noted for safety reasons.

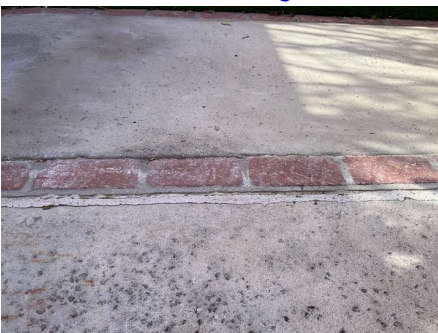
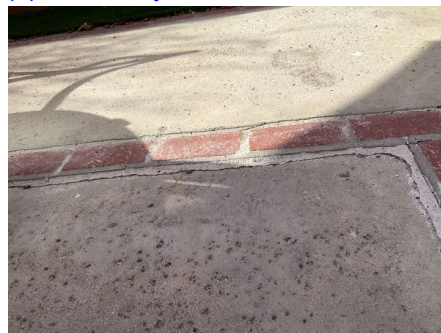
**SC 24:** Uneven sections were observed in the patio surface. This condition is a trip hazard. We recommend correcting the condition(s) for safety reasons.

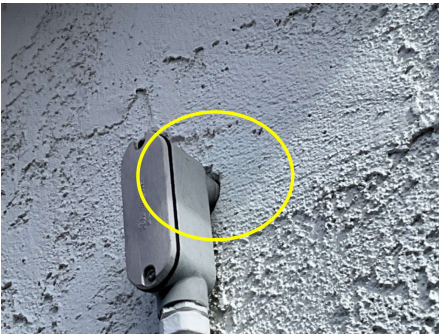
**FE CR 29:** There is a gap(s) in the exterior cladding at joints with dissimilar materials, a utility, pipe or vent penetration. This can permit water entry and result in damage to the cladding and underlying building elements. We suggest that open joints or gaps in the siding should be caulked and sealed.

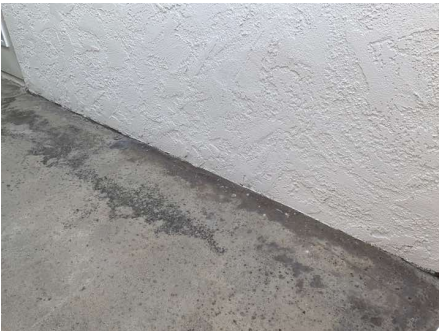
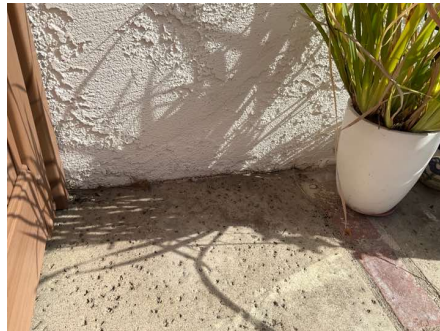
**FE 30:** The patio/walkway surface on several sides of the building had been installed above the metal stucco weep screed material along the bottom edge of the stucco wall. This condition is conducive to moisture intrusion and deterioration. We recommend further evaluation and corrections by a specialist in the appropriate trade.

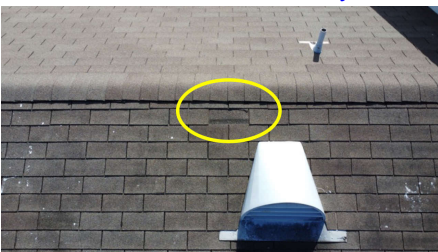
**CR 38:** Shingles are loose or missing on one or more sides of this roof. This may be a result of wind and weather, or it may indicate improper installation. We suggest a qualified technician could make repairs or modifications as necessary.

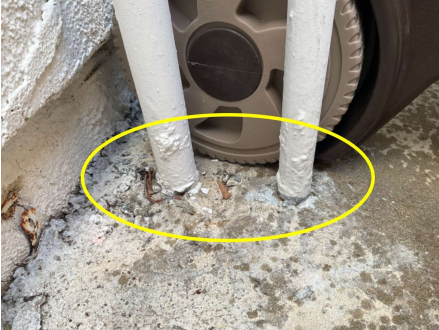
**CR 63:** The copper supply piping at the left front of the building does not appear to have proper protection where it penetrates and/or is embedded in the concrete walkway. This will hasten corrosion and deterioration of the piping, which could lead to leaks. We suggest a qualified plumber should evaluate this condition and make repairs or modifications as necessary.

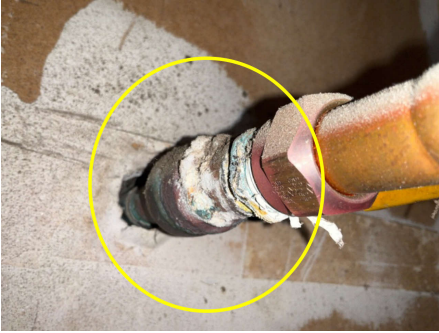
**CR 74:** The water connections are heavily corroded and leaks may occur. We suggest a qualified plumber should replace the corroded connections.

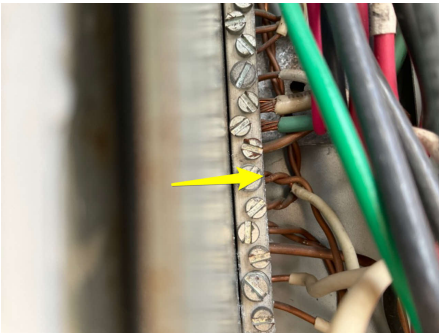
**CR 93:** Multiple neutral wires are installed on the bus bar under one screw. The connectors may not have proper connection which would lead to arcing and overheating. We suggest a licensed electrician should correct all improper double taps.

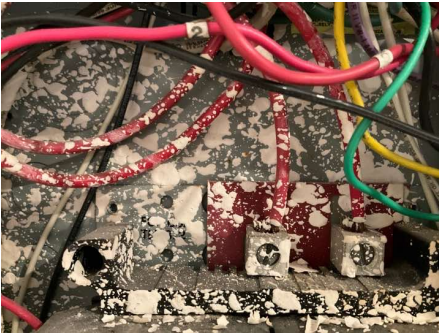
**FE 97:** Most of the interior components of the electrical sub panel have been painted over. This is contrary to industry standards and may affect the performance of the panel. We suggest a qualified electrician should evaluate the panel and determine if the affected internal components and/or entire panel should be replaced.

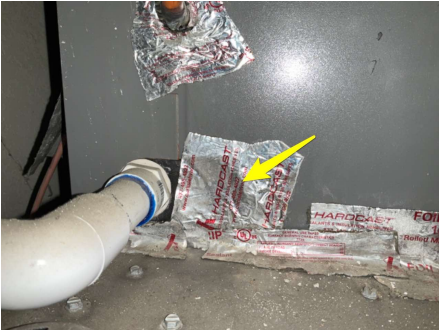
**CR 133:** The secondary condensate drain from the evaporator coil is capped. If the primary drain line clogs, there is no effective backup drain and this could lead to water damage to the adjacent surfaces. We suggest a qualified HVAC technician should install a float switch cutoff, which shuts off the A/C unit if it detects water in the secondary condensate drain.

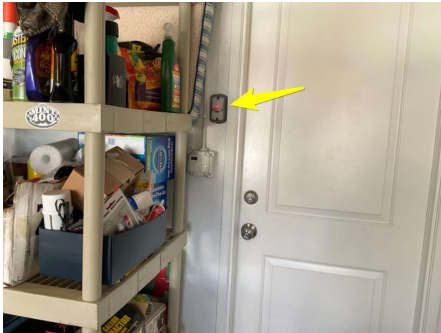
**CR 148:** The control knob for the garage door opener is installed at an incorrect height. This could allow children to activate the garage door opener. This is a safety concern. We suggest the knob should be installed at least five feet above the floor in accordance with the manufacturer's specifications.

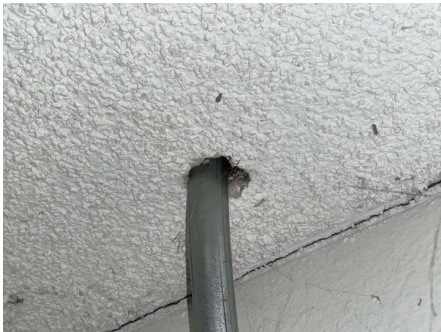
**CR 151:** There are holes/damage in the fire-resistive barrier between the garage and interior or attic. This condition can allow more rapid spread of smoke and flames in the event of a fire. We suggest all voids should be repaired per current industry standards.

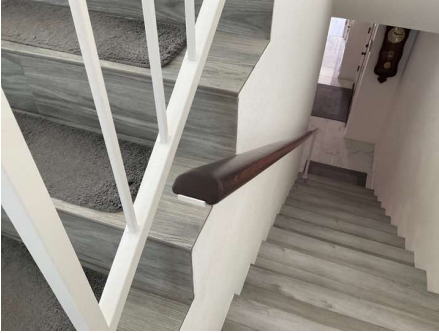
**SC 166:** The end of the stairway handrails do not return to the wall. This can be a fall hazard if someone carrying a purse or bag catches the strap on the end of the handrail as they pass. We suggest the end of all stairway handrails should return to the wall. A qualified technician should do the work.

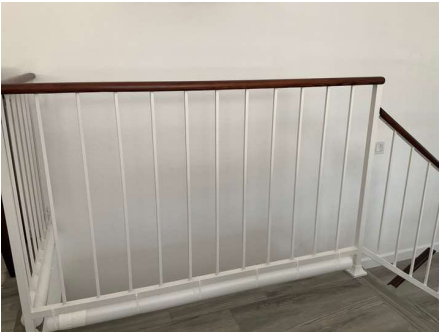
**SC RU 167:** The baluster spacing on the stairs or landing is improper. The balusters are spaced too far apart, climbable and/or are too low. This is a hazard for small children. This installation may have been acceptable at the time of construction. We suggest the railings could be upgraded or modified to meet modern standards.

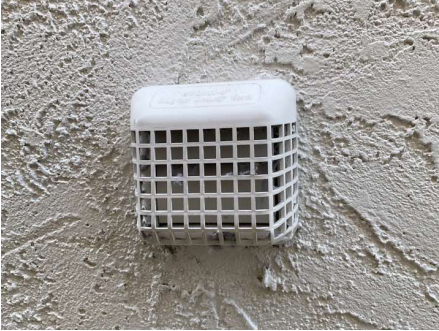
**SC 198:** The clothes dryer vent exterior termination is screened and can clog with lint, dirt or debris. This is a fire hazard, and reduces dryer efficiency. We suggest a damper hood terminal should be installed.
