# WOOD DESTROYING PESTS AND ORGANISMS INSPECTION REPORT

#: 2025169

| BUILDING NO.<br>522 | STREET<br>HIGOS | CITY<br>NIPOMO | ZIP<br>93444 | Date of Inspection<br>10/06/2025 | NUMBER OF PAGES<br>1 of 6 |
| REINSPECTION REPORT <input type="checkbox"/> | | GENERAL DESCRIPTION:<br>Single family residence. | | | |

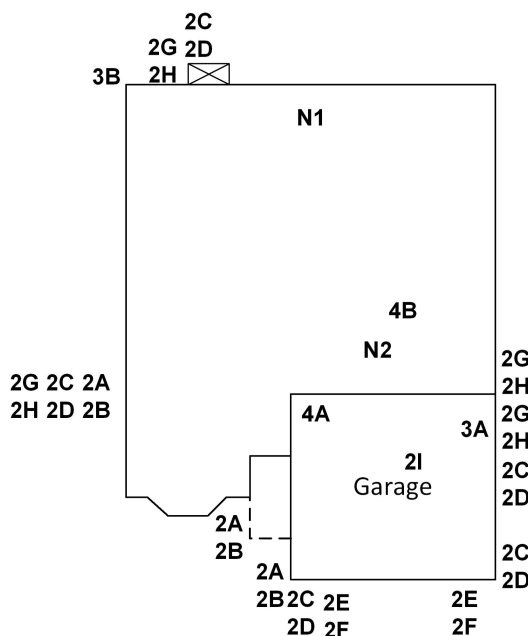
Diagram not to scale  
Findings locations approximate

| Key: 1 = Subterranean Termites 2 = Drywood Termites 3 = Fungus/Dryrot 4 = Other Findings 5 = Further Inspection | | | | | |
