# Inspection Report

**Property Address:**  
2104 Chestnut Ave  
Manhattan Beach CA 90266

**Ferguson Home Inspections**

<b>Date:</b> 1/11/2025	<b>Time:</b> 09:00 AM	<b>Report ID:</b> 01112025ChestnutAve
<b>Property:</b> 2104 Chestnut Ave Manhattan Beach CA 90266	<b>Customer:</b> Yvonne Peltz	<b>Real Estate Professional:</b> Marlene Ramirez

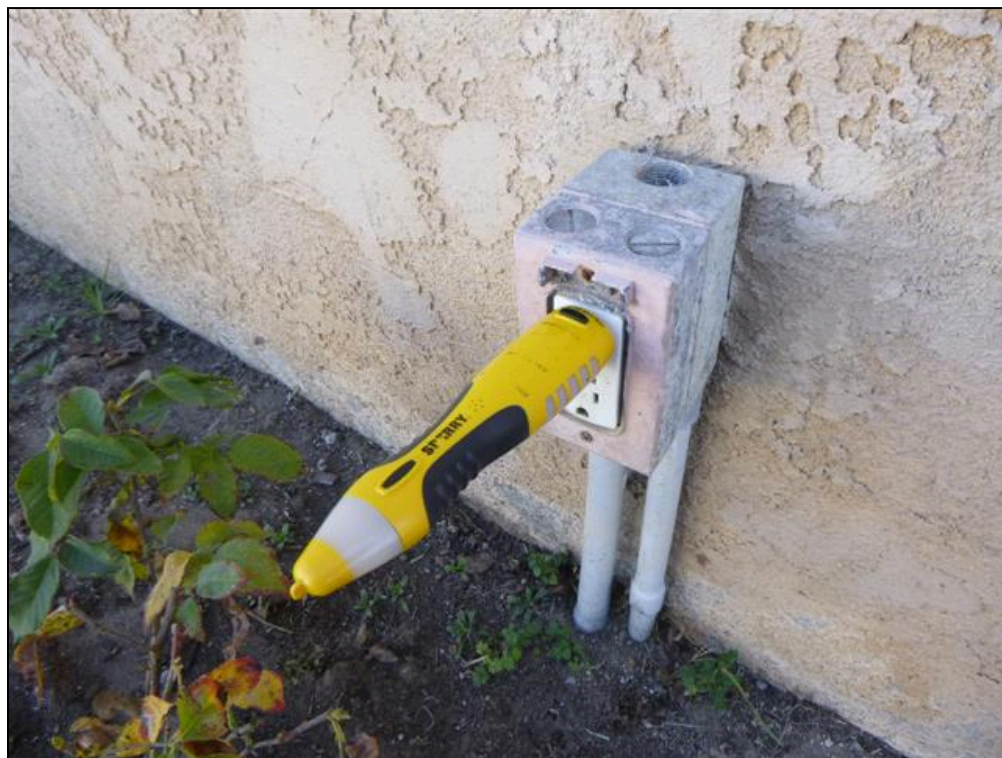
1.8 Item 2(Picture)

**1.8** (2) The inspector was unable to test the GFCI outlet(s) at the front yard as there was no power to the outlet(s). Suggest review with a licensed electrician for repair/replacement cost and confirm correct operation as needed.

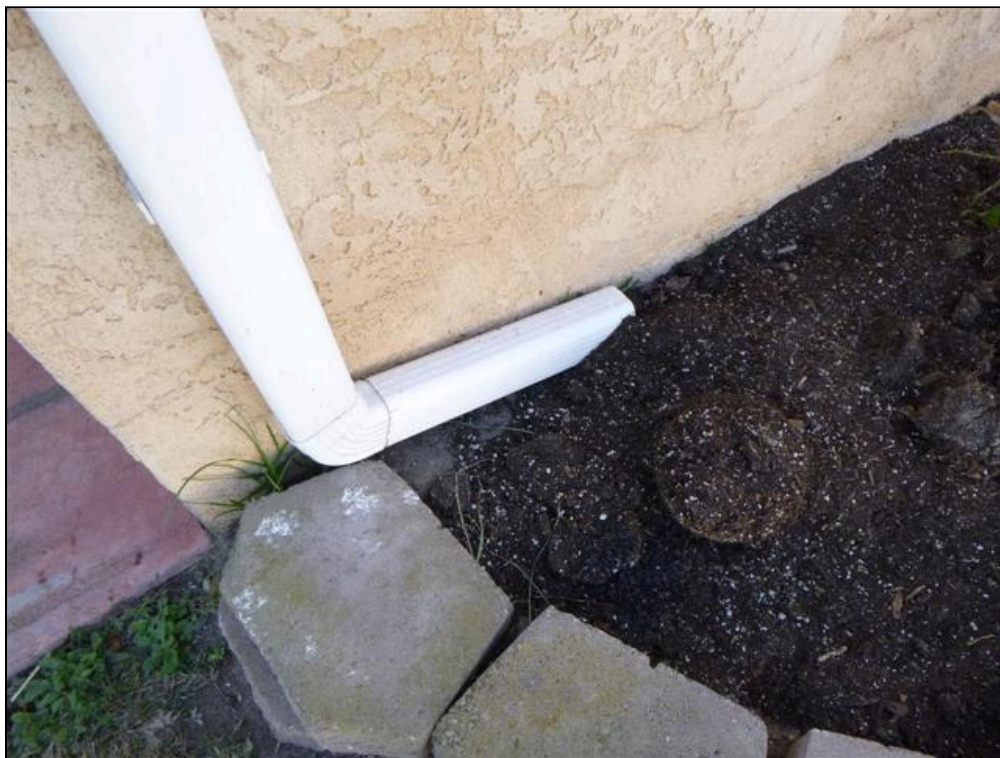
1.9 Item 1(Picture)

**1.9** (1) Suggest installation of gutters throughout all eave areas and installation of an area drainage system to divert the water away from the foundation to the street as an upgrade.

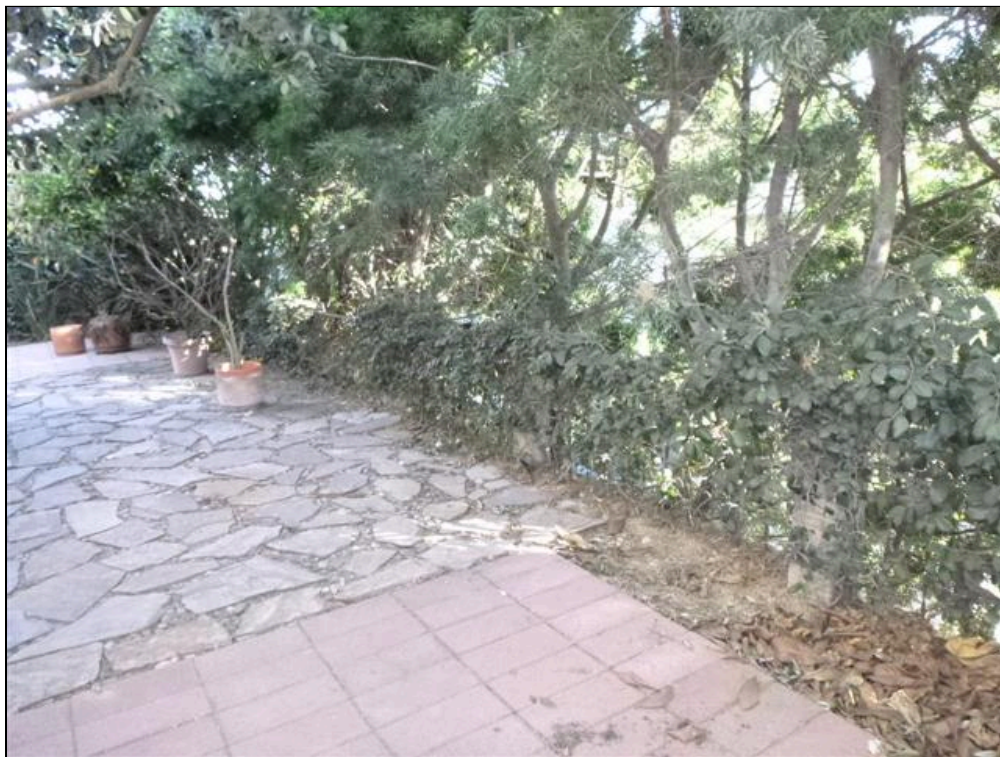
1.10 Item 1(Picture)

**1.10** The rear retaining wall not visible/accessible at the time of the inspection. Suggest review with a licensed contractor on this item as needed.

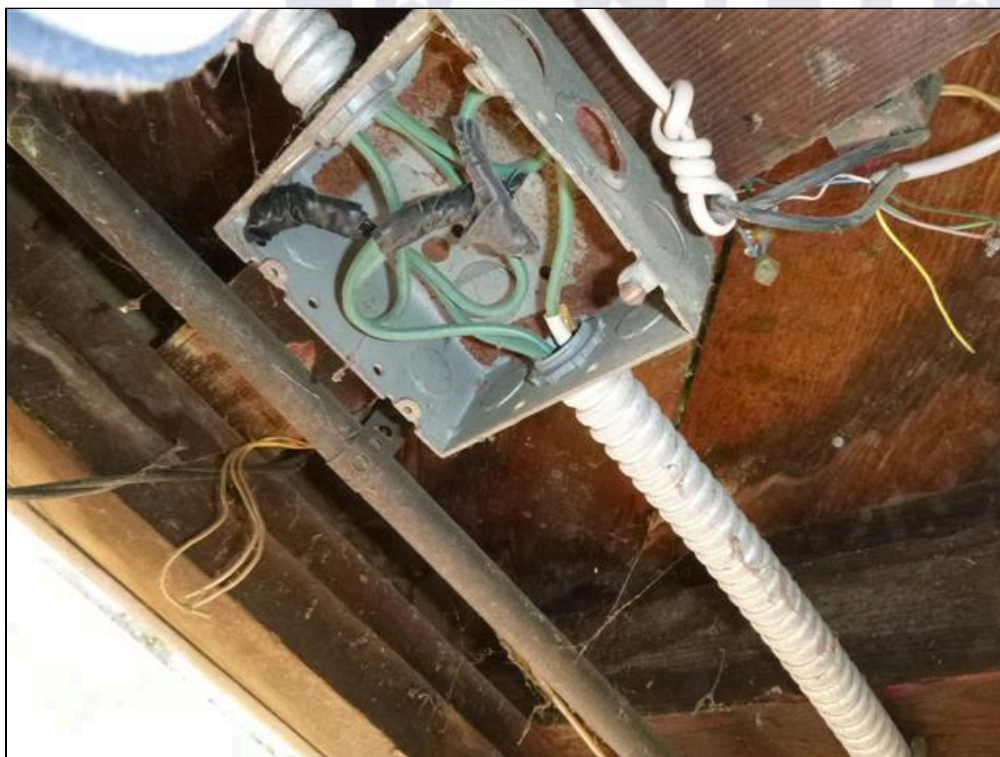
4.3 Item 1(Picture)

**4.3** (1) Open junction boxes were noted. This is a safety concern. Whenever an electrical wire is cut and re-connected, the 'splice' should be encased in a covered junction box to prevent shocks and separation of the splice. Suggest review by a licensed electrician and repair as needed.

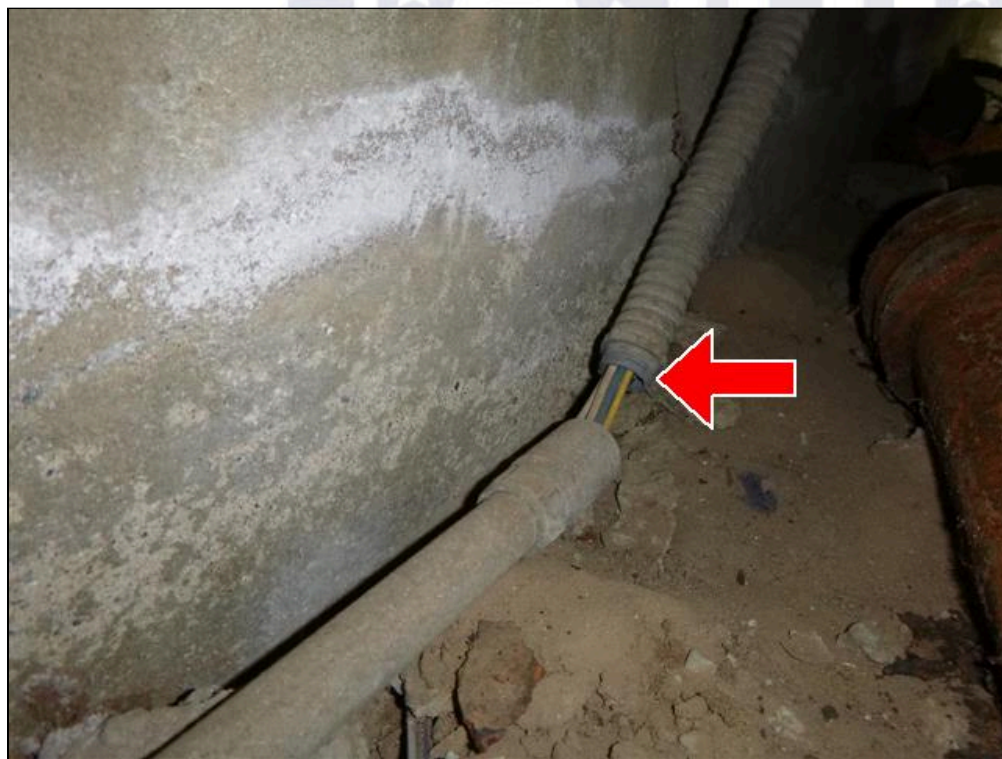
4.3 Item 3(Picture)

**4.3 (2)** The electrical wiring in the crawl area has been inadequately secured. The romex/conduit is in contact with the ground at various areas, suggest review with a licensed electrician to repair/secure as needed for safety and as required.

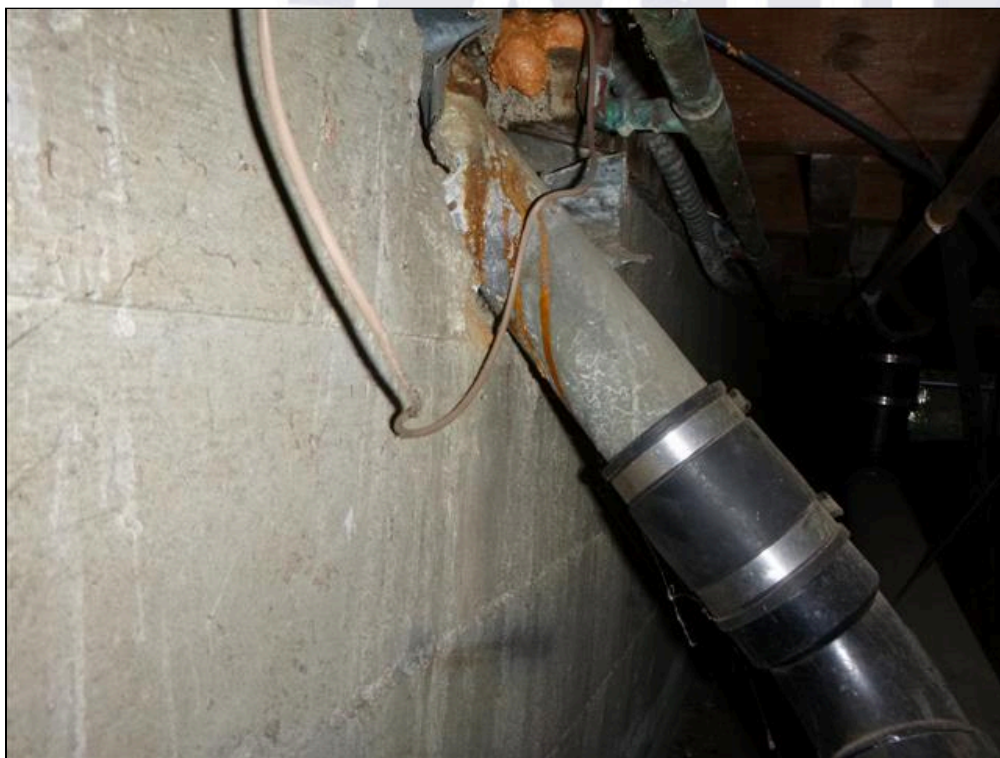
4.4 Item 3(Picture)

**4.4** (2) Rust and corrosion noted at various cast iron drain lines within the crawl space, common for the age, no leaking visible at the time of the inspection. Suggest review by a licensed plumbing contractor for repair/replacement costs as needed.

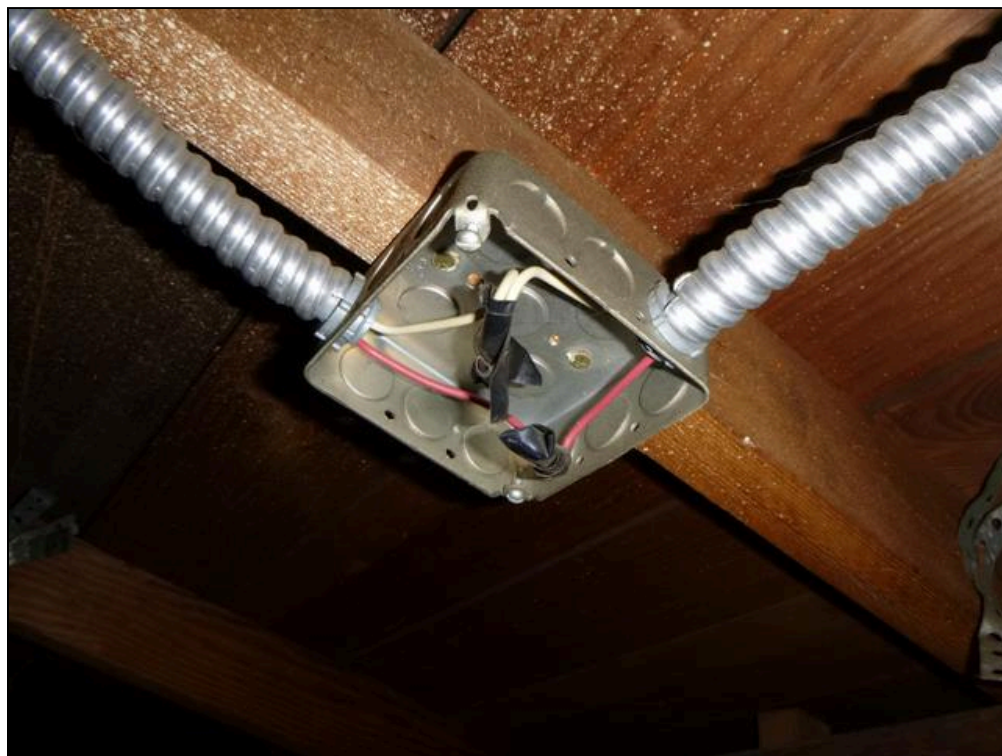
6.3 Item 1(Picture)

**6.3** Open junction boxes were noted. This is a safety concern. Whenever an electrical wire is cut and re-connected, the 'splice' should be encased in a covered junction box to prevent shocks and separation of the splice. Suggest review by a licensed electrician and repair as needed.

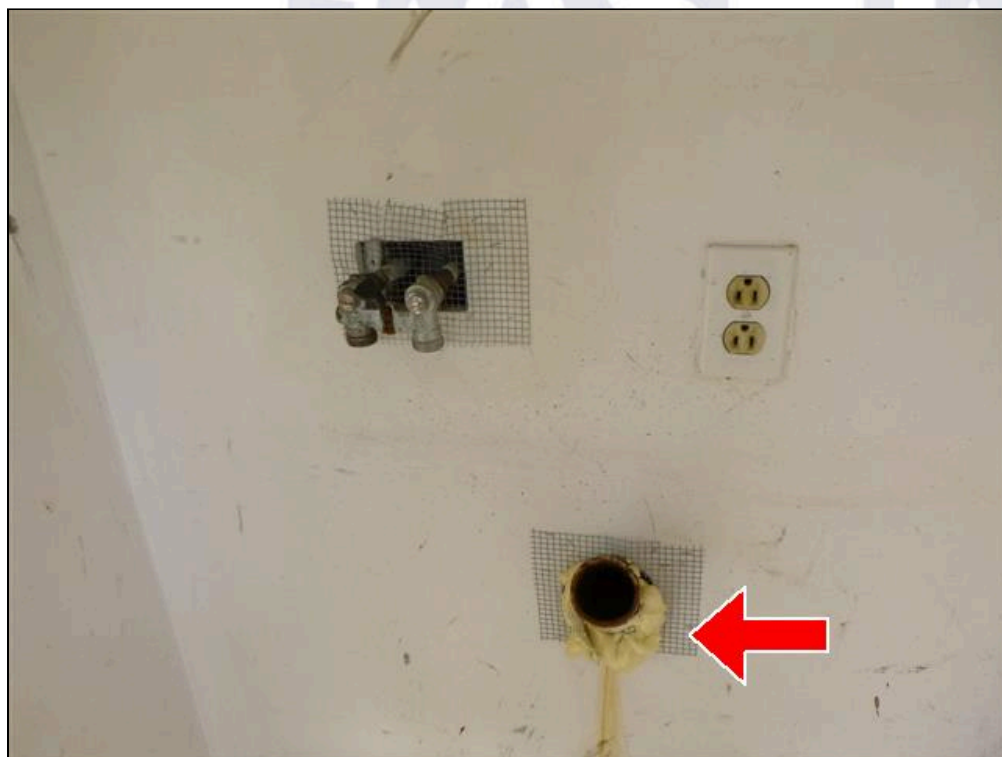
7.7 Item 4(Picture)

**7.7** (2) Corrosion noted at the washing machine drain, no leaking noted at the time of the inspection. Suggest review with a licensed plumber and repair/replace as needed.

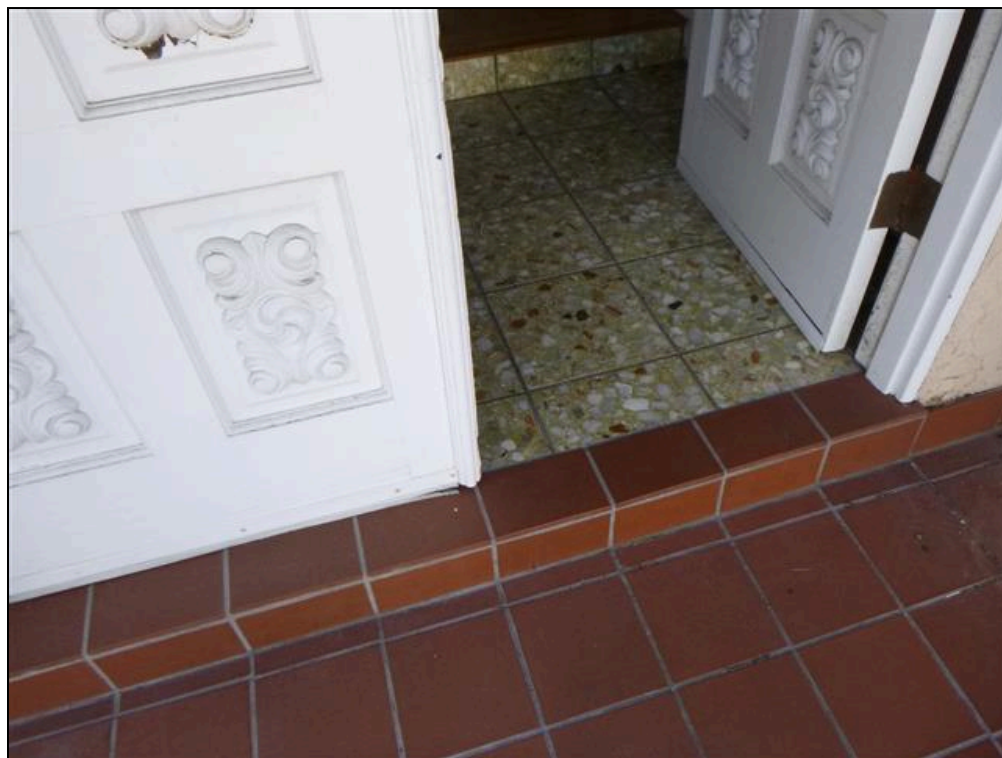
8.5 Item 1(Picture)

**8.5 (1)** The doors are weathered and deteriorated, suggest maintenance and repairs as needed.

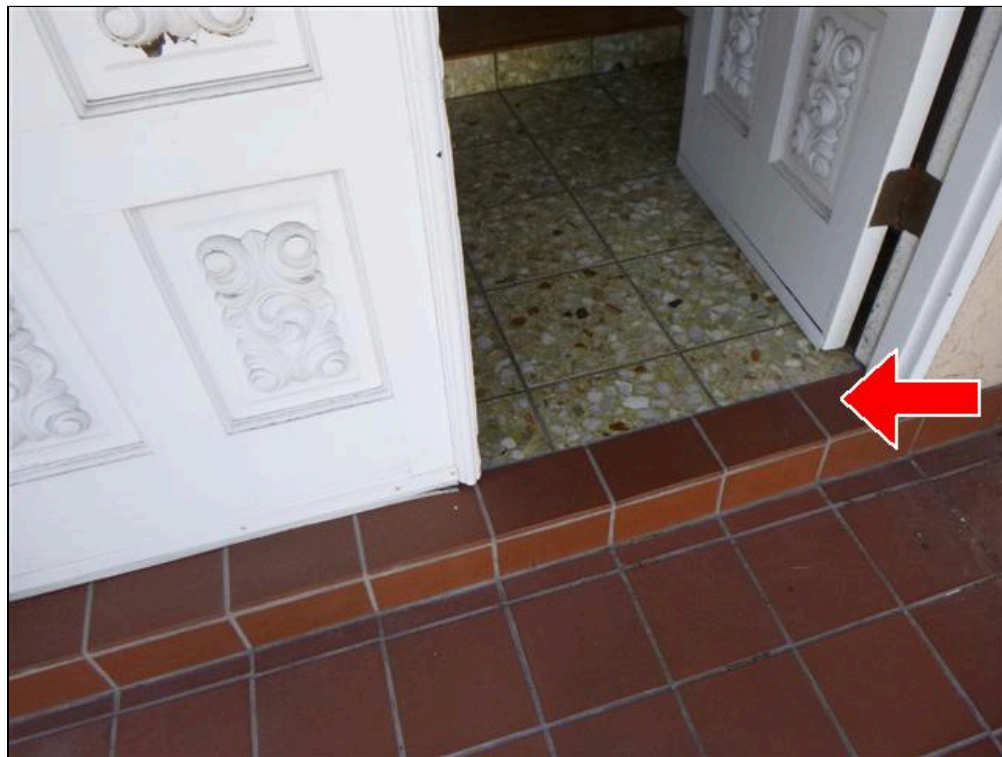
8.5 Item 2(Picture)

**8.5** (2) Suggest review with a licensed contractor for costs to install a door threshold and weather seals as needed.

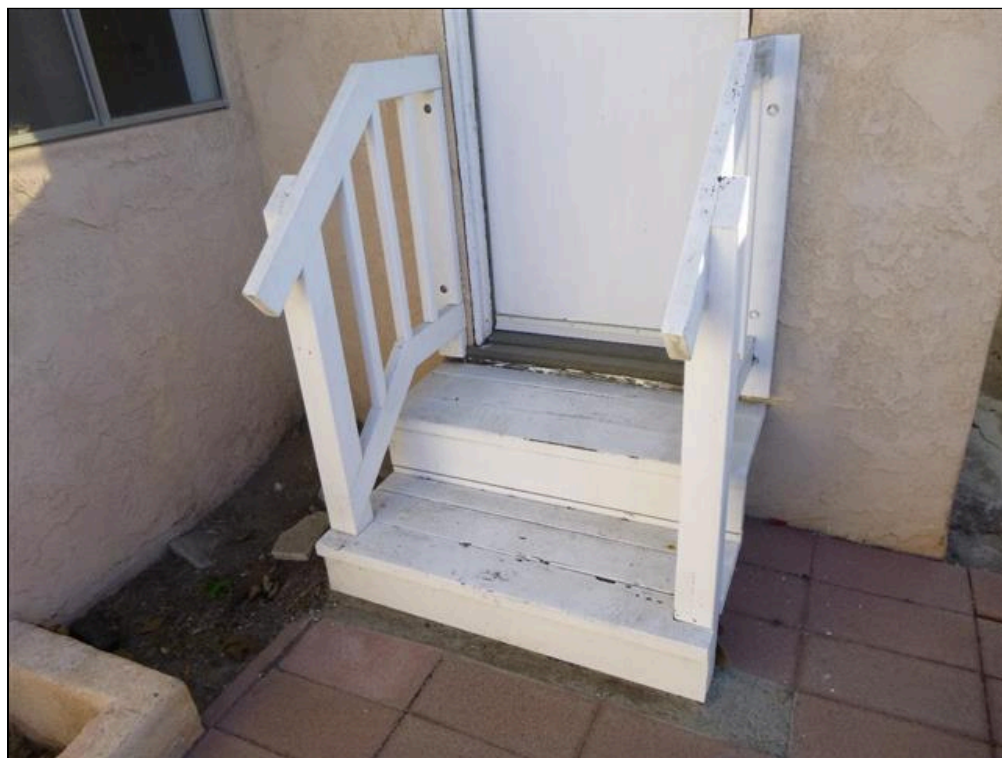
9.0 Item 1(Picture)

**9.0** A potential trip/safety hazard was noted due an inadequate sized deck/landing prior to the step(s) ( this is common for the age of the home/dwelling ). Generally a 36" landing is required at any exterior door prior to any step(s). Suggest review by a licensed contractor for any repair/replacement costs as needed.

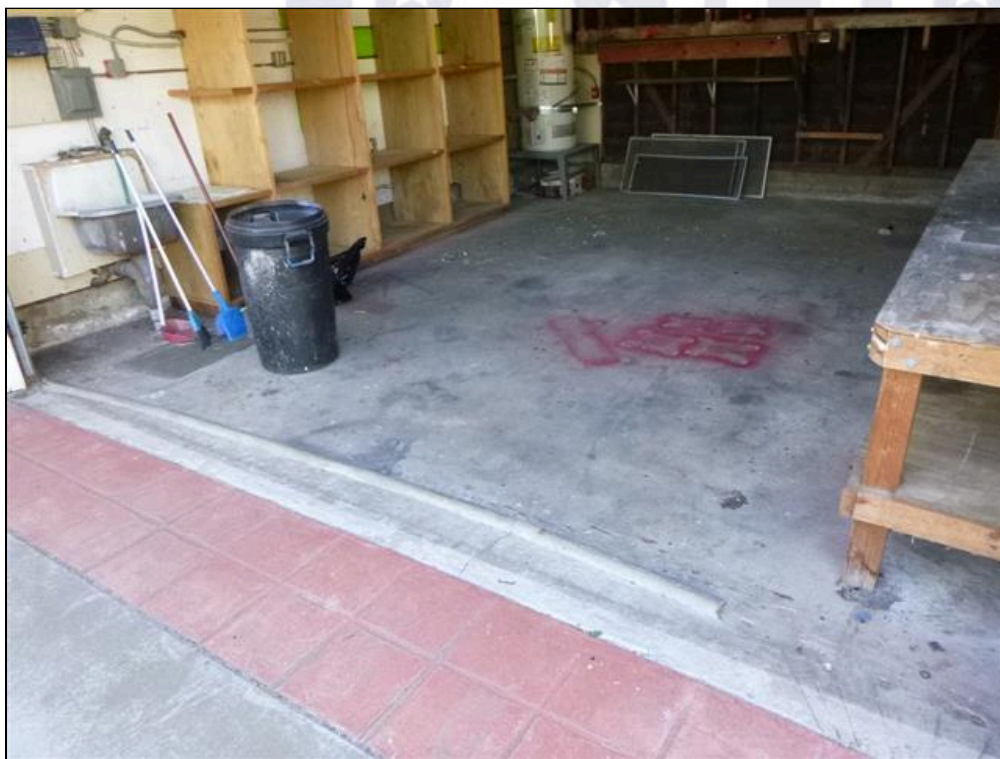
12.0 Item 2(Picture)

**12.0 (3)** Evidence of previous water intrusion into the garage was noted. See the driveway comment and suggest review with a licensed contractor for repair costs as needed.

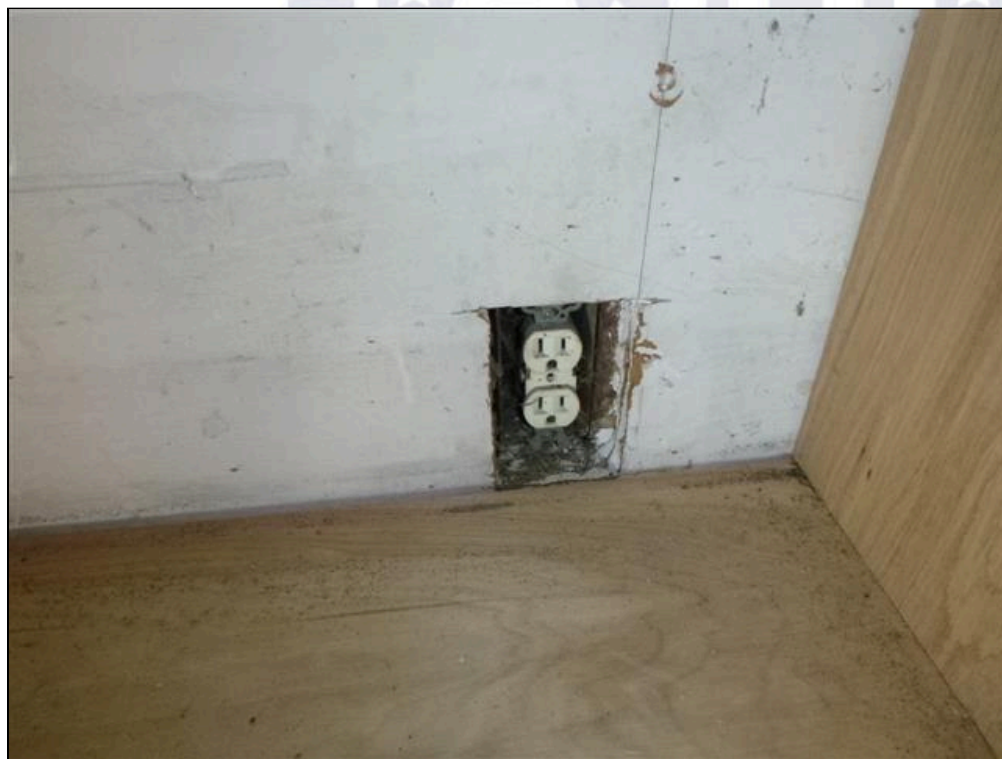
12.6 Item 1(Picture)

**12.6** (1) Various outlet cover(s) are missing, suggest installation for safety.

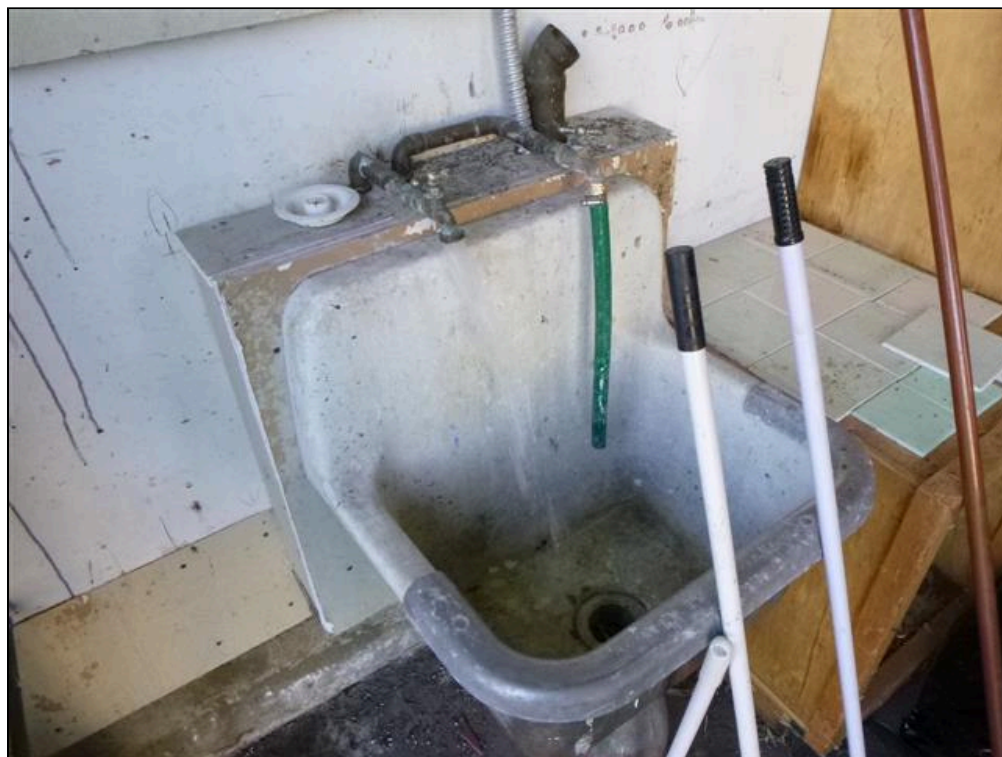
12.7 Item 1(Picture)

**12.7** The existing sink faucet(s) are not low-flow systems as required. Suggest review with a licensed plumber for costs to replace the existing faucets with low flow faucets (2.2 gallons per minute) as required by the State of California as of January 1st, 2017. See the plumbing system comments for further details and a link to the State of California plumbing ordinance.

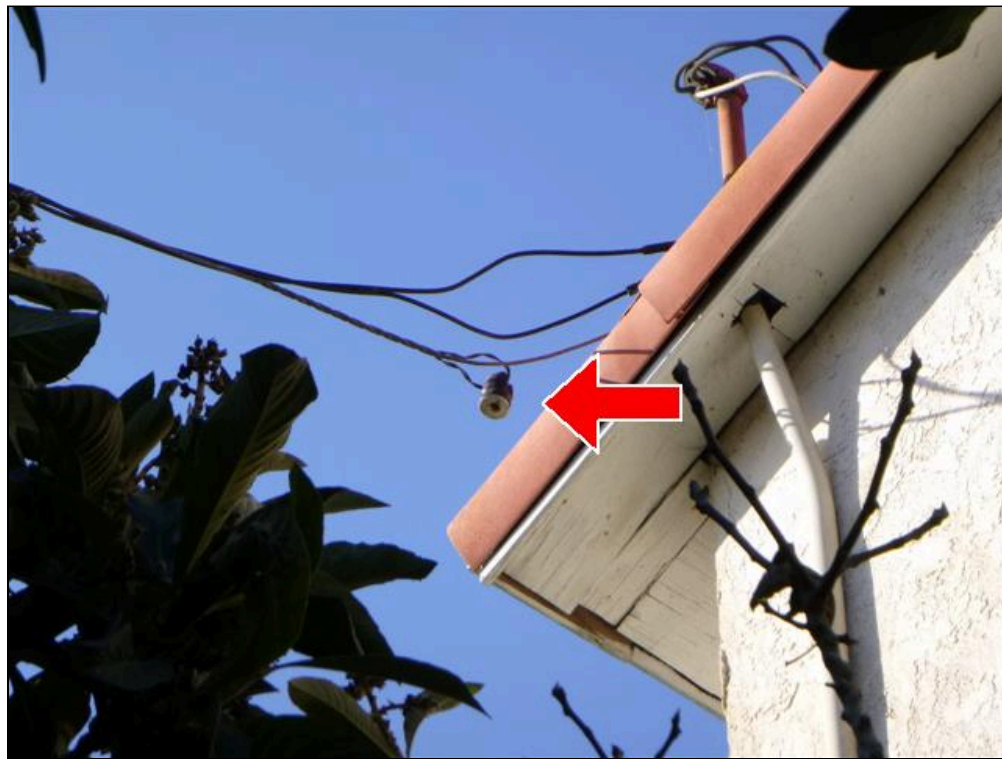
14.0 Item 1(Picture)

**14.0** The electrical service wiring mount is broken and detached from the roof, this is a potential safety hazard. Suggest review with a licensed electrician and/or the local utility company for repair/ replacement costs as required for safety.

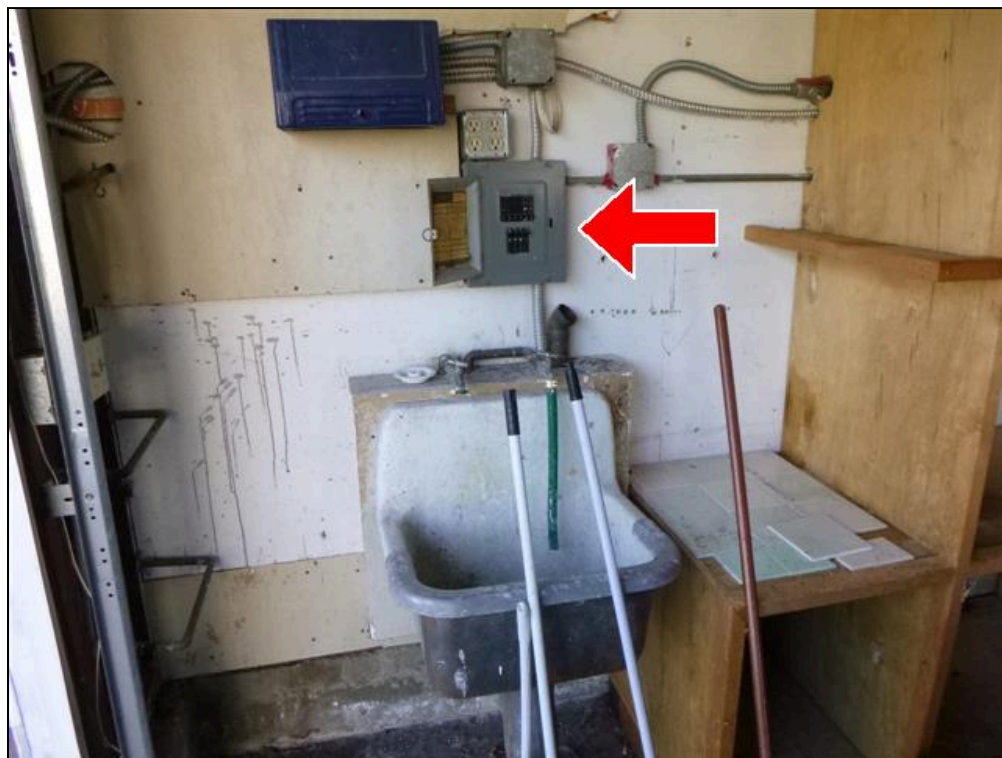
14.1 Item 3(Picture)

**14.1** (2) Inadequate clearance to the front of the garage sub panel. A minimum of 36 inches of clear working space is required at the front side of the electrical panel. Suggest review with a licensed electrical contractor for repair/relocation costs as required.

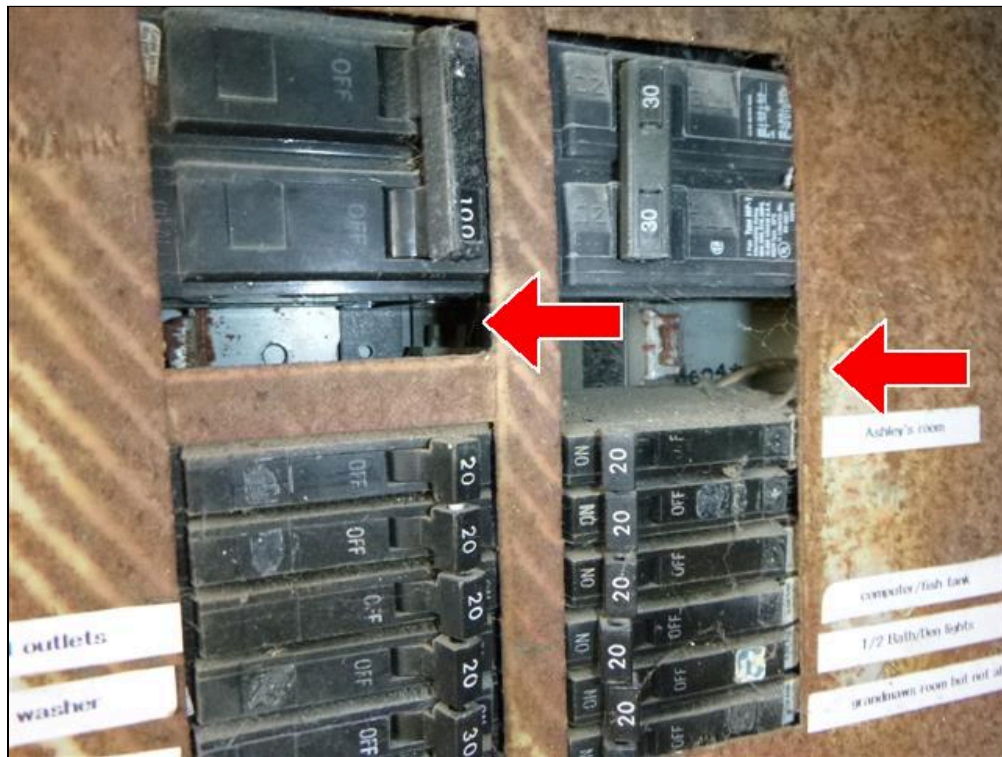
14.1 Item 4(Picture)

**14.1** (3) Potential safety hazard due open areas of the electrical panel cover plate. Suggest installing future plugs in the cover plate where the blanks have been removed as required for safety.

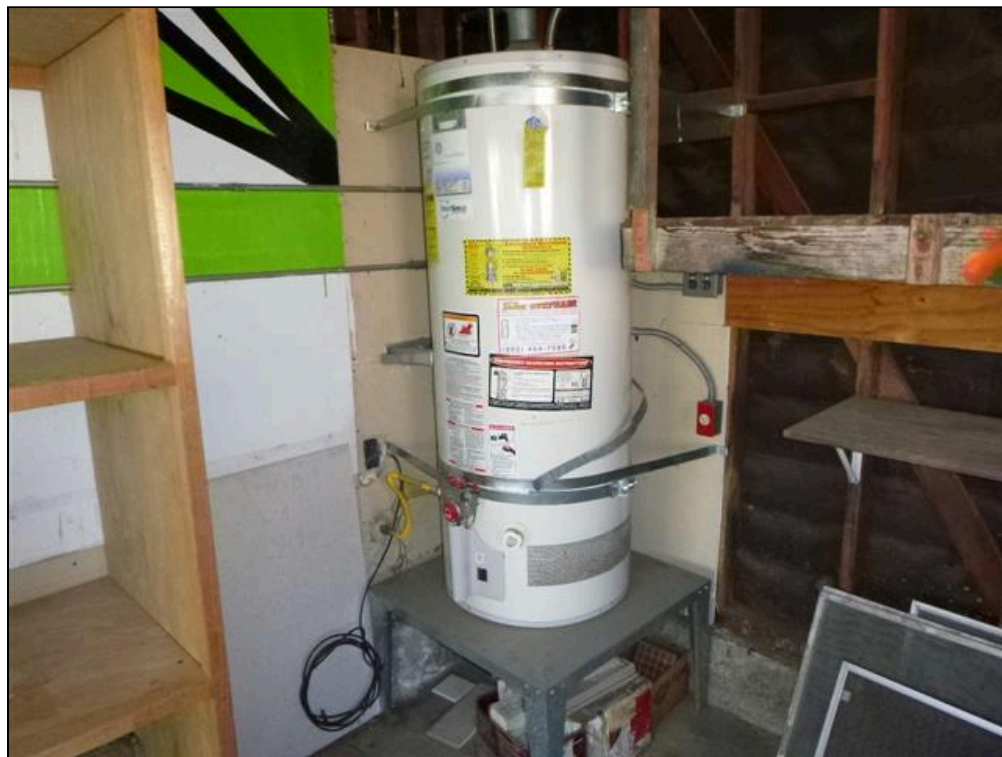
17.0 Item 1(Picture)

**17.0** (1) Due to the age of this unit, suggest review with a licensed plumber for replacement costs as it has exceeded it's intended life span ( 12-15 years ).

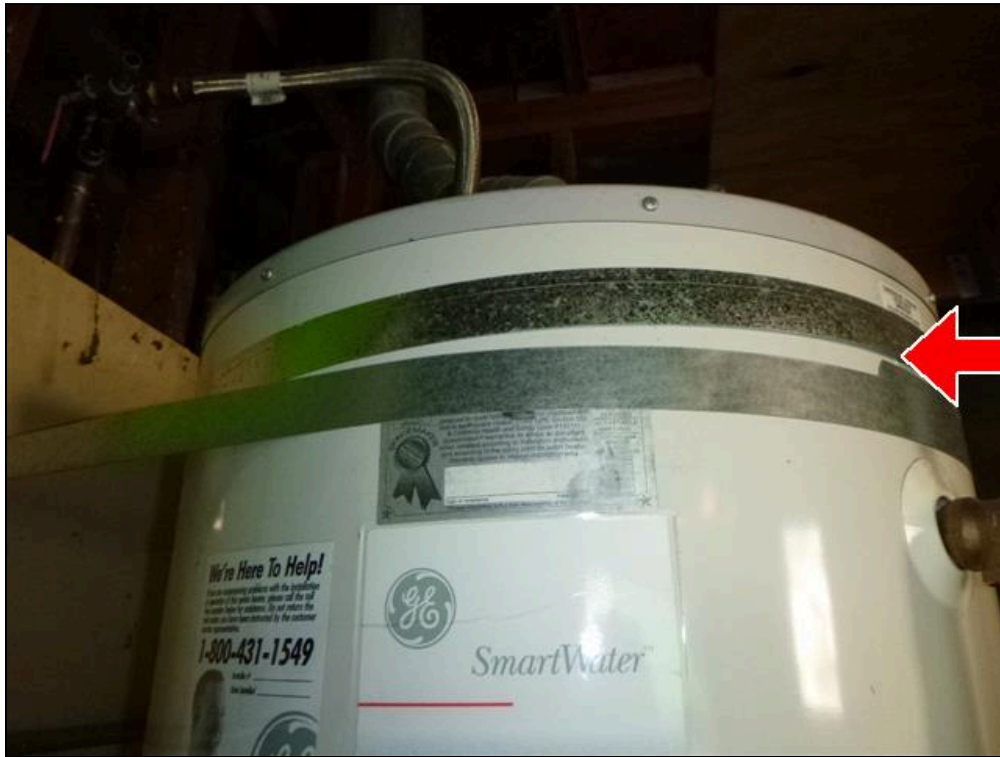
17.0 Item 3(Picture)

**17.0** (4) The earthquake strapping has been installed incorrectly, the upper strap is required to be 1/3 down from the top of the tank. Suggest review with a licensed plumber and repair as required for safety.

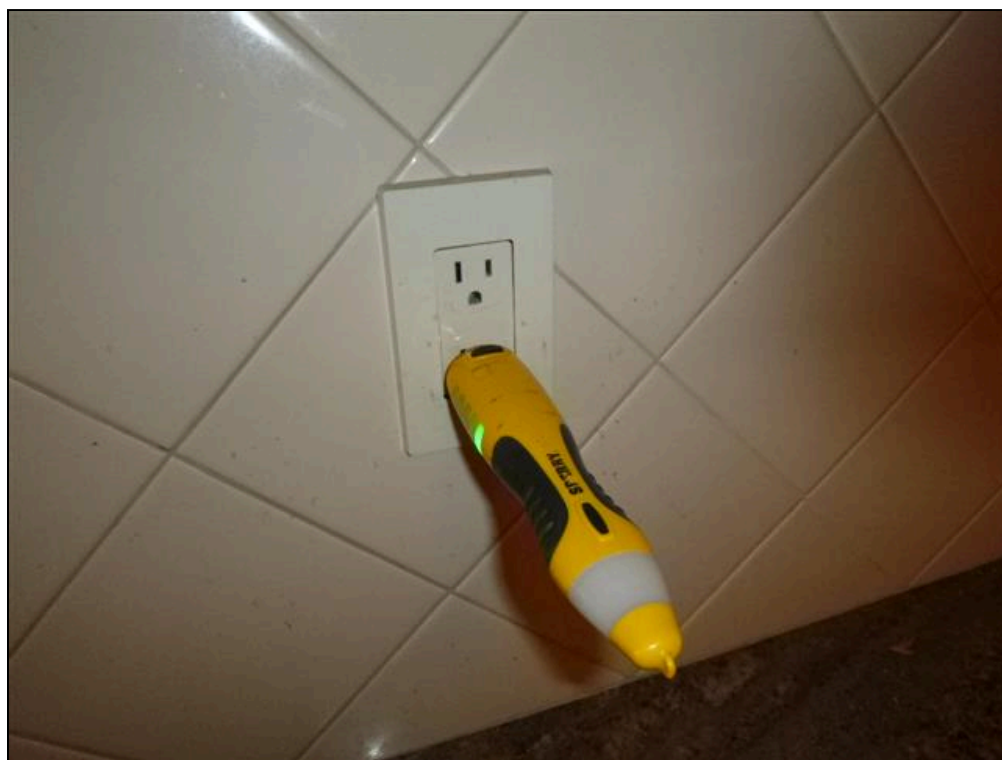
18.7 Item 1(Picture)

**18.7** (1) Various countertop outlets are not GFCI protected as required. Countertop GFCI outlet(s)/protection has been required within six feet of the sink since 1987 and all countertop outlets since 1996. Suggest review by a licensed electrician for installation costs as required for safety.

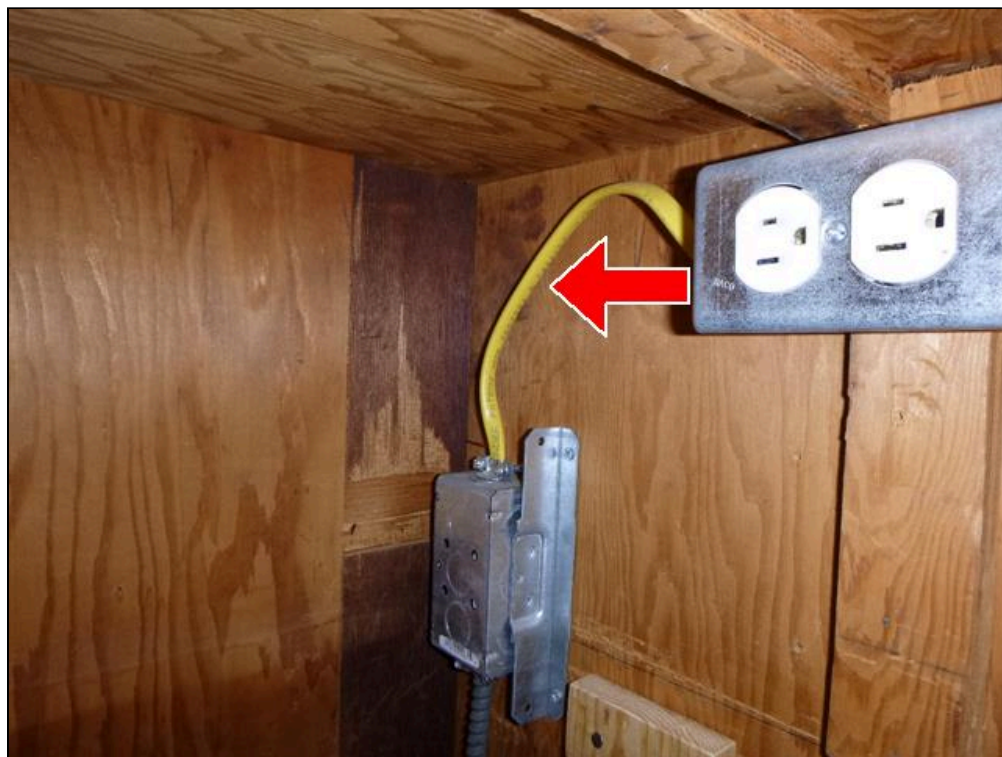
18.7 Item 6(Picture)

**18.7** (3) Exposed romex wiring located in accessible areas. This is a safety concern as it could be subject to physical damage. Romex wiring is allowed in inaccessible areas such as attics, crawl spaces and within walls provided that all proper protective materials and required tie-downs are in place. Suggest review by a licensed electrician for repair/replacement costs as needed.

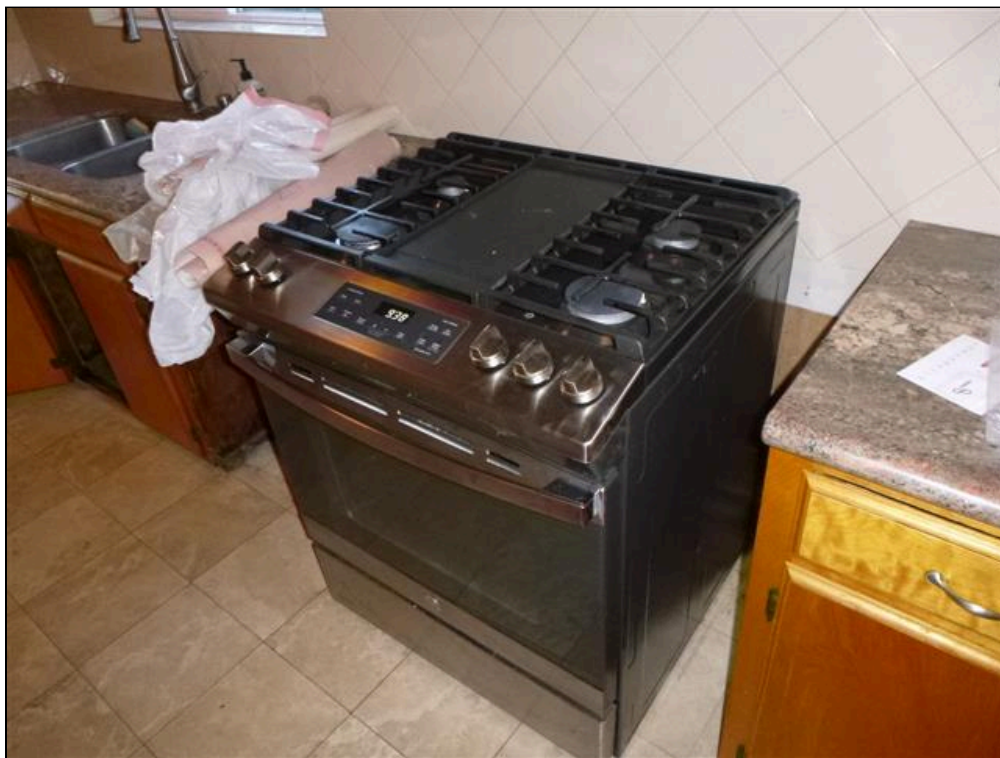
18.13 Item 1(Picture)

**18.13** The anti-tip bracket is not currently installed correctly. An anti-tip bracket is usually installed on the floor and against the wall (towards the back of the stove) for one of the rear legs to slide into. Its purpose is to prevent the stove from tipping when a heavy load is placed on the door ( possible child ) or slide-out racks upsetting the center of gravity. Suggest review with a licensed contractor for costs to relocate/install the bracket correctly for safety as required since 1991.

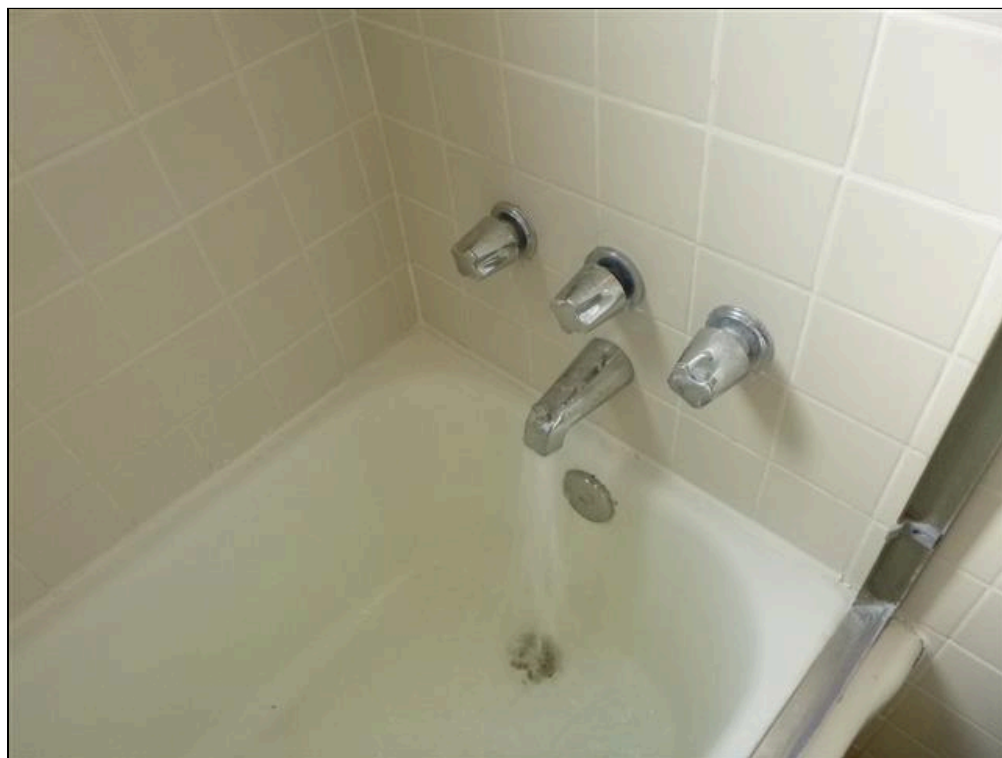
19.10 Item 1(Picture)

**19.10** The existing tub faucet is not a low-flow system as required. Suggest review with a licensed plumber for costs to replace the existing tub faucet with a low flow faucet (2.2 gallons per minute) as required by the State of California as of January 1st, 2017. See the plumbing system comments for further details and a link to the State of California plumbing ordinance. Most retrofit companies/cities do not enforce the low flow tub faucet requirements due to it can take an excessive amount of time to fill the tub ( you will use the same amount of water irrelevant of how long it takes to fill the tub ).

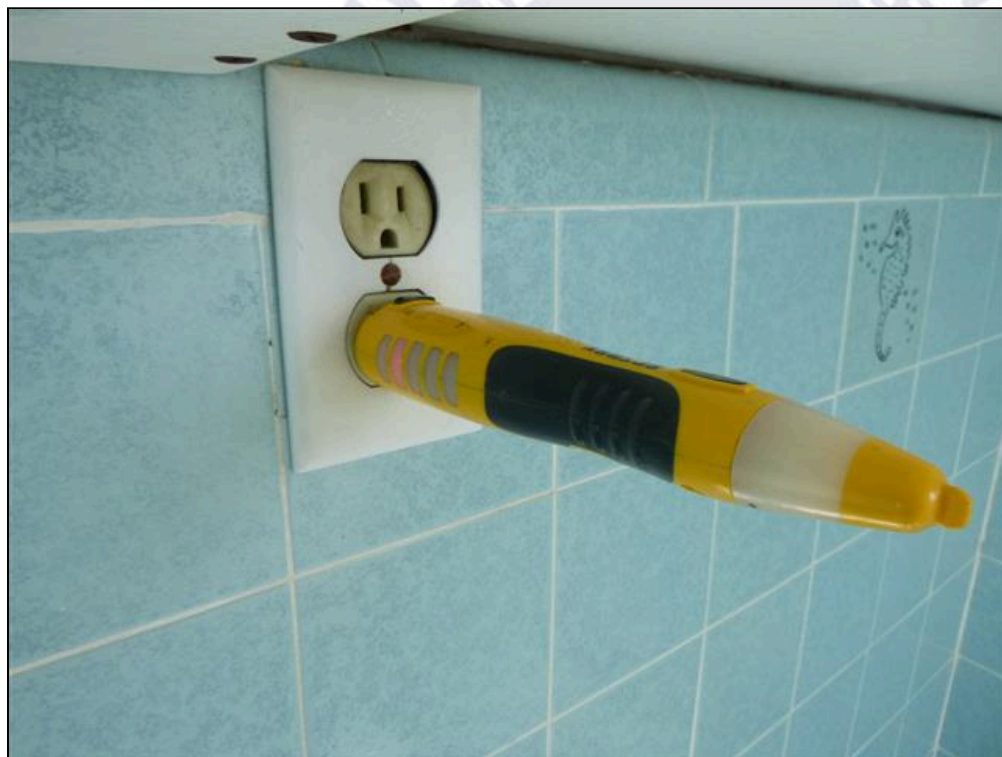
20.6 Item 1(Picture)

**20.6** No GFCI outlet or protection installed in this bathroom. GFCI protection has been required in bathrooms since 1975, suggest review by a licensed electrician for installation as required for safety.

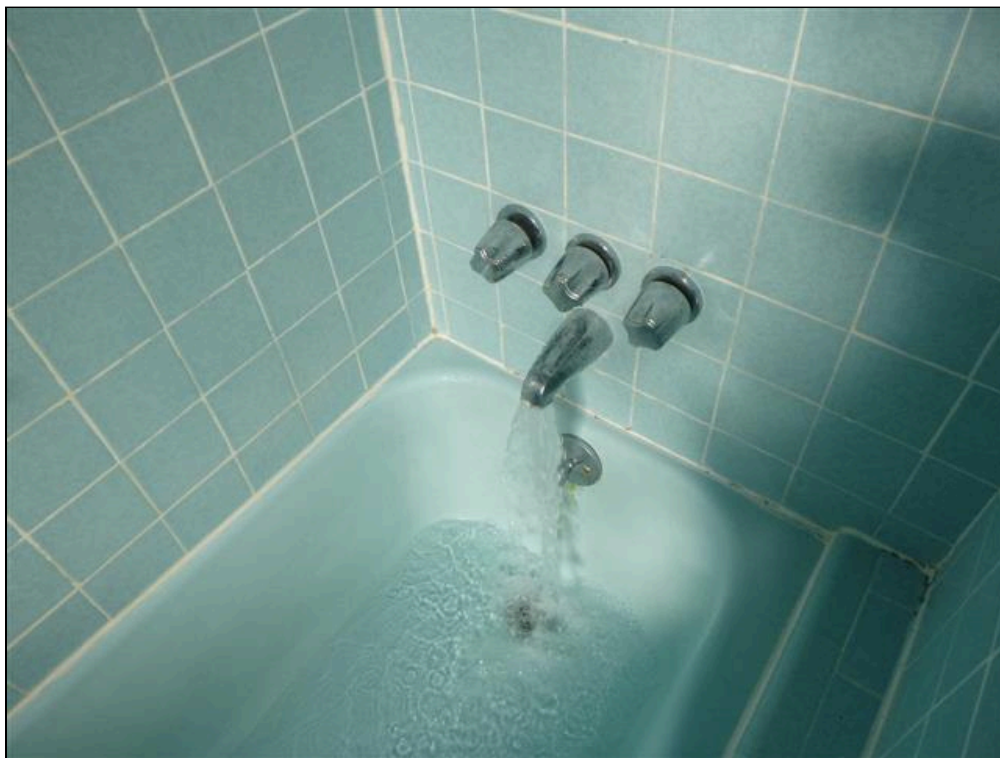
20.9 Item 1(Picture)

plumber for costs to replace the existing tub faucet with a low flow faucet (2.2 gallons per minute) as required by the State of California as of January 1st, 2017. See the plumbing system comments for further details and a link to the State of California plumbing ordinance. Most retrofit companies/cities do not enforce the low flow tub faucet requirements due to it can take an excessive amount of time to fill the tub ( you will use the same amount of water irrelevant of how long it takes to fill the tub ).

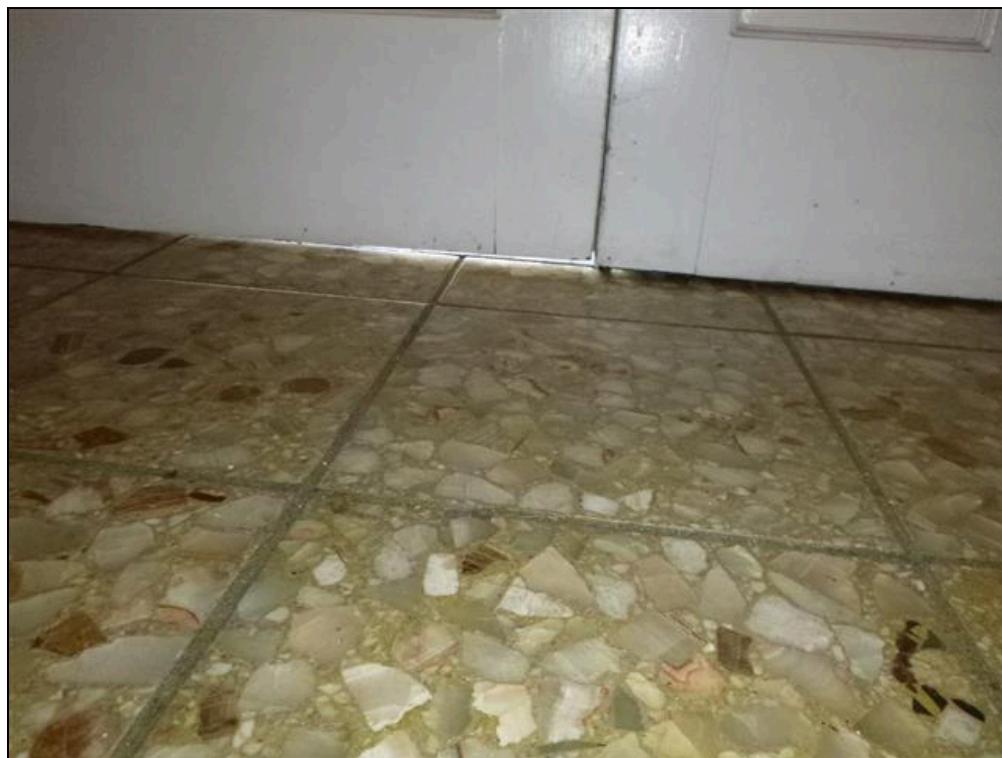
22.3 Item 1(Picture)

**22.3 (2)** Excessive gaps and light noted at the door(s) to the exterior when in the closed position. Suggest review with a licensed contractor for repair/replacement costs as needed to prevent future water, draft and insect/rodent intrusion at this area.

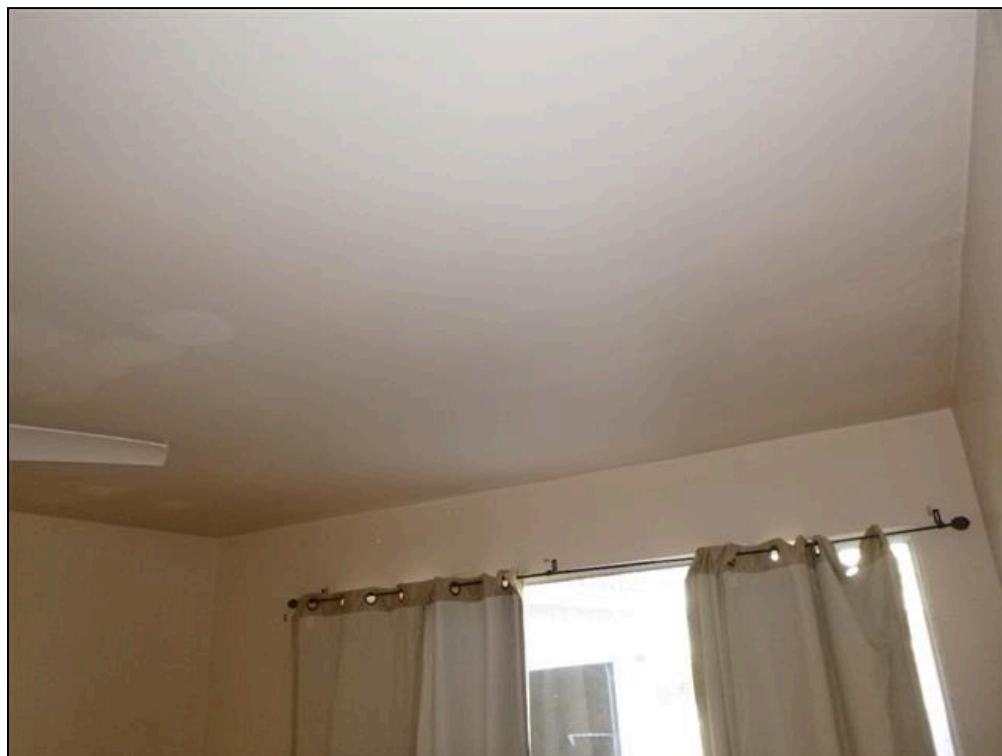
23.2 Item 1(Picture)

**23.2** Patched and uneven areas of the ceiling was noted, suggest review with the seller on the cause and any repairs needed. Suggest review with a licensed contractor for any repair/removal/replacement costs as needed.
