# Inspection Report

**Property Address:**  
2104 Chestnut Ave  
Manhattan Beach CA 90266

**Ferguson Home Inspections**

<b>Date:</b> 1/11/2025	<b>Time:</b> 09:00 AM	<b>Report ID:</b> 01112025ChestnutAve
<b>Property:</b> 2104 Chestnut Ave Manhattan Beach CA 90266	<b>Customer:</b> Yvonne Peltz	<b>Real Estate Professional:</b> Marlene Ramirez

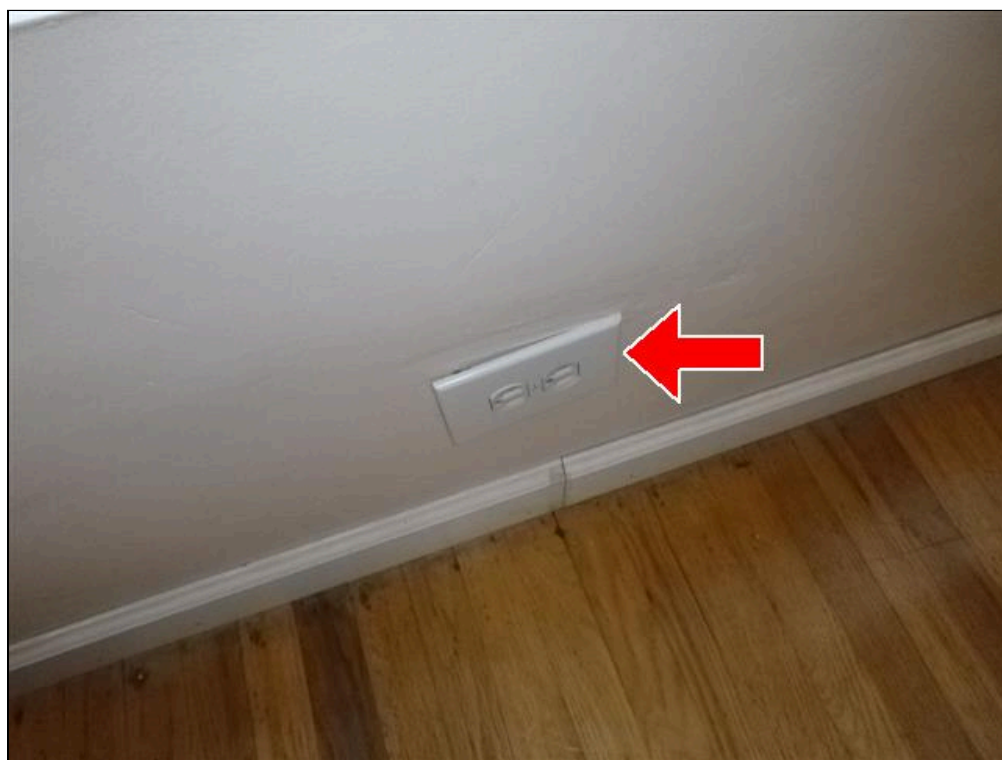
23.6 Item 1(Picture)

**23.6** The outlet at the front wall is loose at the wall mount, suggest review with a licensed electrician for repair/replacement costs as needed.

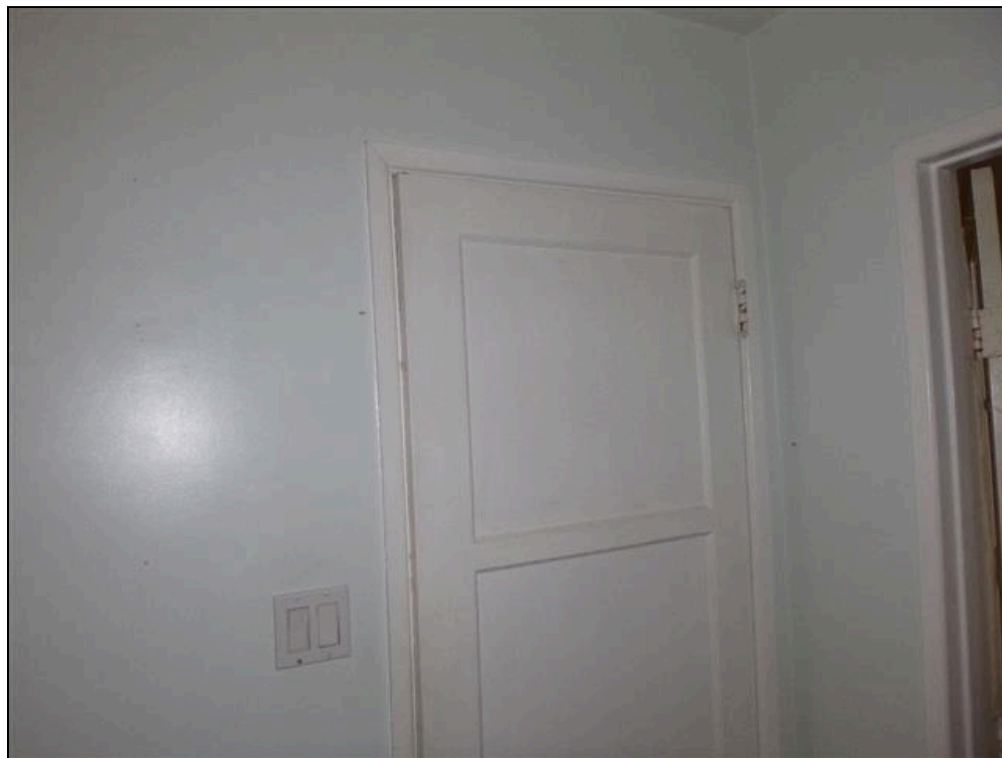
24.3 Item 1(Picture)

24.3 (2) The door sticks/impacts on the jamb when operating, suggest repair as needed.

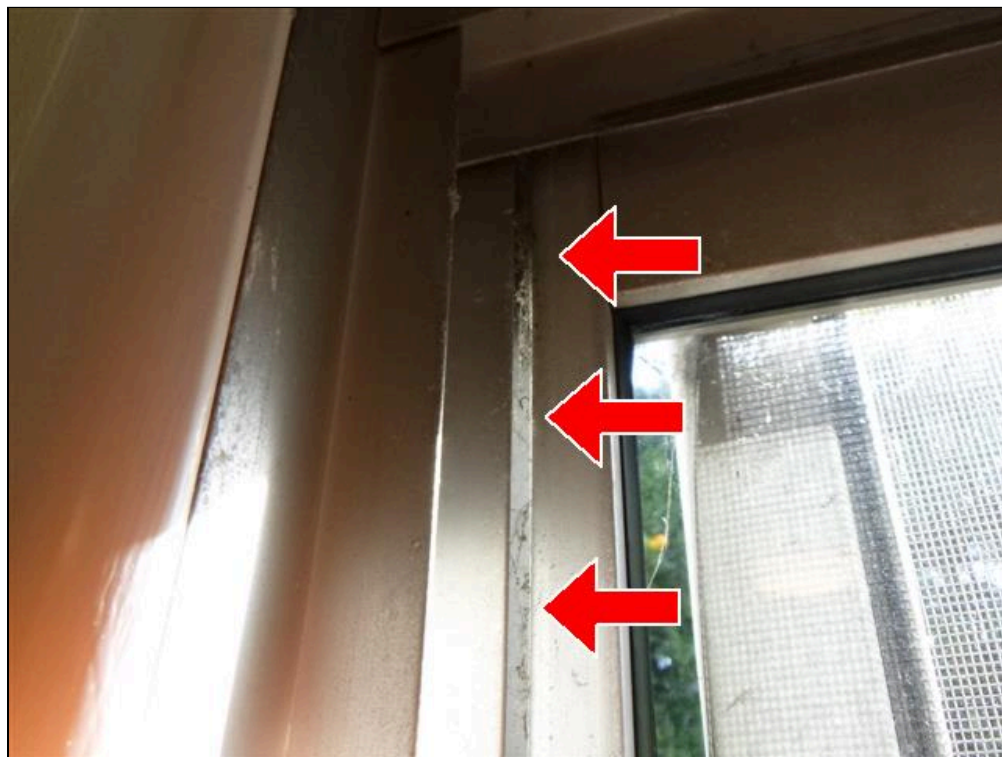
25.3 Item 1(Picture)

**25.3** (1) The fixed section of the rear sliding door is not currently installed level with the frame and excessive gaps were noted. Suggest review with a licensed contractor for any repair/replacement costs as needed to prevent future water, draft and insect intrusion at this area.

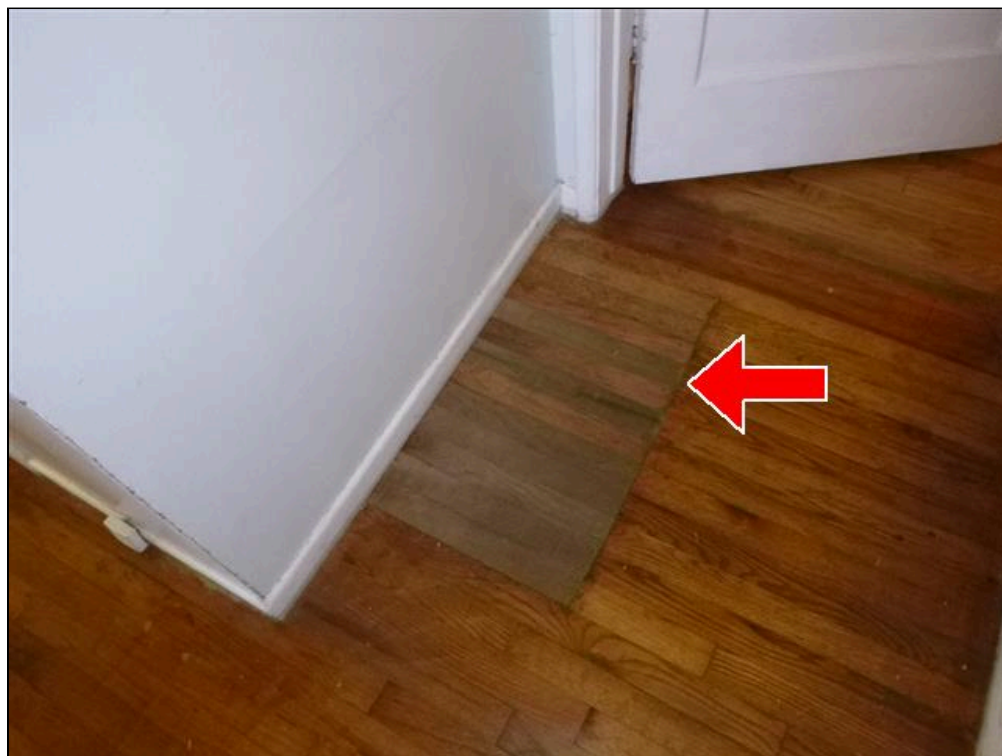
26.0 Item 1(Picture)

**26.0** (2) Patched areas of the floor were noted at the original floor heater location. Suggest repair/replace as needed.

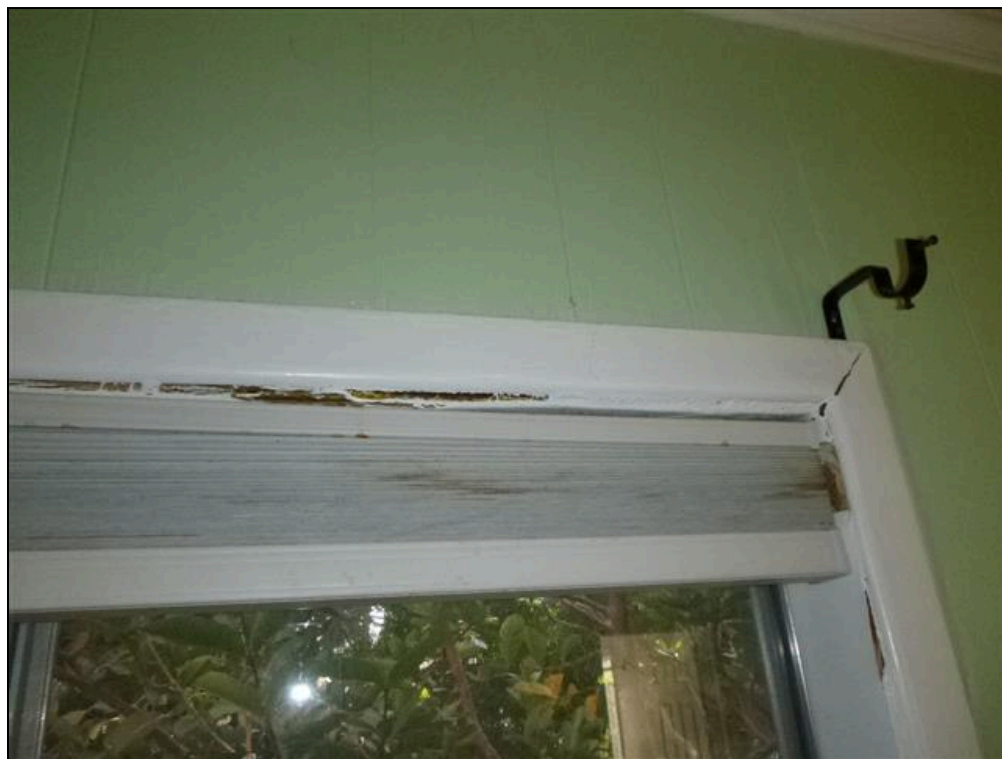
31.1 Item 1(Picture)

**31.1** Stained, patched and damaged areas of the walls were noted at the windows ( evidence of previous/on-going water intrusion was noted ). Suggest review with the seller for the cause and any repairs needed. Suggest review with a licensed contractor for any repair/removal/replacement costs as needed.

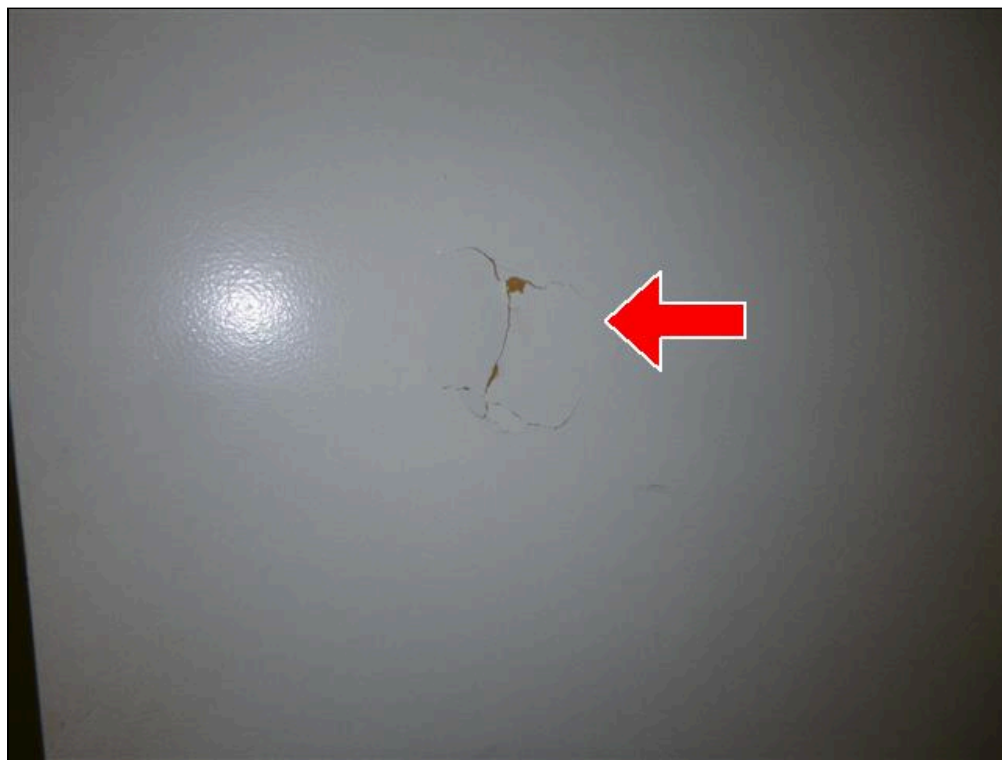
31.3 Item 2(Picture)

**31.3** (2) The door to the hallway is damaged/holes noted, suggest repair as needed.

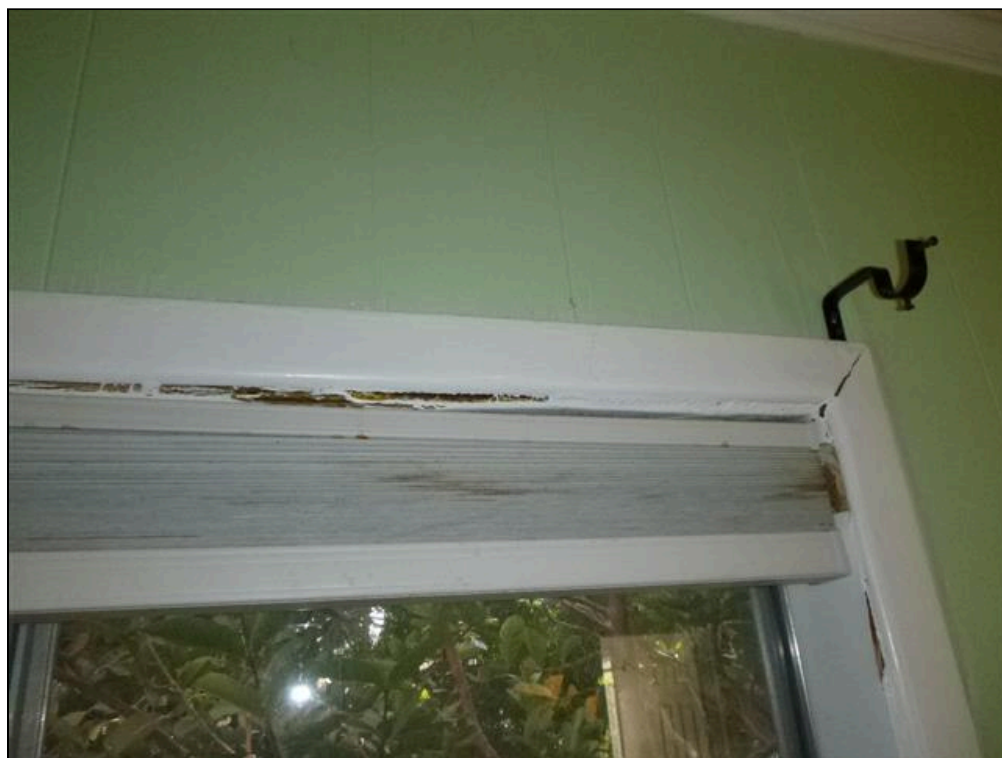
31.4 Item 1(Picture)

**31.4** (2) Excessive deterioration, satins and evidence of previous/on-going leakage was noted at the windows. Suggest review with a licensed contractor for any repair/replacement costs as needed.

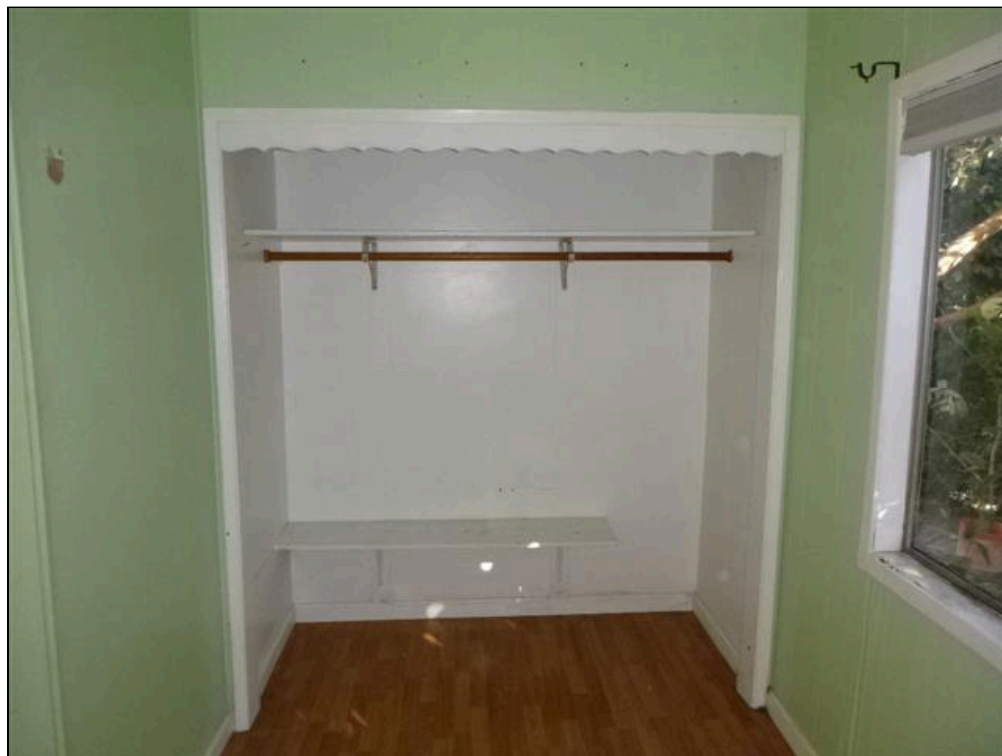
31.7 Item 1(Picture)

**31.7** The closet door(s) were missing/not installed at the time of the inspection, suggest replacing/installing as needed.

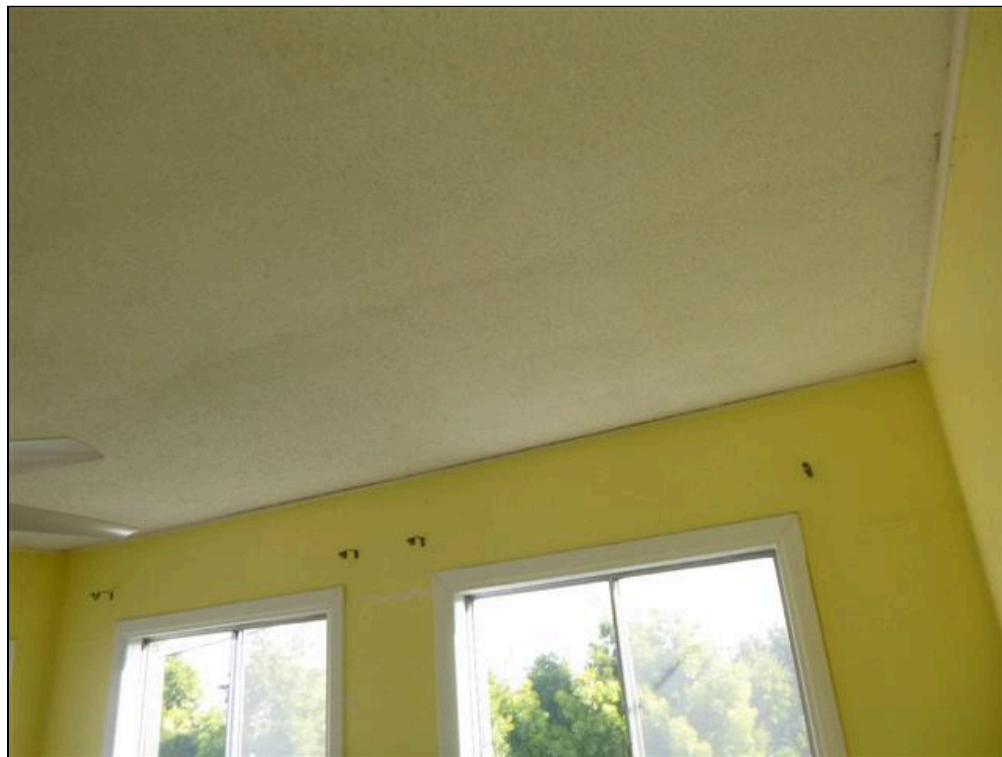
32.2 Item 1(Picture)

**32.2** Patched and uneven areas of the ceiling was noted, suggest review with the seller on the cause and any repairs needed. Suggest review with a licensed contractor for any repair/removal/replacement costs as needed.

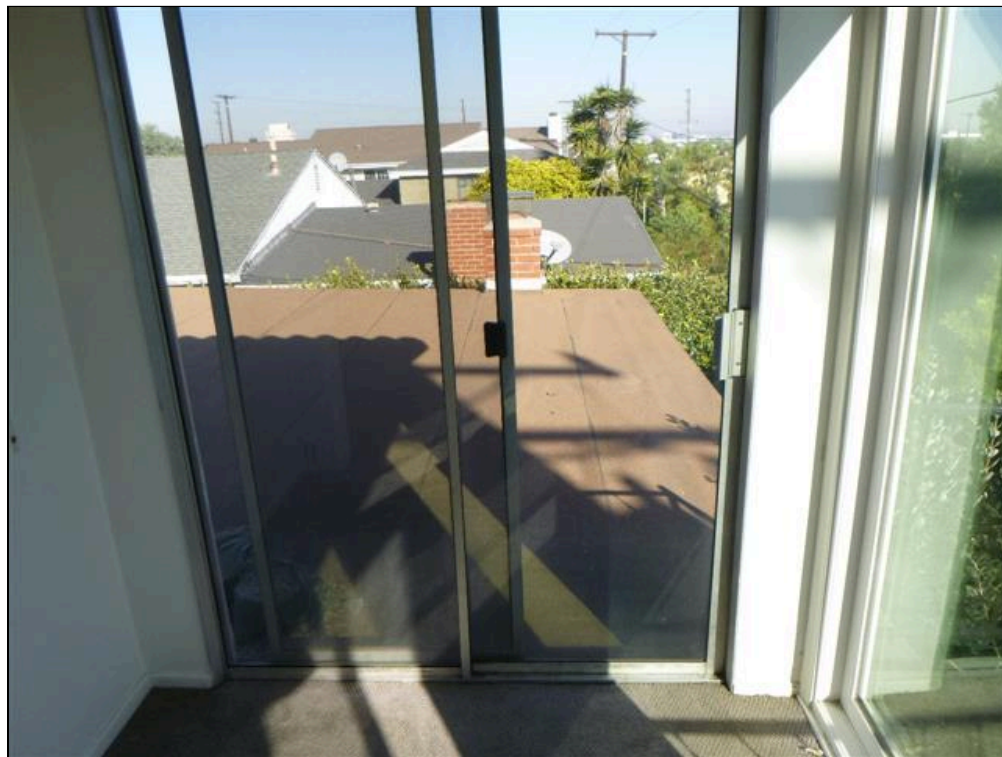
32.8 Item 3(Picture)

roof area ( no railing is installed at the roof area ). Suggest review with a licensed contractor to seal/ screw the door closed to prevent access to the roof area as needed.

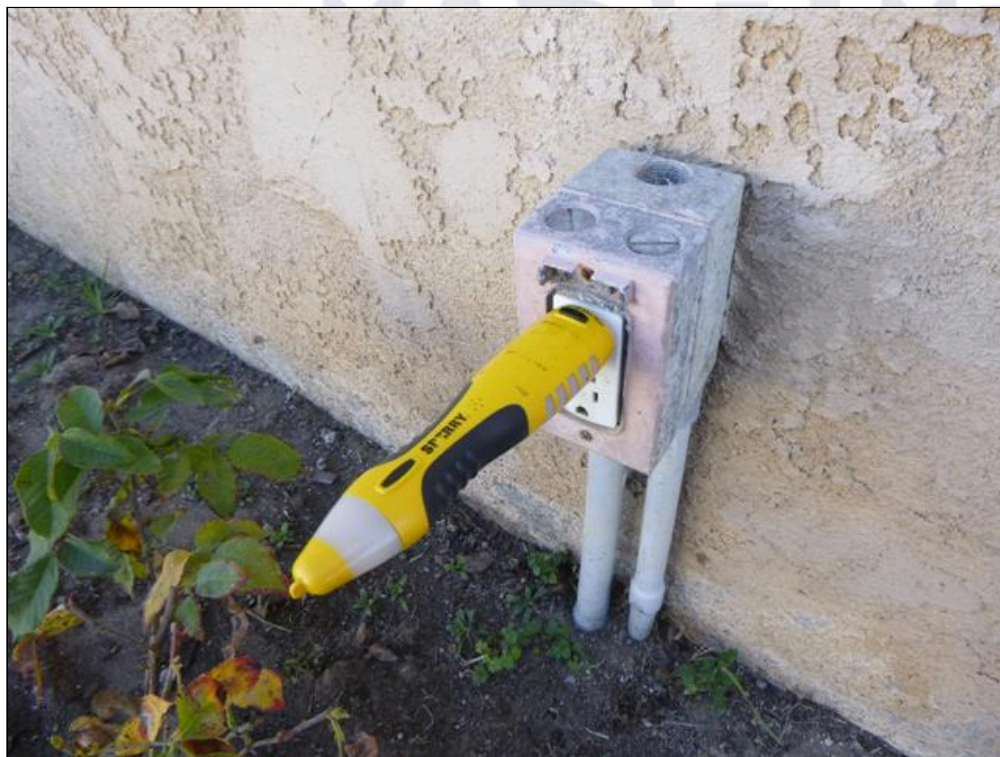
1.8 Item 2(Picture)

(2) The inspector was unable to test the GFCI outlet(s) at the front yard as there was no power to the outlet(s). Suggest review with a licensed electrician for repair/replacement cost and confirm correct operation as needed.

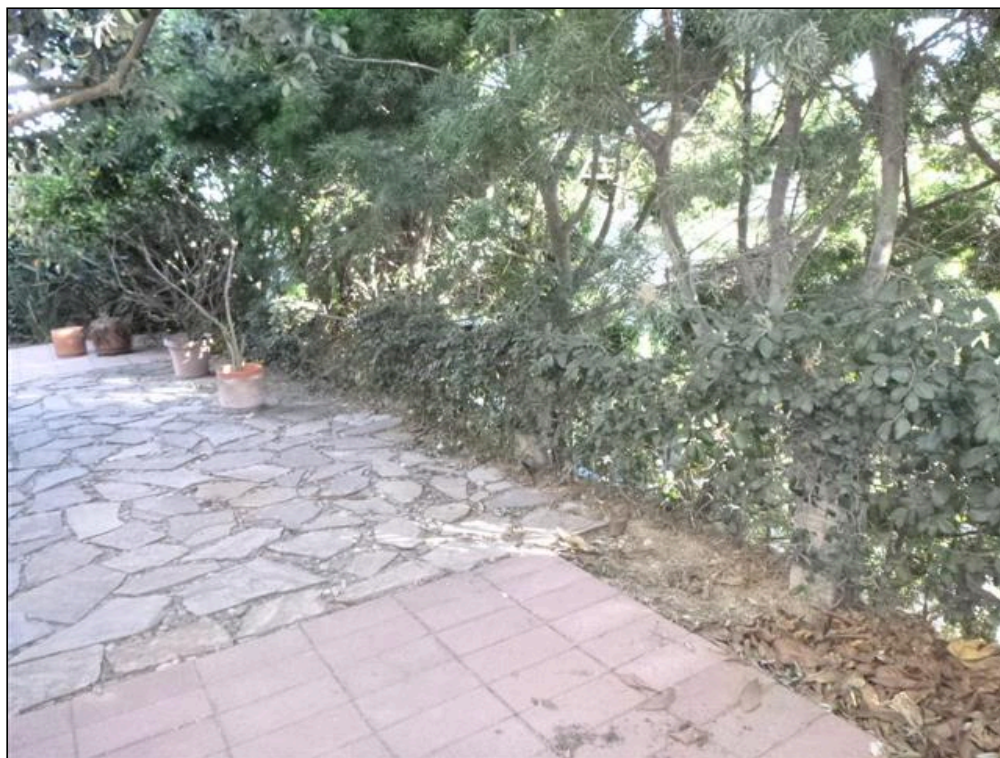
1.10 Item 1(Picture)

The rear retaining wall not visible/accessible at the time of the inspection. Suggest review with a licensed contractor on this item as needed.

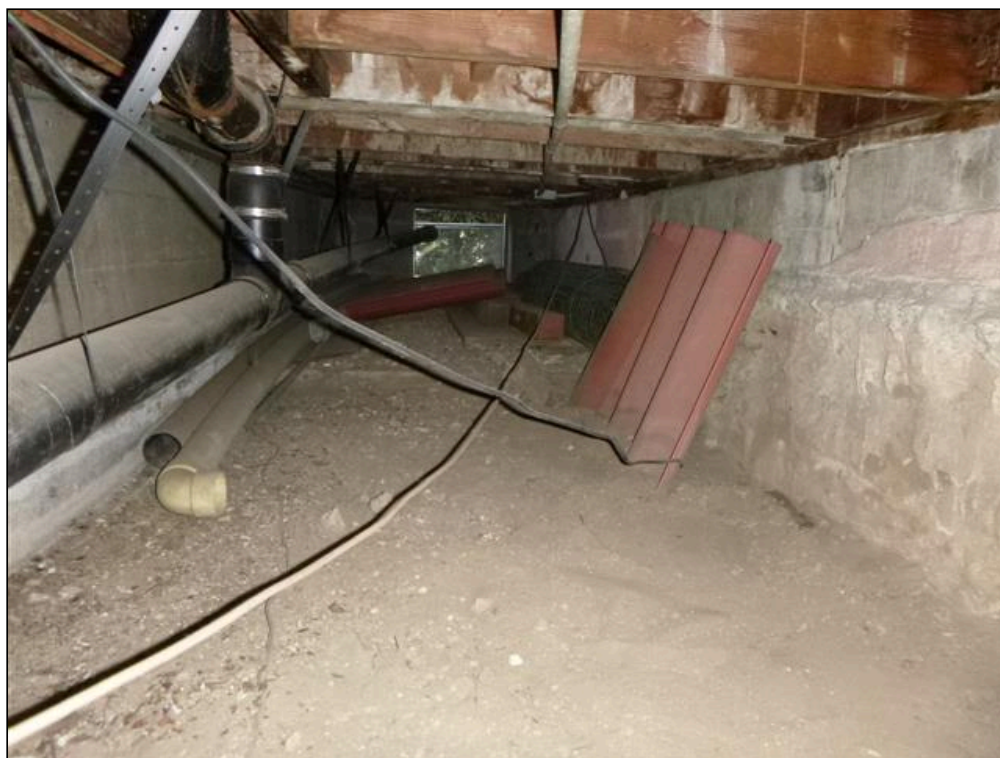
4.0 Item 1(Picture)

Suggest removal of debris and construction items from the crawl area.

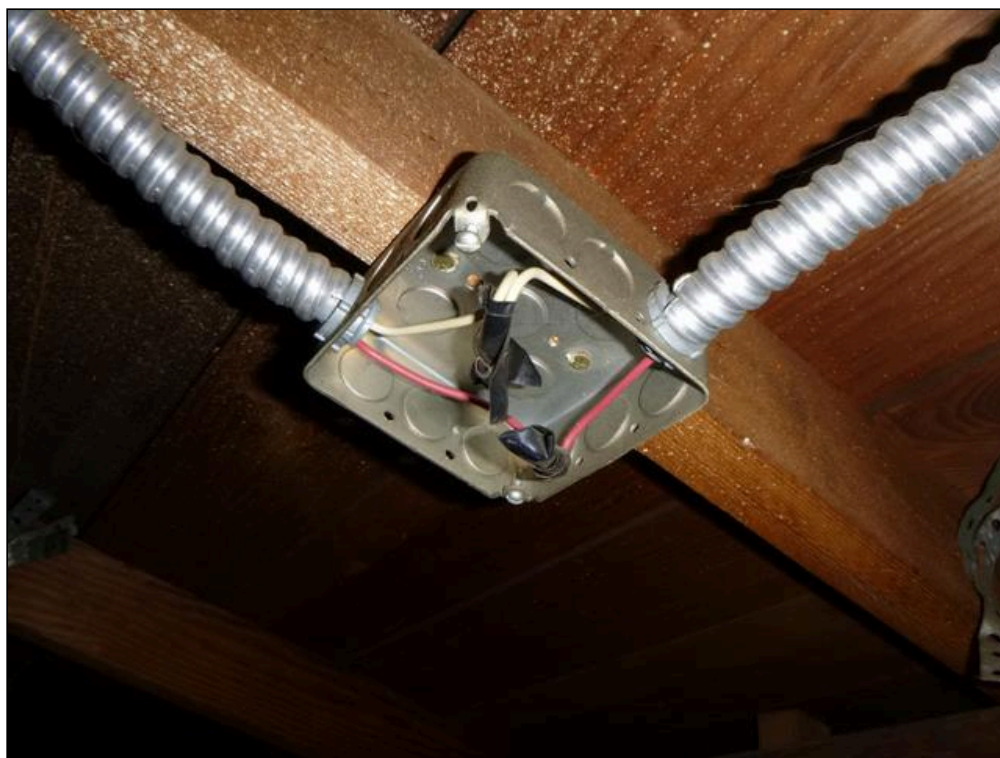
6.3 Item 1(Picture)

of the splice. Suggest review by a licensed electrician and repair as needed.

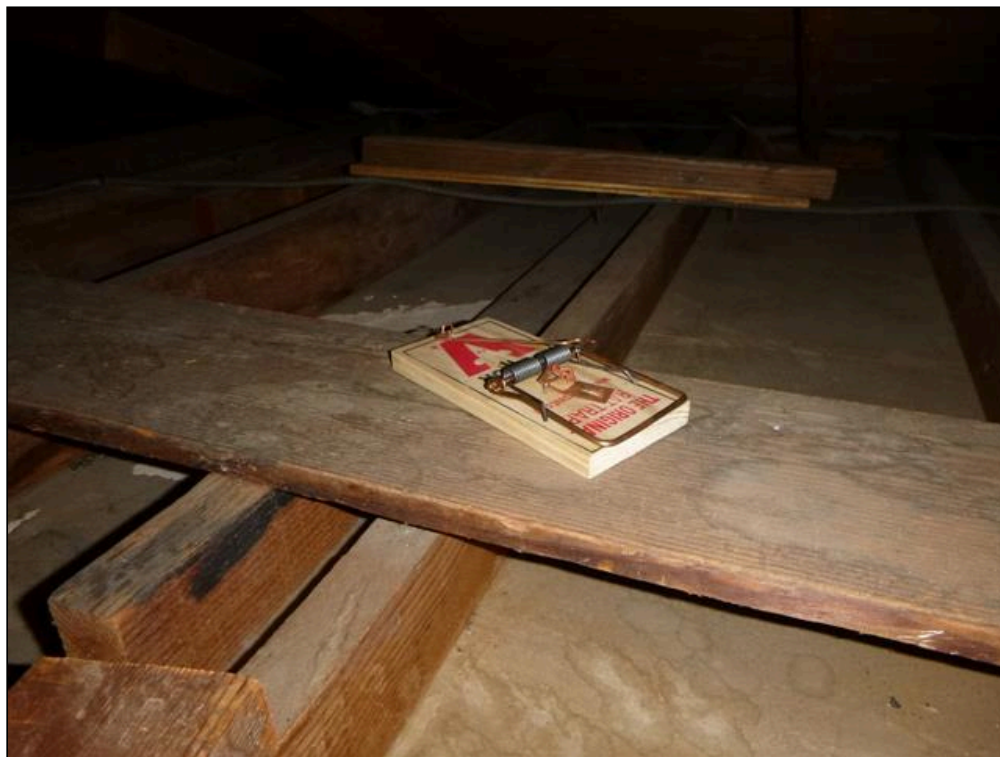
6.6 Item 2(Picture)

(3) Pest traps were noted within the attic. Suggest review with a qualified pest control company and/or a licensed contractor for removal costs of the droppings, re-screening of the vents and any removal/replacement of the attic insulation as needed.

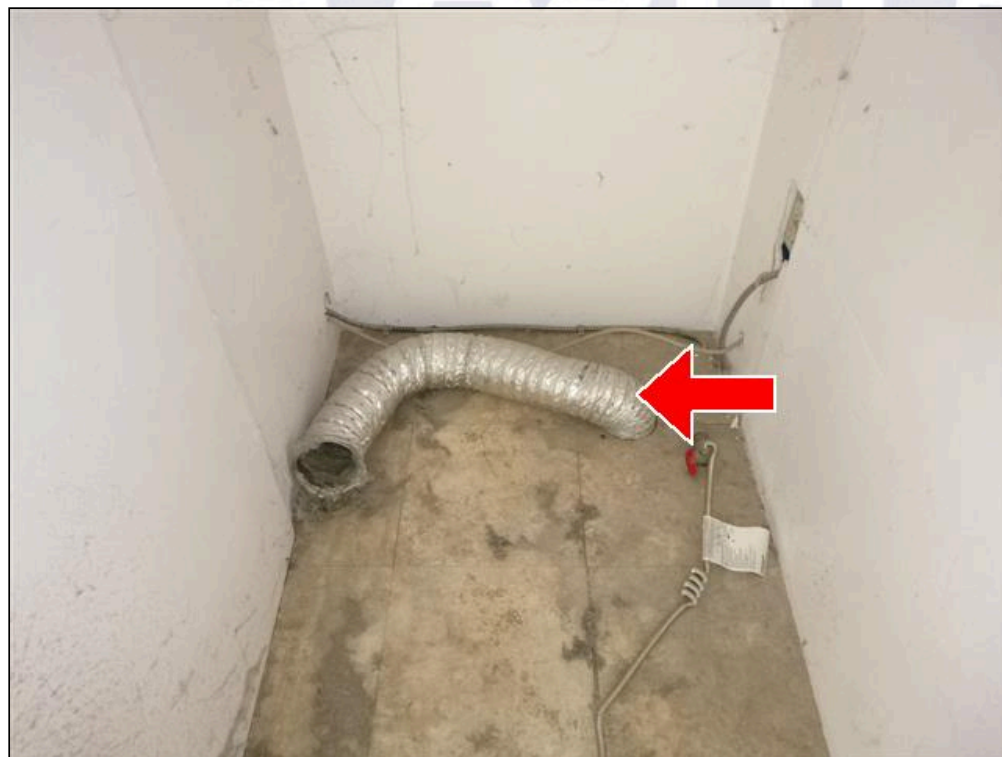
7.8 Item 1(Picture)

(1) Improper aluminum/vinyl flex vent installed to the exterior of the dwelling, this is a potential fire/safety hazard. Suggest remove the existing material and installation of a rigid metal vent pipe/duct and vent cap to the exterior as required.

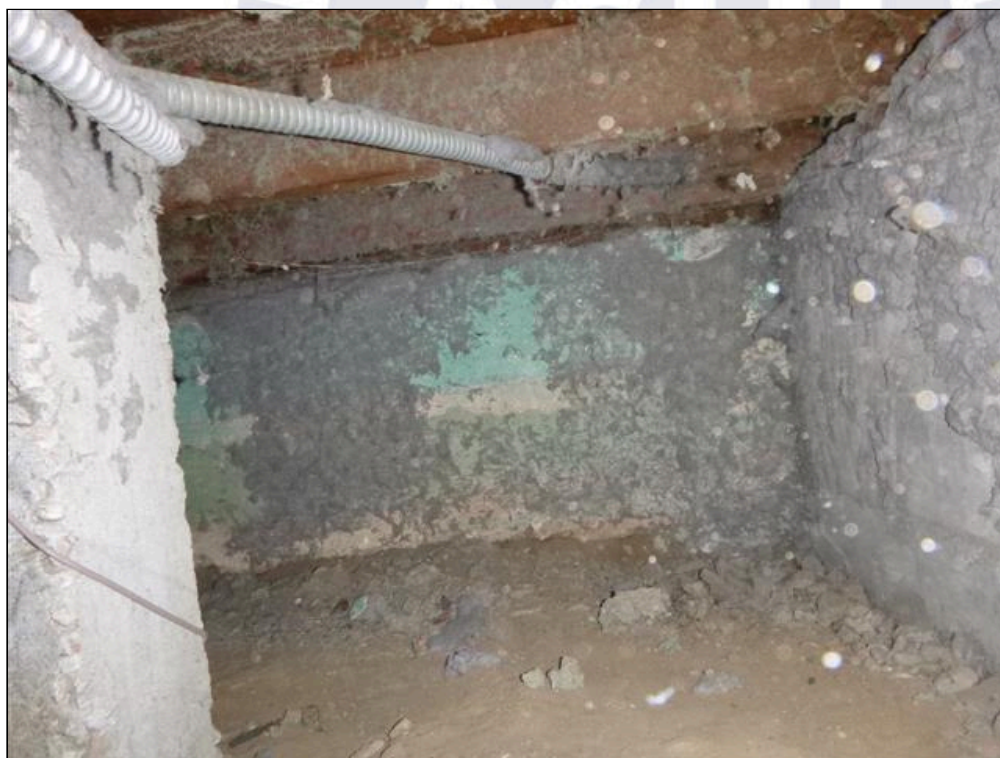
7.8 Item 3(Picture)

(2) The dryer vent is pulled apart/leaking within the crawl space, this is a potential fire safety hazard. Suggest repairs as needed and vent to the exterior of dwelling with approved rigid materials and removal of all lint from the crawl area.

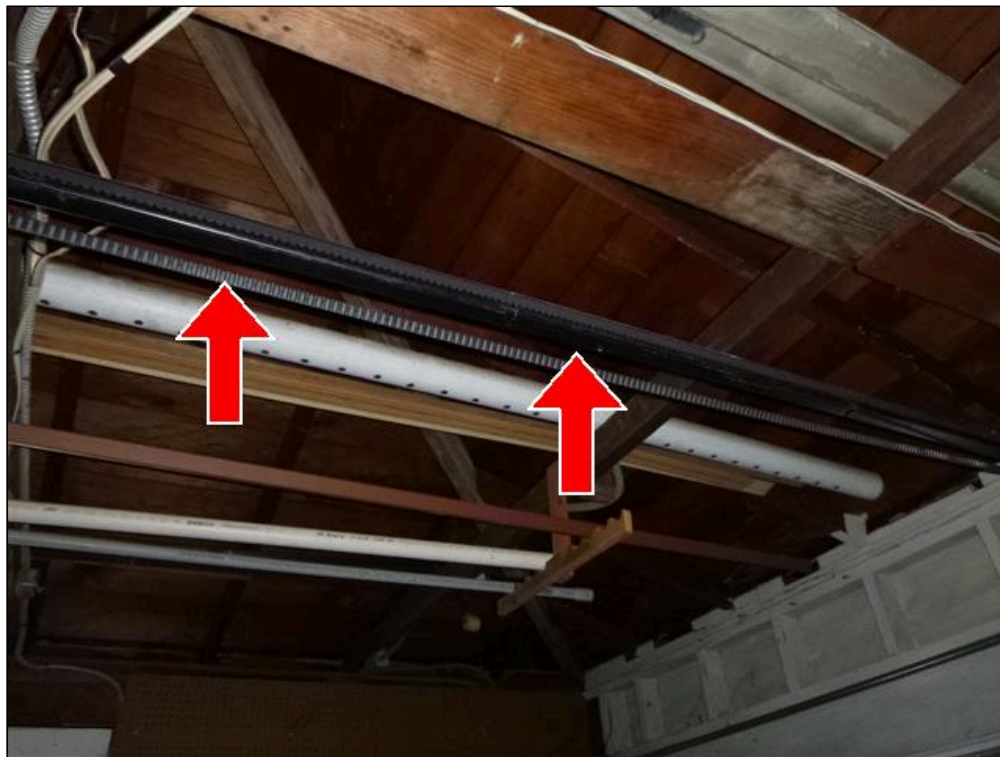
12.3 Item 1(Picture)

(2) The garage door opener(s) pull chain/rubber is excessively loose and periodically catches on the railing mount(s). Suggest review with a licensed contractor for costs to correctly tighten/tension the system as required and confirm correct operation as needed.

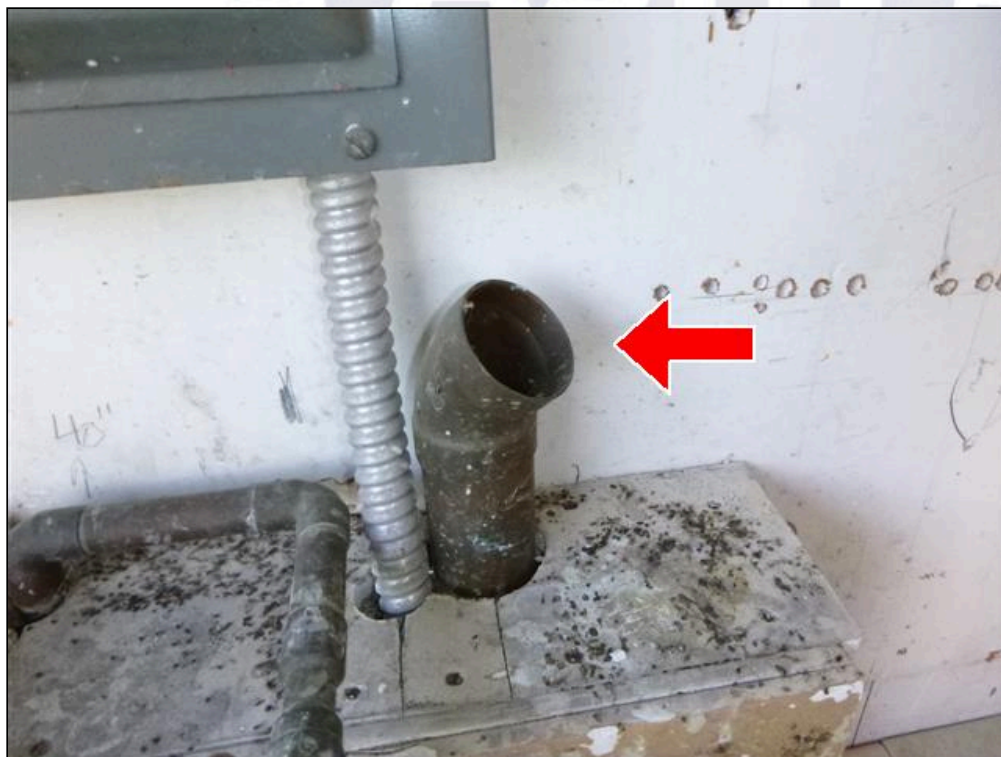
12.8 Item 1(Picture)

The sink drainage vent does not transfer through the roof as required, but terminates inside the garage area. Suggest review by a licensed plumber for costs to complete the installation as required for safety.

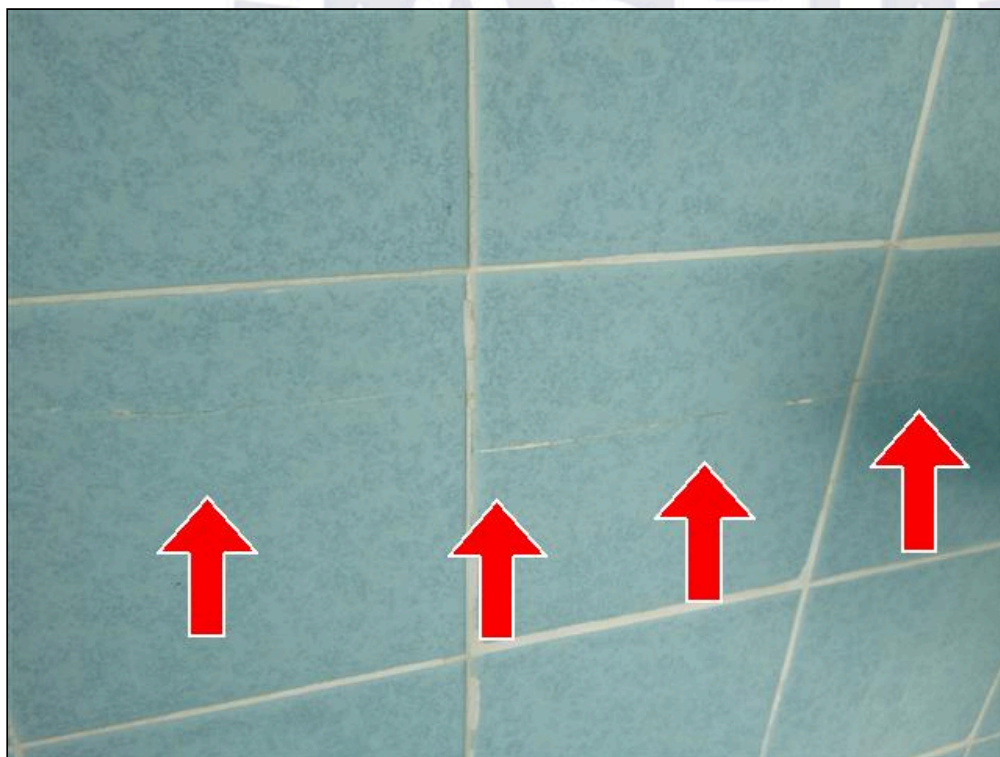
20.10 Item 1(Picture)

Hairline cracks noted at the tile areas, suggest repair/replace as needed.
