SUMMARY 4179 N Santa Lucia St, Orange, CA 92865 Todd Moeller 10/06/2025

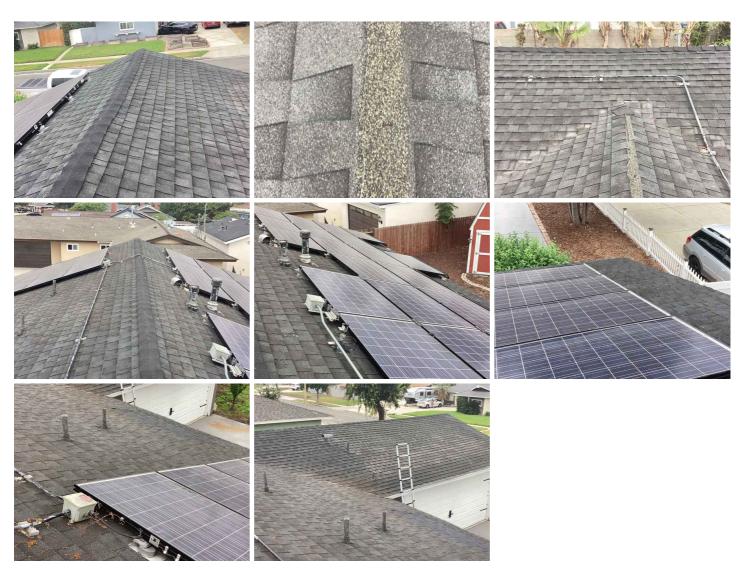
6.1.1 Roof

SHINGLES - END OF LIFESPAN

The roofing materials are showing signs of aging and wear. The roofing system appears to be at or near the end of its useful lifespan. The foregoing is an opinion of the general quality and condition of the roofing material. The inspector cannot and does not offer an opinion or warranty as to whether the roof leaks or may be subject to future leakage. This report is issued in consideration of the foregoing disclaimer. The only way to determine whether or not a roof is watertight is to observe it during a prolonged rainfall. Certification of the roofing system is beyond the scope of this inspection. I recommend a complete evaluation of the roofing system by a licensed roofing contractor.

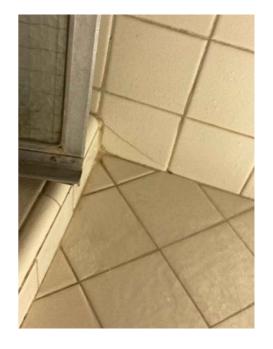
13.6.1 Tub/Shower Walls

CRACK IN SHOWER TILE

There is a crack in the shower tile; recommend evaluation by a plumbing contractor.

Recommendation Contact a qualified professional.
