Inspection report for the property at  
1421 Pontiac Street, Oakdale, CA 95361

This report is prepared exclusively for **Garrett Maxwell**  
Inspected On: **04-26-2024**

Baker Inspection Group  
209-522-5320

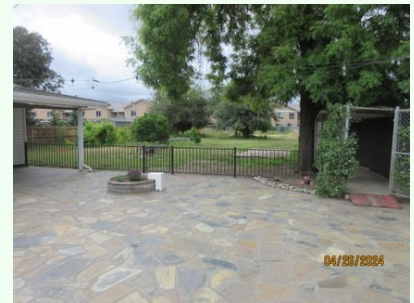
**Q (SEF-1) Due Diligence:** The building is situated on a generally flat lot. This could lead to seasonal drainage problems. Recommend inquiring with the sellers and or building department for any history of water problems on the site.

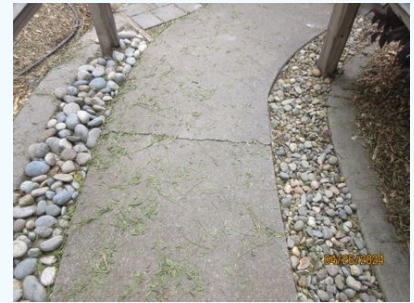
**(SEF-6) Improvement:** Cracks were noted in the driveway and walkway flatwork at the front and right side of the house. No immediate repair appears necessary, though water will continue to deteriorate the surface until the flatwork is repaired or replaced.

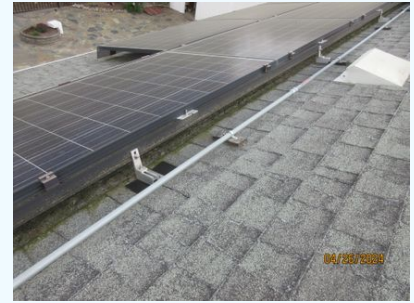
**🏠 (RC-5) Improvement:** The asphalt composition shingles covering the roof of this house were old, appeared to be past the mid point of their long-term service life. Recommend further

evaluation as needed.

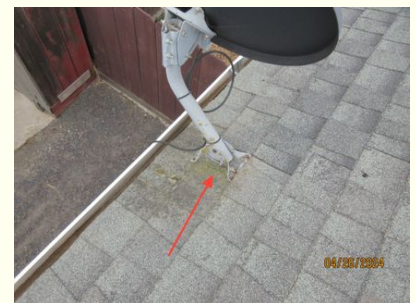
The satellite dish penetrations should be maintained to avoid damage to the underlying structure from moisture intrusion.

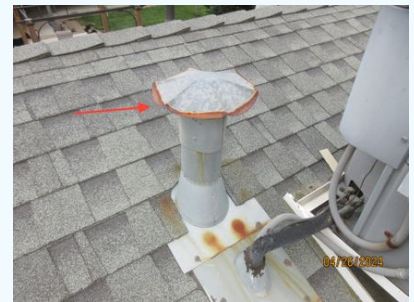
The vents on the roof had corrosion visible and will need to be replaced soon to avoid damage from leakage.

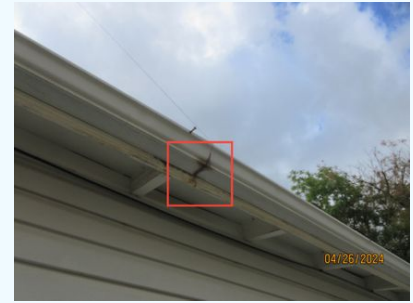
Leaks were noted in the gutters at the right side of the house that need to be repaired to control roof runoff. Seal-up all leaking areas and tune-up to ensure gutters are properly secured and sloped to drain.

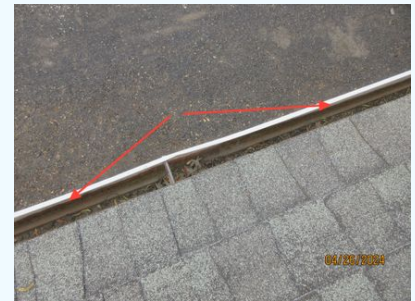
**(RC-13) Improvement:** The gutters had corrosion visible at the areas around the house. Continued corrosion will eventually result in leaking gutters. Good maintenance practices will help extend the long-term service life of the gutters.

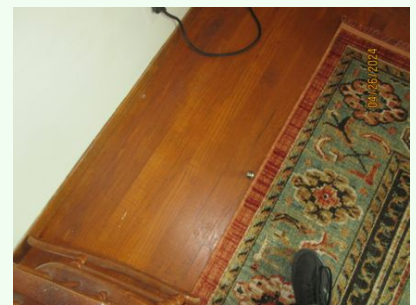
🔍 **(SF-2) Due Diligence:** Minor floor settlement was noted in the house. Inquire with the seller for any history of repairs or movement. No signs of recent movement were visible at the time of inspection.

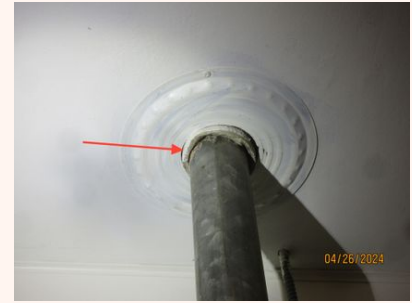
A partial amount of the exhaust flue visible was insulated with a material which had a strong possibility of containing Asbestos. A newer section of metal flue was connected to it from the appliance. A Qualified Contractor should inspect this connection further and correct as needed. Although Asbestos is considered to be a known carcinogen, it is not considered to be a health hazard unless it is in a form in which it can be inhaled. Confirming the presence of Asbestos requires testing by a Qualified Laboratory. Consider consulting with a Qualified Contractor about importance of the presence of this material and the need for removal.

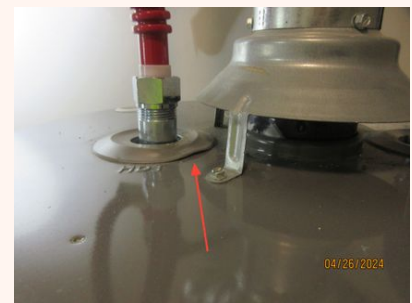
Signs of back-drafting or combustion roll out were noted at the water heater. This is a safety hazard that indicates the unit is not venting as intended. This could allow moisture and carbon monoxide to enter the house. Have this water heater serviced and repaired or replaced as recommended to ensure safe and reliable performance. Examples of specific observations noted during inspection include:

*Distorted plastic bushing*

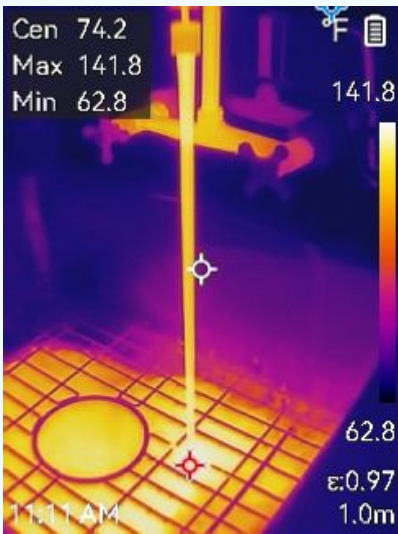
🏠 **(WH-9) Improvement:** Testing of the plumbing system today, the water tested as too hot - 142 degrees F. This is a scalding hazard. To prevent scalding, standards recommend indoor hot water temperatures do not exceed 120 degrees F. There is some evidence that hot water temperatures should be greater than 130 degrees F to prevent Legionnaires' disease from developing in the water heater. If this is a concern, you can heat the water in the tank to 140 degrees F and have a tempering valve installed at the hot water tank. Have this further evaluated and repaired or simply turn down the temperature as desired to eliminate a scald hazard. Please note that during inspection it is difficult to accurately test the water temperature as it can vary between fixtures. Testing is done in multiple locations during inspection and a median temperature is taken.

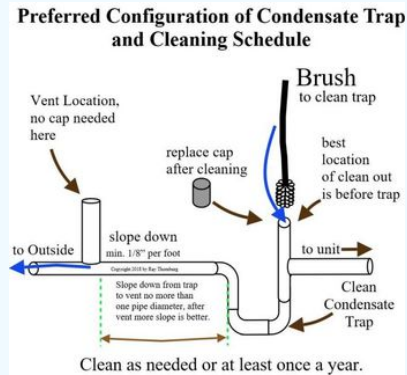
The cooling system evaporator coil had no condensate overflow warning/shutoff device installed. If the condensate drainage system should fail, this condition could result in moisture damage to the home. Recommend that a proper condensate overflow/shutoff device be installed. [Click here for information](#)

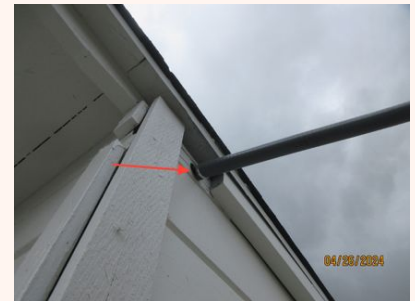
✂️ **(EDF-2) Repair/Replace:**  
The electrical conduit had been disconnected at the shop and requires repair. Repair as needed.

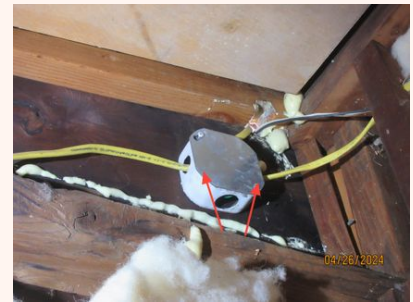
✂ (EDF-5) Repair/Replace: The non-metallic sheathed cable was poorly run into the junction boxes at the shop and has not been properly restrained, protected or sleeved. Also, check for additional boxes that could have a similar condition as most boxes are not visible to inspection. Wiring cable should have proper clamps to protect and secure the wire where it enters the junction box. Recommend further evaluation and repairs as needed.

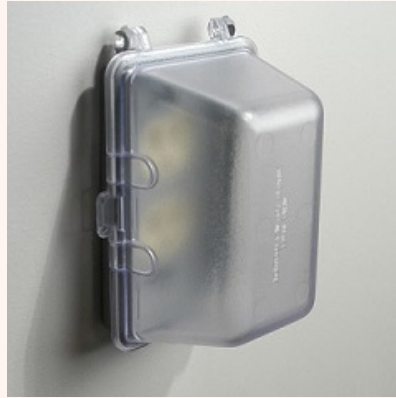
⚡ (EDF-16) Repair/Replace: The exterior electrical receptacles at the shop were not enclosed in weather-resistant covers. Recommend repairs as needed.

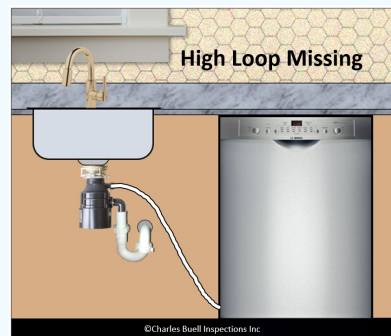
🏠 **(KA-7) Improvement:** An [air gap](#) is recommended to protect the dishwasher from accidental contamination if the sewer line were to back up. If an air gap cannot be installed, at least run the drain line above the level of the sink drain to create a high loop. This was an older way of protecting the dishwasher. Recommend further evaluation to determine if the dishwasher has an internal air gap / high loop or repair as needed to install an air gap.

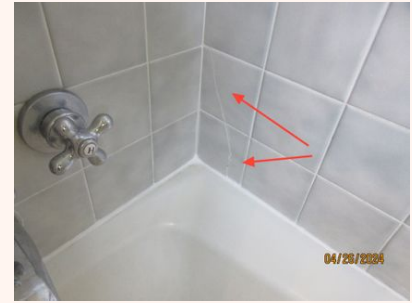
Cracked tile were noted in the Hallway Bathroom [shower surround](#). This can lead to water intrusion behind the tile and subsequent tile failure and water damage. Recommend further investigation and repairs to the cracked tiles as recommended. Please note that the ability to repair this tile depends on what the tile is mounted on and what type of adhesives were used to mount the tile.

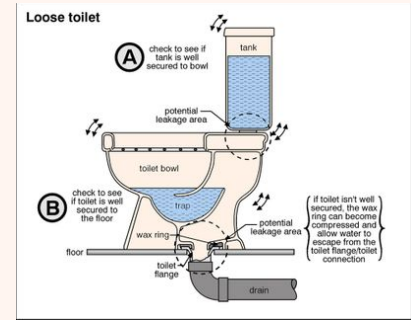
The loose toilets in the Bathrooms need to be reset and the wax rings and flanges should be replaced to prevent hidden plumbing leaks. This is a simple job unless the bolts that fasten the toilet also require repair. Sometimes, loose toilets can even be shimmed for a tight and proper seal and sometimes simply caulking can help prevent the toilet from rocking and twisting.

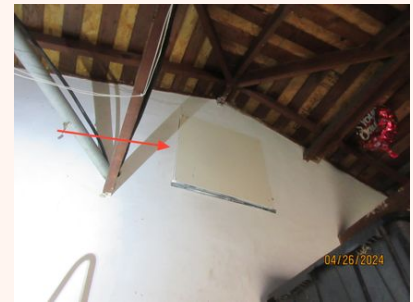
An unprotected opening was found in the Garage wall finishes. This should be repaired to complete the [fire separation](#) between the house and the Garage. Large holes should be repaired with the proper sheetrock materials. Small holes and openings should be sealed with mud or high temperature of "fire stop" caulking. Openings with doors should employ listed fire-rated doors.

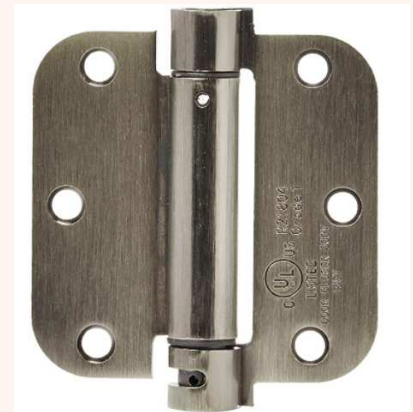
The self-closing hinges on the Garage occupant door were missing. This safety device is recommend to ensure the door to the Garage is closed to keep pollutants and even fire from spreading into the house. This is a requirement that has been enforced and then removed from building standards over the years. It is currently recommended considered best-practices for improved safety.

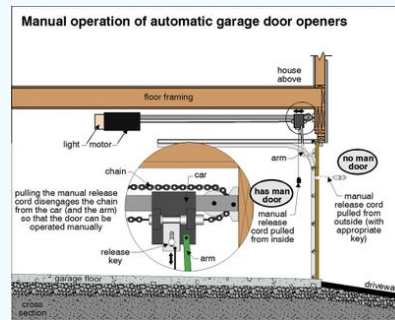
**(G-8) Improvement:** The handle that attaches to the overhead Garage door detaching mechanism was located too high off the floor. These release handles should be accessible, less than 6-feet off the ground. Repair as needed for improved safety.

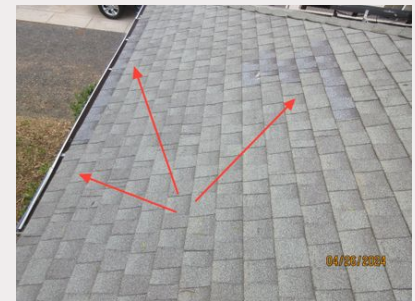
The asphalt composition roof shingles have been repaired. We were unable to determine if these repairs will prevent damage to the underlying roof structure from moisture intrusion. Recommend further evaluation as needed.

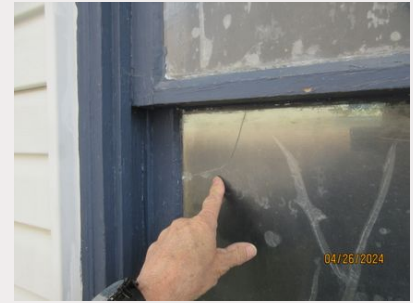
A cracked window pane was noted at the right side of the house. This requires window glass replacement for a proper repair. Recommend further evaluation and repairs as needed.

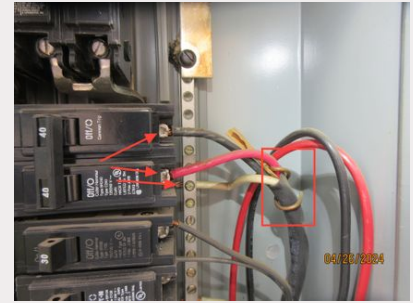
The upper 40 Amp 2 pole breaker feed did not have the grounding conductor landed in the panel, it was coiled around the wiring. Recommend further evaluation to determine if this is proper.

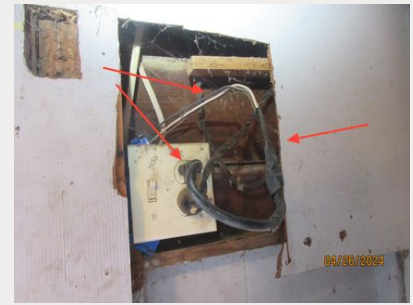
An extension cord is being used to supply power at the shop. This is non-standard and a safety hazard. Hire an electrician to provide an electric receptacle for this opener.

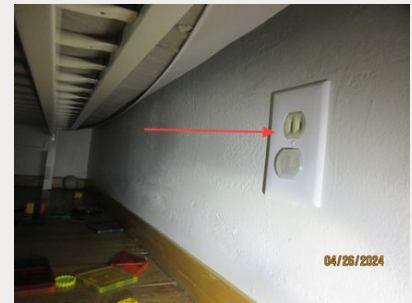
Several electric receptacles in the house were an older, un-grounded, two wire system. Though there is nothing wrong with this configuration you may find it inconvenient in some areas, especially in offices and media areas. In general, this indicates an older electrical system that has not been updated and may not safety or reliably meet modern demands and expectations for the wiring system. Recommend further consultation about options for updating this older wiring.

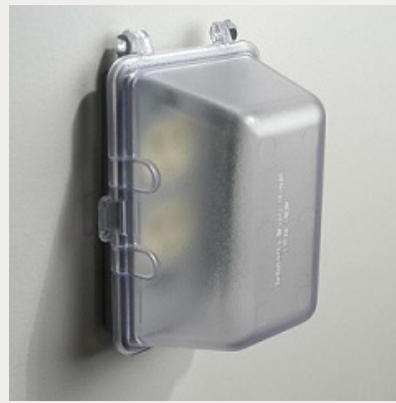
The exterior electrical receptacles at the shop were not enclosed in weather-resistant covers. Recommend repairs as needed.
