**Roof Inspection ( As Part Of  
Home Inspection)**

**434 Devon Ct  
San Ramon, CA 94583**

**Inspected By: Arvin Mabutas**

**Inspected On Fri, Oct 31, 2025 at 9:00 AM**

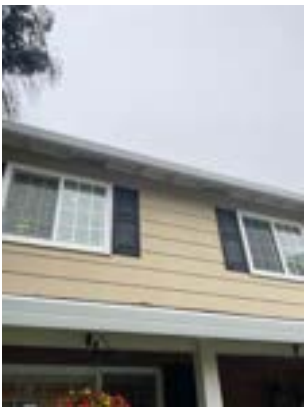
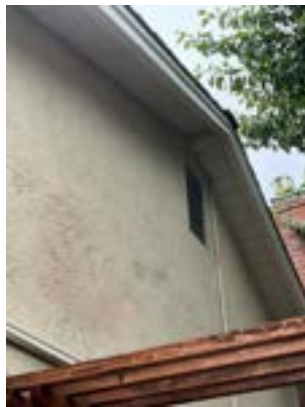
### Ventilation Present

Soffit, Gable Ends

Condition: Satisfactory

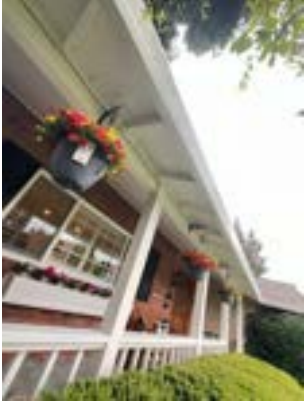
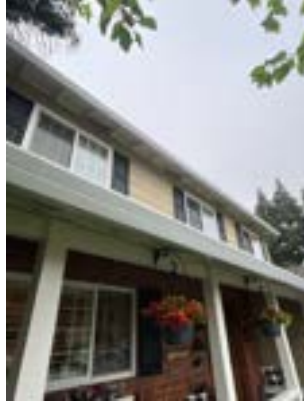
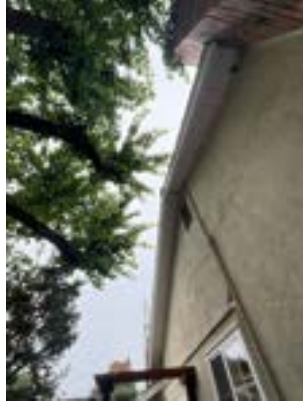
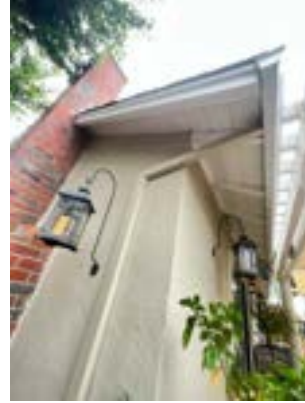
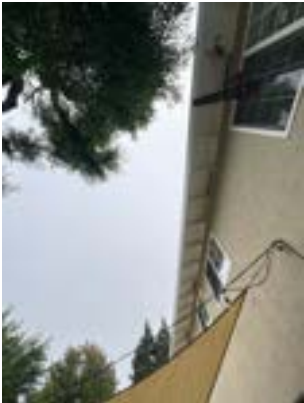
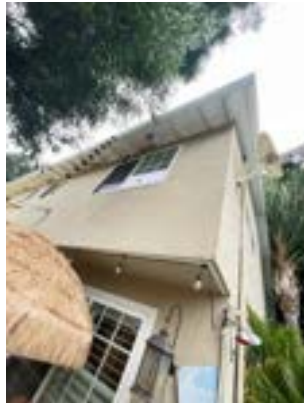
### Soffit and Fascia

Wood

Condition: Satisfactory

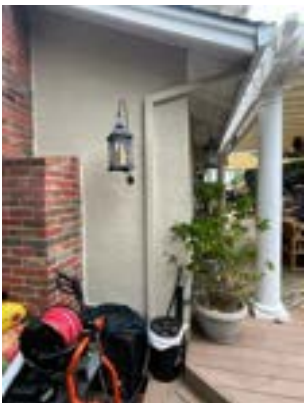
### Gutters & Downspouts

Metal

Condition: Satisfactory

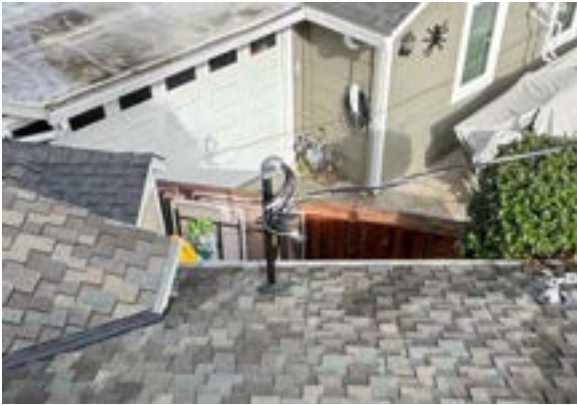
### Type of Service

Roof mounted Mast
