WOOD DESTROYING PESTS AND ORGANISMS INSPECTION REPORT

#: 2019095

BUILDING NO. 1690	STREET 14TH ST	CITY LOS OSOS	ZIP 93402	Date of Inspection 03/14/2019	NUMBER OF PAGES 1 of 6
----------------------	-------------------	------------------	--------------	----------------------------------	---------------------------

Single family residence.

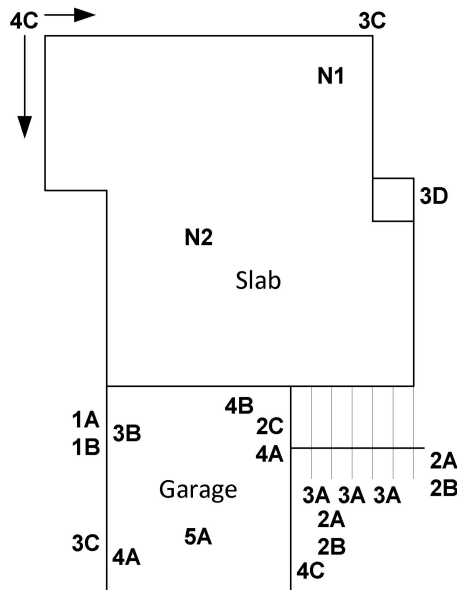
Diagram not to scale
Findings locations approximate
