Transferee / Property Information

Transferee Name:	<u>Paul Love</u>	Street Address:	<u>1802 Hillcrest Dr</u>
City:	<u>Hermosa Beach</u>	State / Zip:	<u>CA / 90254</u>
Customer:	<u>Graebel Companies – GA</u>	File Number:	<u>APROA570015</u>
Customer Contact:	<u>Susan Pendziwater</u>	Report Date:	<u>7/3/2023</u>

Inspection Type: Stucco Identification
Inspection
Customer File Number: APROA570015
ReloOlogy Number: 102176

Worldwide ERC Relocation Property Assessment

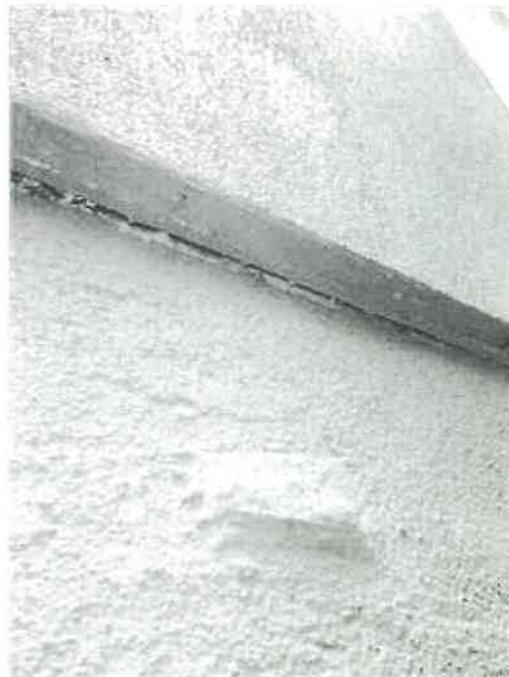
Stucco Weep Screed

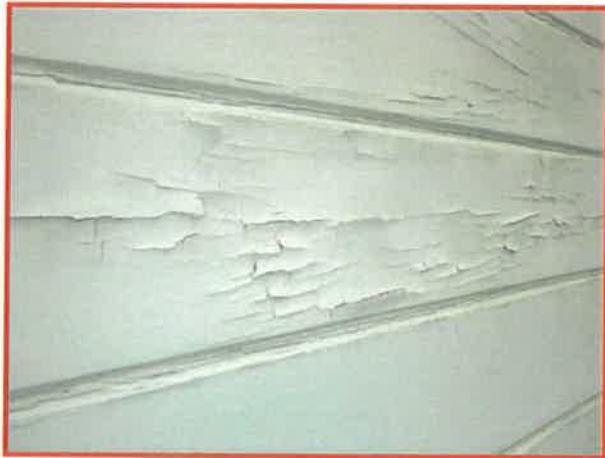
Example of Deteriorating Wood Siding

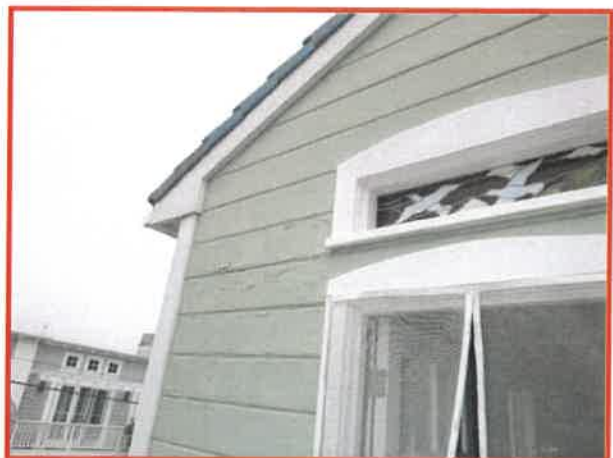
Example of Deteriorating Wood Siding

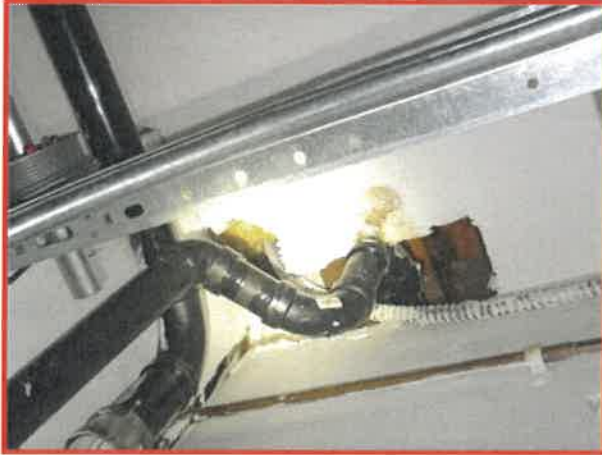
Breach in Fire Barrier in Garage

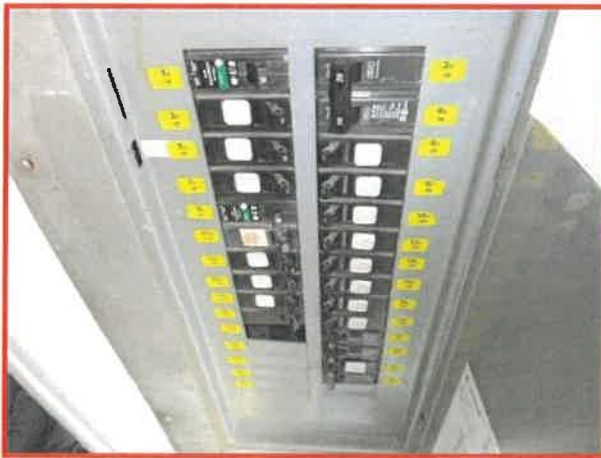
Sub Panel with Open Knockout

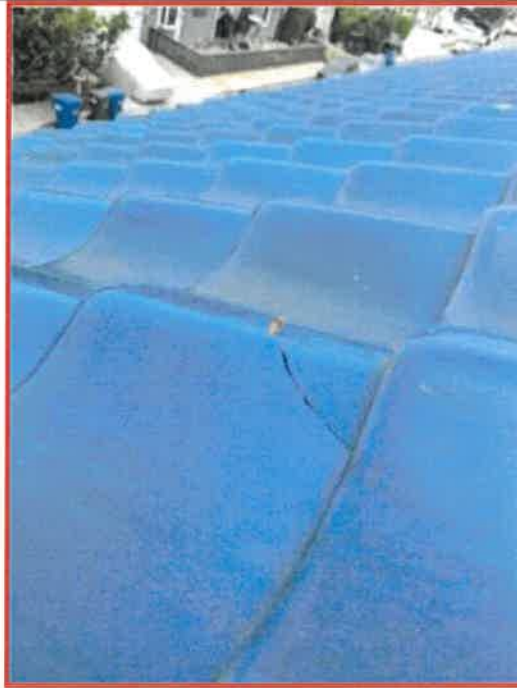
Broken and slid tiles were observed throughout the roof surface. A missing tile was observed at the ridge cap. Exposed nails were observed over entire stretch of ridge cap tiles and throughout the roof. The cap sheet is cracked and rotted plywood was observed at the underlayment throughout the roof. Also, wood rot was observed at the fascia.

Cracked Tile

Qualified contractor to repair / replace the broken / slid tiles, install tiles where missing, repair / seal the exposed nails, repair / replace the underlayment and plywood, and repair / replace the fascia.

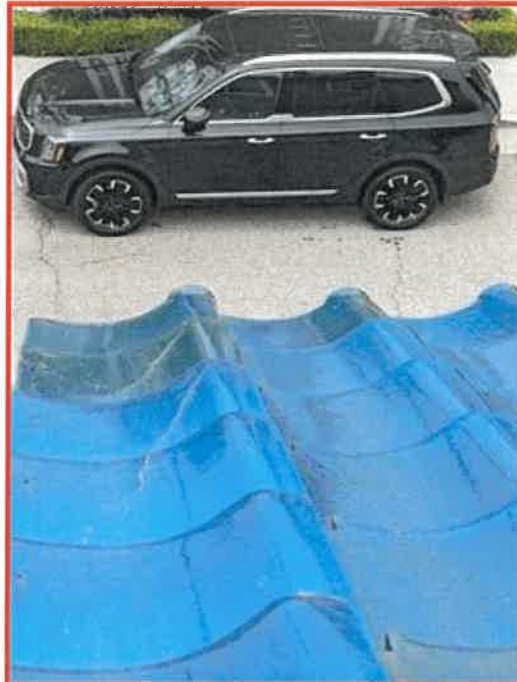
Shifted And Cracked Tile

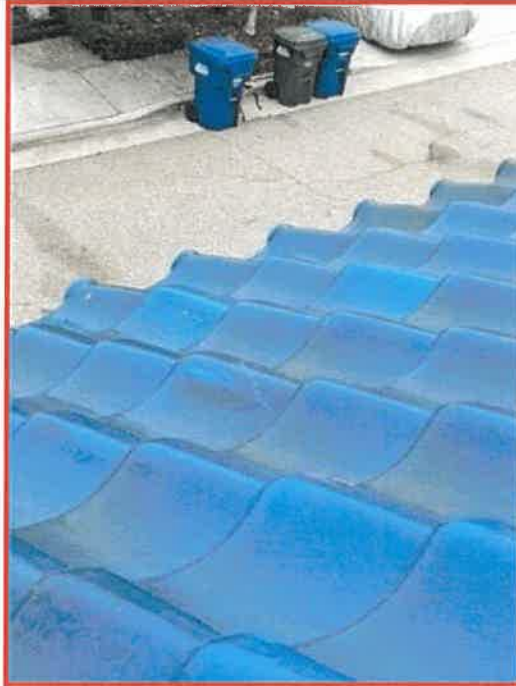
Cracked Tile

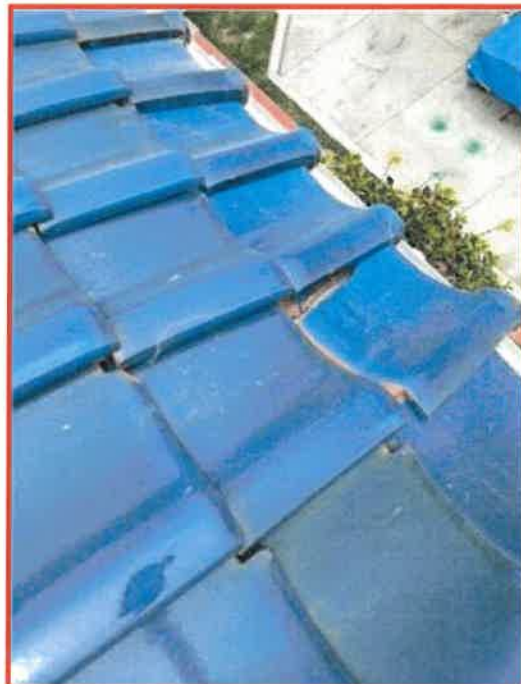
Broken / Slid Tile

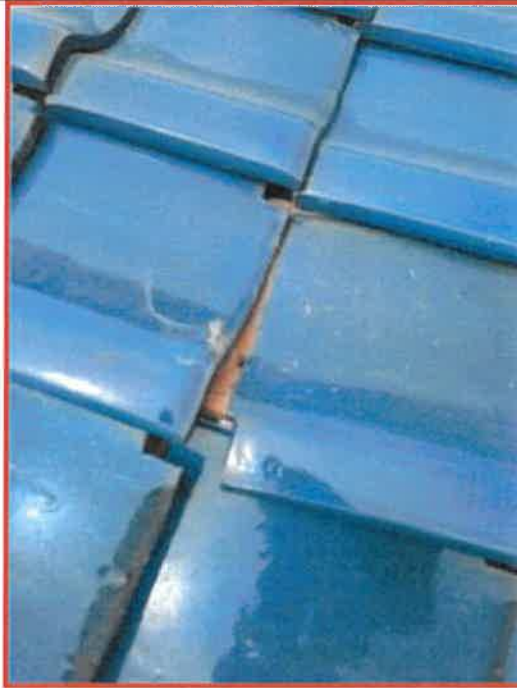
Slid Tile With Missing Nail

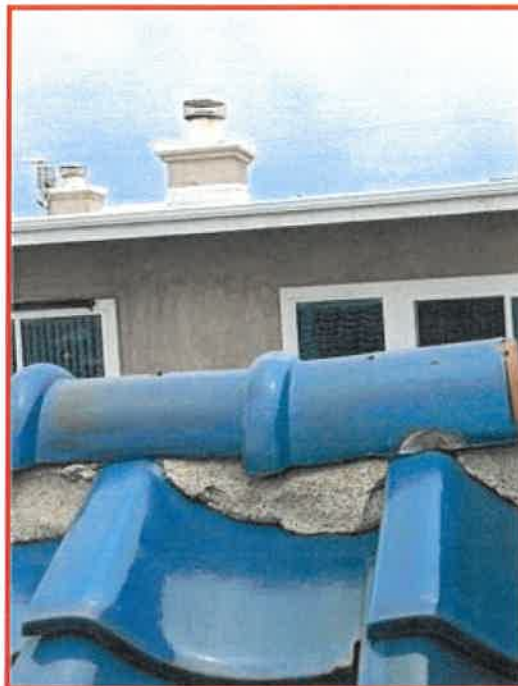
Popped Nails On Ridge Cap Tiles

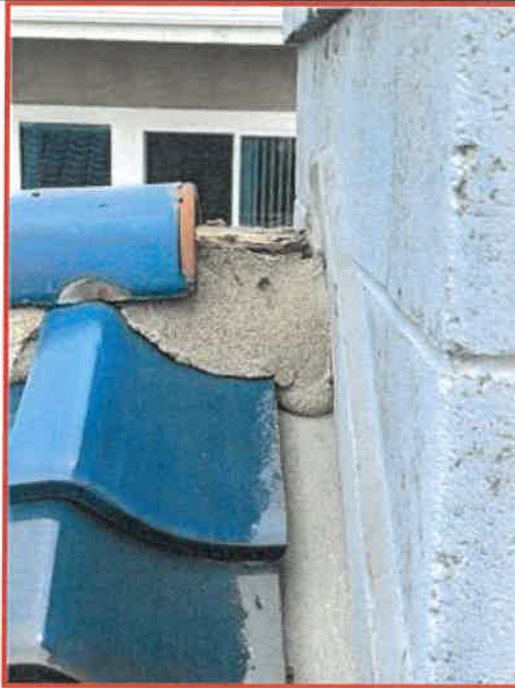
Missing Ridge Cap Tile

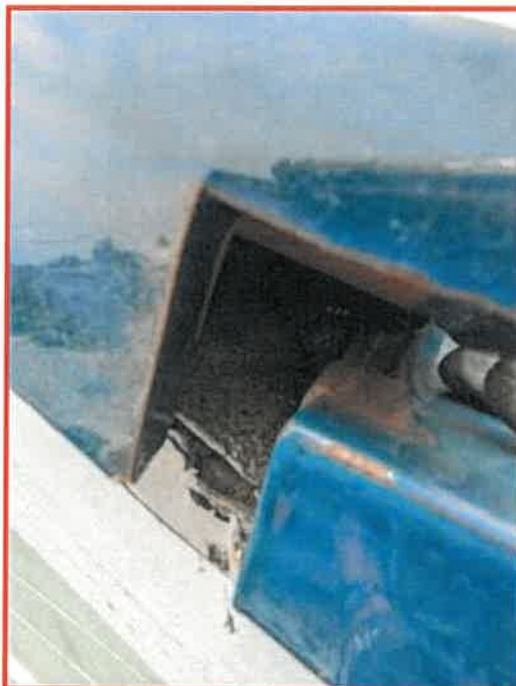
Popped Slid Rake Tile Exposing Capsheet Underlayment And Wood Rot Plywood

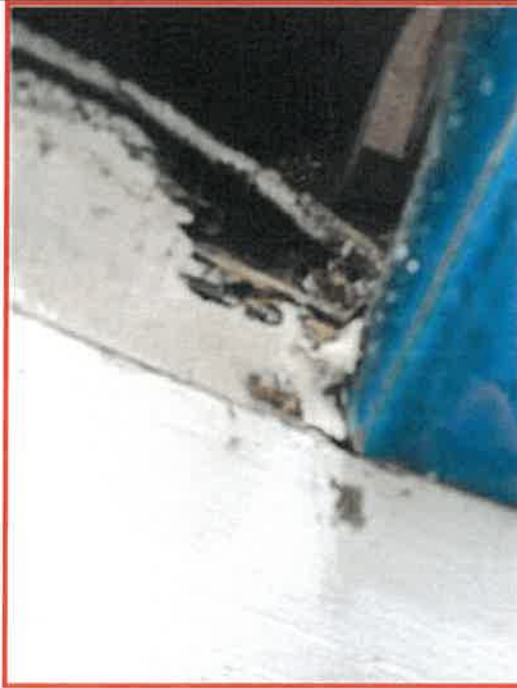
Wood Rot

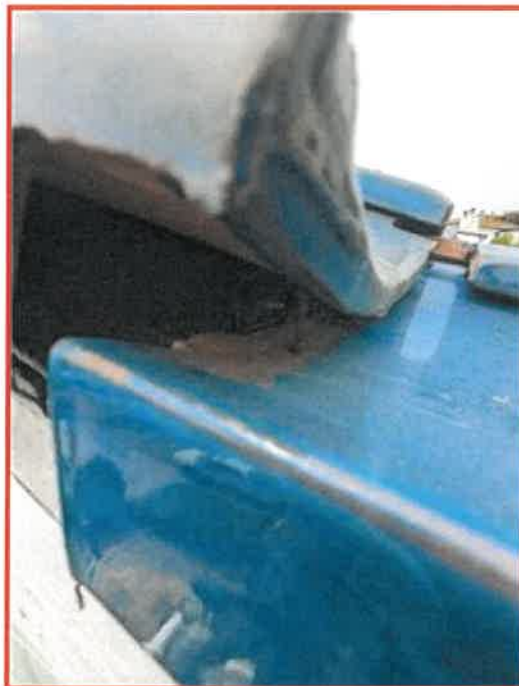
Popped Nail

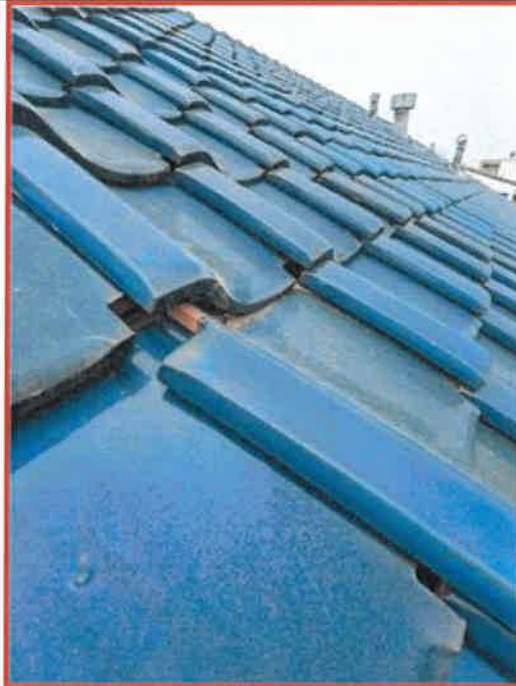
Slid Shifted Tiles

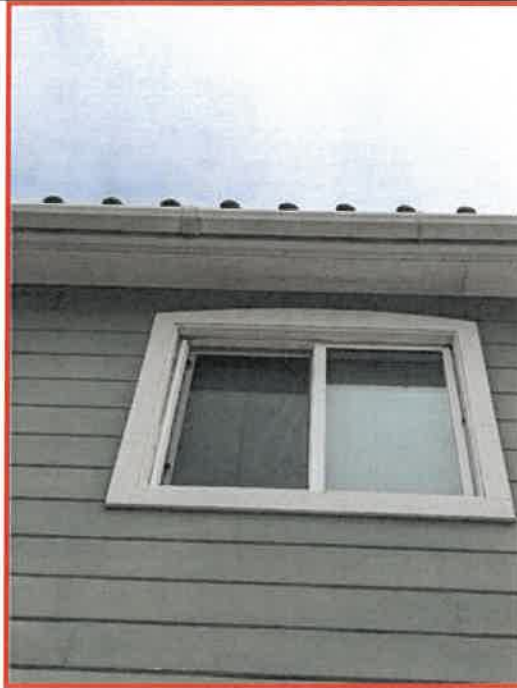
Wood Rot Shiplap And Fascia Board

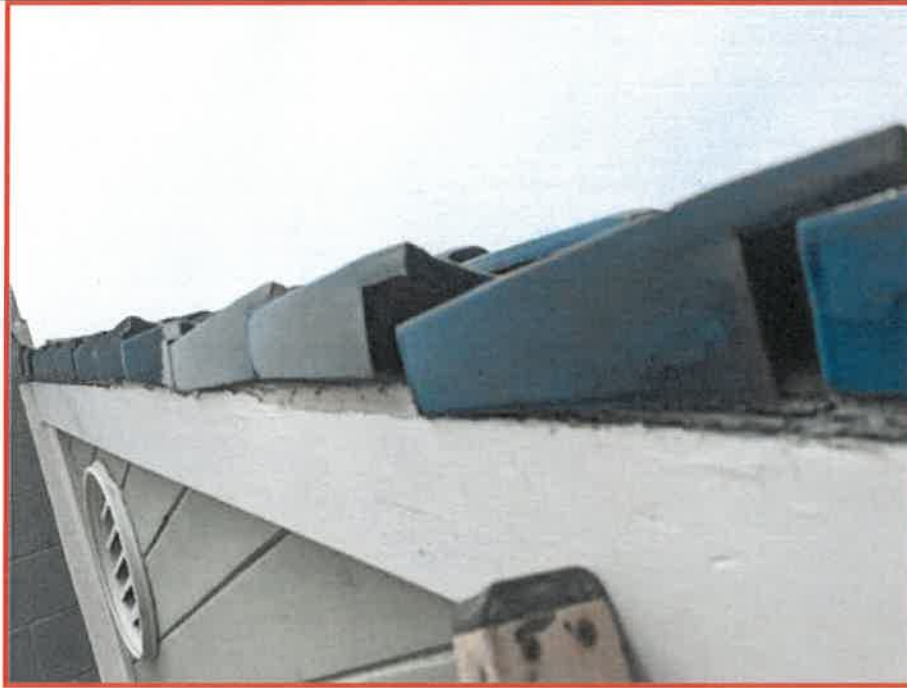
Slid Rake Tiles And Wood Rot At Fascia Board

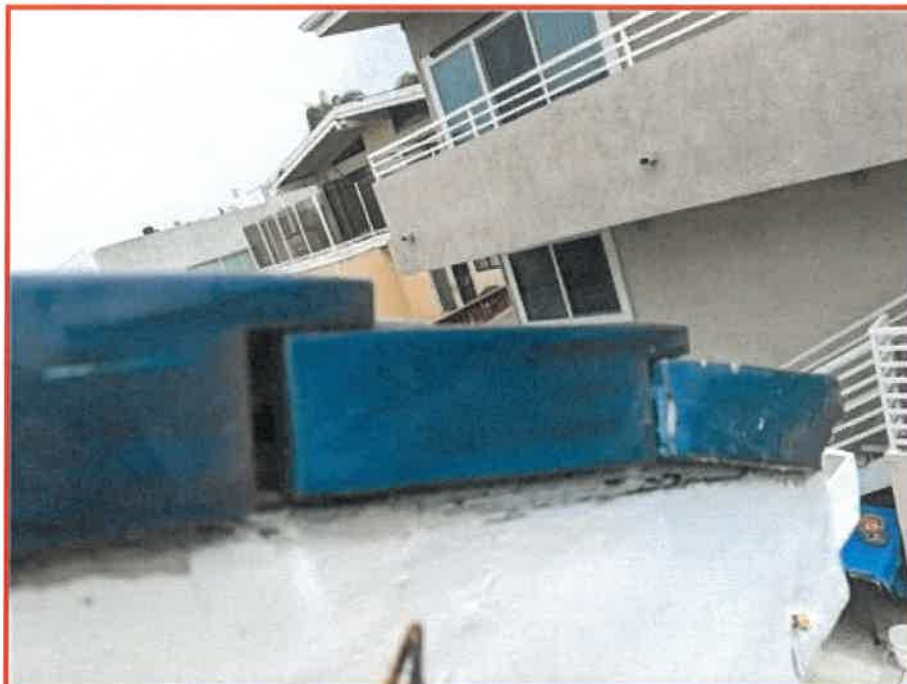
Slid Tile
