WOOD DESTROYING PESTS AND ORGANISMS INSPECTION REPORT

Building No. 1727	Street Dayton Rd	City Chico	ZIP 95928	Date of Inspection 06/11/2024	Number of Pages 6
----------------------	---------------------	---------------	--------------	----------------------------------	----------------------

Report # : 41835
Registration # : PR3779
Escrow # :
 CORRECTED REPORT

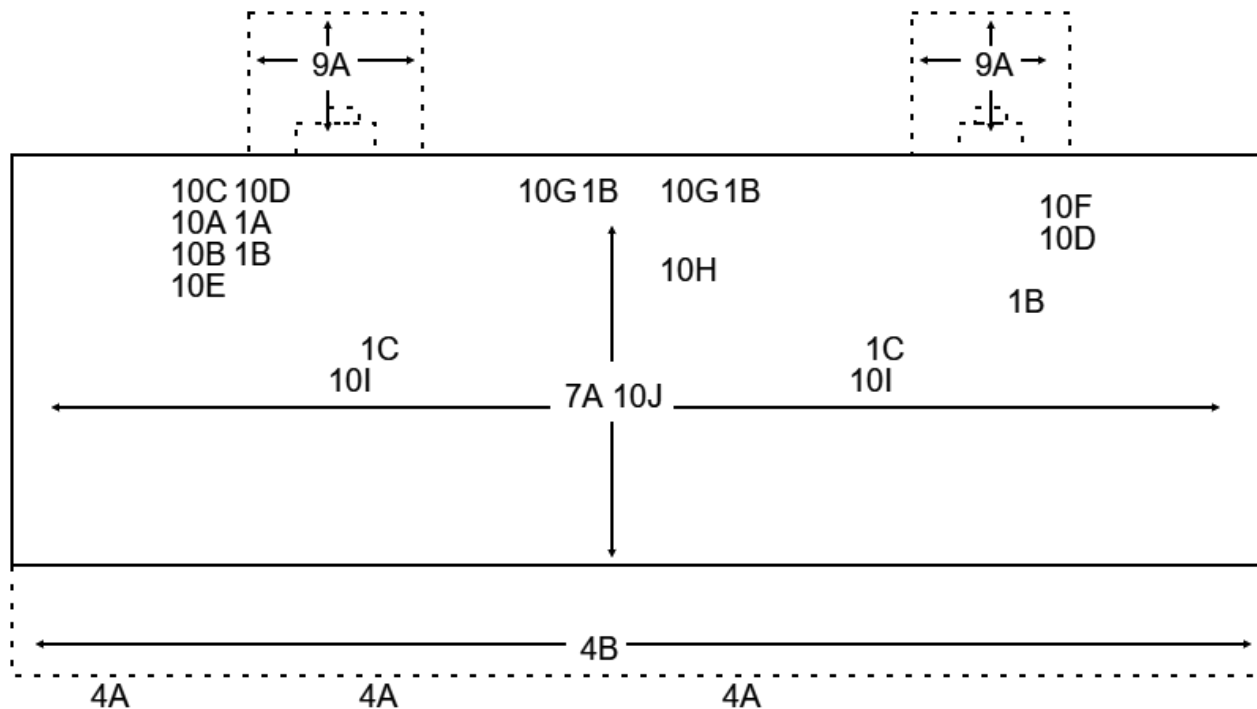
Diagram Not To Scale

FINDING - Toilet stools are loose at the bathroom locations indicated by "10D" on the diagram.

RECOMMENDATION - Re-set the toilet stools as needed.
