Covenant Home Inspection

Home Inspection Report

2113 Bristol Park Cir

Inspected on Thu, Apr 27 2023 at 12:00 PM

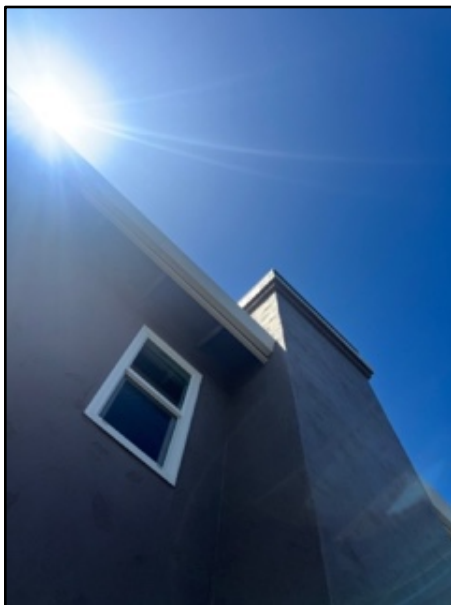
Figure 1-1

Wood trim has damage at areas. Recommend replace damaged wood member to prevent further deterioration.

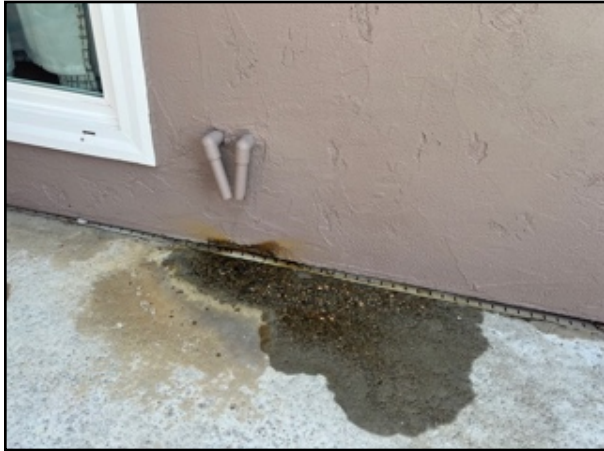
Figure 2-1

AC unit condensate line drippage has caused damage to the stucco. Recommend extending condensate line away from structure to prevent deterioration.

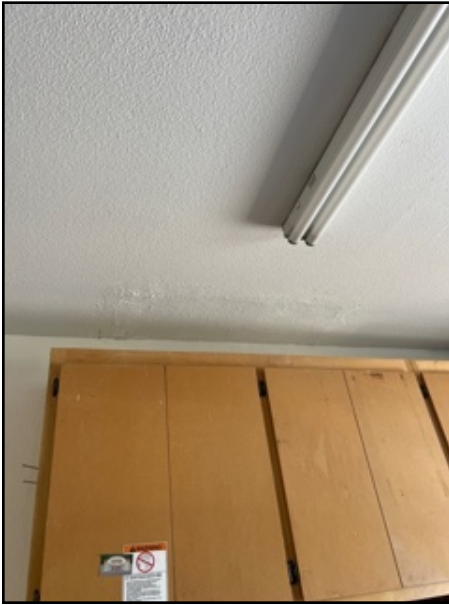
Figure 3-1

Patching noted at the garage ceiling. Recommend determine from homeowner if previous repairs have been done.

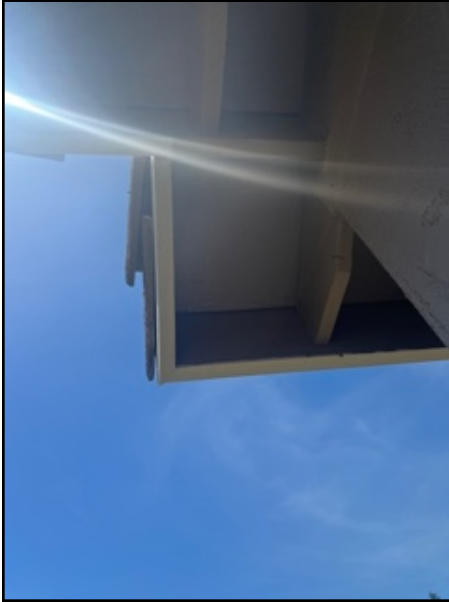
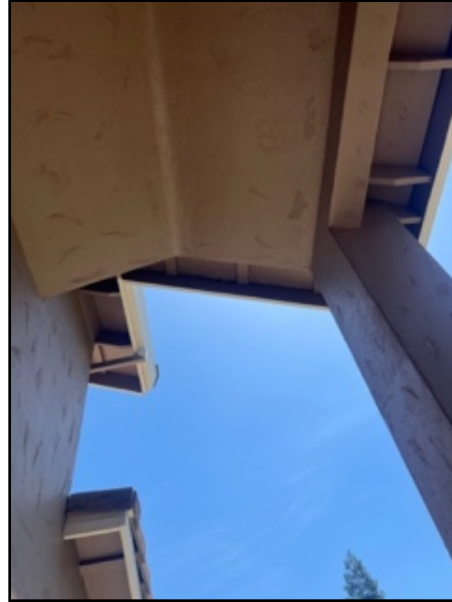
Roof sheathing at areas was damaged and needs correcting. Recommend repairs with proper installation.

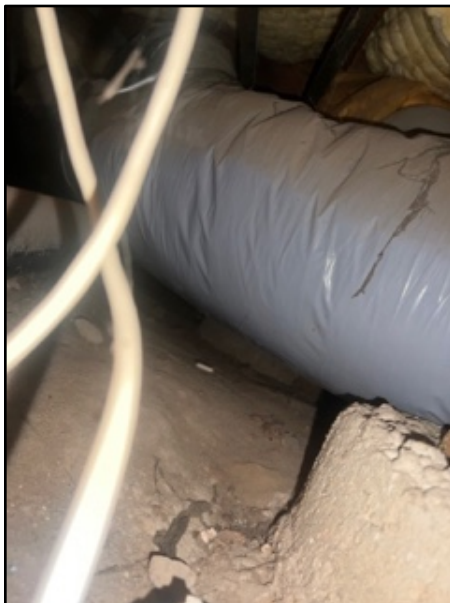
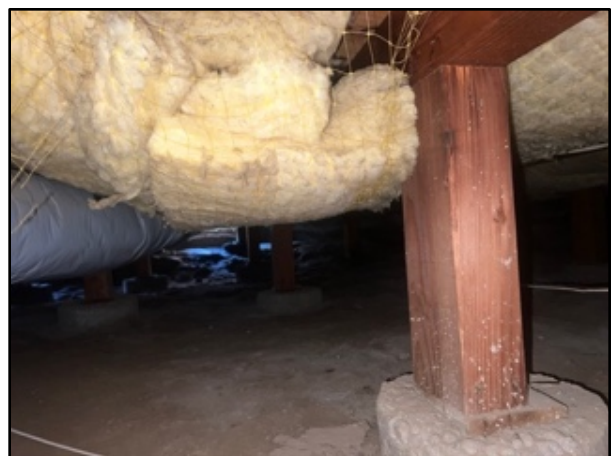
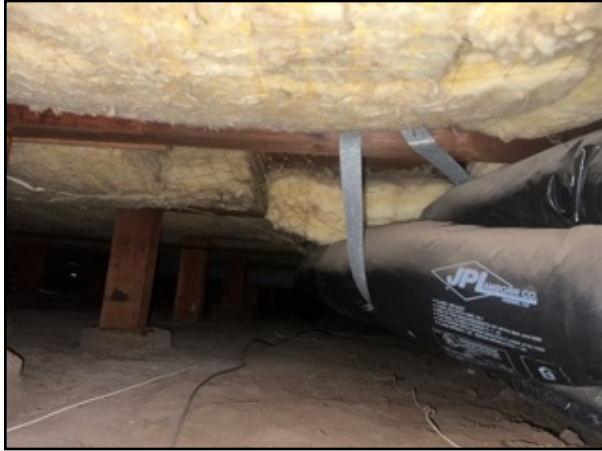
Comment 5:
Substructure area.

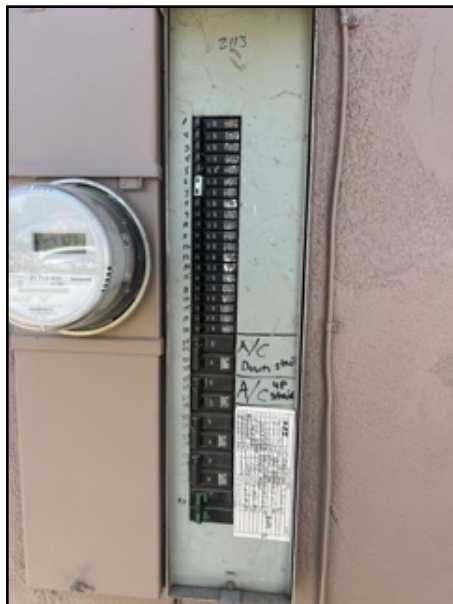
Figure 6-1

Comment 6:
Main Service Panel.

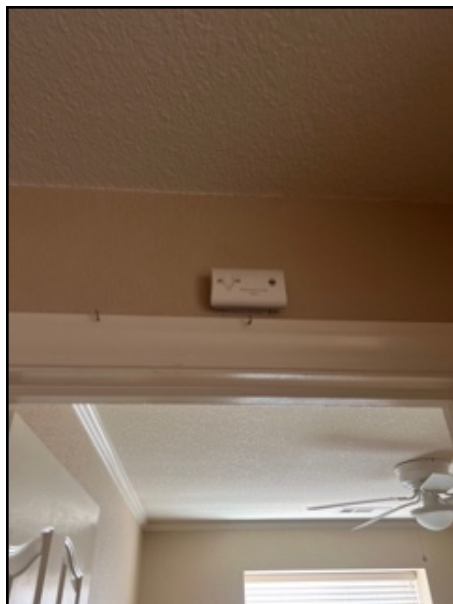
Figure 7-1

Comment 7:
Carbon monoxide detectors are recommend to be placed no higher than 3 feet from the ground for quickest detection.

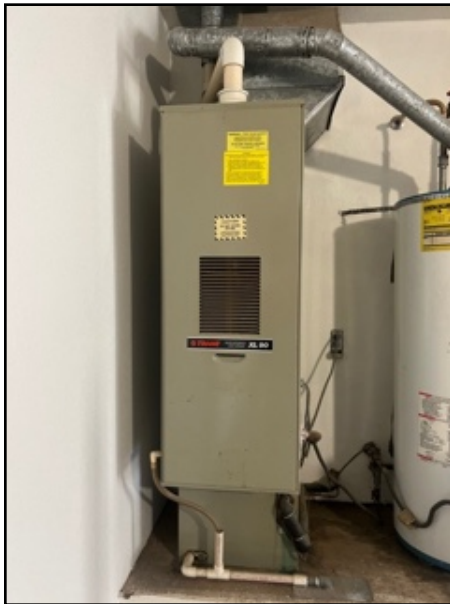
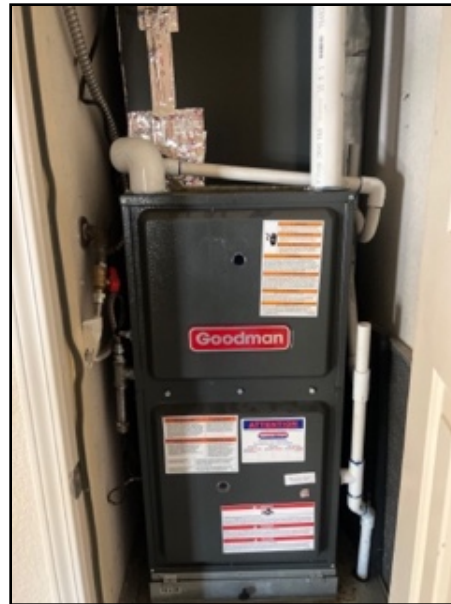
Comment 9:
Heating unit.

Furnaces over 10 years old should be checked, cleaned and serviced yearly by a licensed contractor.

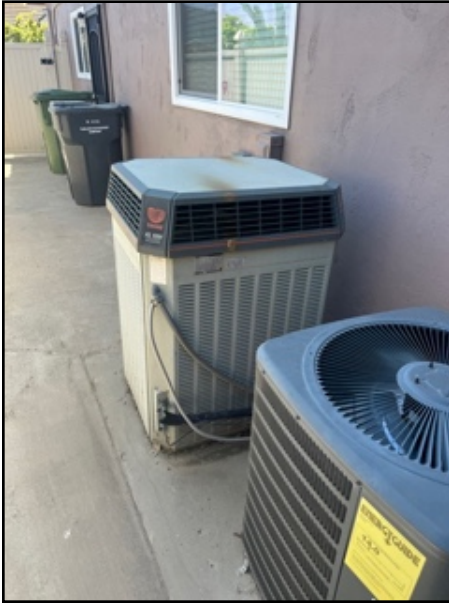
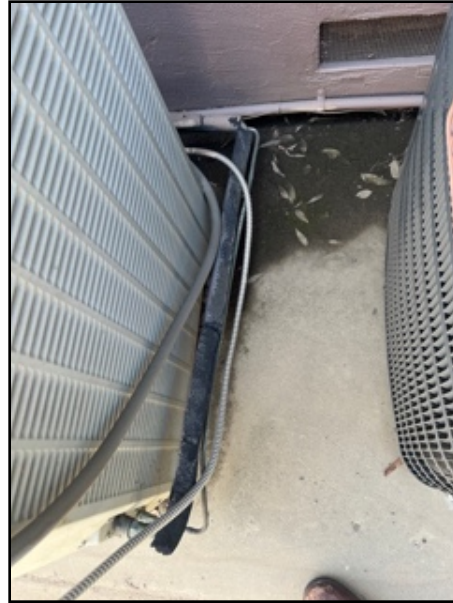
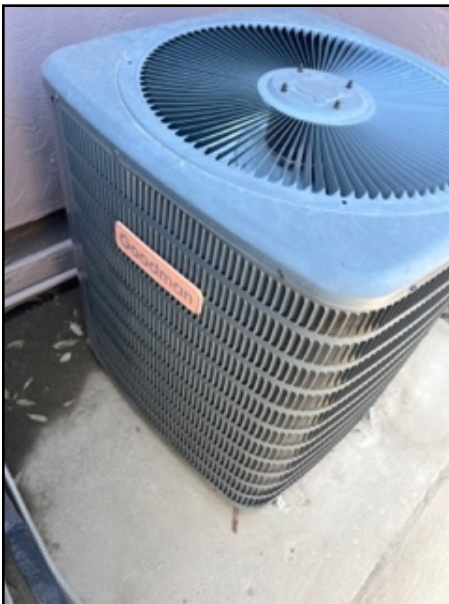
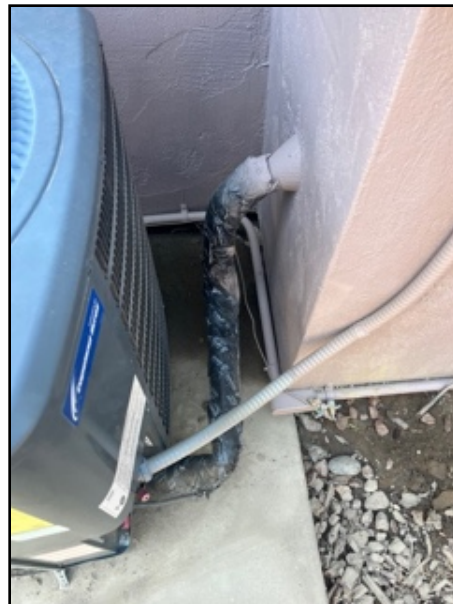
Comment 10:
Cooling unit.

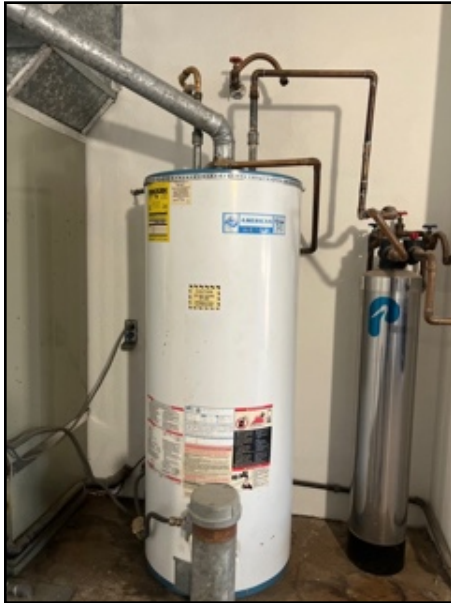
Figure 12-1

Water heater seismic straps should be located on the top one third and bottom one third of the unit. This is a safety issue. I recommended repair or replace as necessary.

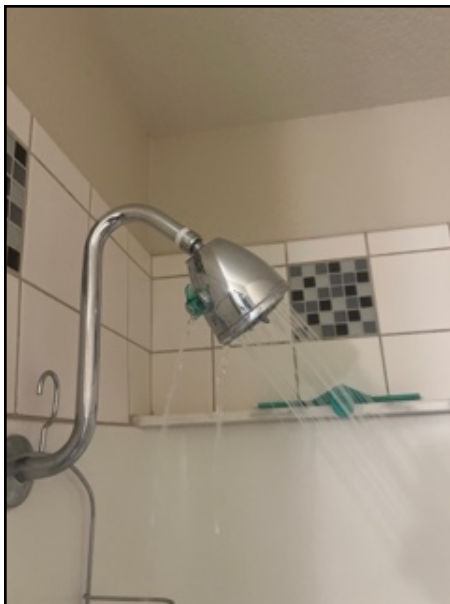
Figure 14-1

Active leak was noted at the shower head. Recommend repair as needed to prevent water damage/water waste.

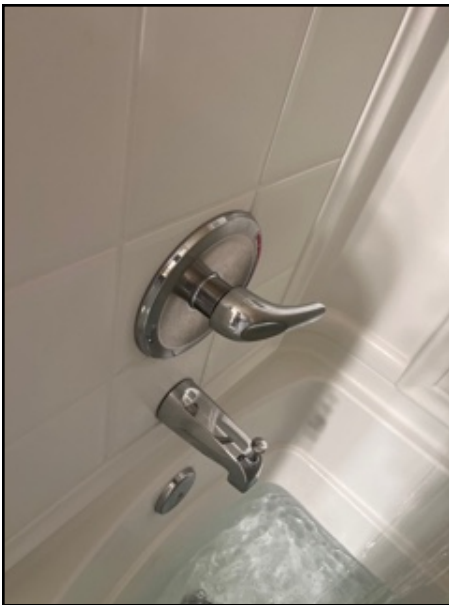
Figure 15-1

**Comment 15:**
Caulking was missing on plumbing fixtures at shower/tub wall. Recommend sealing to prevent water intrusion.

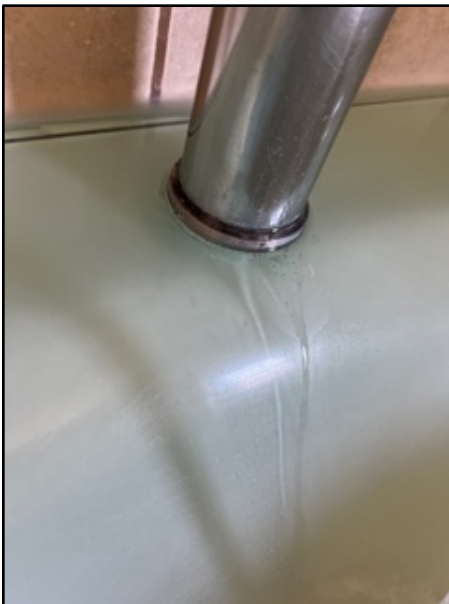
Figure 16-1

Active leak was noted at the right side sink faucet. Recommend repairing for proper drainage and prevent water waste.

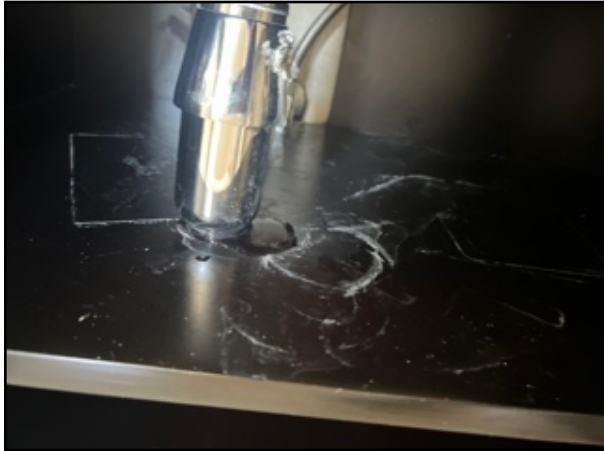
Figure 17-1

Active leak was noted at under sink plumbing. Recommend repairing to prevent further water damage .

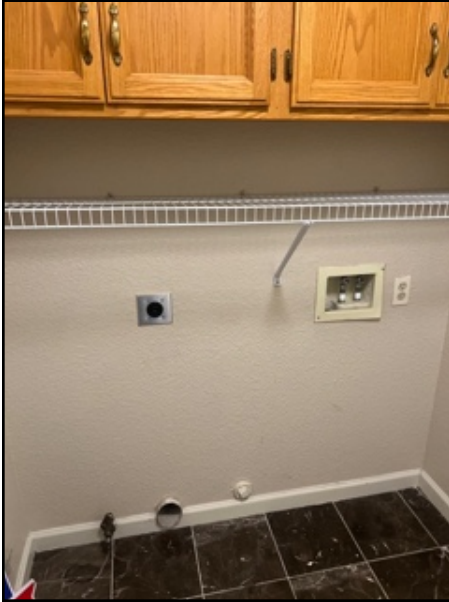
Figure 18-1

i Comment 18:
Laundry hooks ups sufficient at time of inspection. 220v electric connection present.

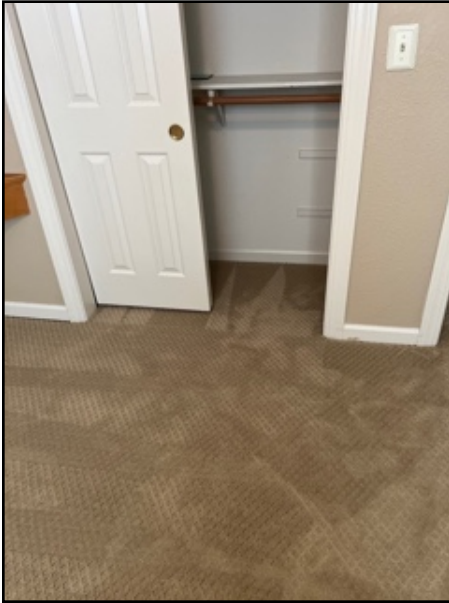
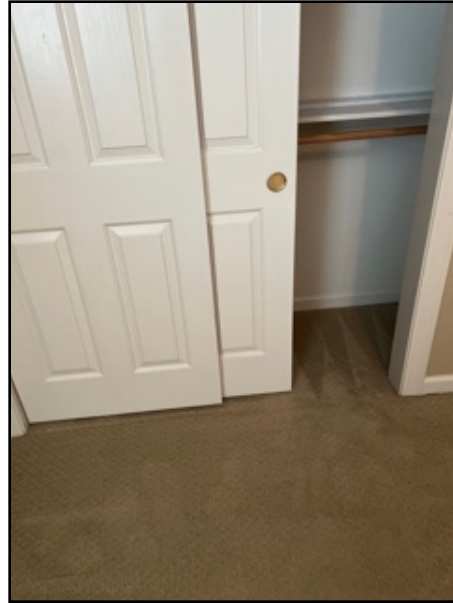
Closet door tracks were missing. Recommend installing to ensure proper function.

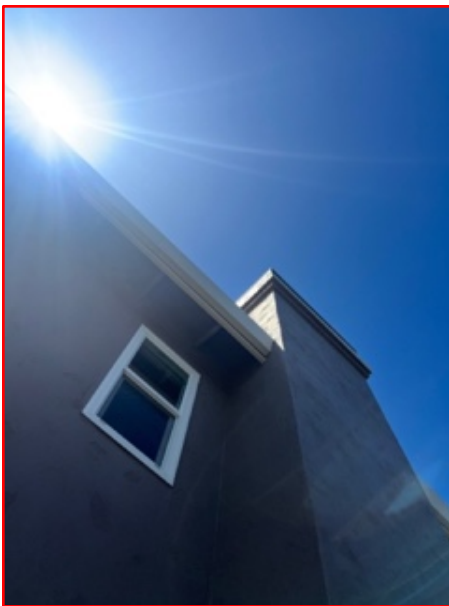
Figure 1-1

1) Wood trim has damage at areas. Recommend replace damaged wood member to prevent further deterioration.

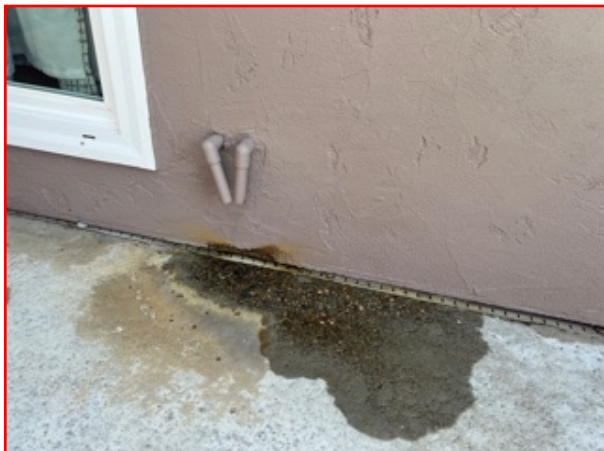
Figure 2-1

2) AC unit condensate line drippage has caused damage to the stucco. Recommend extending condensate line away from structure to prevent deterioration.

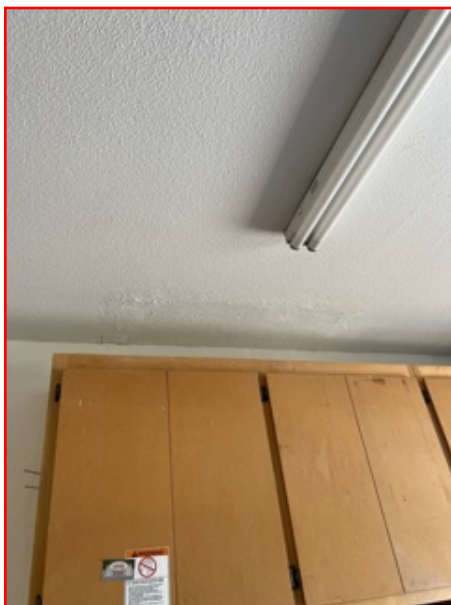
Figure 3-1

3) Patching noted at the garage ceiling. Recommend determine from homeowner if previous repairs have been done.

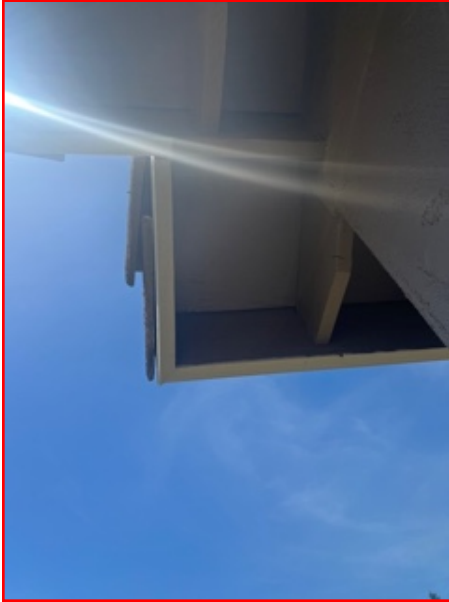
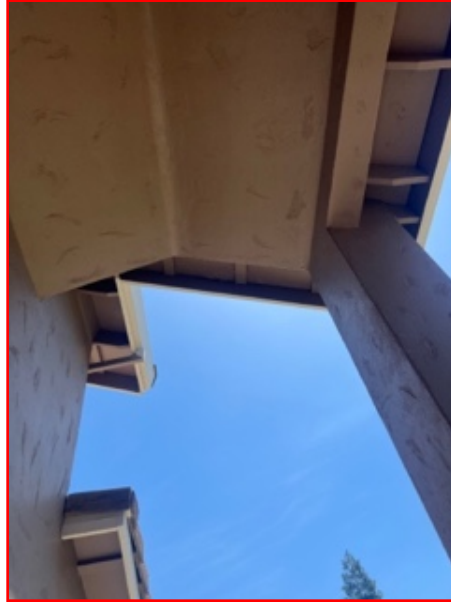
4) Roof sheathing at areas was damaged and needs correcting. Recommend repairs with proper installation.

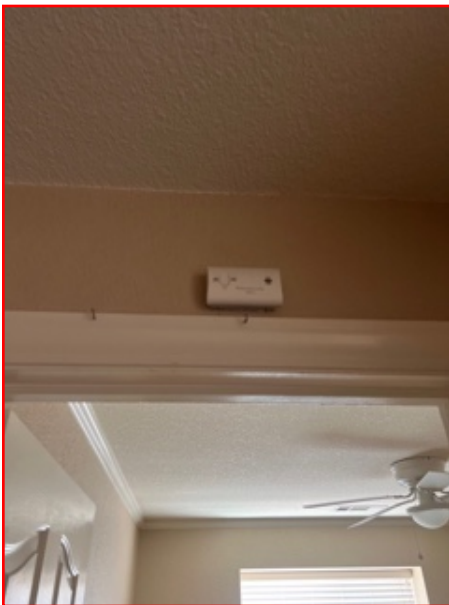
Figure 7-1

5) Carbon monoxide detectors are recommend to be placed no higher than 3 feet from the ground for quickest detection.

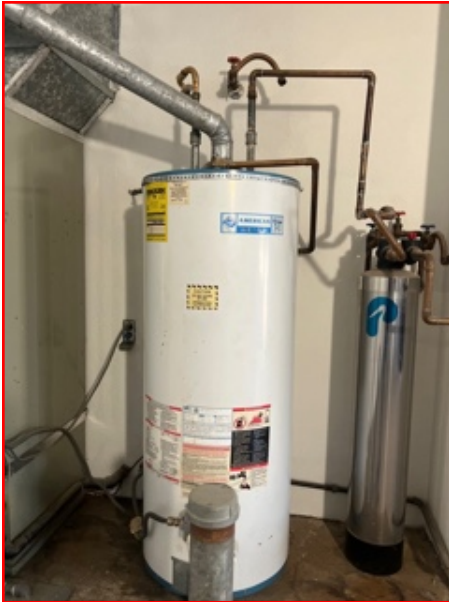
Figure 12-1

8) Water heater seismic straps should be located on the top one third and bottom one third of the unit. This is a safety issue. I recommended repair or replace as necessary.

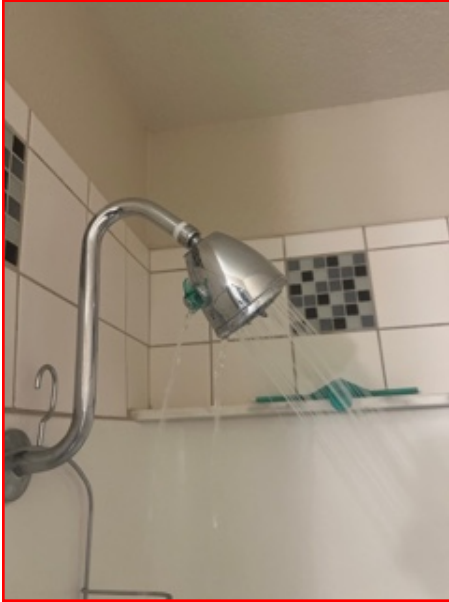
Figure 14-1

10) Active leak was noted at the shower head. Recommend repair as needed to prevent water damage/water waste.

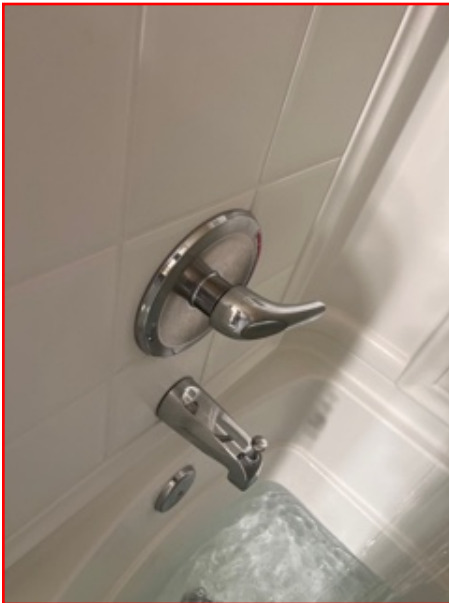
Figure 15-1

11) Caulking was missing on plumbing fixtures at shower/tub wall. Recommend sealing to prevent water intrusion.

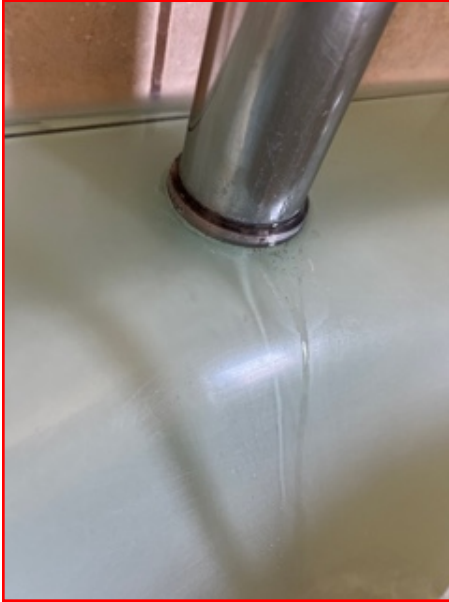
Figure 16-1

12) Active leak was noted at the right side sink faucet. Recommend repairing for proper drainage and prevent water waste.

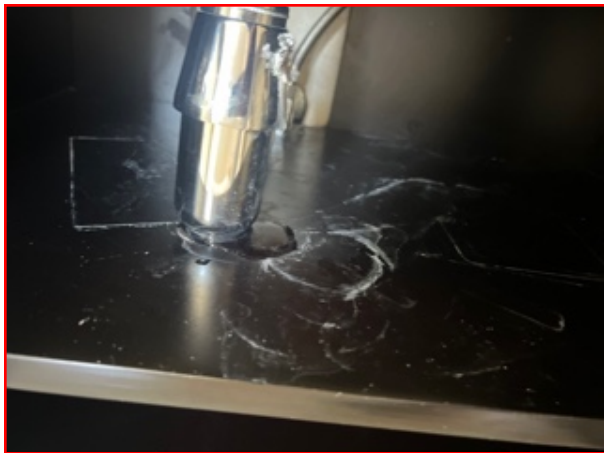
Figure 17-1

13) Active leak was noted at under sink plumbing. Recommend repairing to prevent further water damage .

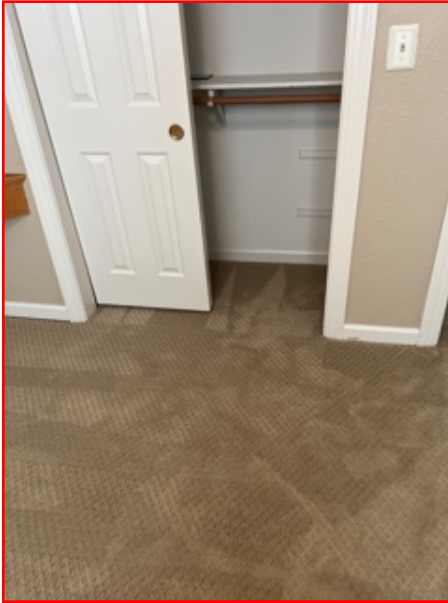
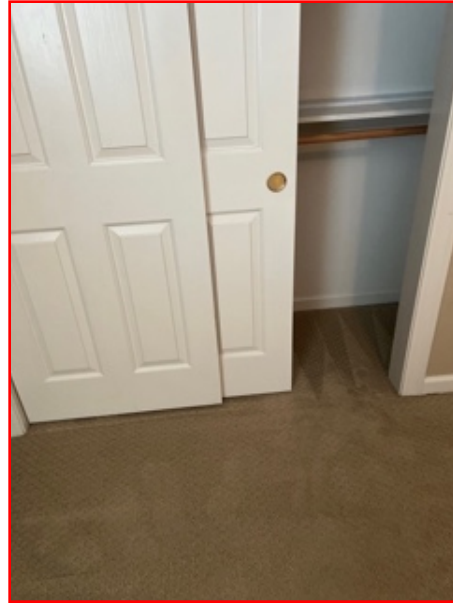
14) Closet door tracks were missing. Recommend installing to ensure proper function.
