March 4, 2025

F.N. 3-25-0110

Subject: Structural Inspection of Single-Family Residence Foundation  
1212 Granvia Altamira, Palos Verdes Estates, CA 90274

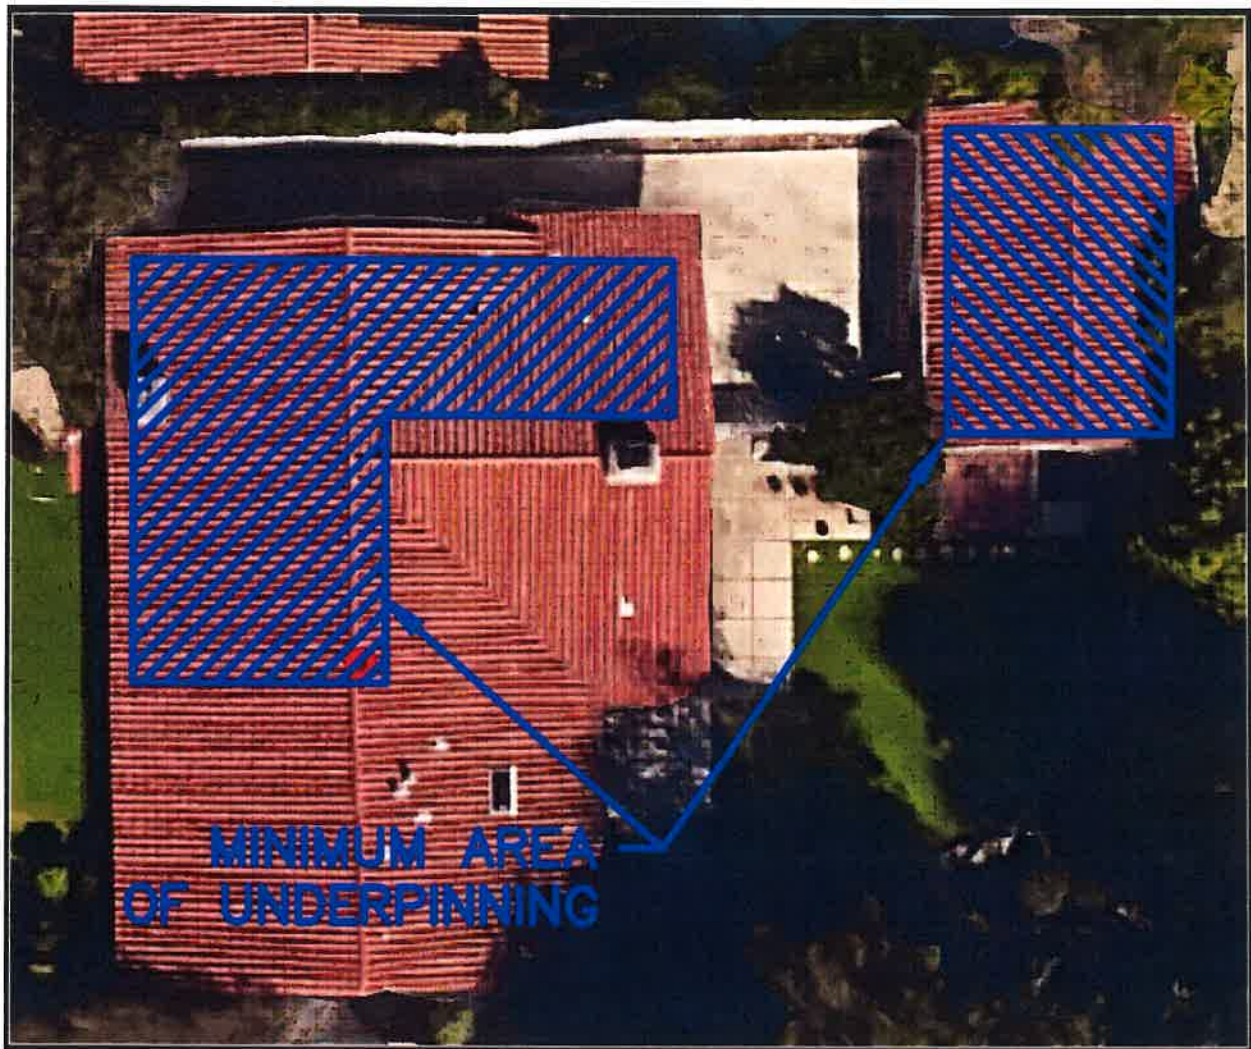
The proper method for this type of repair is to perform a manometer survey of the interior floor surfaces to determine the extent of unevenness around the residence. This manometer survey will help provide information as to how much of the house and garage needs to be underpinned. The next step in the repair process would be to contact a geotechnical engineer to provide a soils report for the repair of the foundations. This soils report will tell the structural engineer how to design the foundations and what type of foundation will work for this property. The two types of foundation repair would be either a caisson and grade beam system, or a deepened trench footing. The former is used when bedrock/good soil is much lower than grade. Deepened trench footings are used when bedrock/good soil is closer to grade. The south side of the residence exhibited minimal signs of foundation movement versus the north side so the assumption would be that trenched footings can be used (this will need to be verified with a soils report for permitting purposes). Assumed trenched footing information can be estimated to be 3-4 feet wide x 6 feet deep with 4-ton sacrificial jacks at 48 inches on center. The footing will require approximately 8 - #5 bars to adequately reinforce the footing. The deepened trench footings will also need to have dowels be epoxy injected into the existing footing for a positive connection. Underpinning the house will require removing the exterior hardscape/planters/porch around the house. The driveway, planters, and porch will need to be reinstalled after the repairs are performed. Below is a marked-up plan view of the property and the extent of underpinning assumed to be required.

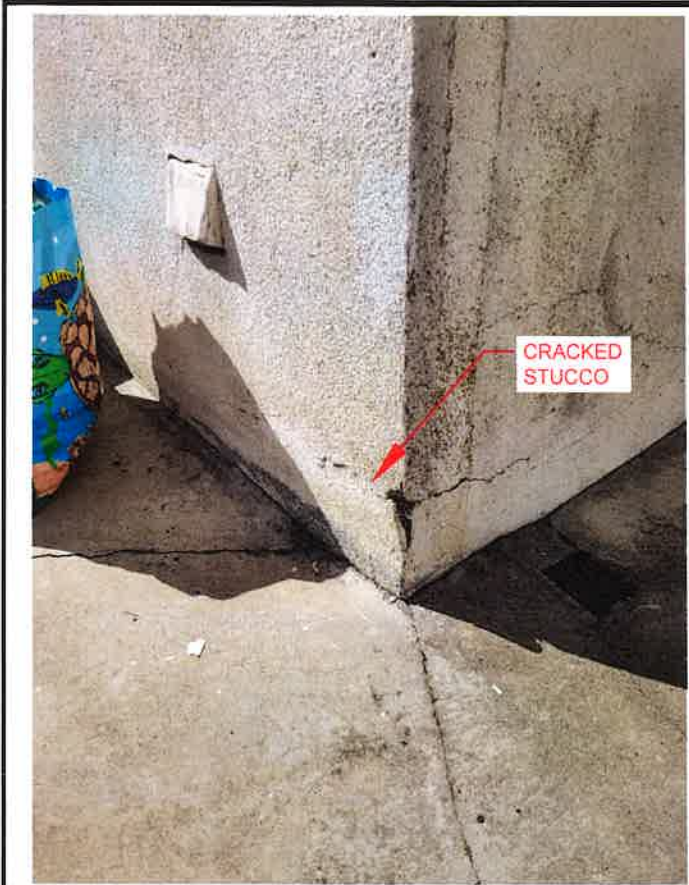
Picture 85

- The stucco was found to be cracked in various location around the perimeter of the residence. These cracks occur due to similar reasons as the drywall/plaster.

CRACKED STUCCO

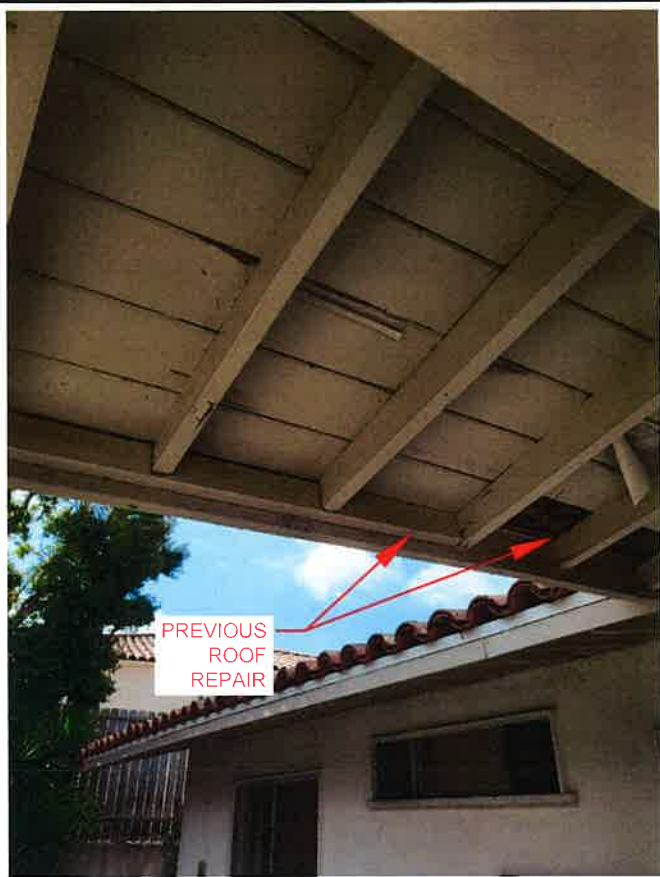
Picture 87

- The house and garage roof has been patched and repaired in the past. There are still signs of wood rot and other damaged wood members in the eaves.
  - o Palos Verdes Estates used to prefer the look of concealed roof gutters where the gutter was hidden behind the fascia board. This led to water damage issues from poor waterproofing and bad gutter connections.

PREVIOUS ROOF REPAIR

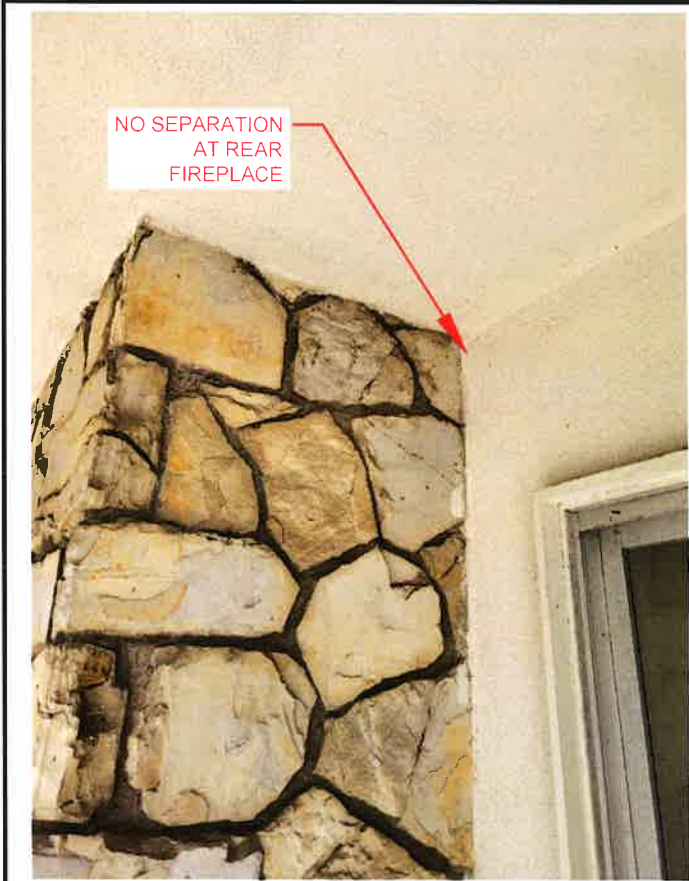
Picture 86

NO SEPARATION AT REAR FIREPLACE

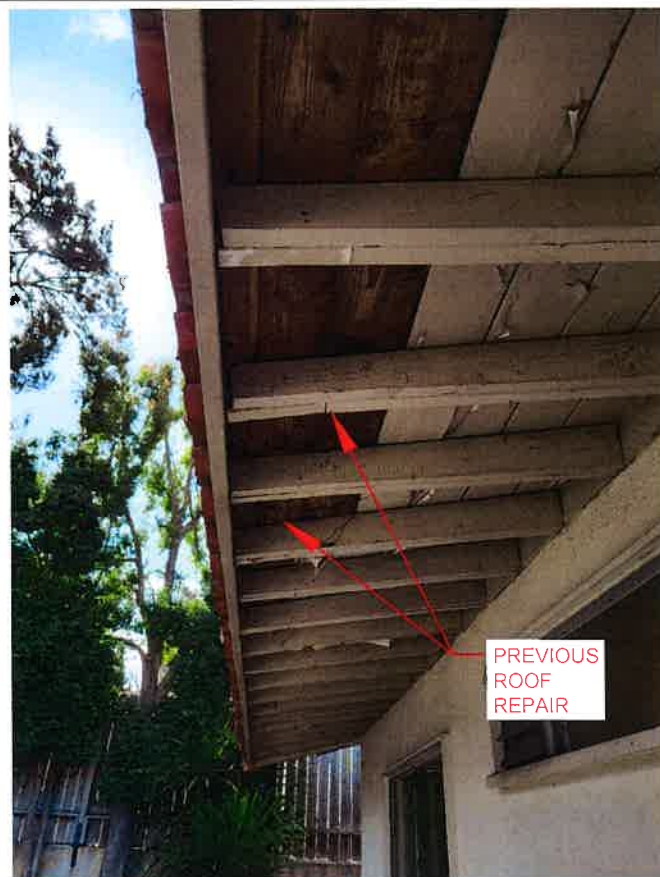
Picture 88

PREVIOUS ROOF REPAIR
