# Inspection Report

**Property Address:**  
813 & 813-1/2 Bayview Dr  
Manhattan Beach CA 90266

**Ferguson Home Inspections**

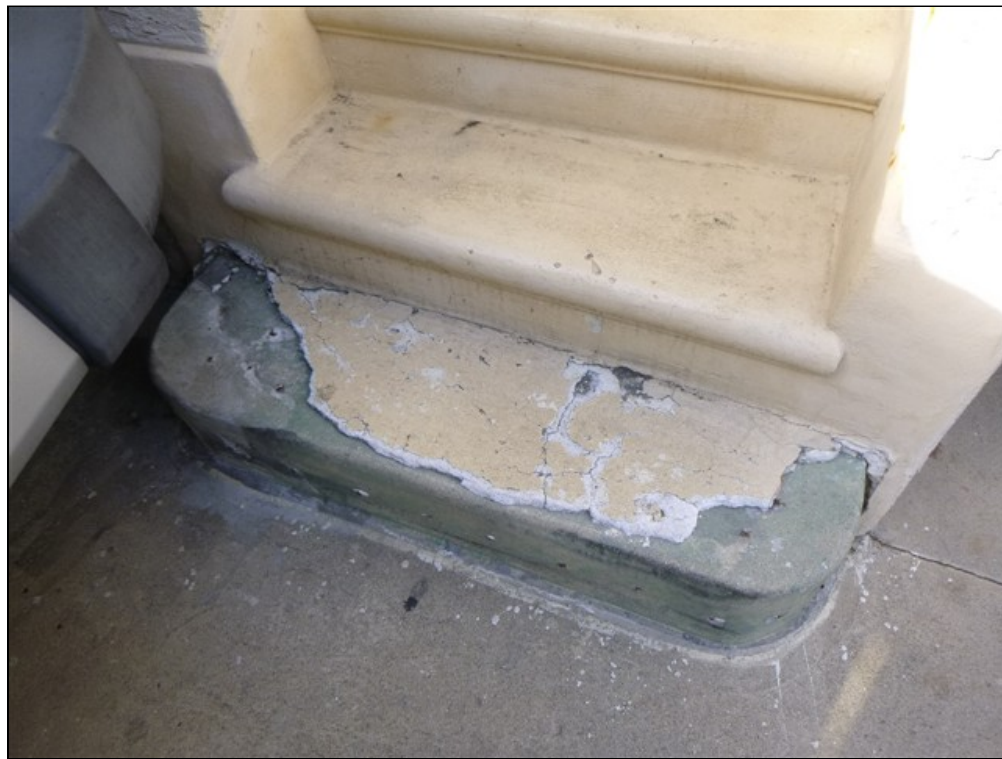
1.1 Item 1(Picture)

**1.1** (1) Surface cracking, patched and deteriorated areas noted at the stairs to the upper unit. Suggest review by a licensed decking contractor for any repair/sealing/replacement costs as needed to prevent future deterioration and possible leakage at this area.

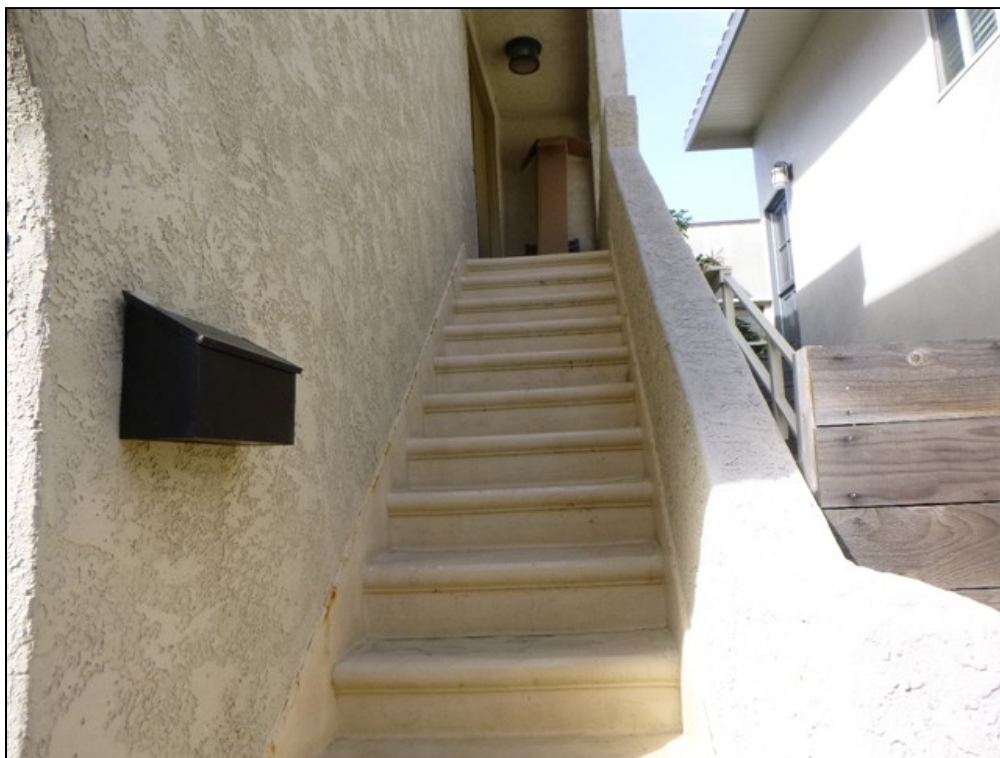
1.1 Item 2(Picture)

**1.1** (2) A potential safety/trip hazard was noted due to no graspable hand railing is currently installed at the stairs to the upper unit ( this is common for the original age of the dwelling ). Suggest review with a licensed contractor for costs to install a graspable hand railing if desired or concerned.

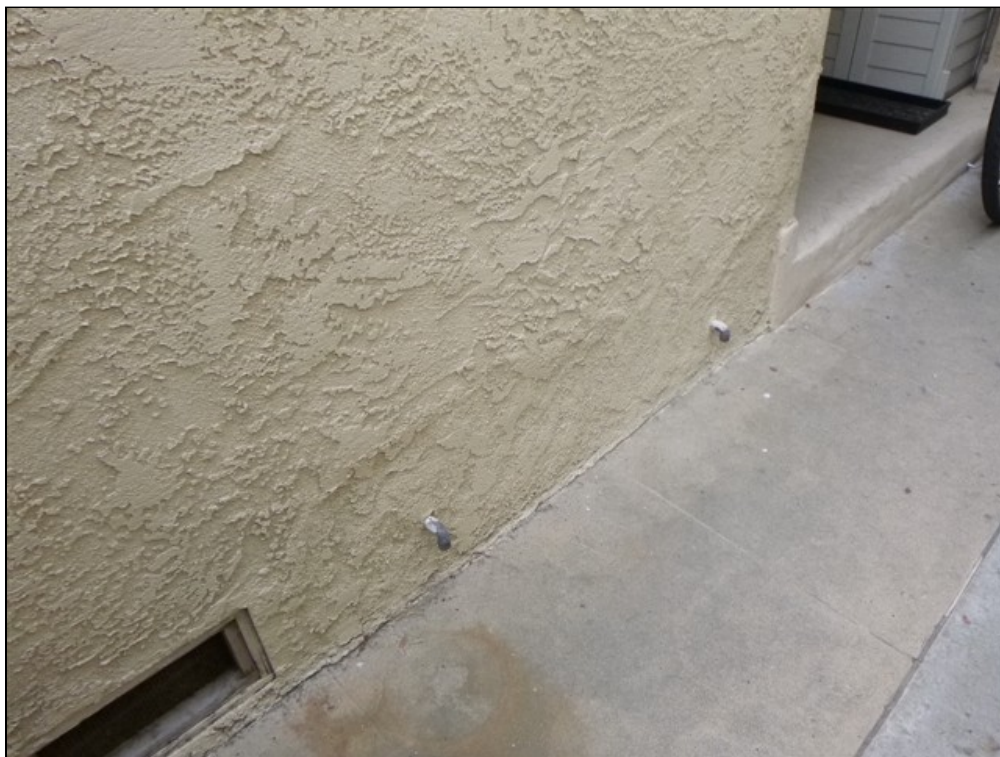
1.4 Item 1(Picture)

**1.4** (1) Various areas of the siding have been patched, suggest review with the seller on the cause and any repairs needed.

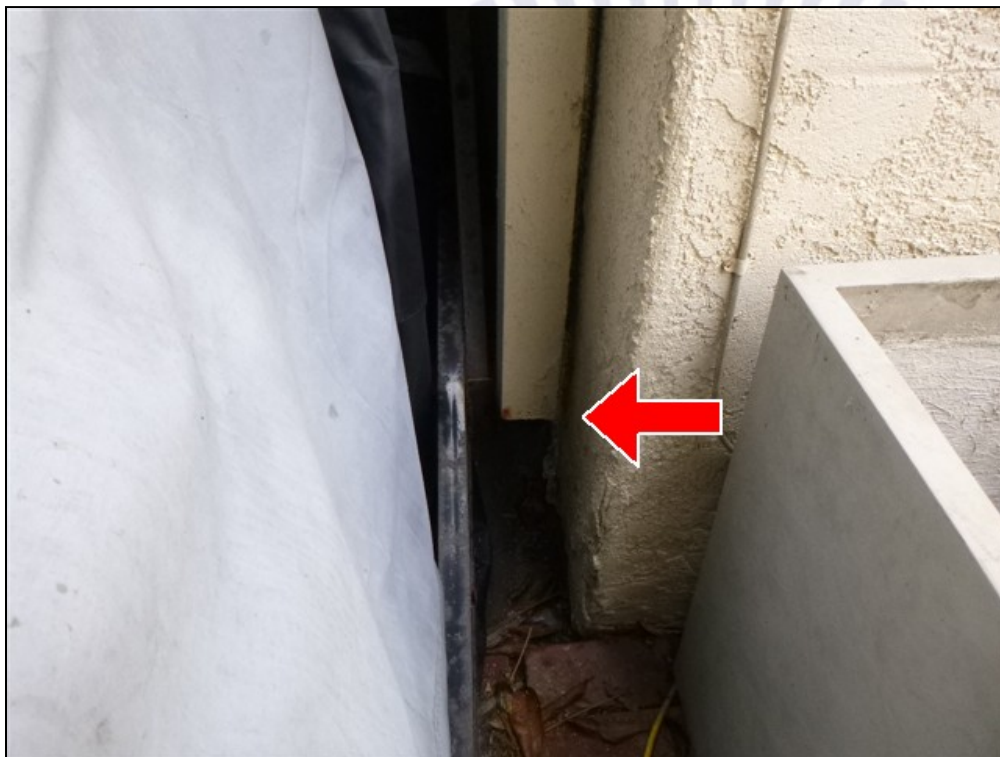
1.9 Item 1(Picture)

**1.9** Suggest review by a licensed contractor for possible installation of an area drainage system to divert drainage away from the foundation.

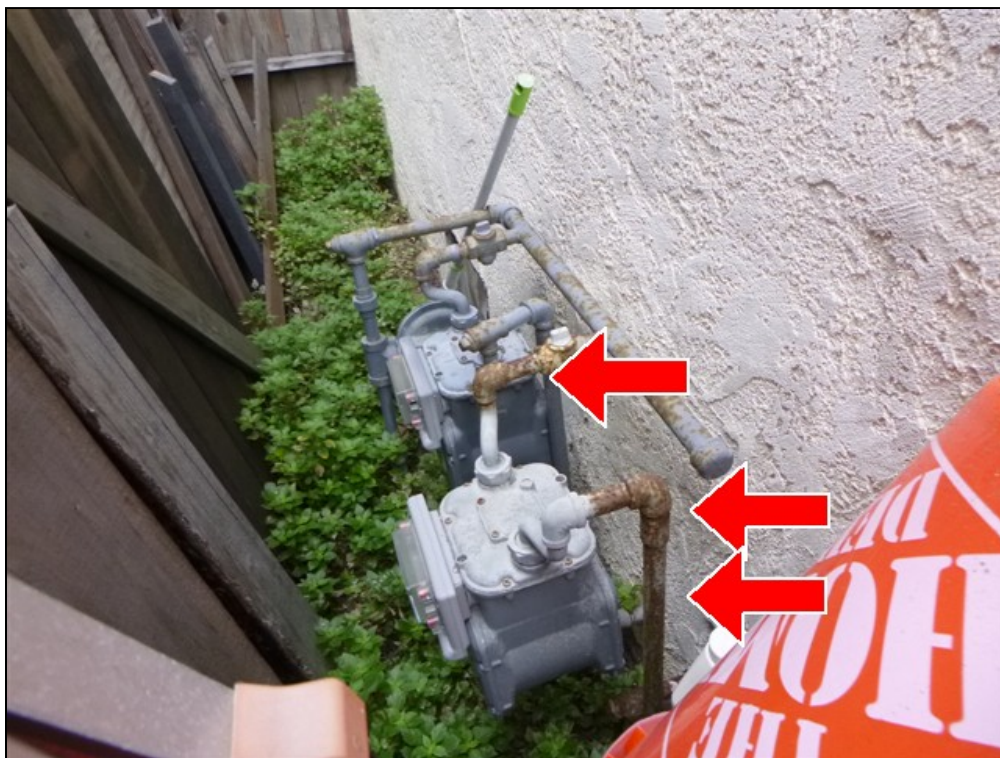
1.11 Item 2(Picture)

**1.11** (2) Excessive rust noted at the gas line at the gas meter area ( this is a potential safety hazard ). Suggest review with the gas company and/or a licensed plumber for any repair/replacement costs as needed.

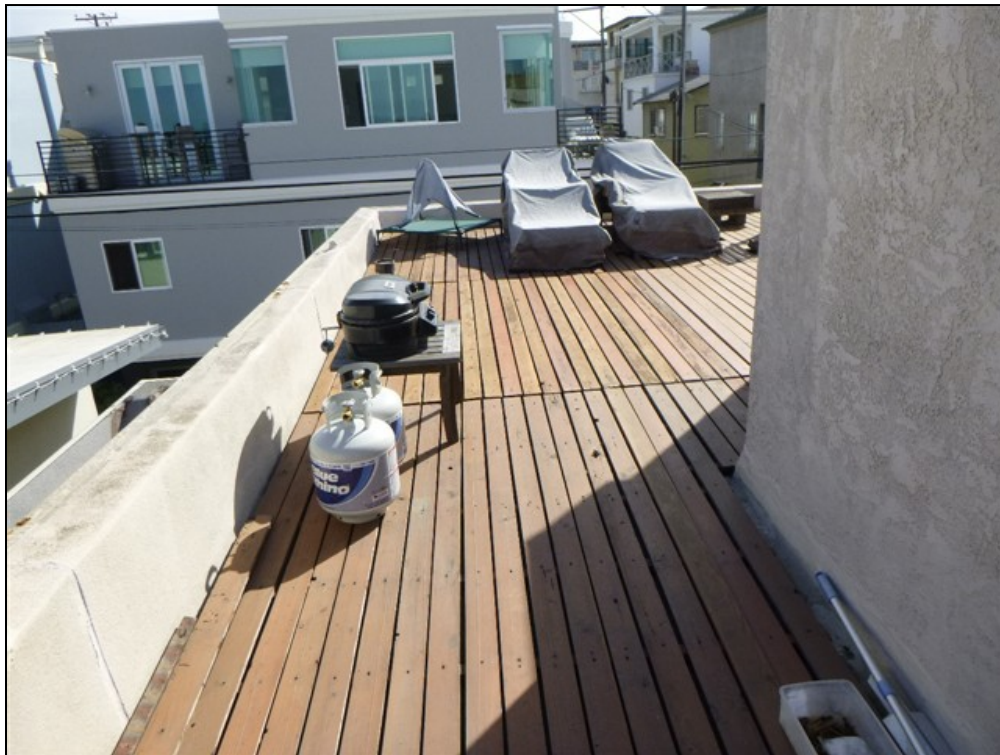
5.0 Item 1(Picture)

**5.0** (1) The roof covering is old and deteriorated. It is nearing the end of its useful life and the covering will need to be replaced. While it could last a year or so, some areas may need patching/repairs as leaks develop ( evidence of leakage to the interior was noted ). Please review with a licensed roofer to determine the remaining life expectancy and for costs to repair/remove and replace the existing roofing material as needed.

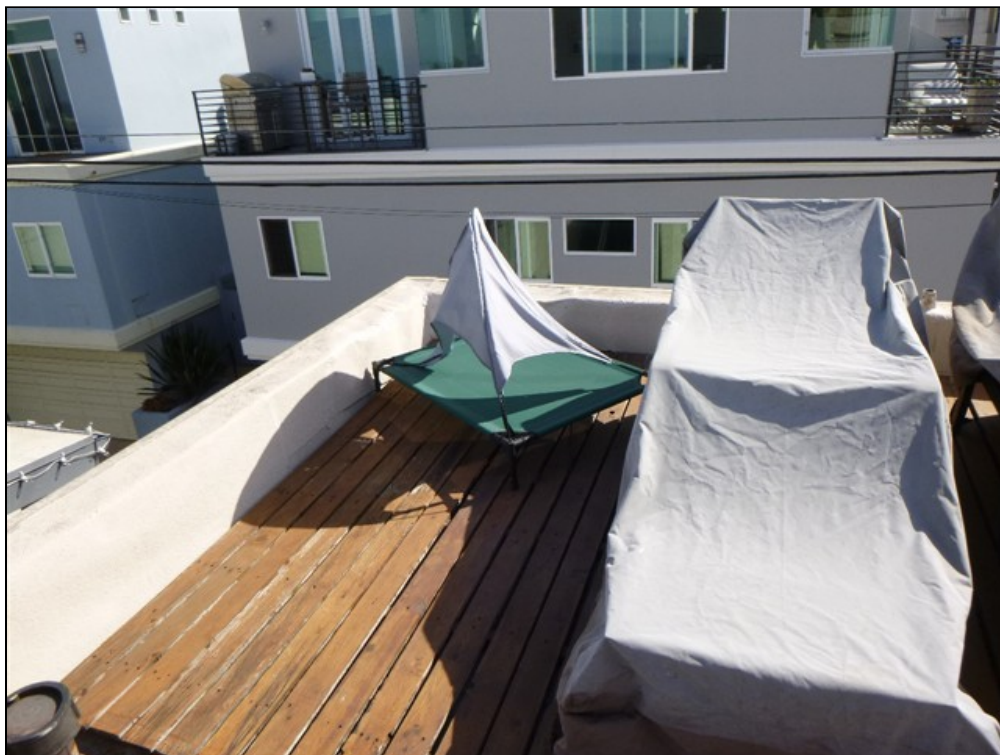
5.3 Item 2(Picture)

**5.3** (1) A potential fall/safety hazard was noted due to the additional wood decking over the roof but no handrailings are currently installed at the perimeter of the roof area ( excessive wood deterioration was noted at the wood decking ). Suggest review with a licensed contractor for any repair/removal/ replacement costs as needed for safety.

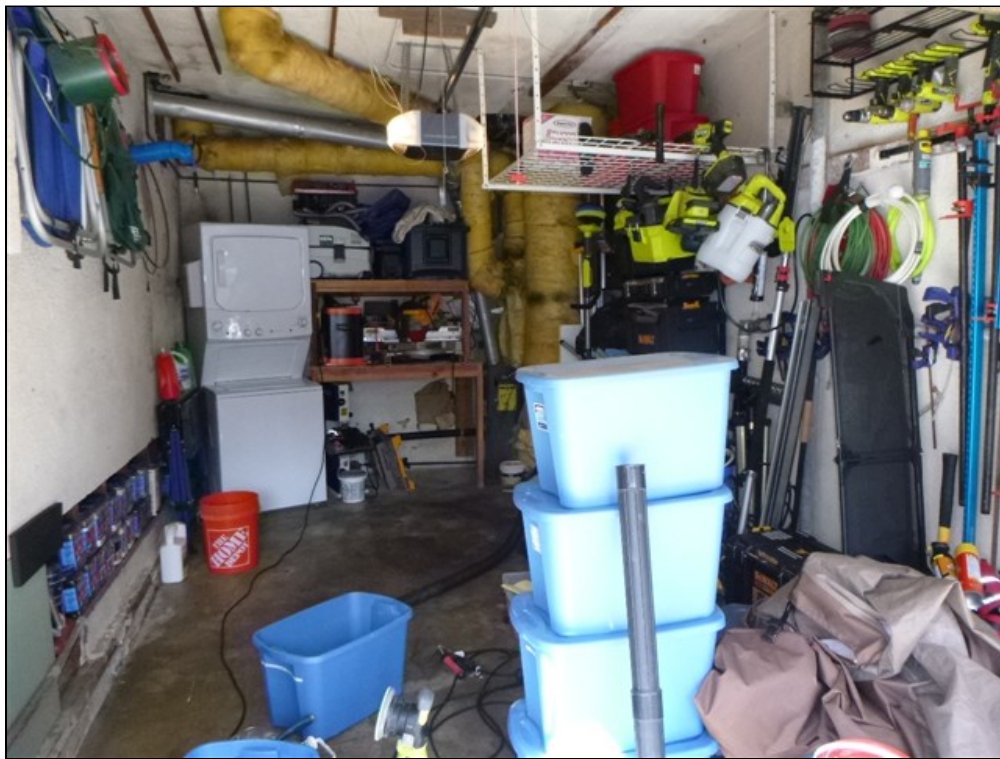
7.0 Item 1(Picture)

**7.0** Access within this area was blocked or severely limited at the time of the inspection. An inspection of this area can be performed by appointment and at an additional cost when the area is made accessible.

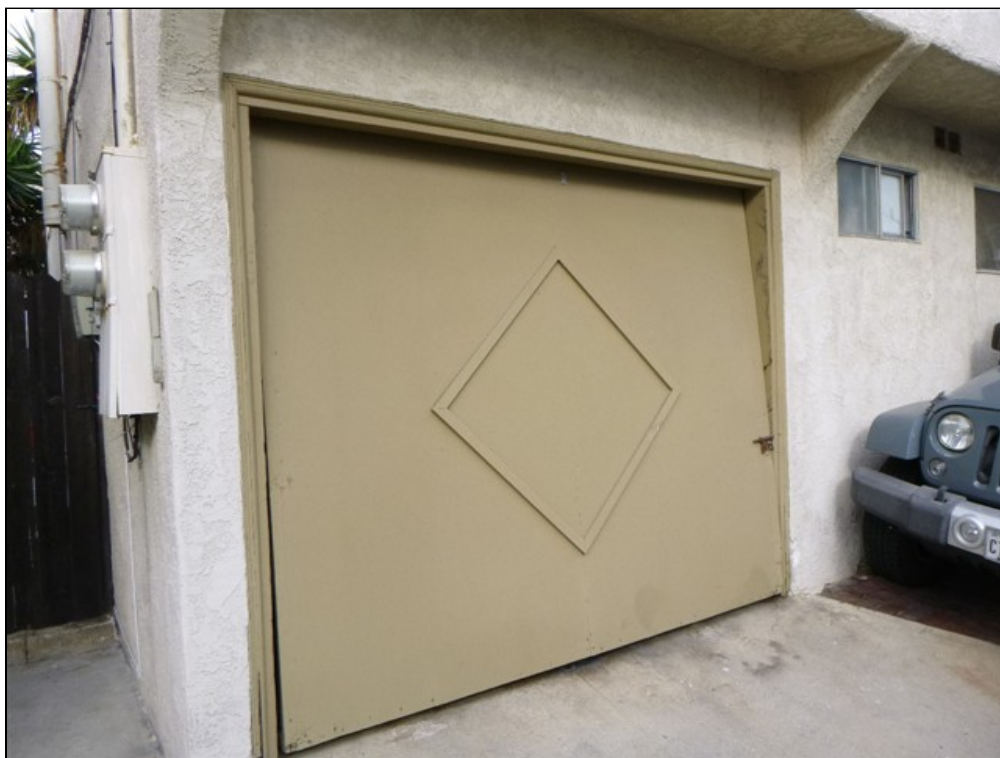
7.1 Item 1(Picture)

**7.1** The wood garage door is weathered and deteriorated, suggest repair/replace as needed.

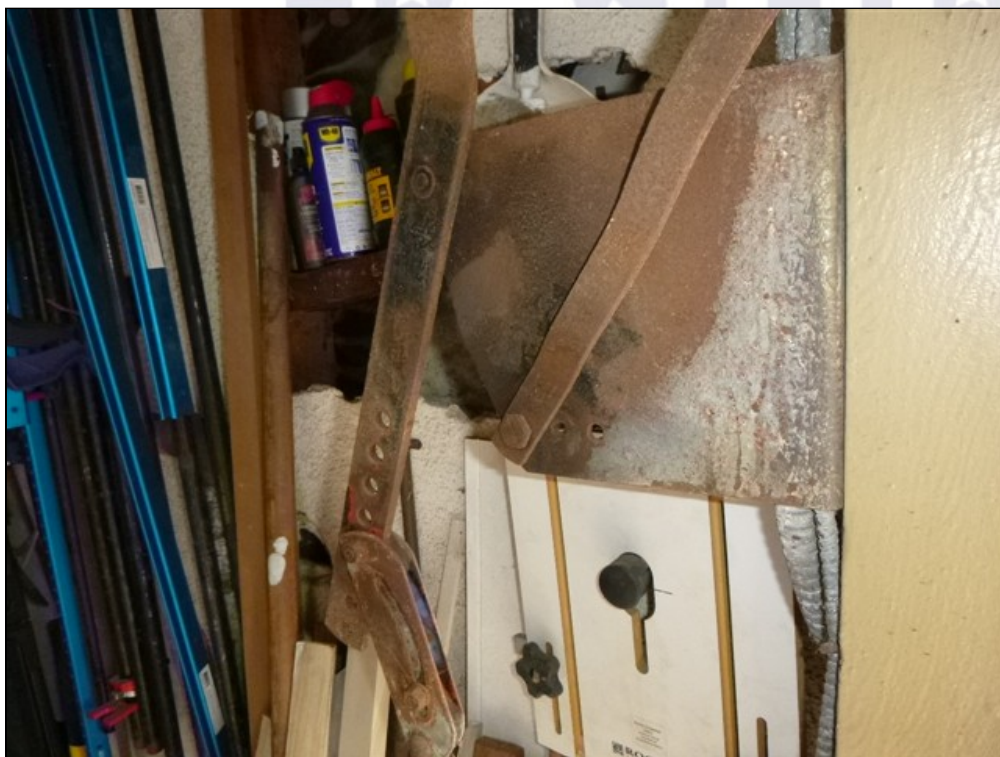
7.2 Item 1(Picture)

**7.2** Bent and damaged hinge hardware was noted, this is a potential safety hazard. Suggest review with a licensed contractor for repair/replacement costs as needed.

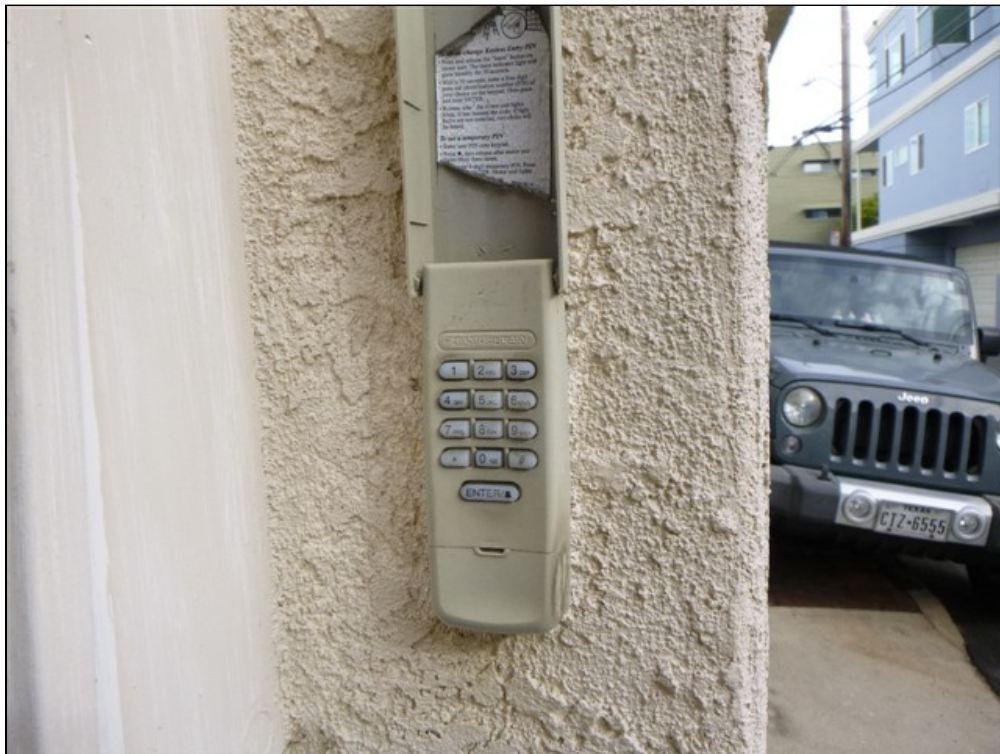
7.3 Item 1(Picture)

**7.3** (1) Unreasonable resistance was required to stop the main garage door(s) in motion, this is a safety concern. Suggest adjusting door opener(s) so the safety reverse operates as required. The US Product Safety Commission recommends these devices be checked monthly.

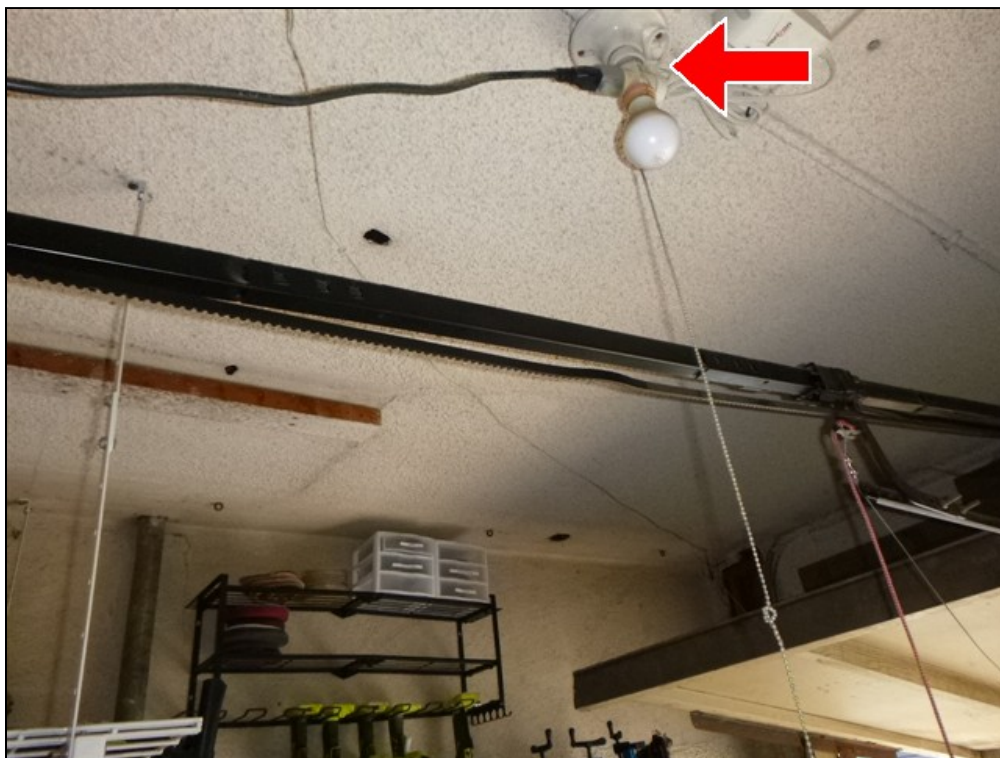
7.3 Item 2(Picture)

**7.3** (3) The garage door opener is currently improperly wired into the light fixture. Suggest review with a licensed electrician for costs to install a dedicated hard wired outlet adjacent to the garage door opener as required.

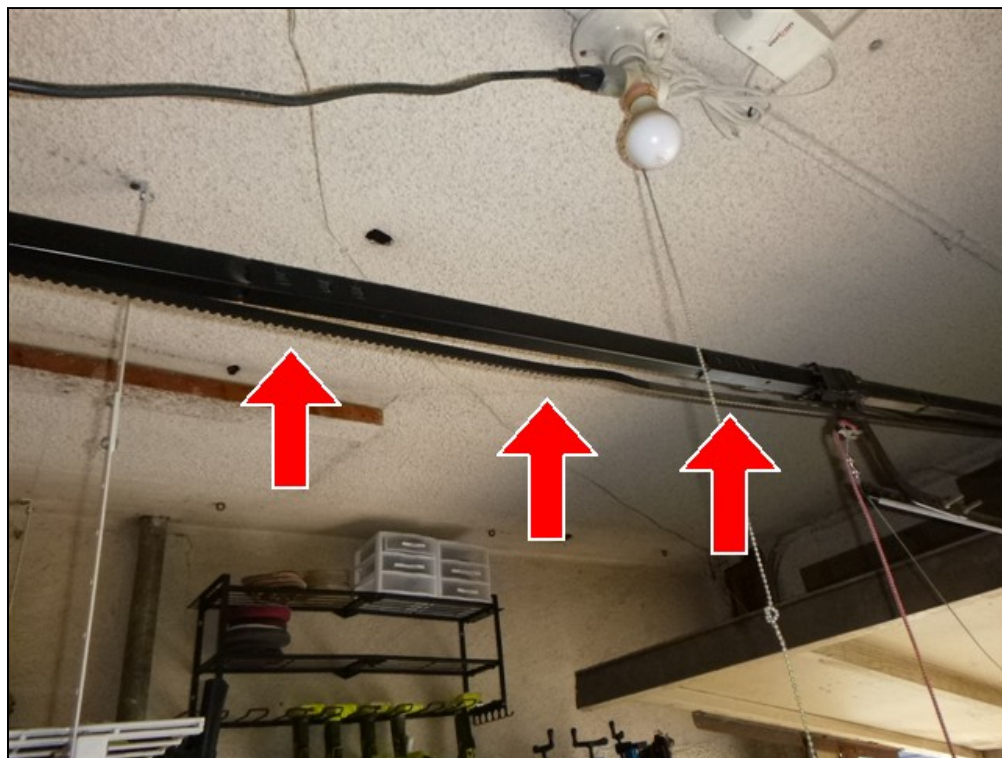
7.3 Item 3(Picture)

**7.3** (4) The garage door opener(s) pull chain/rubber is excessively loose and periodically catches on the railing mount(s). Suggest review with a licensed contractor for costs to correctly tighten/tension the system as required and confirm correct operation as needed.

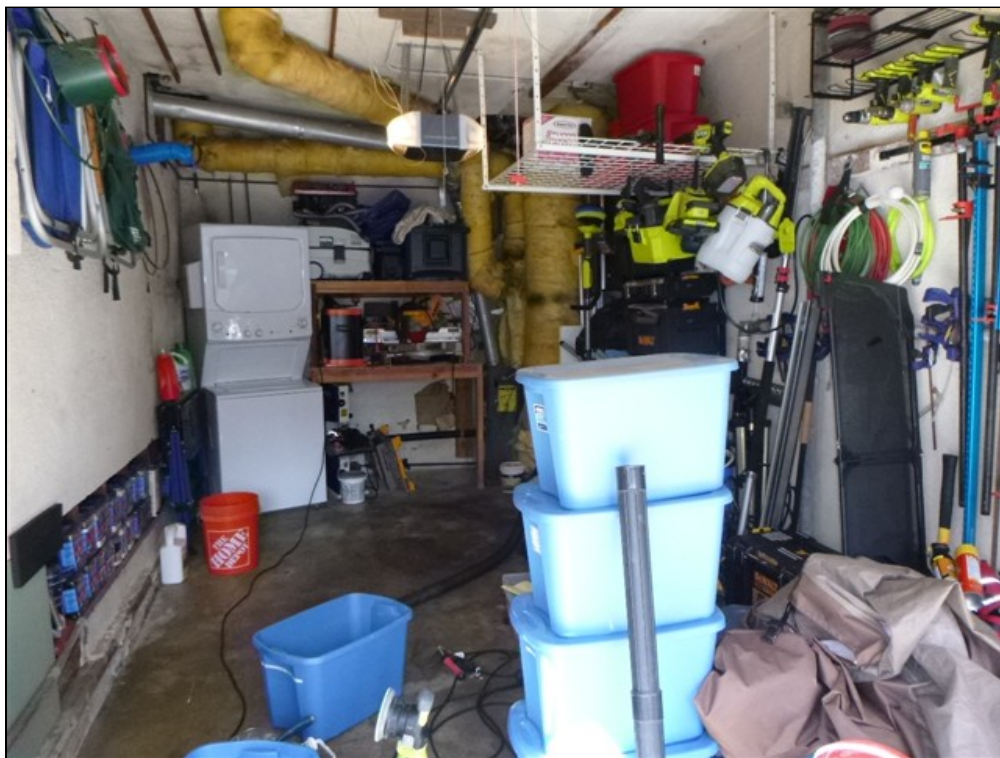
7.4 Item 1(Picture)

**7.4** (1) The inspector was unable to make a complete inspection of firewall/ceiling due to a large concentration of personal effects/vehicles etc. Suggest review of firewall/ceiling once the garage area has been cleared. If any breaches or damage to firewall/ceiling is found, suggest review with a licensed contractor for costs to patch/repair/replace the affected areas with 5/8 fire-rated drywall to complete the firewall/ceiling as required.

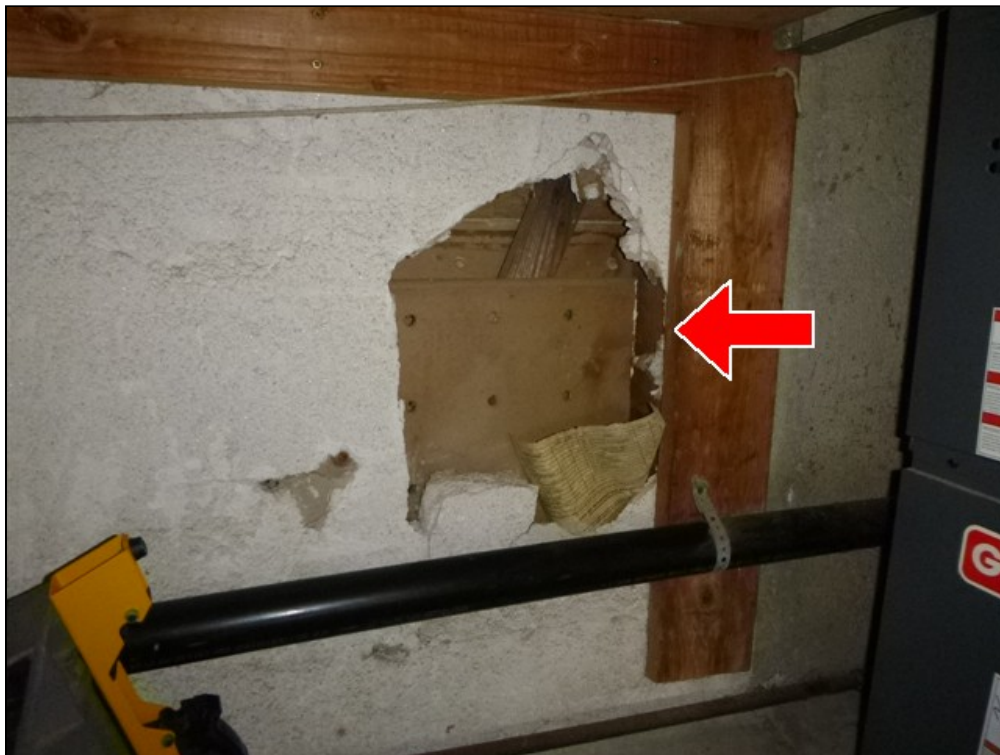
7.4 Item 2(Picture)

**7.4** (2) Holes and unfinished sections of the firewall/ceiling were noted, this is a potential fire spread hazard. 5/8 inch sheetrock may be installed as a minimum standard material and as a requirement for a one hour burn through rating for the firewall/ceiling. Suggest review by licensed contractor for repair/ installation costs as needed.

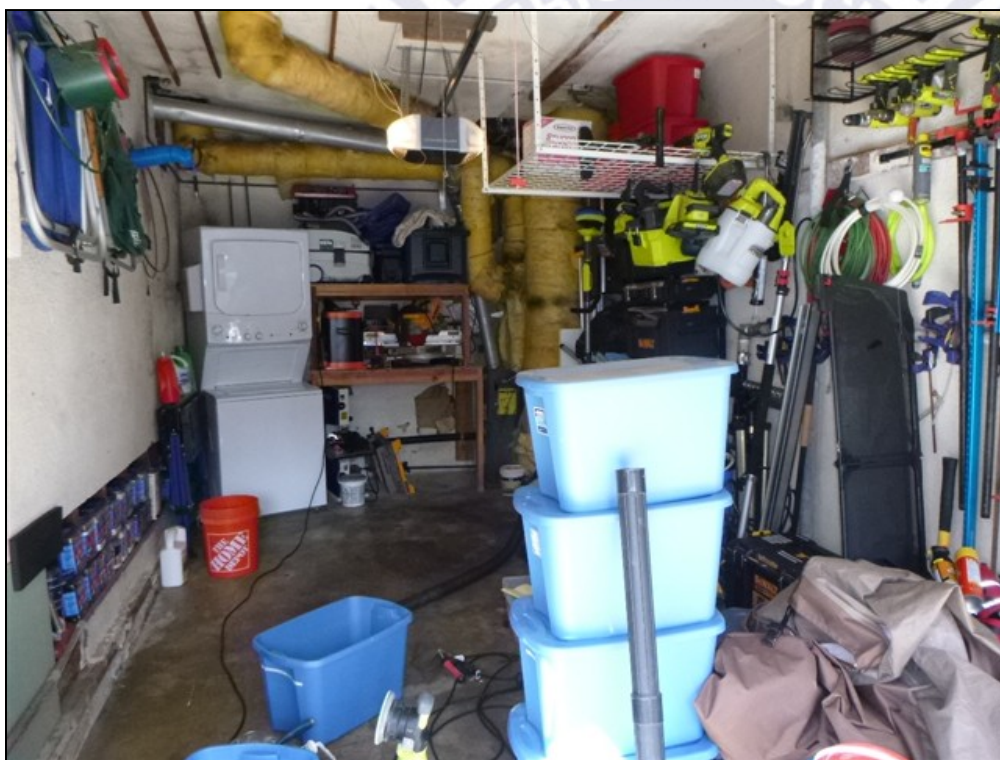
7.6 Item 1(Picture)

**7.6** (1) Access within this area was blocked or severely limited at the time of the inspection. An inspection of this area can be performed by appointment and at an additional cost when the area is made accessible.

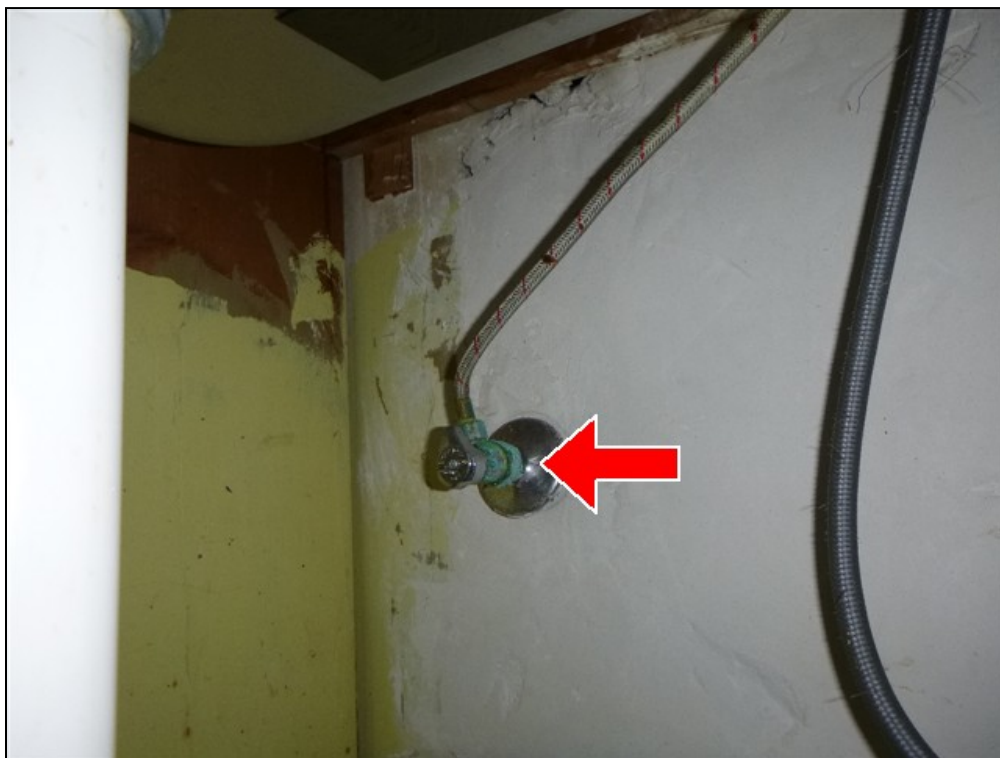
8.0 Item 1(Picture)

**8.0** (5) Corroded plumbing and fittings noted at various areas within the dwelling/structure(s). Suggest further review by a licensed plumber for repair/replacement costs as needed to prevent future leakage, pin hole leaks and possible stains/damage to the interior of the dwelling.

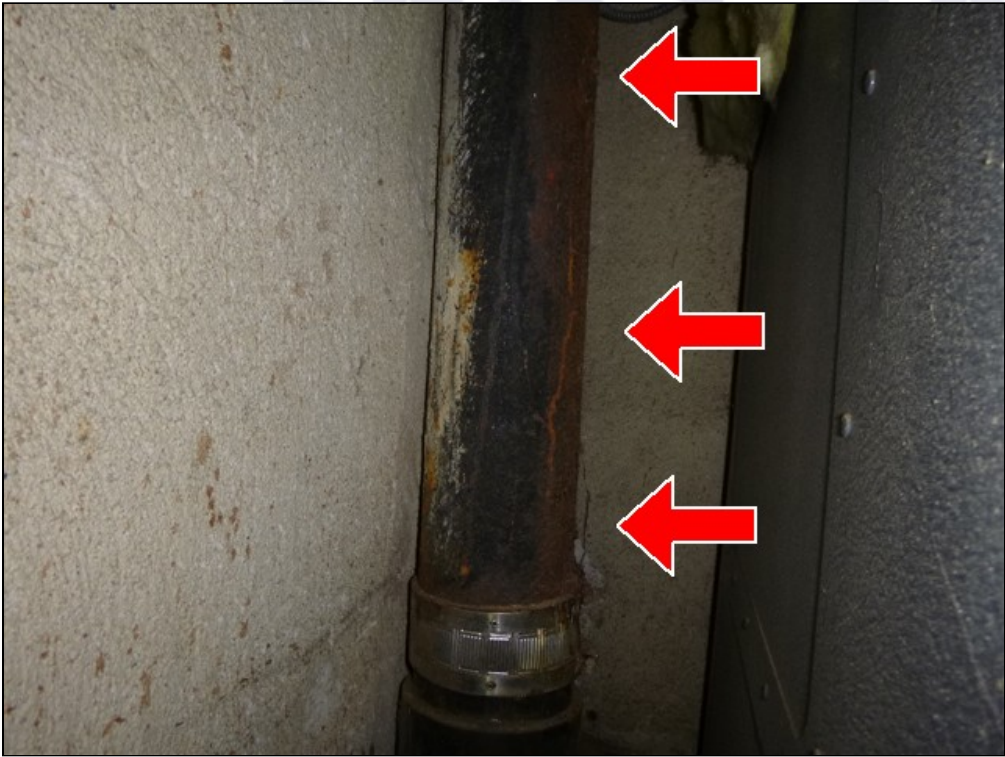
9.0 Item 1(Picture)

9.0 (1) Excessive rust/corrosion and evidence of previous/on-going leakage at the noted at the drains within the units/dwellings and the common garage area(s). Suggest review with a licensed plumbing contractor for any repair/removal/replacement costs as needed.

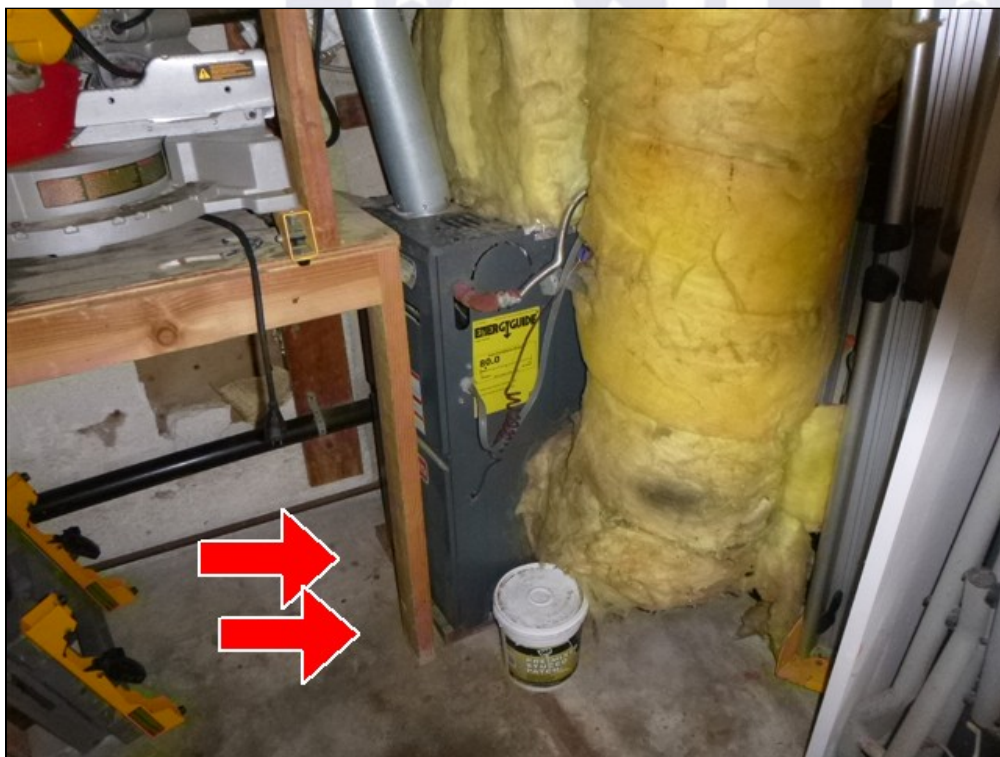
14.0 Item 4(Picture)

**14.0** (3) The heating unit has been installed on wooden stands, suggest review by a licensed heating contractor for installation on non-combustible stands as required.

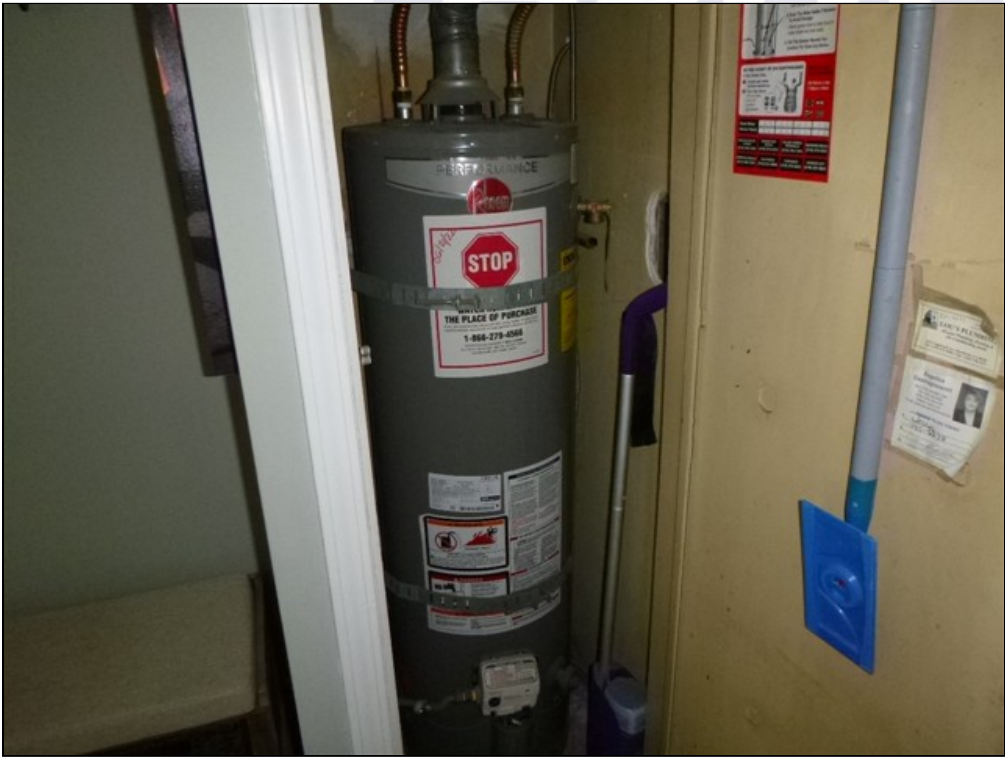
15.0 Item 1(Picture)

15.0 (1) The water heater was operational at the time of the inspection.

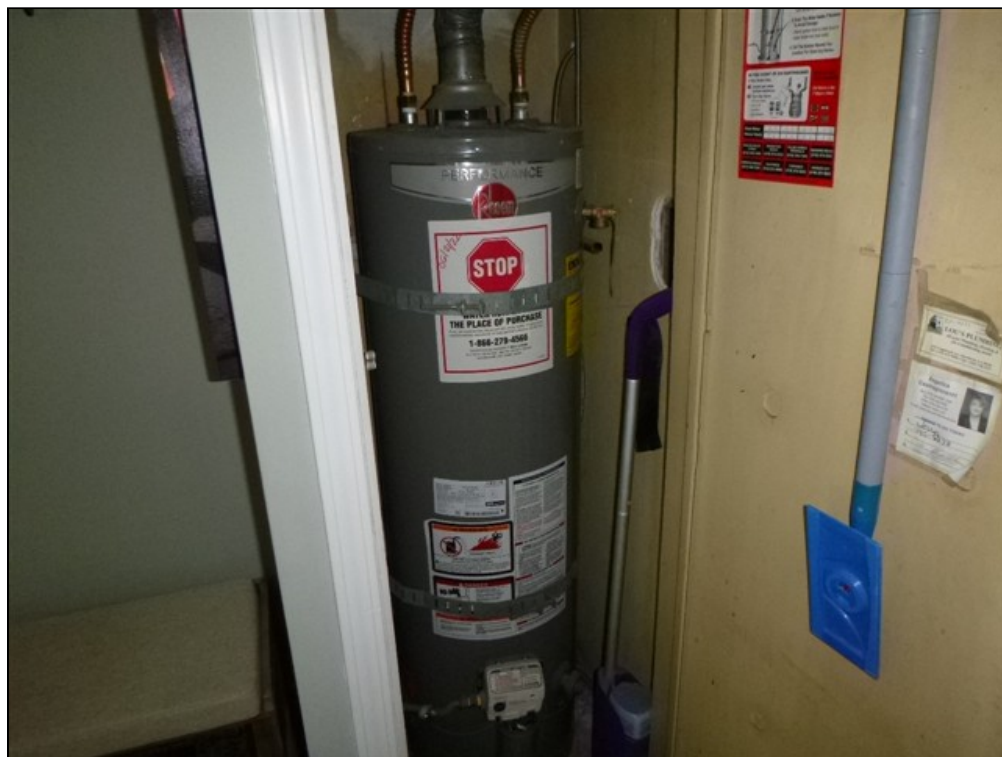
15.0 Item 2(Picture)

**15.0** (2) The capacity of the existing water heater is below plumbing standards for adequate hot water heating for this size dwelling ( based on the number of beds/bathrooms ). Suggest review by a licensed plumbing contractor for evaluation of this dwellings water heating system for replacement costs as needed.

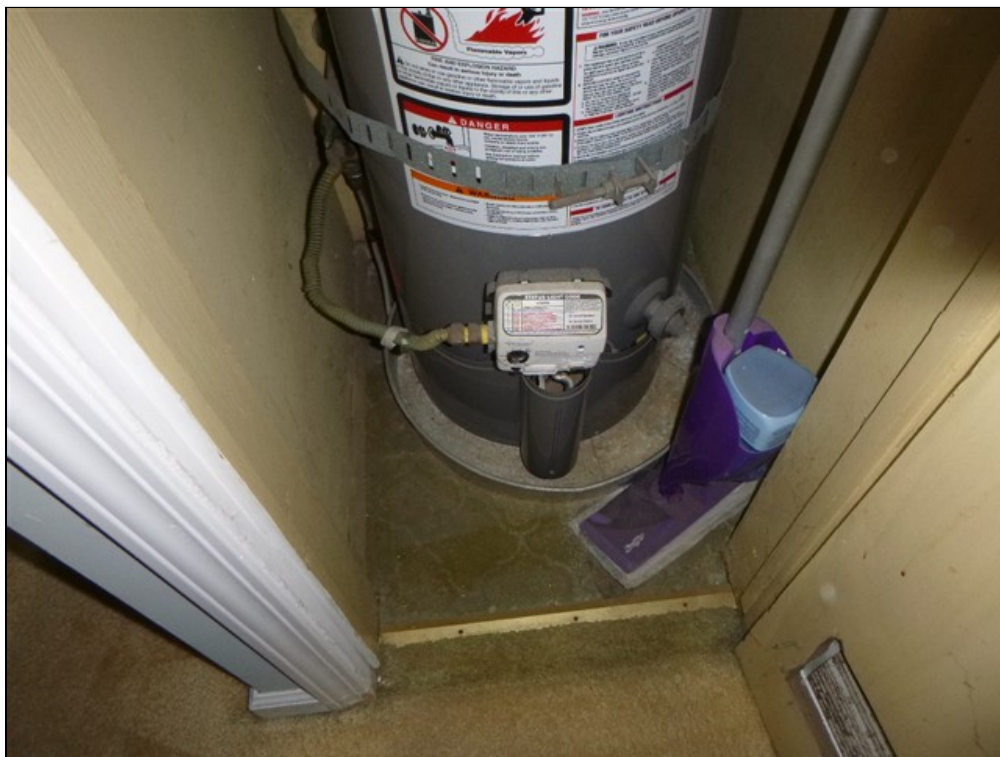
15.0 Item 3(Picture)

**15.0** (4) A spill pan is installed under the water heater but no drain line is currently installed. Suggest installing the drain line to the exterior of the closet/dwelling as required when the water heater was installed.

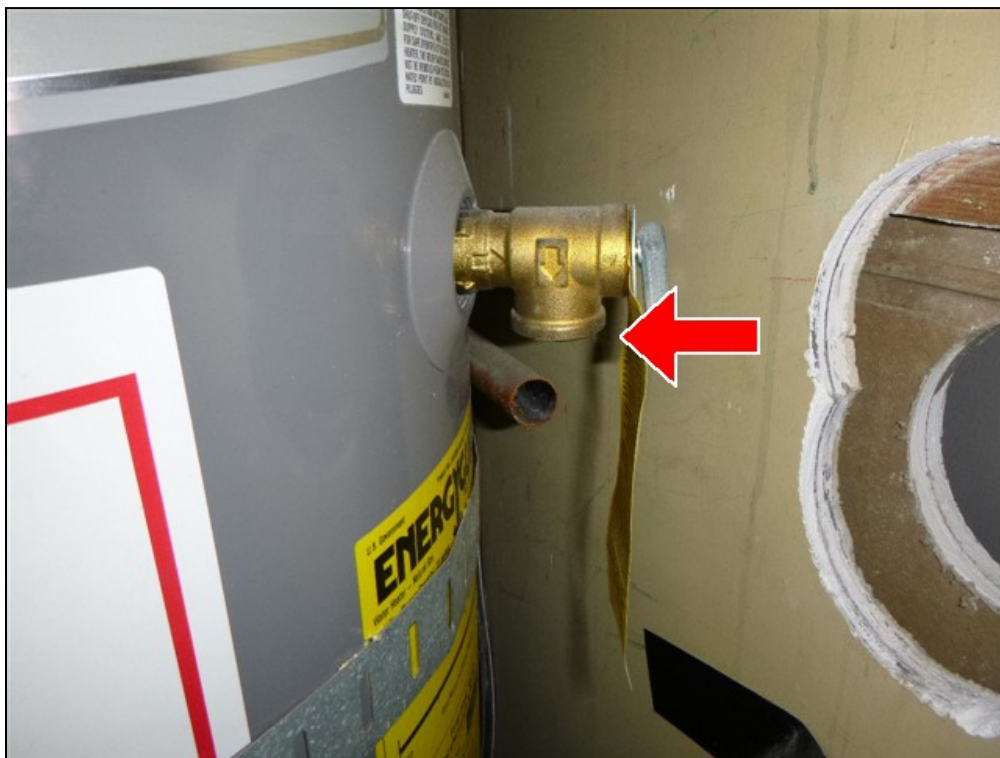
15.0 Item 4(Picture)

**15.0** (5) No discharge pipe connected to the TP&R valve, this is a potential safety hazard. Suggest review by a licensed plumber for costs to install the TP discharge drain down to within 4-6 inches of the exterior grade/deck as required for safety.

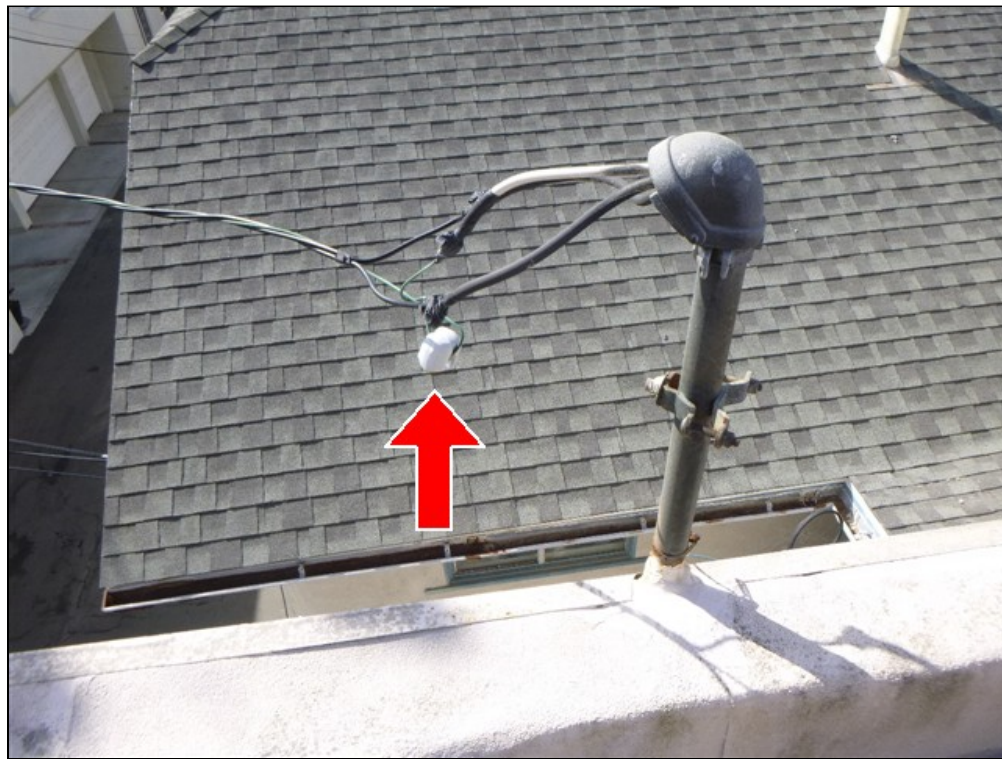
16.0 Item 1(Picture)

**16.0** The electrical service wiring mount is broken and detached from the roof, this is a potential safety hazard. Suggest review with a licensed electrician and/or the local utility company for repair/ replacement costs as required for safety.

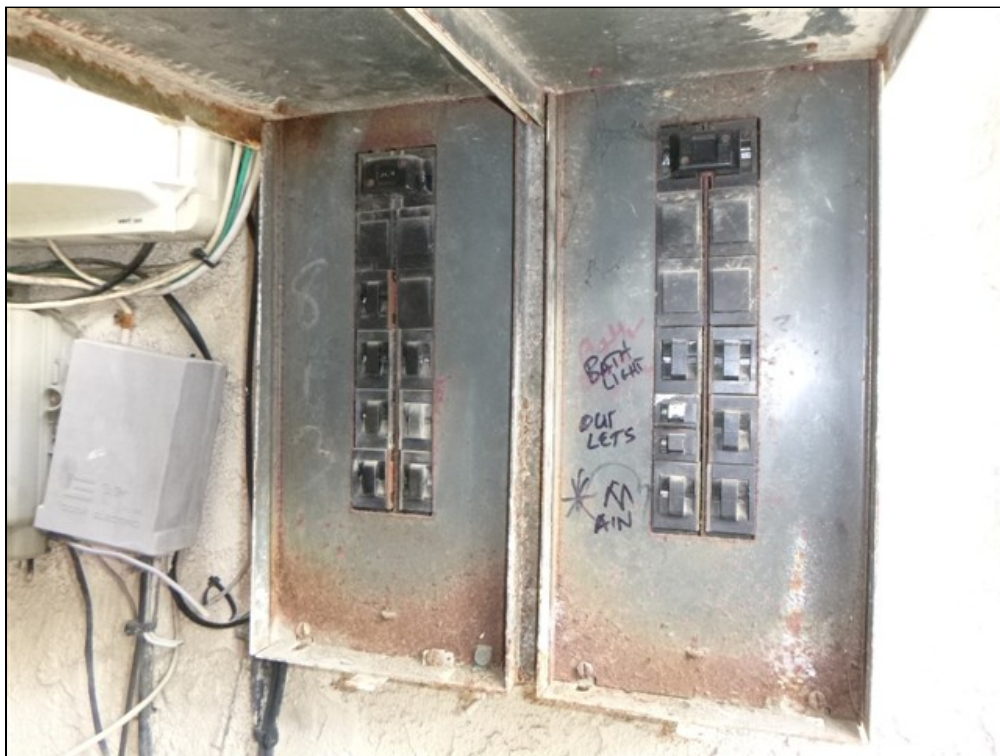
16.1 Item 2(Picture)

**16.1** (2) The electrical panel(s) are a Bulldog breaker system. Problems with this style panel include circuit breakers (depending on the vintage) with a dismal performance record and the possibility of unbalanced multi-wire circuits. Also, please be aware that various insurance companies will not insure homes with this style of electrical panel. Suggest review by a licensed electrician for replacement costs as needed.

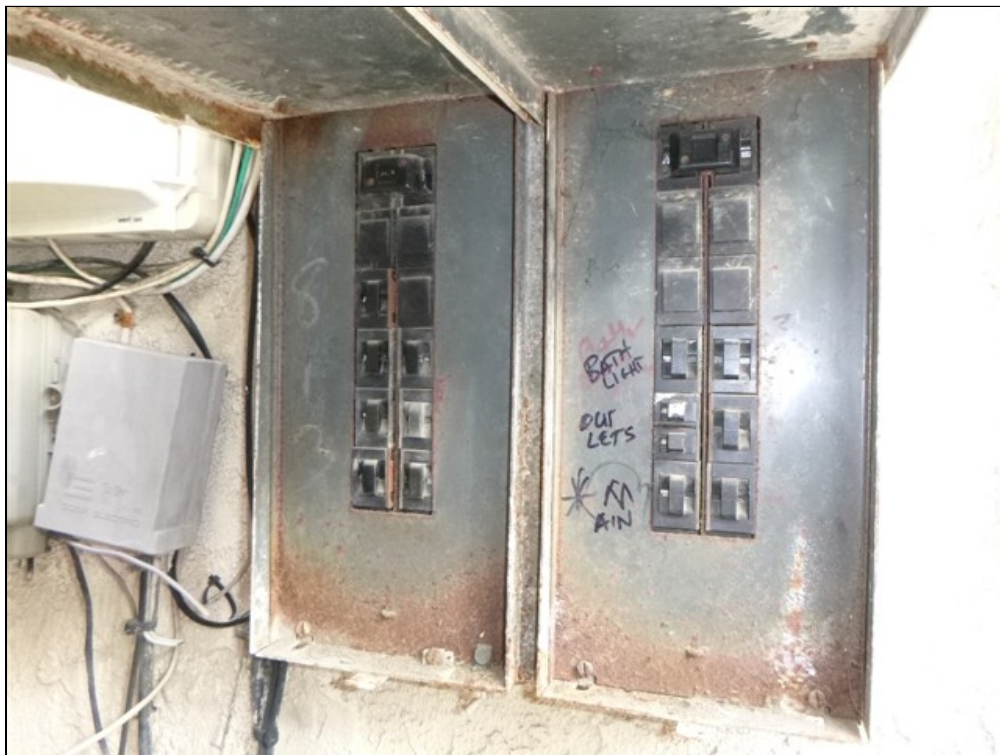
16.1 Item 3(Picture)

**16.1** (3) Suggest adding correct/complete indexing/labelling to all breakers for identification of each circuit for safety.

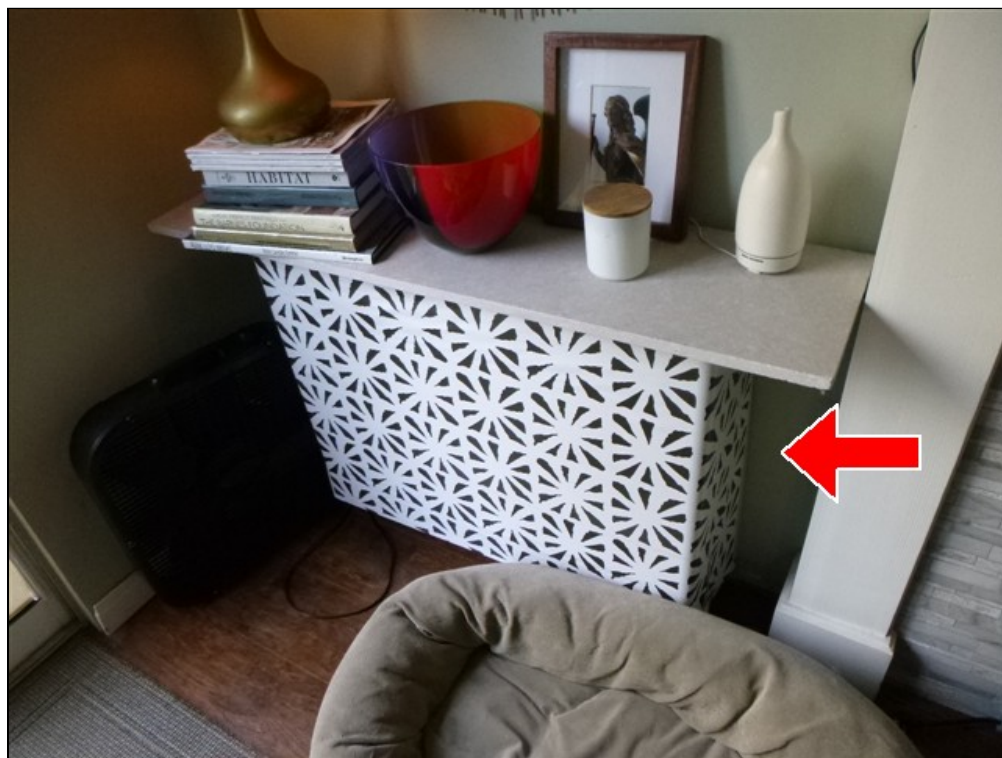
20.0 Item 1(Picture)

**20.0** Unable to test the heating system as the gas was turned off to the unit at the time of the inspection. Suggest review by the Gas Company or a licensed heating company for further review to determine if the unit is operational/usable, the remaining life of the unit and/or any repair/replacement costs as needed.
