# Inspection Report

**Property Address:**  
813 & 813-1/2 Bayview Dr  
Manhattan Beach CA 90266

**Ferguson Home Inspections**

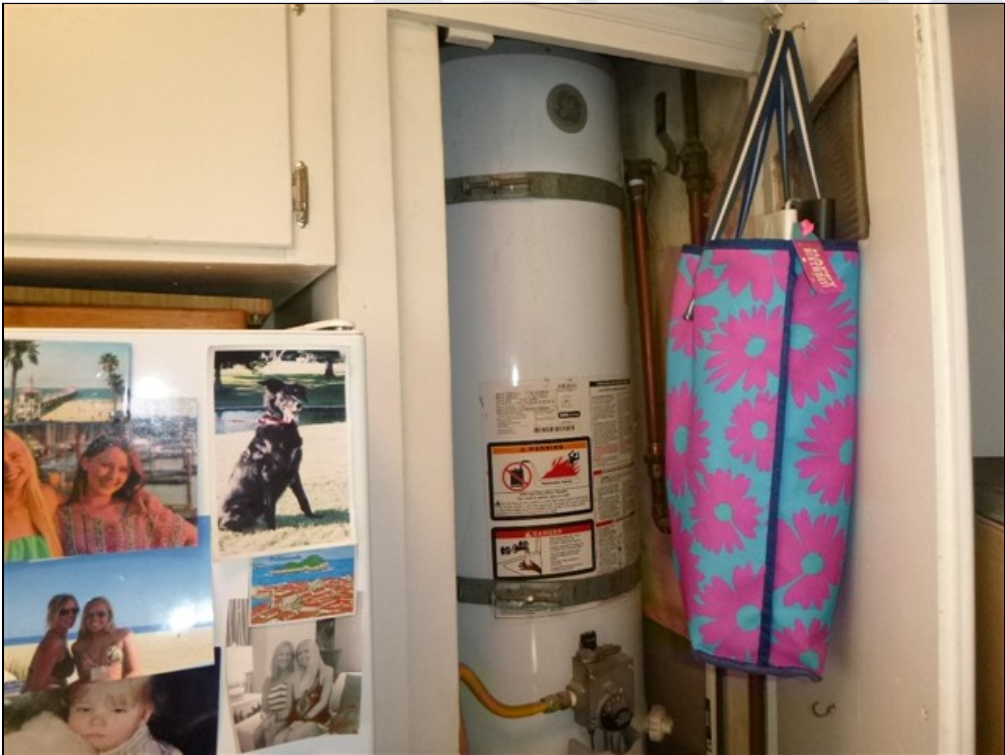
21.0 Item 1(Picture)

**21.0** (1) Due to the age of this unit , suggest review with a licensed plumber for replacement costs as it is nearing the end of it's intended life span ( 12-15 years ).

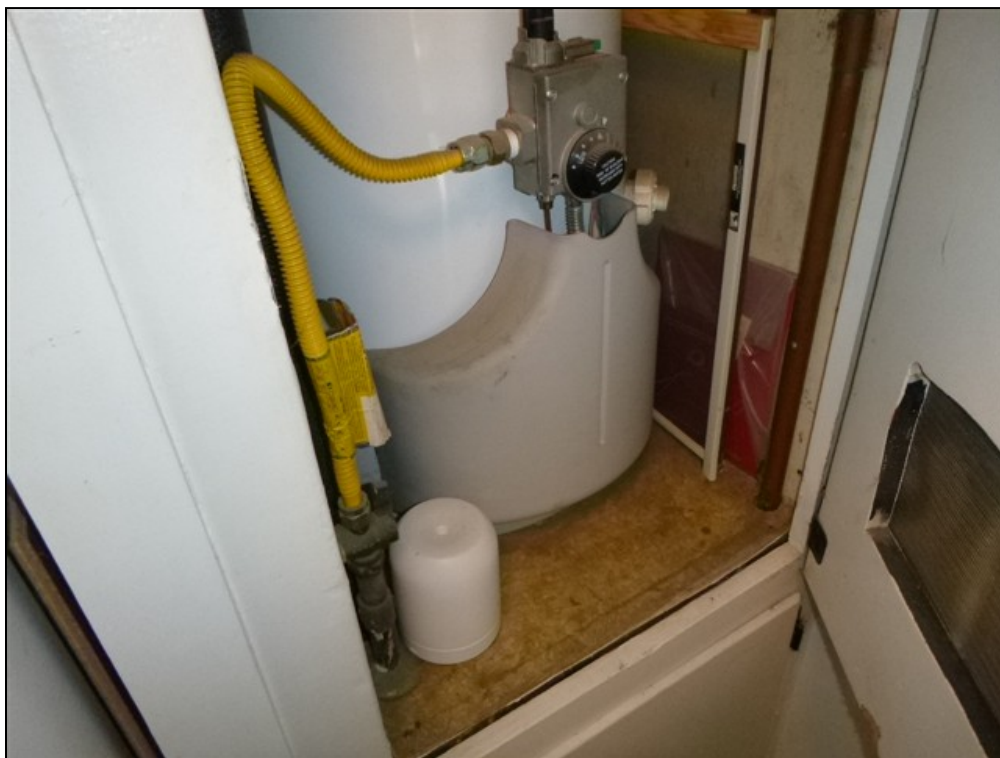
21.0 Item 2(Picture)

**21.0** (2) No spill pan or drain line installed at the time of inspection. Suggest installation of a spill pan with a drain line to the exterior of the dwelling as required as leakage would cause damage to the stand and surrounding area.

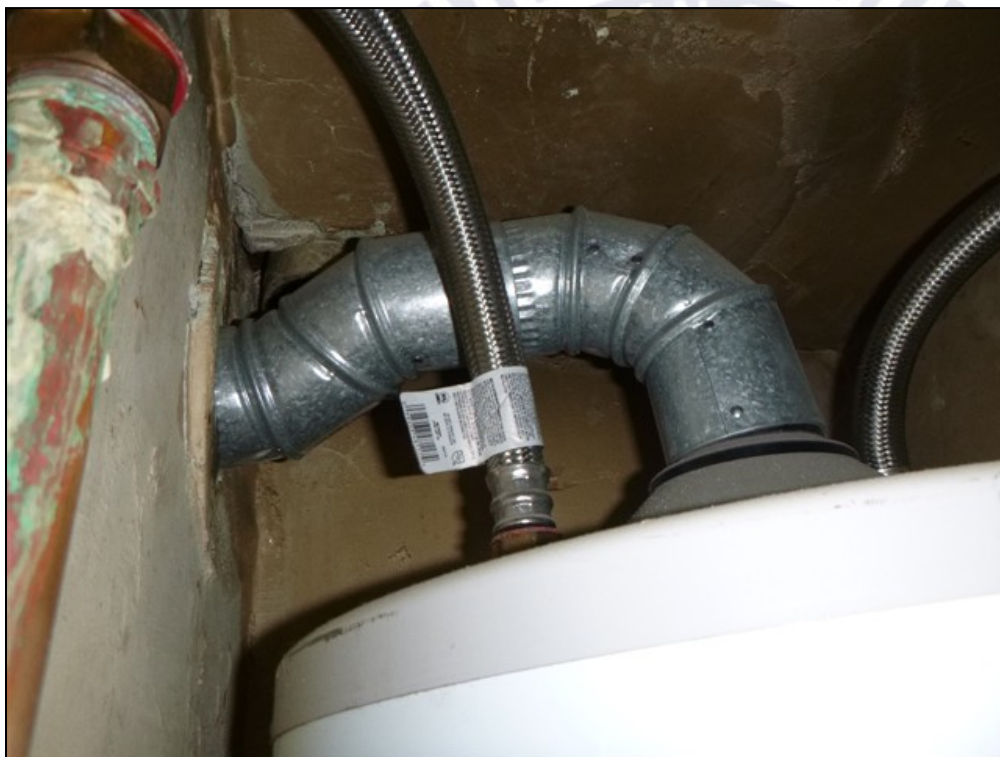
21.1 Item 1(Picture)

**21.1** Negative slope and a poor fitting vent pipe was noted. Loose, disconnected or improperly sloped vent pipes will not allow for products of combustion to escape. This is a potential safety hazard requiring immediate attention. Suggest review by a licensed plumbing/heating contractor for repairs/ replacement costs as required for safety.

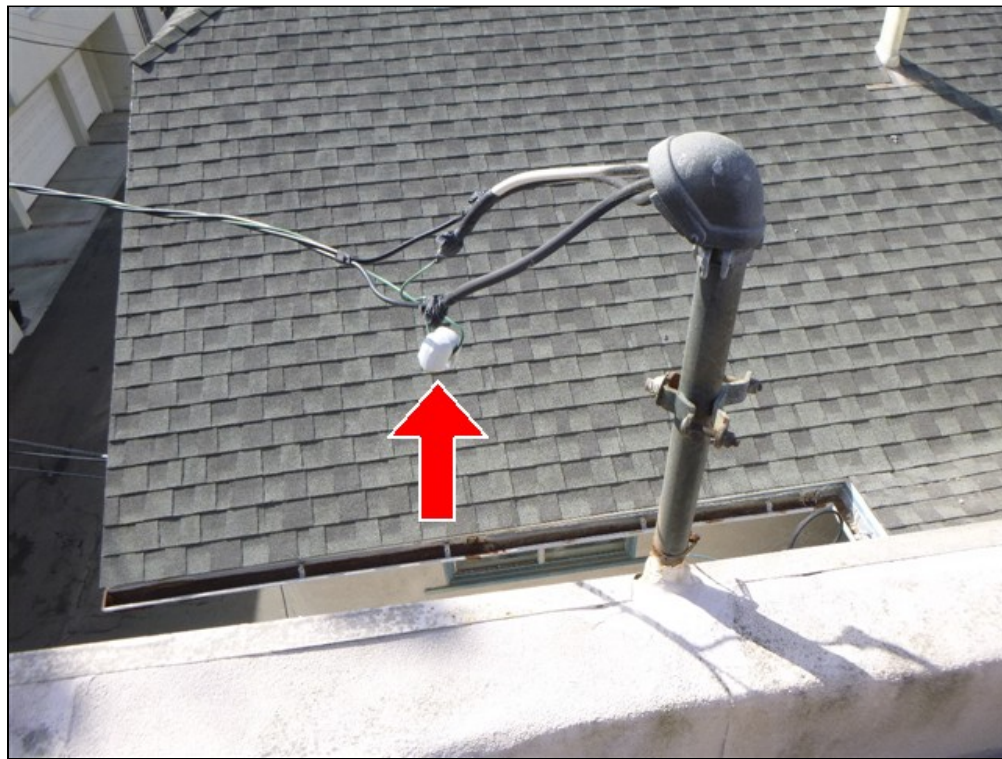
22.0 Item 1(Picture)

**22.0** The electrical service wiring mount is broken and detached from the roof, this is a potential safety hazard. Suggest review with a licensed electrician and/or the local utility company for repair/replacement costs as required for safety.

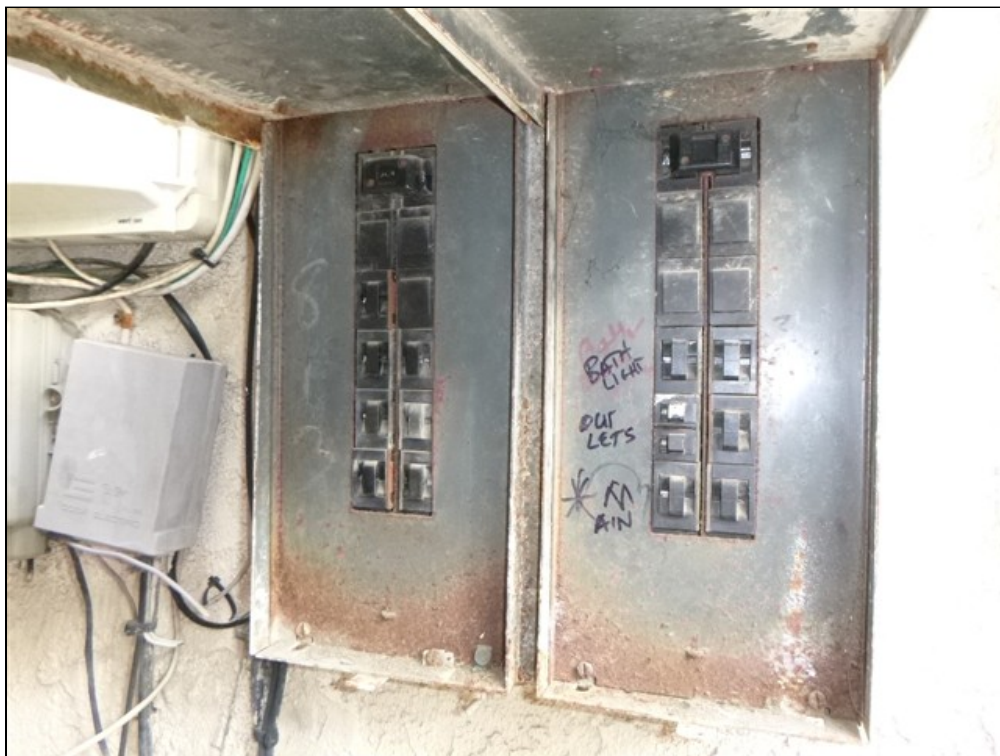
22.1 Item 3(Picture)

**22.1** (3) The electrical panel(s) are a Bulldog breaker system. Problems with this style panel include circuit breakers (depending on the vintage) with a dismal performance record and the possibility of unbalanced multi-wire circuits. Also, please be aware that various insurance companies will not insure homes with this style of electrical panel. Suggest review by a licensed electrician for replacement costs as needed.

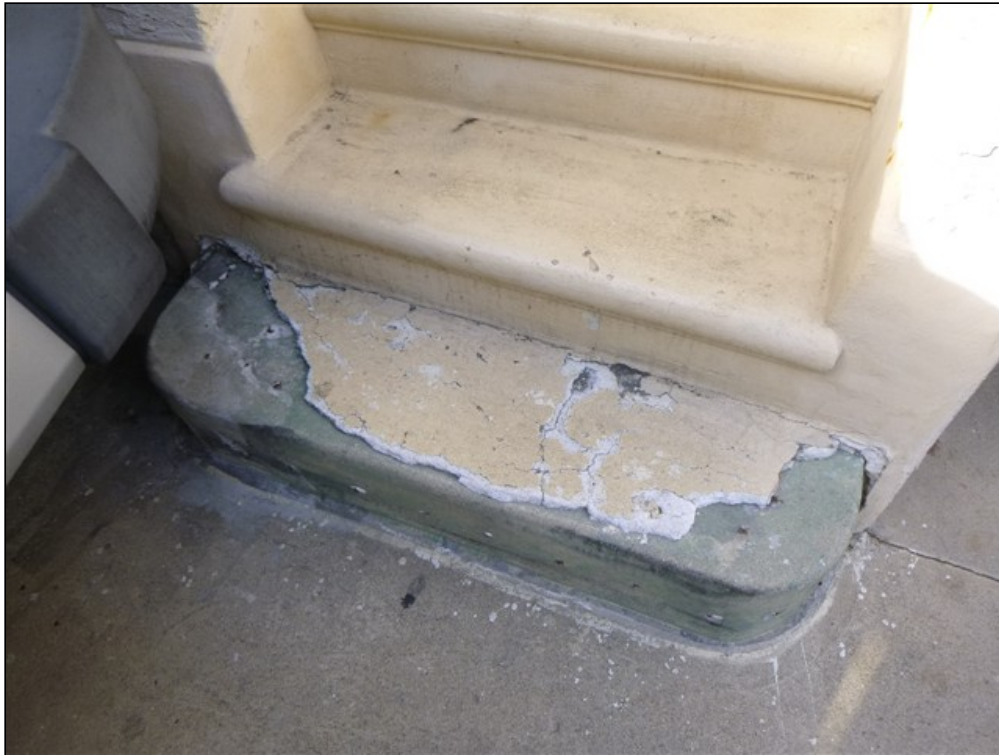
1.1 Item 1(Picture)

(1) Surface cracking, patched and deteriorated areas noted at the stairs to the upper unit. Suggest review by a licensed decking contractor for any repair/sealing/replacement costs as needed to prevent future deterioration and possible leakage at this area.

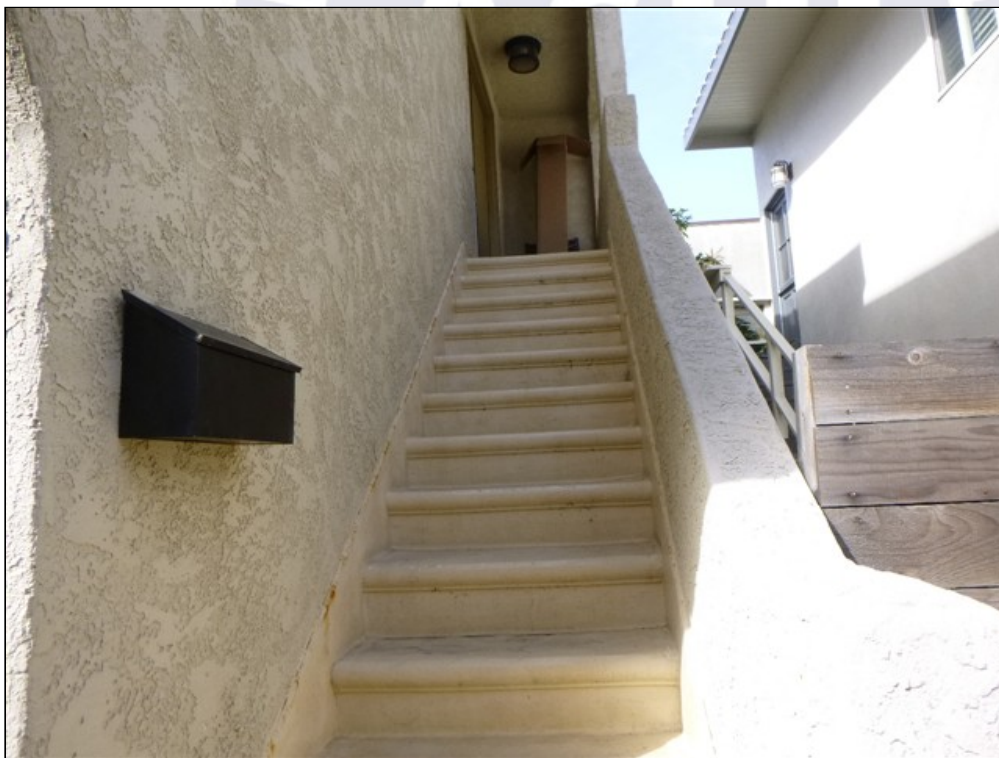
1.1 Item 2(Picture)

(2) A potential safety/trip hazard was noted due to no graspable hand railing is currently installed at the stairs to the upper unit ( this is common for the original age of the dwelling ). Suggest review with a licensed contractor for costs to install a graspable hand railing if desired or concerned.

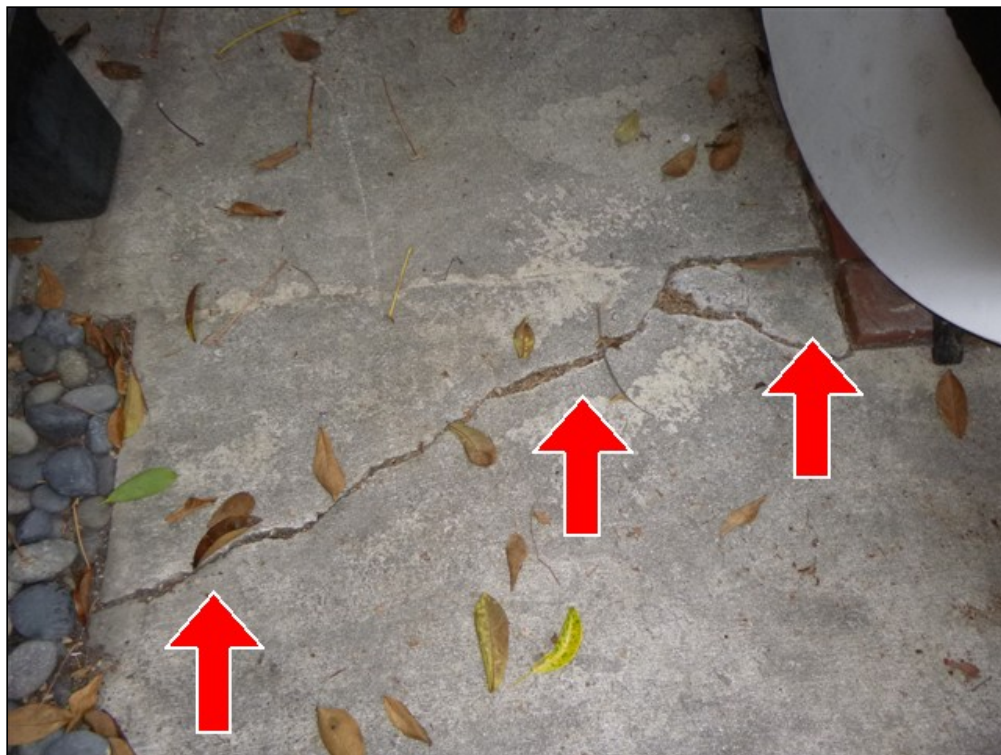
1.1 Item 3(Picture)

(3) Settling, expansion cracks and heaving noted at various areas, this is a potential trip hazard. Suggest review with a licensed contractor for any repair/replacement costs as needed.

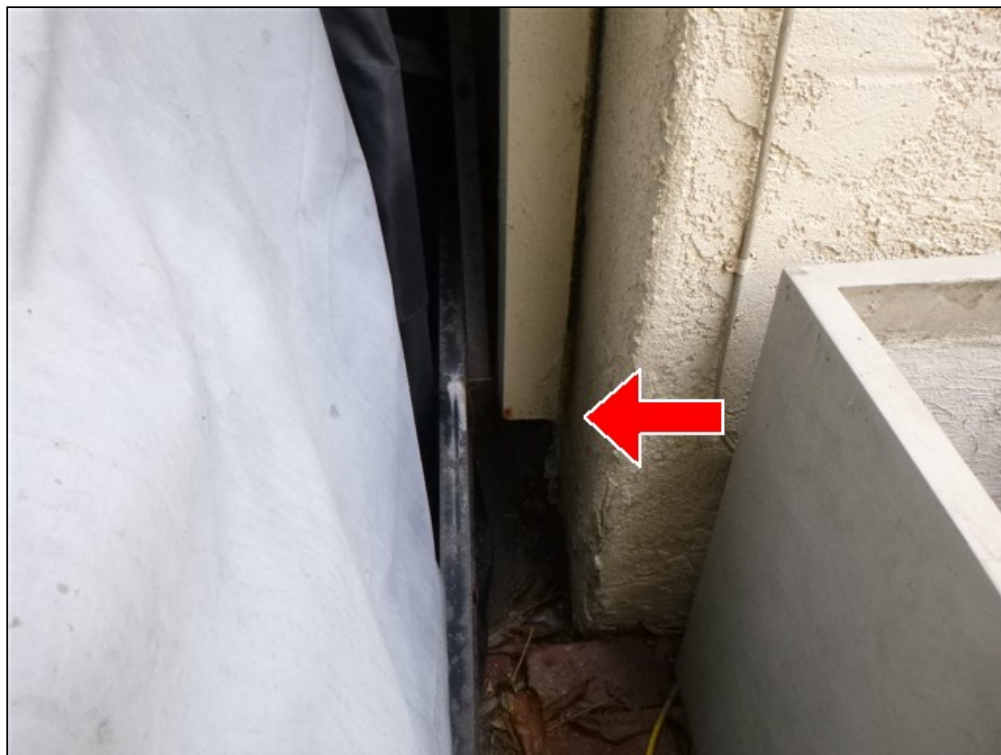
1.9 Item 1(Picture)

Suggest review by a licensed contractor for possible installation of an area drainage system to divert drainage away from the foundation.

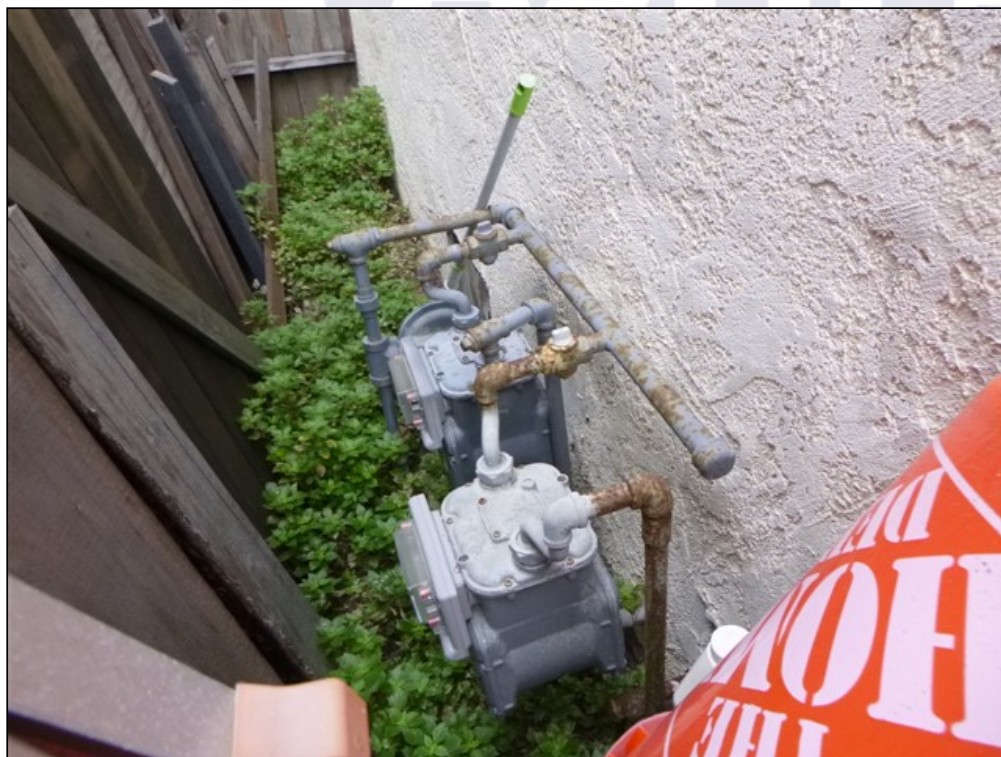
1.11 Item 1(Picture)

(1) The gas meters are not currently individually labelled/marked as per each unit. Suggest review with the owner/plumber and/or the gas company to label/mark each gas meter per unit as required for safety.

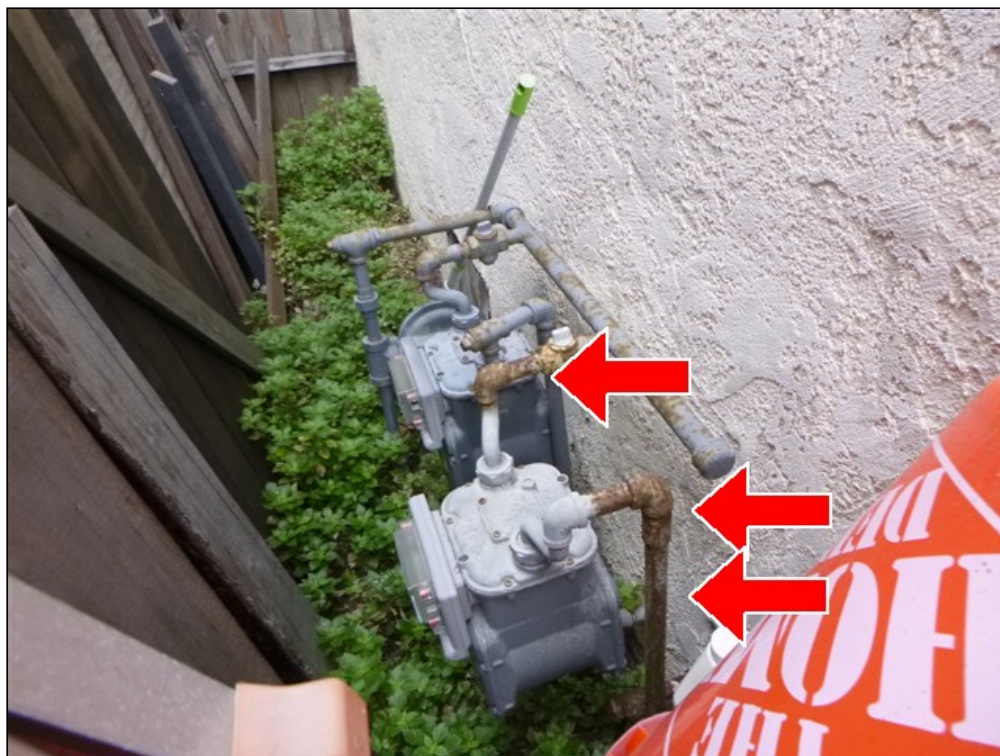
1.11 Item 2(Picture)

Suggest review with the gas company and/or a licensed plumber for any repair/replacement costs as needed.

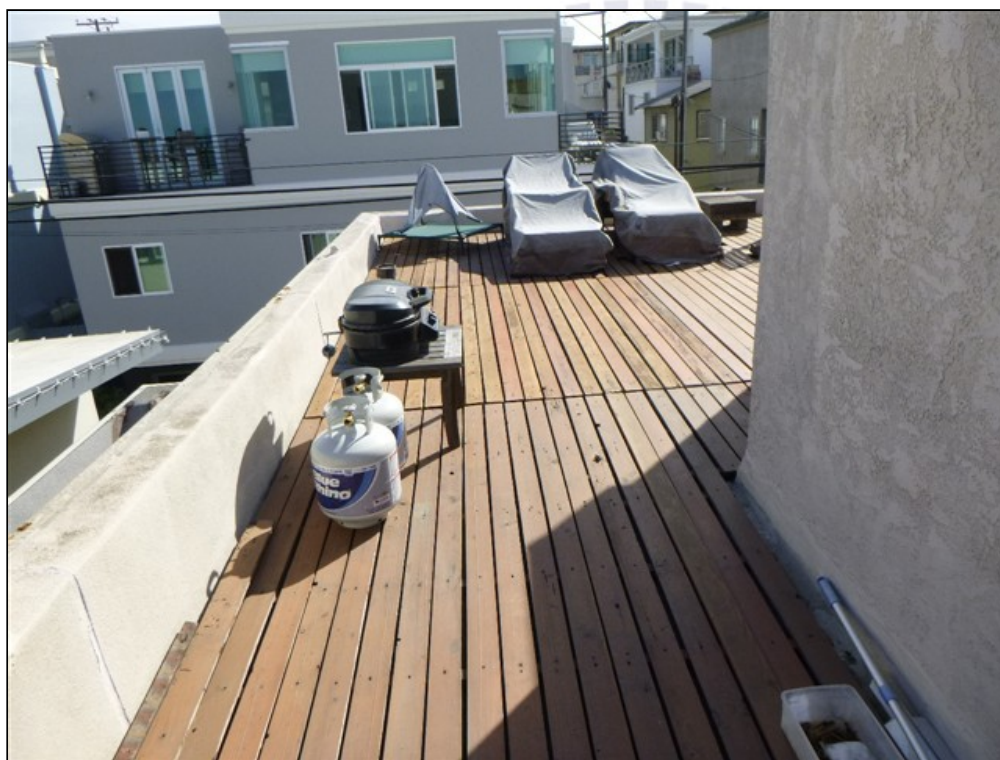
5.0 Item 1(Picture)

(1) The roof covering is old and deteriorated. It is nearing the end of its useful life and the covering will need to be replaced. While it could last a year or so, some areas may need patching/repairs as leaks develop ( evidence of leakage to the interior was noted ). Please review with a licensed roofer to determine the remaining life expectancy and for costs to repair/remove and replace the existing roofing material as needed.

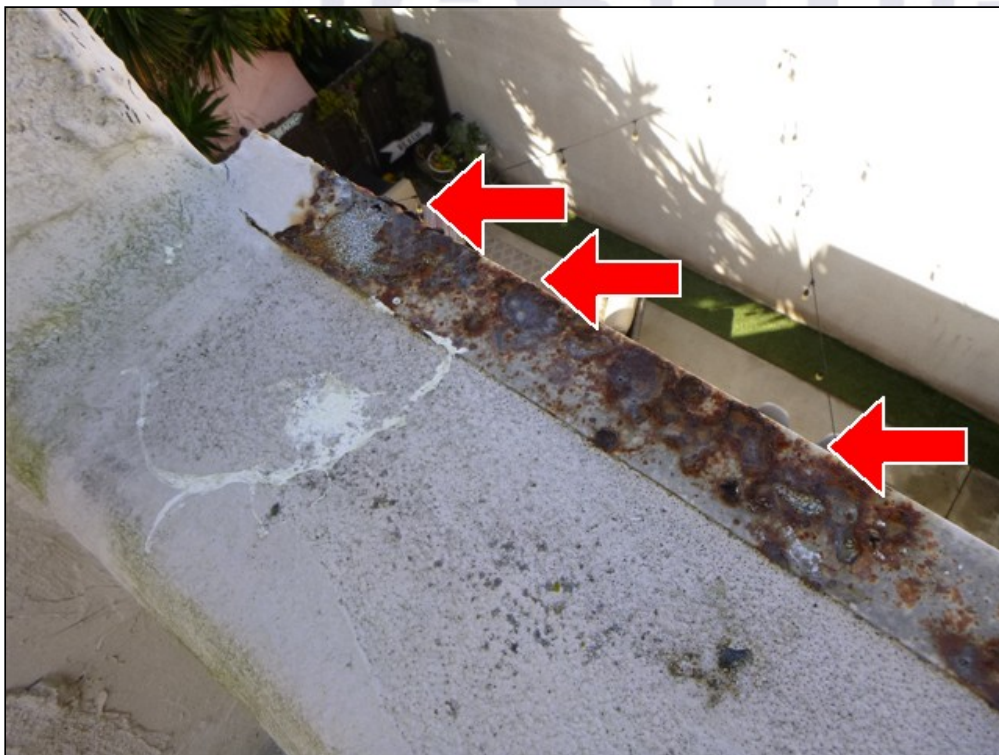
5.1 Item 1(Picture)

Deteriorated and rusted stem wall flashings were noted at various areas. Suggest review with a licensed roofer for any repair/replacement costs as needed.

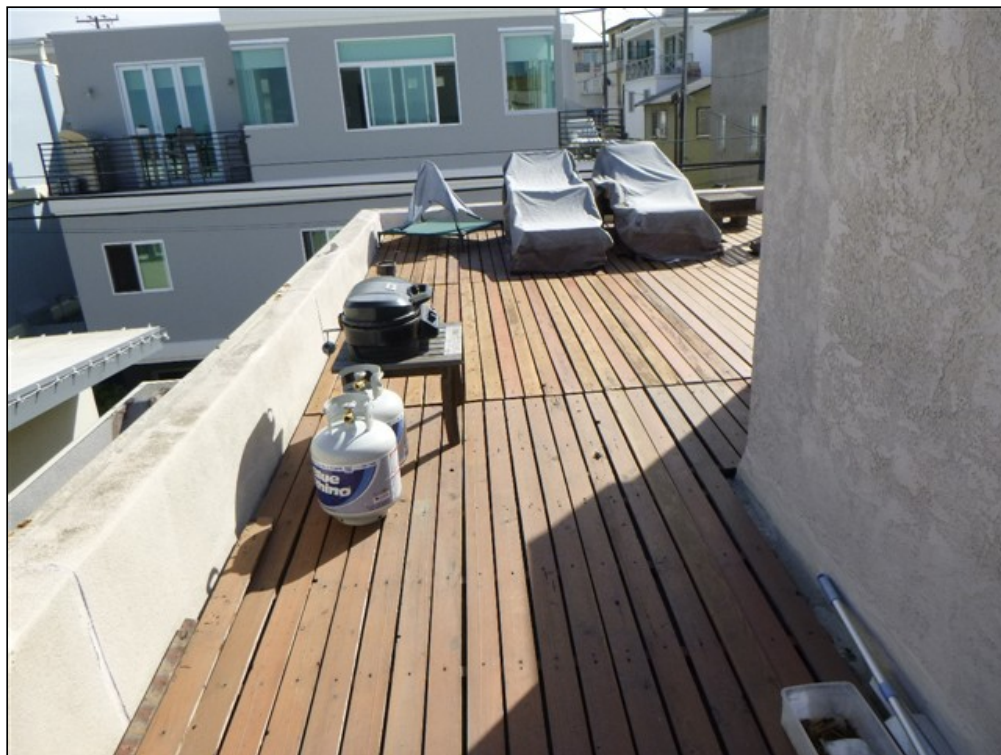
5.3 Item 1(Picture)

(1) A potential fall/safety hazard was noted due to the additional wood decking over the roof but no handrailings are currently installed at the perimeter of the roof area ( excessive wood deterioration was noted at the wood decking ). Suggest review with a licensed contractor for any repair/removal/ replacement costs as needed for safety.

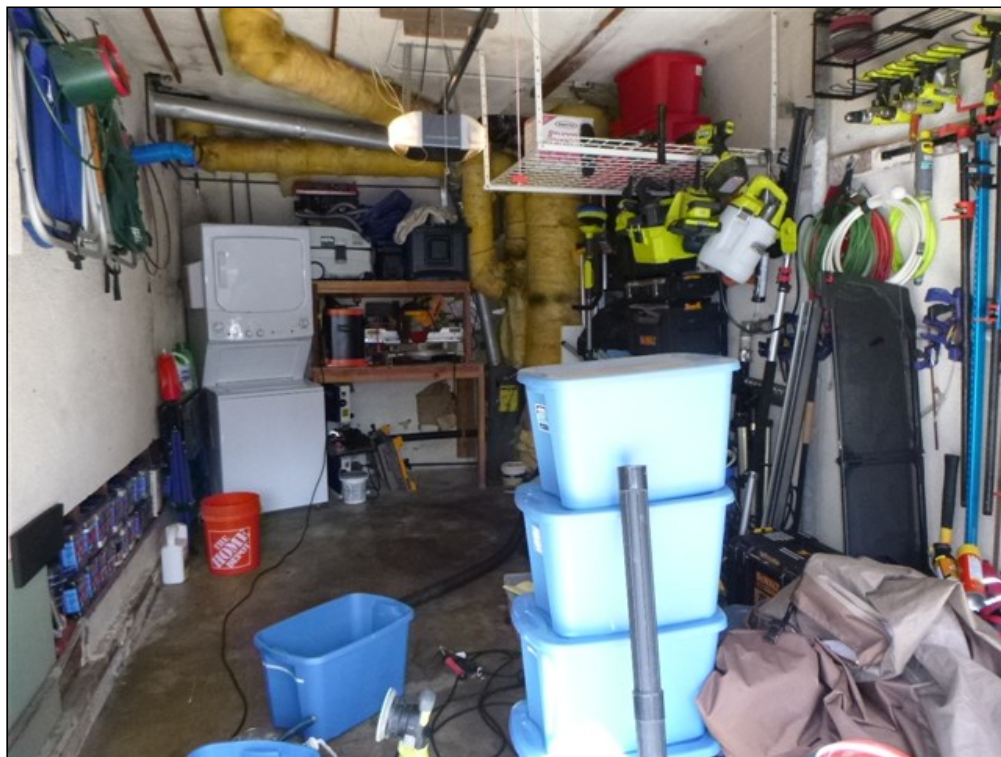
7.0 Item 1(Picture)

Access within this area was blocked or severely limited at the time of the inspection. An inspection of this area can be performed by appointment and at an additional cost when the area is made accessible.

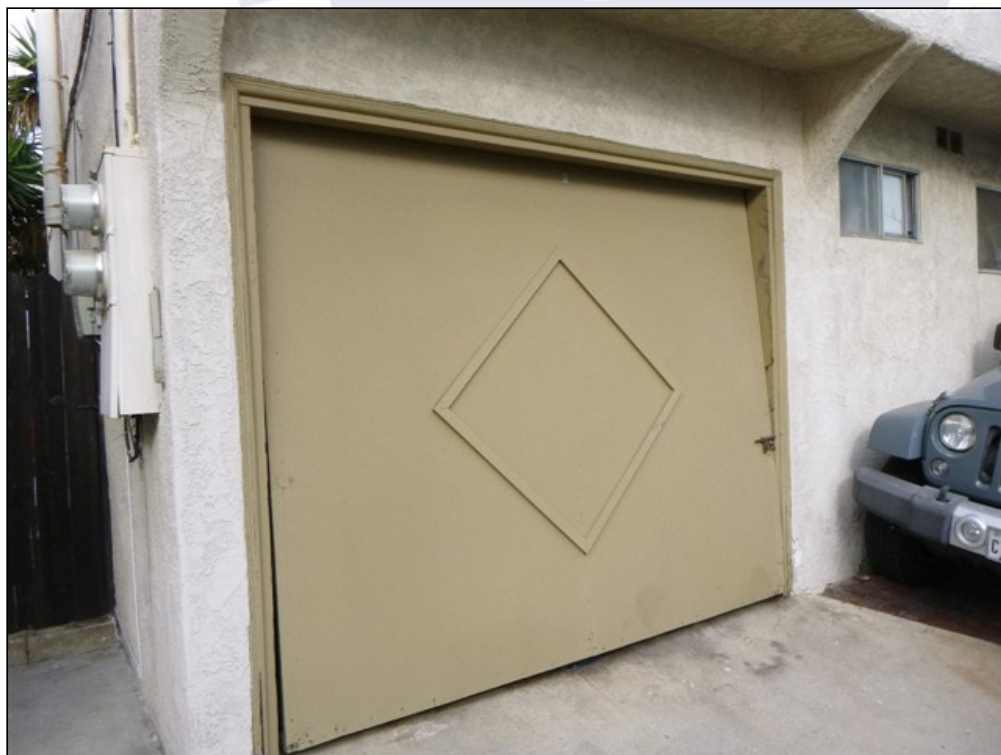
7.1 Item 1(Picture)

The wood garage door is weathered and deteriorated, suggest repair/replace as needed.

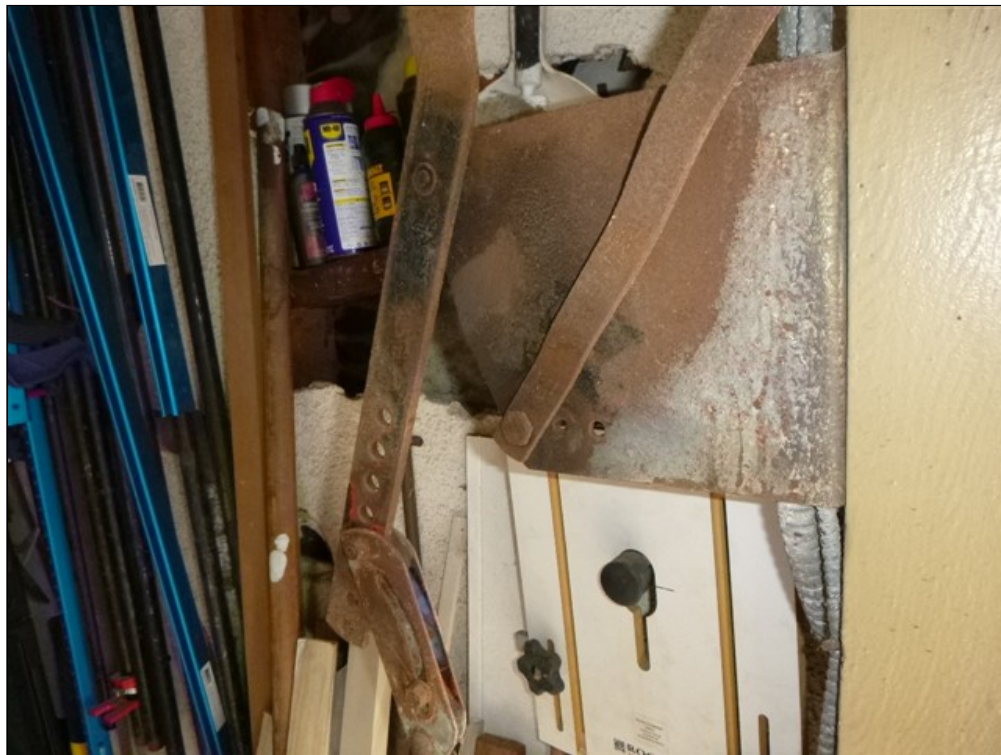
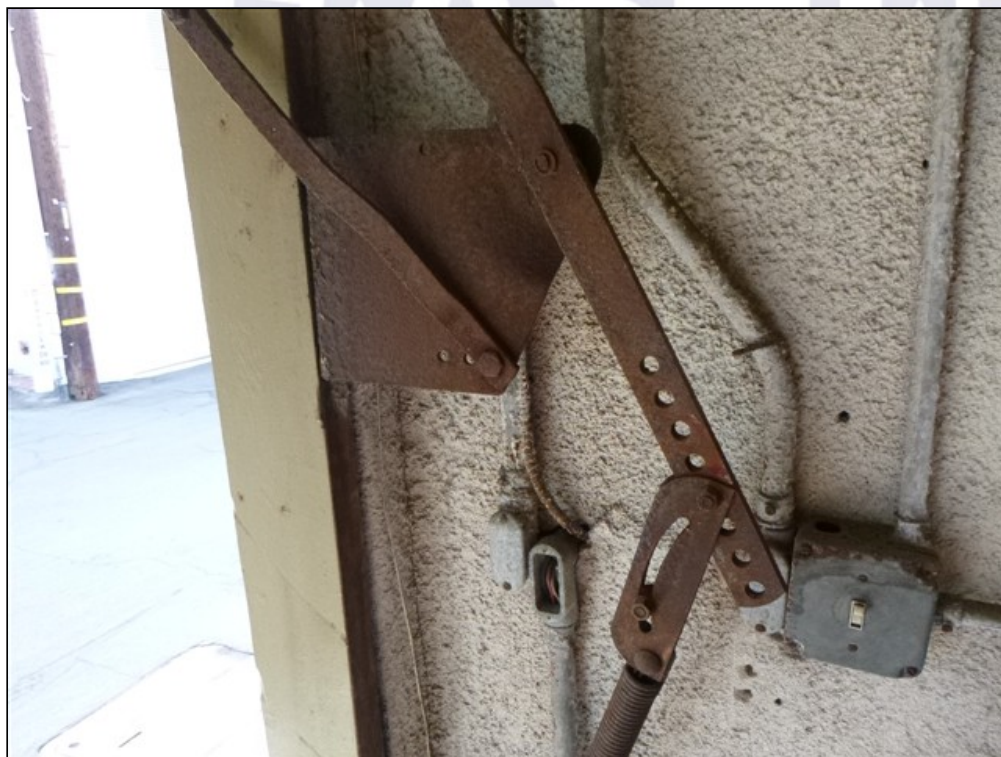
Bent and damaged hinge hardware was noted, this is a potential safety hazard. Suggest review with a licensed contractor for repair/replacement costs as needed.

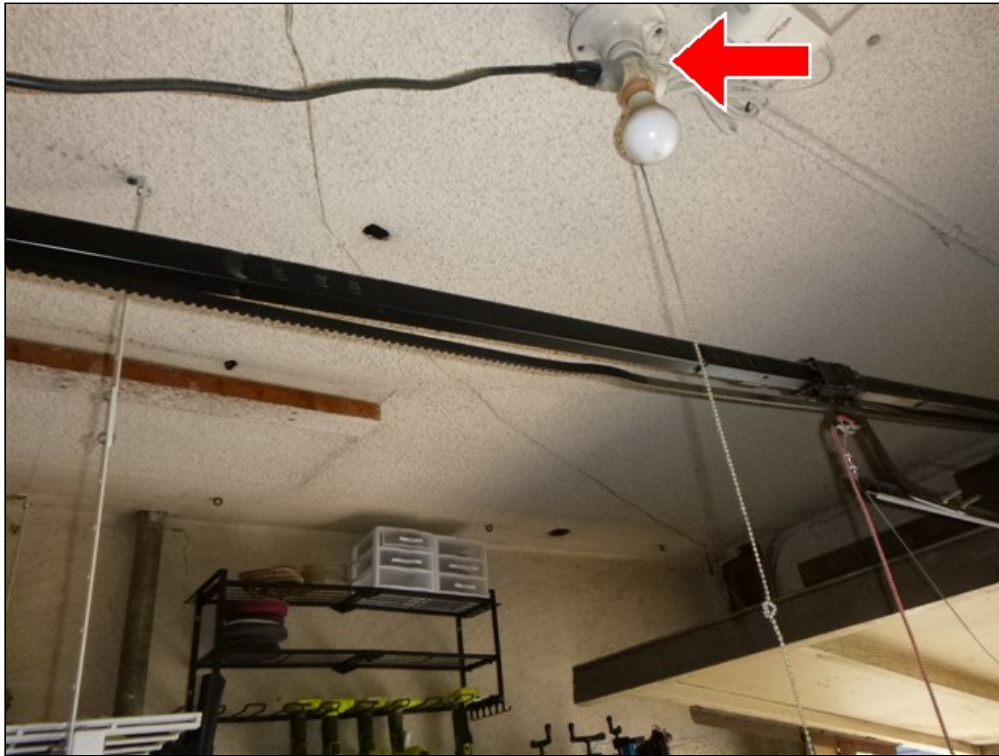
7.3 Item 2(Picture)

(3) The garage door opener is currently improperly wired into the light fixture. Suggest review with a licensed electrician for costs to install a dedicated hard wired outlet adjacent to the garage door opener as required.

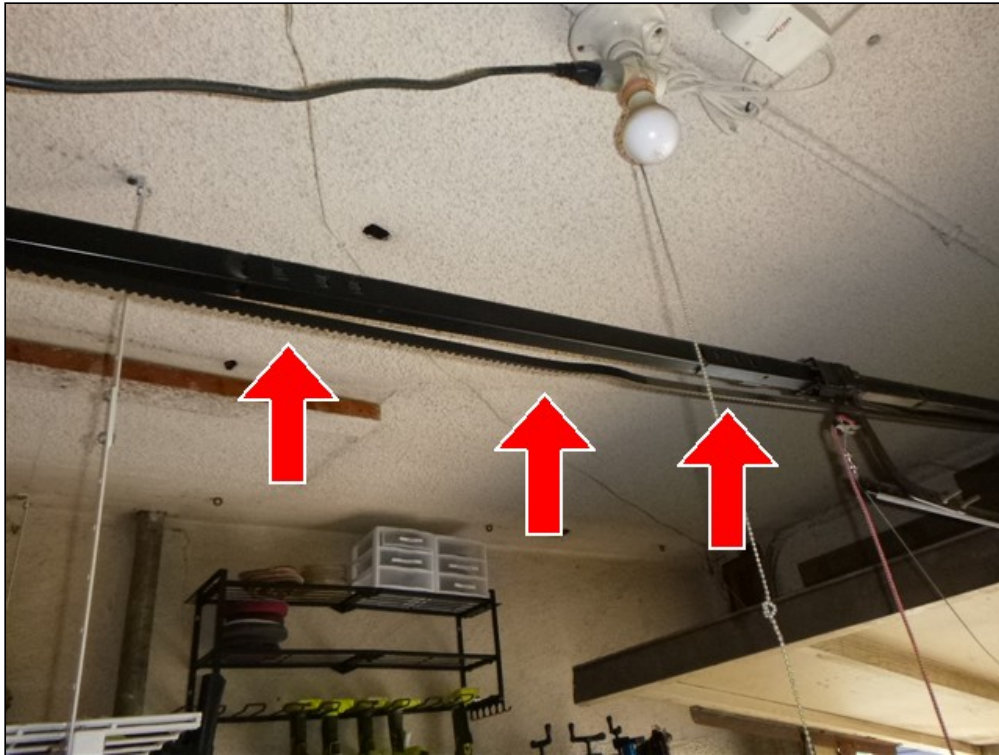
7.3 Item 3(Picture)

(4) The garage door opener(s) pull chain/rubber is excessively loose and periodically catches on the railing mount(s). Suggest review with a licensed contractor for costs to correctly tighten/tension the system as required and confirm correct operation as needed.

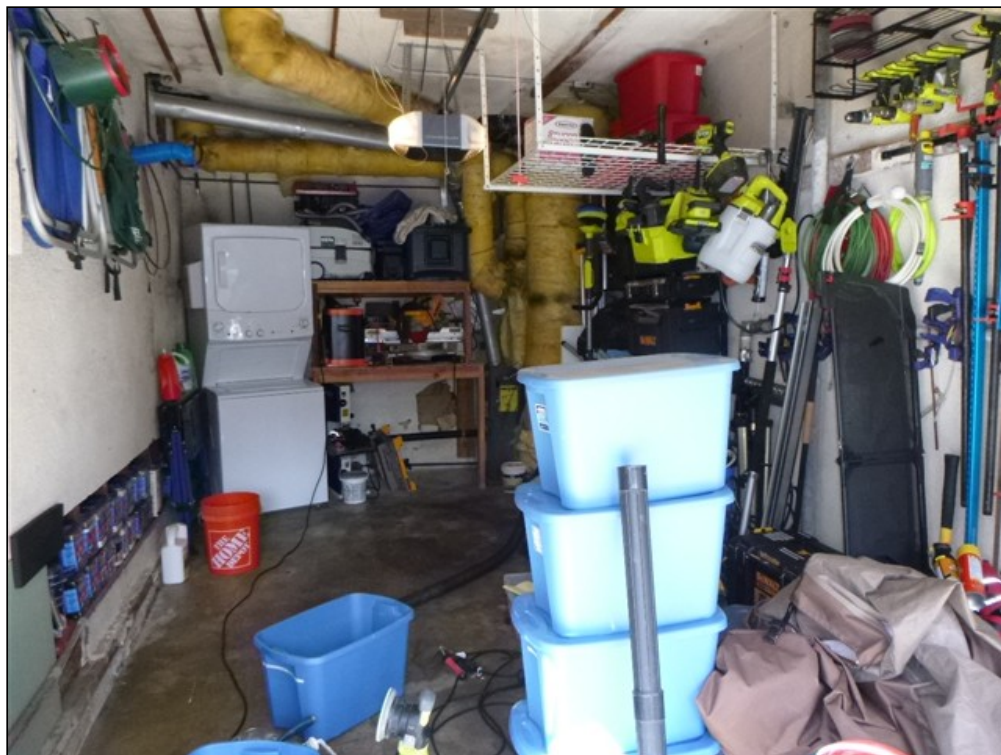
7.4 Item 1(Picture)

(1) The inspector was unable to make a complete inspection of firewall/ceiling due to a large concentration of personal effects/vehicles etc. Suggest review of firewall/ceiling once the garage area has been cleared. If any breaches or damage to firewall/ceiling is found, suggest review with a licensed contractor for costs to patch/repair/replace the affected areas with 5/8 fire-rated drywall to complete the firewall/ceiling as required.

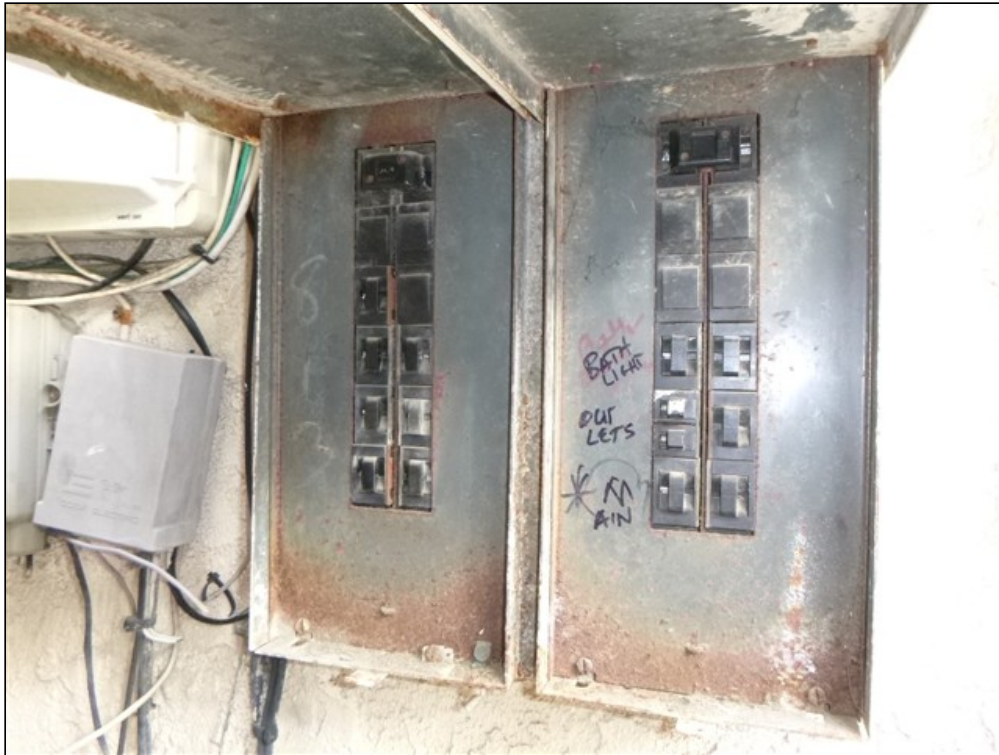
22.1 Item 2(Picture)

(2) Suggest adding correct/complete indexing/labelling to all breakers for identification of each circuit for safety.
