RESIDENTIAL INSPECTION

3360 Kallin Ave Long Beach, CA 90808

Frank Anarumo
Certified Master Inspector; NACHI14090311
(CPI); CREIA #166950; IAC2 Cert. #IAC2-03-7334; CRT # 2019121114; CCPIA-000545, Branch 2 & 3 Field Representative 65837
(Green Mantis Pest Control), NFPA Member 1113628417
3109256664

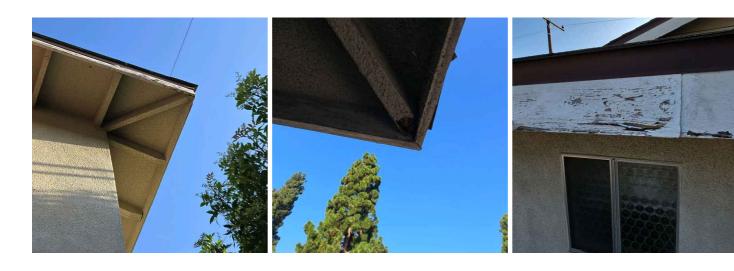
One or more sections of the trim are deteriorated. Recommend a Termite Company evaluate the whole home.

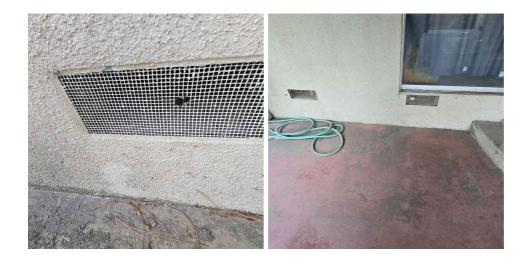
VENT SCREENS - DAMAGED

1 or more vent screens are torn, damaged, and/or missing. Recommend correcting.

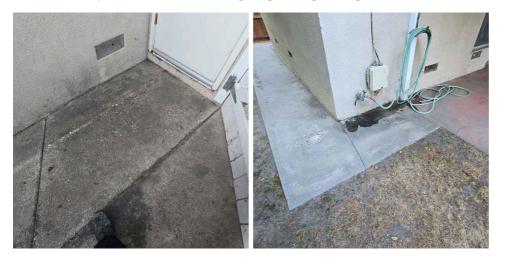
5.17.1 Grading and Drainage

Grading is sloping towards the home in some areas. This could lead to water intrusion and foundation issues. Recommend qualified landscaper or foundation contractor regrade so water flows away from home.

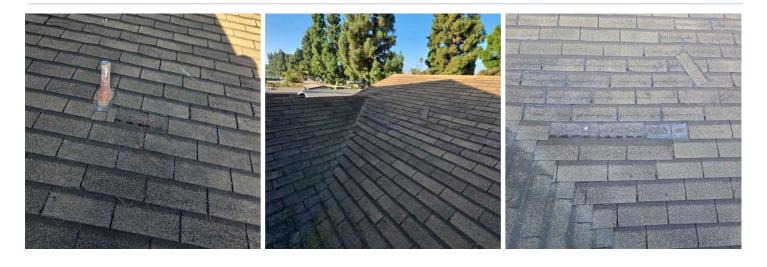
Roof shows normal wear for its age and type. We recommend repairs be made in the few areas where roofing materials are damaged or missing. Recommend a qualified roofing professional evaluate and repair.

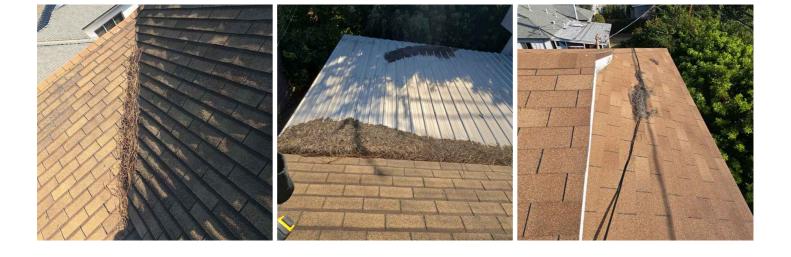
Suggest clearing all debris from roof. Debris left on roof may retain moisture and cause that section of roof to age prematurely.

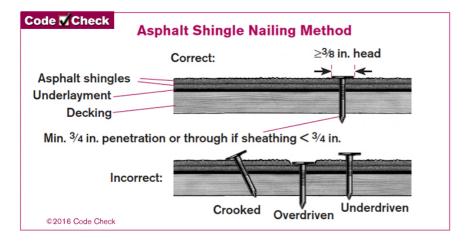
Observed one or more exposed / under-driven nails/fasteners. Suggest sealing exposed nail heads. Recommend a qualified roofing contractor evaluate and repair.

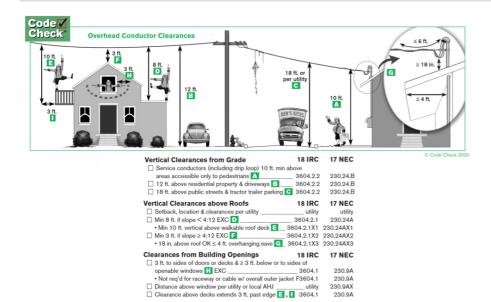
Wires laying on the roof Are damaging roof. Recommend raising to proper height or removing wires.

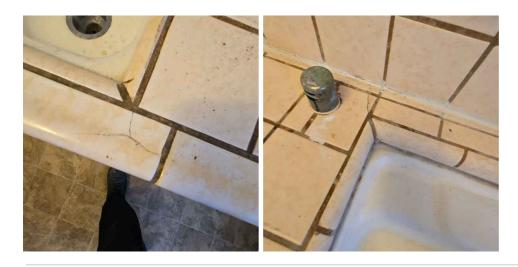
COUNTERTOP - DAMAGED MATERIAL

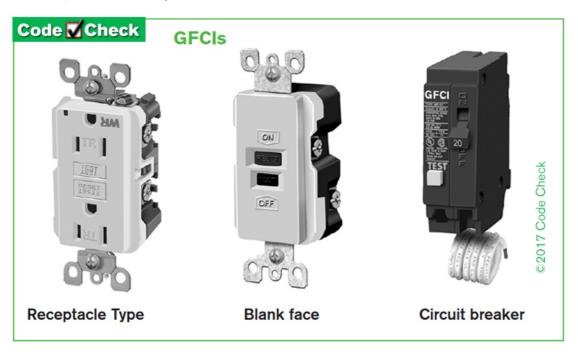
There is no ground fault interrupter in this area (which should be the entire counter) which may not have been standard at the time of construction. However, todays standards require ground fault interrupters at all areas within six feet of running water and external outlets. We suggest installing a ground fault interrupter in this area as a safety upgrade. If it is connected to a GFI and NOT labeled this is still improper.

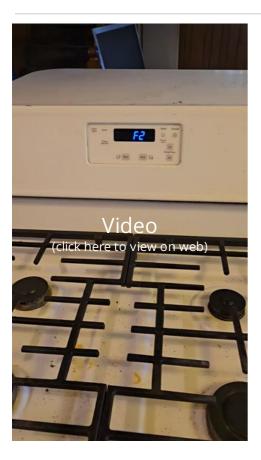
TOUCH SCREEN IS UNRESPONSIVE AND ERROR CODE
