Inspection Report

Property Address:
447 E Hullett St
Long Beach CA 90805

Ferguson Home Inspections

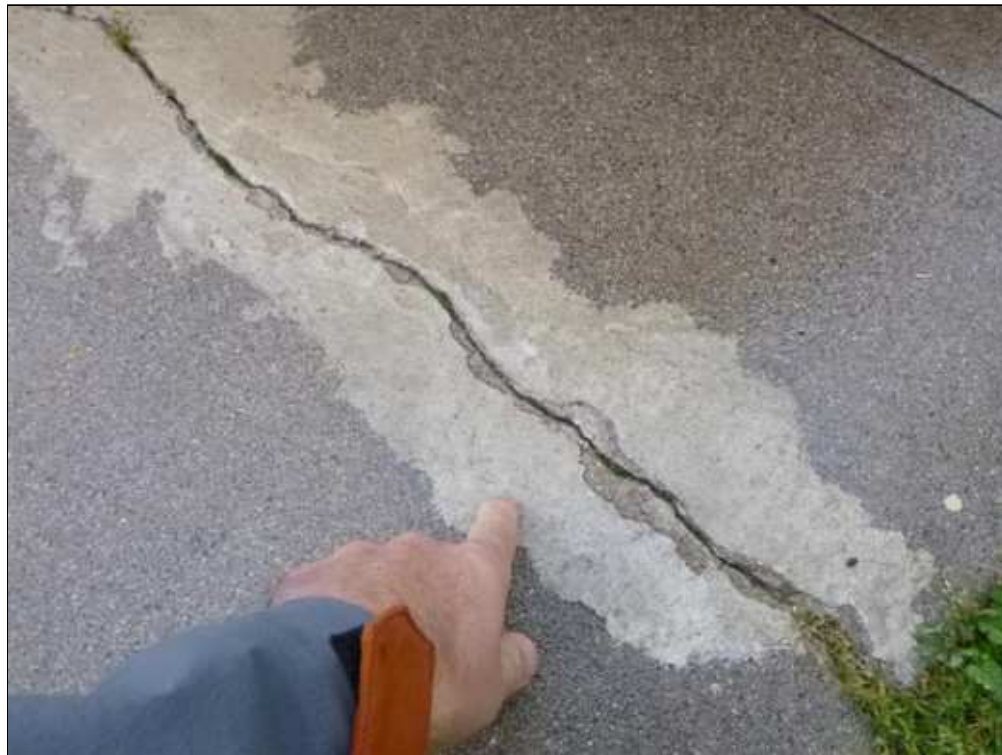
1.0 Item 1(Picture)

1.0 Settling, expansion cracks and heaving noted at various areas, this is a potential trip hazard. Suggest review with a licensed contractor for repair/replacement costs as needed.

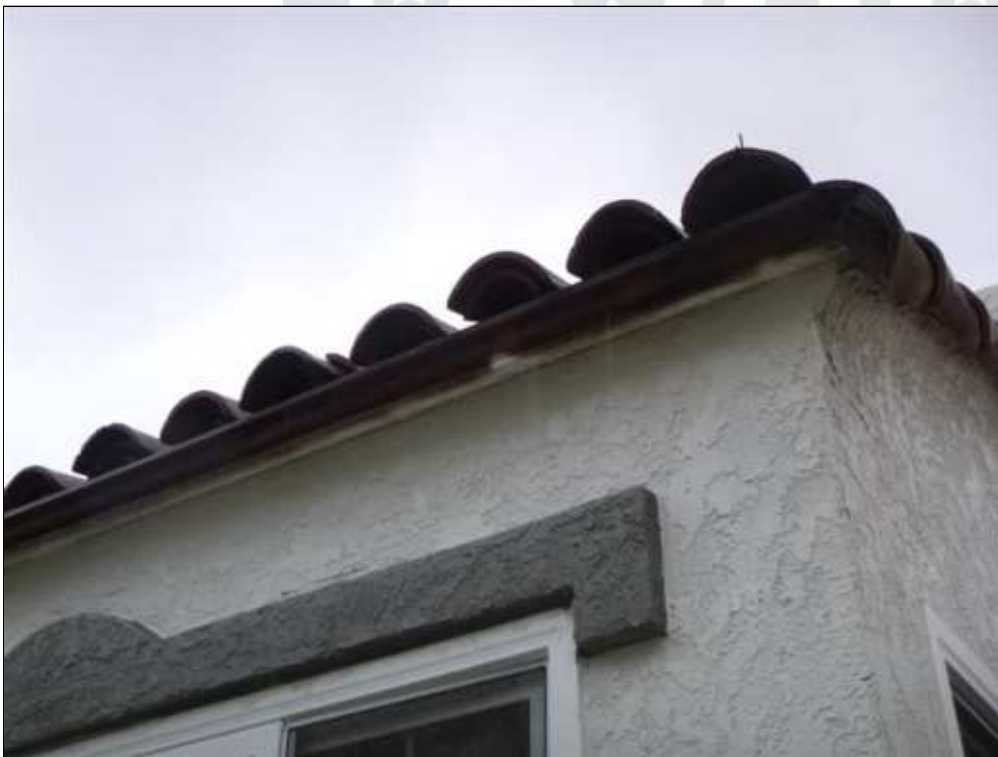
1.9 Item 2(Picture)

1.9 (2) The gutters are rusted and deteriorated at various areas, suggest replacing the gutters as needed.

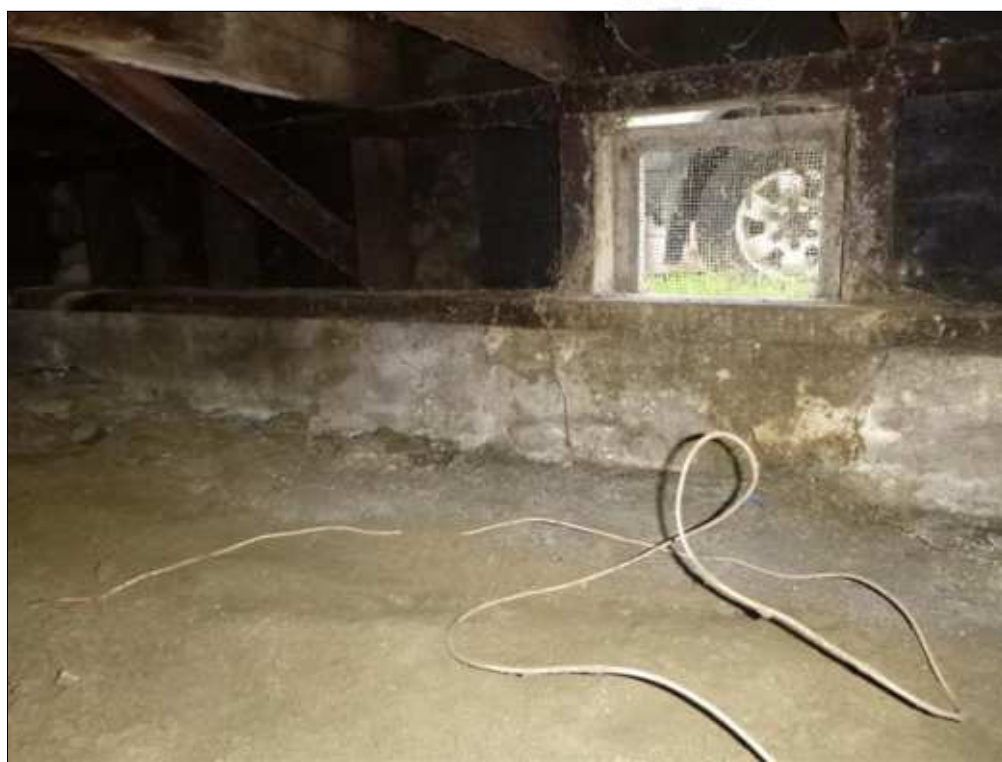
3.0 Item 1(Picture)

3.0 (2) White efflorescence (powder substance) on foundation footings indicates prior, and possibly ongoing, excessive moisture build up at the exterior of the foundation. Ongoing water intrusion at the foundations can, in some cases, cause the steel in the foundations to rust, called spawling, which can lead to horizontal cracking of the foundation (currently there are no major cracks visible at the foundation). Any future cracking/damaged can be an expensive repair as the foundation is now structurally weak and susceptible to horizontal movement. Suggest review of the Lot/Grade and drainage systems, including rain gutters, to reduce and prevent further and future water buildup at the exterior of the dwellings foundations.

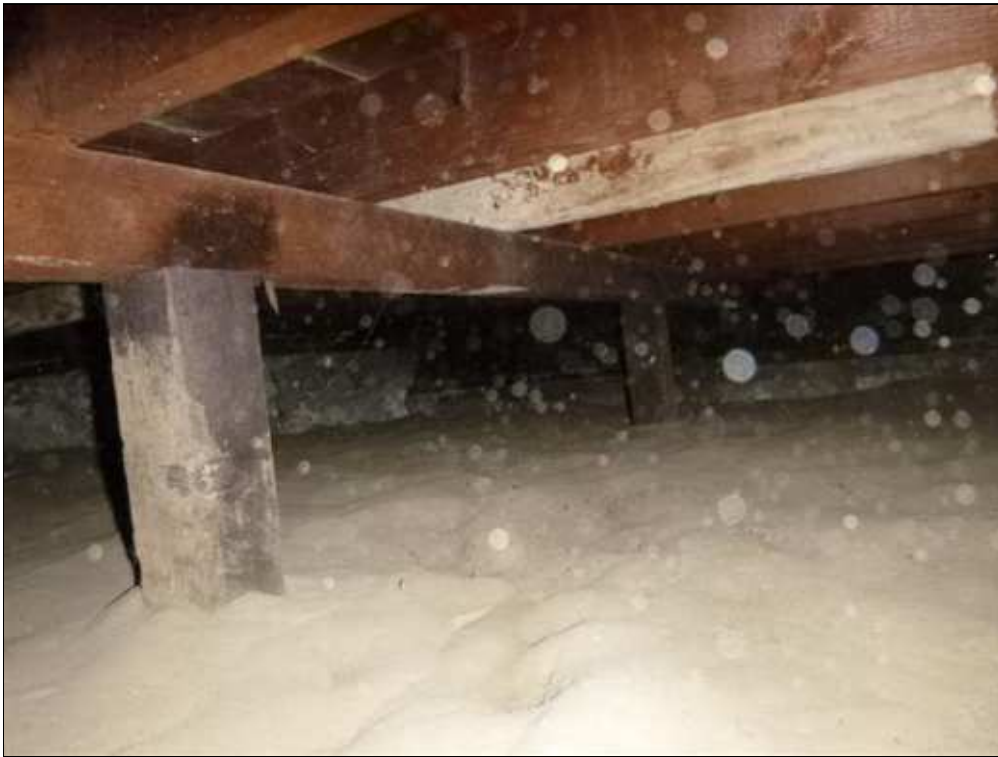
3.1 Item 4(Picture)

3.1 (2) Inadequate support noted at various girder beams due to the excessive span and inadequate support posts, common for the original age of the dwelling. Suggest review by a licensed contractor for costs to add additional supports to prevent possible future structural and floor movement as needed.

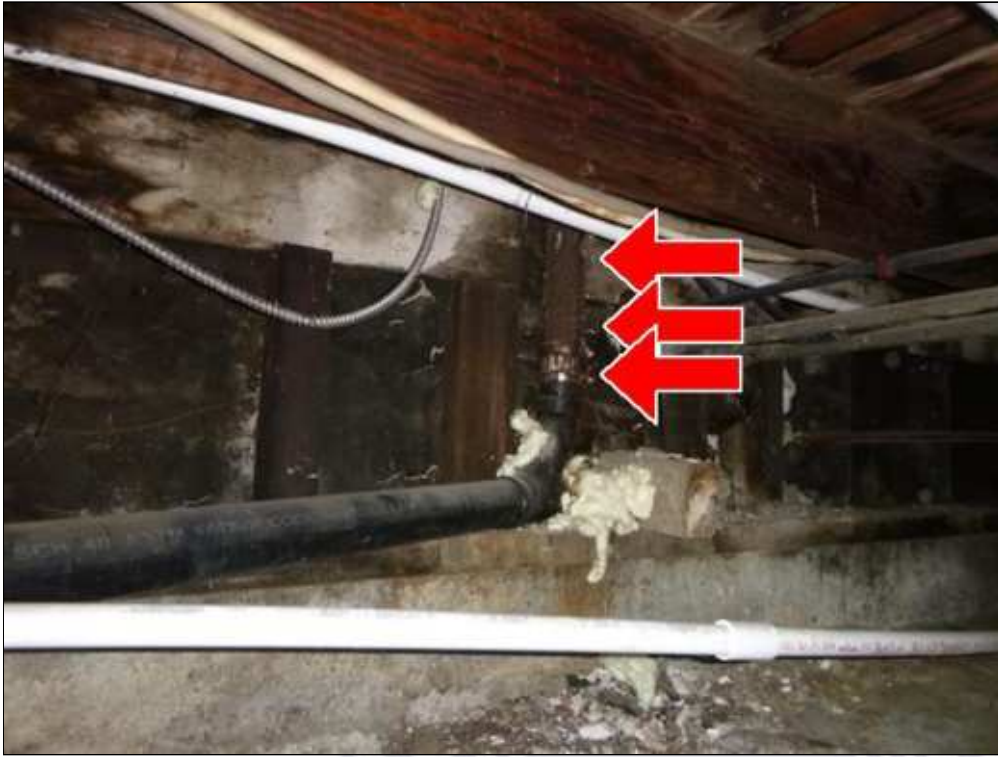
4.3 Item 5(Picture)

4.3 (1) Excessive rust, seepage and corrosion noted at various cast iron drain lines within the crawl space. Suggest review by a licensed plumbing contractor for replacement costs as needed to prevent future leakage at the crawl area.

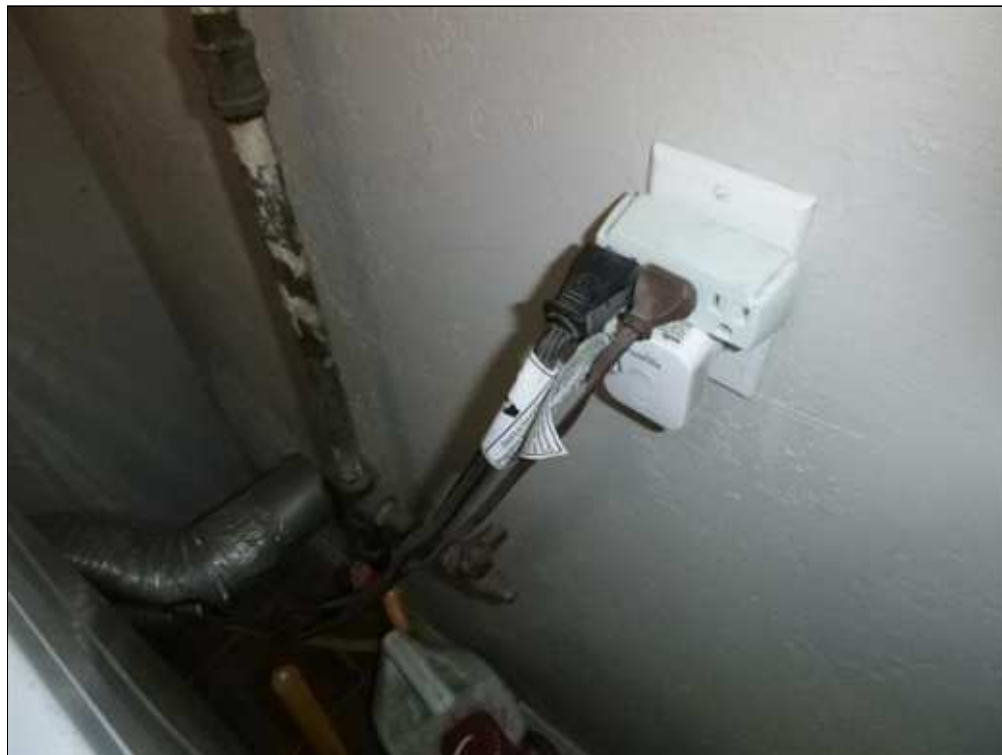
7.6 Item 1(Picture)

7.6 The appliances are currently being powered off a plug strip/extension cord, this is a potential fire hazard. Suggest remove the plug strip/extension cord and review by a licensed electrician for costs to install additional outlets as needed/required for safety.

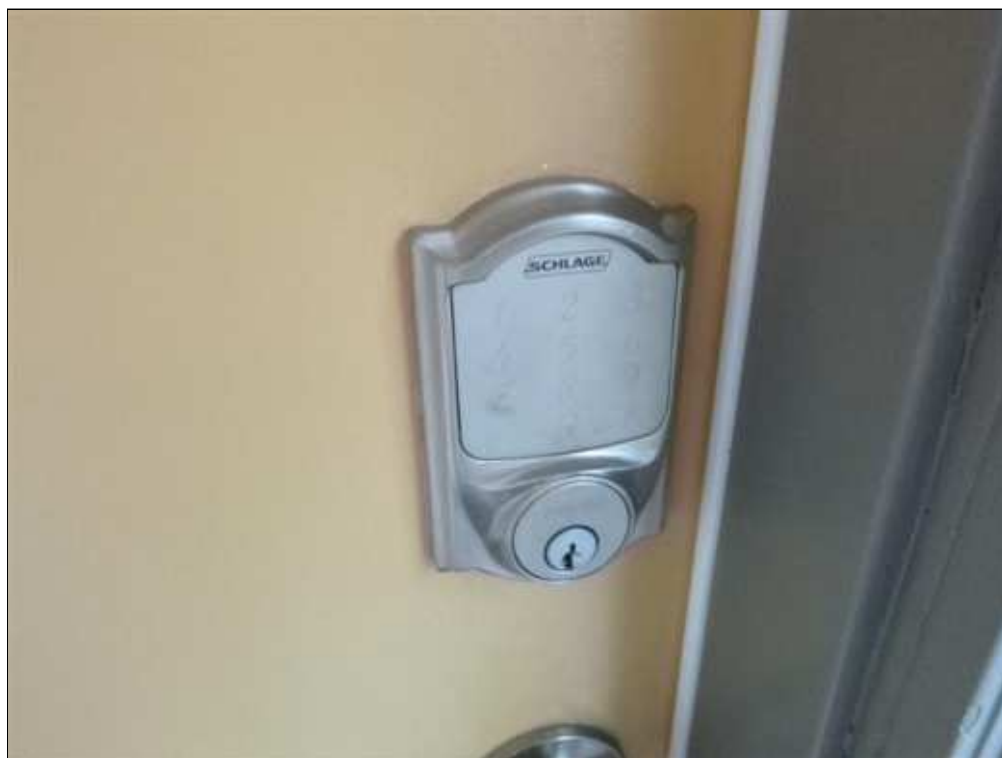
8.5 Item 1(Picture)

8.5 A keypad door lock system was noted. Suggest review with seller for operational brochure, codes for operation and confirm correct operation as needed.

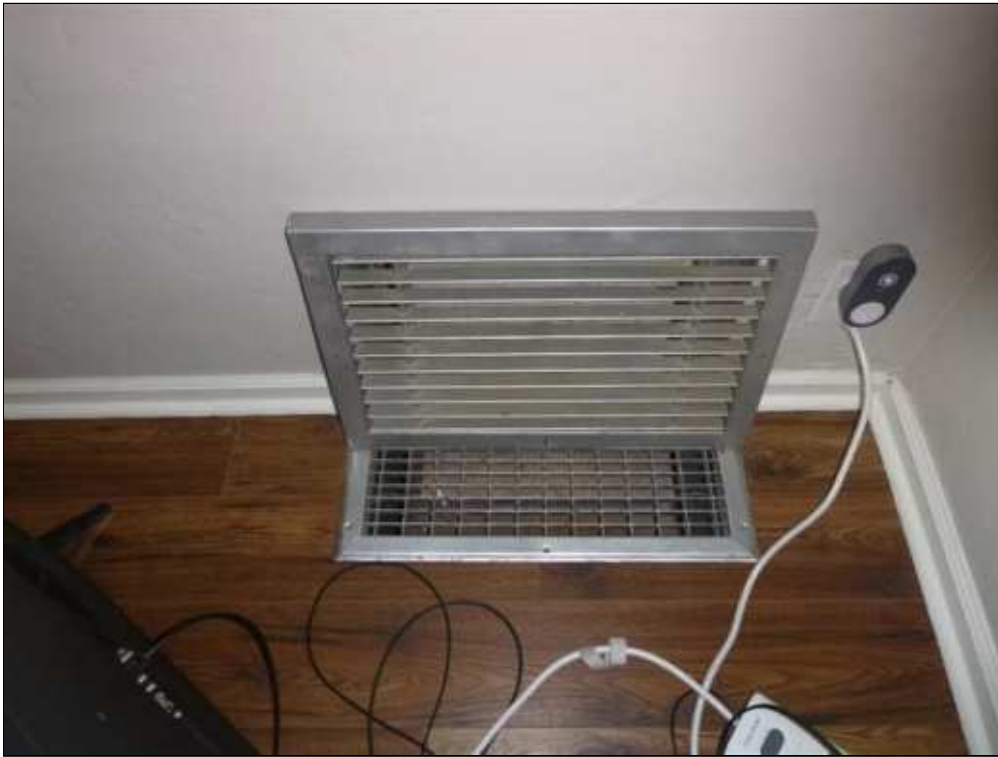
10.0 Item 1(Picture)

10.0 (1) The heater/furnace is very old but did work at the time of inspection. The inspector is unable to determine remaining life expectancy of this system. Due to the age and style of this system, suggest review with the Gas company and/or a licensed heating company for further review to determine the remaining life expectancy of the unit and any repair/replacements costs as needed

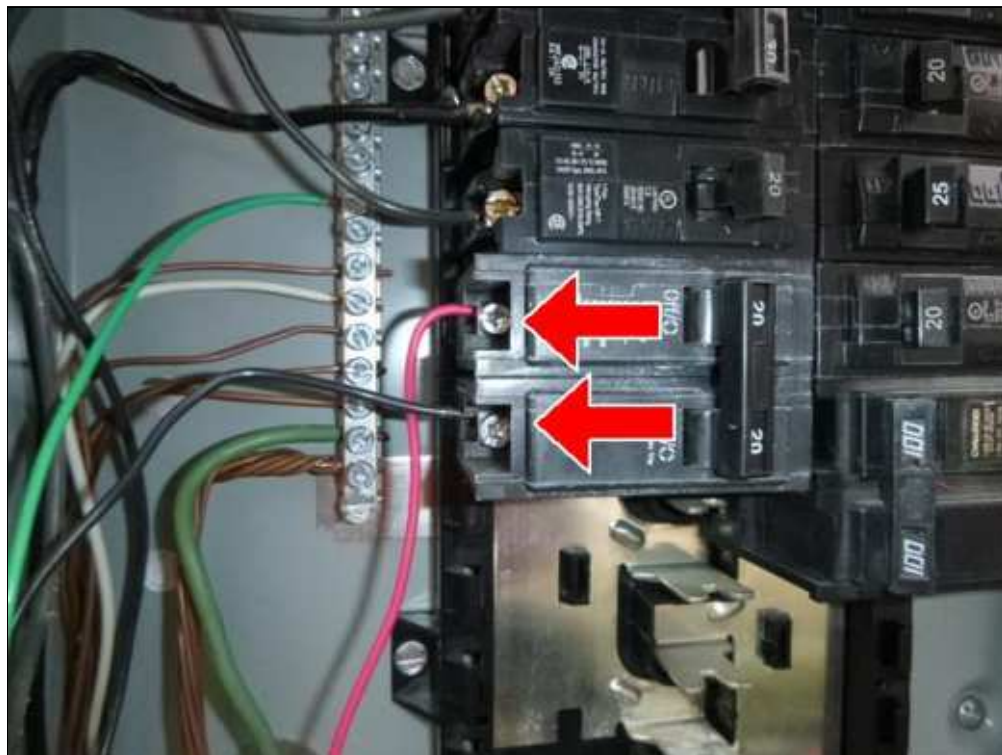
12.2 Item 1(Picture)

12.2 (2) A potential fire/safety hazard was noted due to the incorrect sized wiring connected to the breakers. 14 gauge wiring is currently connected to 20 amp breaker(s) in the sub panel, 15 amp breakers are required. Suggest review by a licensed electrician for any repair/replacement costs as needed.

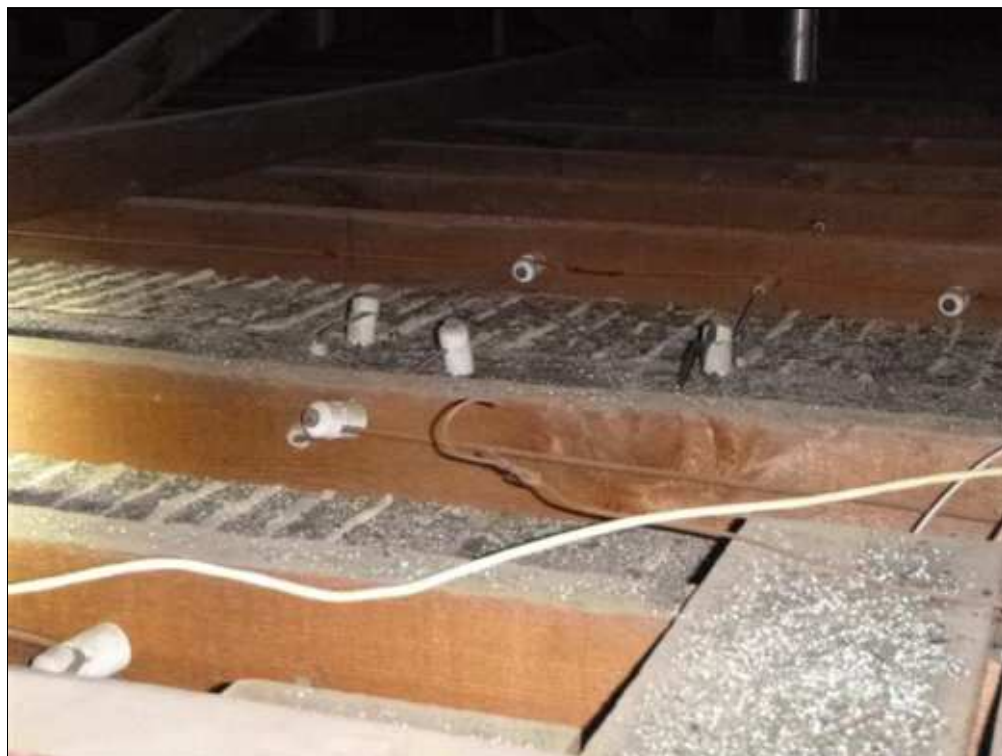
12.2 Item 2(Picture)

12.2 (3) Knob & Tube wiring noted throughout the attic area, this is common for the original age of the dwelling. Suggest review by a licensed electrician for replacement costs to upgrade the wiring to today's standards for safety.

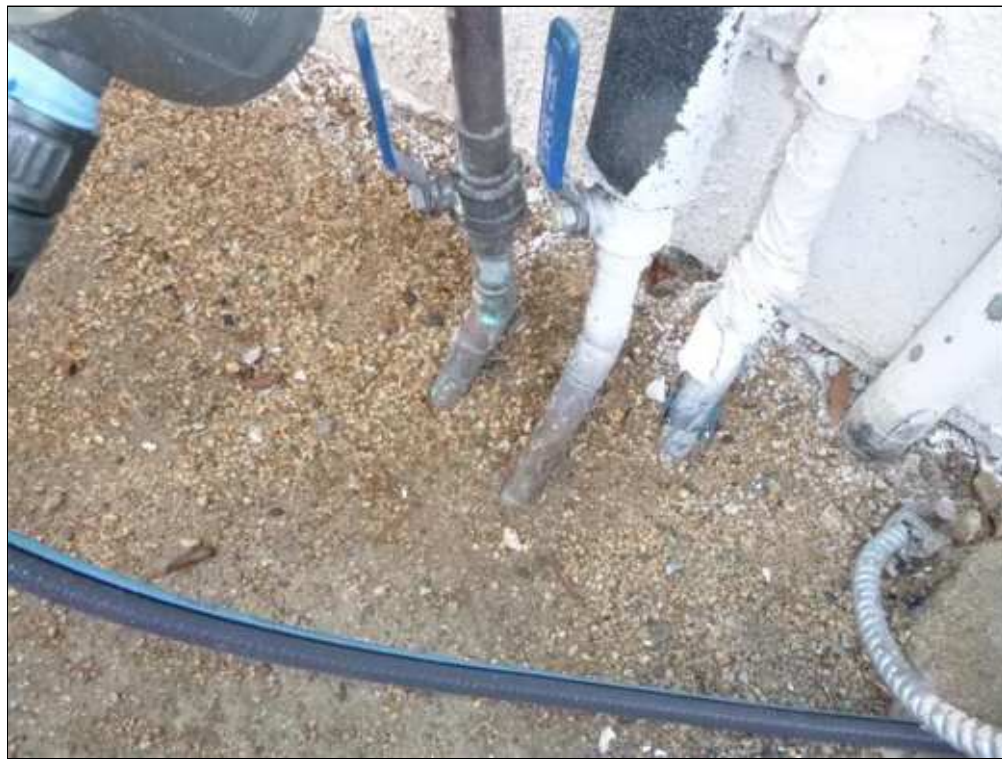
13.0 Item 1(Picture)

13.0 (1) The copper plumbing that transfers from the dwelling to the guest house/ADU area does not appear to be wrapped or insulated below grade. Suggest review by a licensed plumber and repair/replace as needed.

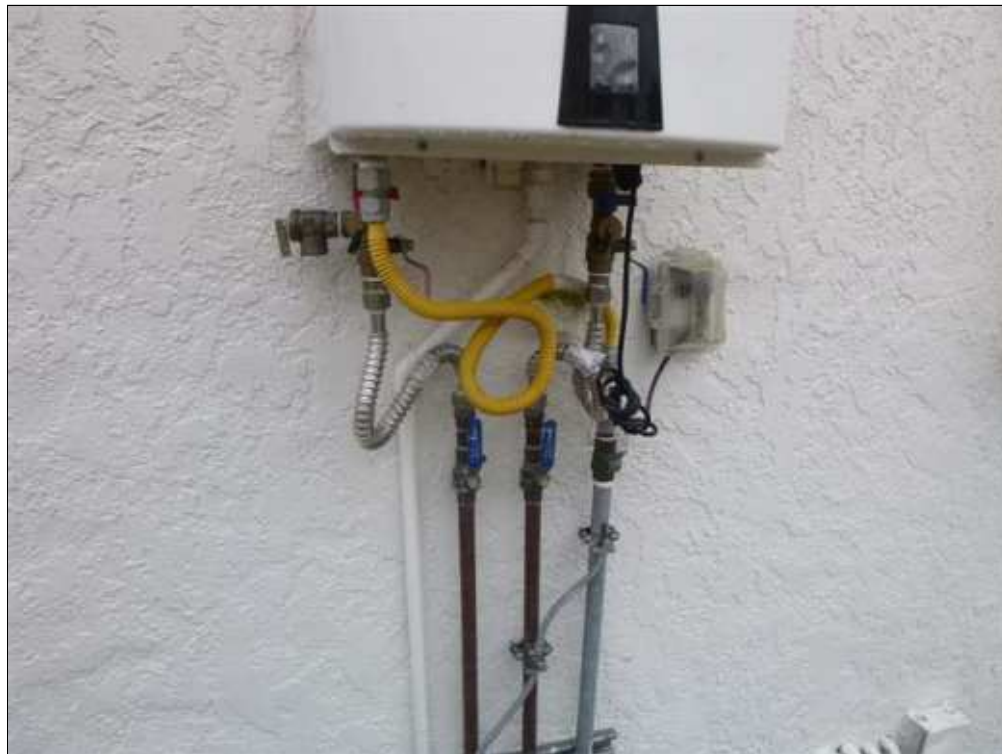
15.0 Item 2(Picture)

15.0 (3) The current water heater does not have a "Thermal Expansion tank" which is generally installed to prevent a possible leak at the T&P or "pop-off" valve and/or excessive pressure build-up at the internal plumbing, fixtures and joints. Recent changes (2012) require one when a new water heater is installed, but various cities do not enforce this installation for multiple reasons (the home is not on a closed system and various tankless units do not require it) . There were no leaks or drips at the T&P valve during inspection. If your water heater does begin to drip or leak, then a thermal expansion tank may be needed. Suggest review with the city and/or a licensed plumber to determine if this installation is required and install as needed.

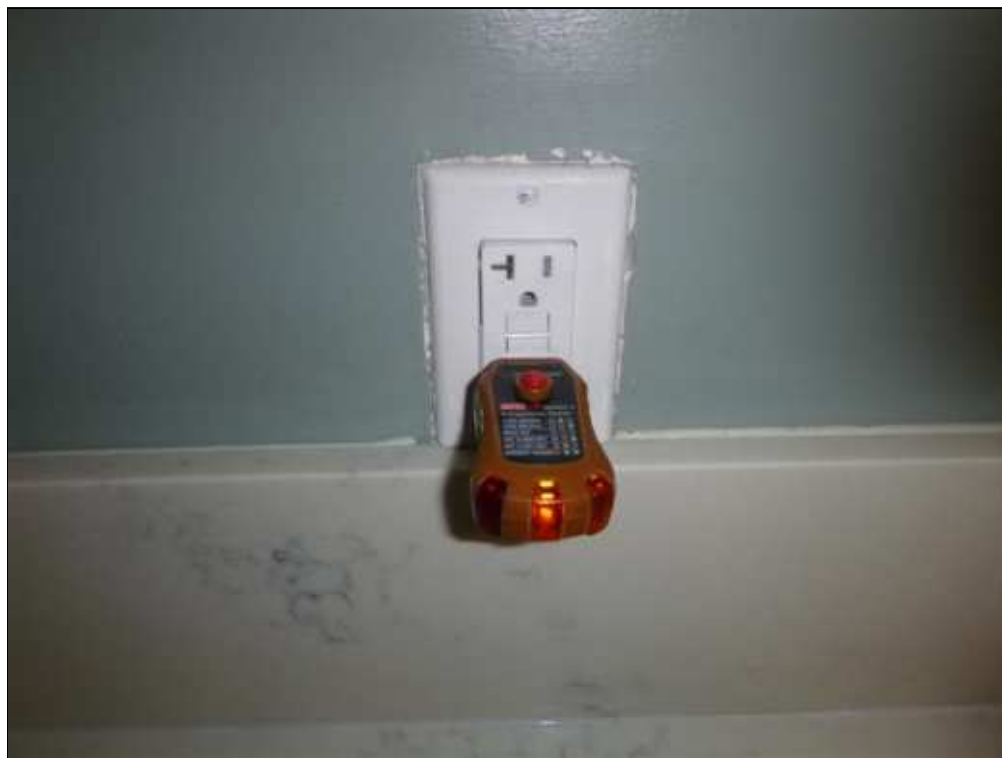
16.7 Item 3(Picture)

16.7 (3) The GFCI outlet(s) at this area are not grounded. The GFCI should still provide GFCI protection but the outlet should generally be grounded. Suggest review by a licensed electrician for repair/grounding cost as needed and required for safety.

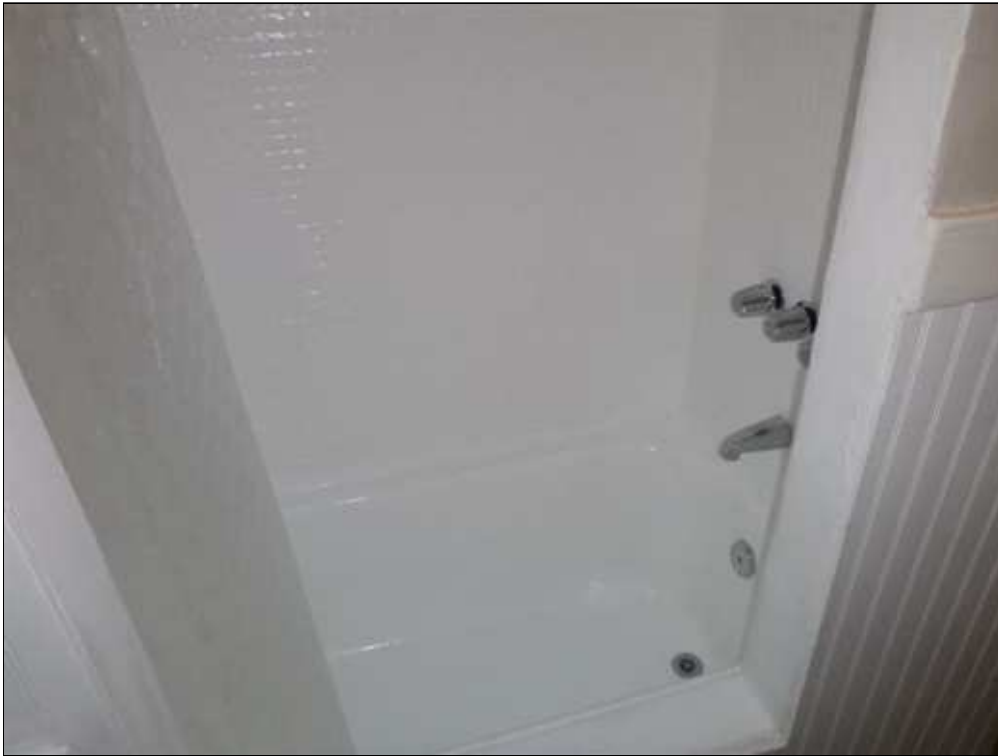
17.10 Item 1(Picture)

17.10 Reglazing noted at the shower wall tiles. Suggest review with the seller and/or installation company for care and maintenance requirements.

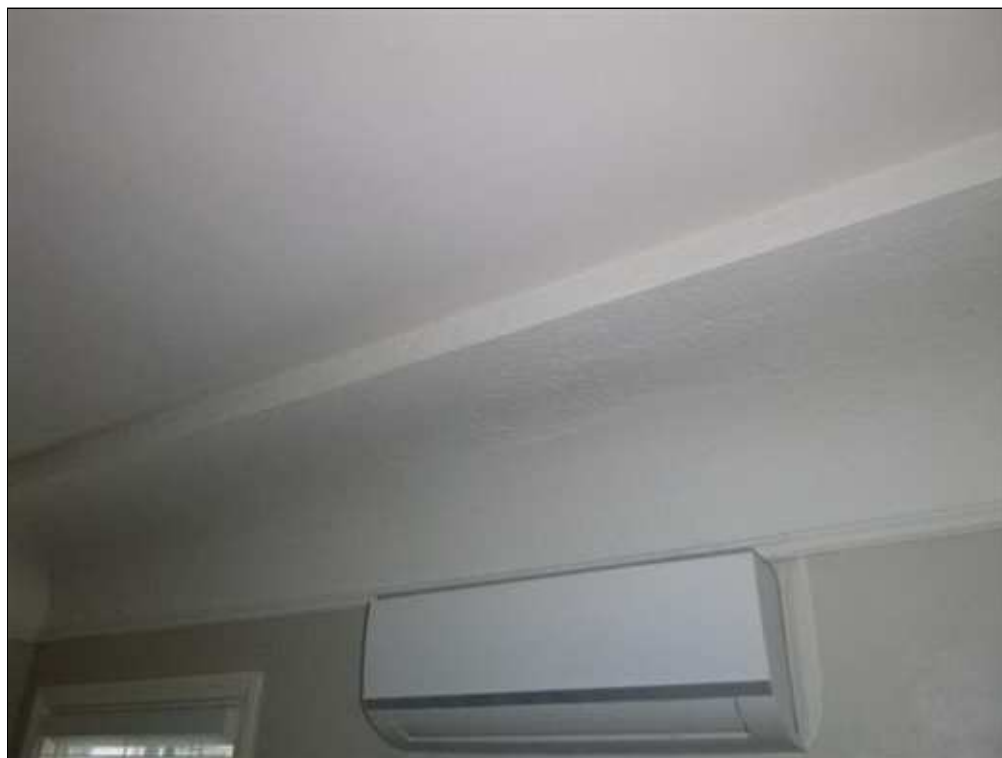
19.1 Item 1(Picture)

19.1 Patched areas of the walls was noted, suggest review with the seller for the cause and any repairs needed. Suggest repair as needed.

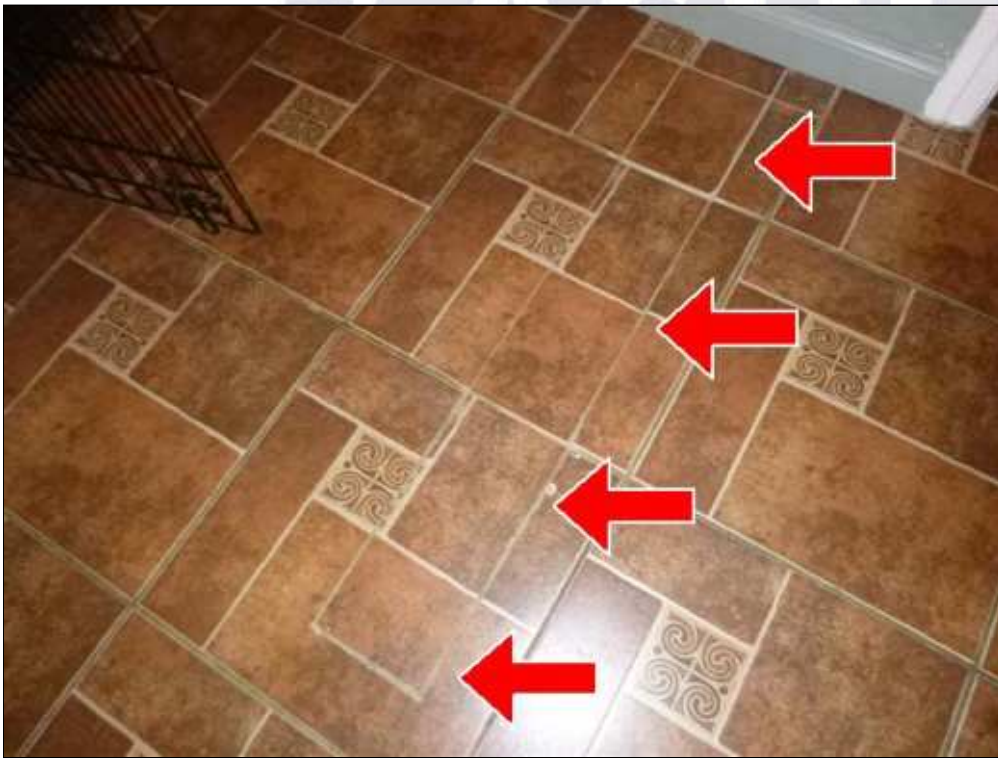
21.0 Item 1(Picture)

21.0 Patched repaired areas of the tile flooring was noted (this appears to be from a removed wall). Suggest review with the seller and/or a licensed contractor on this item as needed.

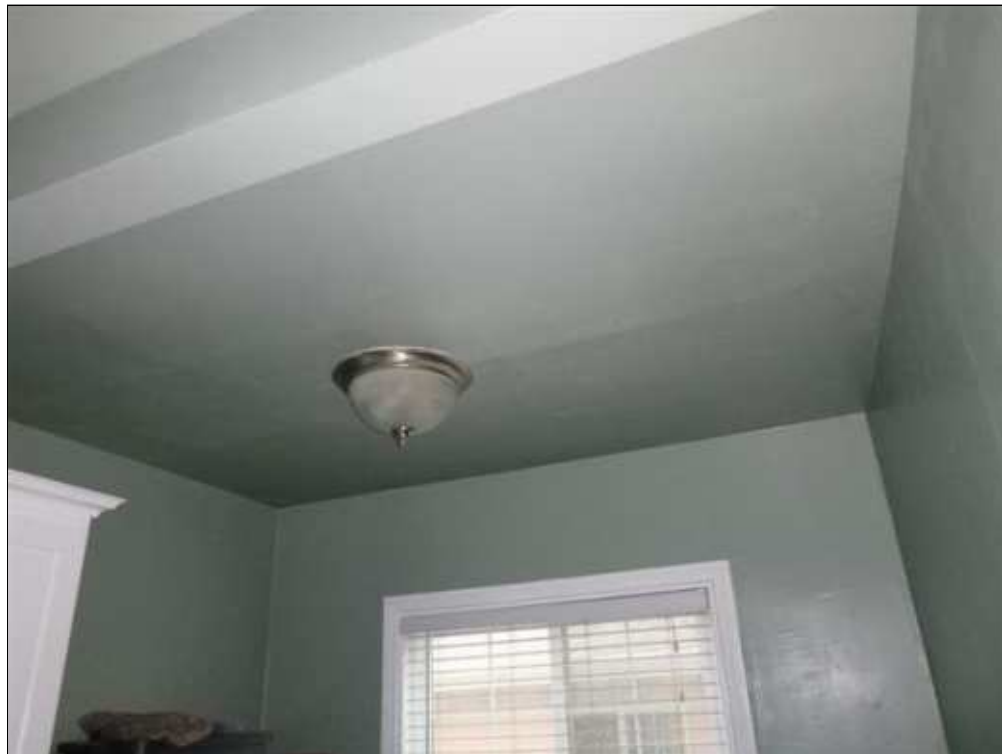
21.2 Item 1(Picture)

21.2 Patched and uneven areas of the ceiling was noted, suggest review with the seller on the cause and any repairs needed. Suggest review with a licensed contractor for any repair/removal/replacement costs as needed.

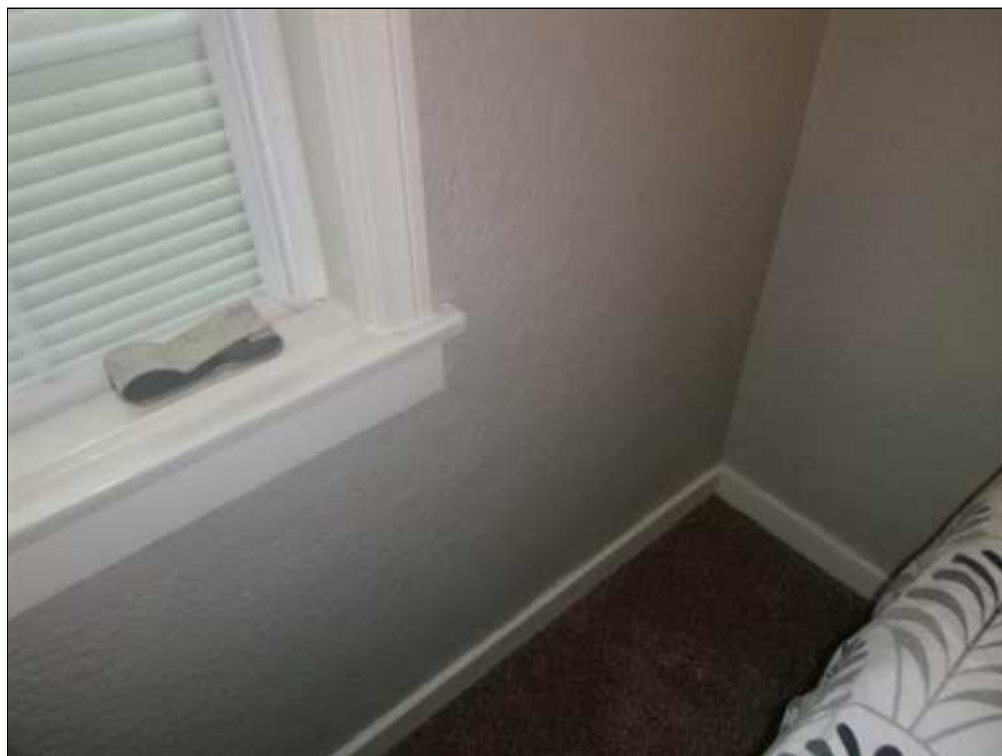
23.1 Item 1(Picture)

23.1 Patched areas of the walls was noted, suggest review with the seller for the cause and any repairs needed. Suggest repair as needed.

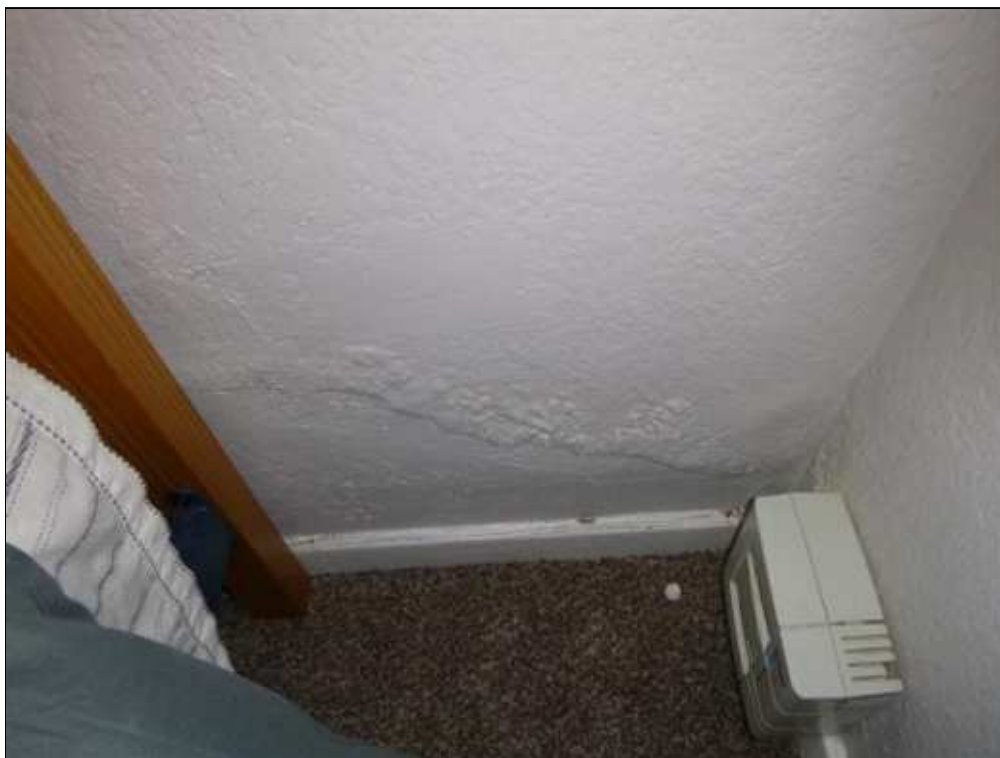
24.1 Item 2(Picture)

24.1 (2) Deteriorated/blistered/damaged areas of the front wall were noted (this area tested dry at the time of the inspection). This area is adjacent to the bathroom tub/shower area. Suggest review with the seller and/or a licensed contractor for any repair/removal/replacement costs as needed.

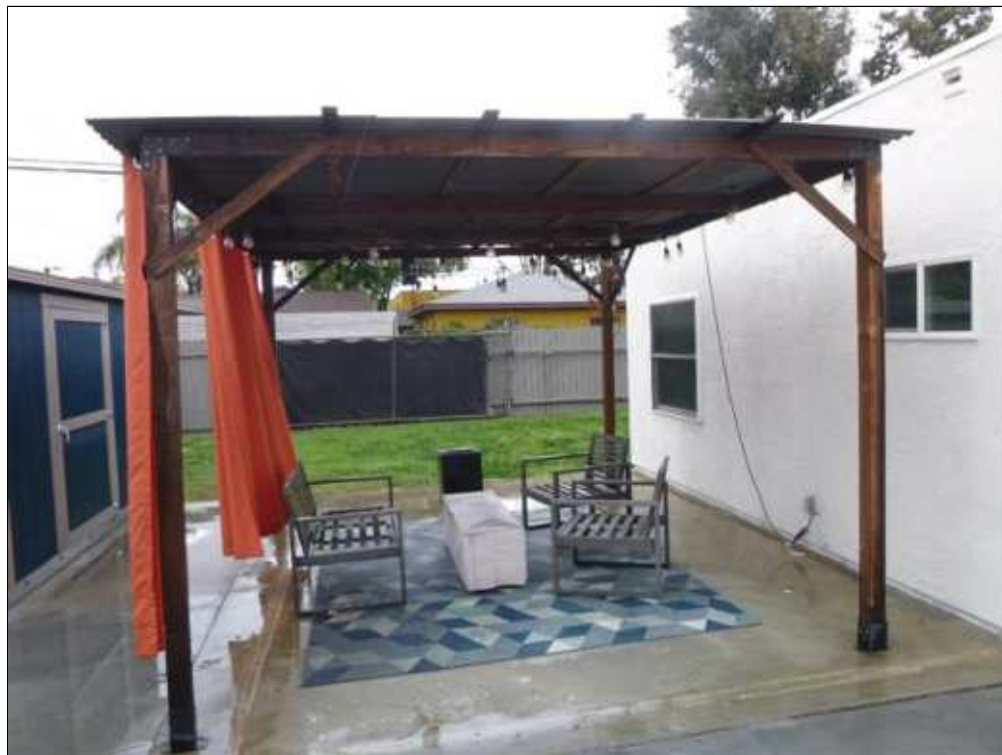
25.6 Item 1(Picture)

25.6 The wood awning at the left side is not currently bolted/secured to the concrete slab. Suggest review with the seller and/or a licensed contractor for costs to bolt/secure the awning as needed.

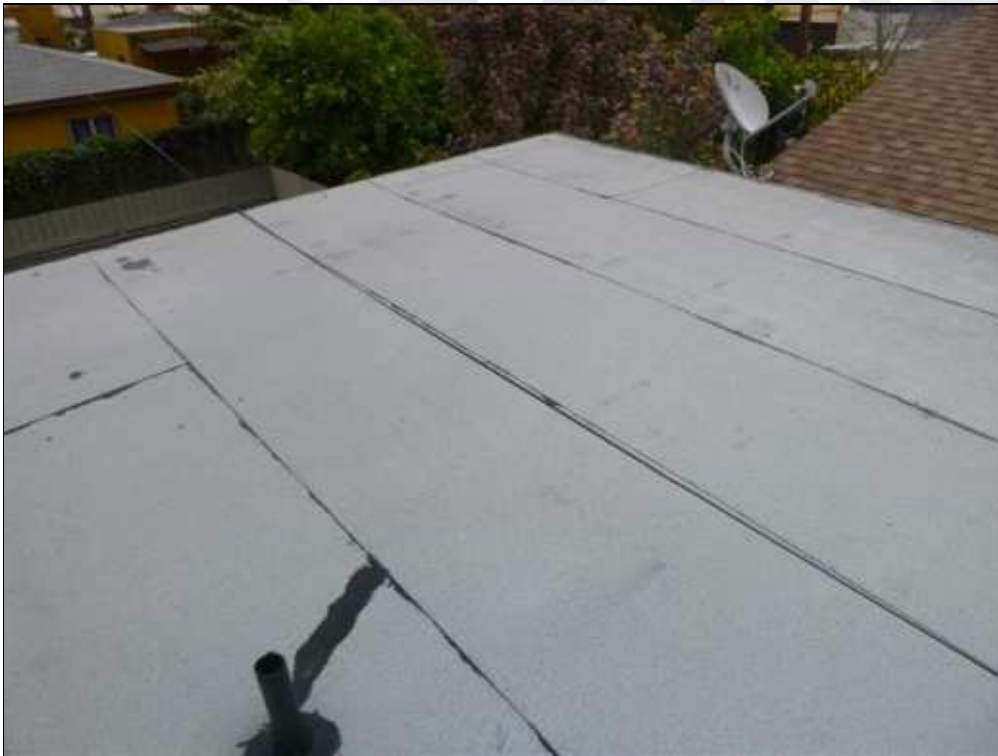
27.0 Item 1(Picture)

27.0 Patched and repaired areas of the roofing was noted. Suggest review with a licensed roofing contractor for any repair/replacement costs as needed and to determine the remaining life expectancy of the roof.

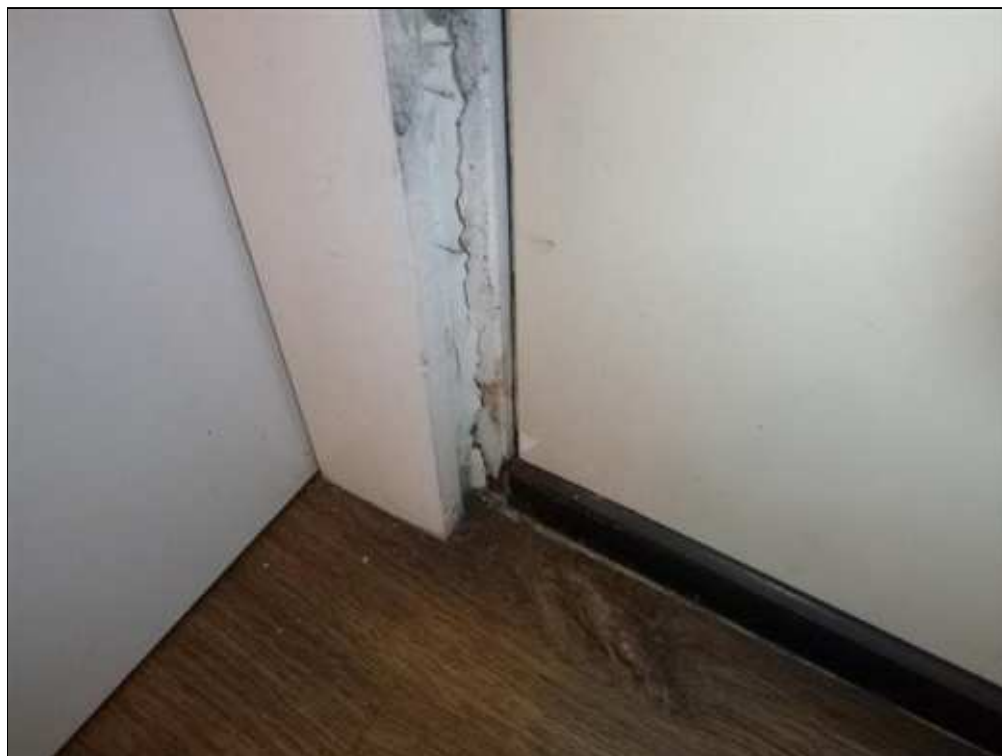
28.3 Item 3(Picture)

28.3 (3) Evidence of previous and ongoing water intrusion noted at the door(s) to the interior. Deteriorated and loose door trim/casings were noted. Suggest review with a licensed contractor for any repair/replacement costs as needed to prevent further and future water intrusion at this area.

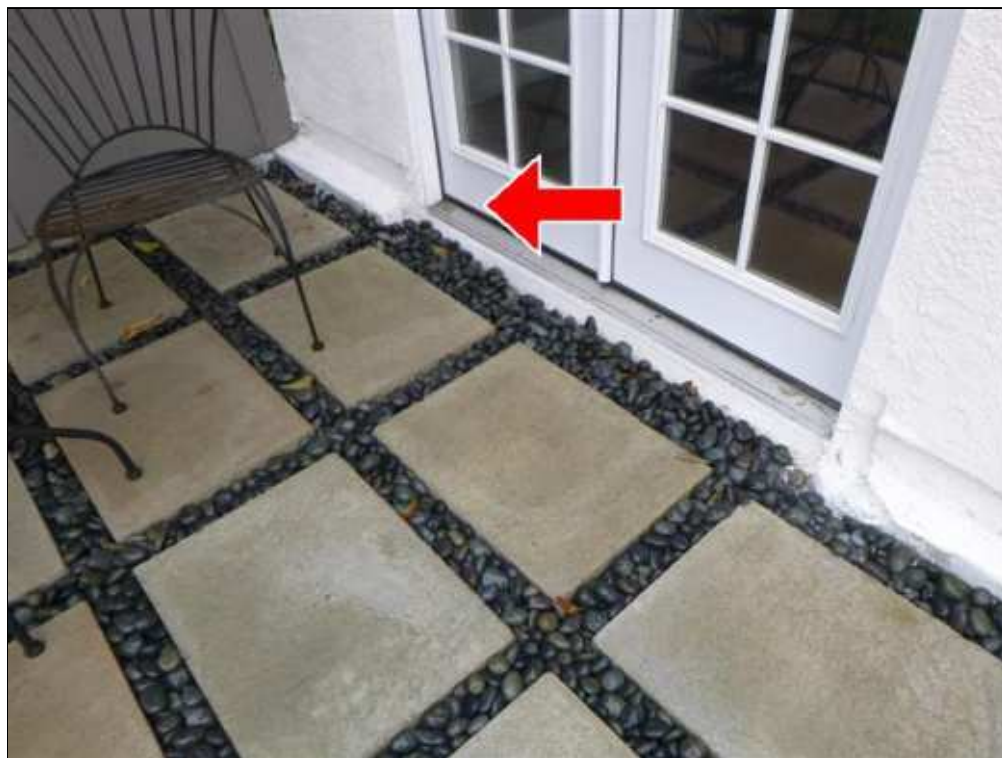
29.2 Item 1(Picture)

29.2 Evidence of previous and ongoing water intrusion noted at the door(s) to the interior. Deteriorated and stained flooring/baseboards noted. Suggest review with a licensed contractor for any repair/replacement costs as needed to prevent further and future water intrusion at this area.

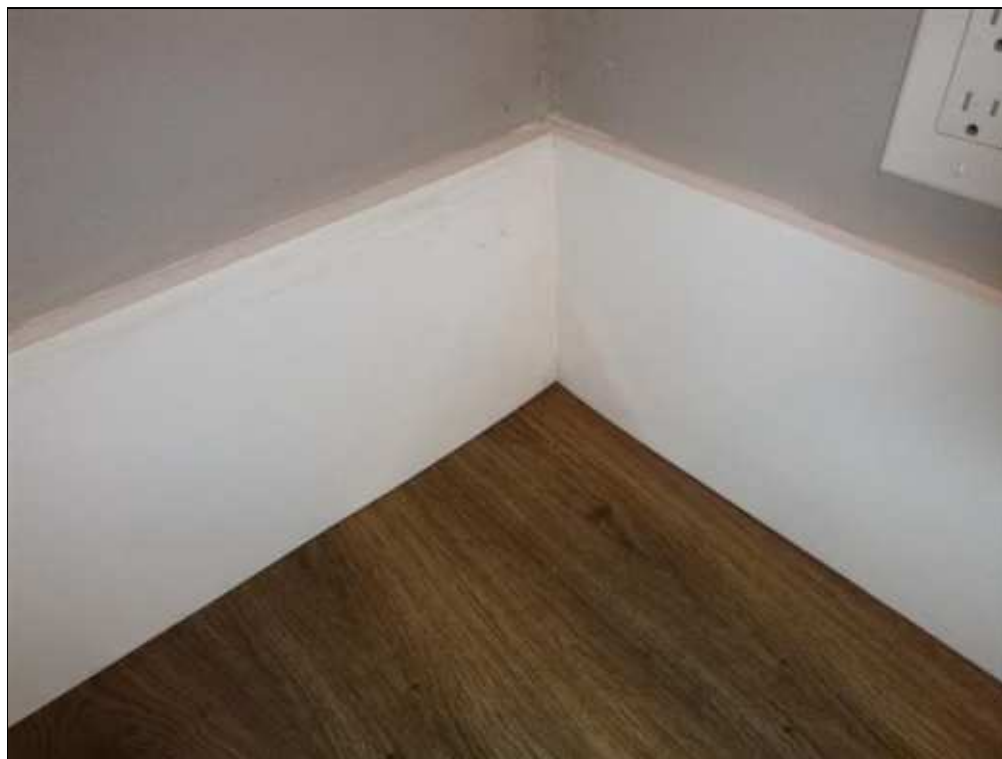
35.1 Item 1(Picture)

35.1 Stains, deterioration and water damage noted at the walls (this area tested positive for moisture at the time of the inspection). Suggest review with the seller and/or a licensed contractor to determine/verify the source of the leak and any repairs needed. Suggest review with a licensed contractor for repair/removal/replacement costs as needed.

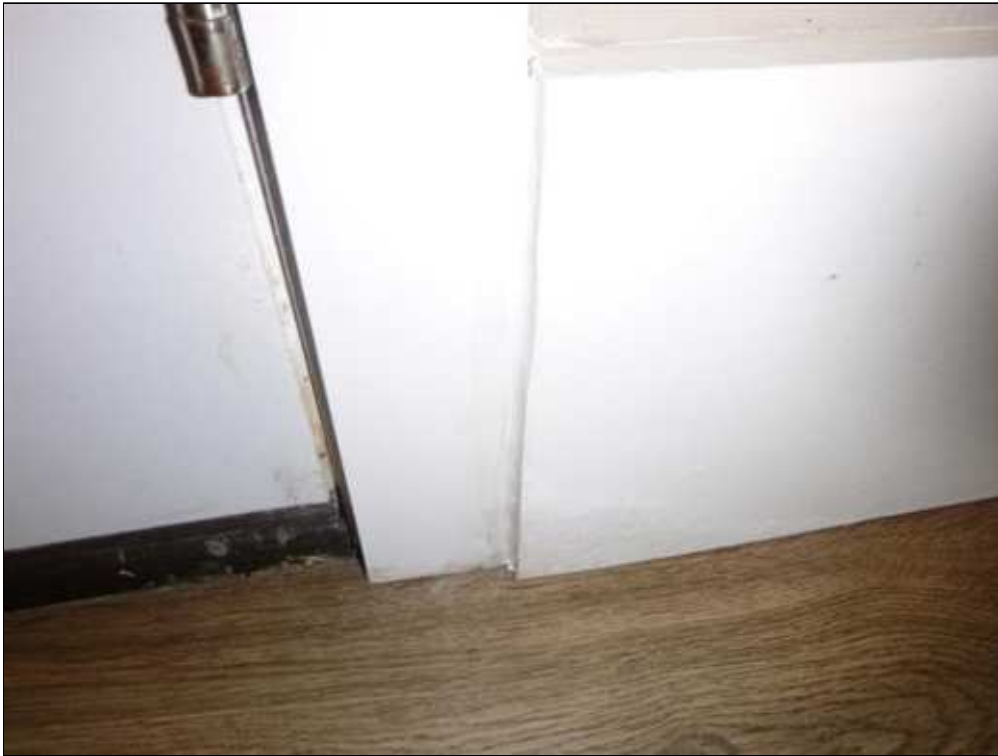
35.3 Item 1(Picture)

35.3 (2) Evidence of previous and possible on-going water intrusion was noted at the door(s) to the exterior (this area tested positive for moisture at the time of the inspection). Suggest review with a licensed contractor for any repair/removal/replacement costs as needed.

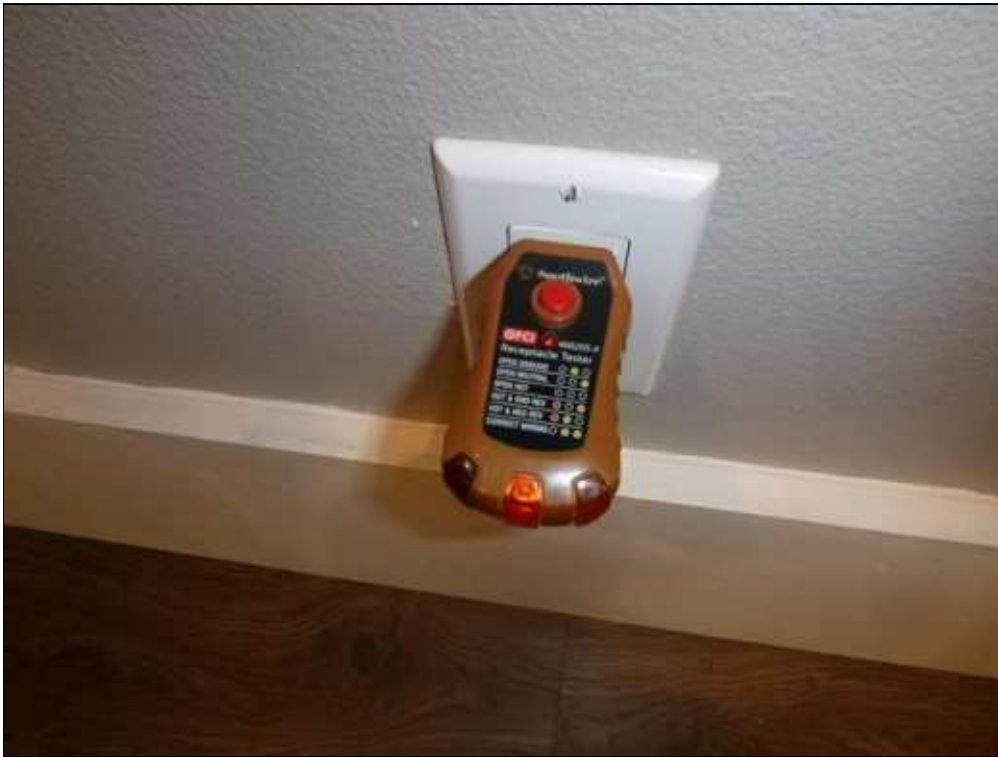
35.6 Item 1(Picture)

35.6 Ungrounded three prong outlets noted at this area. Suggest review with a licensed electrician for costs to ground the outlets as needed as an upgrade and/or protect the outlet(s) on a GFCI circuit where recommended.

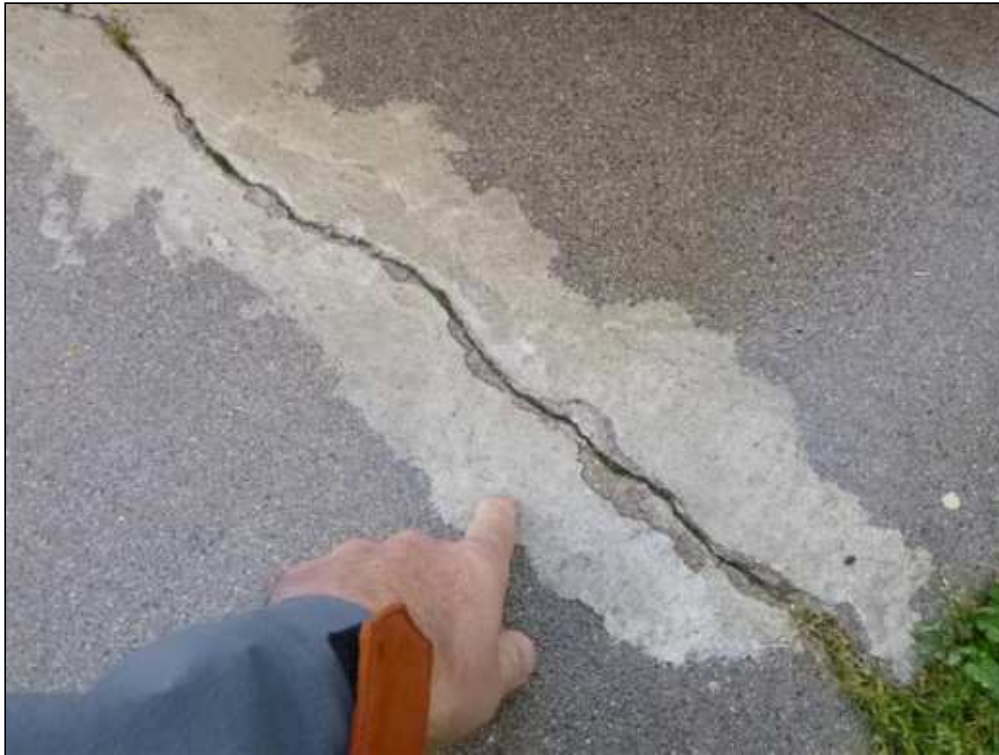
1.0 Item 1(Picture)

Settling, expansion cracks and heaving noted at various areas, this is a potential trip hazard. Suggest review with a licensed contractor for repair/replacement costs as needed.
