Inspection Report

Property Address:
447 E Hullett St
Long Beach CA 90805

Ferguson Home Inspections

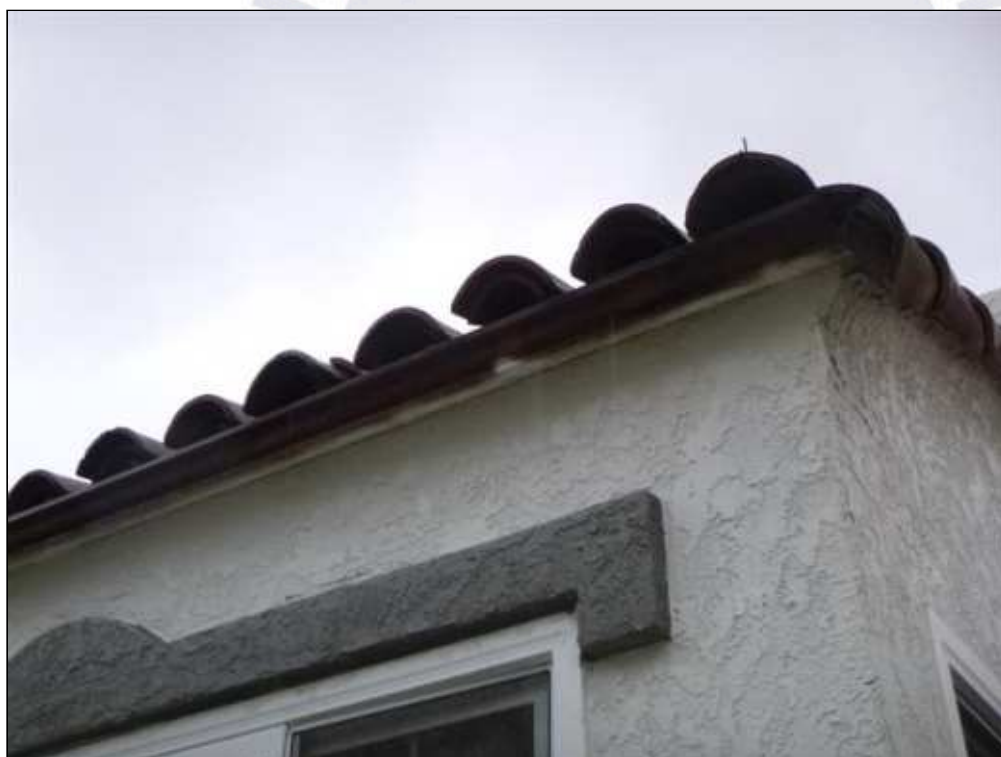
1.9 Item 2(Picture)

(2) The gutters are rusted and deteriorated at various areas, suggest replacing the gutters as needed.

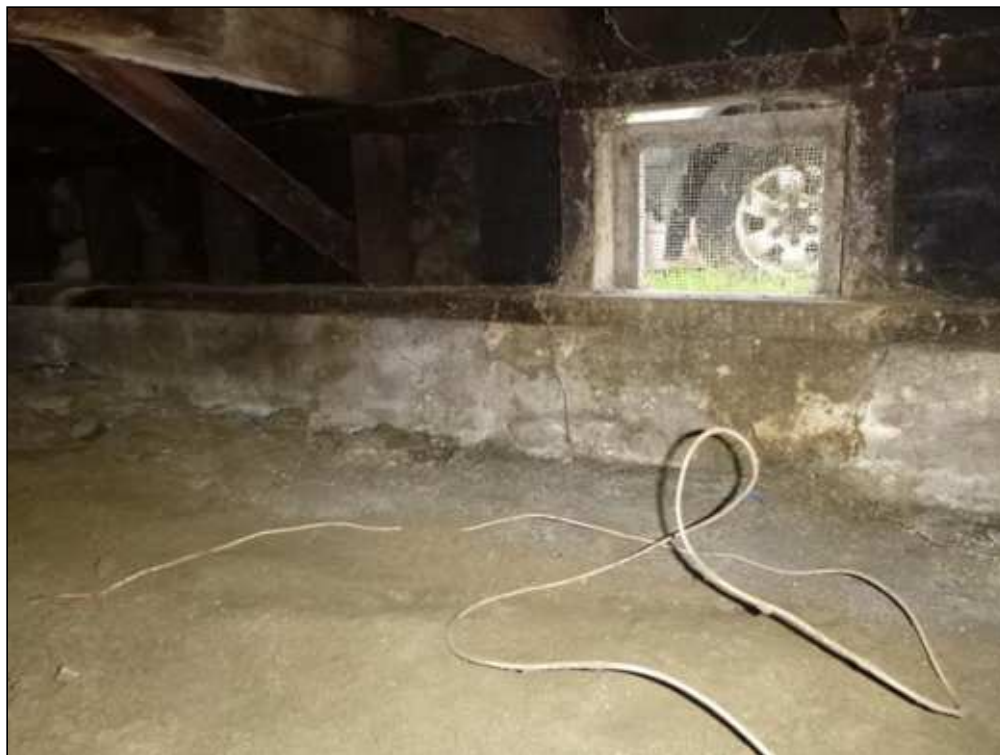
2.0 Item 1(Picture)

Re-grading where needed is recommended to assure all water drains away from the home's foundation. The inadequate drainage has caused the excessive moisture buildup at the foundation and intrusion into the crawl area. Suggest review with a licensed contractor for installation of concrete walkways/barriers, water proofing membranes, rain gutters and an area drainage/sump pump system to divert all the water away from the foundation/structure.

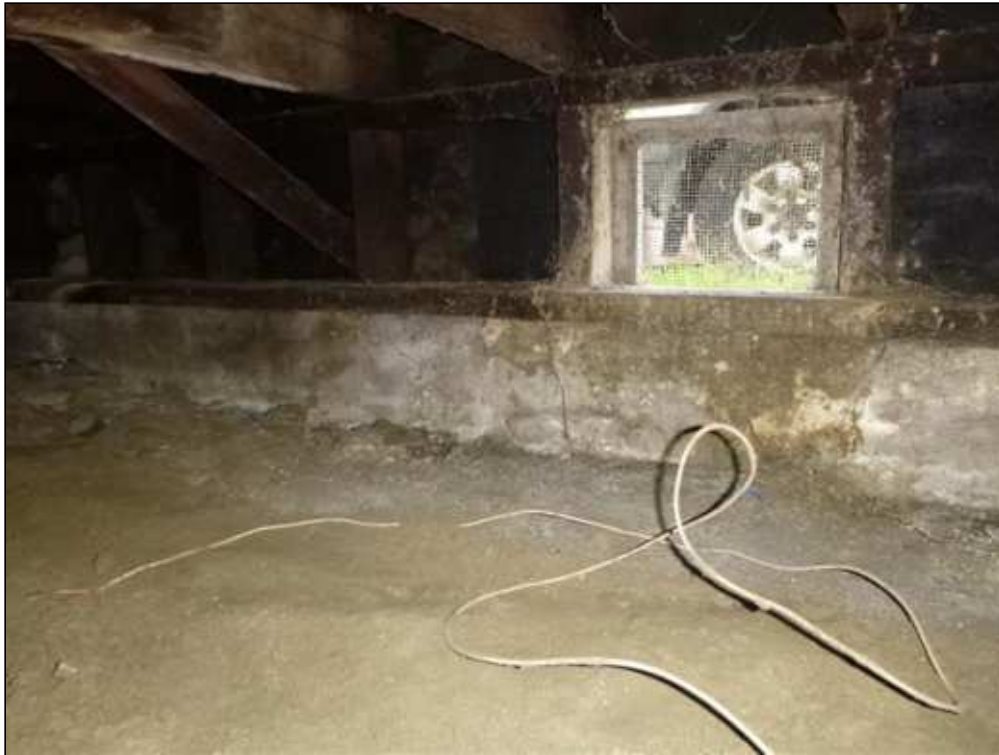
3.0 Item 1(Picture)

(2) White efflorescence (powder substance) on foundation footings indicates prior, and possibly ongoing, excessive moisture build up at the exterior of the foundation. Ongoing water intrusion at the foundations can, in some cases, cause the steel in the foundations to rust, called spawling, which can lead to horizontal cracking of the foundation (currently there are no major cracks visible at the foundation). Any future cracking/damaged can be an expensive repair as the foundation is now structurally weak and susceptible to horizontal movement. Suggest review of the Lot/Grade and drainage systems, including rain gutters, to reduce and prevent further and future water buildup at the exterior of the dwellings foundations.

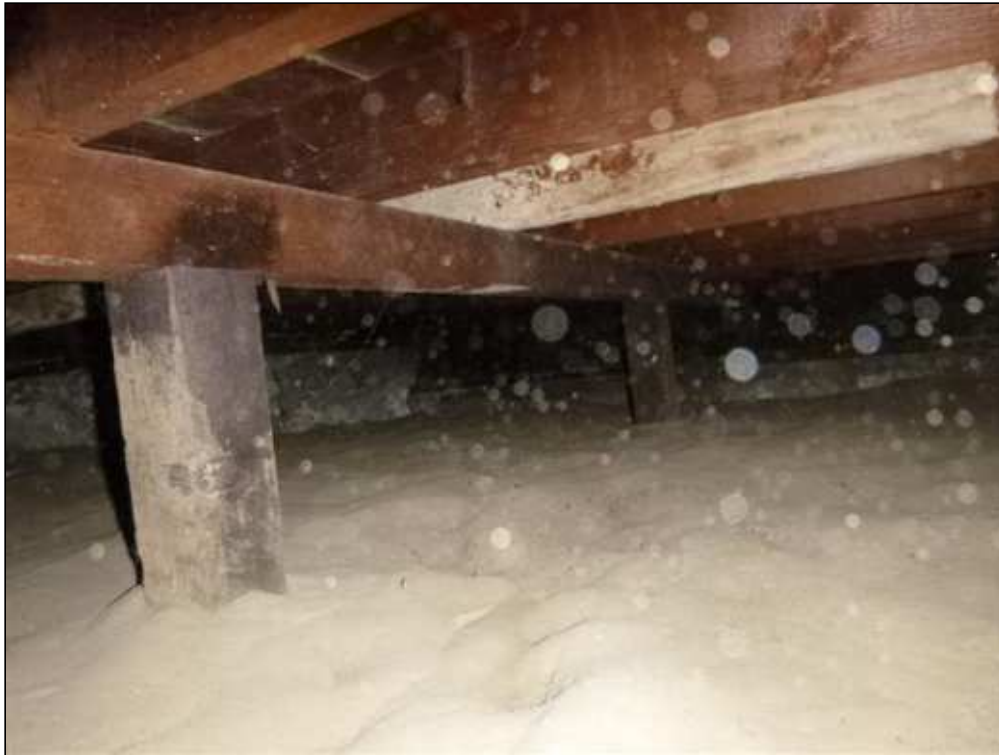
3.1 Item 4(Picture)

(2) Inadequate support noted at various girder beams due to the excessive span and inadequate support posts, common for the original age of the dwelling. Suggest review by a licensed contractor for costs to add additional supports to prevent possible future structural and floor movement as needed.

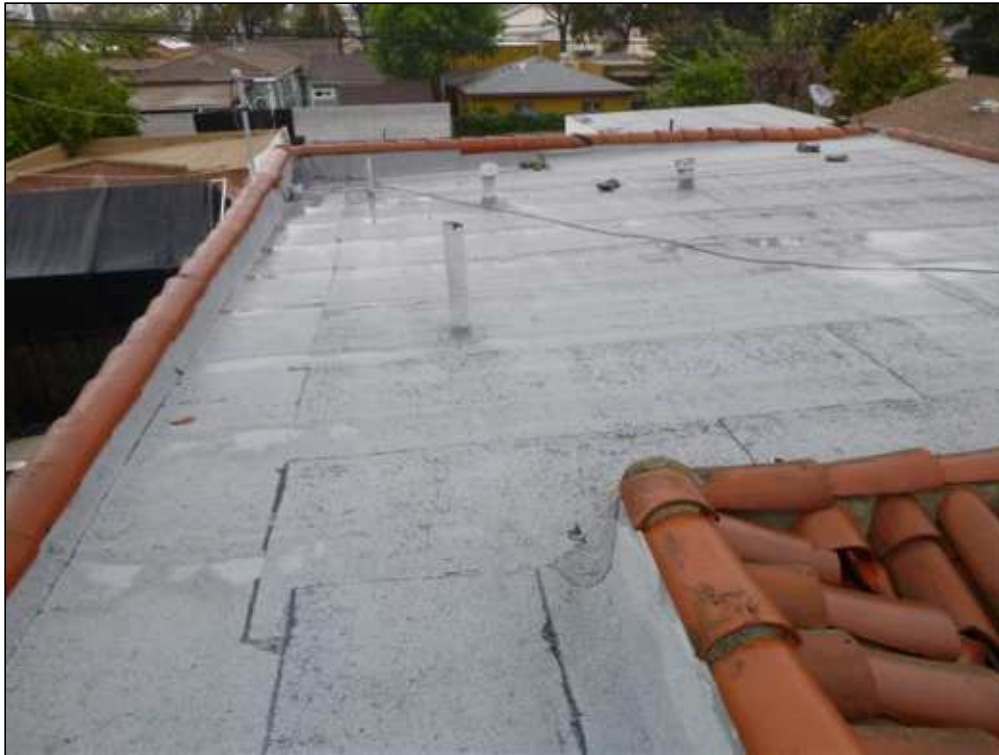
5.0 Item 1(Picture)

(1) The sloped roof covering is old and deteriorated. It is nearing the end of its useful life and the covering will need to be replaced. While it could last a year or so, some areas may need patching/repairs as leaks develop. Please review with a licensed roofer to determine the remaining life expectancy and for costs to repair/remove and replace the existing roofing material as needed.

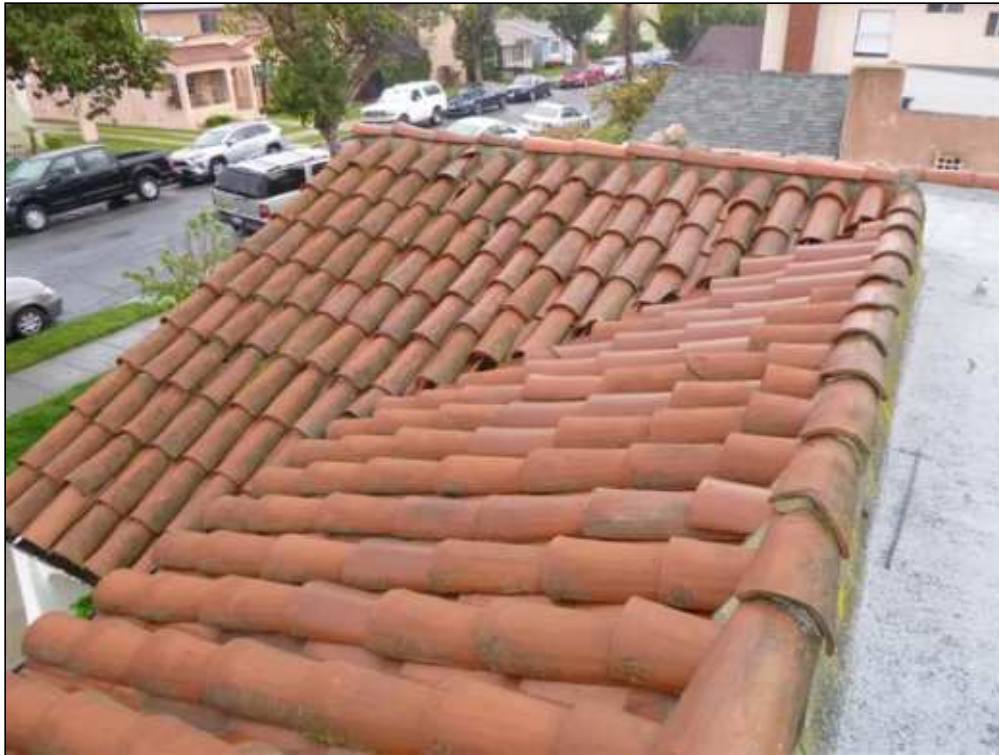
5.0 Item 8(Picture)

(5) Deteriorated, cracked, loose and missing sections of the roof tiles was noted, suggest review by a licensed roofer for repair/replacement costs as needed to prevent any future leakage during the rainy season.

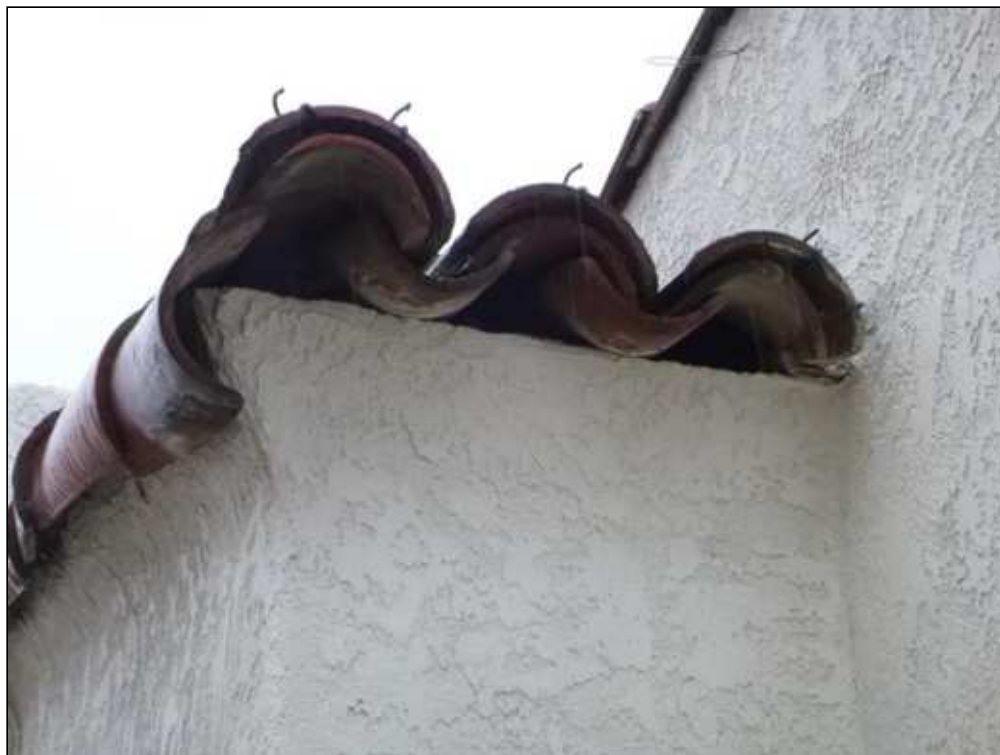
5.0 Item 16(Picture)

(6) No 'bird stops' were installed at the tile roof time of the inspection. Suggest review with a licensed roofer for installation costs as needed.

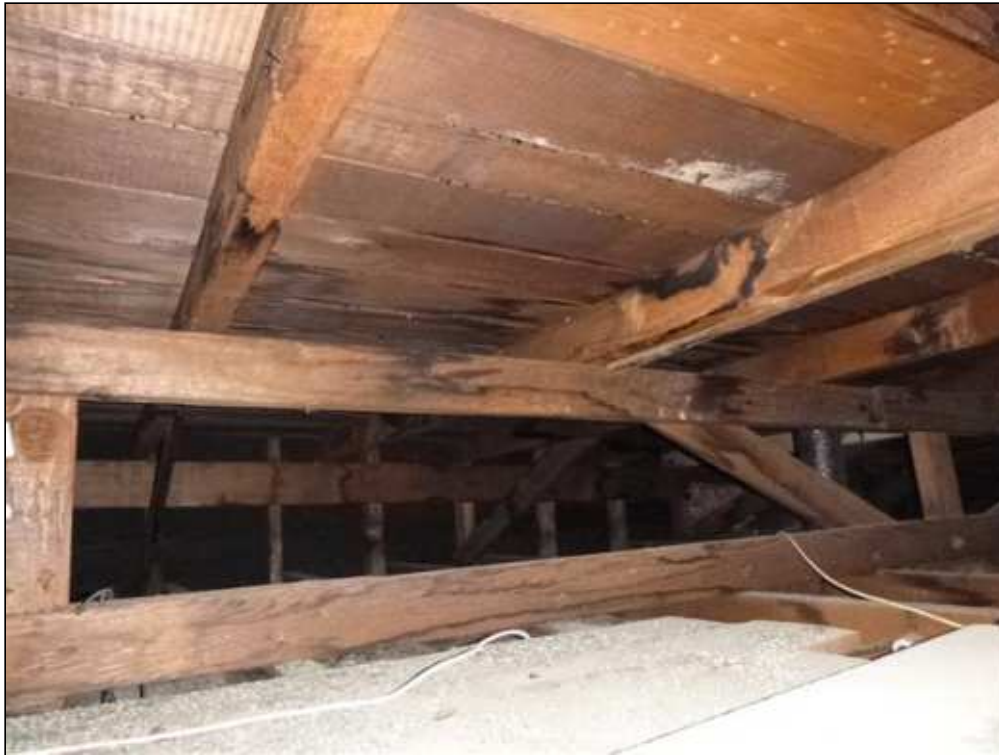
6.0 Item 1(Picture)

Moisture stains noted at various areas of the attic sheathing/framing, see roof comments and repair as needed.

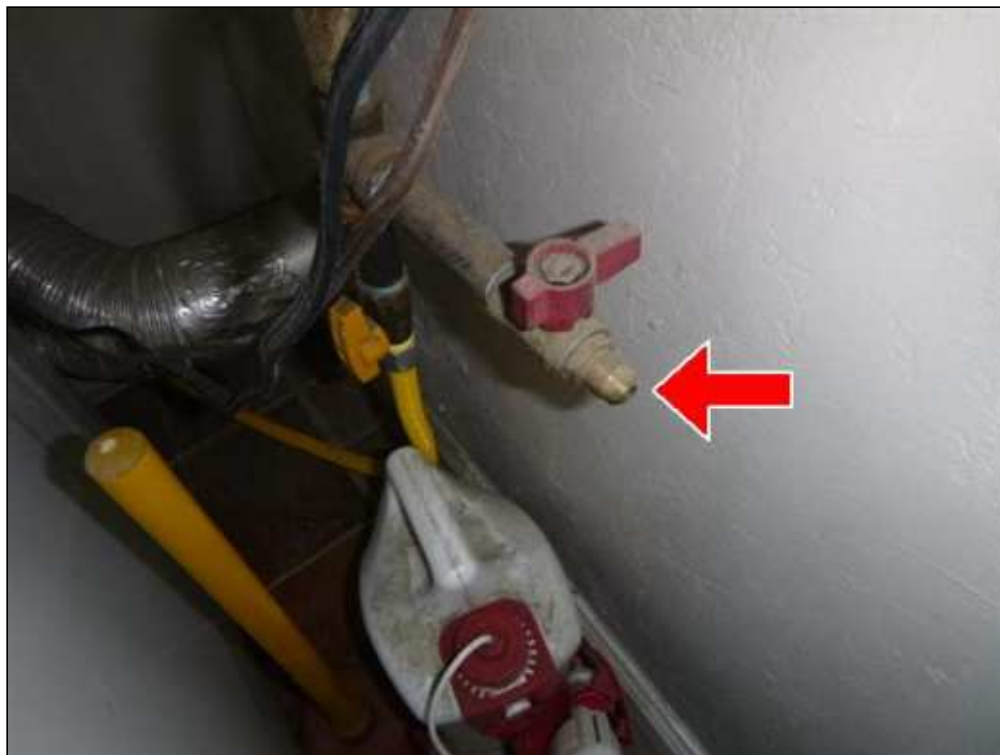
7.8 Item 1(Picture)

(2) Suggest capping the unused gas line/valve as required for safety.

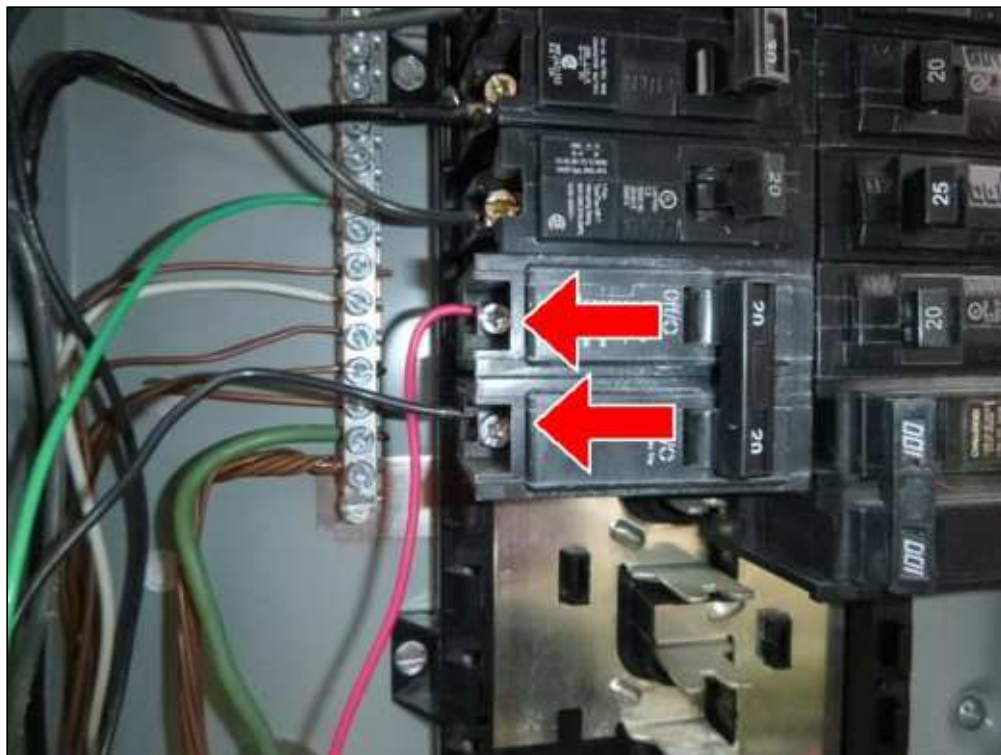
12.2 Item 1(Picture)

(2) A potential fire/safety hazard was noted due to the incorrect sized wiring connected to the breakers. 14 gauge wiring is currently connected to 20 amp breaker(s) in the sub panel, 15 amp breakers are required. Suggest review by a licensed electrician for any repair/replacement costs as needed.

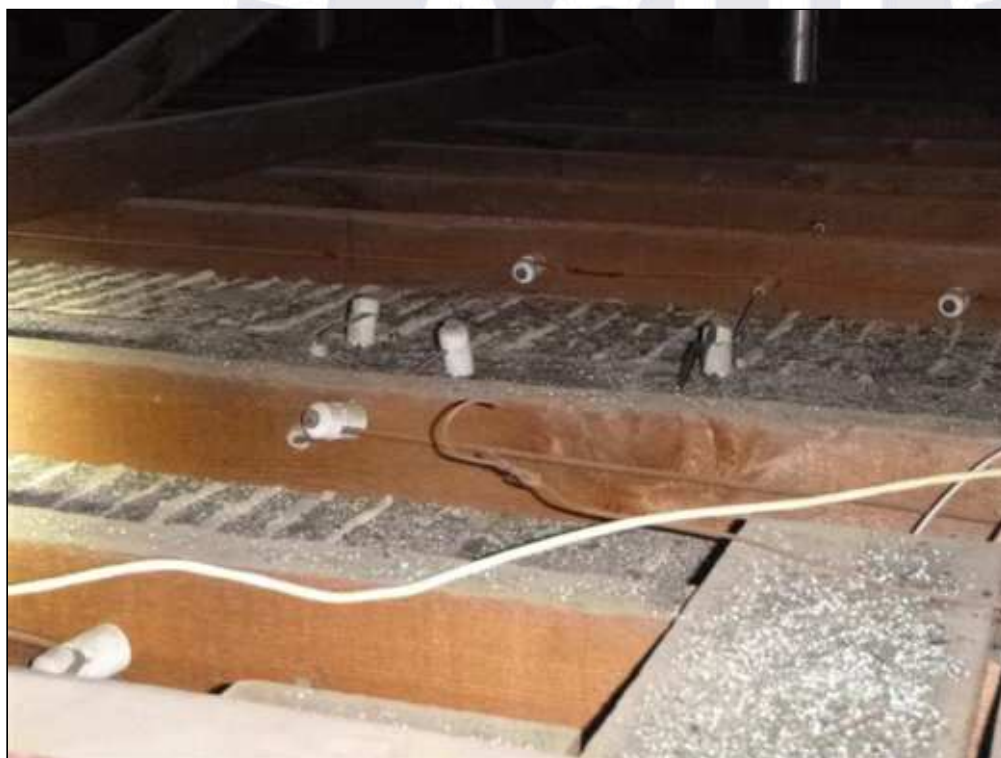
12.2 Item 2(Picture)

(3) Knob & Tube wiring noted throughout the attic area, this is common for the original age of the dwelling. Suggest review by a licensed electrician for replacement costs to upgrade the wiring to todays standards for safety.

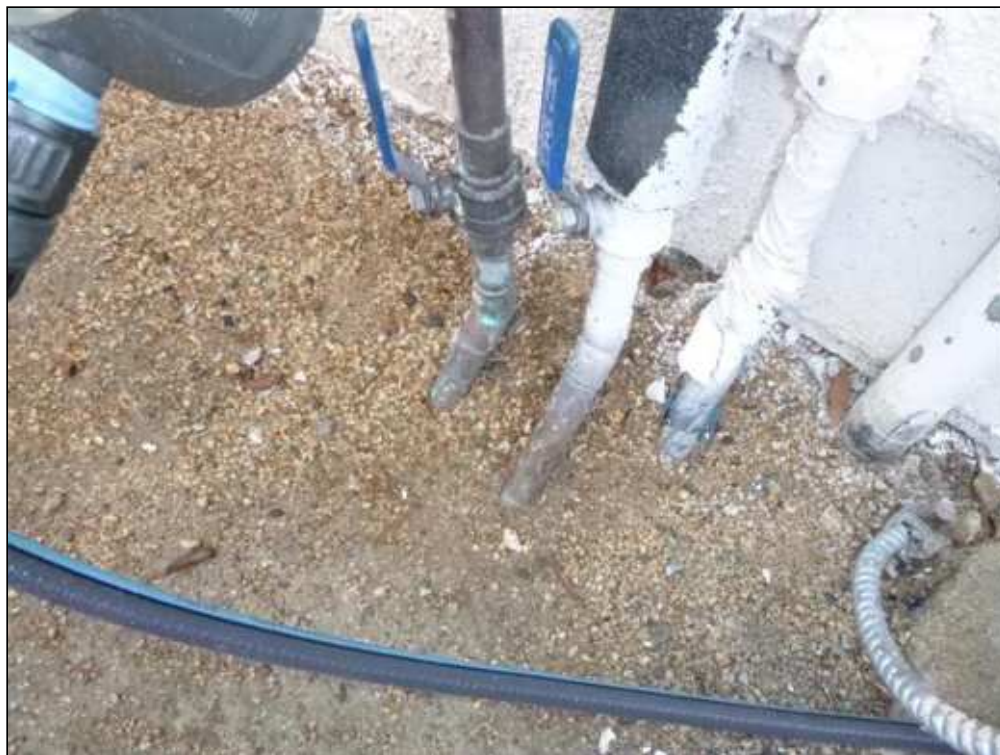
13.0 Item 1(Picture)

(1) The copper plumbing that transfers from the dwelling to the guest house/ADU area does not appear to be wrapped or insulated below grade. Suggest review by a licensed plumber and repair/replace as needed.

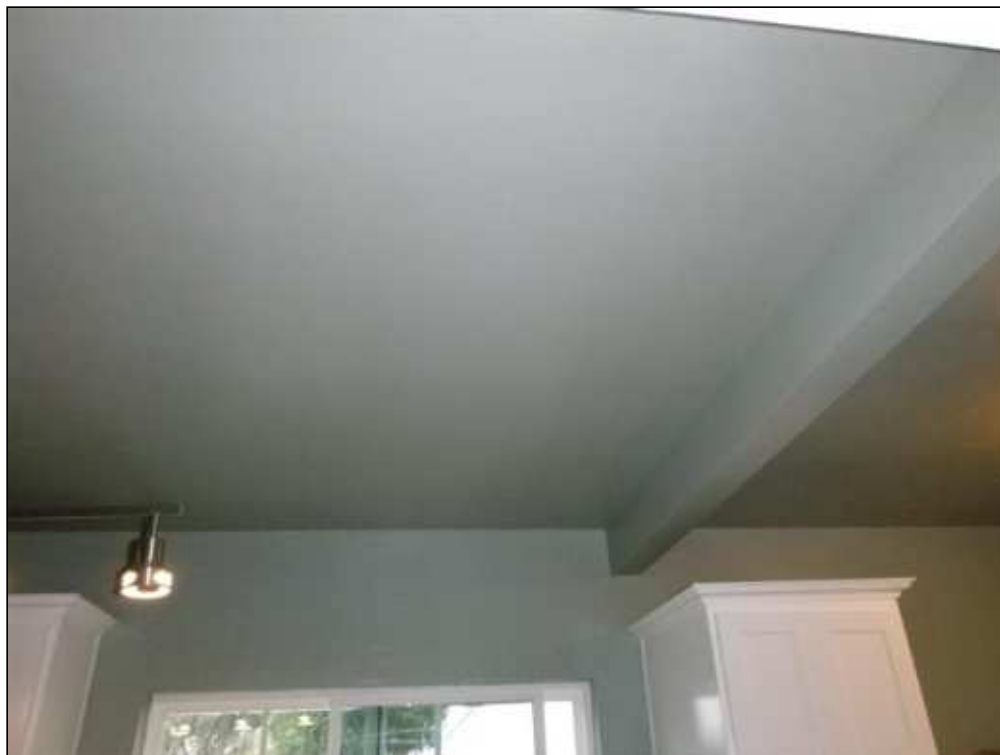
16.2 Item 1(Picture)

Patched and uneven areas of the ceiling was noted, suggest review with the seller on the cause and any repairs needed. Suggest review with a licensed contractor for any repair/removal/replacement costs as needed.

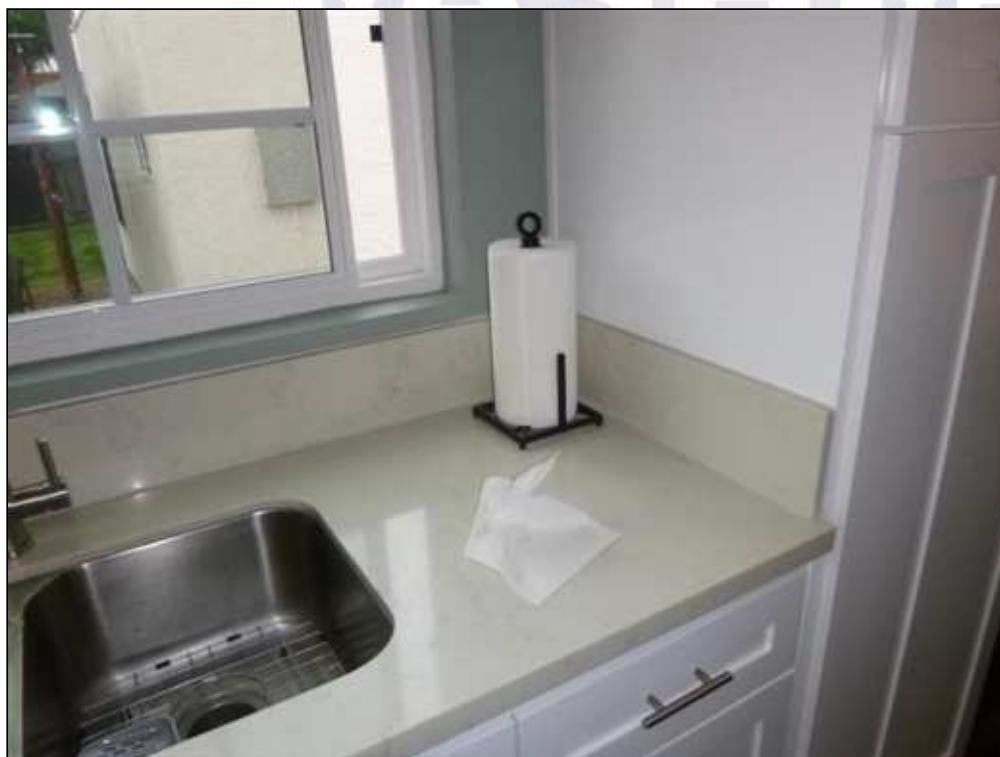
16.7 Item 1(Picture)

(1) Inadequate/incorrectly installed countertop/appliance outlets/circuits were noted, suggest review with a licensed electrician for installation costs as needed/required.

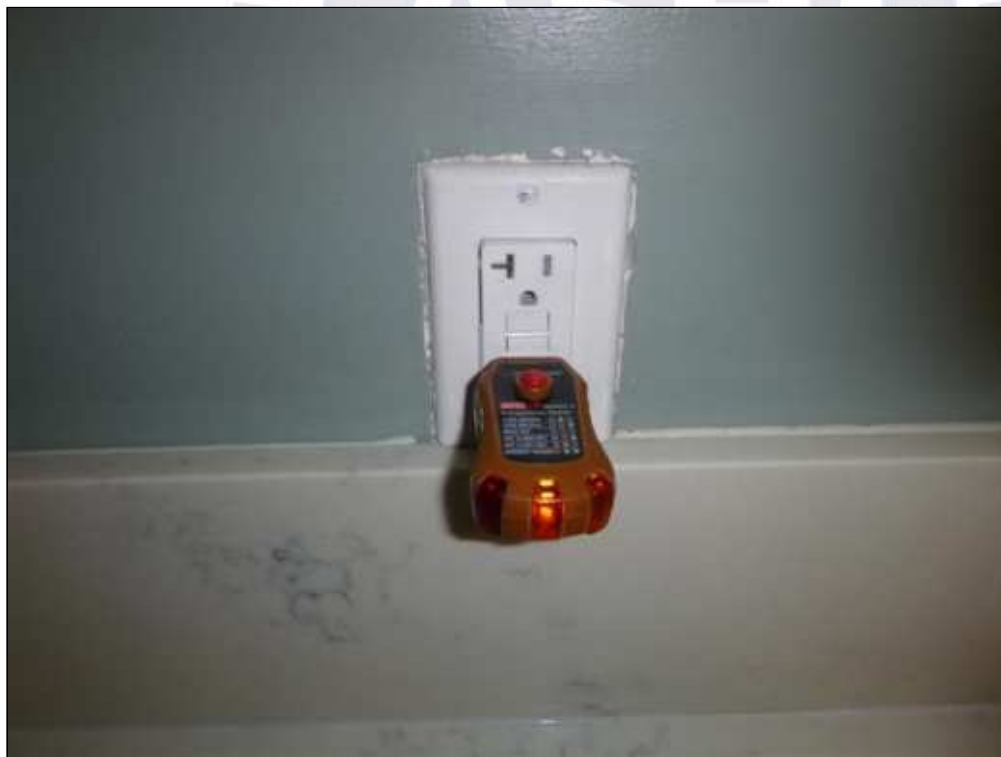
16.7 Item 3(Picture)

(3) The GFCI outlet(s) at this area are not grounded. The GFCI should still provide GFCI protection but the outlet should generally be grounded. Suggest review by a licensed electrician for repair/grounding cost as needed and required for safety.

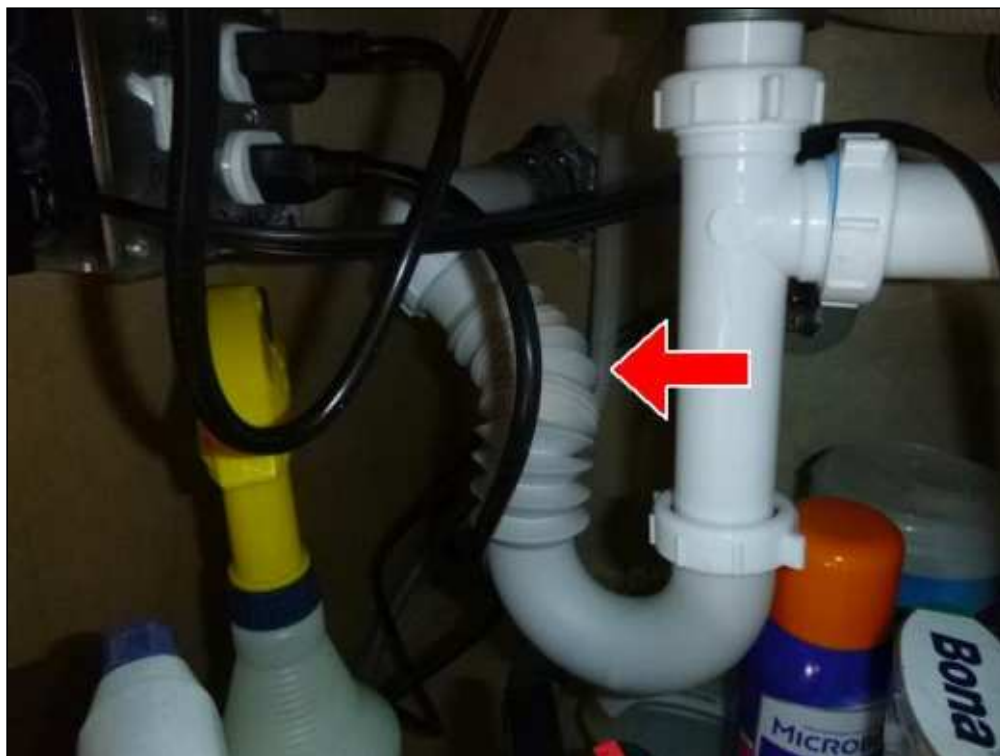
16.10 Item 1(Picture)

Suggest review by a licensed plumber for costs to replace the sink flex drain(s) with the appropriate materials as required.

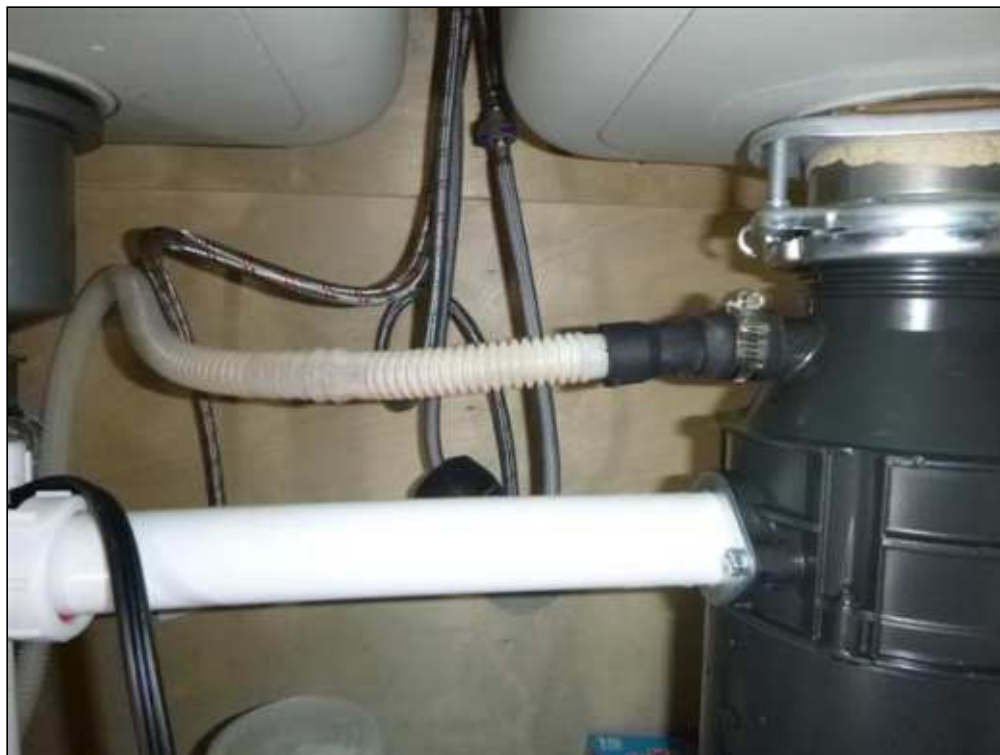
16.11 Item 1(Picture)

There is no air gap installed for the dishwasher as required, the system currently drains directly into the disposal. Suggest review by a licensed plumber for costs to install the air gap and drain as required by the State of California.

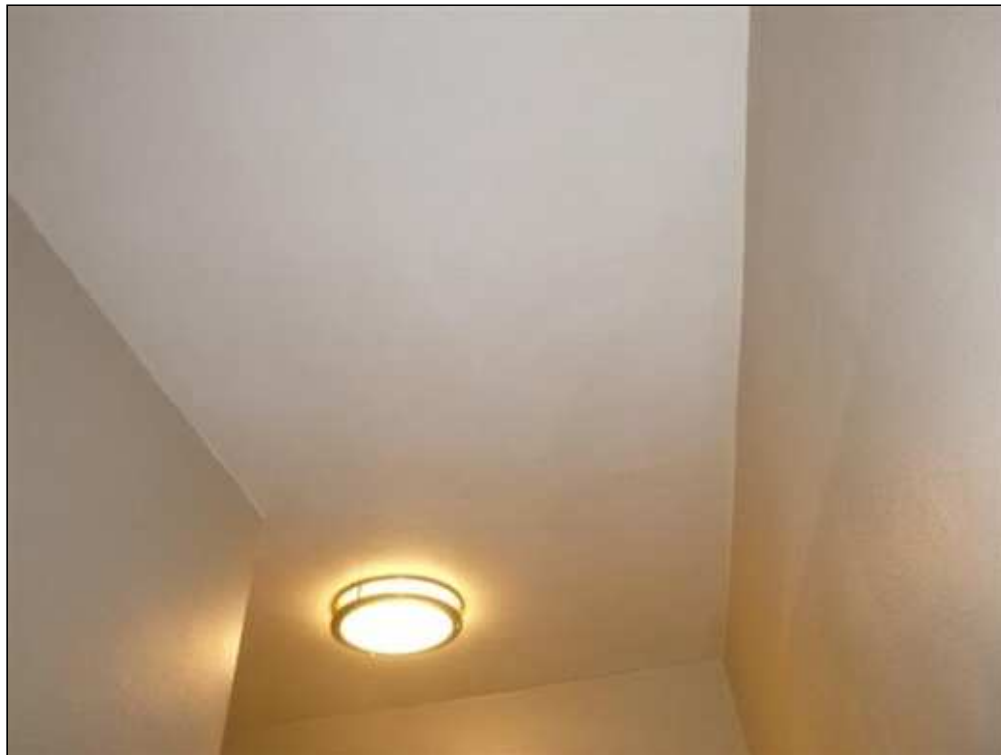
17.2 Item 1(Picture)

Patched and uneven areas of the ceiling was noted, suggest review with the seller on the cause and any repairs needed. Suggest review with a licensed contractor for any repair/removal/replacement costs as needed.

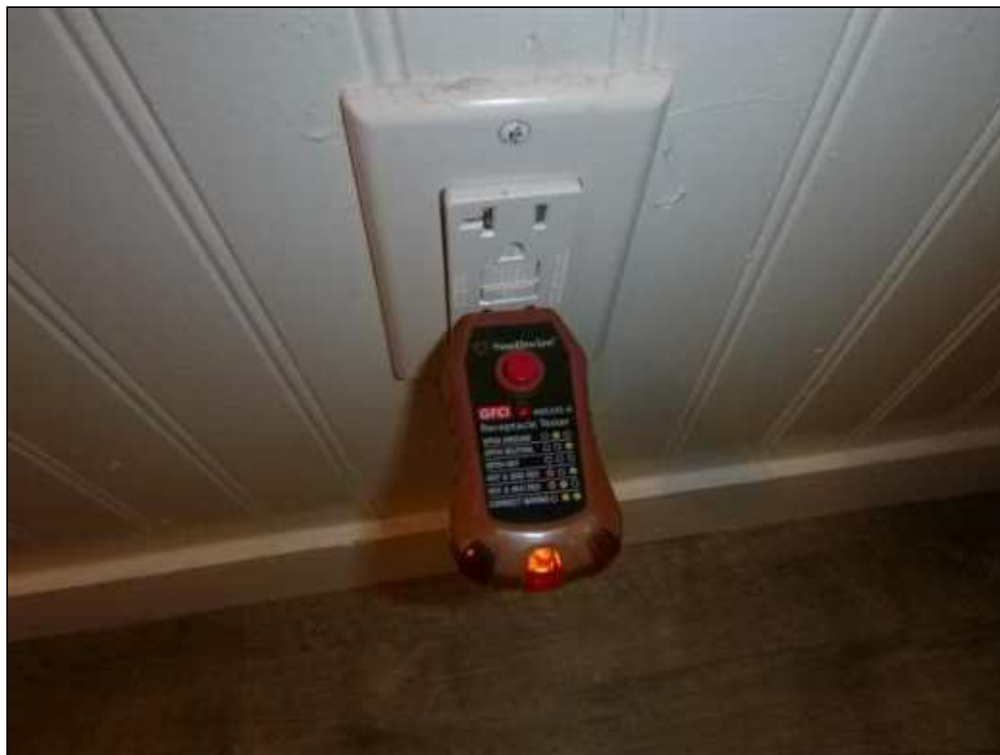
17.6 Item 1(Picture)

The GFCI outlet(s) at this area are not grounded. The GFCI should still provide GFCI protection but the outlet should generally be grounded. Suggest review by a licensed electrician for repair/grounding cost as needed and required for safety.

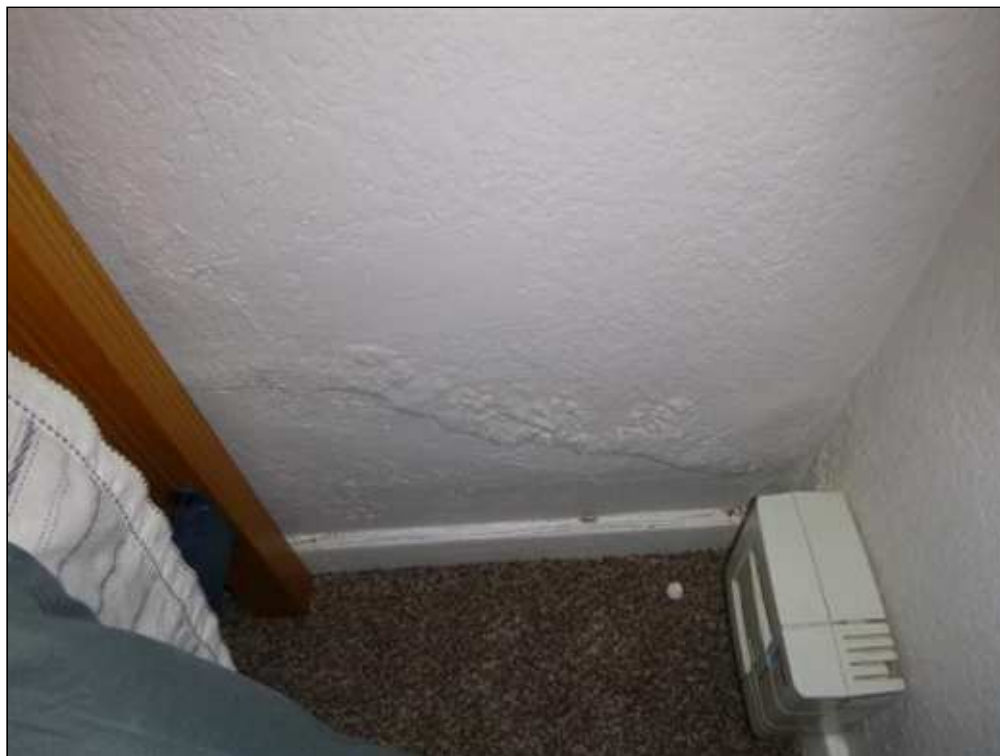
17.18 Item 1(Picture)

Excessive deterioration/damaged areas of the wall in bedroom #2 was noted noted which is adjacent to the tub/shower area. Suggest review with the seller and/or a licensed contractor for any repair/removal/replacement costs as needed.

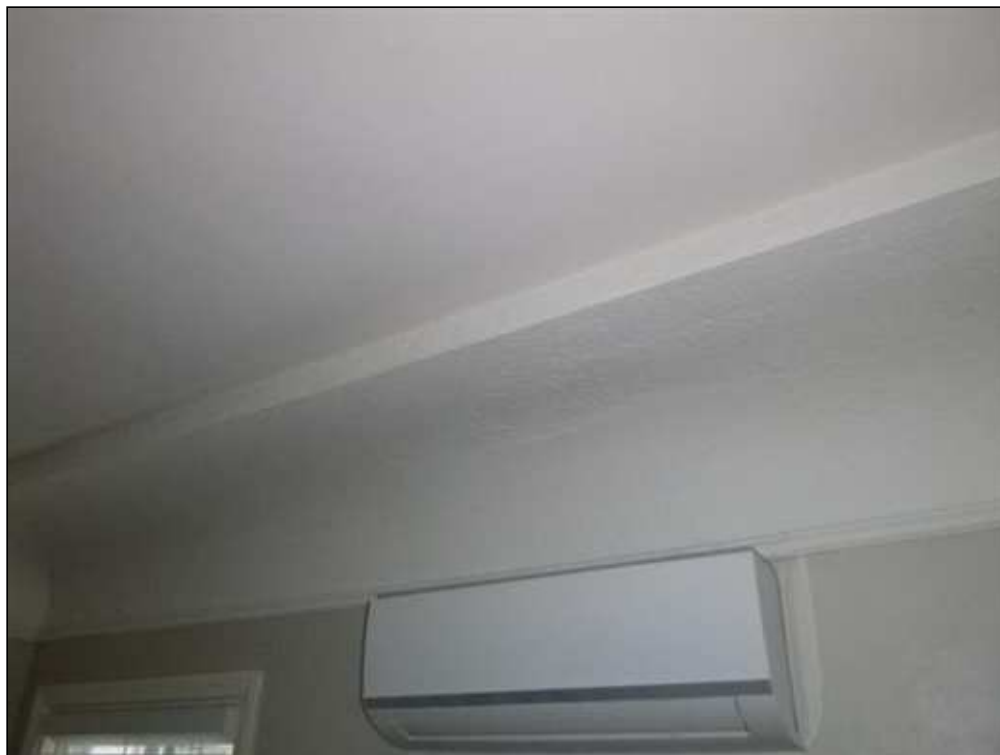
19.1 Item 1(Picture)

Patched areas of the walls was noted, suggest review with the seller for the cause and any repairs needed. Suggest repair as needed.

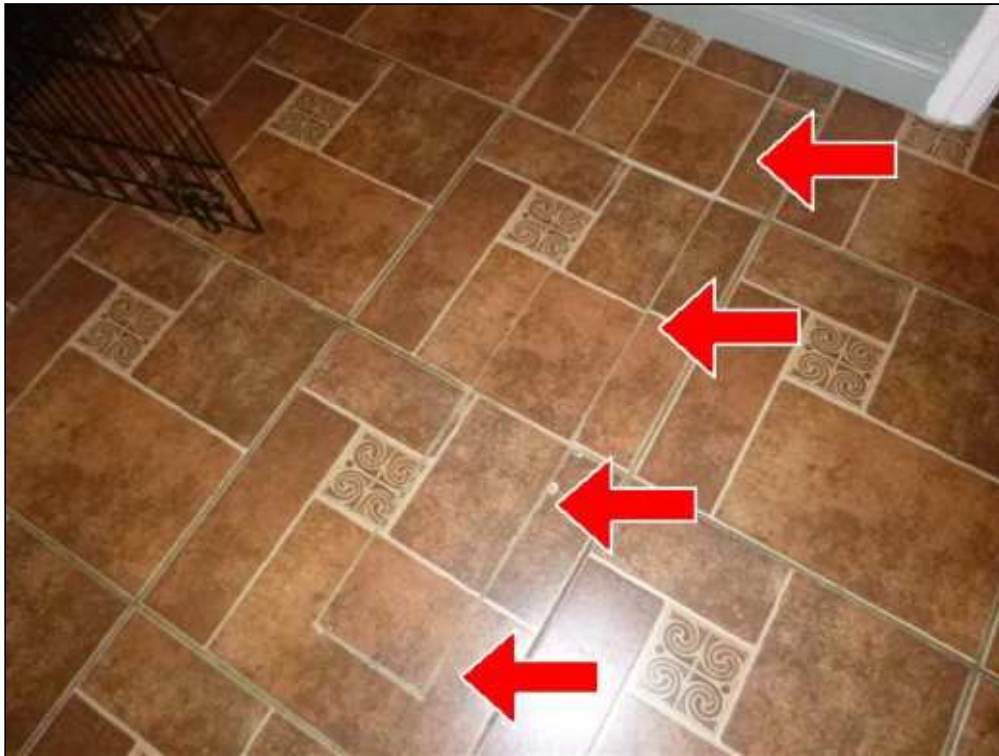
21.0 Item 1(Picture)

Patched repaired areas of the tile flooring was noted (this appears to be from a removed wall). Suggest review with the seller and/or a licensed contractor on this item as needed.

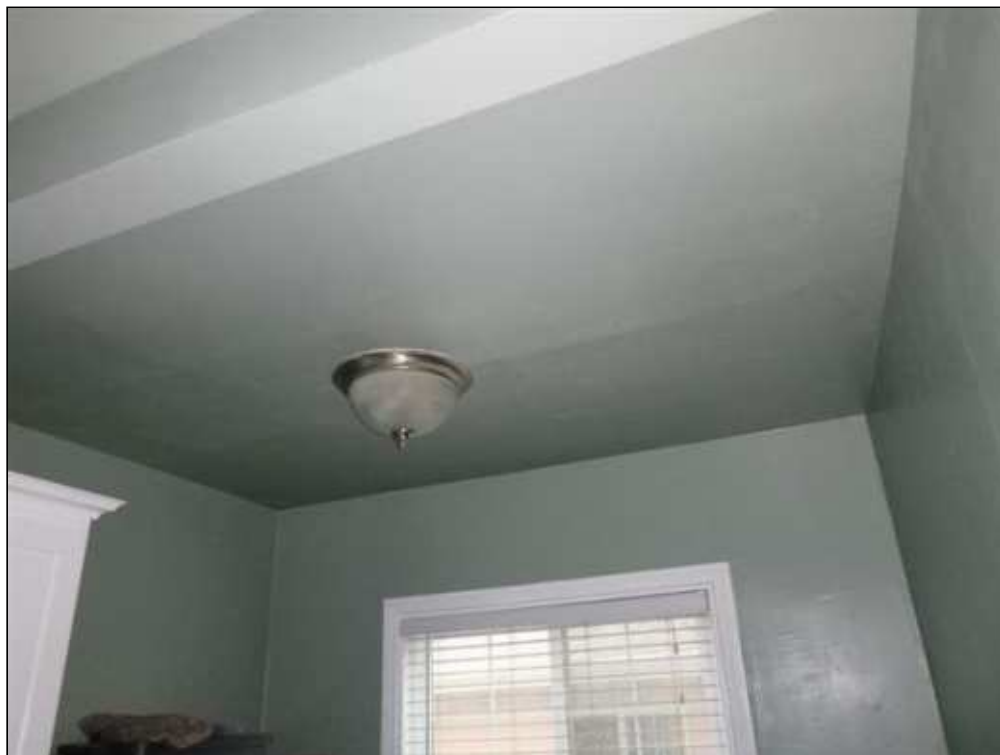
21.2 Item 1(Picture)

Patched and uneven areas of the ceiling was noted, suggest review with the seller on the cause and any repairs needed. Suggest review with a licensed contractor for any repair/removal/replacement costs as needed.

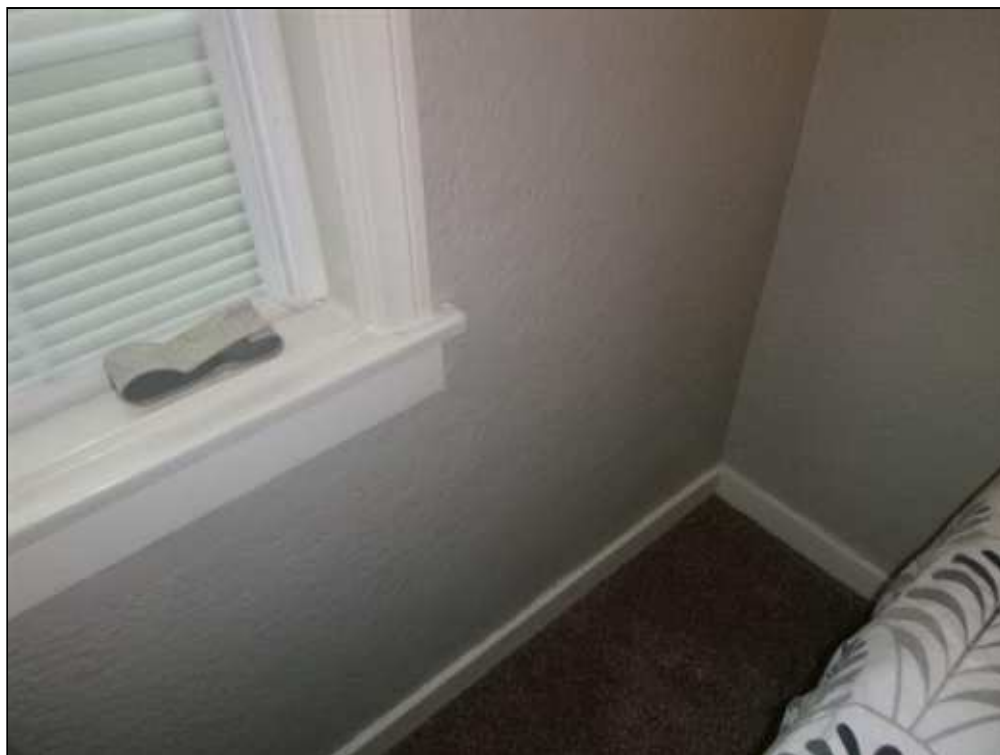
23.1 Item 1(Picture)

23.1 Patched areas of the walls was noted, suggest review with the seller for the cause and any repairs needed. Suggest repair as needed.

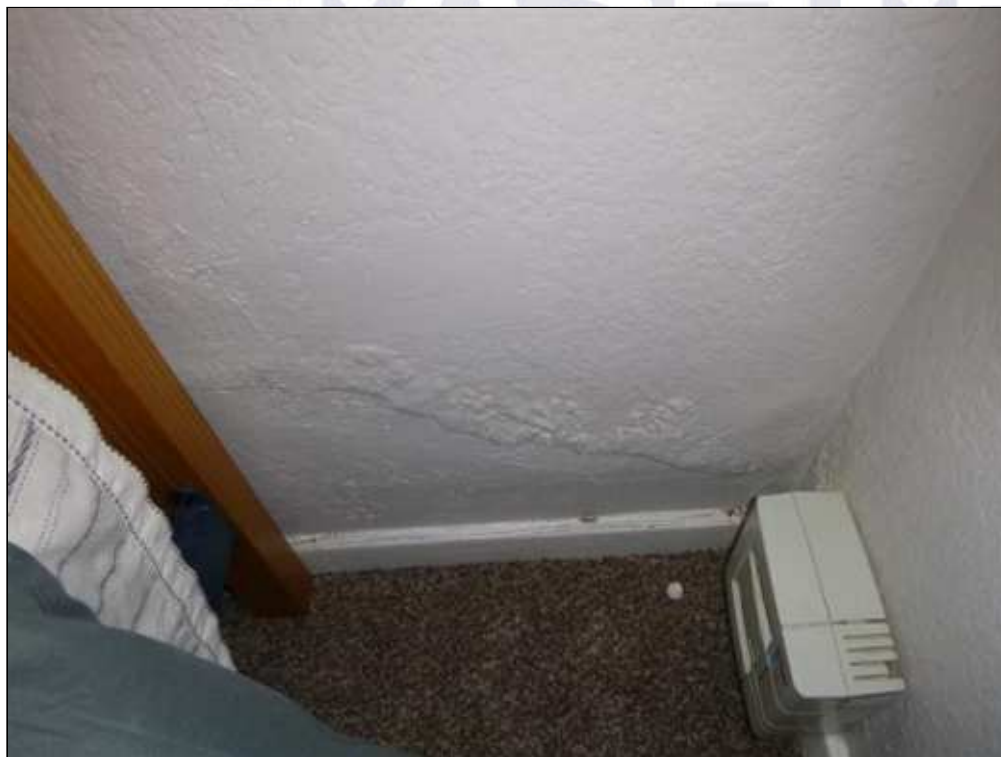
24.1 Item 2(Picture)

24.1 (2) Deteriorated/blistered/damaged areas of the front wall were noted (this area tested dry at the time of the inspection). This area is adjacent to the bathroom tub/shower area. Suggest review with the seller and/or a licensed contractor for any repair/removal/replacement costs as needed.

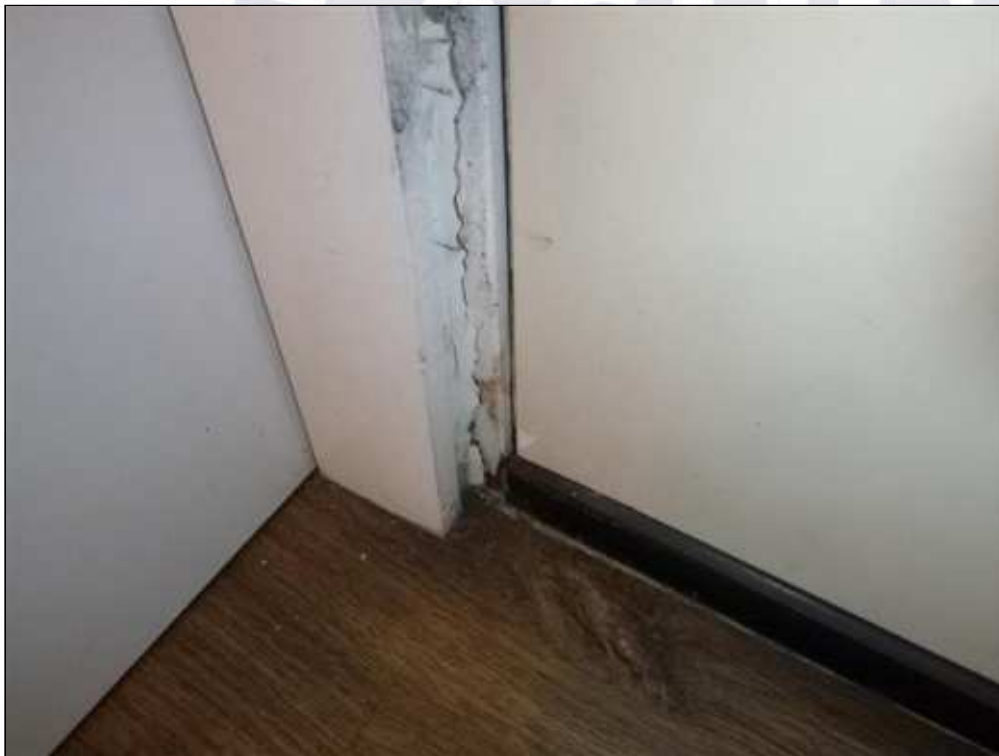
28.3 Item 3(Picture)

28.3 (3) Evidence of previous and ongoing water intrusion noted at the door(s) to the interior. Deteriorated and loose door trim/casings were noted. Suggest review with a licensed contractor for any repair/replacement costs as needed to prevent further and future water intrusion at this area.
