WOOD DESTROYING PESTS AND ORGANISMS INSPECTION REPORT

#: 20251171

BUILDING NO. 10675	STREET PARAMOUNT RD	CITY PHELAN	ZIP 92371	Date of Inspection 06/17/2025	NUMBER OF PAGES 1 of 6
GOLD CREST EXTERMINATORS, INC 12494 REATA RD APPLE VALLEY CA 92308 PH# 760-508-7880 goldcrest77@gmail.com PR460					
Ordered by: PAMELA SHEEHAN CENTURY 21 MASTERS PH.# 909-631-9050		Property Owner and/or Party of Interest LILLIAN TIFFANY 10675 PARAMOUNT RD PHELAN, CA 92371		Report sent to:	
COMPLETE REPORT <input checked="" type="checkbox"/>		LIMITED REPORT <input type="checkbox"/>		SUPPLEMENTAL REPORT <input type="checkbox"/>	
REINSPECTION REPORT <input type="checkbox"/>		GENERAL DESCRIPTION: This is a one story, wood sided, single family residence. It has a detached garage and an attached patio. It has a tile roof and was occupied and furnished at the time of inspection.			
Inspection Tag Posted: Garage.				Other Tags Posted:	
An inspection has been made of the structure(s) on the diagram in accordance with the the Structural Pest Control Act. Detached porches, detached steps, detached decks and any other structures not on the diagram were not inspected.

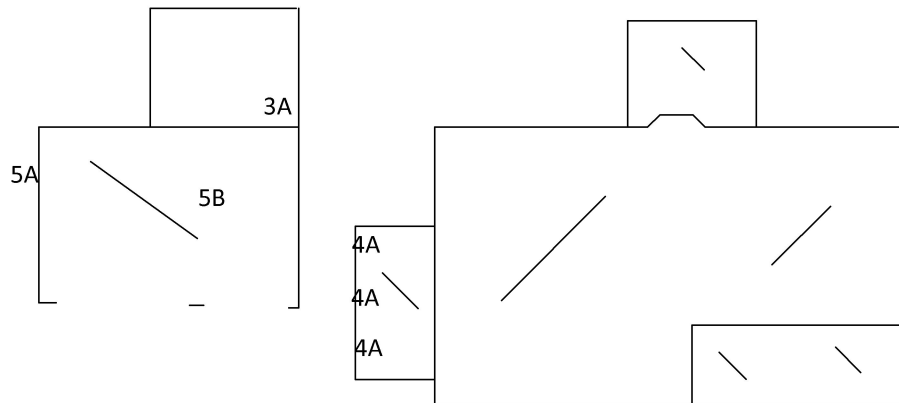
FUNGUS DAMAGE indicated by 3A on diagram. The FUNGUS infection was noted in or near: plywood atop of "kennel covering".

Water stains / slight delamination noted as 4A on the diagram. No moisture was noted. The stains were located in or near: plywood eaves of side porch.

We recommend to remove plywood & discard. No new plywood to be installed
Cost included in Sect II Item 4A

REC: Remove/repair/ replace as necessary. Install new rolled roofing as necessary
