## **STRUCTURAL FINDING SUMMARY**

**Site Address:** 24441 Hillsdale Ave, Laguna Hills, CA 92653

**Inspection Date:** October 1, 2026    **Project No.:** 26-10760

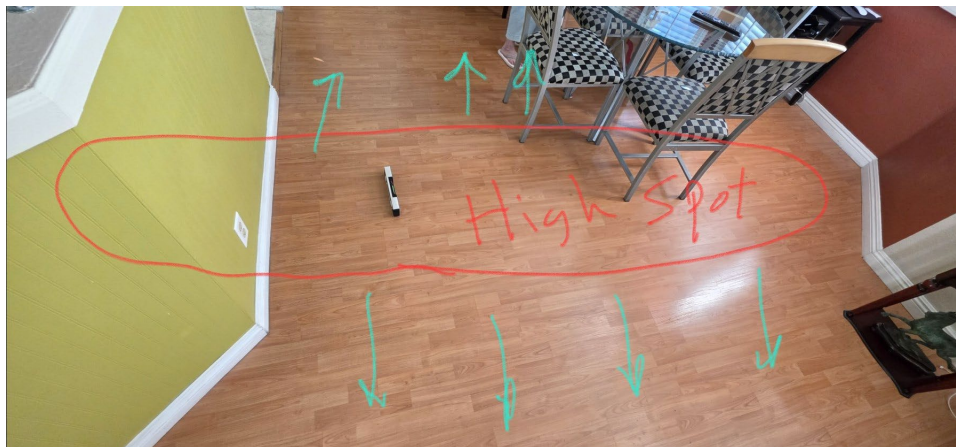
A raised, linear high spot was observed in the finished floor at the dining area, extending across the adjoining living area and the kitchen tile floor. The high spot runs perpendicular to the exterior wall and is located approximately above the wall that separates the single-car garage from the adjacent garage below. Digital level readings taken on either side of the high spot show the floor falling away from it in both directions, at approximately 0.7% on one side and approximately 2.1% on the opposite side, with readings of similar magnitude recorded at the kitchen tile floor. The Client reports that the condition has been present for approximately twenty seven seven years, since the property was purchased, and that it has not changed during that time.

A high point located directly over a wall line, with the floor falling away on both sides, is consistent with a floor framing system that bears on the wall below while the spans on either side finish, or have settled, at a slightly lower elevation. Several ordinary explanations fit this pattern: the subfloor or finish flooring may not have been leveled at the time of original construction; joist crown or lapped framing over the bearing wall may have produced a slightly higher line at the support; or long-term creep deflection of the joists in the spans on either side may have developed over the life of the building. No corroborating signs of structural distress were observed: there was no cracking, separation, or other distress at the interior or exterior walls in the bedroom, kitchen, or living areas, and the garage ceiling directly below showed no sagging, cracking, or displacement. The floor joists and subfloor framing are concealed and were not accessible, so the framing configuration at the high spot could not be directly verified. Based on the visible conditions and the Client's account, the high spot appears to be a long-

standing surface irregularity rather than evidence of active structural movement, and it is not considered a structural deficiency at this time.

Red outline marks the raised high spot in the dining area floor; teal arrows indicate the direction of floor slope away from the high spot.

**Recommendation:** Request any available records for the building — the original construction drawings or floor framing plan on file with the City of Laguna Hills Building Division (or the homeowners' association, if applicable) — to confirm the floor framing configuration (joist size, span direction, and bearing at the garage separation wall). No corrective action is required at this time. To document stability, mark the current high-spot location and re-measure with a digital level at the same locations in approximately 12 months, or sooner if new cracking, door or window binding, or an increase in floor slope is noticed. Should the Client wish to verify the framing directly, a small inspection opening in the garage ceiling along the high-spot line could be coordinated to view the joist bearing; this would constitute Additional Services under a separate written authorization, and the garage ceiling assembly should be restored to maintain the required fire separation from the living space above.

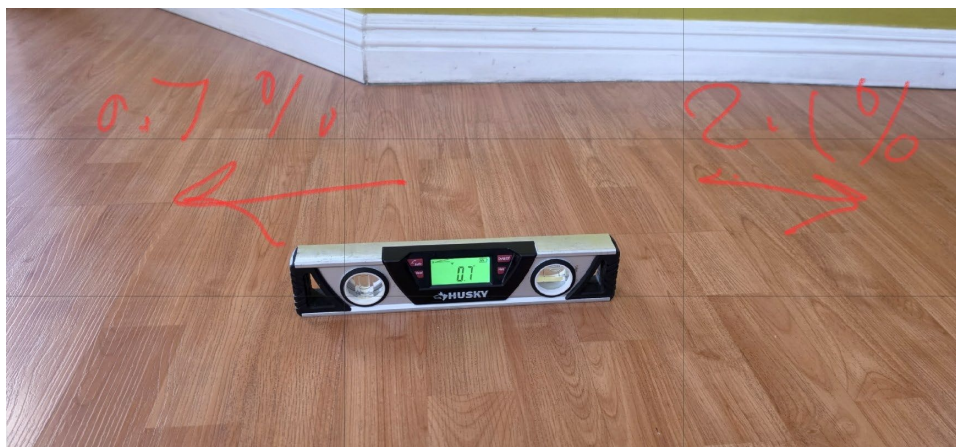
Digital level readings of approximately 0.7% on one side of the high spot and 2.1% on the opposite side; red arrows indicate the direction of slope.

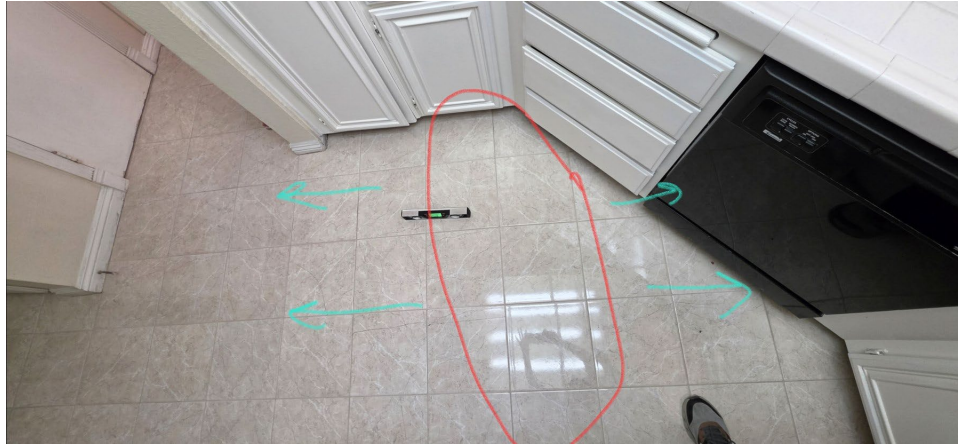
*Red outline marks the high spot continuing across the kitchen tile floor; teal arrows indicate floor slope away from the high spot on both sides.*

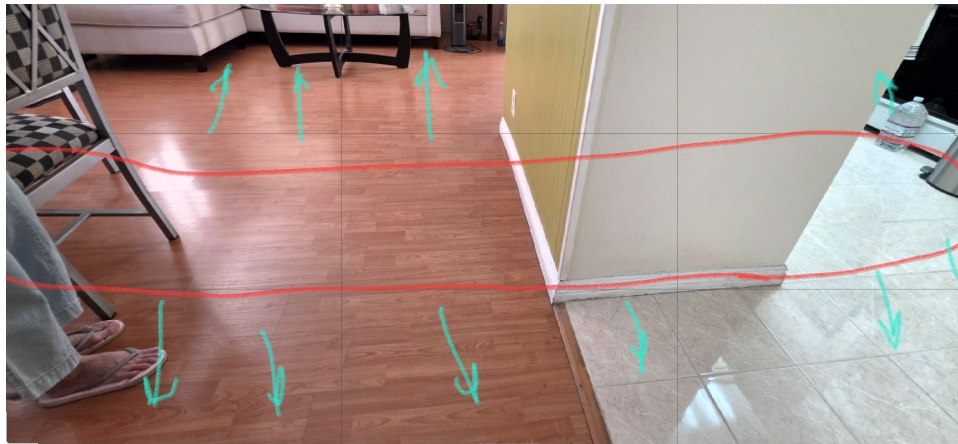
*Red outline marks the high spot extending across the living area and the kitchen threshold; teal arrows indicate floor slope away from the high spot.*

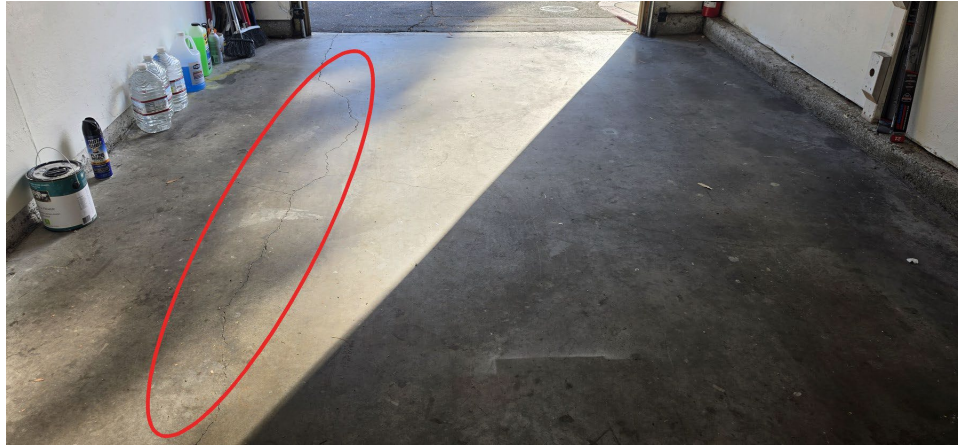
A narrow, meandering crack was observed in the garage concrete slab, extending from the base of the side wall across the slab. The crack is hairline to very narrow in width, no vertical offset between the two sides was apparent, and its weathered appearance indicates that it is long-standing. Cracks of this type are typical of concrete shrinkage and curing and are generally cosmetic. No other significant slab cracking, heaving, or settlement was observed, and no cracking was observed in the foundation around the garage. This condition is not considered a structural concern and has no apparent relationship to the floor high spot described in Item 1.

*Red outline marks the hairline crack in the garage slab.*

**Recommendation:** No corrective action is required at this time. Monitor the crack for widening or vertical offset. As routine maintenance, the crack may be sealed with a flexible polyurethane or epoxy crack sealant to limit moisture and debris intrusion.

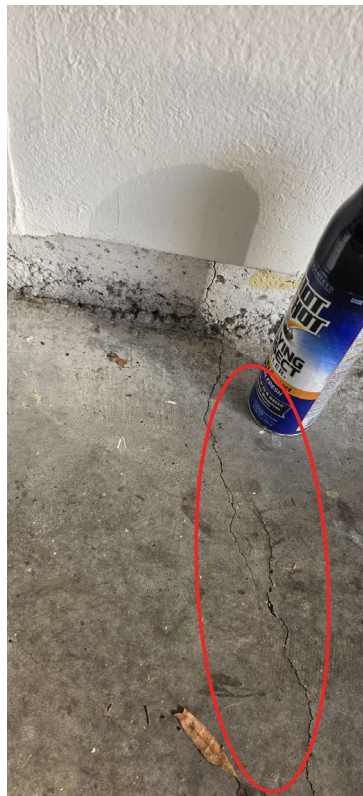
*Red outline marks the hairline crack extending from the base of the garage side wall.*

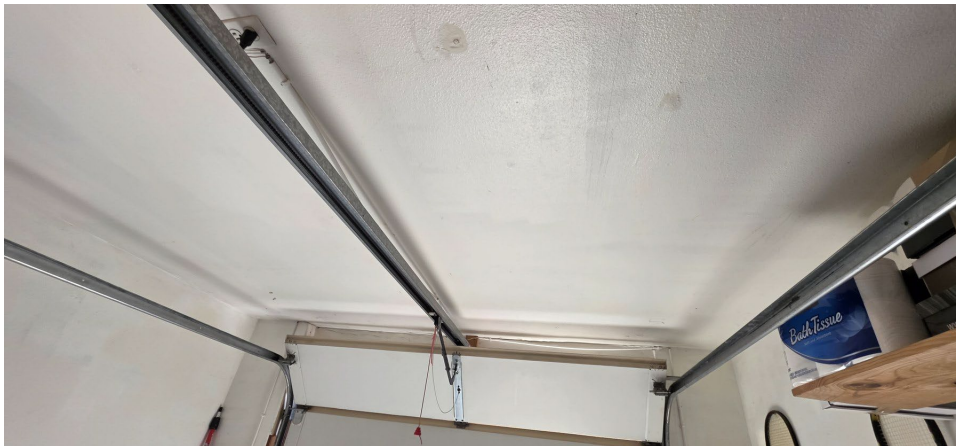
The garage ceiling directly below the living-level floor was observed for signs of distress, including along the line beneath the high spot described in Item 1. The ceiling finish was continuous, with no sagging, deflection, cracking, or separation at the visible ceiling-to-wall junctions. Isolated minor surface discoloration was noted on the ceiling; it is cosmetic in appearance and was not associated with

any deformation of the ceiling. The floor joists and subfloor framing above the garage ceiling are concealed and were not accessible for direct observation.

*Garage ceiling below the living-level floor; the finish is continuous with no sagging, cracking, or separation observed.*

**Recommendation:** No corrective action is required at this time. Monitor the garage ceiling periodically for new cracking, sagging, or staining. If new discoloration develops, identify and correct its source before cosmetic repair.

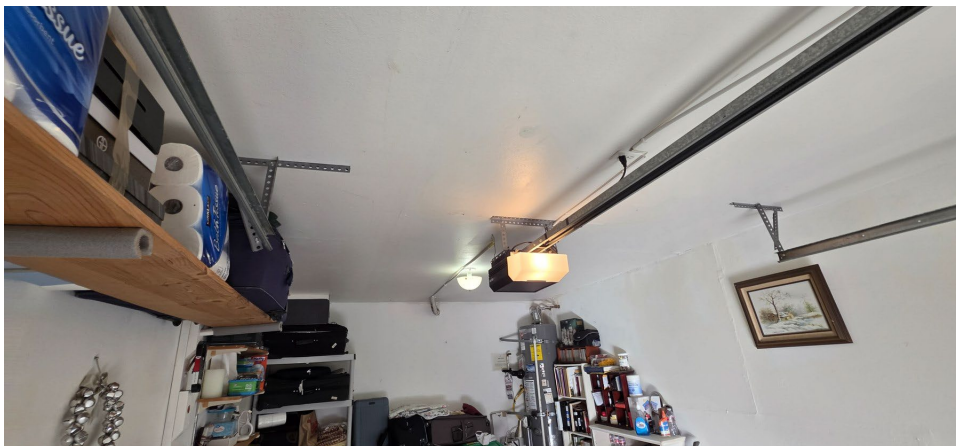
*Garage ceiling and wall junctions toward the garage interior; no structural distress observed.*

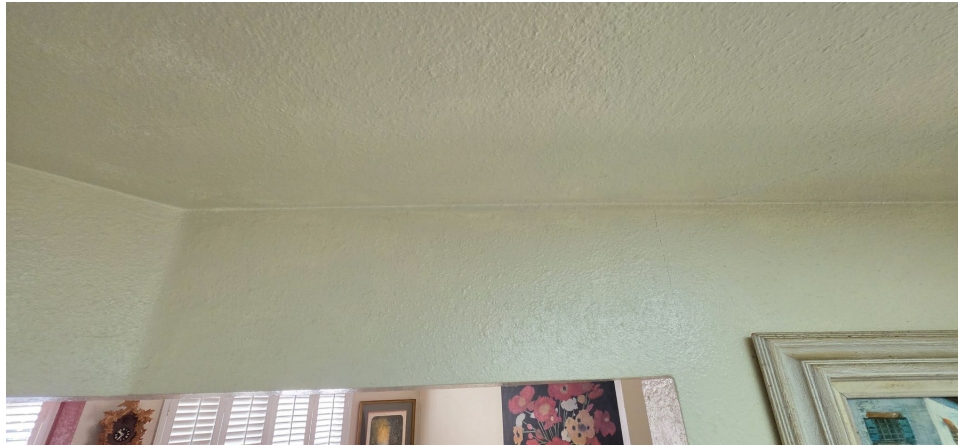
The interior walls and ceilings of the bedroom, kitchen, and living areas were observed, including the wall-to-ceiling junctions, and no cracking, separation, or other indication of structural distress was noted. No indication of framing or subfloor movement was observed at the interior walls. The exterior walls were also observed, and no cracking or other distress was noted that would indicate a structural issue with the framing or subfloor.

*Interior wall-to-ceiling junction at the living area; no cracking or separation observed. See attached link to additional photos.*

**Recommendation:** No corrective action is required at this time. Monitor the walls and ceilings periodically for new cracking, and report any new cracking, door or window binding, or increase in floor slope for further evaluation.

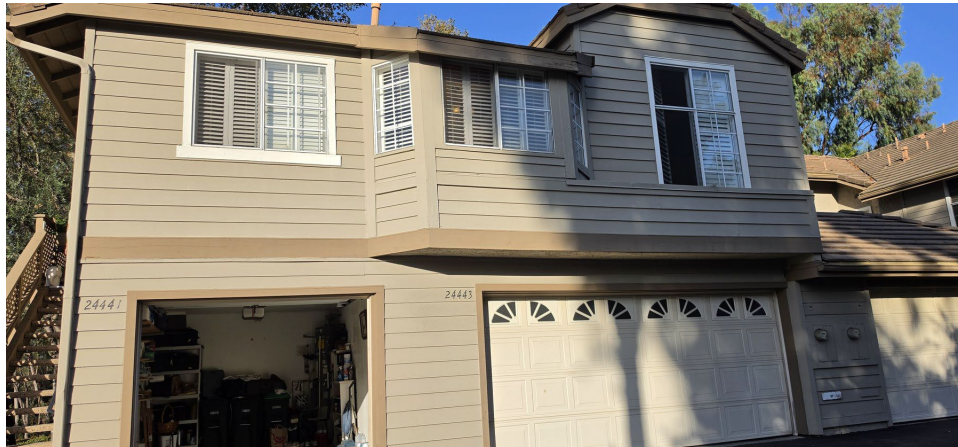
*Exterior elevation showing the garage below the living-level floor; no cracking or distress observed at the exterior walls.*
