WOOD DESTROYING PESTS AND ORGANISMS INSPECTION REPORT

Building Address: 9150 Dinsdale St., Downey , CA 90240		Date of Inspection 06/24/2024	Number of Pages 5
Richview Termite 8636 Bluford Ave. Whittier CA 90602 Phone: (562) 789-4083 Fax:		Report # W10603	
		Lic. Registration # PR 4233	
		Escrow #	
Ordered by: Daniel Huerta	Property Owner and/or Party of Interest:	Report Sent to: Daniel Huerta	
COMPLETE REPORT <input checked="" type="checkbox"/> LIMITED REPORT <input type="checkbox"/> SUPPLEMENTAL REPORT <input type="checkbox"/> REINSPECTION REPORT <input type="checkbox"/>			
General Description: Single story stucco and wood residence with two car attached garage		Inspection Tag Posted: Attic	
		Other Tags Posted:	
		None	
An inspection has been made of the structure(s) shown on the diagram in accordance with the Structural Pest Control Act. Detached porches, detached steps, detached decks and any other structures not on the diagram were not inspected.

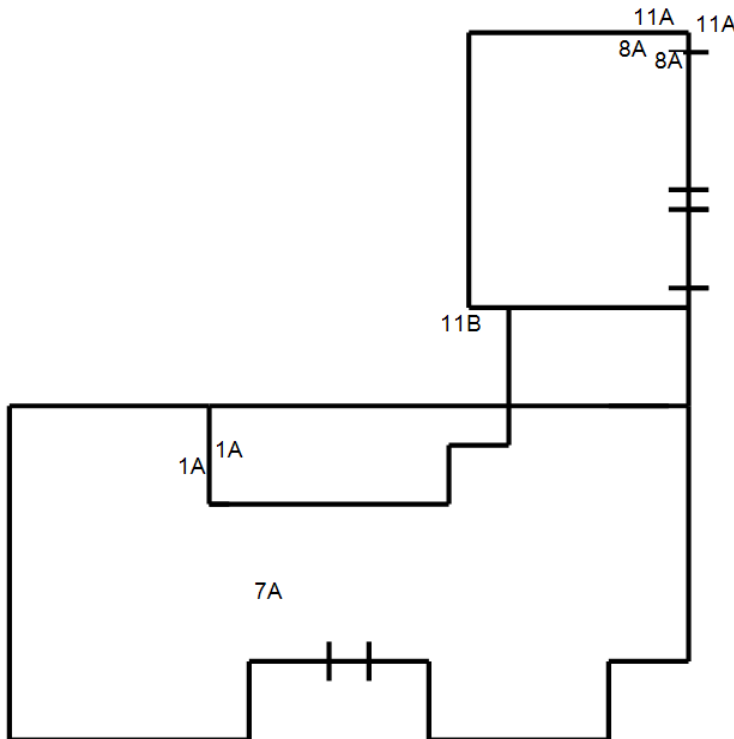
This Diagram is not to scale

1A PRICE: \$598.00
FINDINGS: Evidence of subterranean termite infestation as indicated on the diagram. Section I
RECOMMENDATION: Pressure "ROD" treat, trench application or low pressure spot spray as necessary.
Break accessible sub tubes.

7A PRICE: \$798.00
FINDINGS: Evidence of drywood termite infestation at as indicated on the diagram. Section I
RECOMMENDATION: Chemically treat visible and accessible infestations. Remove or cover accessible pellets.

8A PRICE: See 7A
FINDINGS: Evidence of drywood termite infestation at as indicated on the diagram. Section I
RECOMMENDATION: Chemically treat visible and accessible infestations. Remove or cover accessible pellets.

11A PRICE: \$1,100.00
FINDINGS: Evidence of termite damaged wood members noted at time of inspection on 2x6x16 fascia, 2-1x12x8 siding & 3-1x4x8 trims as indicated on the diagram. Section I
RECOMMENDATION: Replace/Repair termite damaged wood members as necessary. painting is included in this estimate.

11B PRICE: See 11A
FINDINGS: Dry-rot wood members found at time of inspection on 4x6 fascia as indicated on the diagram. Section I
RECOMMENDATION: Replace dry-rot damaged wood members as necessary. painting is included in this estimate.
