# WOOD DESTROYING PESTS AND ORGANISMS INSPECTION REPORT

| Building Address:<br><b>27846 Palos Verdes Drive East, Rancho Palos Verdes, CA 90275</b> | | Date of Inspection<br><b>08/07/2025</b> | Number of Pages<br><b>6</b> |
| <p style="margin-top: 20px;">Moon's Termite Solutions<br/>511 S. Carondelet St, Suite 202, Los Angeles, CA 90057<br/>(213)378-3378</p> | | Report #<br><b>MT 018725</b> | |

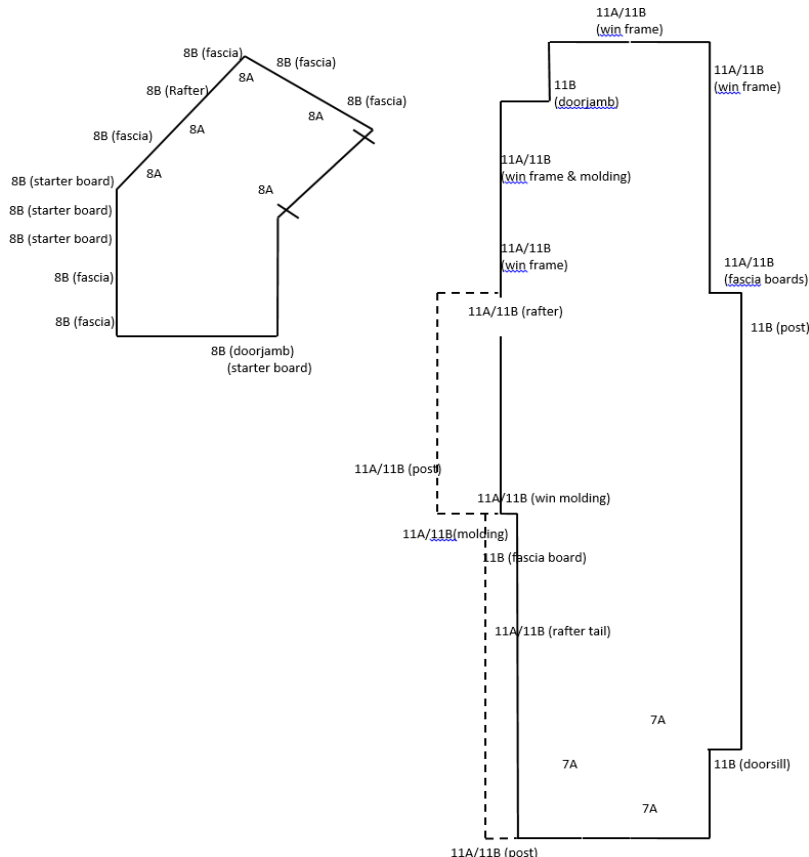
FINDINGS: Evidence of drywood termite infestation found in the attic as indicated on the diagram

FINDINGS: Evidence of drywood termite infestation found in the garage as indicated on the diagram

RECOMMENDATION: Vacate the premises and seal the structure for fumigation with Vikane Gas.
