WOOD DESTROYING PESTS AND ORGANISMS INSPECTION REPORT

Building Address: 1235 N. Brand Blvd. #1-10, Glendale, CA 91202		Date of Inspection 05/07/2024	Number of Pages 9

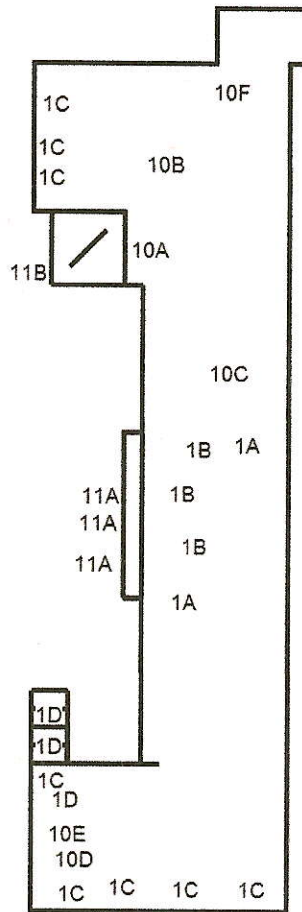
This Diagram is not to scale

- 1A (Section II)
FINDINGS: Moisture condition noted at time of inspection at sub area as indicated on the diagram.
RECOMMENDATION: Contact proper tradesman to repair plumbing leaks and any water damage from same.

- 1B (Section I)
FINDINGS: Evidence of subterranean termites noted at the sub area.
RECOMMENDATION: Chemically treat this area for the control of subterranean termites. Local treatment is not intended to be an entire structure treatment method. If infestations of wood-destroying pests extend or exist beyond the area(s) of local treatment, they may not be exterminated.

- 1C (Section I)
FINDINGS: Evidence of dry-wood termite infestations at the sub area as indicated on the diagram.
RECOMMENDATION: Vacate the premises and seal the structure for fumigation with Vikane (Sulfuryl Flouride) gas with a Chloropicrin warning agent or Zythor (Sulfuryl Flouride) with a Chloropicrin warning agent, for a kill of the drywood termite infestation(s), then this Company to remove or mask the evidence of the drywood termites for the benefit of future inspections. Fumigation may be cancelled due to inclement weather such as, strong winds or rain. King Termite Control, Inc. nor the fumigation company assumes any responsibility or liability for plant, antenna or roof damage. Fumigation notice forms must be signed prior to fumigation and neighbor's authorization, if applicable. See fumigation notice for terms and liabilities.

- 1D (Section I)
FINDINGS: Evidence of subterranean termites noted at the front stairs.
RECOMMENDATION: Chemically treat this area for the control of subterranean termites. Local treatment is not intended to be an entire structure treatment method. If infestations of wood-destroying pests extend or exist beyond the area(s) of local treatment, they may not be exterminated.

- 8A (Section I)
FINDINGS: Dry-rot wood members found at time of inspection at the fascia and rafters as indicated on the diagram.
RECOMMENDATION: Repair and/or replace damaged wood as necessary. Painting included. If additional damage is uncovered during repairs, further inspection may be recommended and a supplemental report will be issued indicating any infection, or additional repairs.

- 8B (Section I)
FINDINGS: Evidence of dry-wood termite infestations at the ? as indicated on the diagram.
RECOMMENDATION: Vacate the premises and seal the structure for fumigation with Vikane (Sulfuryl Flouride) gas with a Chloropicrin warning agent or Zythor (Sulfuryl Flouride) with a Chloropicrin warning agent, for a kill of the drywood termite infestation(s), then this Company to remove or mask the evidence of the drywood termites for the benefit of future inspections. Fumigation may be cancelled due to inclement weather such as, strong winds or rain. King Termite Control, Inc. nor the fumigation company assumes any responsibility or liability for plant, antenna or roof damage. Fumigation notice forms must be signed prior to fumigation and neighbor's authorization, if applicable. See fumigation notice for terms and liabilities.
SECONDARY RECOMMENDATION: SECONDARY RECOMMENDATION IN LIEU OF FUMIGATION: Chemically treat visible and accessible infestations only. Remove or cover accessible evidence of infestation. This is a sub-standard recommendation. Limited guarantee due to concealed areas not being treated. Secondary work requested by _____.

- 10A (Section I)
FINDINGS: Unit 9 Excessive moisture damage noted at time of inspection at front window sill as indicated on the diagram.
RECOMMENDATION: Contact proper tradesman to correct moisture condition and repair or replace water damaged plaster as necessary.

- 10B (Section II)
FINDINGS: Plaster and/or drywall damage noted at time of inspection at kitchen ceiling as indicated on the diagram.
RECOMMENDATION: Owner to have tradesman to repair plaster and/or drywall damage as necessary.

- 10C (Section I)
FINDINGS: Unit 6 evidence of dry-wood termite infestations at the kitchen cabinets as indicated on the diagram.
RECOMMENDATION: Vacate the premises and seal the structure for fumigation with Vikane (Sulfuryl Flouride) gas with a Chloropicrin warning agent or Zythor (Sulfuryl Flouride) with a Chloropicrin warning agent, for a kill of the drywood termite infestation(s), then this Company to remove or mask the evidence of the drywood termites for the benefit of future inspections. Fumigation may be cancelled due to inclement weather such as, strong winds or rain. King Termite Control, Inc. nor the fumigation company assumes any responsibility or liability for plant, antenna or roof damage. Fumigation notice forms must be signed prior to fumigation and neighbor's authorization, if applicable. See fumigation notice for terms and liabilities.

- 10D (Section I)
FINDINGS: Unite 1 Evidence of dry-wood termite infestations at the window frame as indicated on the diagram.
RECOMMENDATION: Vacate the premises and seal the structure for fumigation with Vikane (Sulfuryl Flouride) gas with a Chloropicrin warning agent or Zythor (Sulfuryl Flouride) with a Chloropicrin warning agent, for a kill of the drywood termite infestation(s), then this Company to remove or mask the evidence of the drywood termites for the benefit of future inspections. Fumigation may be cancelled due to inclement weather such as, strong winds or rain. King Termite Control, Inc. nor the fumigation company assumes any responsibility or liability for plant, antenna or roof damage. Fumigation notice forms must be signed prior to fumigation and neighbor's authorization, if applicable. See fumigation notice for terms and liabilities.

- 10E (Section I)
FINDINGS: Evidence of subterranean termites noted at the wall framing.
RECOMMENDATION: Chemically treat this area for the control of subterranean termites. Local treatment is not intended to be an entire structure treatment method. If infestations of wood-destroying pests extend or exist beyond the area(s) of local treatment, they may not be exterminated.

- 10F (Section I)
FINDINGS: Unit 10 kitchen evidence of dry-wood termite infestations at the kitchen window as indicated on the diagram.
RECOMMENDATION: Vacate the premises and seal the structure for fumigation with Vikane (Sulfuryl Flouride) gas with a Chloropicrin warning agent or Zythor (Sulfuryl Flouride) with a Chloropicrin warning agent, for a kill of the drywood termite infestation(s), then this Company to remove or mask the evidence of the drywood termites for the benefit of future inspections. Fumigation may be cancelled due to inclement weather such as, strong winds or rain. King Termite Control, Inc. nor the fumigation company assumes any responsibility or liability for plant, antenna or roof damage. Fumigation notice forms must be signed prior to fumigation and neighbor's authorization, if applicable. See fumigation notice for terms and liabilities.
