Property Inspection Report

1798 Alrita Street, San Luis Obispo, CA 93401
Inspection prepared for: Moses Gastelum
Real Estate Agent: Christa Lowry - Coldwell Banker Premier

Date of Inspection: 3/30/2023 Time: 1:00 PM Size: 1347
Order ID: 9463

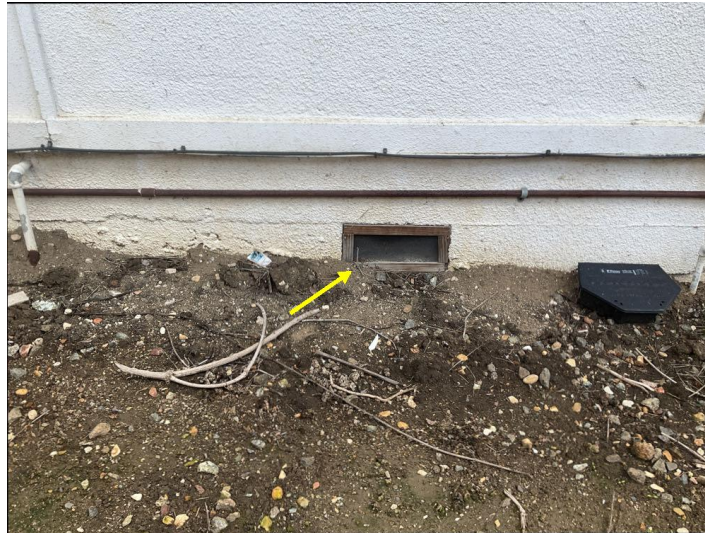
The general topography directs water toward the crawlspace ventilation screen(s) or crawlspace access, which could funnel water into the crawlspace. We recommend the grade be lowered and made the slope away from the house foundation.

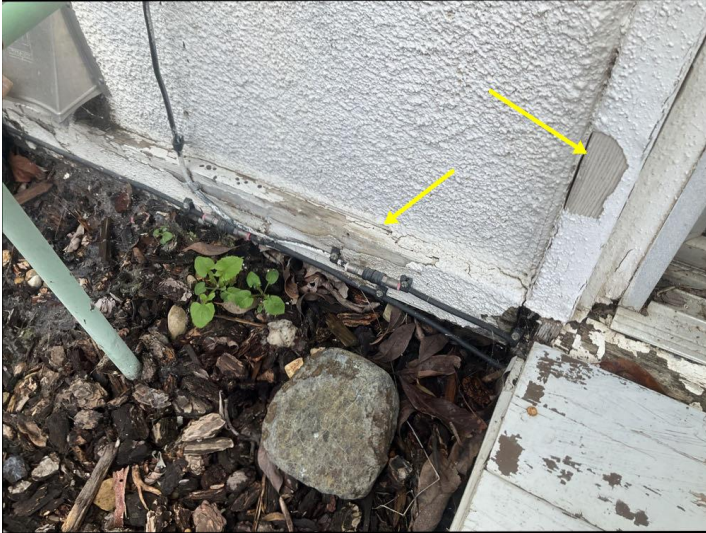
The stucco has been applied over a wood substrate is peeling in places, as a result of inadequate bonding or preparation.

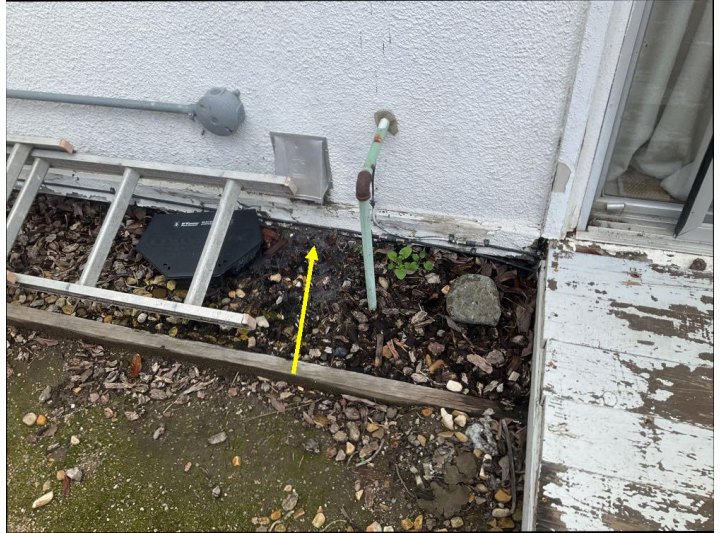
The soil is too high against the home at various areas around the home which should be serviced. Siding clearance should be maintained 2" to hard surfaces, and 4" to soils.

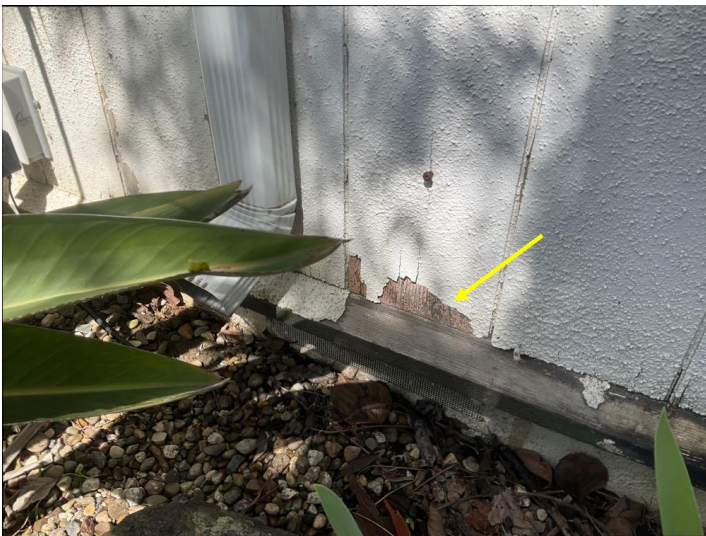
The stucco has been applied over a wood substrate is peeling in places, as a result of inadequate bonding or preparation.

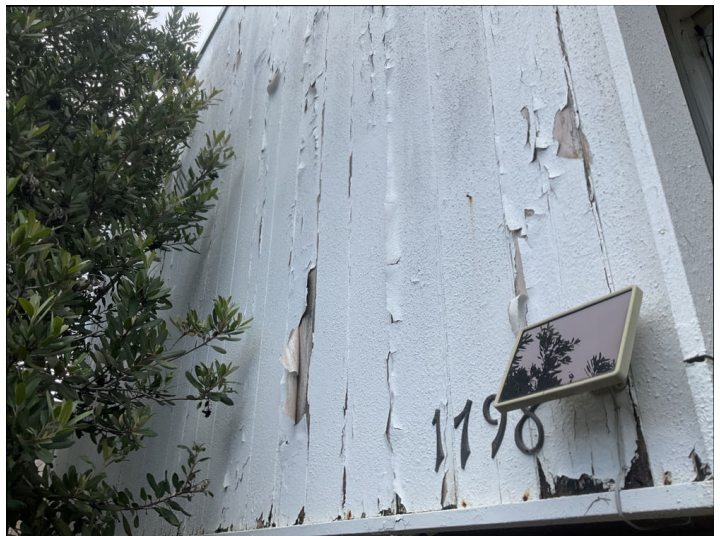
The siding needs typical maintenance such as sealing and painting. This should include caulking and filling gaps or openings such as small cracks or openings at hose bibs, and sealing with a proper primersealer, then one or two finish coats.

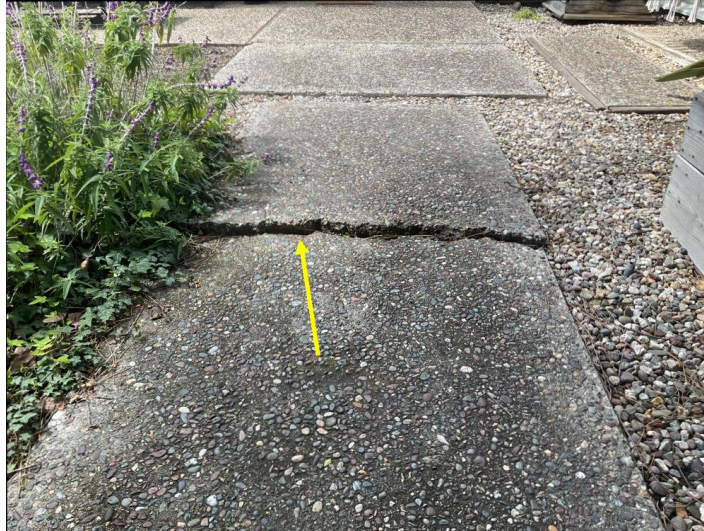
There are several offsets in the walkways that could prove to be trip-hazards.

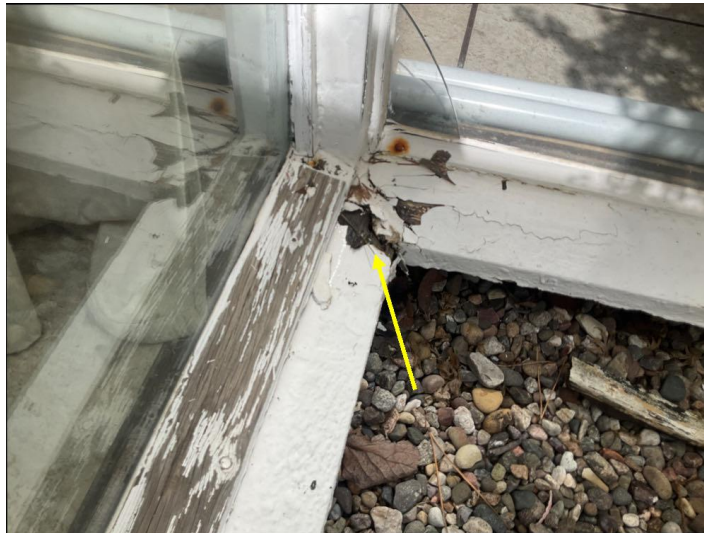
There is damage to the wood trim that should be evaluated by a termite inspector.

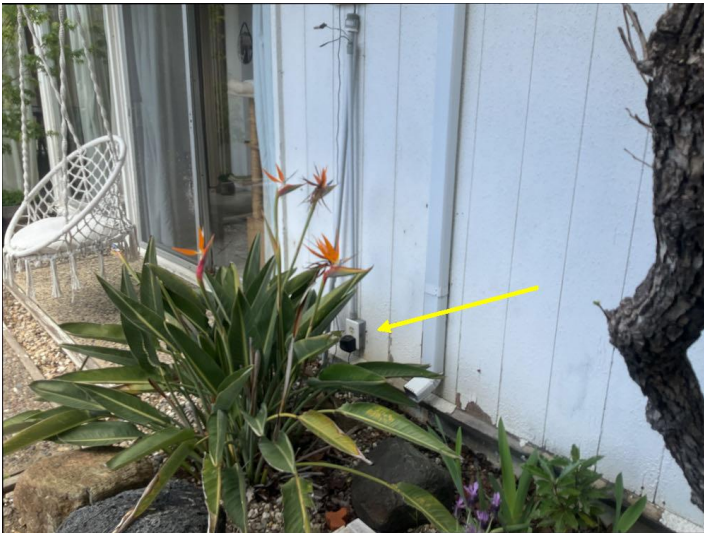
An outlet at the front does not function and should be evaluated and serviced by a licensed electrical contractor.

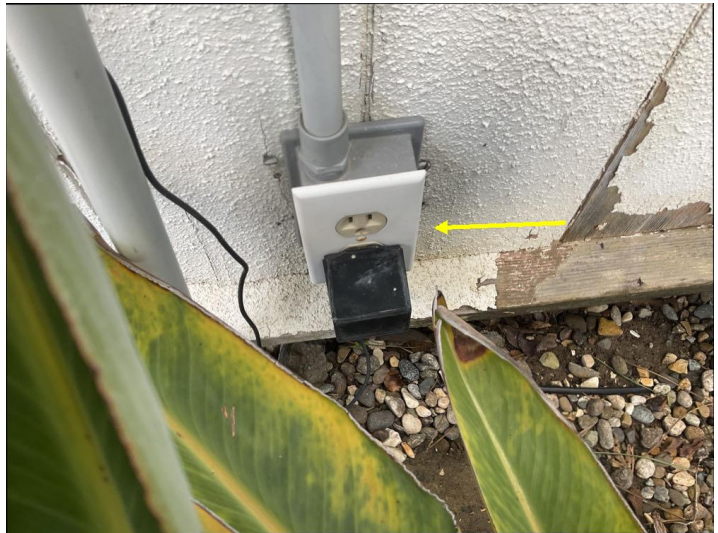
Some of the exterior electrical outlets do not have a weather rated cover or the cover is damaged and should be serviced.

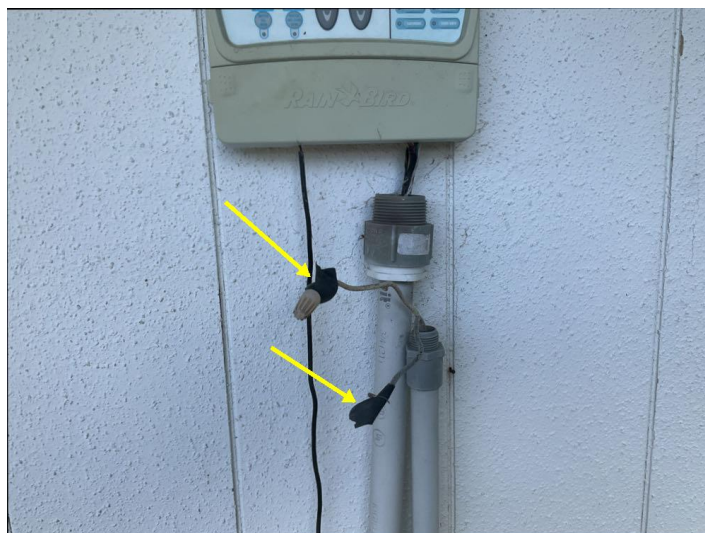
There is an exposed electrical termination that should be in a junction box and is a safety hazard.

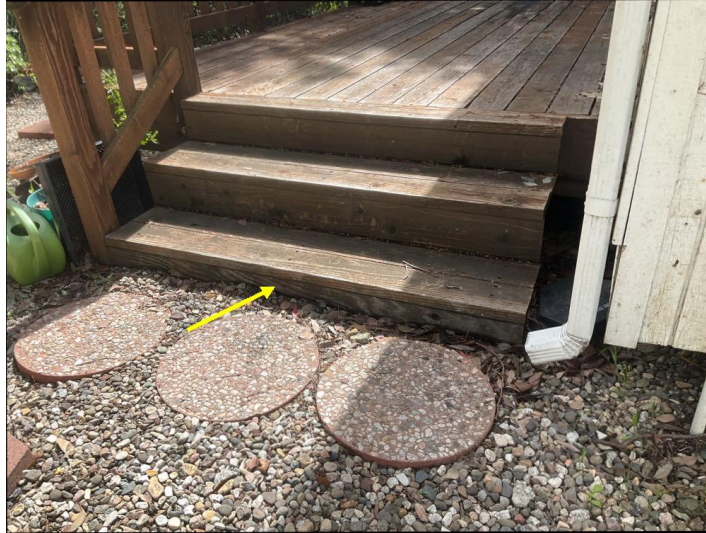
Some of the steps have unequal treads or risers. Steps are required to be uniform to prevent trip-hazards. The rise of any step should be no less than four inches and no greater than seven inches, and the run should be no less than eleven inches. Also, the dimensions of the largest step should not exceed that of the smallest by more than three-eighths of an inch.

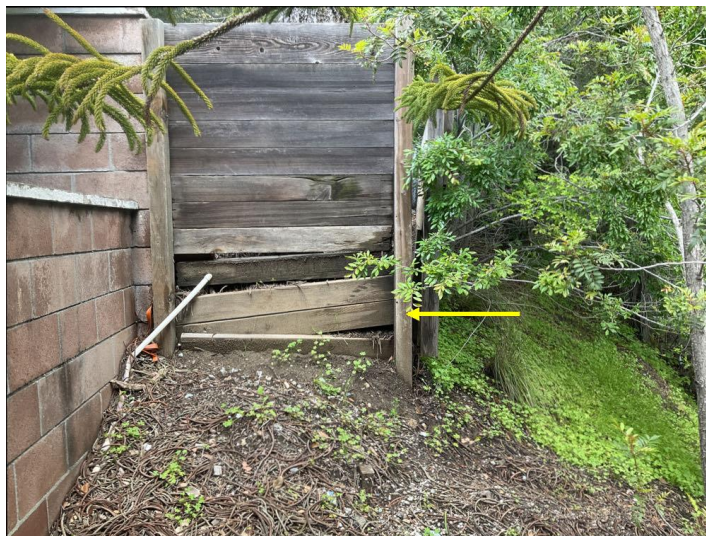
The fence has damaged or missing board(s) which should be replaced.

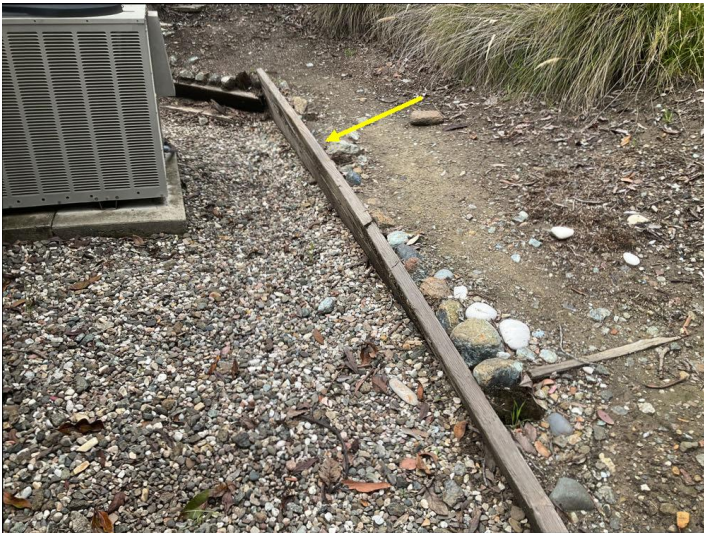
The wooden planks at the rear of the property have no structural value, and are intended to inhibit surface soil movement, and should be periodically monitored for damage or stability. Most should be repaired or replaced.

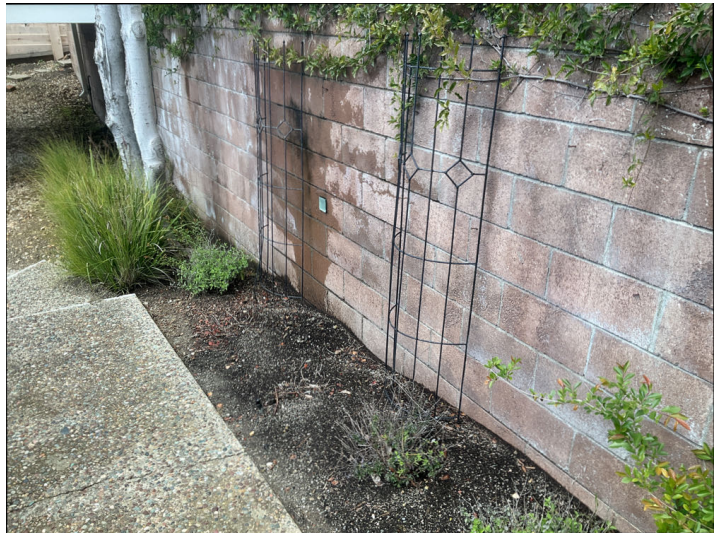
There are no weep holes or open grout joints at the base of the yard walls, which permit drainage and prevent pressure from building up behind them. Subsurface drainage, French drain may have been added during construction but cannot be viewed.

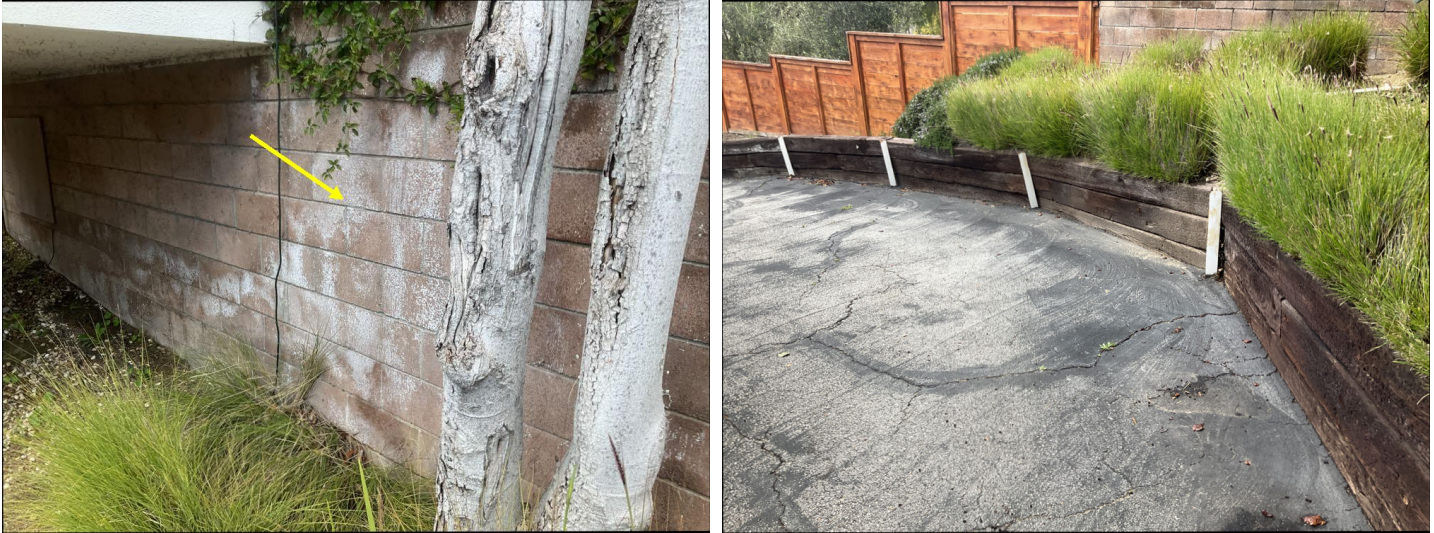
There is efflorescence, or salt-crystal formations, at various points on the yard walls. Such efflorescence is relatively common and is activated by moisture, but has only a cosmetic significance.

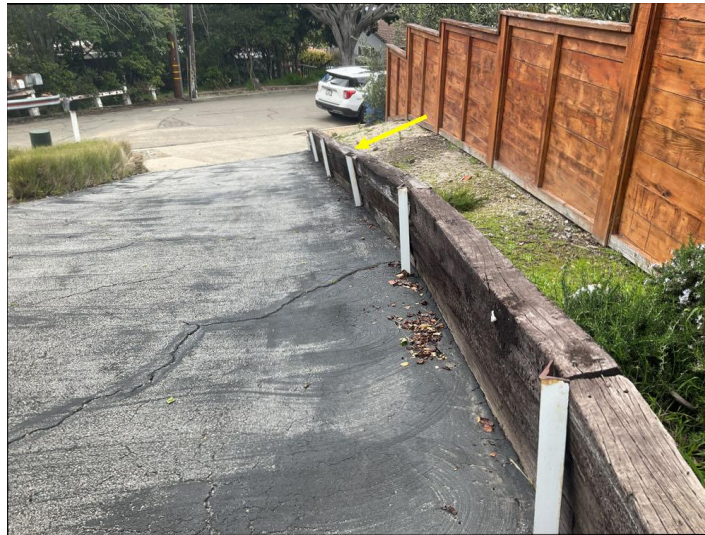
The railroad-tie yard walls are leaning and should be served.

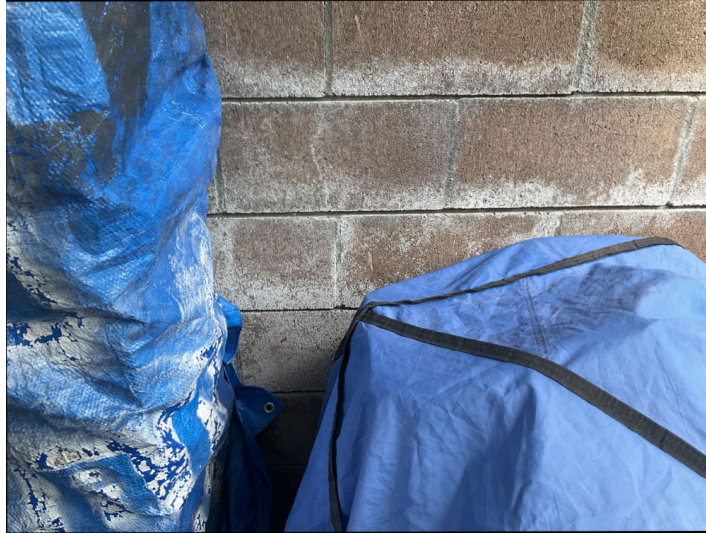
There is efflorescence, or salt-crystal formations, at various points on the walls. Such efflorescence is relatively common and is activated by moisture, but has only a cosmetic significance.

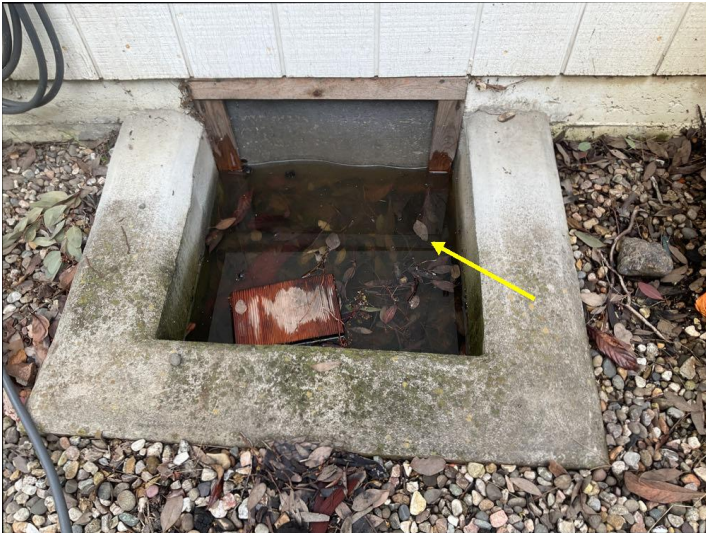
We cannot access all areas of the foundation crawlspace, due to the obstruction of ducts pipes or conduit and or limited space. We were able to inspect or view about 80%. The Area under the office is under water and was not evaluated.

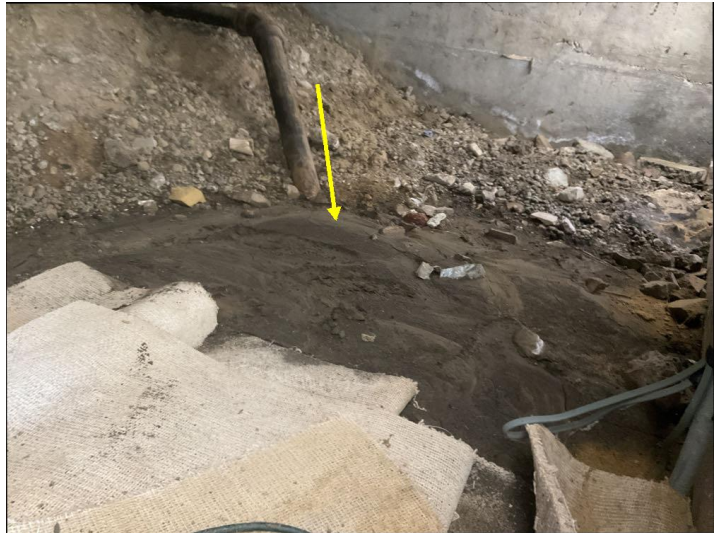
The soils within the crawlspace are moist, which appear to have resulted from recent rains. This can contribute to differential settling, and facilitate the growth of a variety of molds and fungi that can produce unhealthy conditions. The crawlspace should be carefully monitored to insure there is adequate ventilation and that it dries out in an appropriate manner and time.

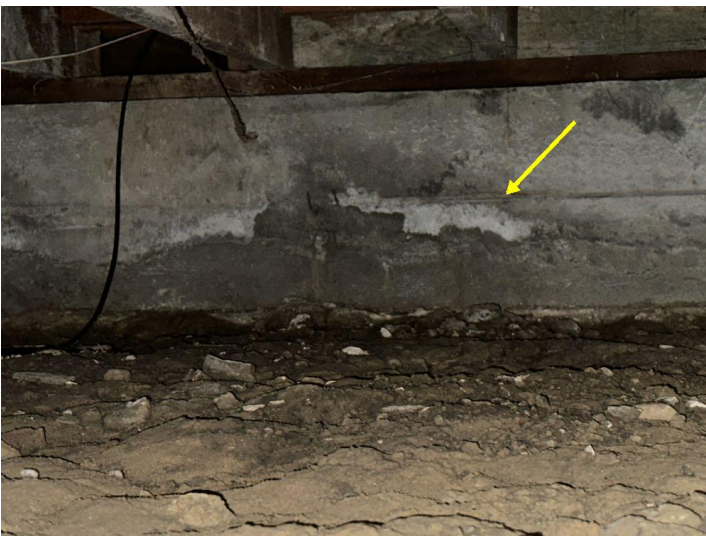
Moisture has entered the crawlspace, as is evident by salt crystal formations around the base of the stem walls. However, this is a common phenomenon that does not necessarily indicate a chronic or serious problem. The soils are currently dry, but it would be prudent to monitor this area.

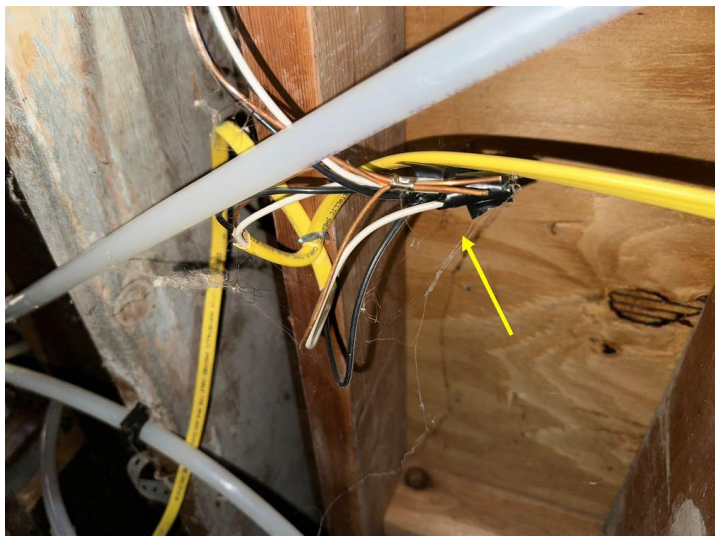
An electrical connection within the crawlspace have been incorrectly made outside of junction boxes. All such connections should be made within junction boxes in order to contain any arcing or sparking that could occur.

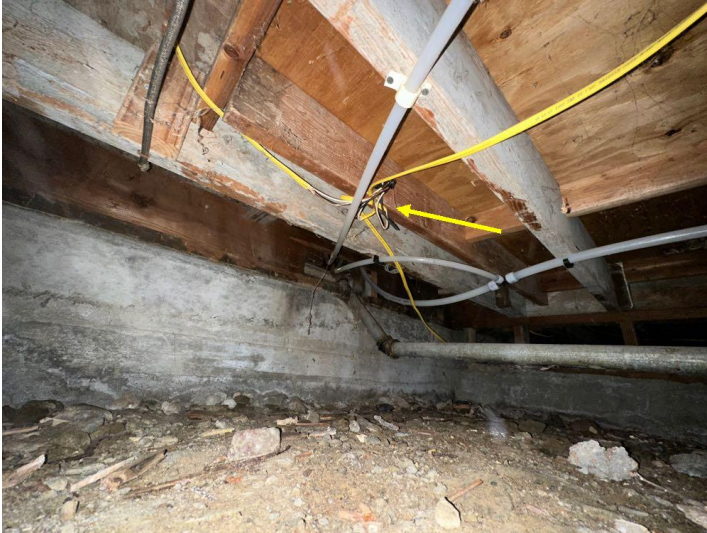
An electrical connection within the crawlspace have been incorrectly made outside of junction boxes. All such connections should be made within junction boxes in order to contain any arcing or sparking that could occur.

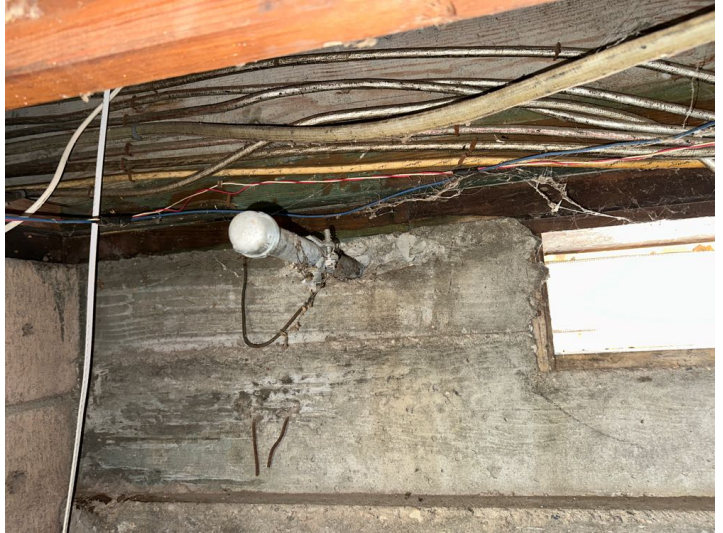
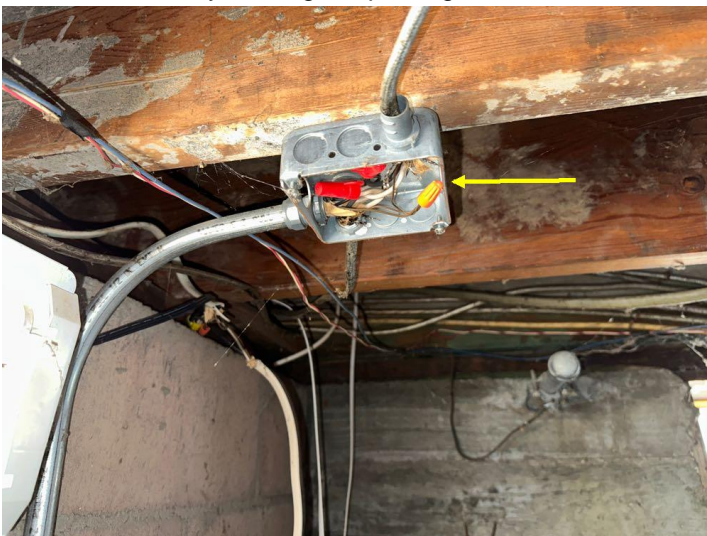
There are open electrical junction boxes, which should be sealed so that any arcing or sparking would be contained within the box.

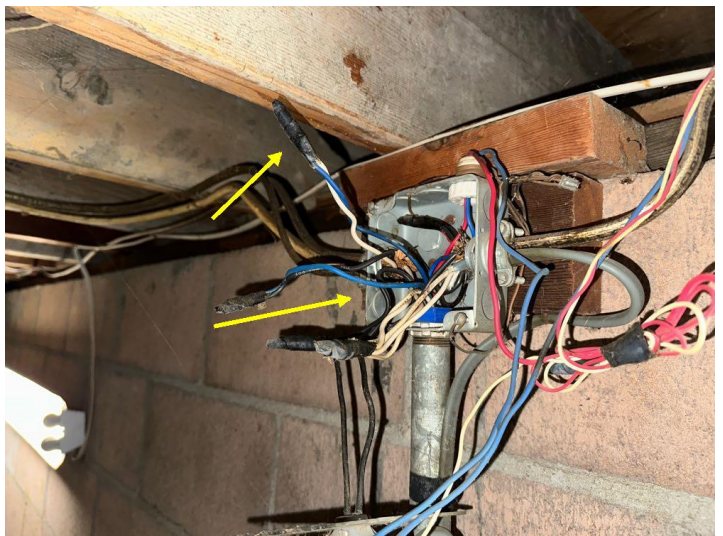
Electrical conduits within the crawlspace were not professionally installed and include detached electrical junction boxes, loose or unsecured vinyl conduit, or conduit without restraint clamps, et cetera, which should be evaluated serviced by a licensed electrician.

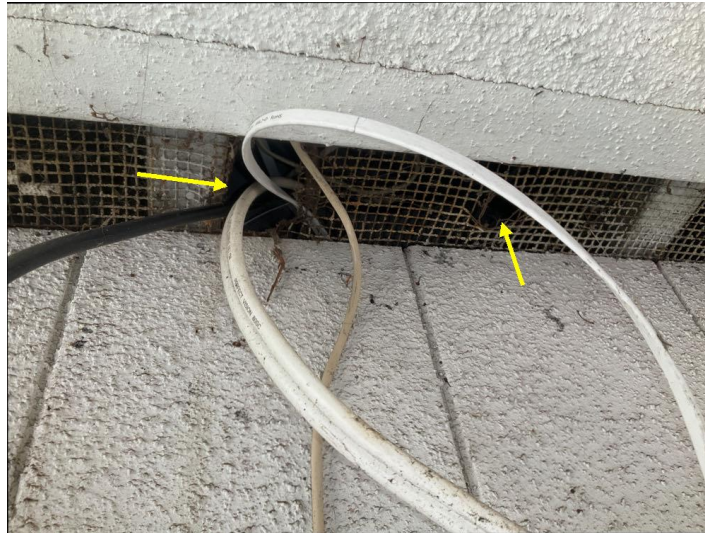
Foundation ventilation screen(s) are damaged or missing, and should be repaired or replaced to keep rodents and other pests out.

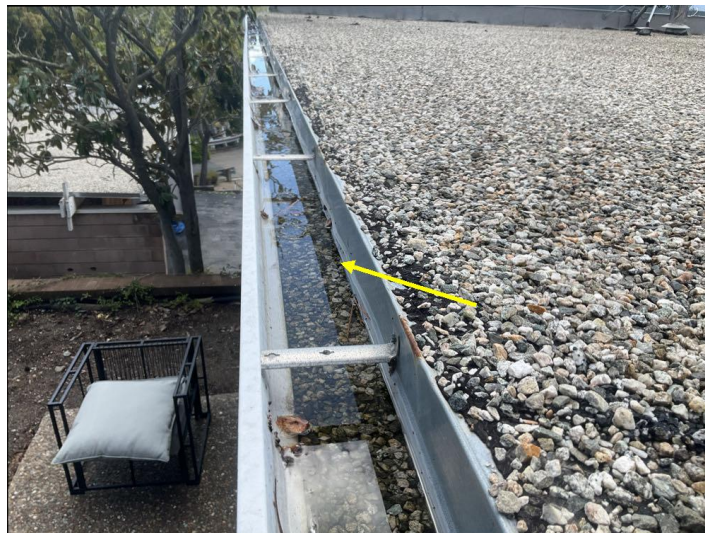
The gutters need to be serviced as well as being cleaned such as securing them or sealing separated seams.

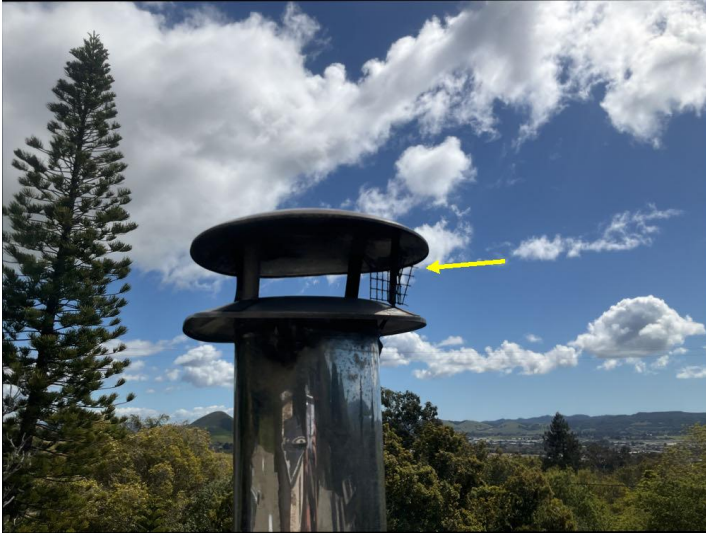
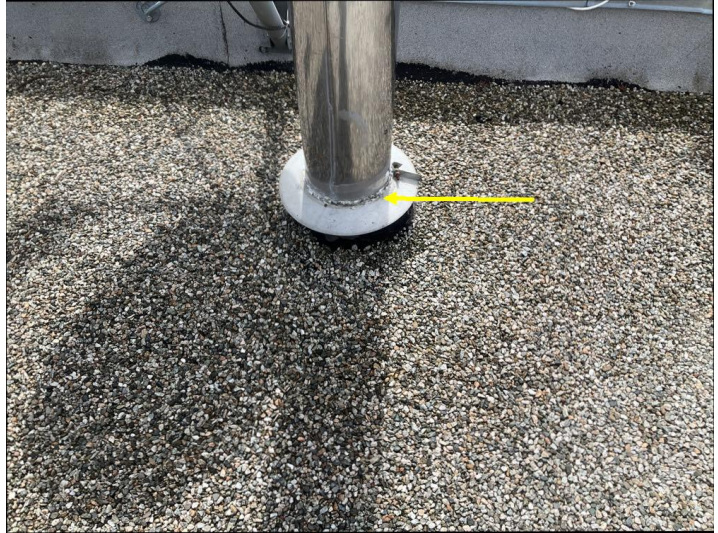
There is no spark arrestor on the chimney, which is required by current standards, and should be installed.

The chimney flashing is worn and should be serviced. Evidence of moisture was noted on the chimney as viewed from the living room.

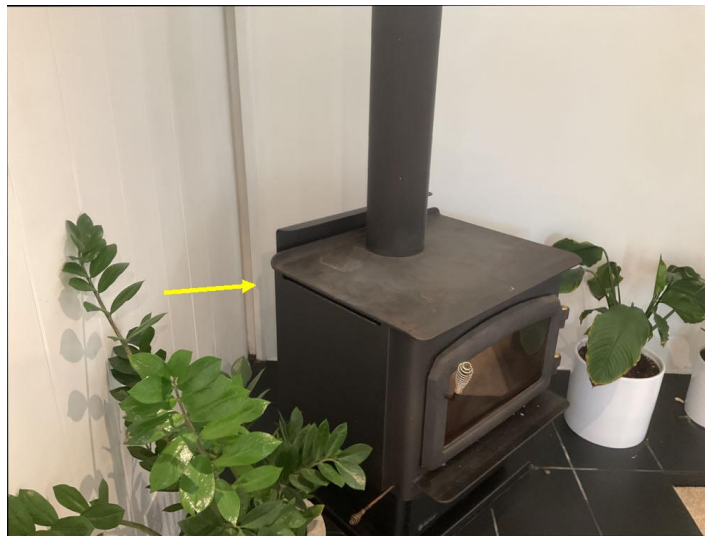
The wood burning stove does not have proper clearance to combustibles. Clearances are determined by the manufacture. Refer to original manufacture installation requirements. We recommend further evaluation by a qualified licensed specialist and serviced as required.

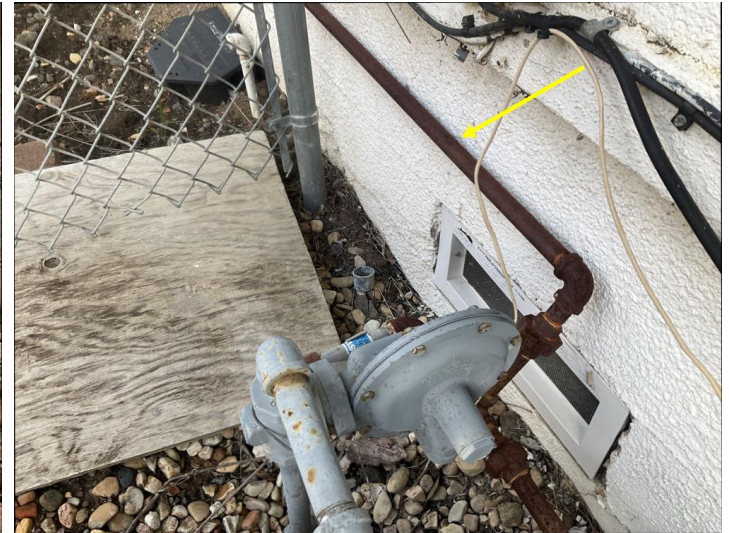
Some gas lines are rusted and should be painted to prevent further corrosion.

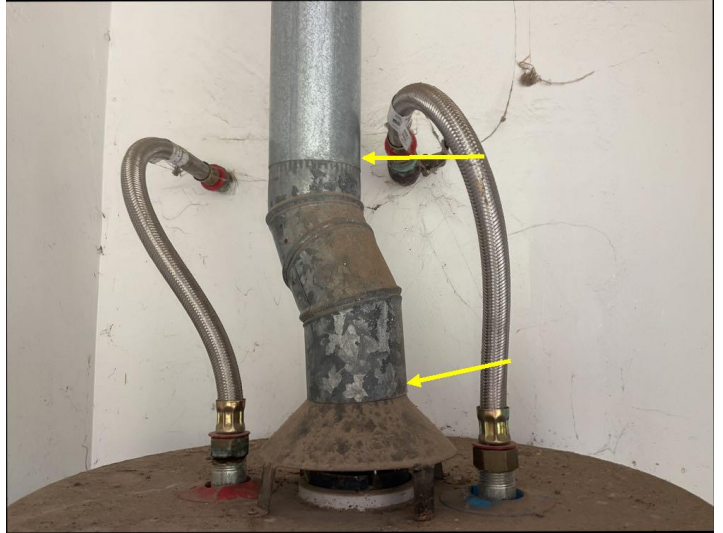
The vent pipe is not properly connected. It is required to have a minimum of 3 fasteners where the pipe connects to the draft hood or other single wall vent pipes.

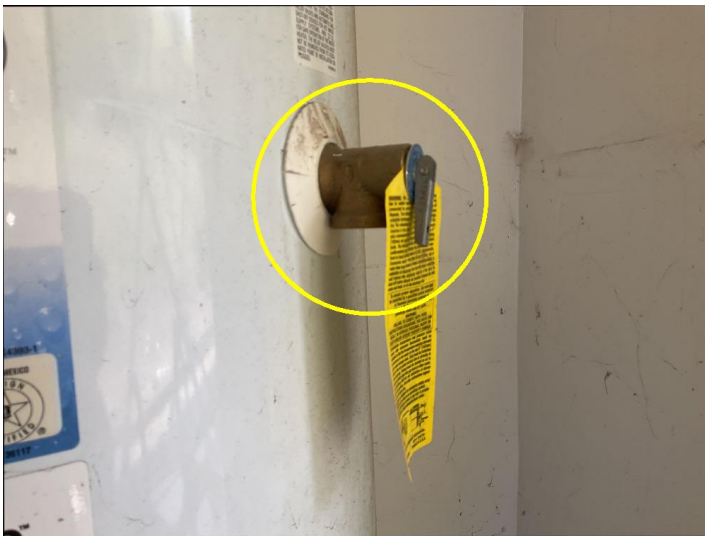
The pressure relief valve on the water heater does not have a discharge pipe. One should be installed to terminate no more than 24 inches above grade and no closer than 6 inches to it and be directed down towards the ground.

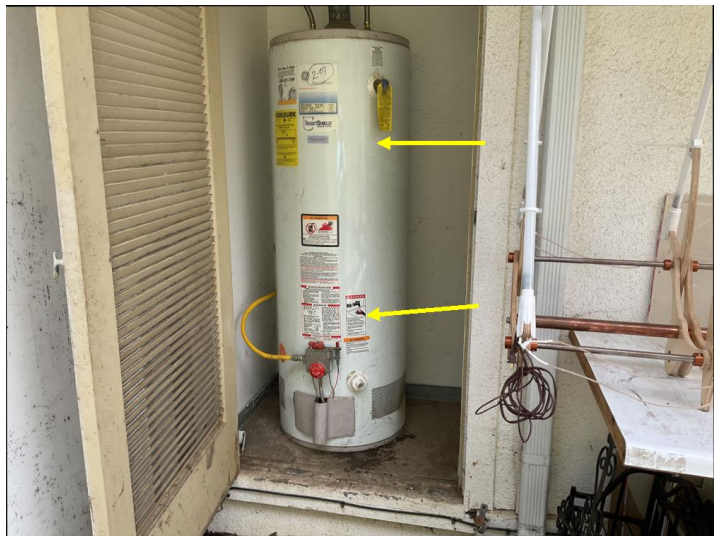
The water heater is not correctly secured, and needs to be seismically strapped and braced in accordance with local standards.

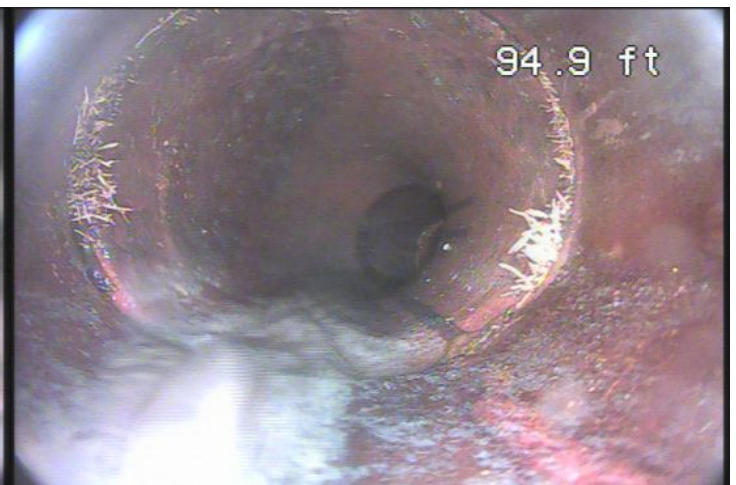
There is root growth present which is commonly a result of a damaged drain line or void in a joint. We recommend further review and repair as needed.

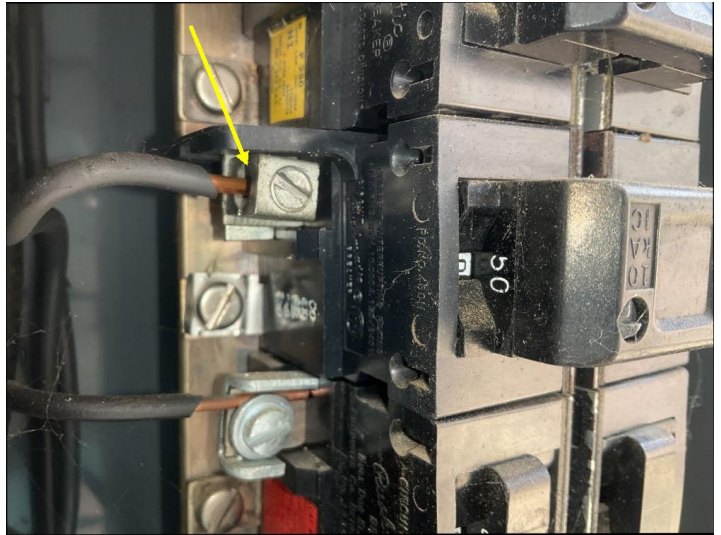
A 50 amp breaker in the main panel is serving undersized, or number 10 gauge wires, which can be a fire-hazard that should be corrected by an electrician.

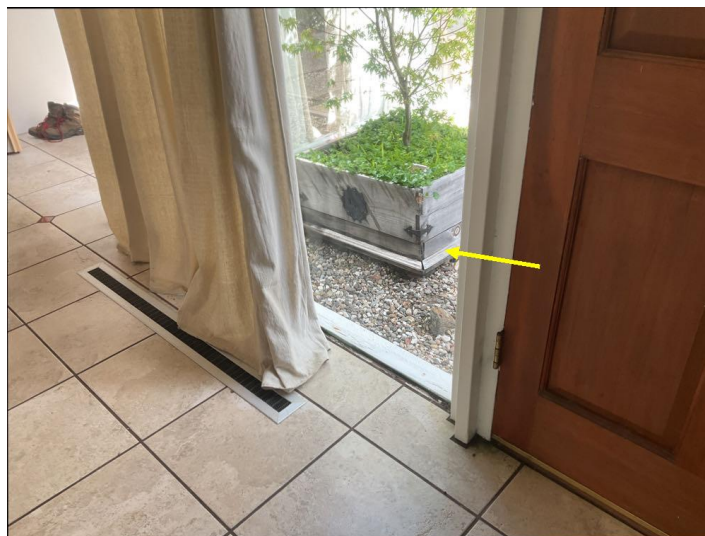
There's one or more windows installed within 18 inches of the finished floor that could not be identified as tempered glass. Current standards require such windows to be tempered or safety glass. We recommend further evaluation by a glass specialist. Often a film can be added that would hold the glass together in case of breakage.

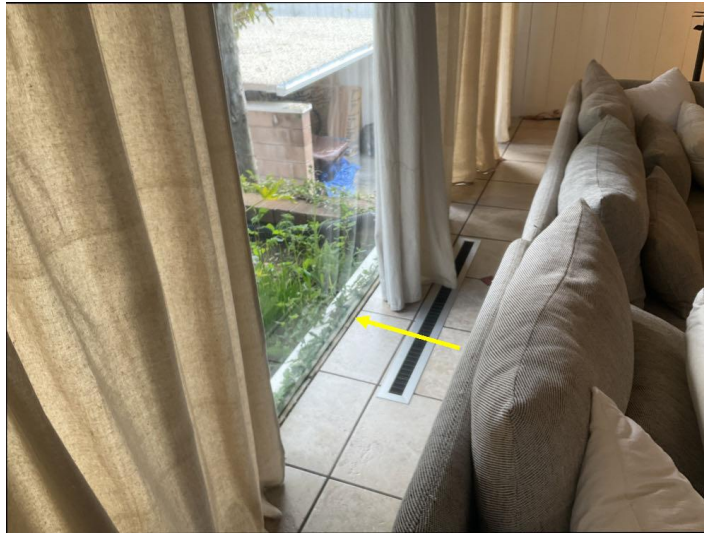
There's one or more windows installed within 18 inches of the finished floor that could not be identified as tempered glass. Current standards require such windows to be tempered or safety glass. We recommend further evaluation by a glass specialist. Often a film can be added that would hold the glass together in case of breakage.

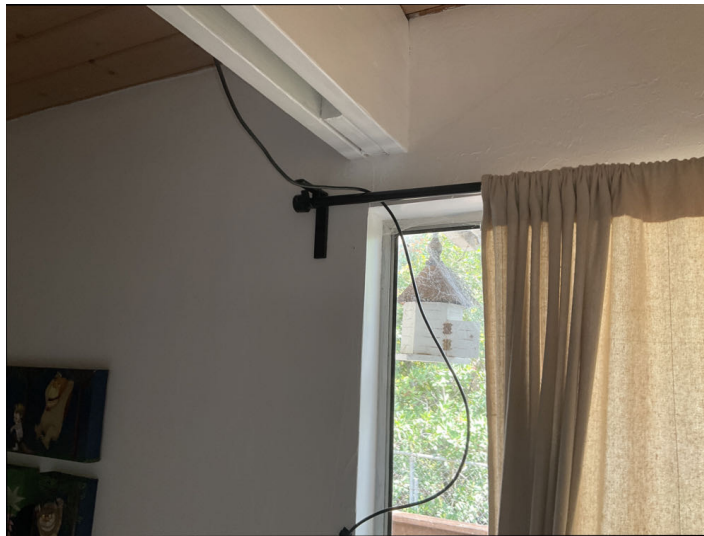
The window does not appear to have an appropriately sized header and support framing. We recommend further evaluation by a qualified licensed structural engineer and serviced or corrected as required.

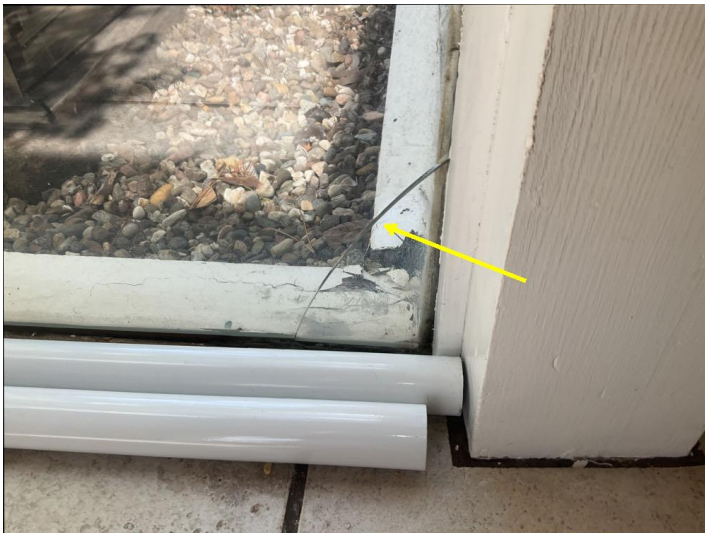
A window pane is cracked or broken and should be replaced.

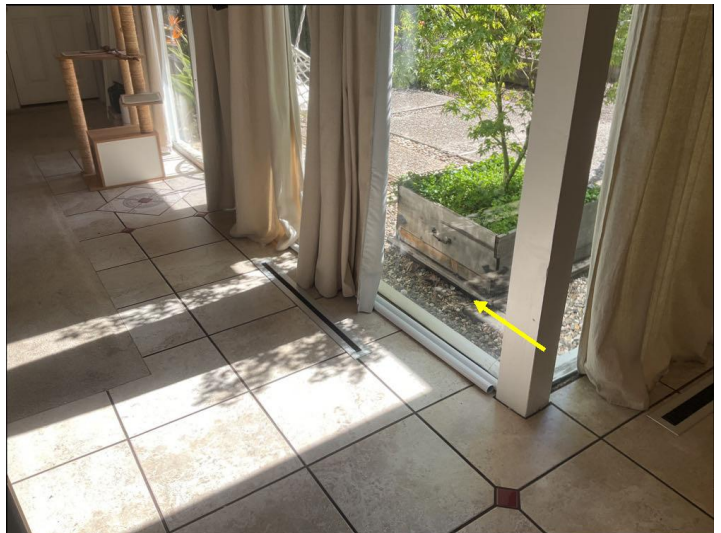
There's one or more windows installed within 18 inches of the finished floor that could not be identified as tempered glass. Current standards require such windows to be tempered or safety glass. We recommend further evaluation by a glass specialist. Often a film can be added that would hold the glass together in case of breakage.

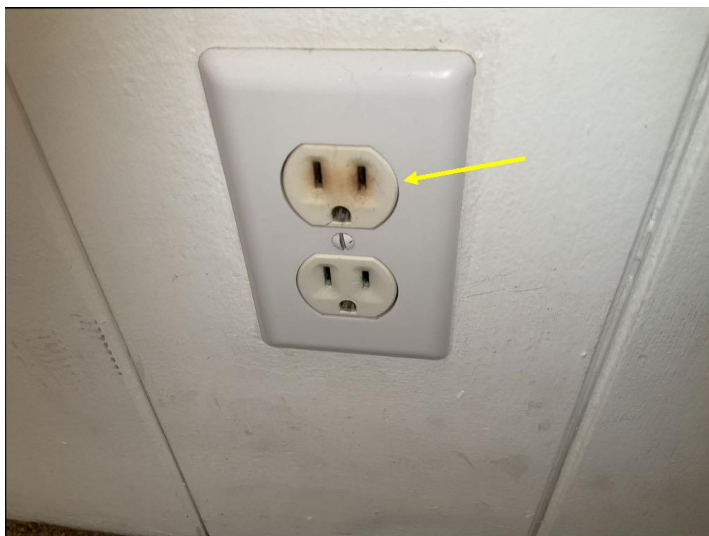
One or more outlets is damaged or has a scorch mark on it, and should be evaluated and serviced by a licensed electrical contractor.

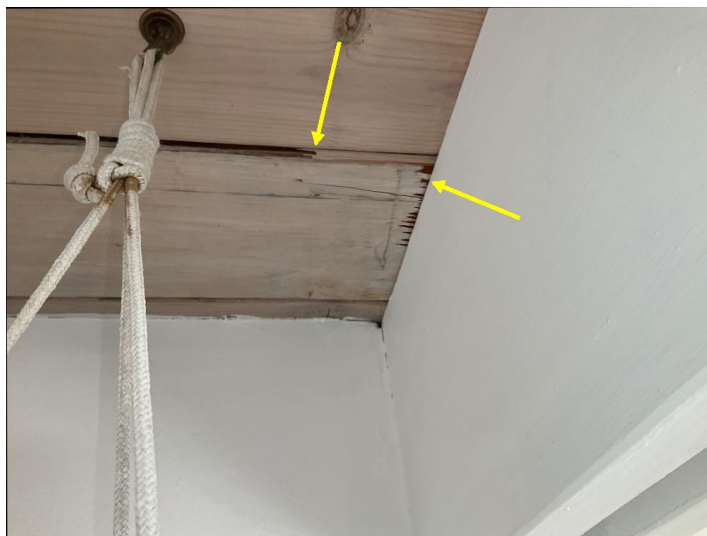
There is a moisture stain/damaged on the ceiling that should be explained or explored further. The area is currently dry after recent storms.

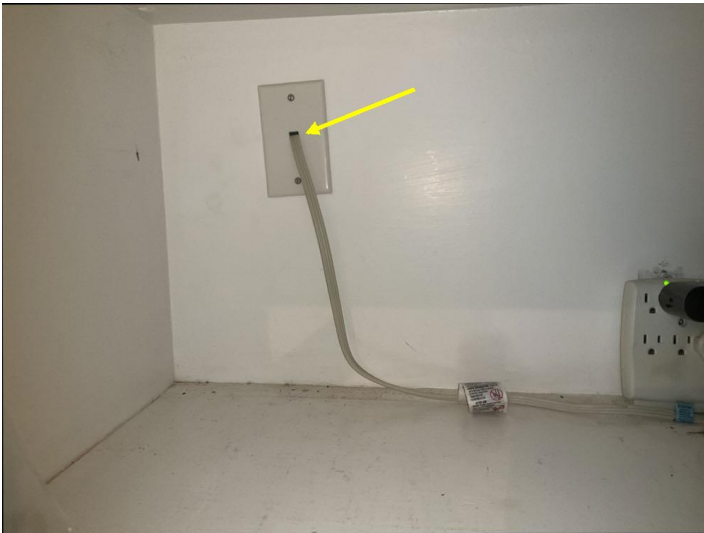
We have noted that an extension cord or extension cord material, is being used for permanent wiring, and through a wall, which is not allowed in most jurisdictions, and you may want to have it evaluated and serviced by a licensed electrical contractor.

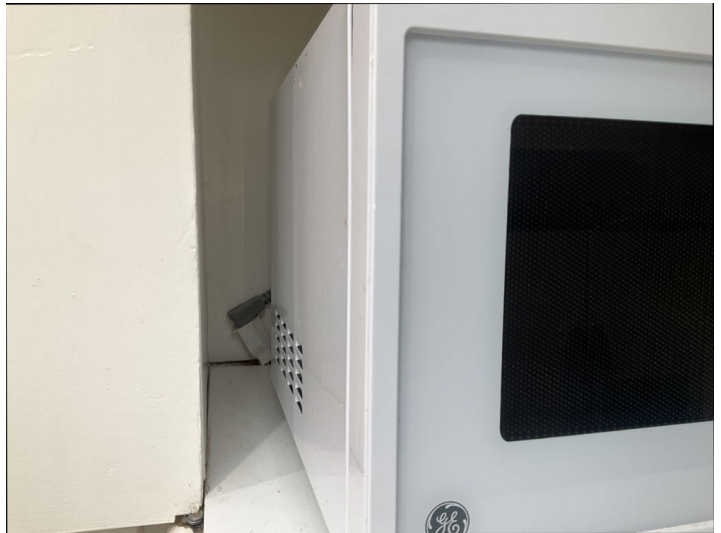
We have noted that an extension cord or extension cord material, is being used for permanent wiring, and through a wall, which is not allowed in most jurisdictions, and you may want to have it evaluated and serviced by a licensed electrical contractor.

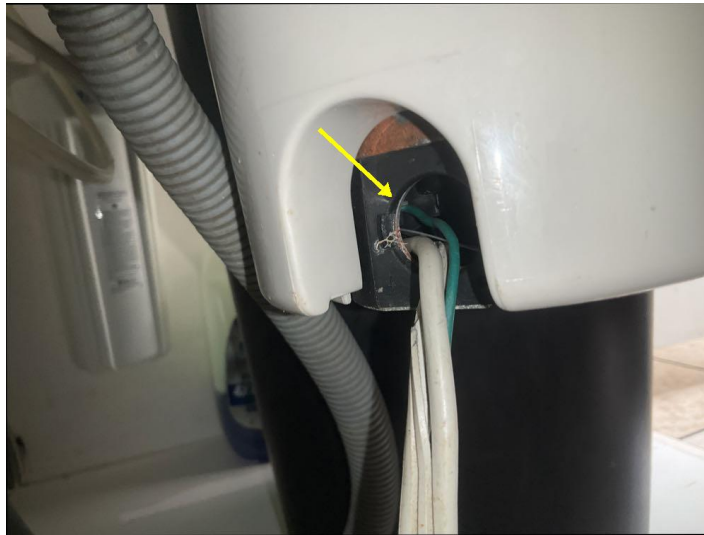
The electrical connection to the garbage disposal is substandard. The approved appliance cord is missing its protective clamp.

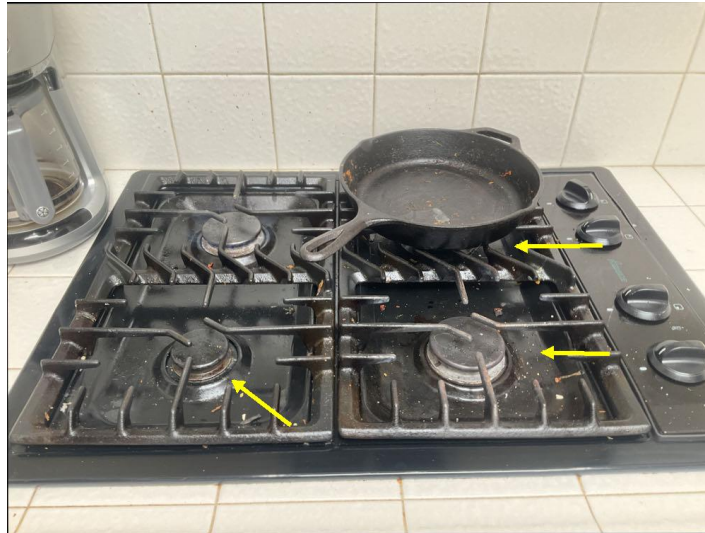
Burner(s) on the gas cook top do not respond or need to be serviced.

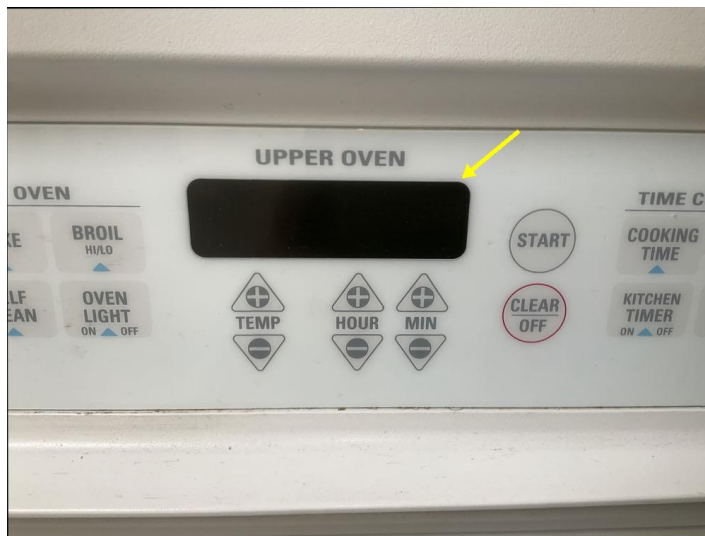
The LED readout is not functional and you may wish to have it evaluated

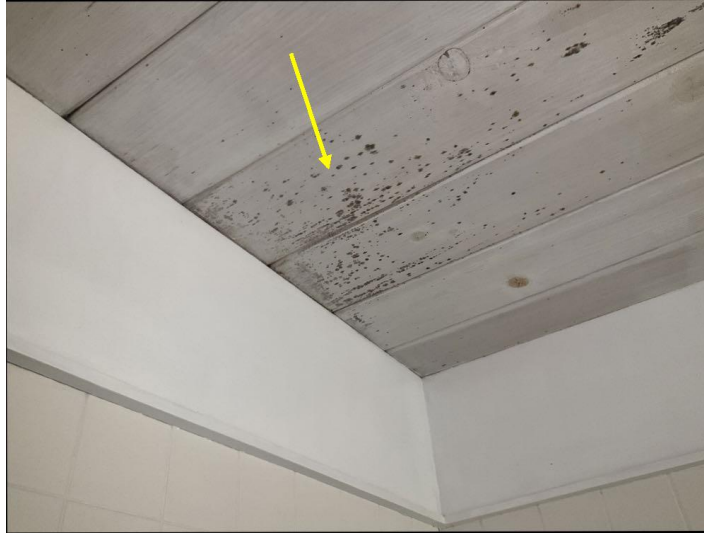
There are moisture stains on the ceiling which appear to be caused from a lack of ventilation. We recommend servicing the ceiling and adding mechanical ventilation.

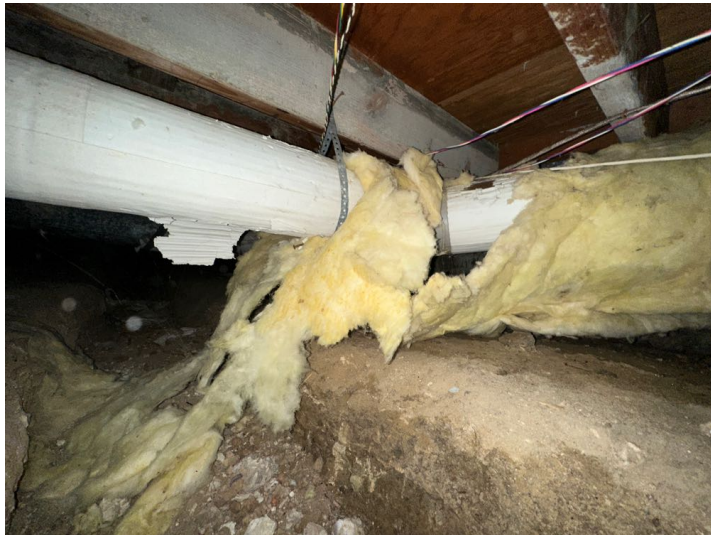
The ducts are rigid metal type that are mostly insulated with fiberglass. Some insulation is missing and should be serviced for more efficiency.
