PIVOT PROPERTY INSPECTION

PROPERTY INSPECTION REPORT

4179 N Santa Lucia St Orange, CA 92865

> Todd Moeller 10/06/2025

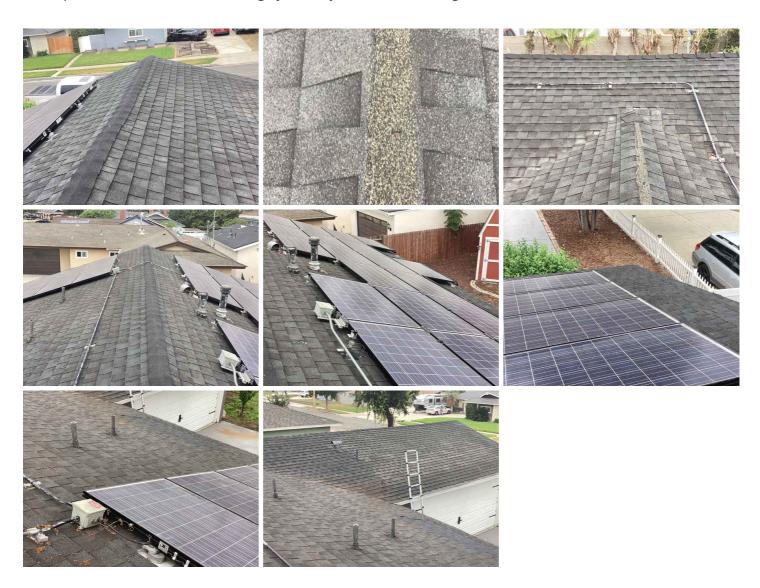
6.1.1 Roof

SHINGLES - END OF LIFESPAN

The roofing materials are showing signs of aging and wear. The roofing system appears to be at or near the end of its useful lifespan. The foregoing is an opinion of the general quality and condition of the roofing material. The inspector cannot and does not offer an opinion or warranty as to whether the roof leaks or may be subject to future leakage. This report is issued in consideration of the foregoing disclaimer. The only way to determine whether or not a roof is watertight is to observe it during a prolonged rainfall. Certification of the roofing system is beyond the scope of this inspection. I recommend a complete evaluation of the roofing system by a licensed roofing contractor.

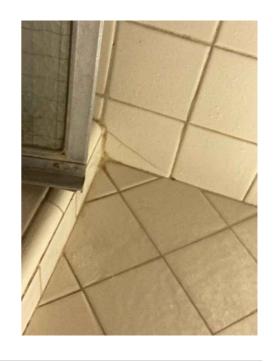
CRACK IN SHOWER TILE

There is a crack in the shower tile; recommend evaluation by a plumbing contractor.

Contact a qualified professional.
