Alliance SEPTIC SERVICE

Inspection/Certification

Date of Inspection: **09/05/2024**

Inspection Address: **1375 Nacimiento Lake Drive, Paso Robles CA 93446**

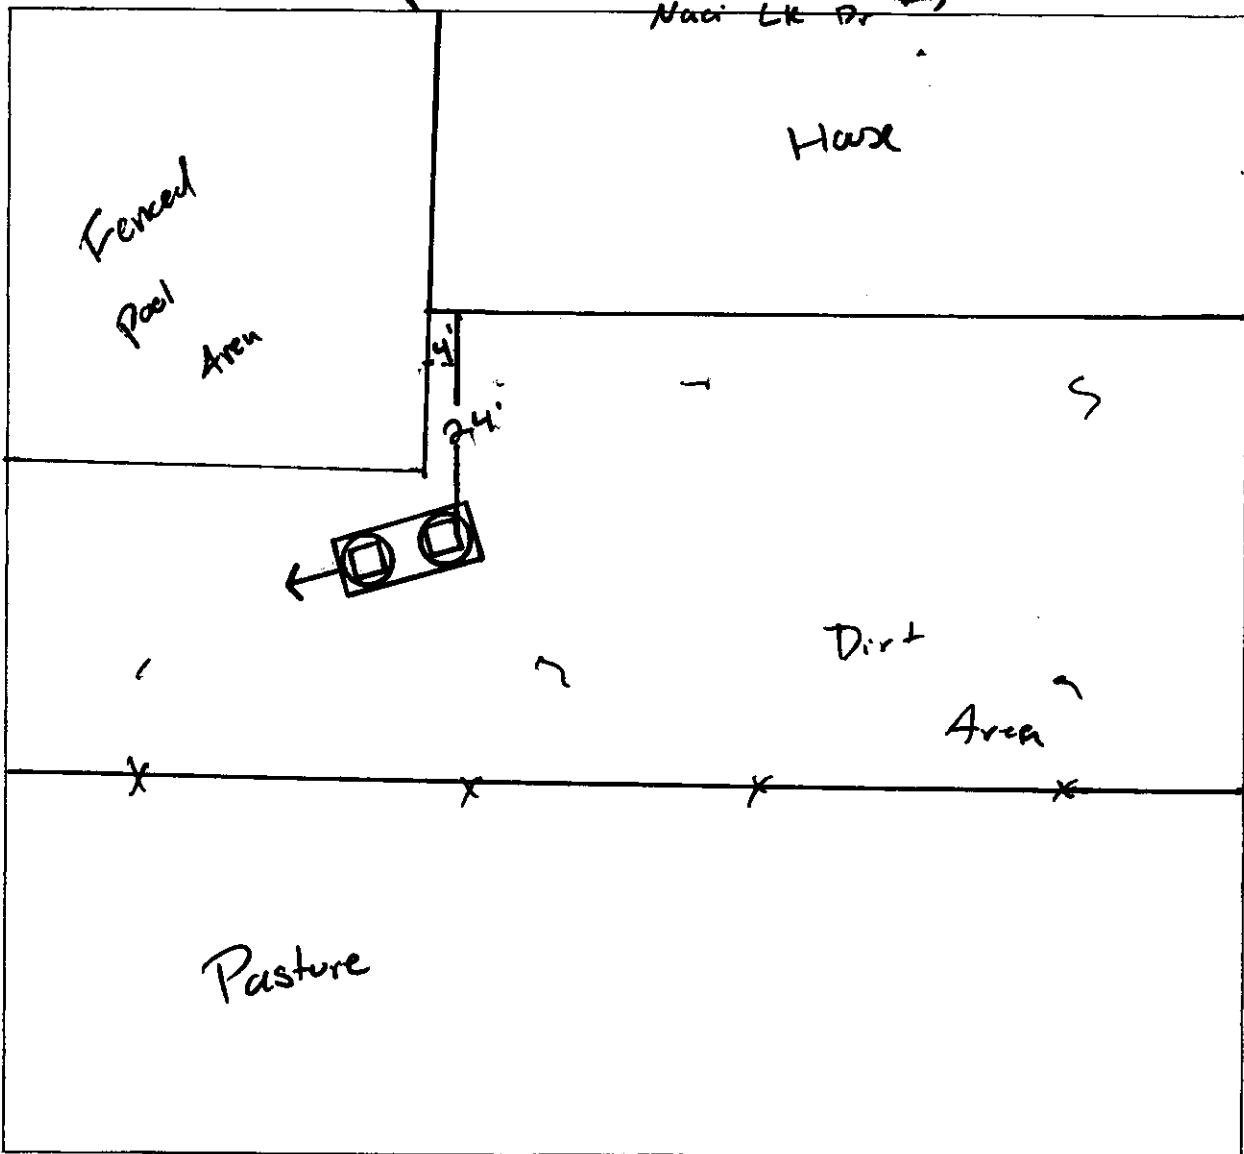
Comments: 1500 gal Conc tank

Full Diameter Access Risers to Grade Depth From Top of Tank to Grade 48"

Distance to wellhead 100+' Clean Out Present N
