Property Inspection Report

Ken & Sandy Pickar

Inspection Date:
02/16/2023

Prepared by:
Bona Fide Home Inspections
310-560-4394

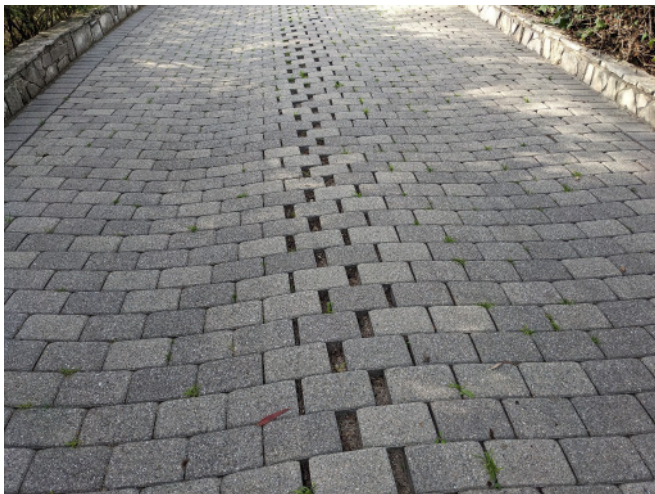
3. Concrete pavers, The driveway surface has been raised by adjacent tree roots, the outer retaining wall appears to have moved and gaps and movement of the pavers noted. We recommend repair by a paver contractor.

Gaps in driveway pavers due to settlement and movement

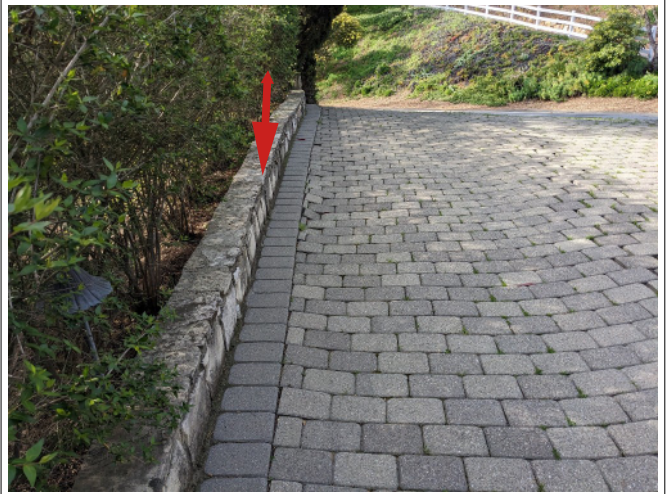
Side retaining wall is leaning and appears to have moved

The pool equipment area retaining wall has large cracks and separations, the edge of drive wall appears to be leaning and has moved causing gaps in the pavers, consult a qualified concrete contractor.

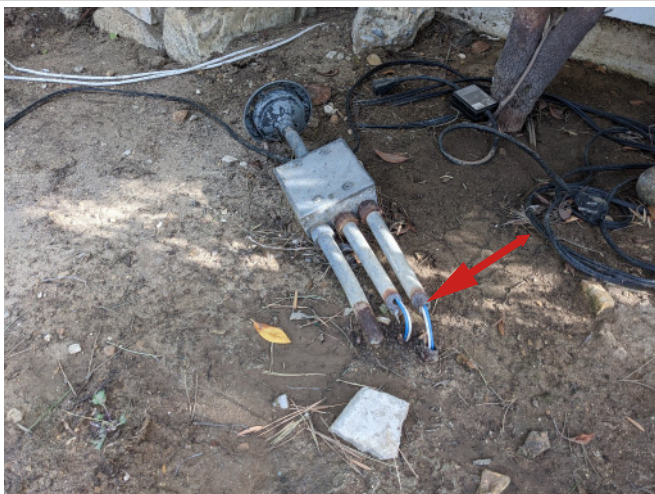
Landscape lighting is damaged in many areas, we recommend further evaluation, testing and repair by a qualified electrical contractor.

Damaged landscape lighting

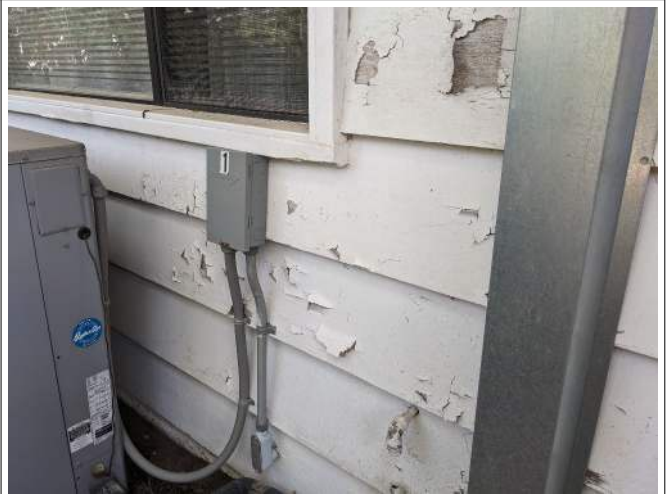
Wood siding paint finish peeling

CONDITION: The exterior siding appears properly installed. The exterior surfaces are in fair condition due to weathering and age. We recommend repainting and/or refinishing in the near future to maximize their service life.

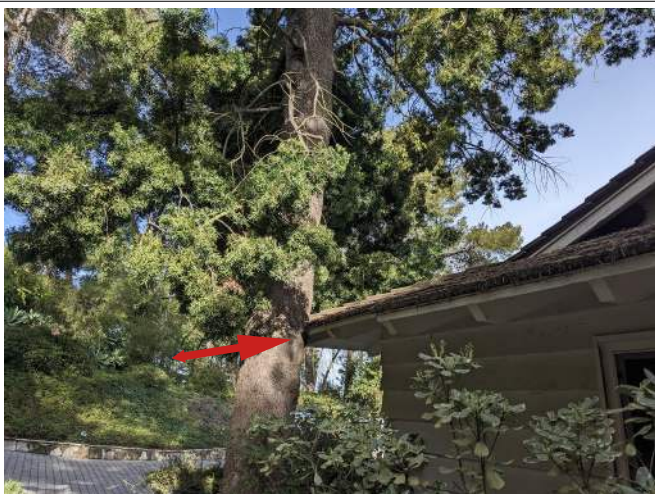
Trees are touching or overhanging the roof. We recommend they be trimmed to prevent damage to the roofing surface, and allow free flow of roof runoff.

Tree touching garage roof

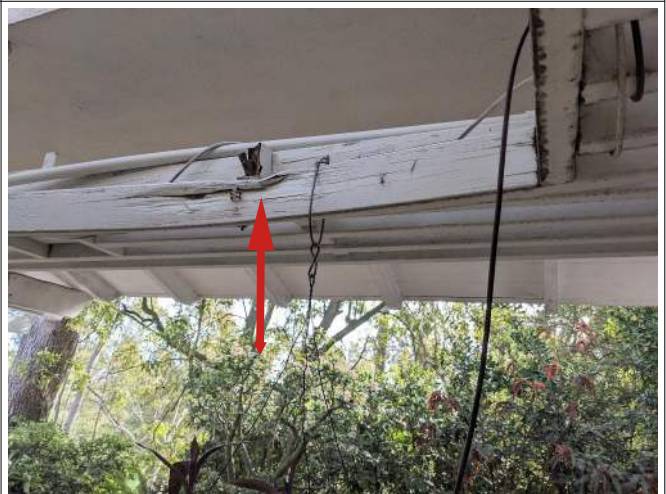
Wood damage outside kitchen window

Wood, Damaged wood trim was observed at the wood sturcture above kitchen window,. We recommend review of the pest inspection report regarding repairs.

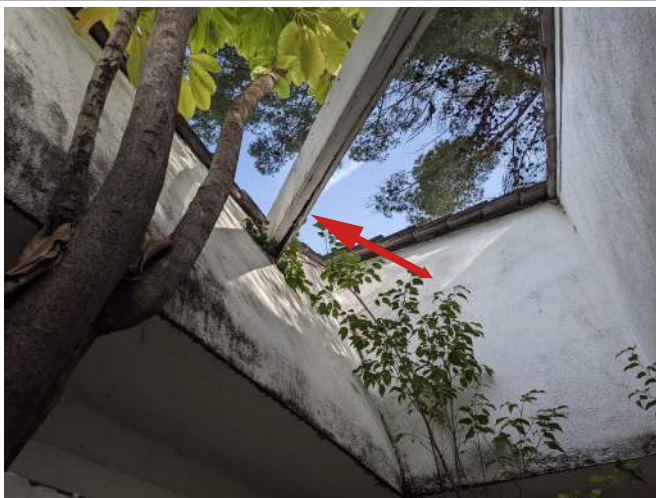
Wood damage

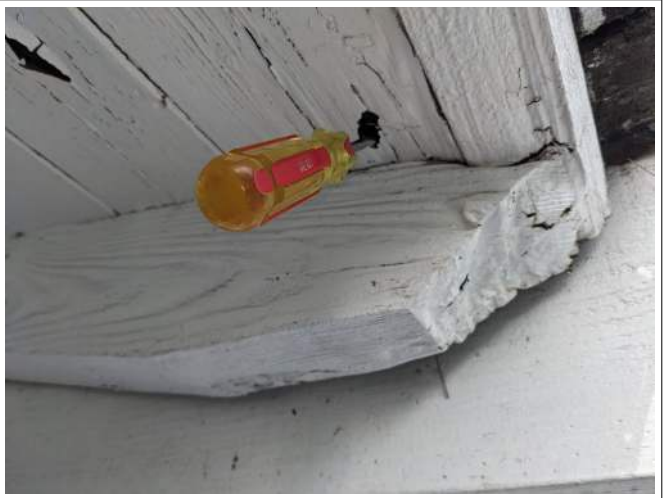
Wood damage roof eaves, roof leaks

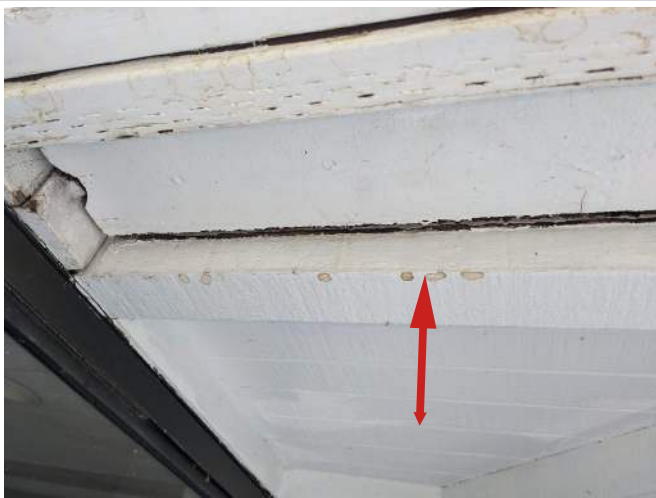
Water drips from roof leaks

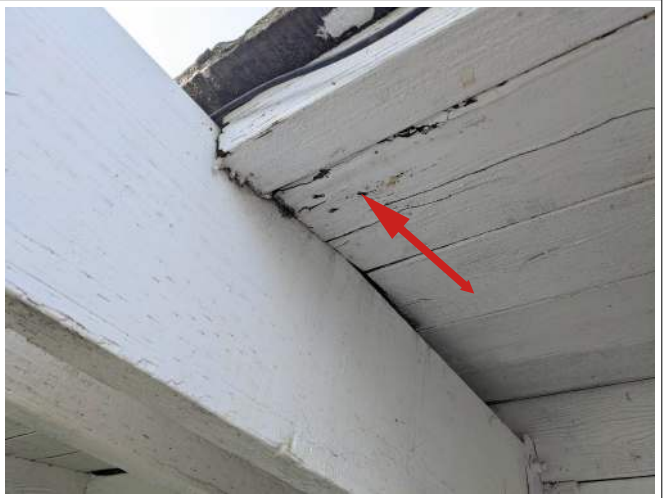
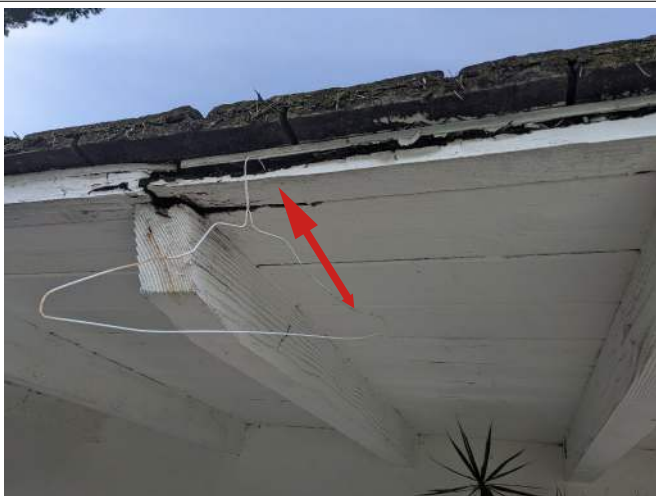
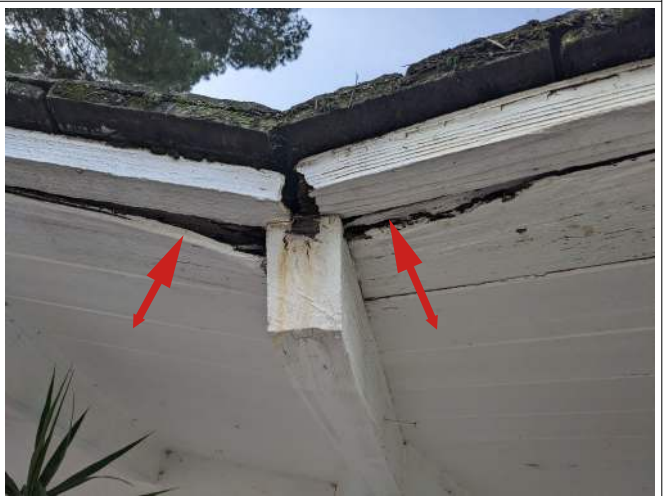
1. Moisture stains/damage noted under eaves and to the wood support rafters at the rear, this may be from an active roof leak due to low slope of roofing, we recommend repair of all damaged wood and the source of leakage also corrected.

Wood damage rear eaves

Wood damage rear eaves, roof slope too low

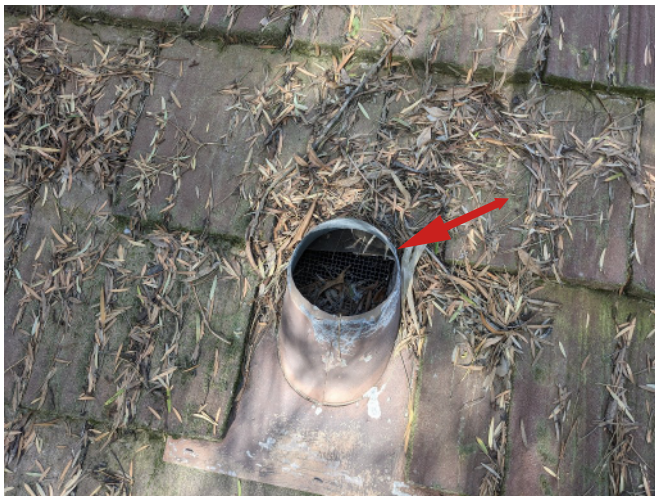
Roof vent flashing cover missing

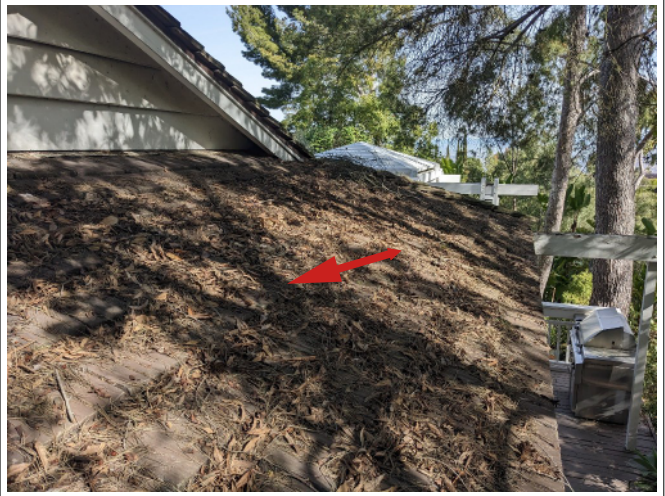
Tree leaf debris on roof

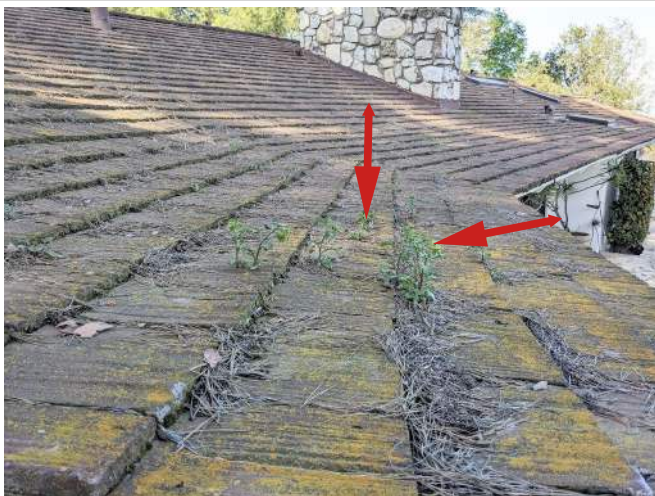
Roof slope too low, debris and weeds growing on roof

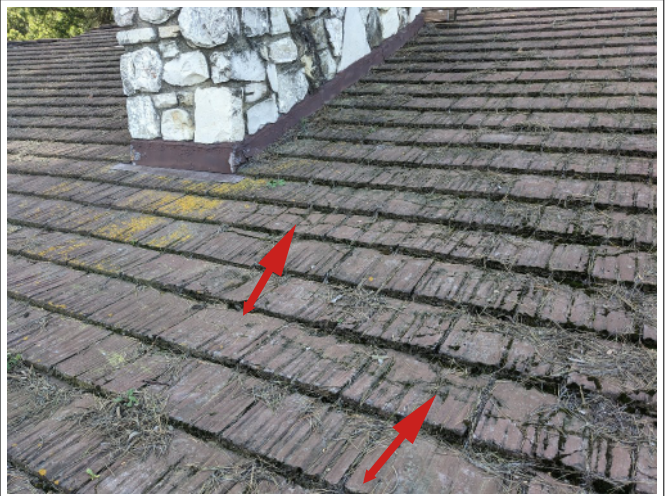
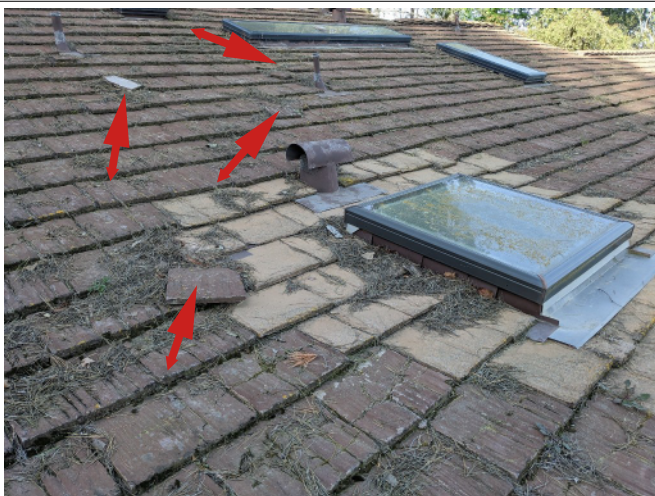
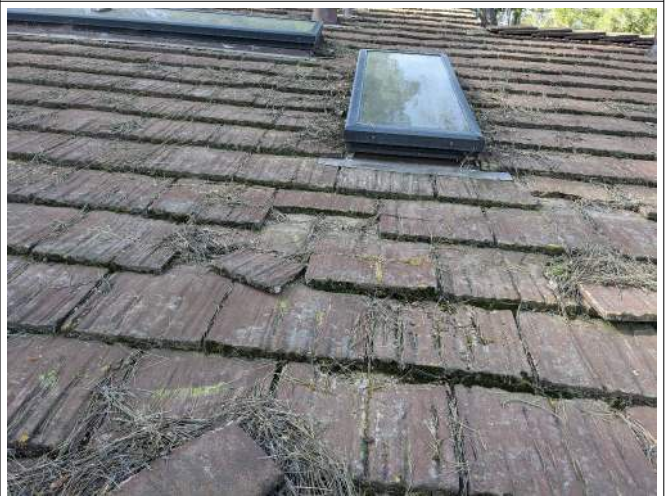
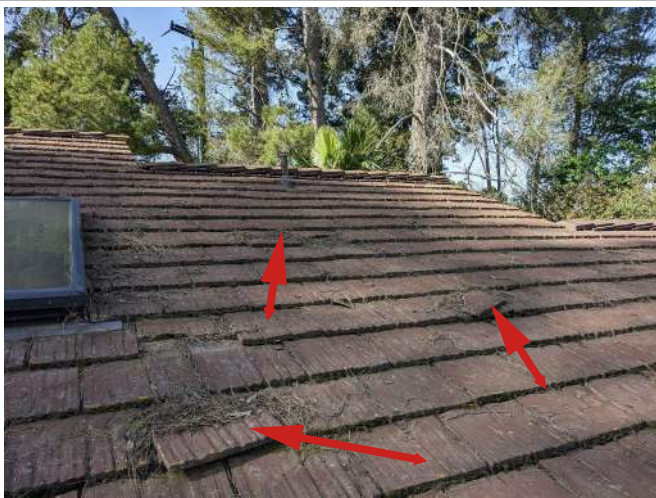
6. This is a very old CalShake tile roof, these are a poor quality tile and have been involved in class action lawsuits. The tiles have surface wear and numerous cracks and broken tiles. There is an excessive amount of tree leaf/needle debris on the roofing. Low slope areas at the rear has resulted in moisture damage to the wood eaves. A qualified licensed roofing contractor should be called to make further evaluation and cost estimates to remove and replace.

Cracked and damaged tiles

Lots of broken tiles

Broken tiles

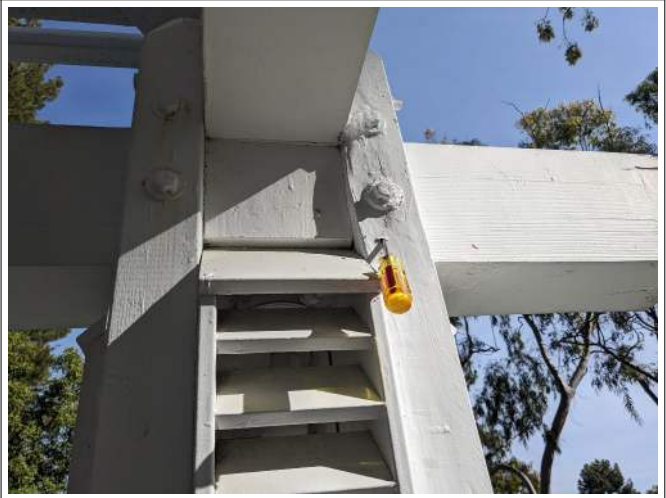
Wood damage at deck cover structure

CONDITION: The decking wood structure cover is damaged in areas, (posts have wood decay) and should be repaired or budgeted for removal and replacement.

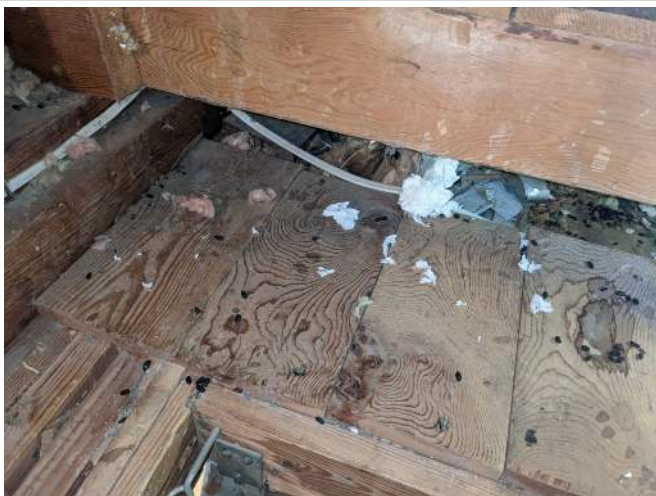
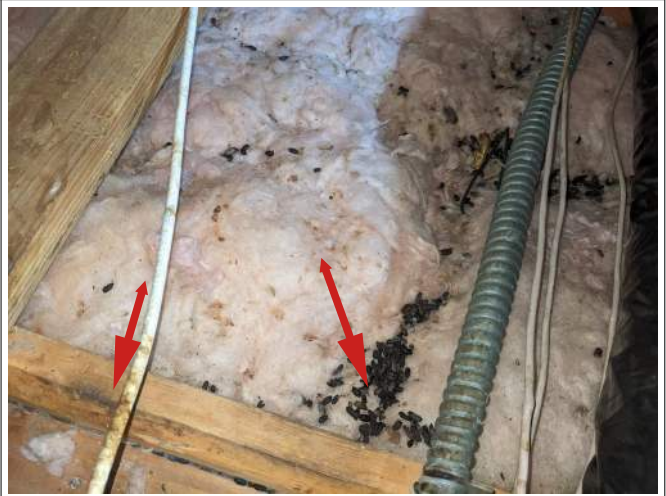
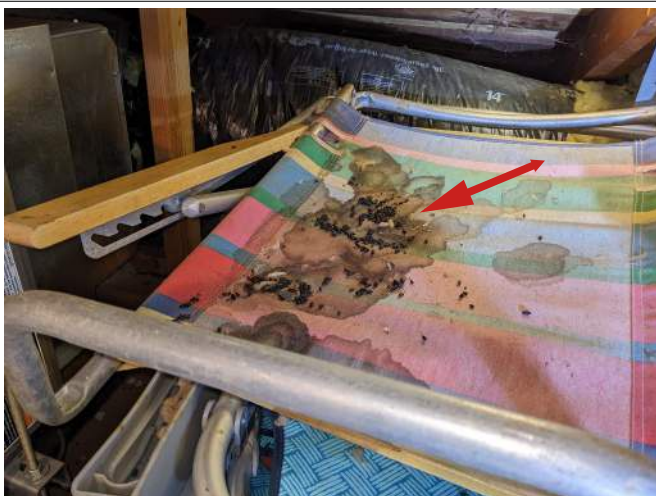
5. There is evidence of rodent activity/droppings in the attic. We recommend inspection and treatment be carried out by a licensed exterminator.

Rat dropping in attic

Rat droppings

Rat droppings and urine stains in garage attic

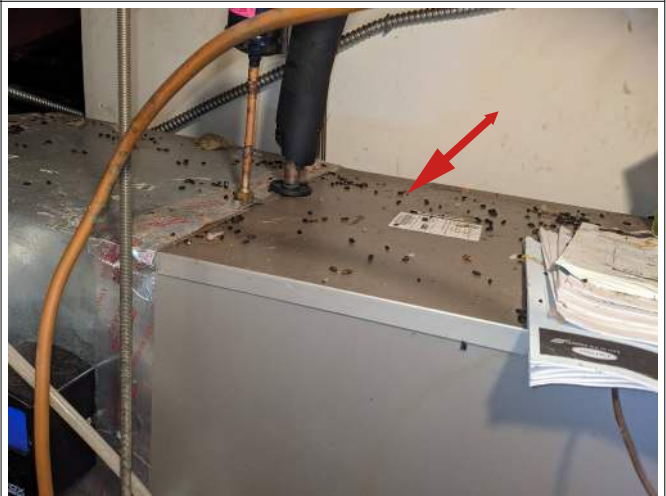
15. Rodent feces were on and around all 3 furnaces, we recommend it be cleaned and traps and screens be installed to eliminate the rodents.

Rat dropping on and around furnace in garage attic

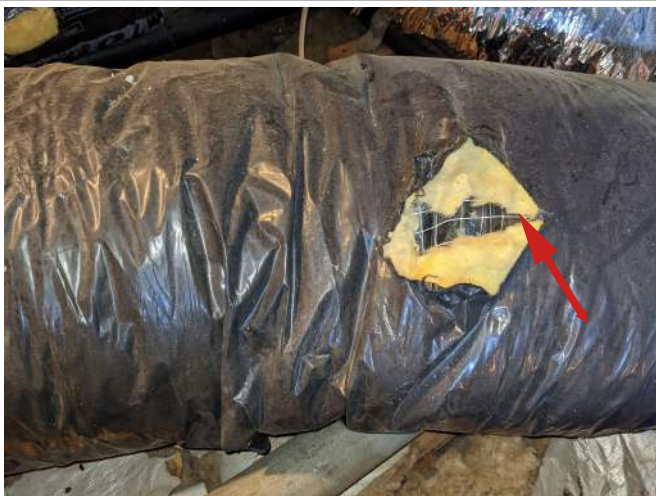
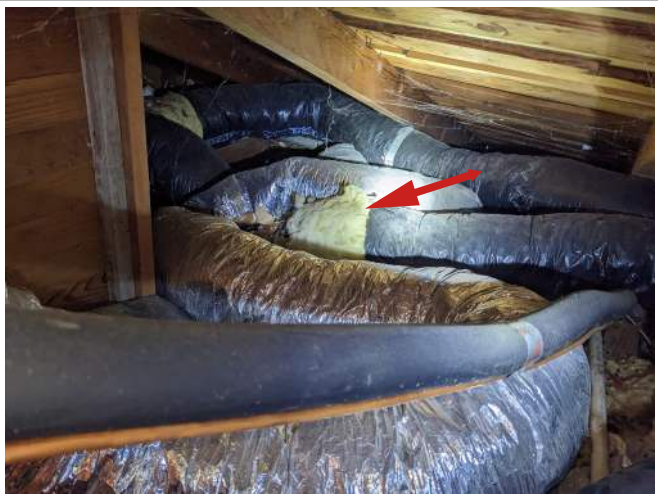
16. There are damaged/torn ducts in the attic with visible air leaks. We recommend that all damaged ducting be replaced to restore proper air flow to all registers.

Damaged duct in main attic

Air leaking from ducting in main attic

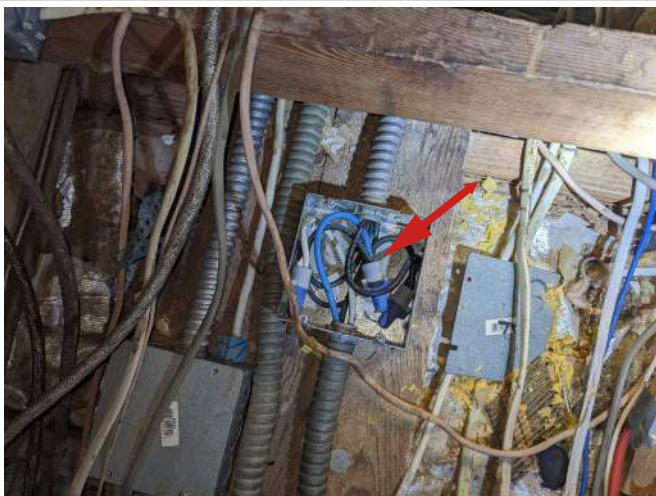
Open electrical junction box, no safe walkway in attic to furnaces

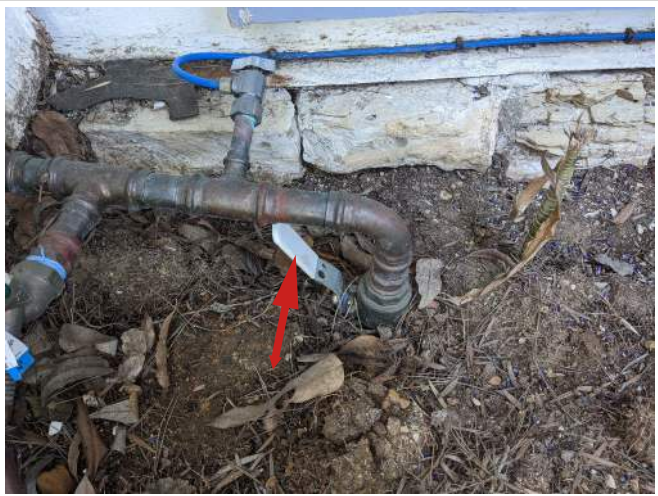
Main plumbing water shut off valve buried in soil

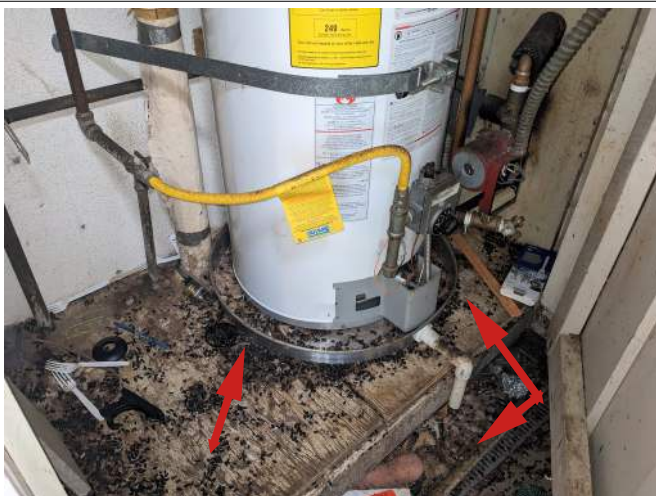
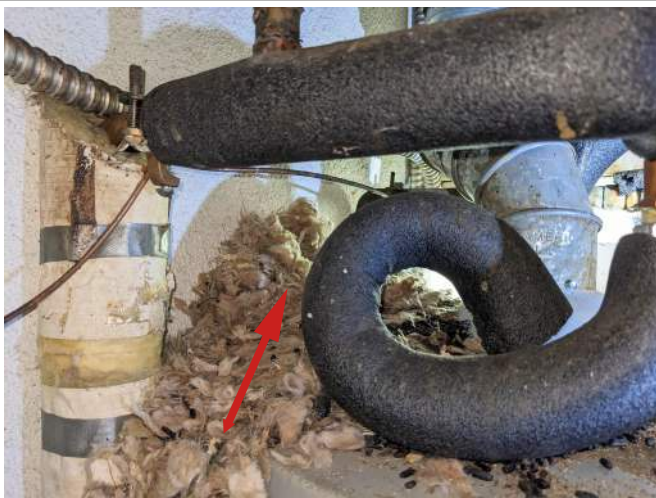
10. Rodent feces and urine stains noted all around the water heater and insulation brought down from the garage attic to nest on top of the water heater, we recommend entire area be cleaned, new screens be installed and traps be set to eliminate the rats.

Rat droppings around rear water heater

Rat nesting insulation on top of water heater

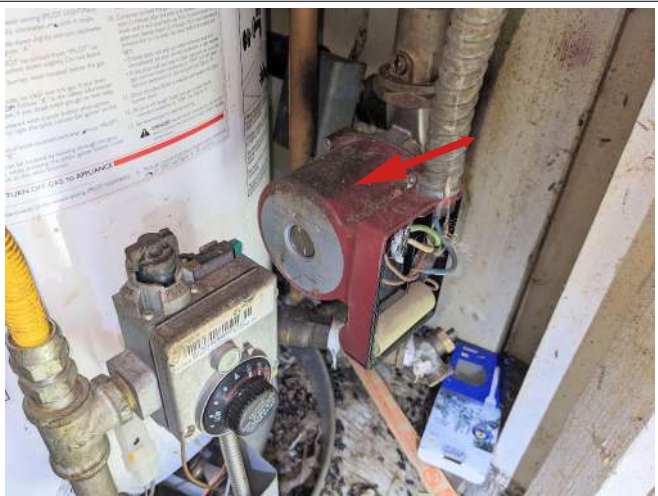
9. The hot water recirculating pump was not functioning or is defective, we recommend it be repaired or replaced.

Water heater recirculation pump inoperable

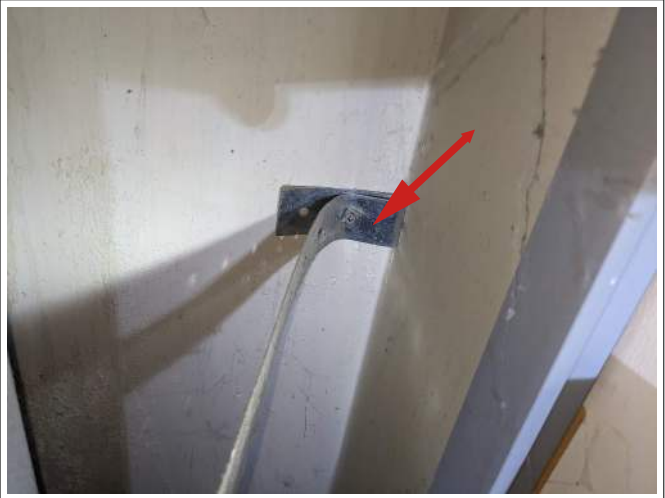
11. The water heater earthquake strapping has been installed in a non professional manner, or is minimally secured. We recommend approved double straps be installed per the manufactures instructions as required by state regulations.

Hallway water heater strapping improperly secured

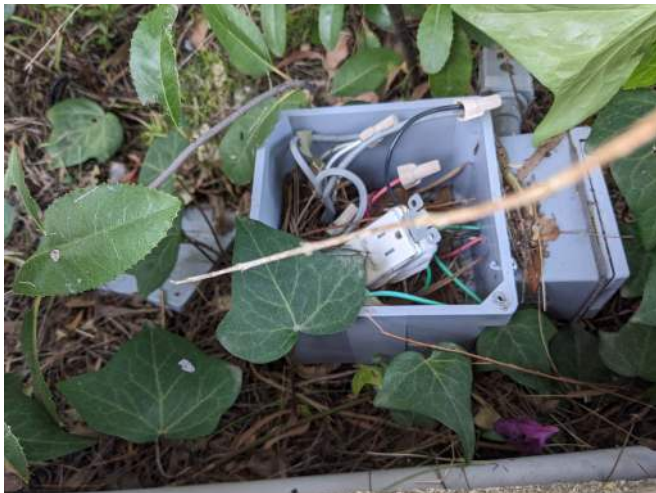
Missing cover at electrical box alongside driveway

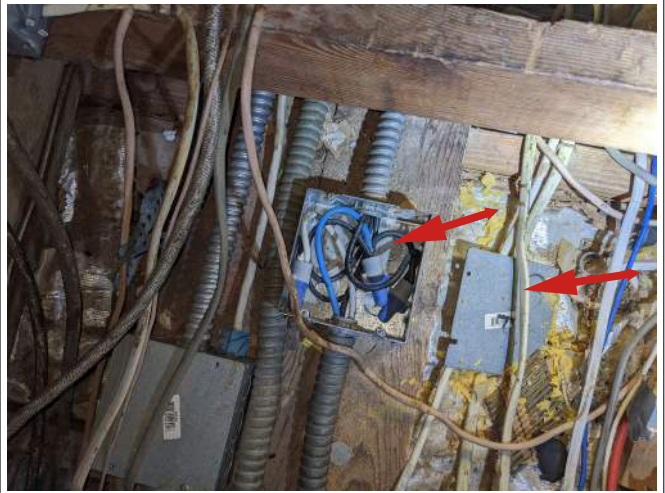
Exposed wires in attic

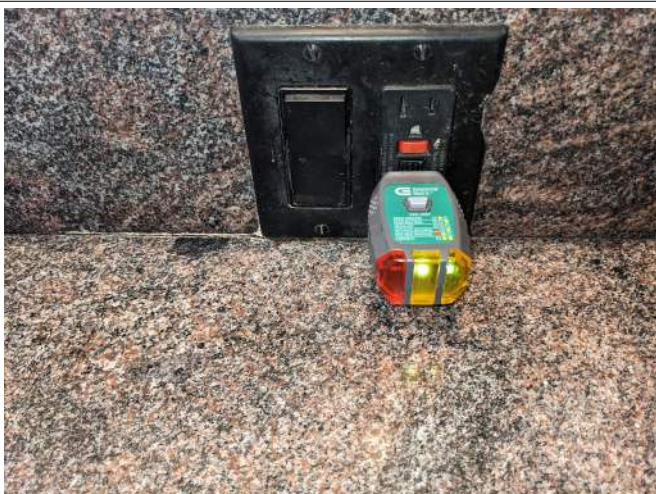
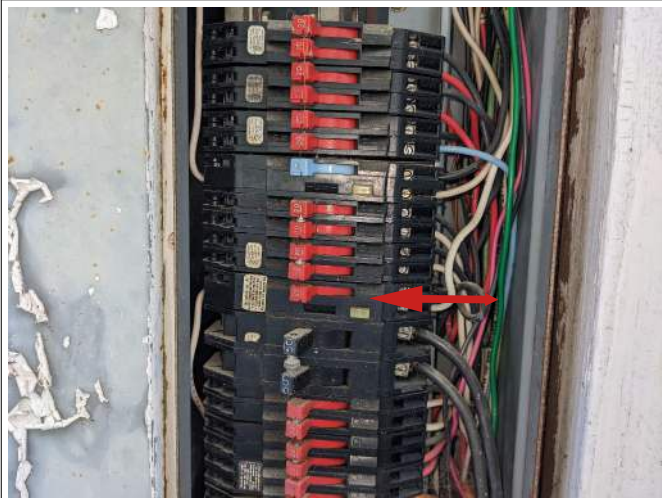
The GFCI outlet was not operational with the test button at several exterior locations, we recommend the wiring be checked or the unit be replaced for safety.

GFCI inoperable in kitchen

GFCI breaker inoperable

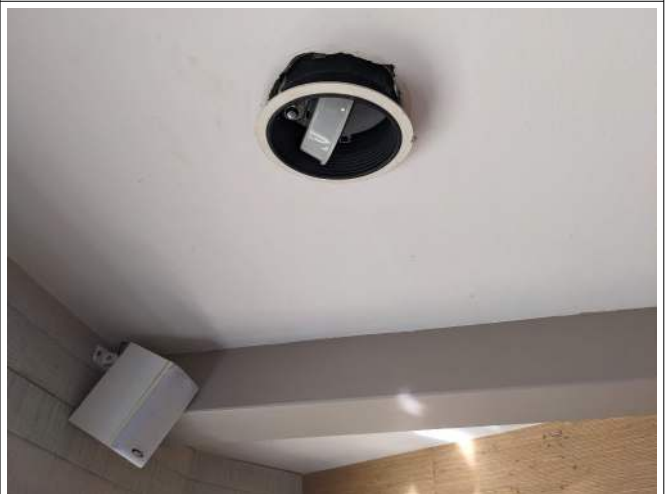
Loose lights

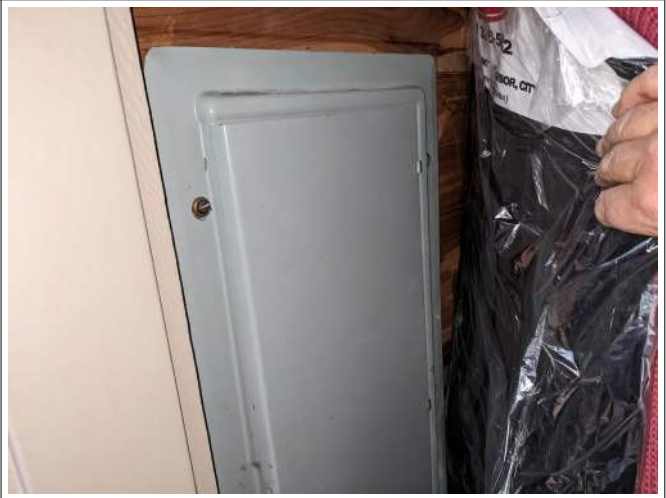
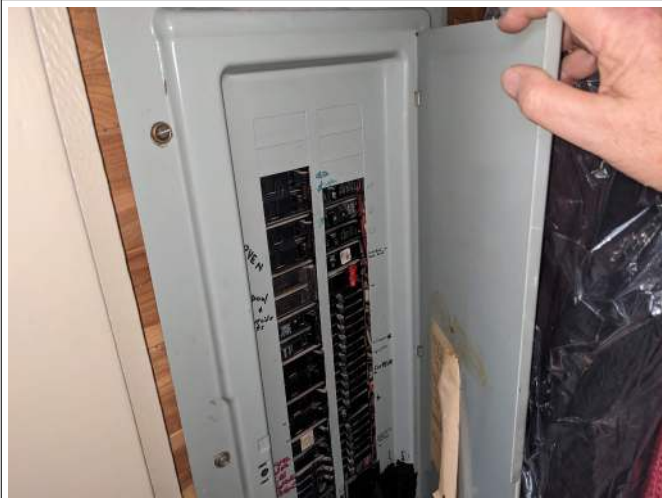
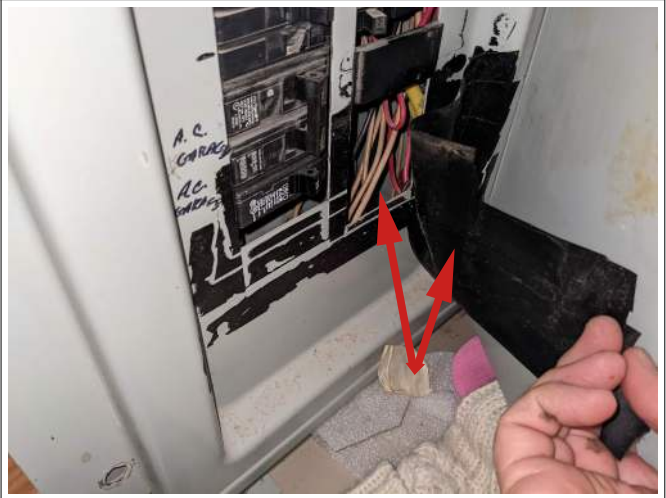
12. Master bedroom closet. This is not an approved location, we recommend it be relocated out of the closet.

13. The panel electrical wiring and/or breakers are installed in a substandard manner. We recommend repair or replacement per present standards by a qualified electrician.

Improper electrical panel in clothes closet

Substandard panel installation in closet

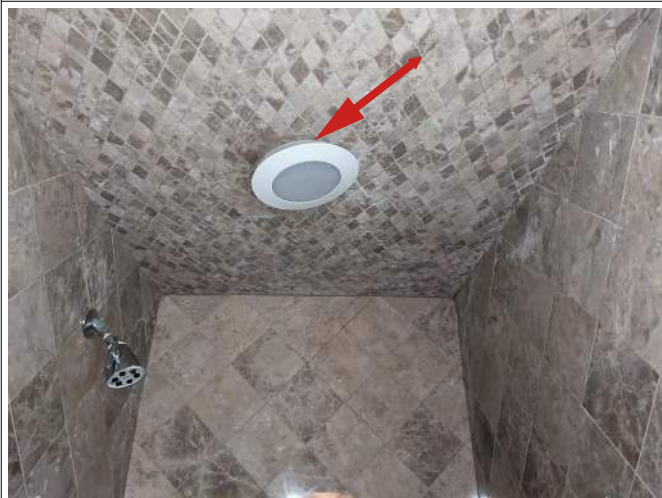
Light in shower inoperable

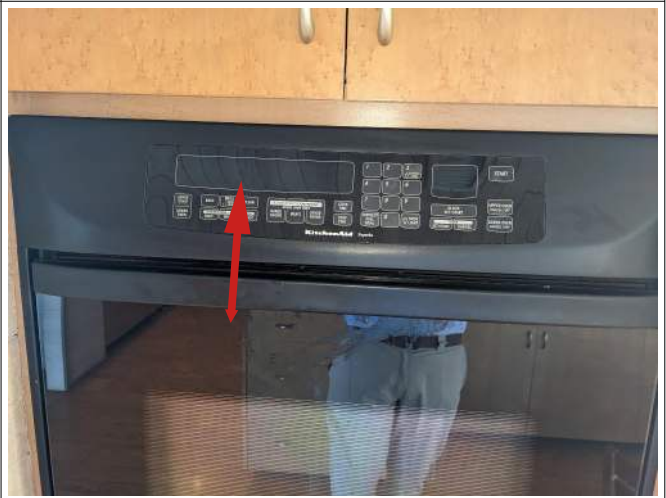
The oven was turned on but the circuit breaker trips and power shuts off when both ovens are on due to undersized circuit breaker, we recommend it be repaired or replaced by a qualified electrical contractor.

Over power shut off, circuit breaker improper size

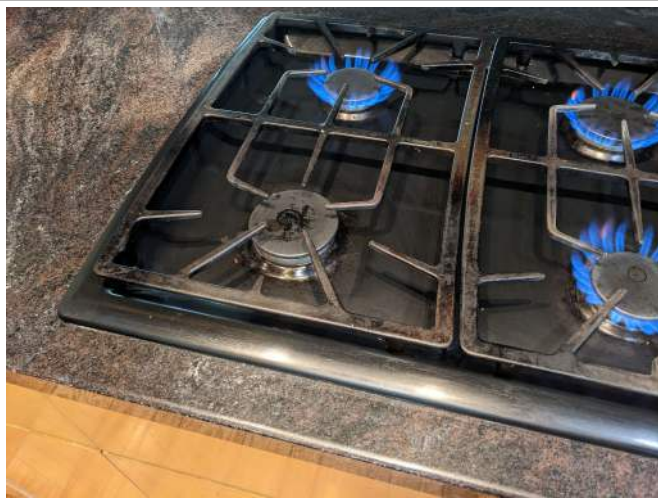
17. One of the range burners is inoperative, we recommend cleaning, adjustment or replacement of the ignitor.

Burner ignitor inoperable

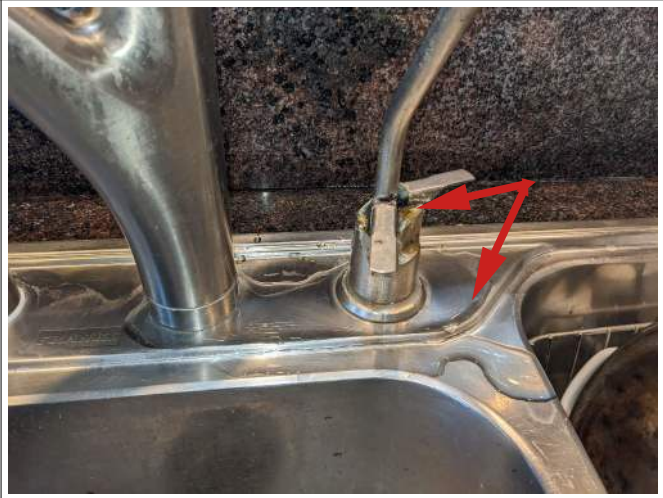
19. The water dispenser faucet at the sink is damaged and leaking, we recommend it be repaired/replaced.

Water dispenser faucet leaking

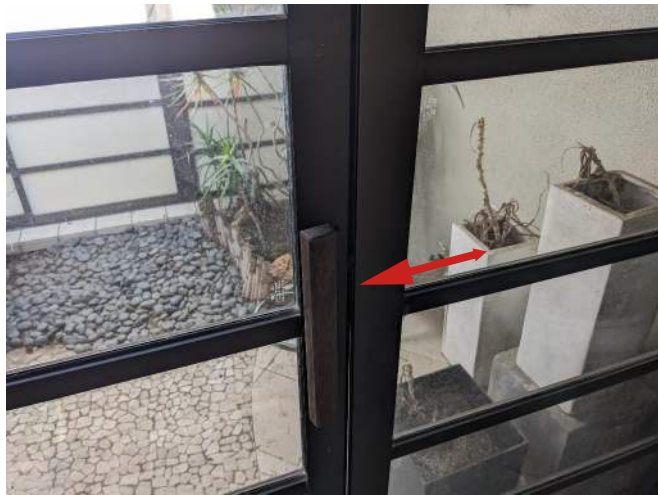
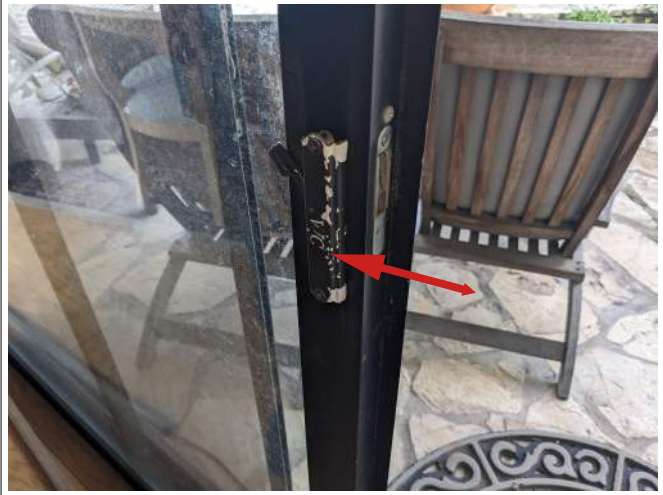
2. The sliding doors do not operate smoothly, probably because of worn or poorly adjusted rollers. We recommend the track be cleaned and the rollers replaced and adjusted for proper operation.

The sliding door locking hardware is not latching and broken handles noted at several doors, the master bathroom door does not close or latch, we recommend they be repaired or replaced.

Master bathroom door miss aligned and not latching

Sliding doors difficult to open, door handle broken

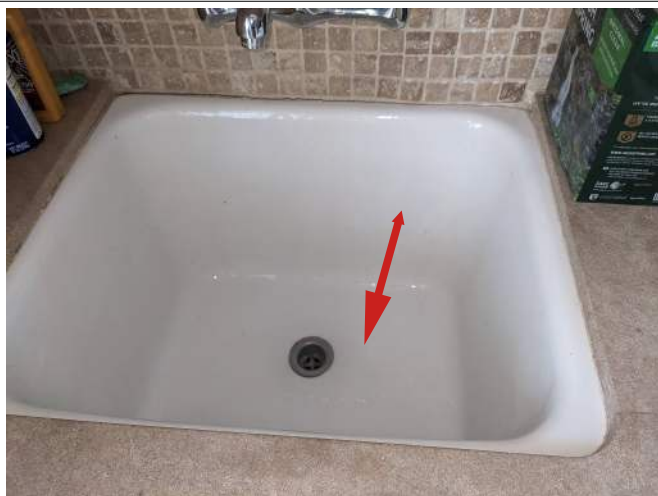
20. A laundry sink is provided which is slow draining, we recommend the drains be cleaned to restore proper functional drainage.

Laundry sink slow draining

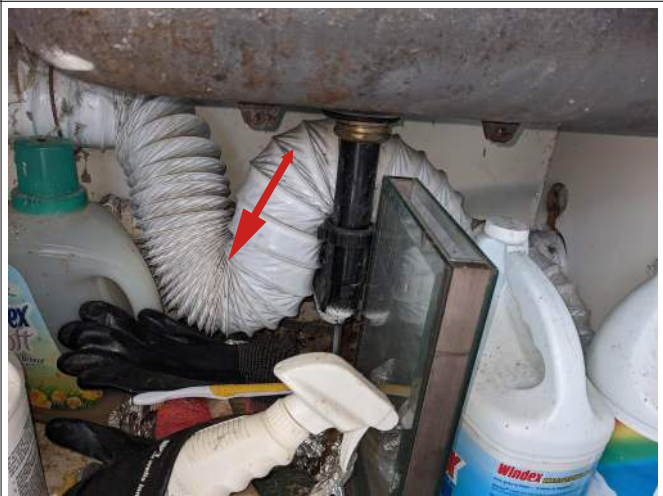
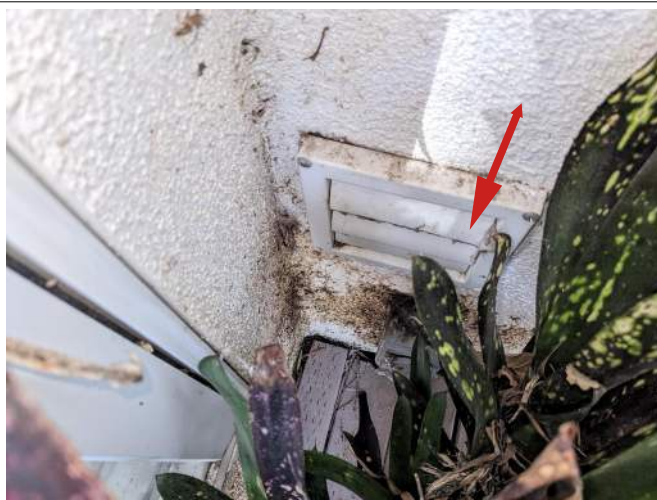
21. The dryer vent is damaged or incorrectly installed, we recommend it be repaired or replaced to vent to the exterior and prevent lint and moisture conditions.

Laundry dryer vent improper and clogged

No air flow at dryer termination while dryer was operating

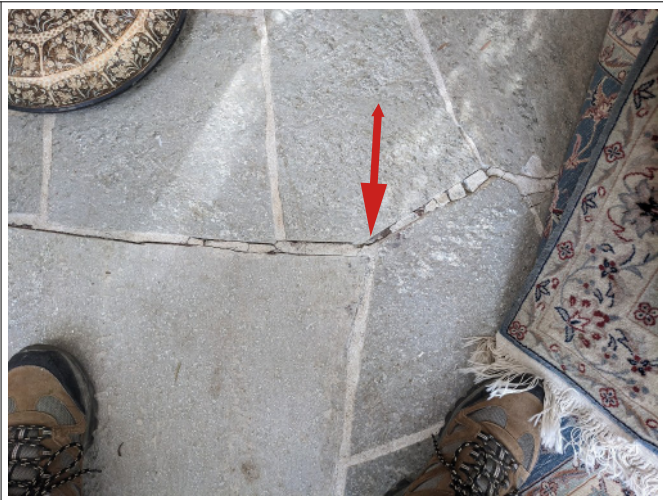
Cracks in rear office floor tile joints

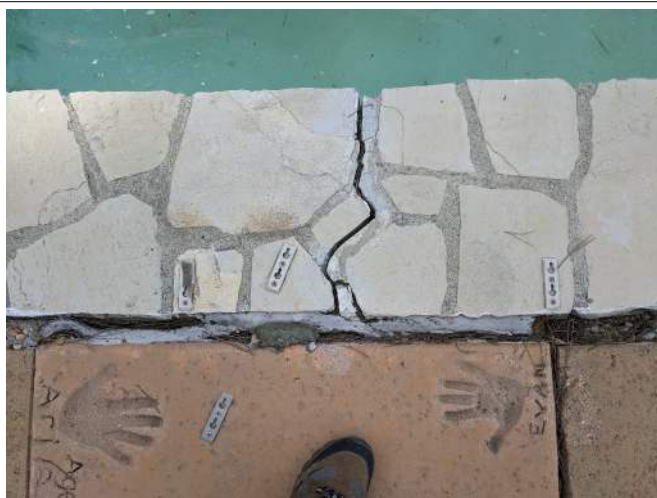
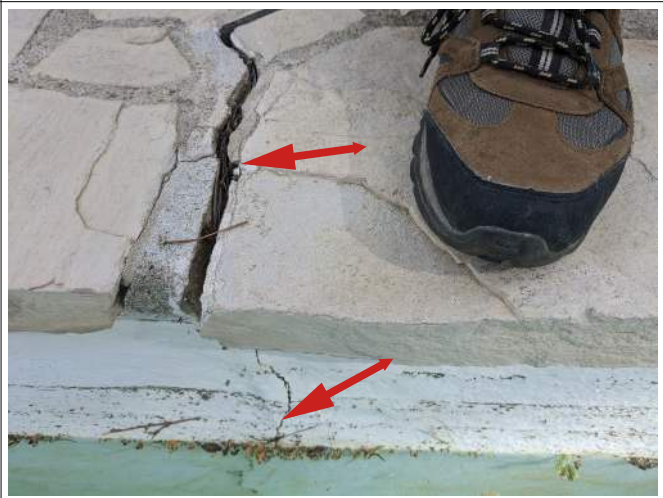
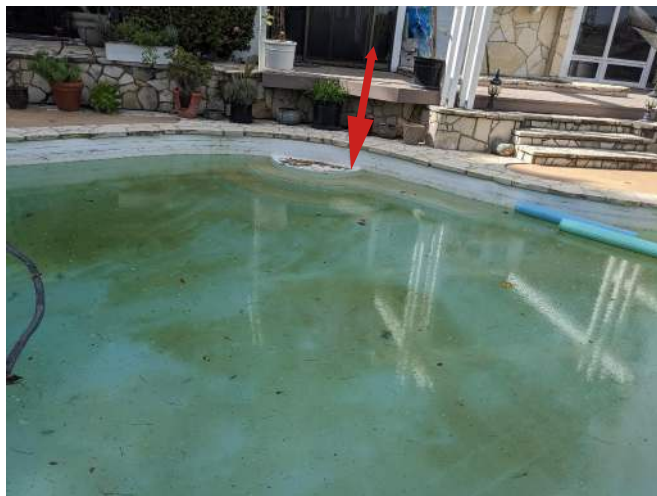
24. The pool has cracks in the concrete shell, repairs have been attempted and they have reappeared, water level cannot be maintained to correct height due to leaks through the cracks. A qualified pool contractor should be called to make further evaluation and recommendations for repair or replacement.

Pool patio separations, large cracks through bond beam and into pool

large cracks through bond beam and into pool

Pool water level cannot be maintained due to water leaks

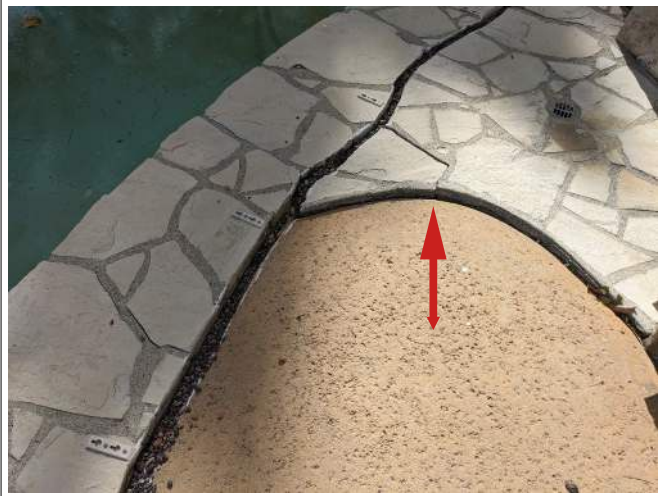
Pool patio settlement and movement

TYPE & CONDITION: Concrete and PV stone. The upper patio areas appear serviceable. The pool patio areas have settled and separated, removal and replacement should be budgeted for.

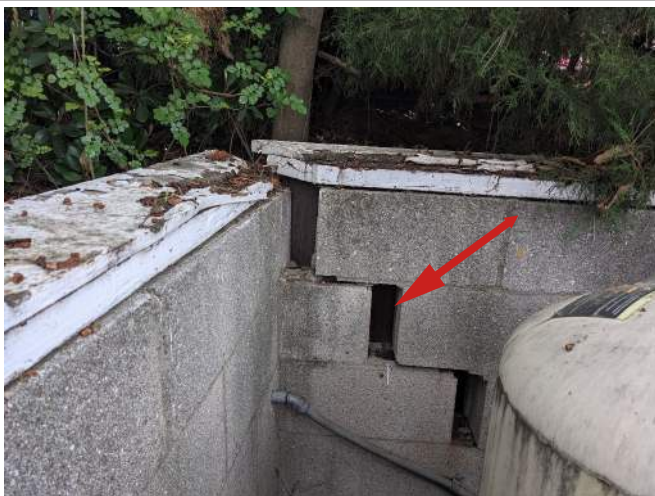
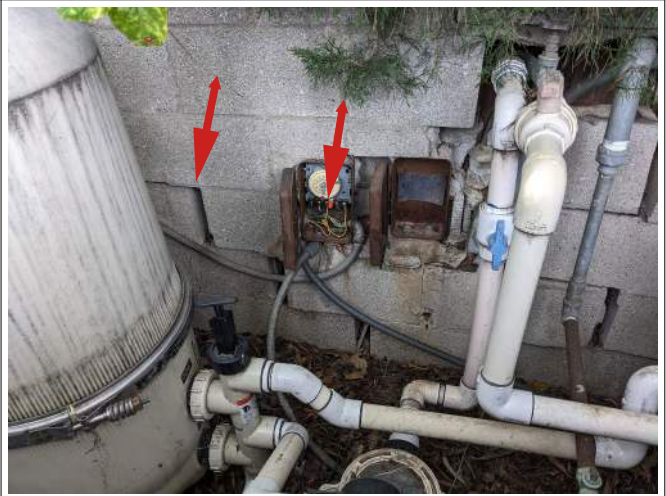
Pool equipment wall movement

Pool equipment wall movement, filter timer damaged

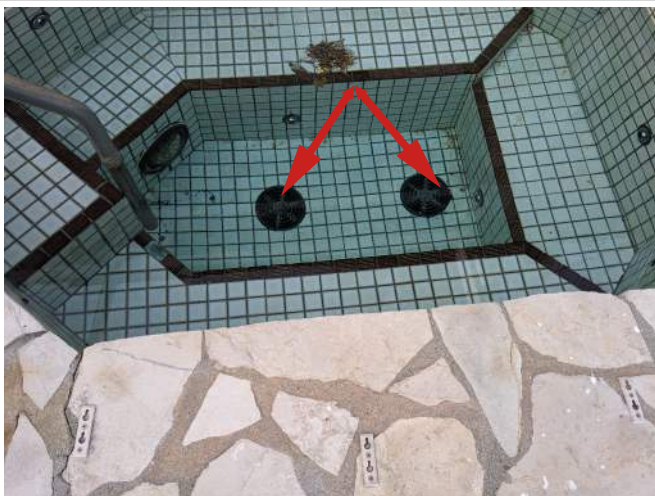
25. The drain cover at the bottom of the pool/spa is an older type that is a safety hazard due to possible hair entrapment or body being held down by the drain suction, we recommend it be replaced with a new approved safe type.

Sap outdated unsafe suction drain covers

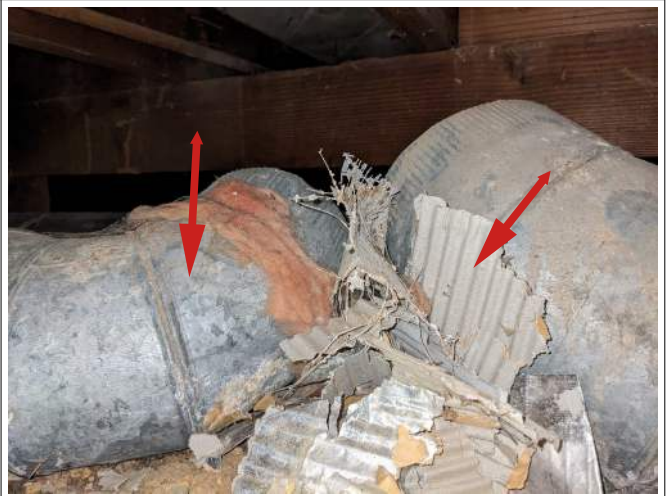
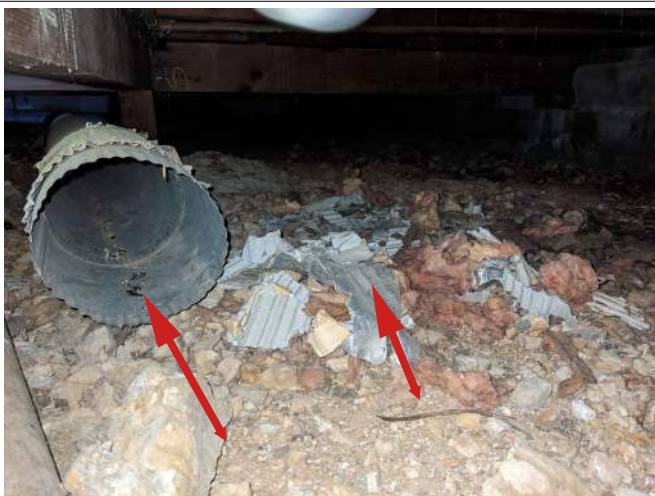
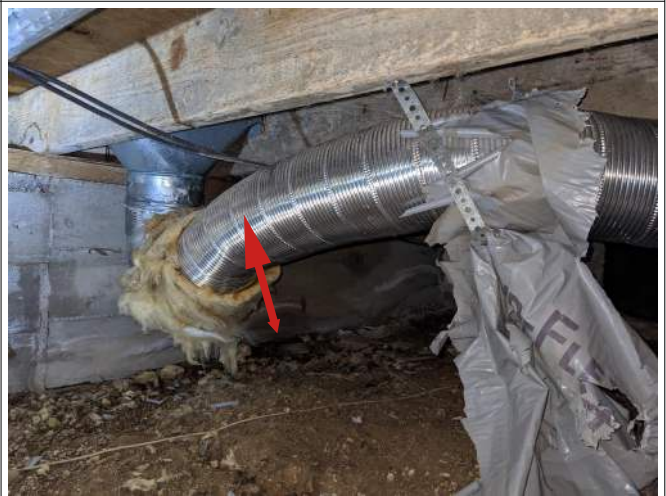
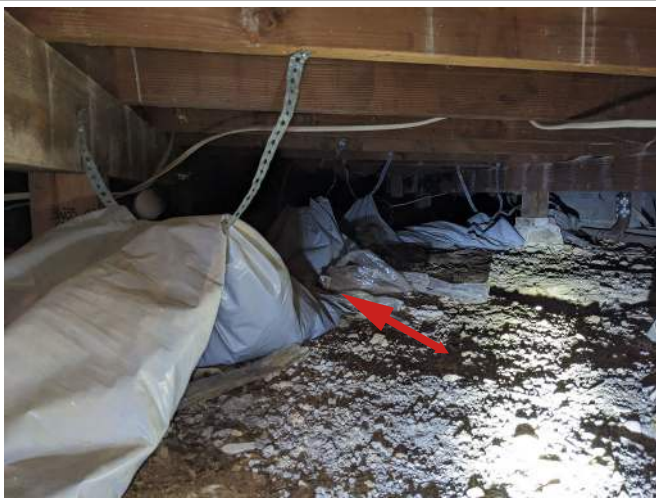
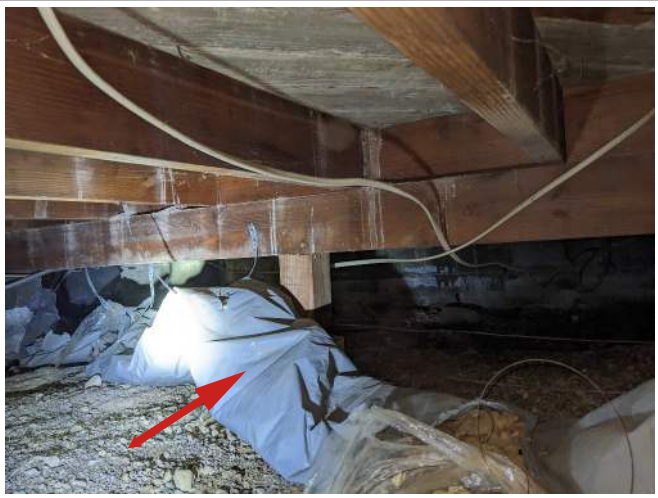
There are old unused ducts under the house, some metal ducts with asbestos type material under the kitchen crawlspace area. Damaged and partially removed flexible ducting under the master bedroom, we recommend all abandoned ducting be removed and floor vent be properly sealed to prevent drafts and odors.

Old ducting under houses, asbestos insulation

Damaged/abandoned ducting under master bedroom

Damaged abandoned ducting under house

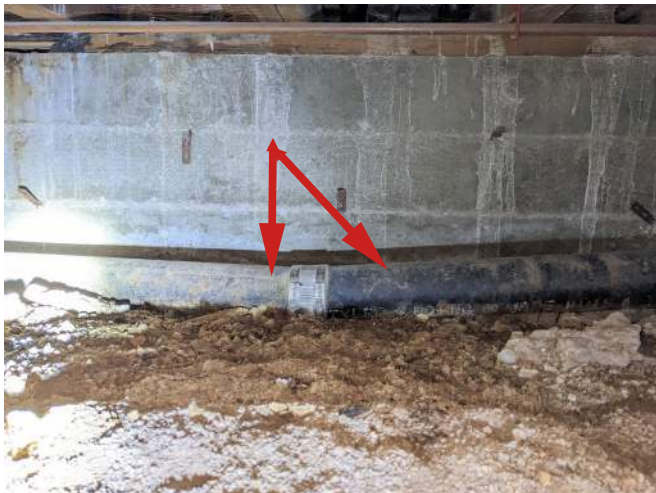
Master bathroom main drain piping not sloped correctly
