Property Inspection Report

Ken & Sandy Pickar

Inspection Date:
02/16/2023

Prepared by:
Bona Fide Home Inspections
310-560-4394

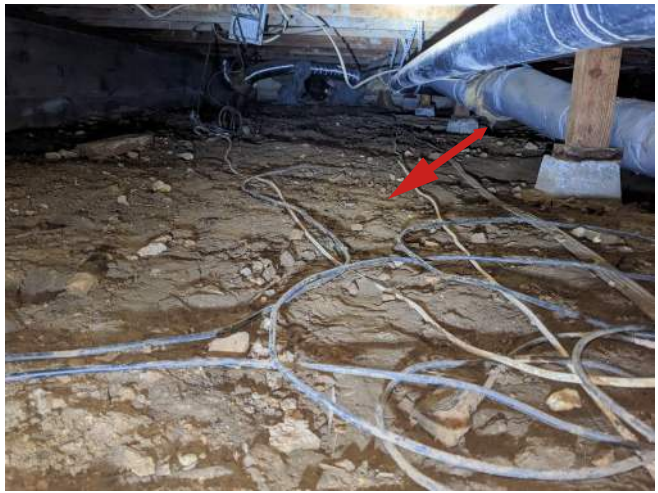
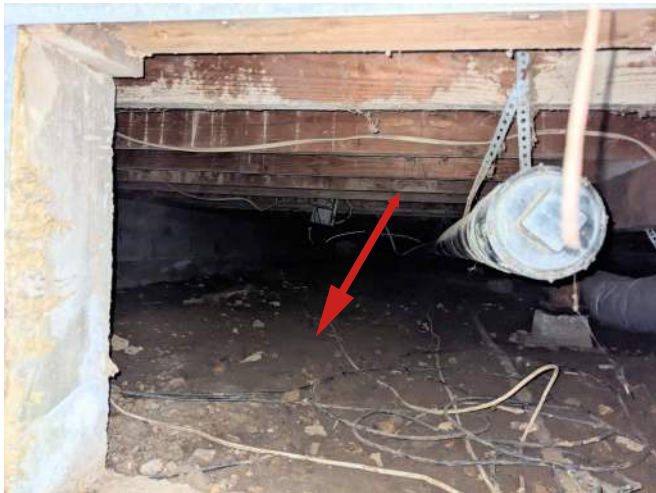
28. The crawl space soil was damp/wet in areas under the master bedroom. We recommend that all exterior roof drainage/downspouts be directed away from the building. The crawl space should be monitored during rains to determine if excessive moisture re-develops. Further evaluation by a geotechnical engineer would be required to determine if a permanent drainage system should be installed.

Moist soil under master bedroom area

Moist/damp soil under master bedroom area, source not determined
