December 22, 2023

File No. 3169-31

SUBJECT: **GEOLOGICAL REVIEW OF SITE CONDITIONS**  
3914 Dauntless Drive, Rancho Palos Verdes, CA 90275

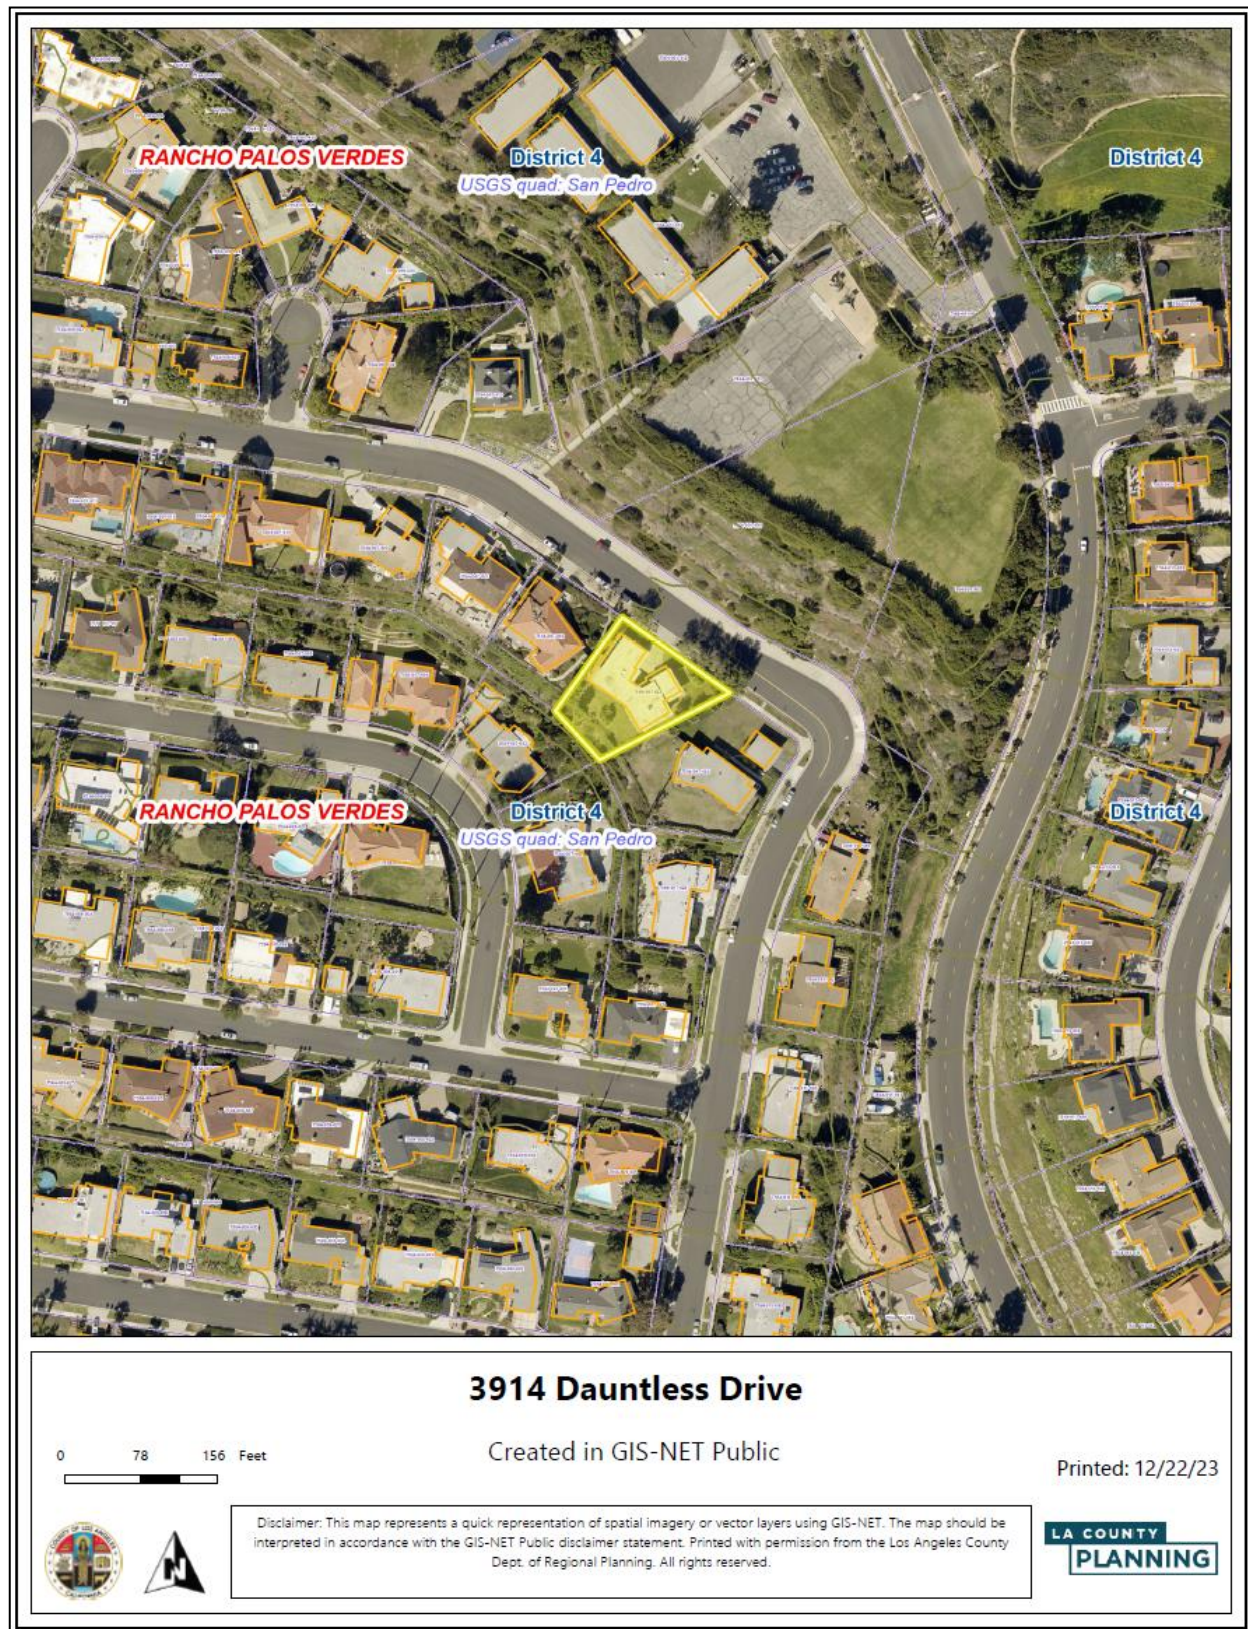
The subject site is located on the south side of Dauntless Drive, in Rancho Palos Verdes Estates, California. The property site currently consists of a relatively level pad located above a slope that descends about 30 feet at an approximately 1.5:1 (horizontal to vertical) gradient to the southwest to the property below. Figure 1 is an aerial photo with a topographic overlay of the property and surrounding area.

Figure 1: Aerial view of the subject site with a topographic overlay

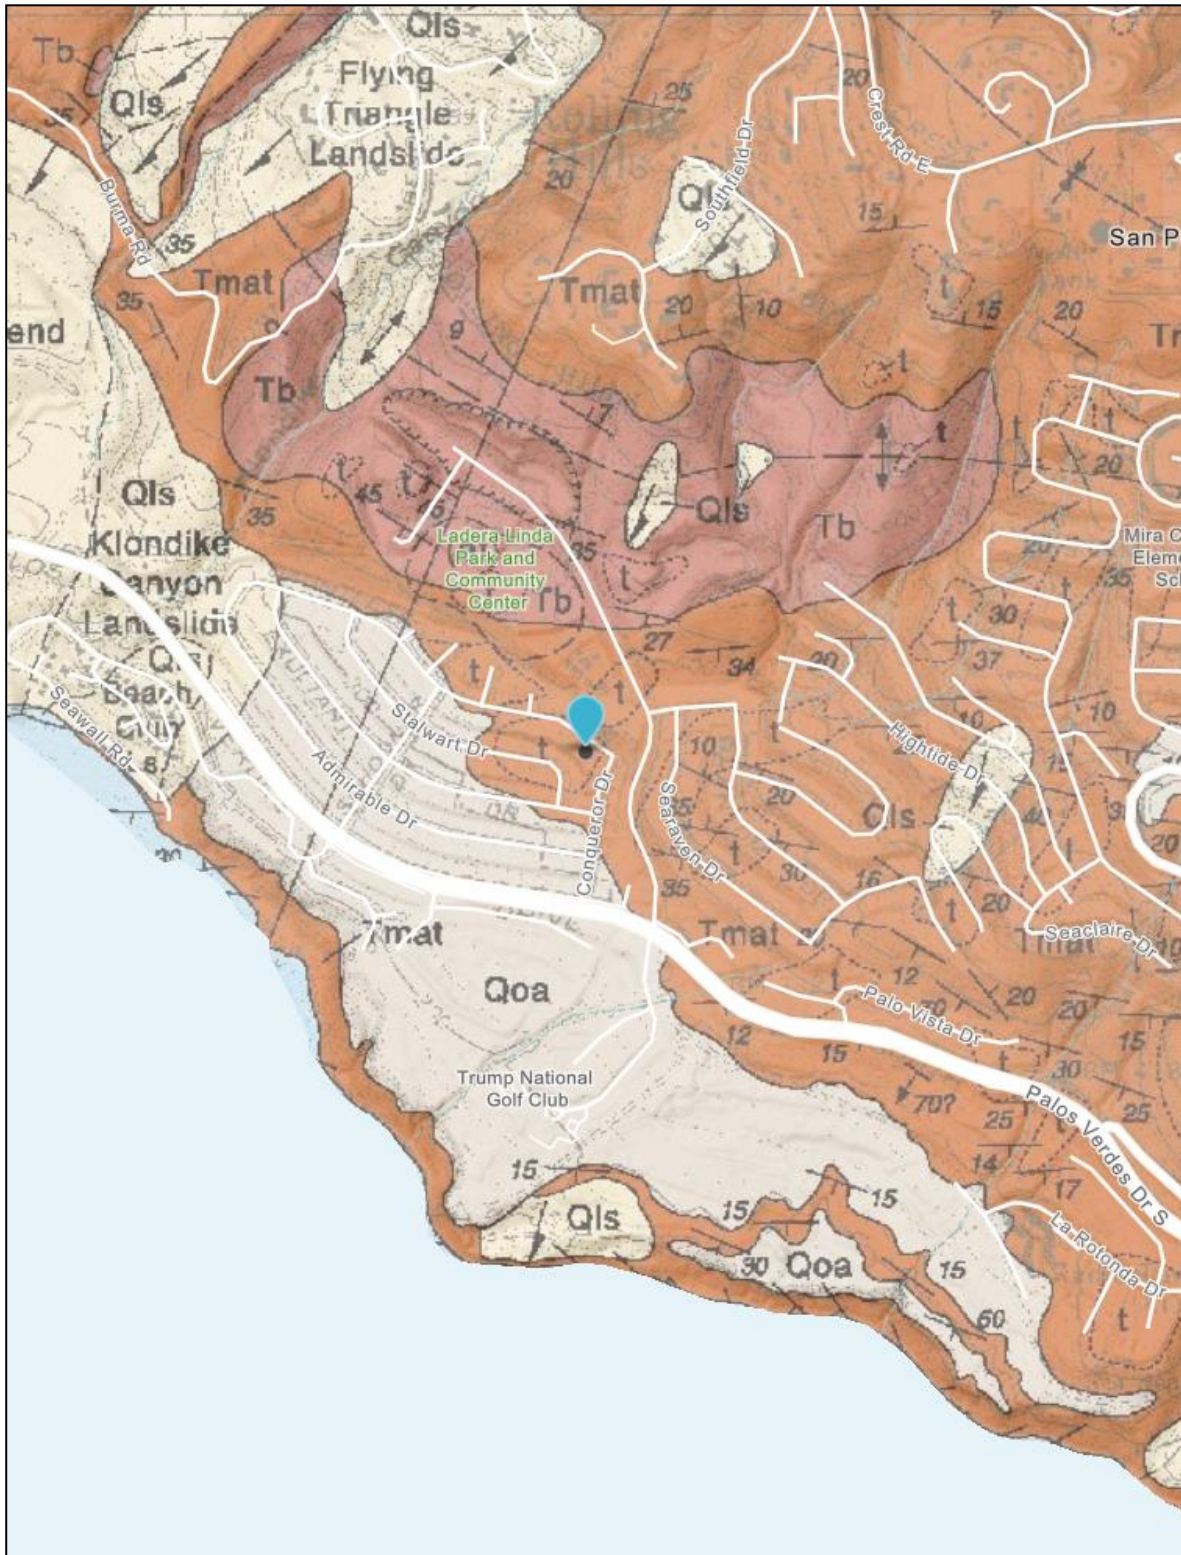
A review of a geological maps<sup>1</sup> indicates that the material underlying the subject site consists of siltstone of the Altimira member of the Monterey Formation (Figure 2). The bedrock is generally described as white-weathering, thin-bedded siliceous and phosphatic shale with interbeds of limestone and siltstone to shale and mudstone that is gray in color and contains tuffaceous and dolomitic strata throughout. Structural measurements from regional geologic map shows that the bedding varies in the area around the subject site but generally dips to the northeast, which is favorable for slope stability at the site.

Figure 2: Portion of Dibblee, T.W., 1999, Geologic Map of the Palos Verdes Peninsula and Vicinity, Redondo Beach, Torrance, and San Pedro Quadrangles, Los Angeles County, California, Dibblee Geologic Foundation Map DF-70

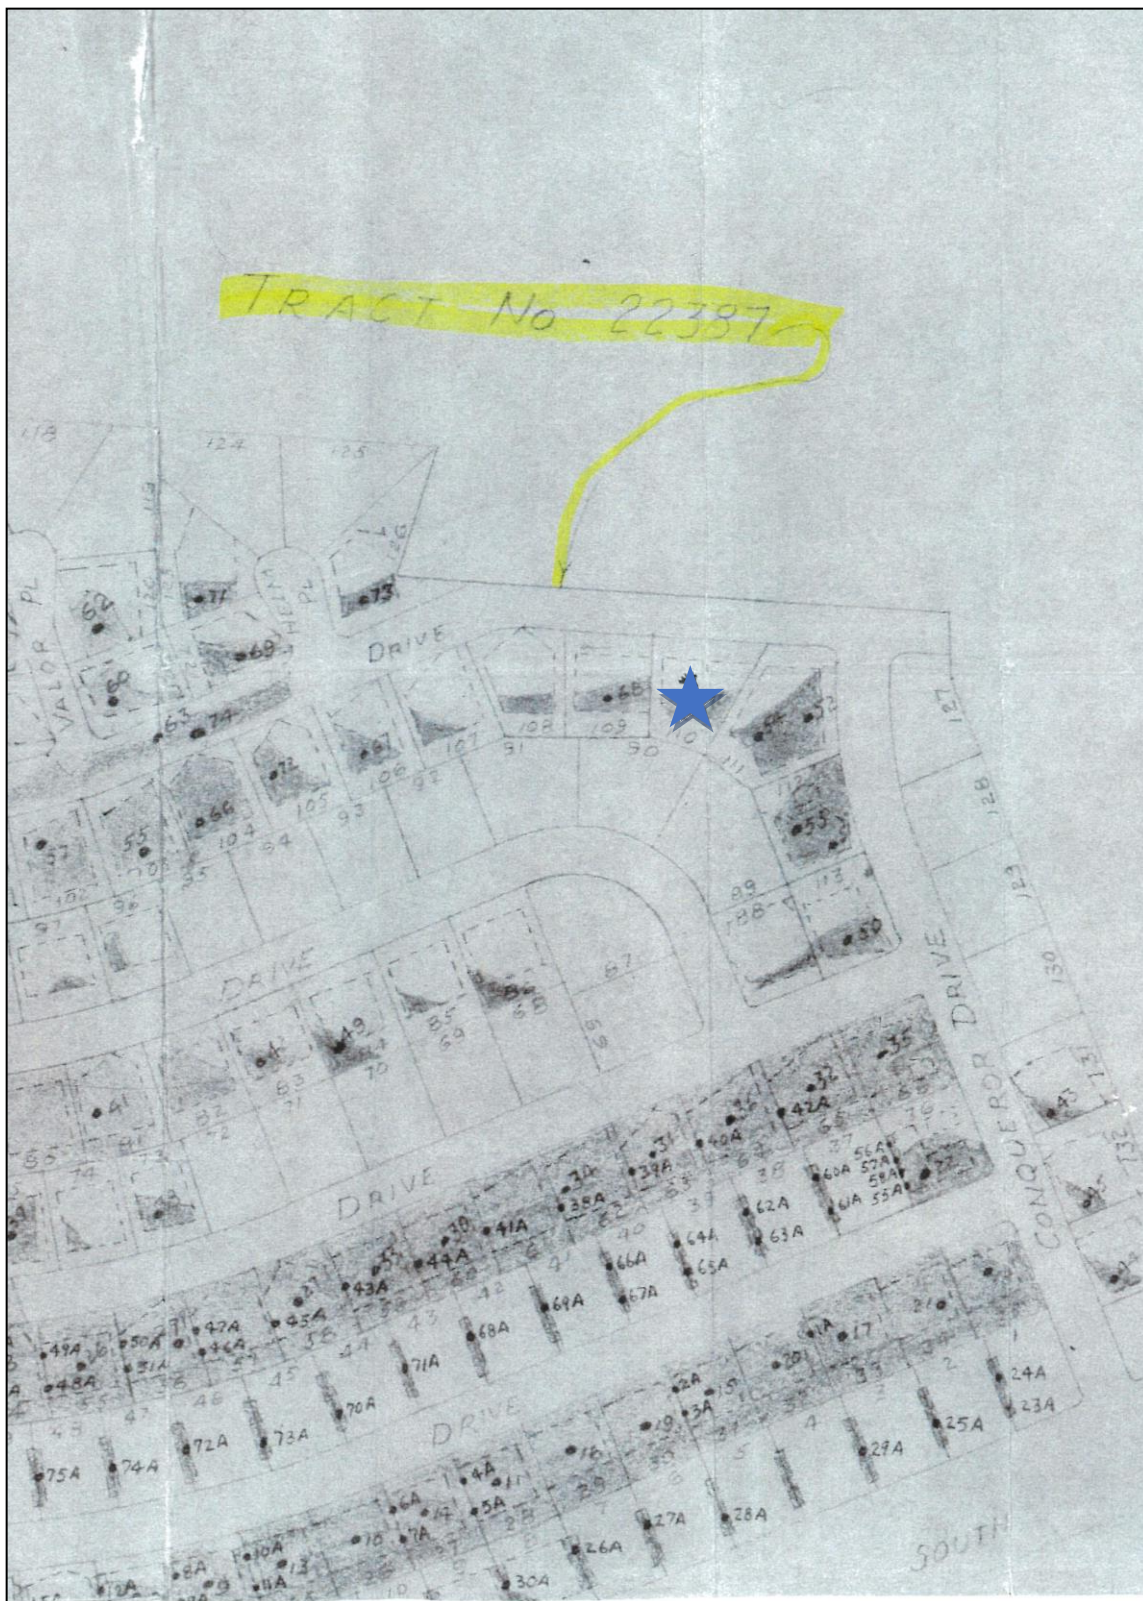
Grading was done for tracts 22387 and 22835 in 1956. The subject property is located in tract 22387 and is designated as lot 110. The map shows that a portion of the southern end of the pad is underlain by compacted fill, with compaction test number 76 having been done in that area (Figure 3). The remaining portion of the pad and the descending slope don't show any fill compaction. The home that currently exists on the subject lot was constructed in 1960, with renovations done in 1962.

Figure 3: Portion of Grading Map for Tract 22387 & 22835, by The Donald R. Warren Company & HR. Lovette & Associates. The subject property is shown by a blue star.

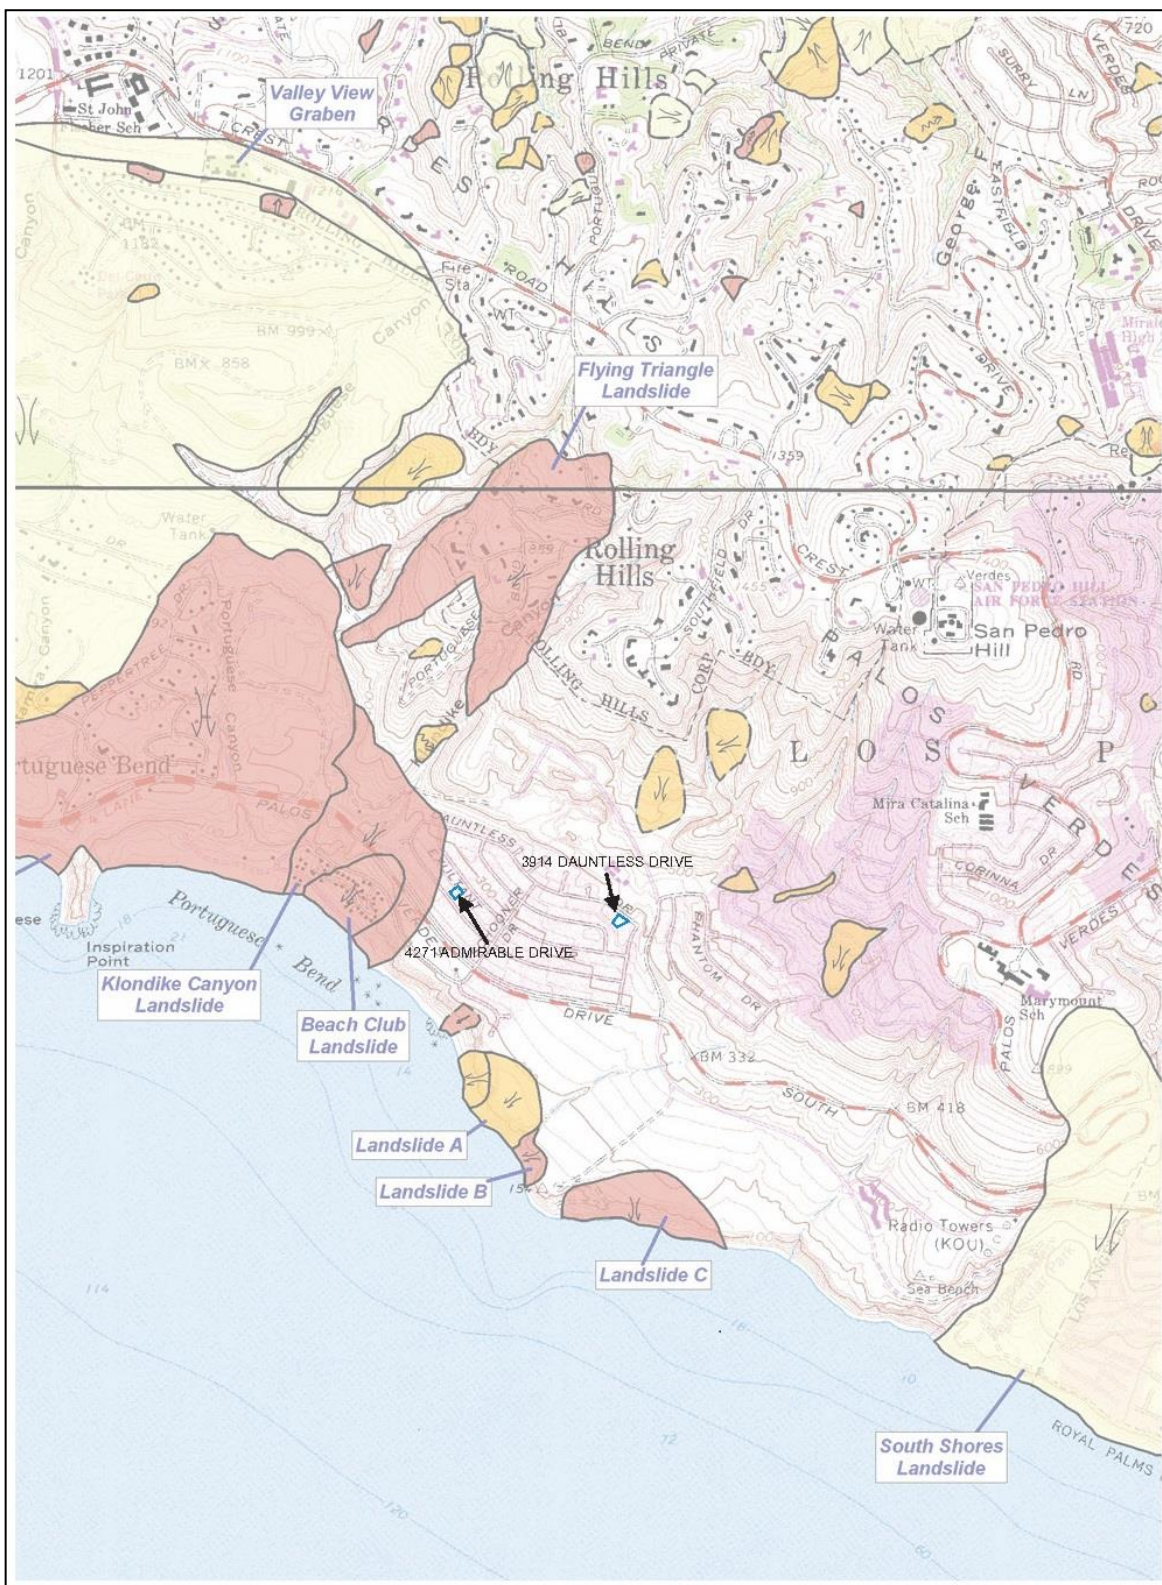
As can be seen on Figures 2, 4 and 5, nearby landslides include the Klondike Canyon Landslide, which is approximately 0.5 miles distance from the subject site. The Flying Triangle Landslide, which is approximately 0.5 miles from the subject site. The Portuguese Bend Landslide, which is approximately 1 mile from the subject site. Finally, the recent Pear Tree Lane Landslide, which is approximately 3 miles from the subject site and is not shown on any of the figures due to its distance. The subject property is not affected by any of these landslides.

Figure 4: Portion of Landslide Inventory Map of the Palos Verdes Peninsula, Los Angeles County, California (2007). Subject and referenced sites are noted on the map.

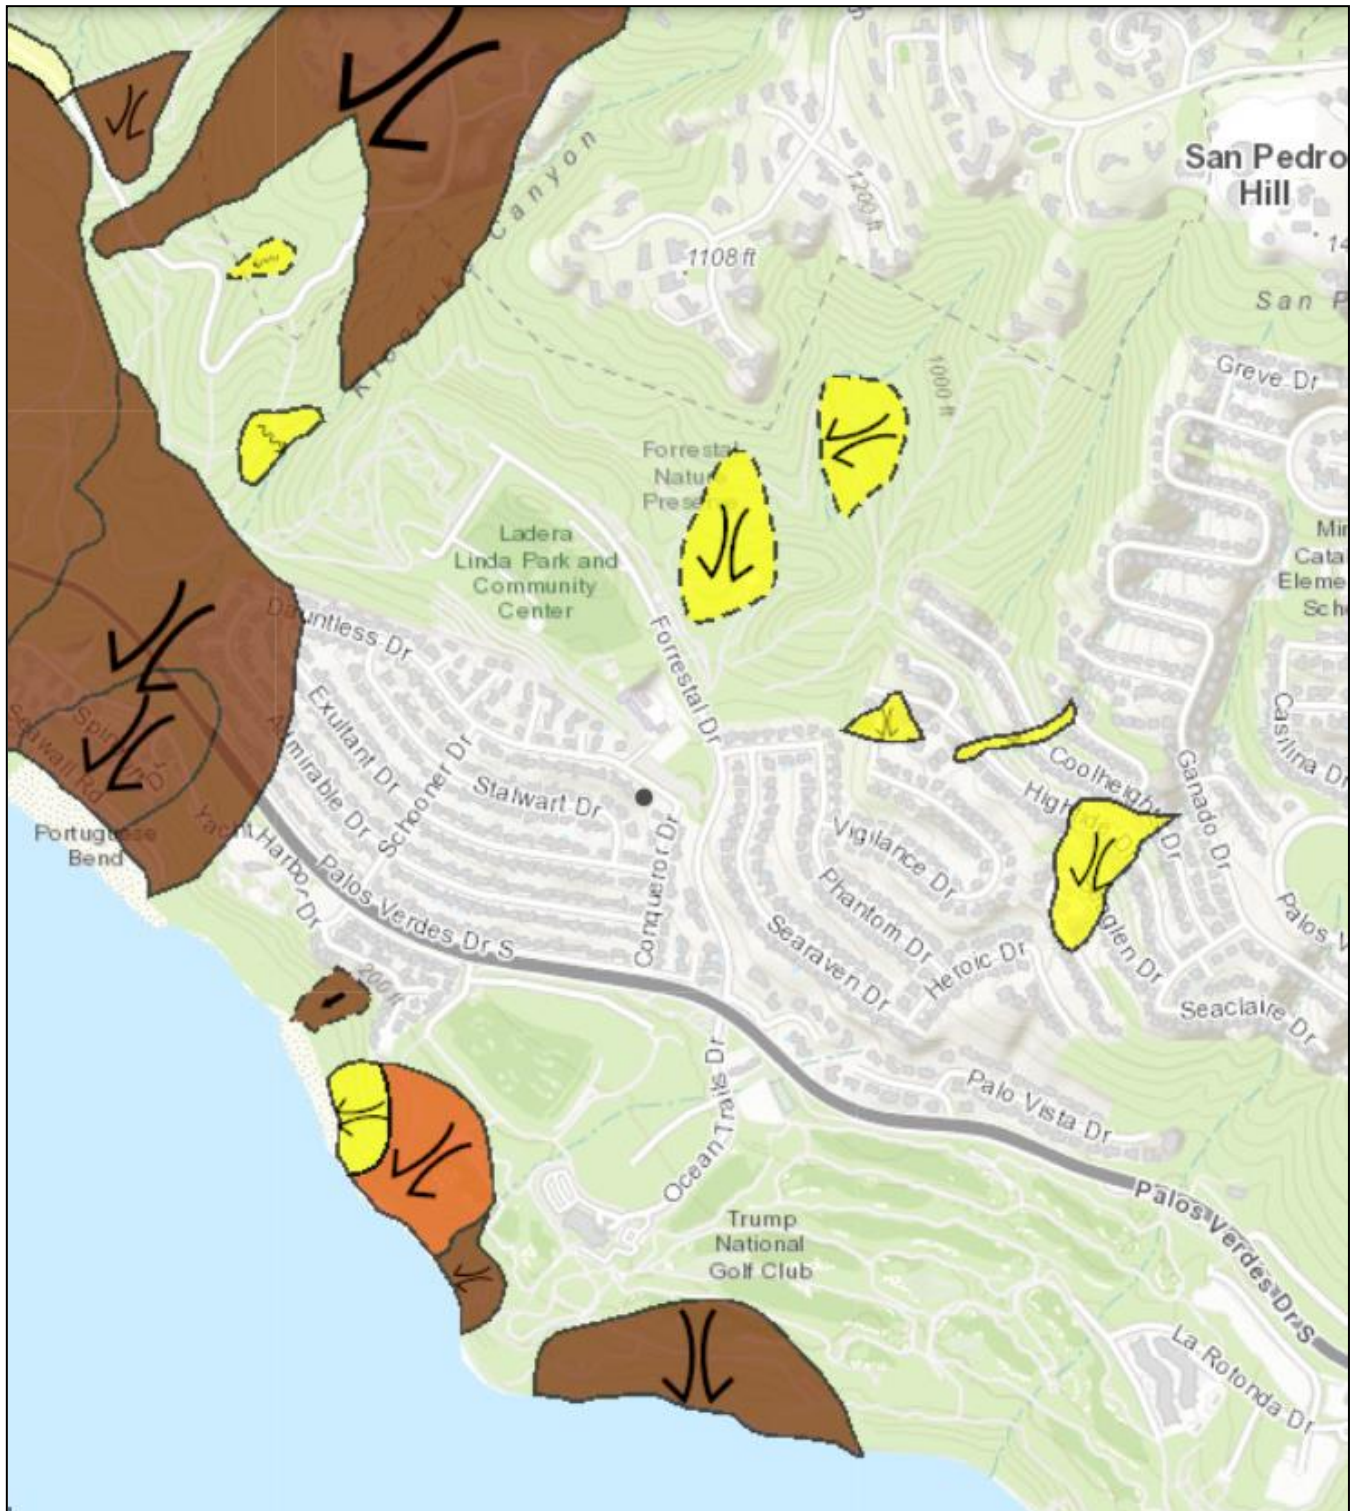
Figure 5: Portion of California Department of Conservation Landslide Inventory. Site is denoted by a black point.
