Duration Plumbing

Sewer Inspection Report

231 Avenue B

Wednesday, April 6, 2022 at 10:45 AM

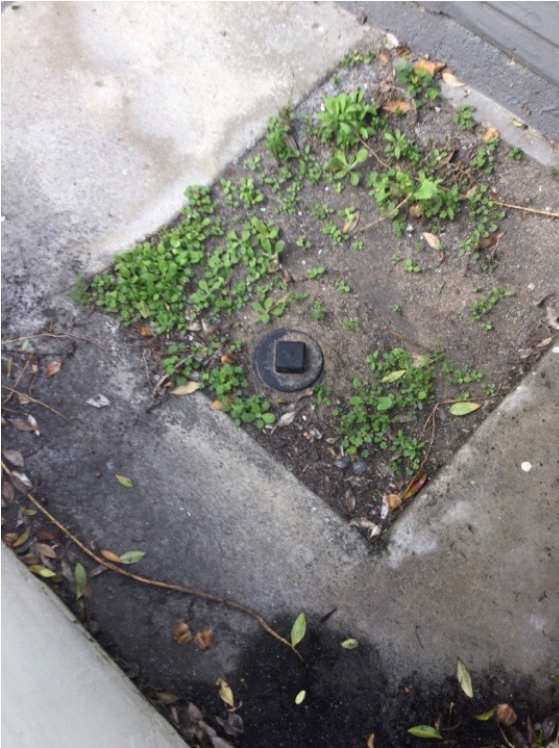
Four inch abs plastic clean out.

West side of the house.

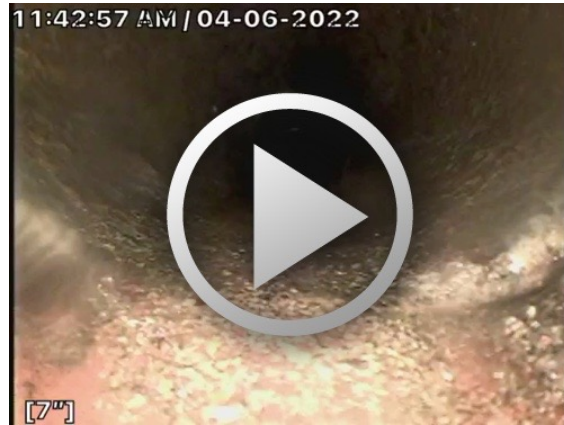
Downstream towards the street.

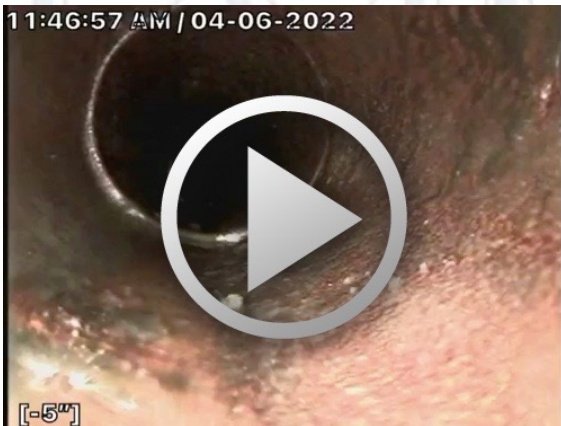
Upstream towards the backyard.
