F.N. 1-20-0013

Subject: STRUCTURAL EVALUATION OF SINGLE FAMILY RESIDENCE
6347 Tarragon Road, Rancho Palos Verdes, CA 90275

PALOS VERDES ENGINEERING CORPORATION

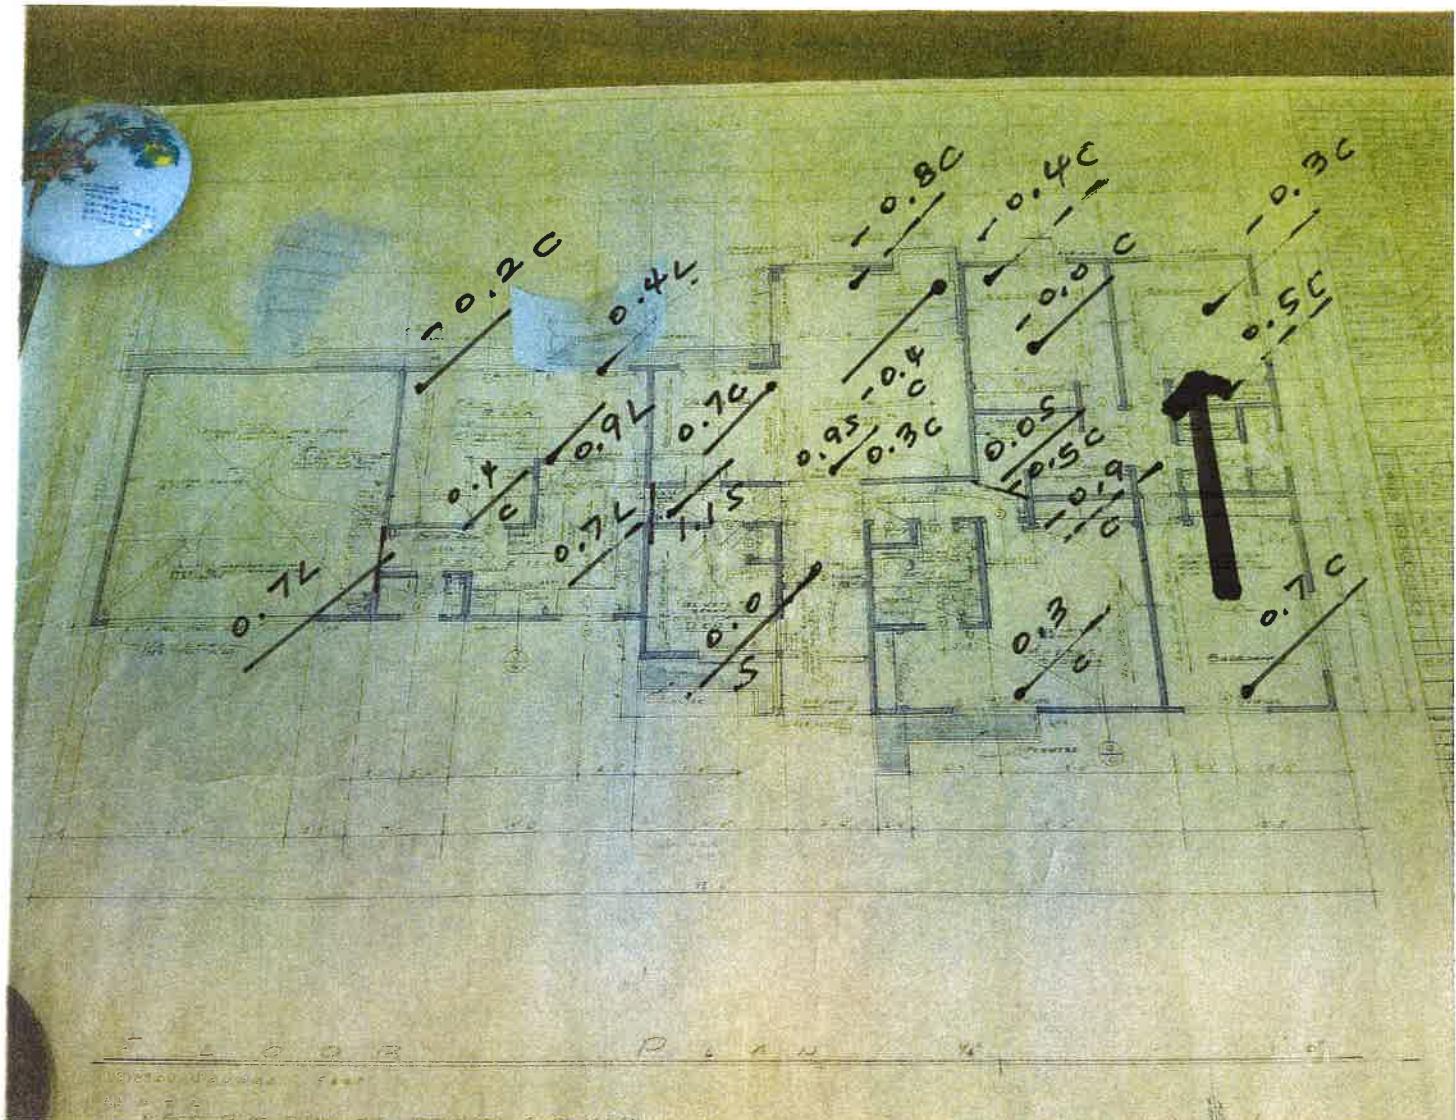
EXHIBIT A

A manometer survey of the interior floor surfaces was conducted to determine its topography. In general, we noted that the floor surfaces slopes downward from the north toward the south direction.

An elevation deviation of 1.3 inches occurs in the floor surface from the northwest bedroom toward the southwest bedroom.

In living room, we measured an elevation deviation from the north corner to the south exterior wall near the fireplace occurs of 1.2 inches.

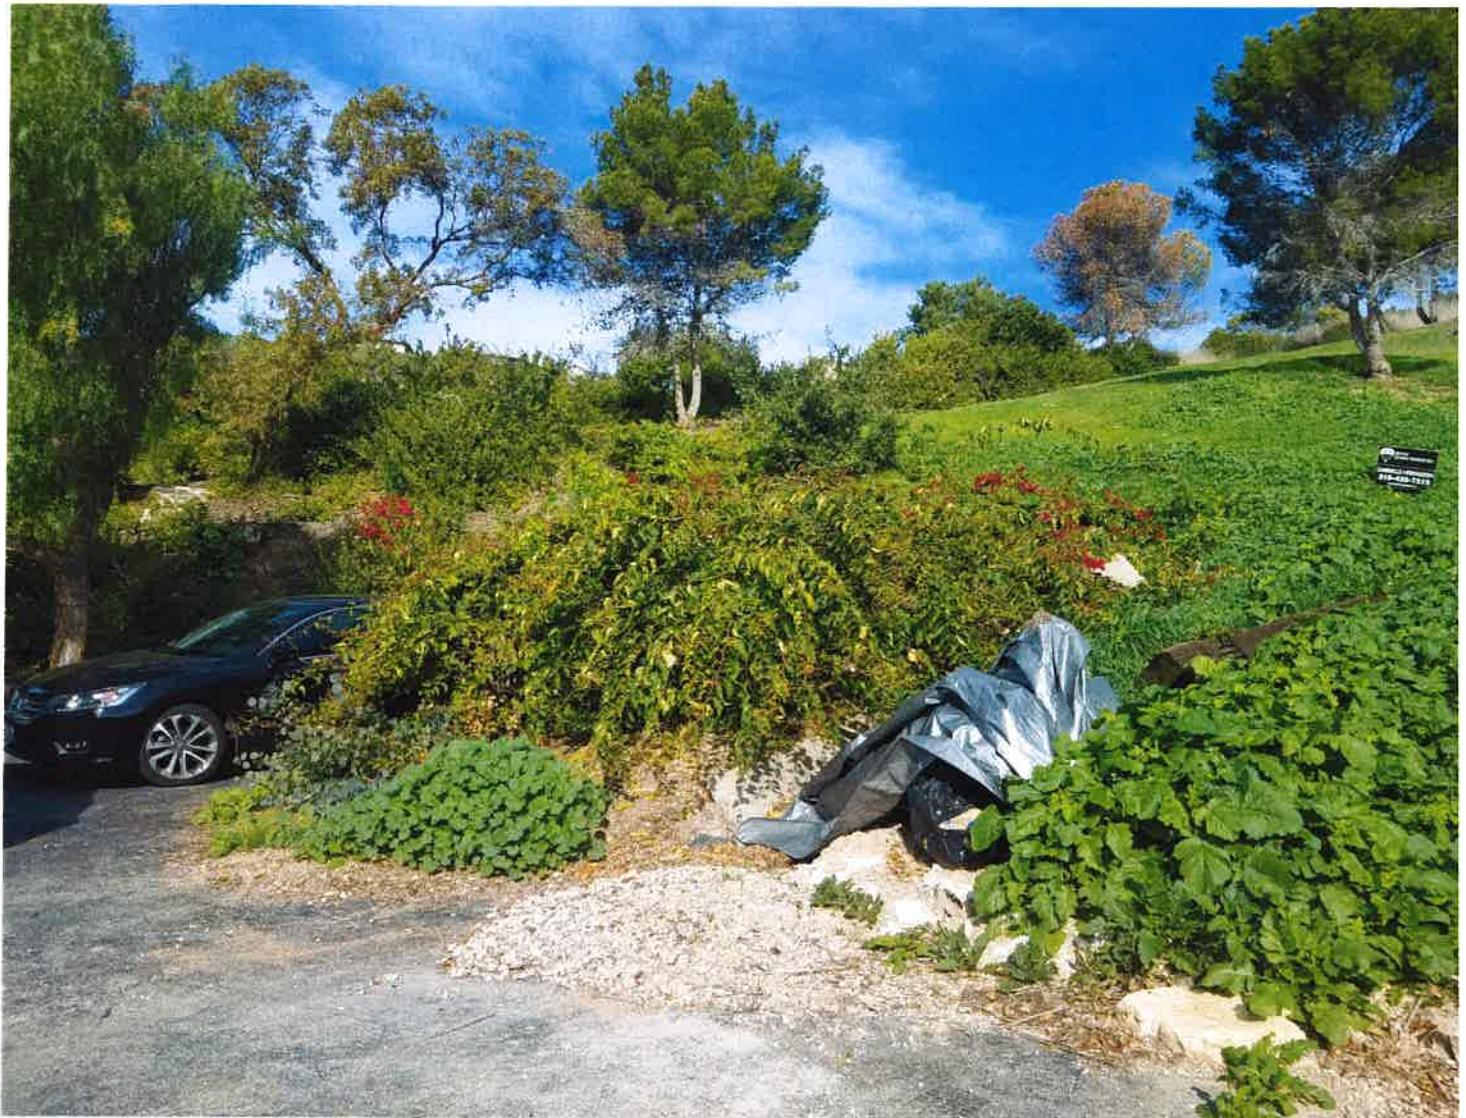
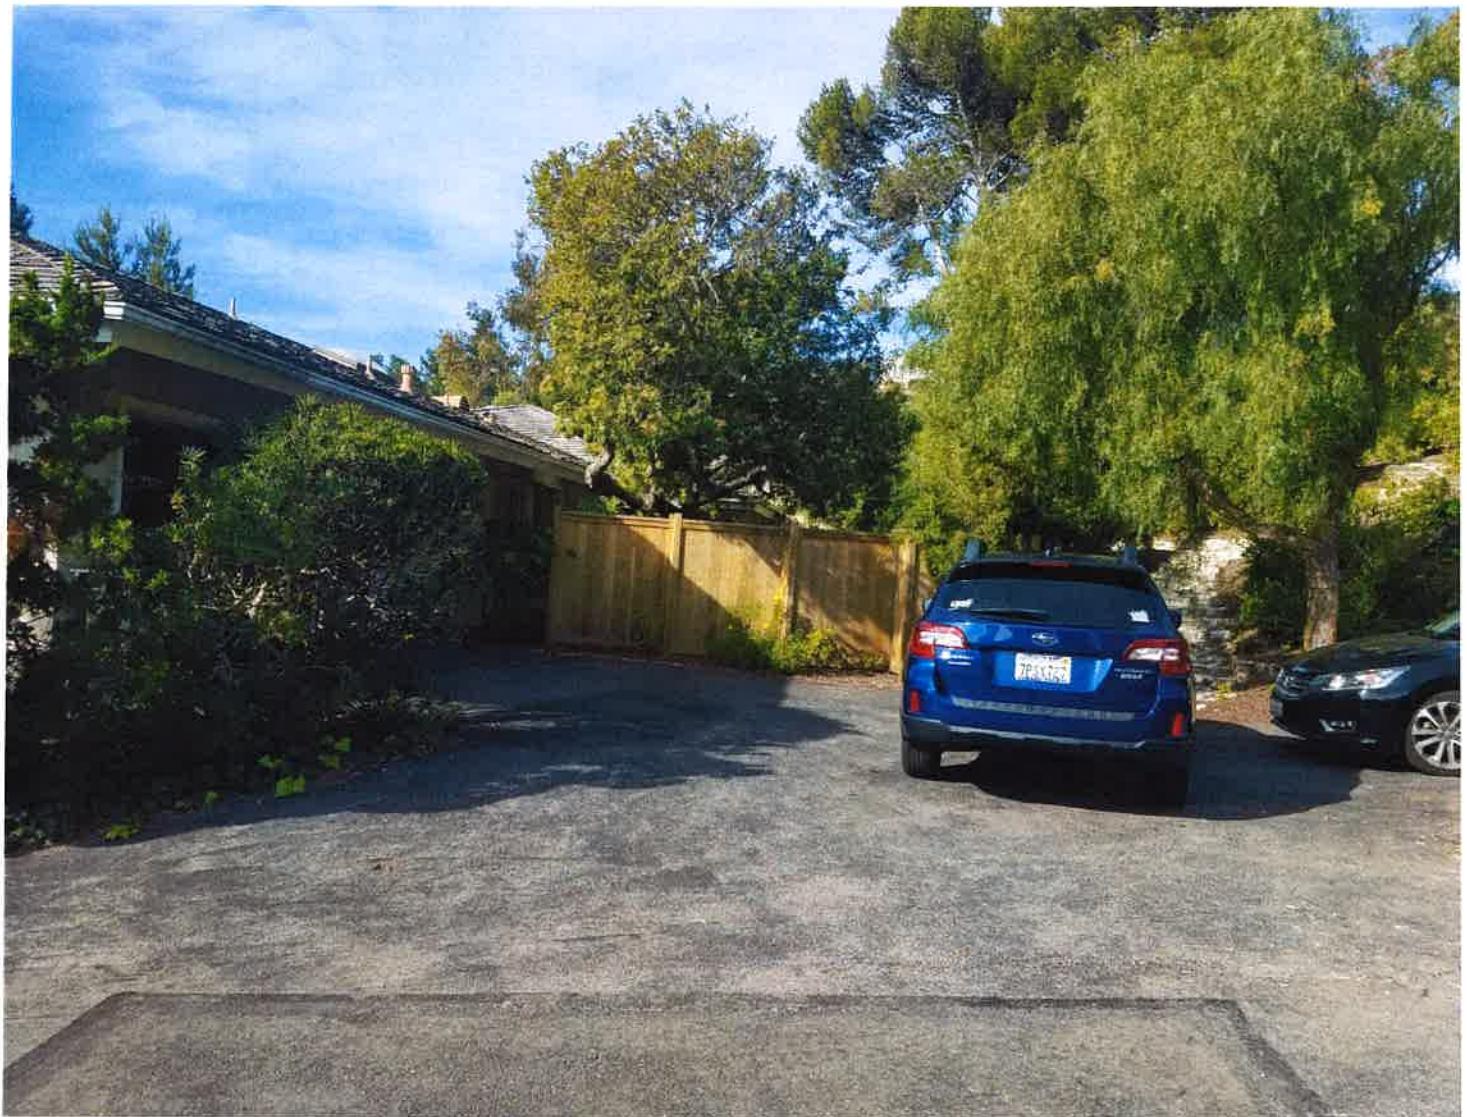
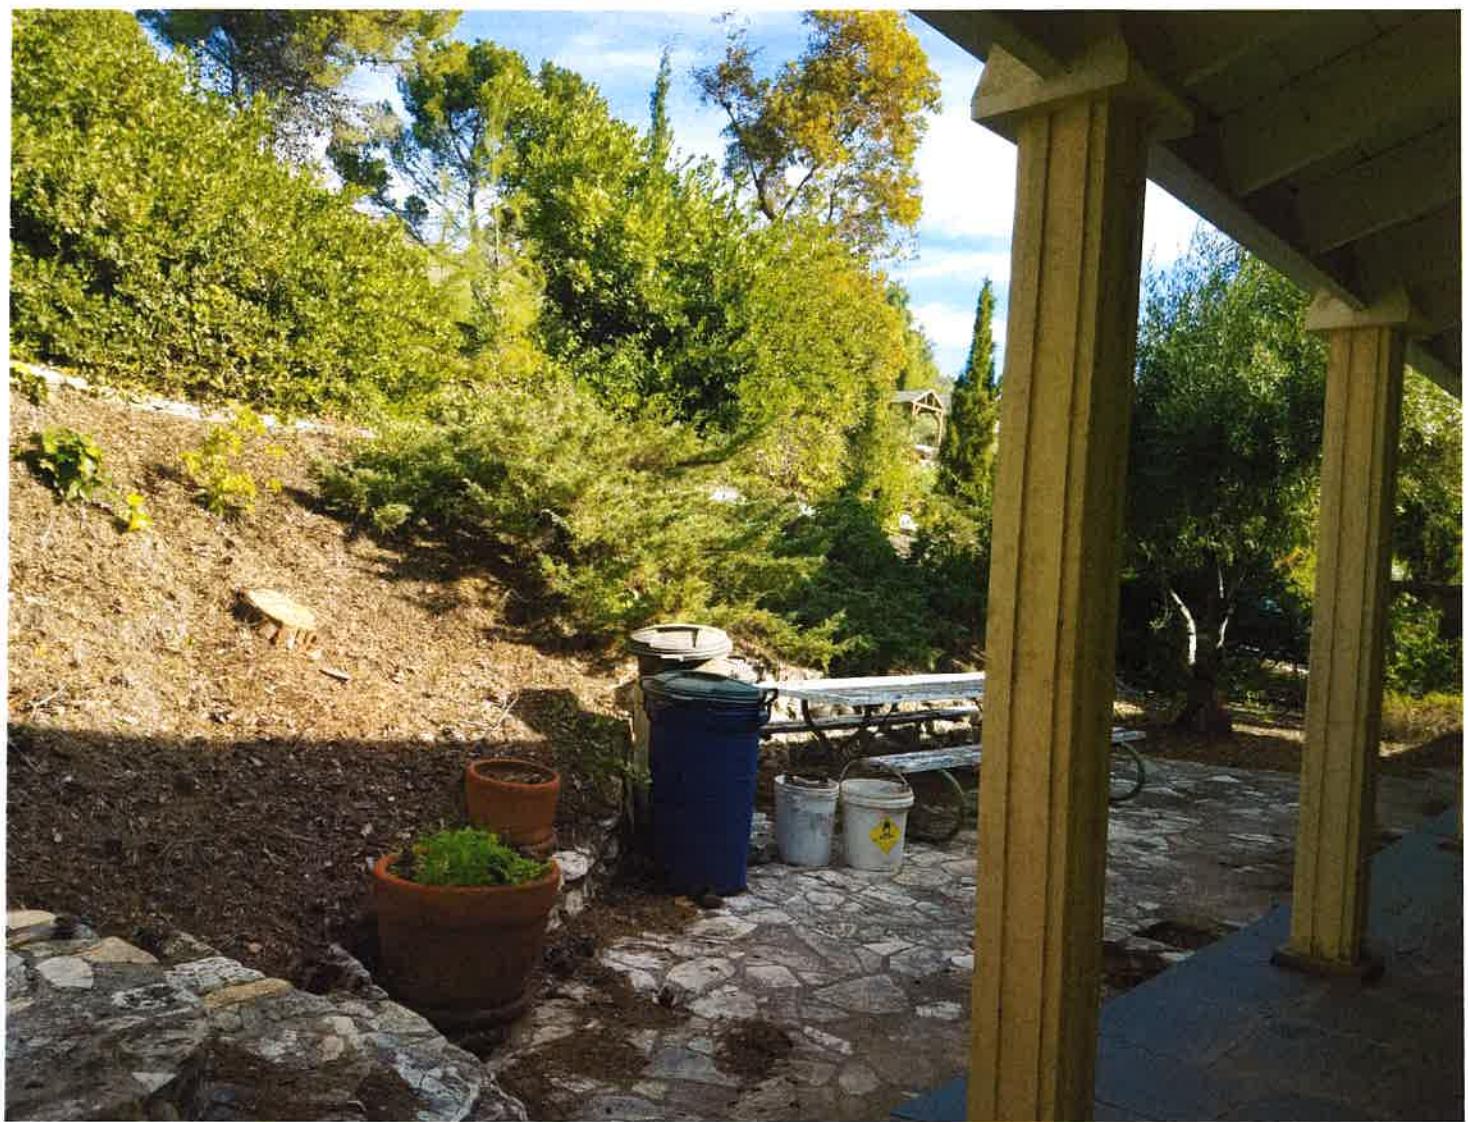
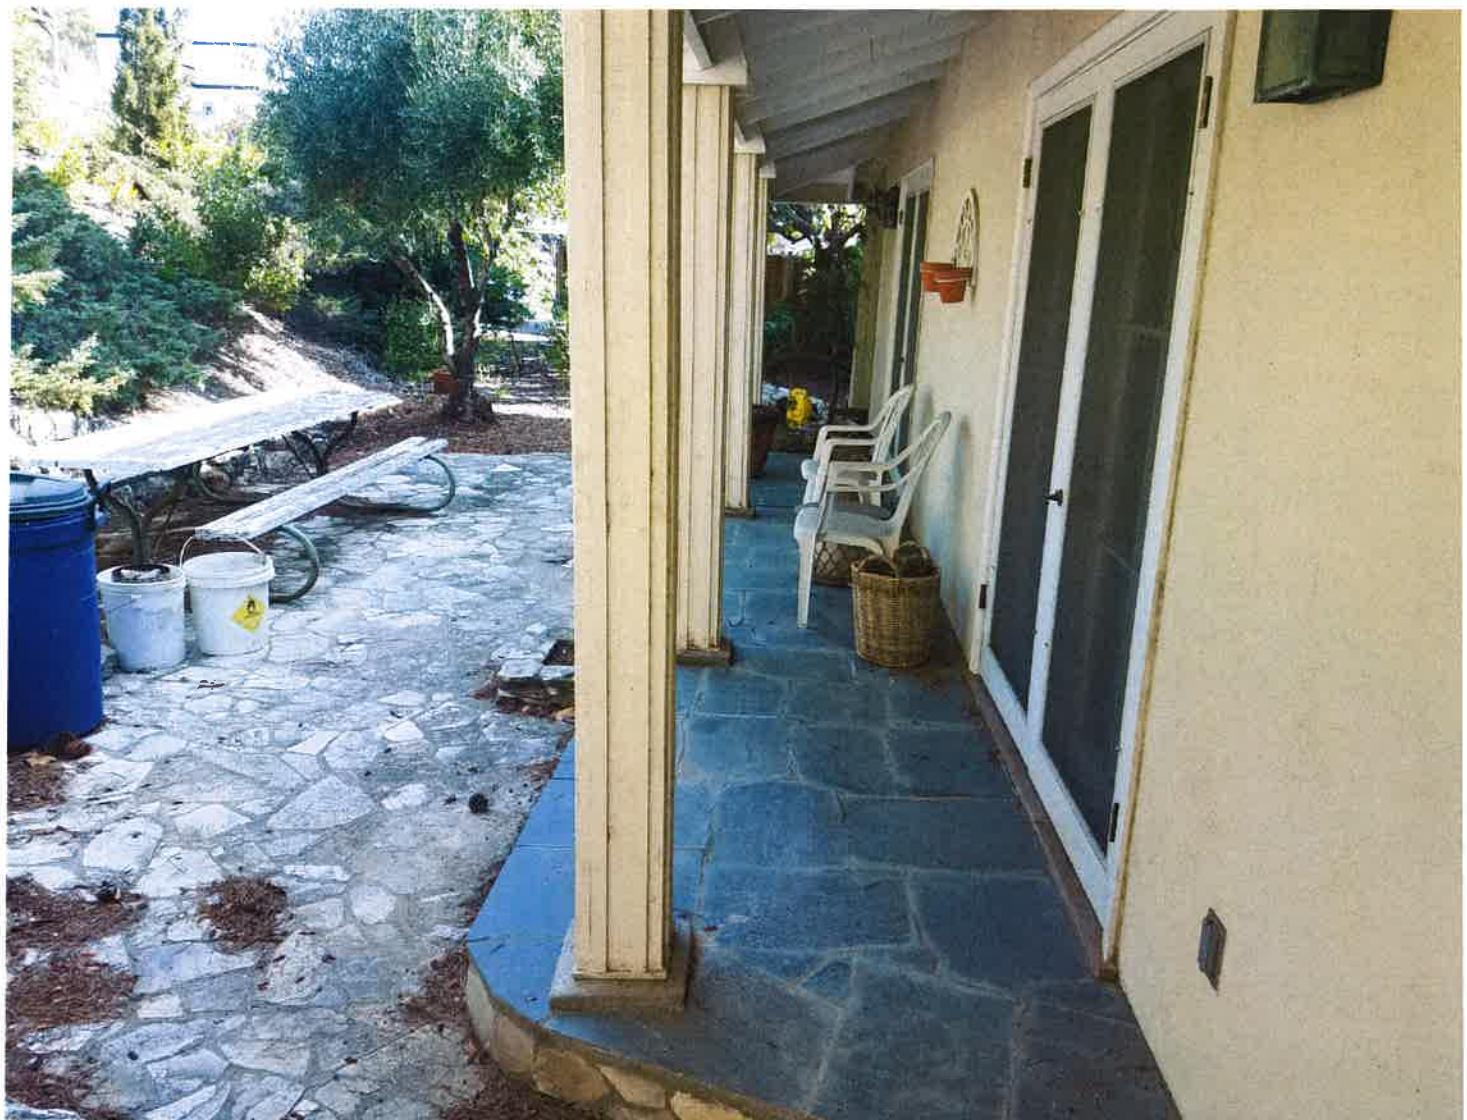
The subject property accepts both surface and subsurface runoff from the uphill neighboring properties to the north as shown on Photographs 5, 6, 30 & 31.

Subsurface runoff is directed beneath the raised foundation system from the higher elevated areas to the north as indicated by the wide dessication soil cracks and moist soil observed in the underfloor crawlspace. In addition, we noted that there are no area drains in both the hardscape and softscape areas to collect surface runoff and there are an insufficient number of downspouts to collect roof runoff from the eave gutters.

It is our recommendation that a geotechnical engineer be consulted to perform a soils investigation to provide recommendations to stabilize the existing foundations. It is expected that they will also recommend improving the site drainage condition to reduce the amount of runoff that can be directed beneath the residence. A French Drain system should be constructed along the base of the north ascending slope to collect subsurface runoff. This French Drain should have a minimum 5 foot depth and should contain a 6 inch diameter perforated drain line covered in clean gravel and wrapped with a Mirafi filter fabric.

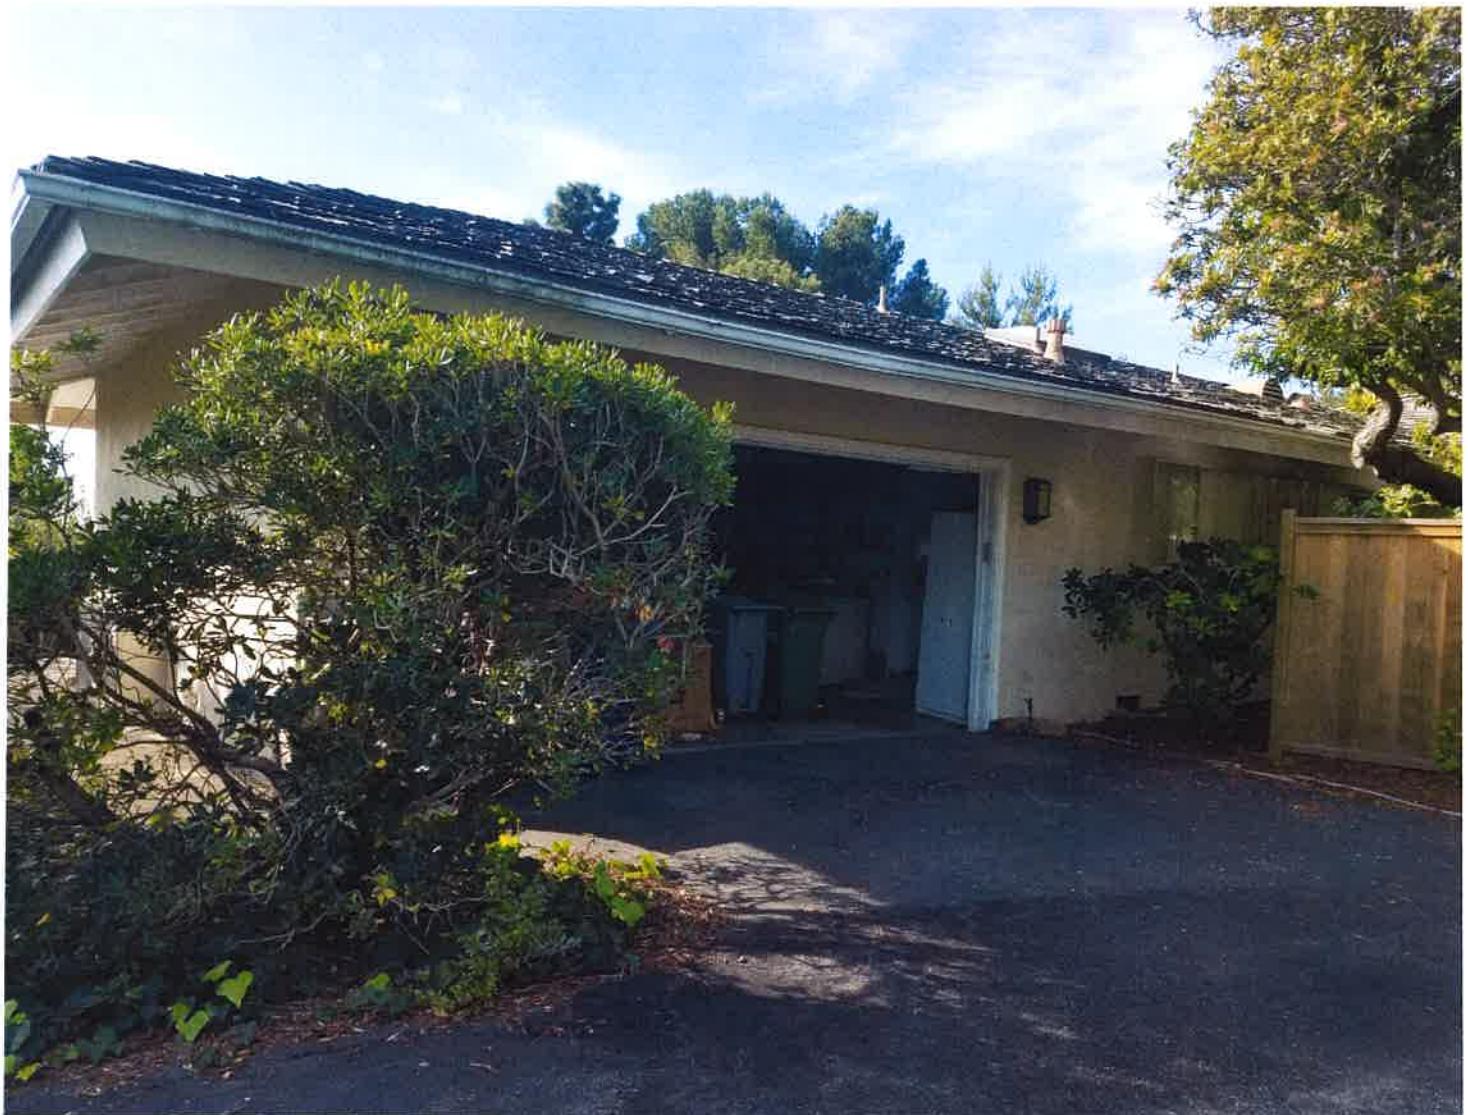
2

There are an insufficient number of downspouts to handle the amount of roof runoff from the eave gutters as represented on Photograph 7. There are cracks in the asphalt driveway as shown on Photograph 8.

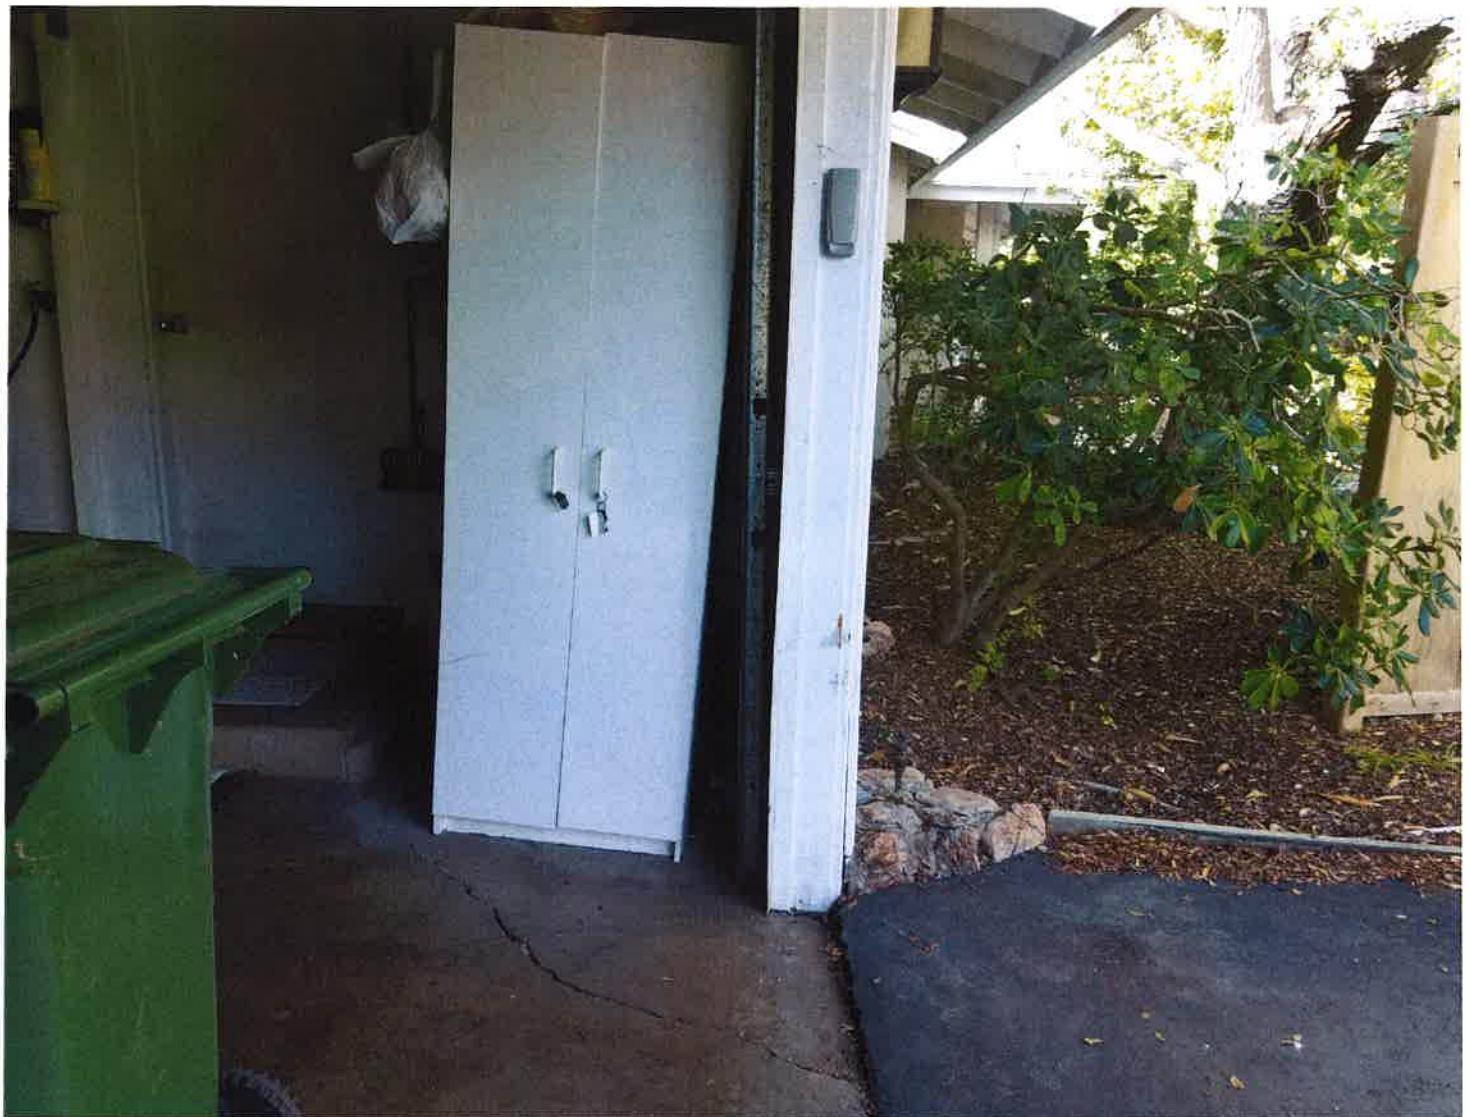
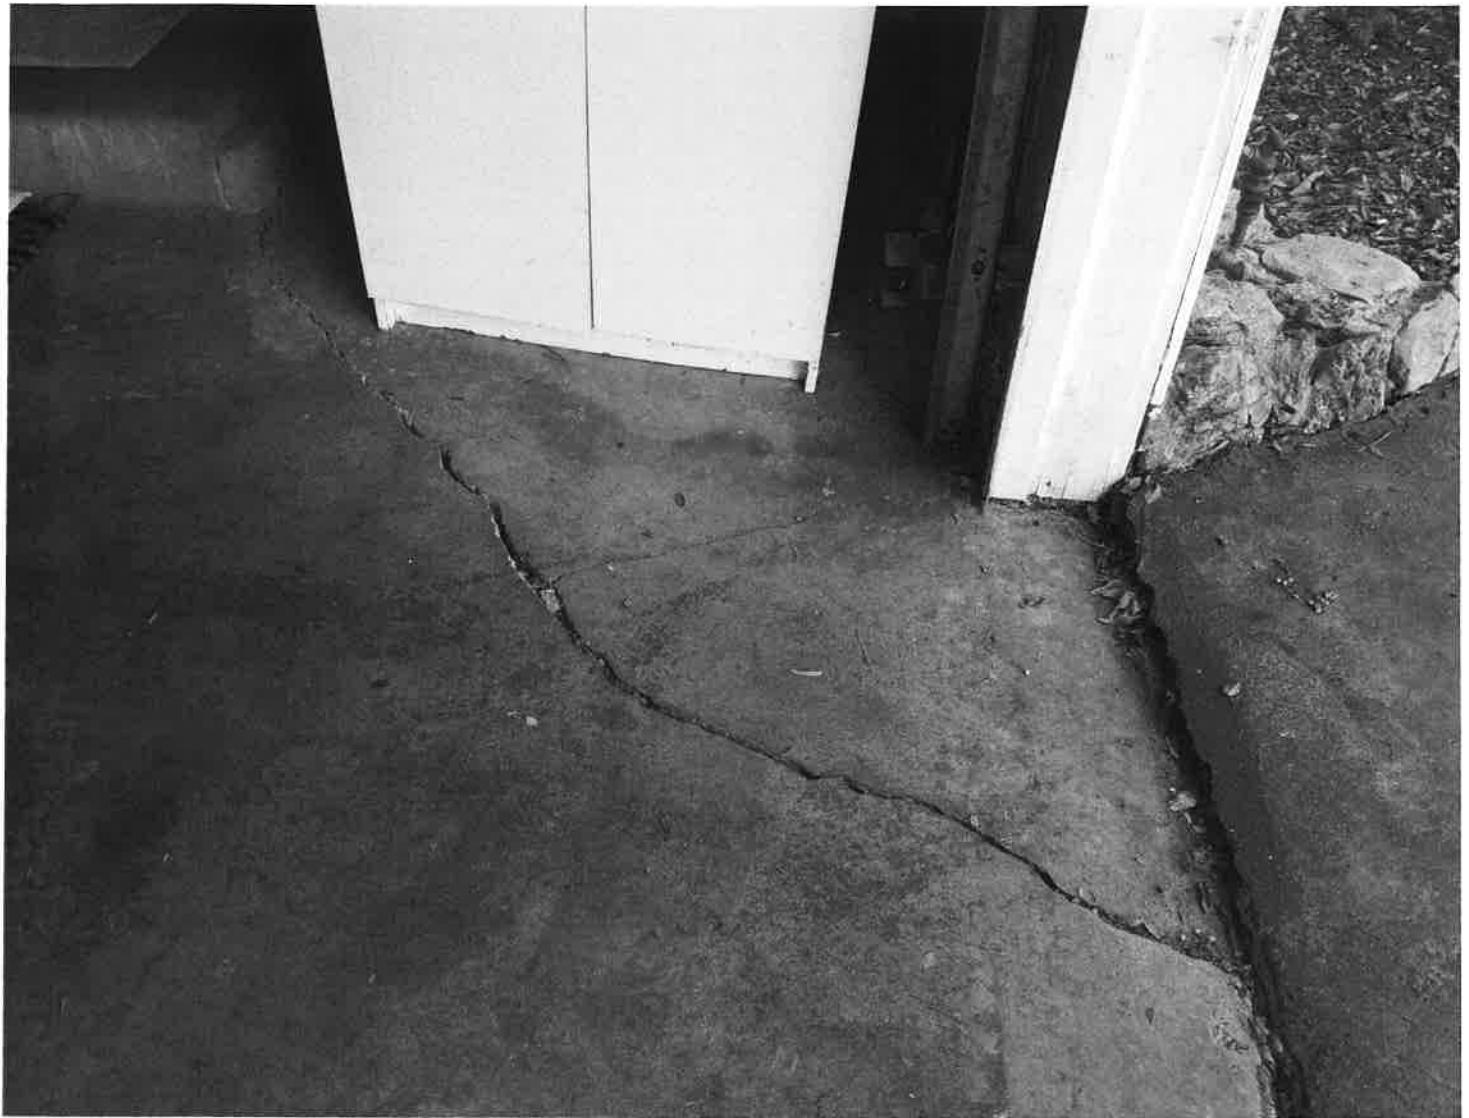
There is also noticeable cracking in the northwest corner of the garage slab as depicted on Photographs 9 & 10.

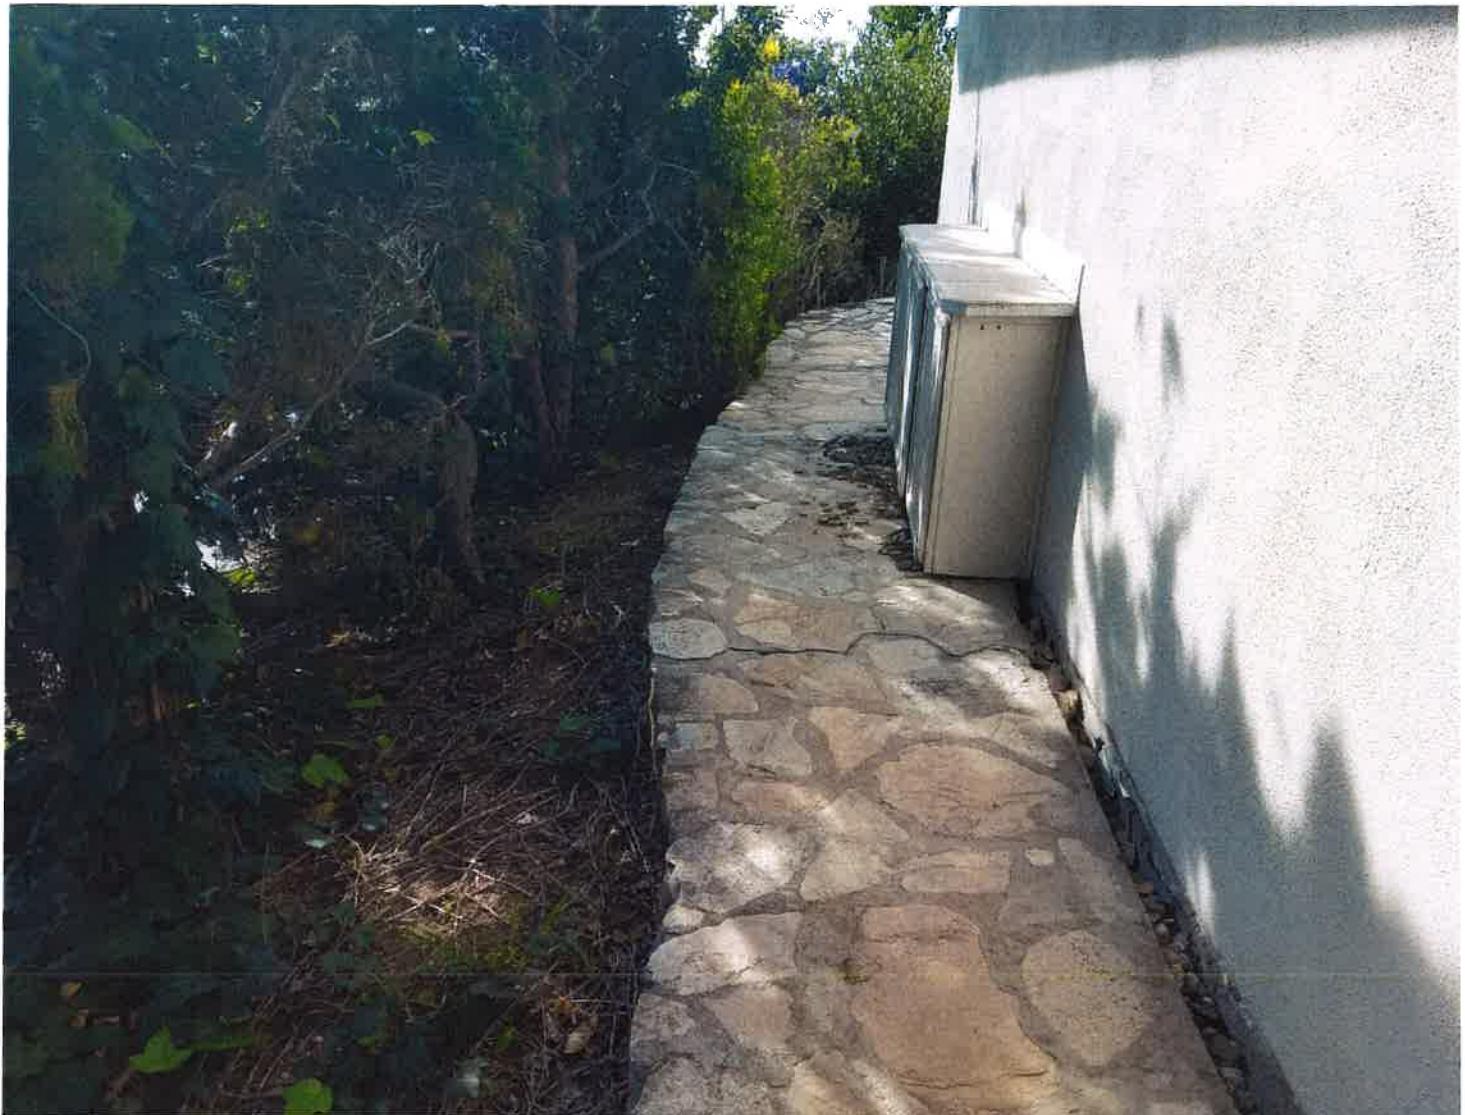
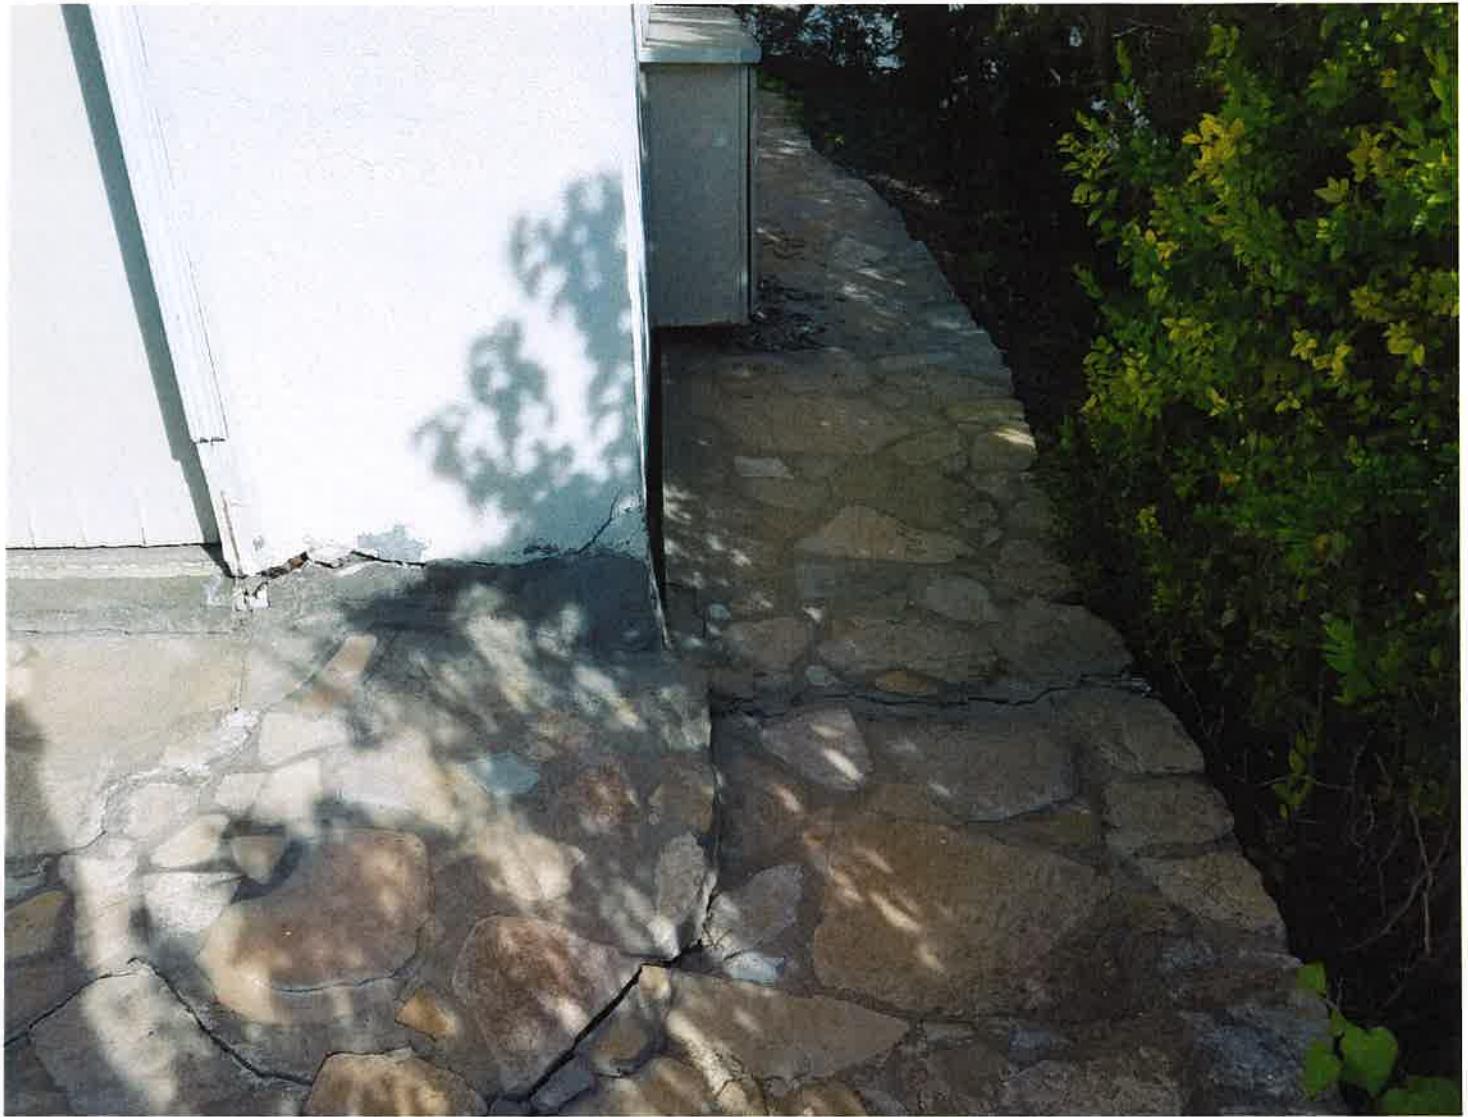
The property also descends toward the east at the attached garage where we observed significant horizontal separation between the east walkway and the adjoining garage foundation as depicted on Photographs 11 & 15.
