F.N. 1-20-0013

Subject: STRUCTURAL EVALUATION OF SINGLE FAMILY RESIDENCE
6347 Tarragon Road, Rancho Palos Verdes, CA 90275

PALOS VERDES ENGINEERING CORPORATION

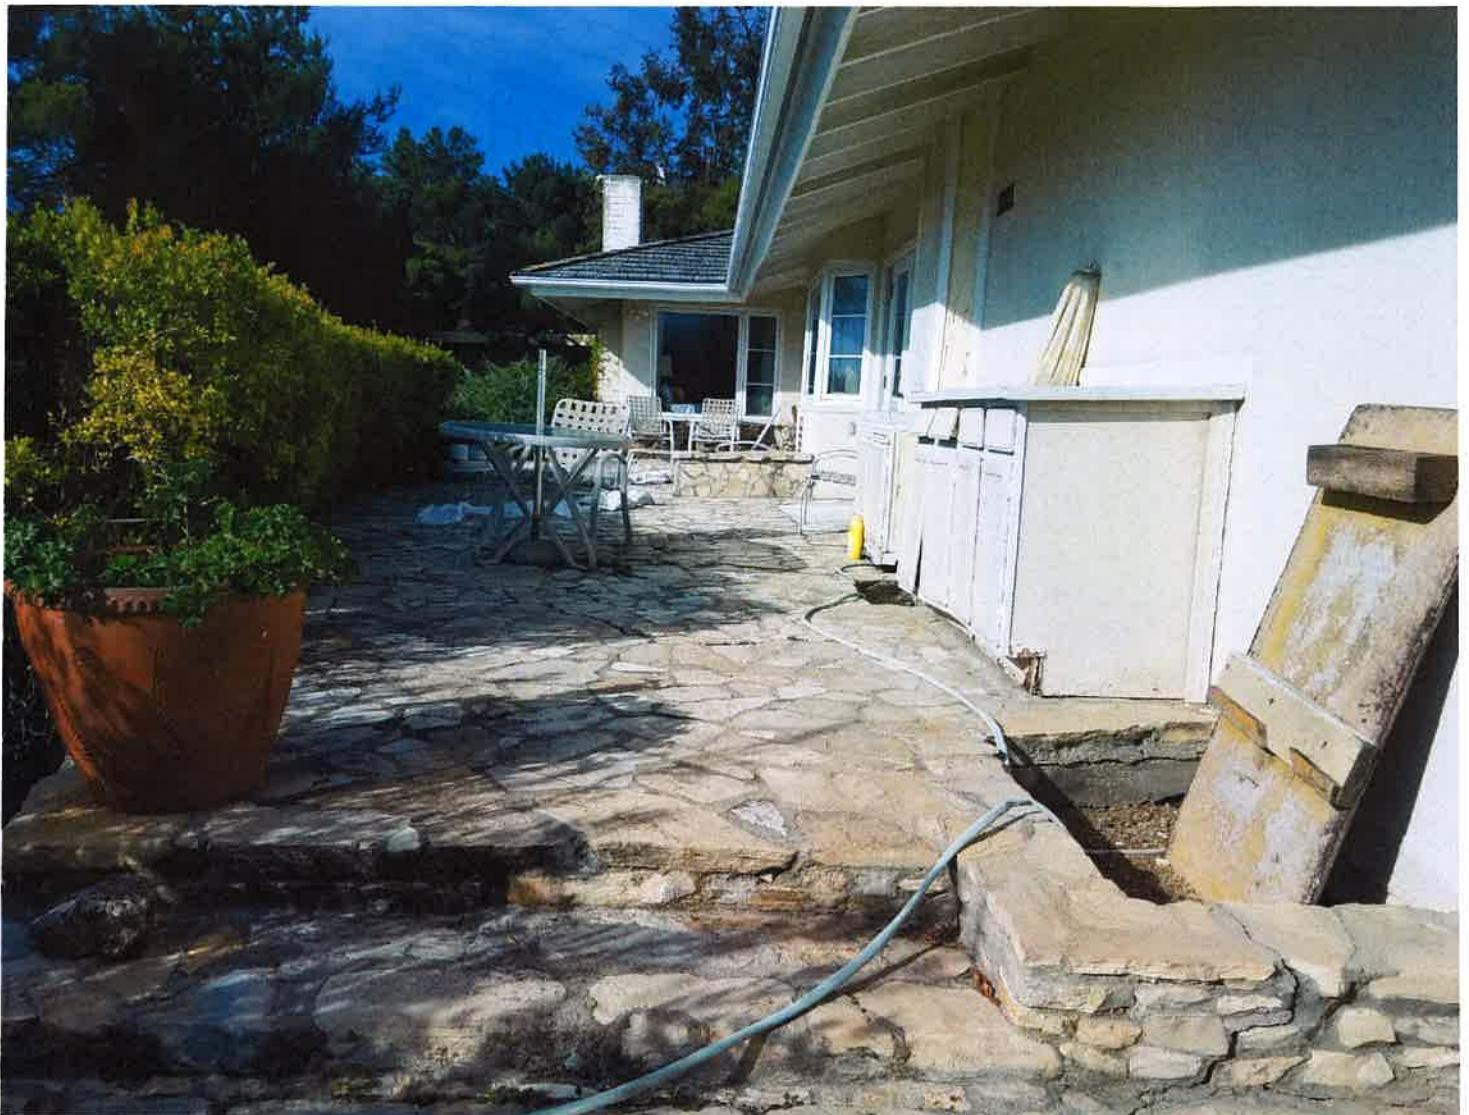
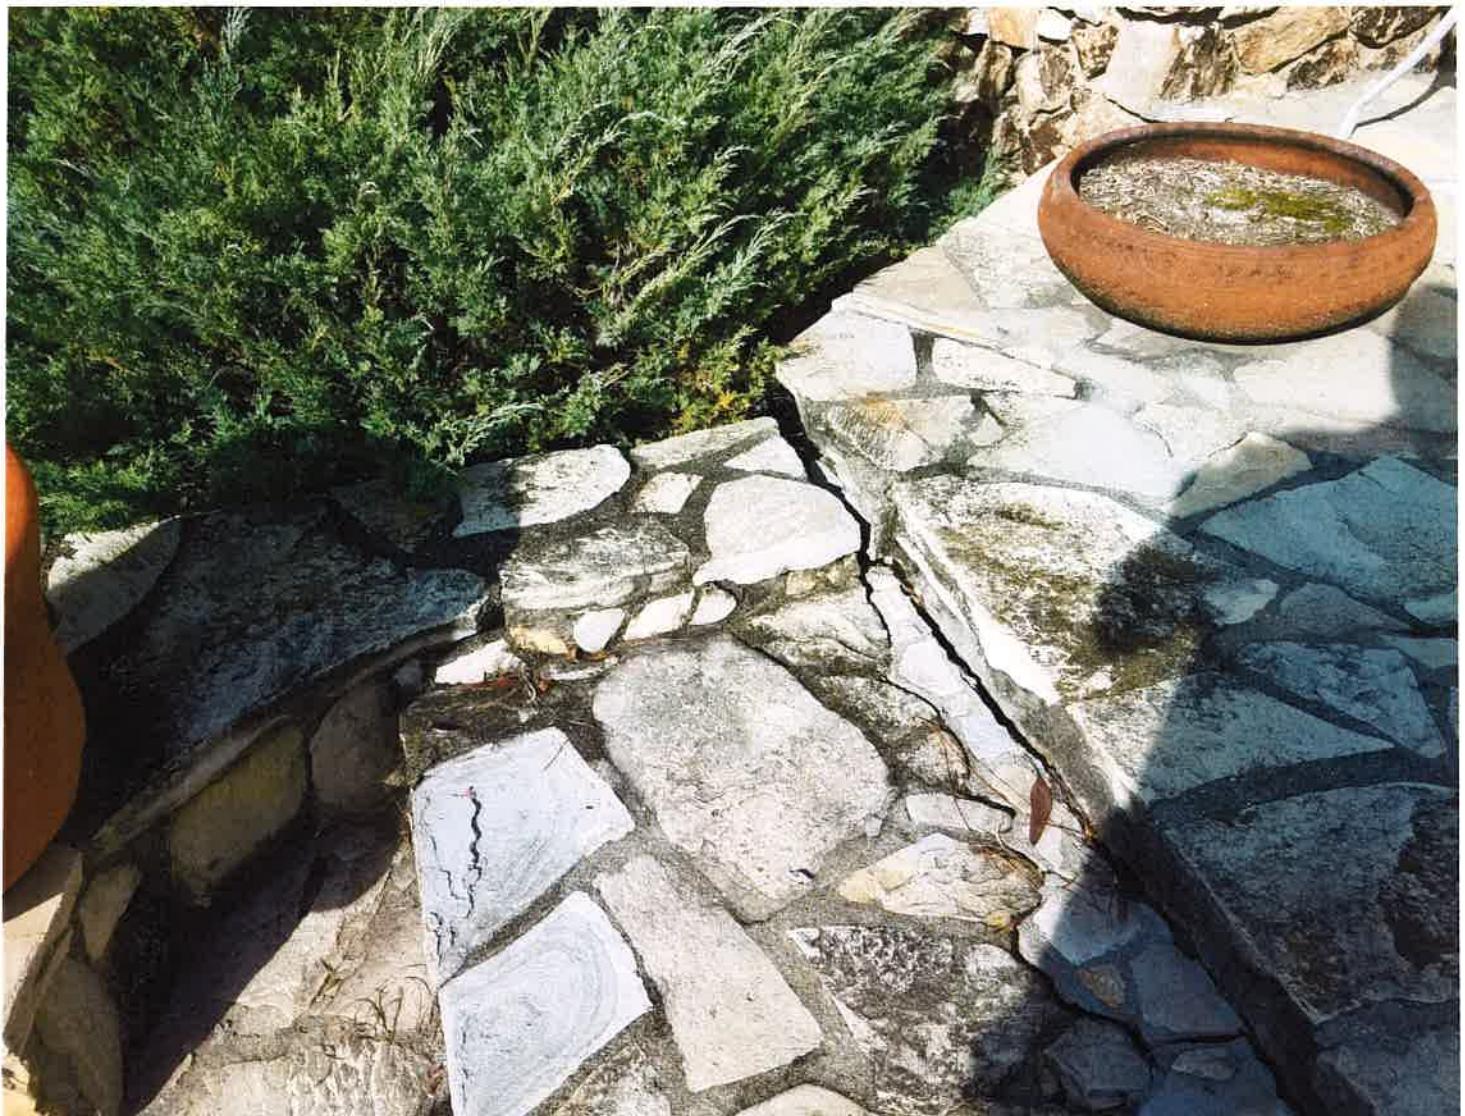
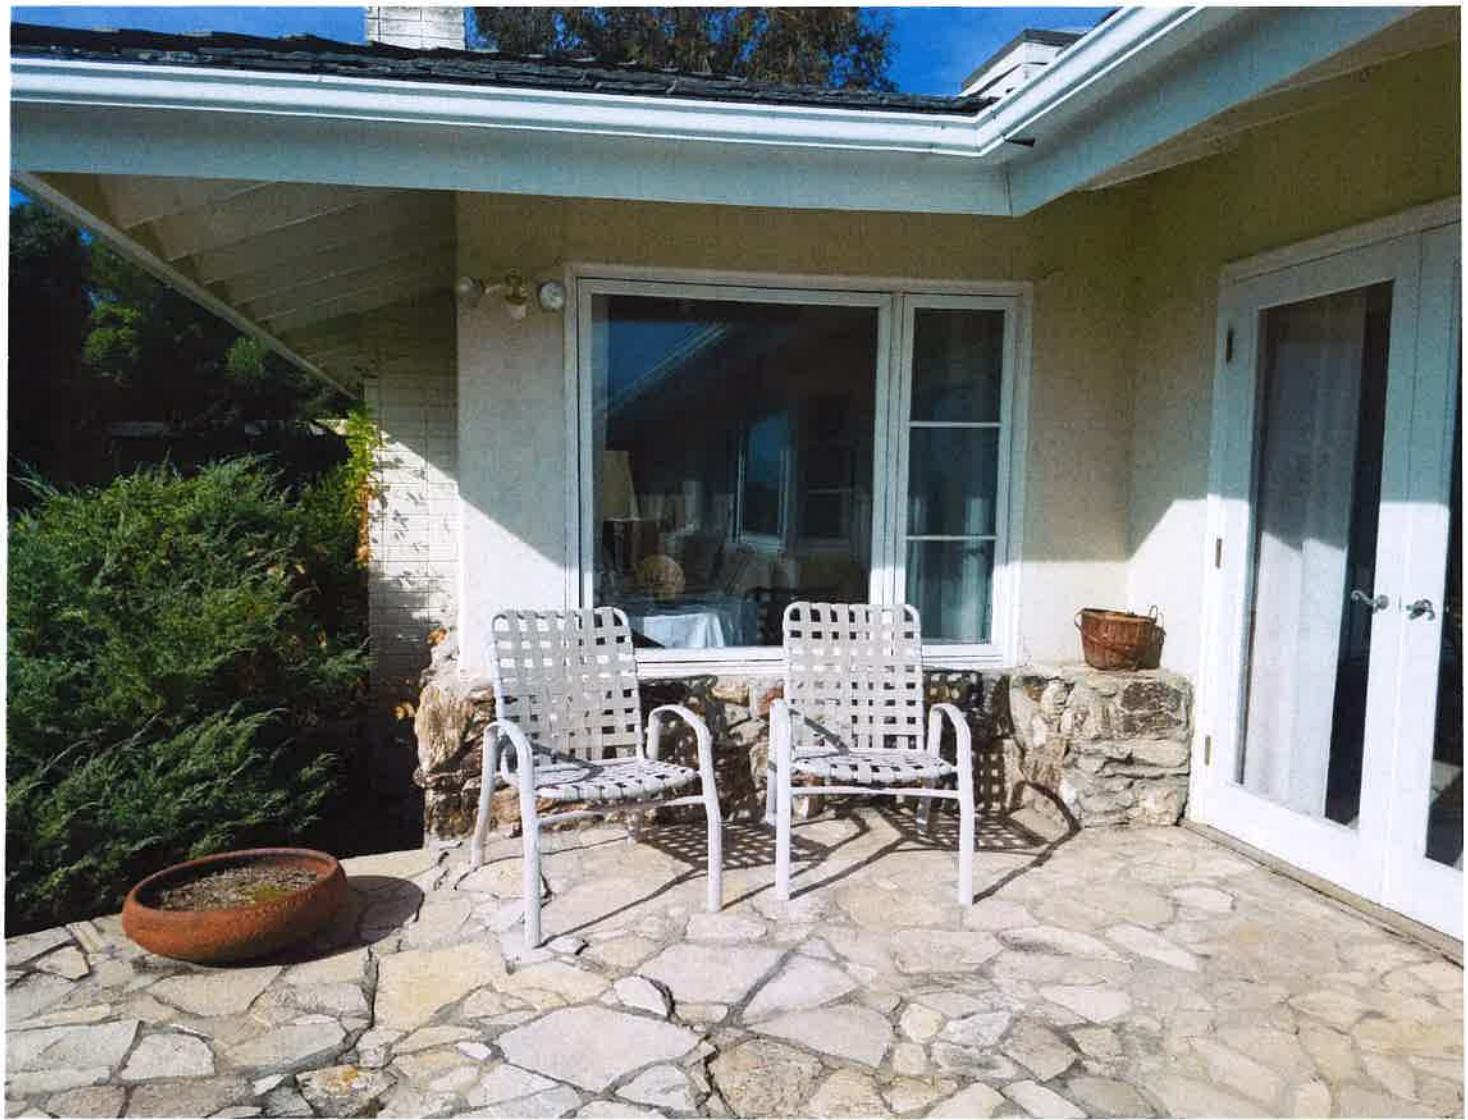
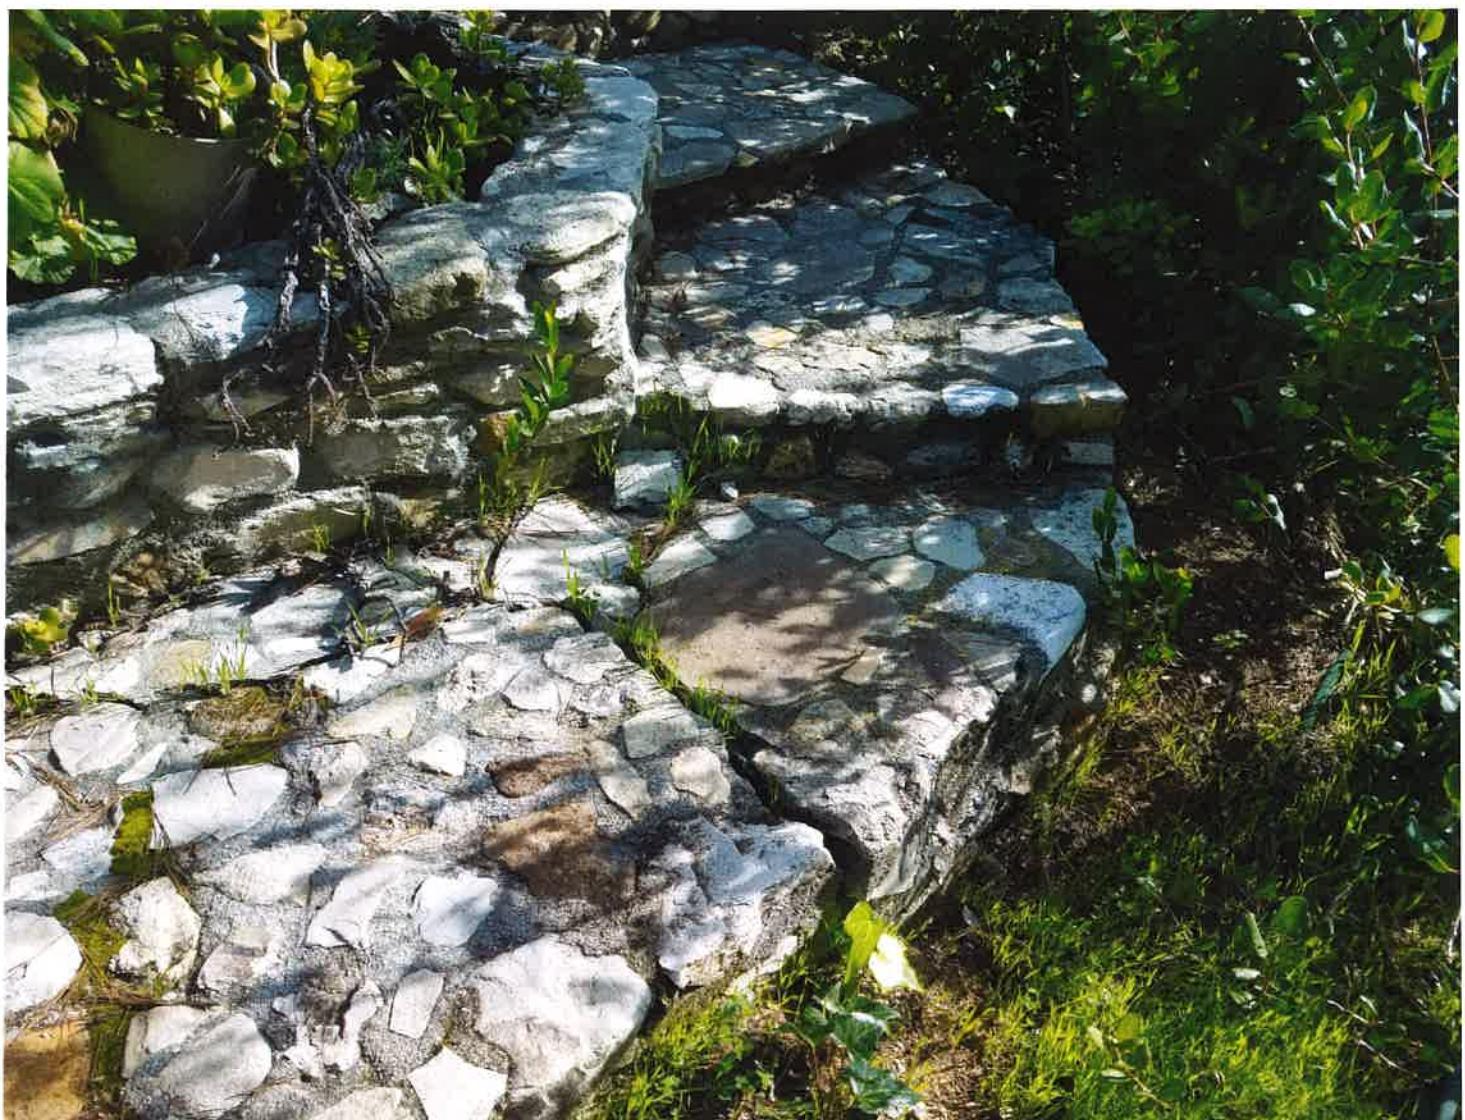
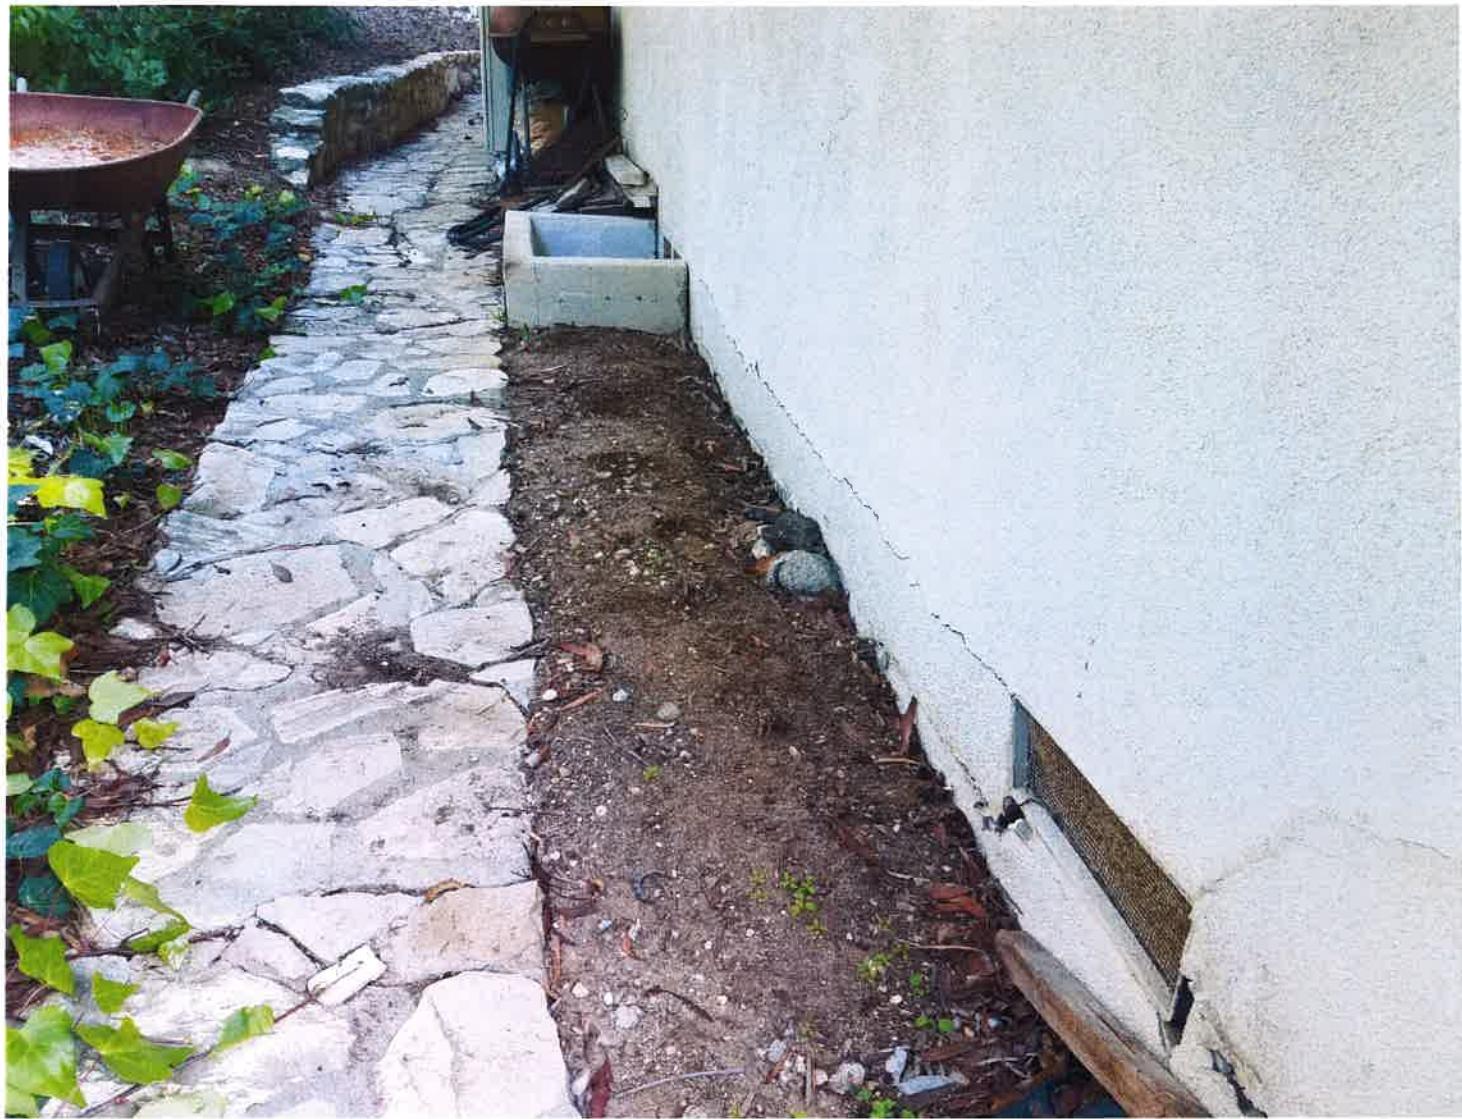
The property also descends toward the south from the rear patio. There are no area drains in the patio and walkways to collect surface runoff as depicted on Photographs 12, 16, 17, 25 & 26. We observed cracking throughout the exterior flatwork.

Cracking was also detected on the exterior stucco wall surfaces as represented on Photographs 13, 20, 22 – 24, 26 – 29 & 32. Noticeable horizontal cracking at the base of the exterior stucco walls was detected at the southwest corner of the home where we expect there to be greatest depth of fill soil.

It is our recommendation that a geotechnical engineer be consulted to perform a soils investigation to provide recommendations to stabilize the existing foundations. It is expected that they will also recommend improving the site drainage condition to reduce the amount of runoff that can be directed beneath the residence. A French Drain system should be constructed along the base of the north ascending slope to collect subsurface runoff. This French Drain should have a minimum 5 foot depth and should contain a 6 inch diameter perforated drain line covered in clean gravel and wrapped with a Mirafi filter fabric.

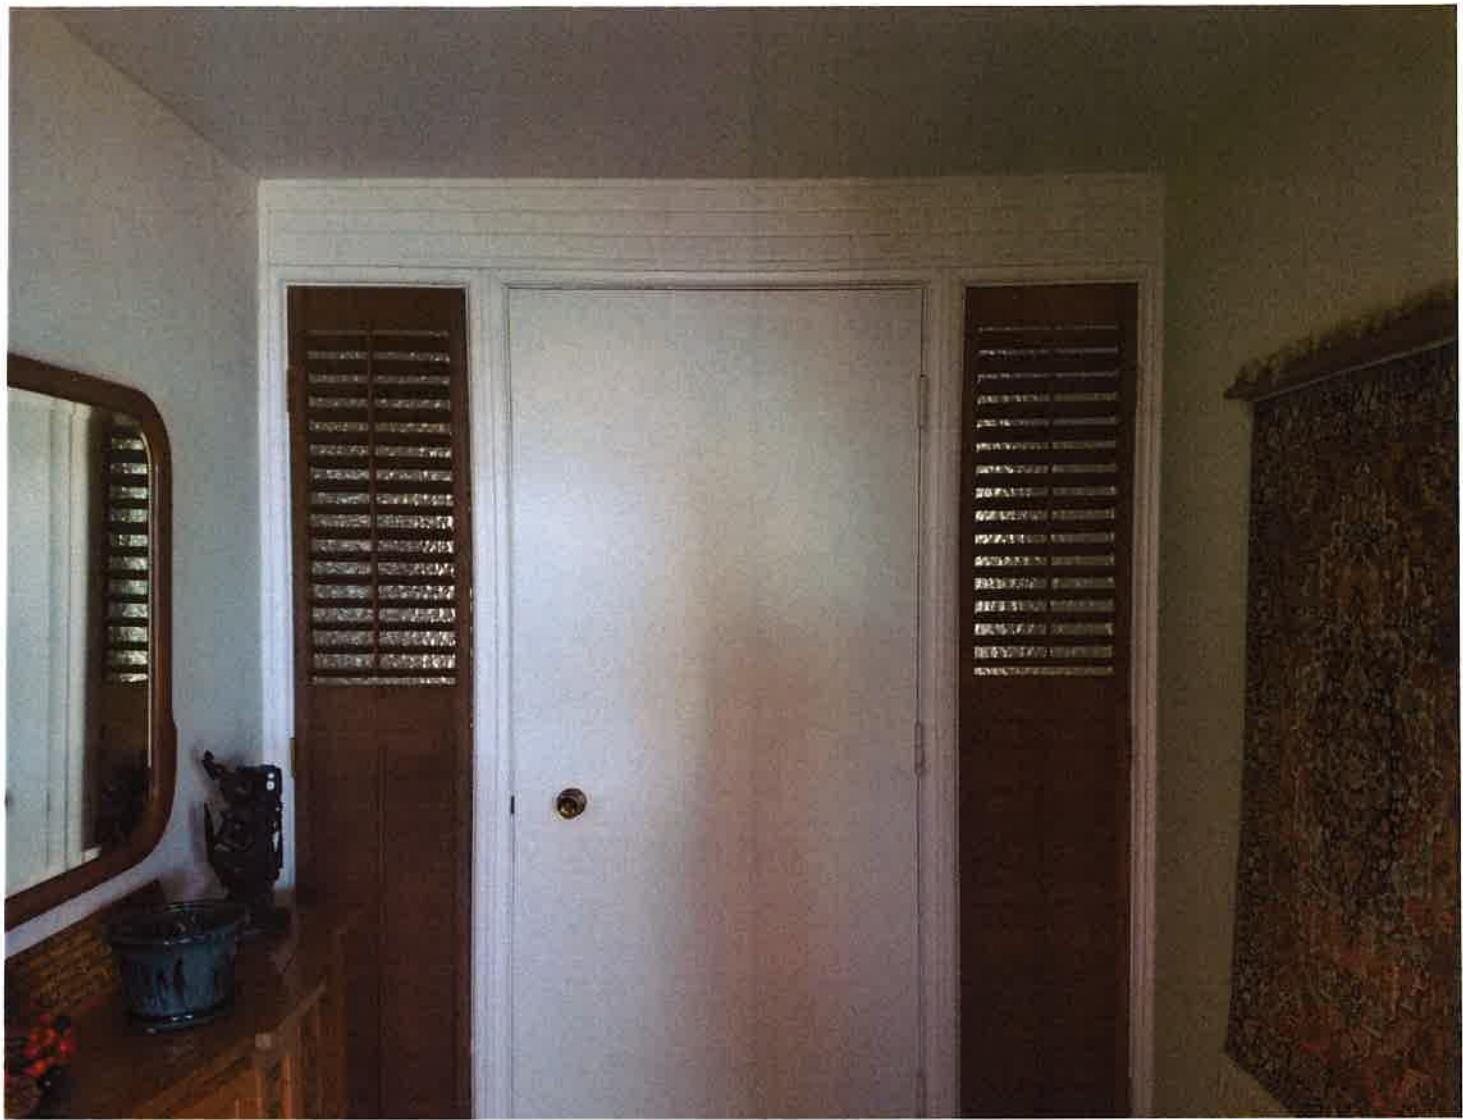
36

We entered the home through the attached garage as shown on Photograph 33 since we were informed that the front doors are not operating properly as depicted on Photograph 36.

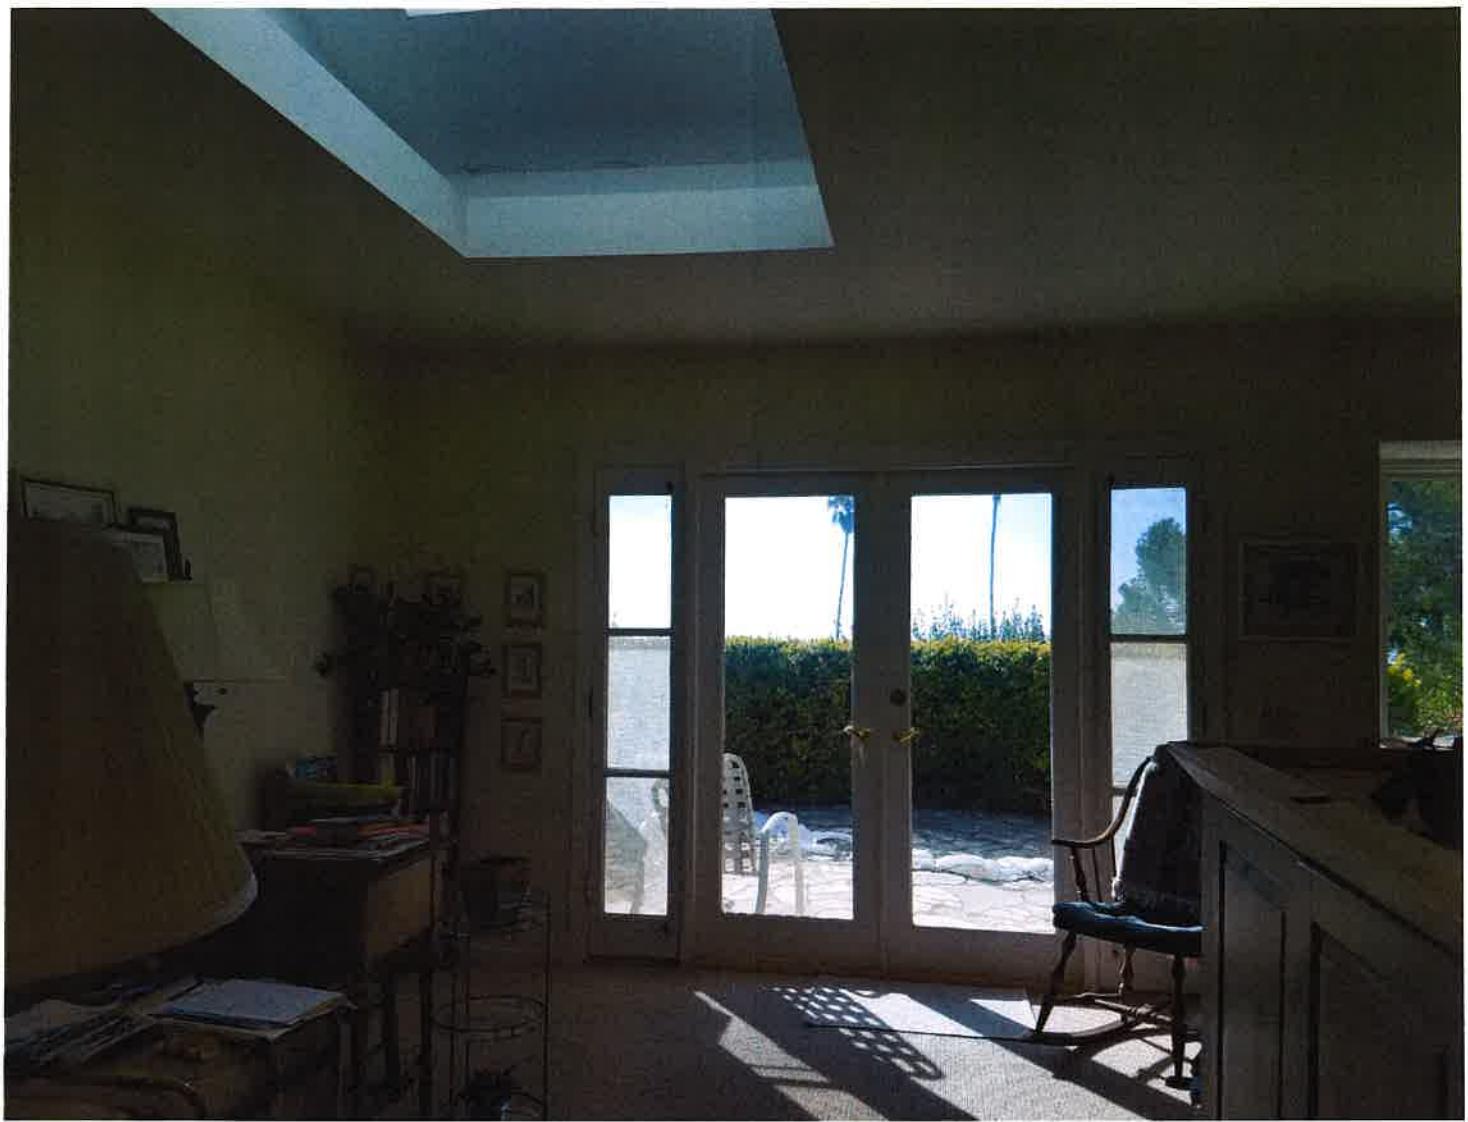
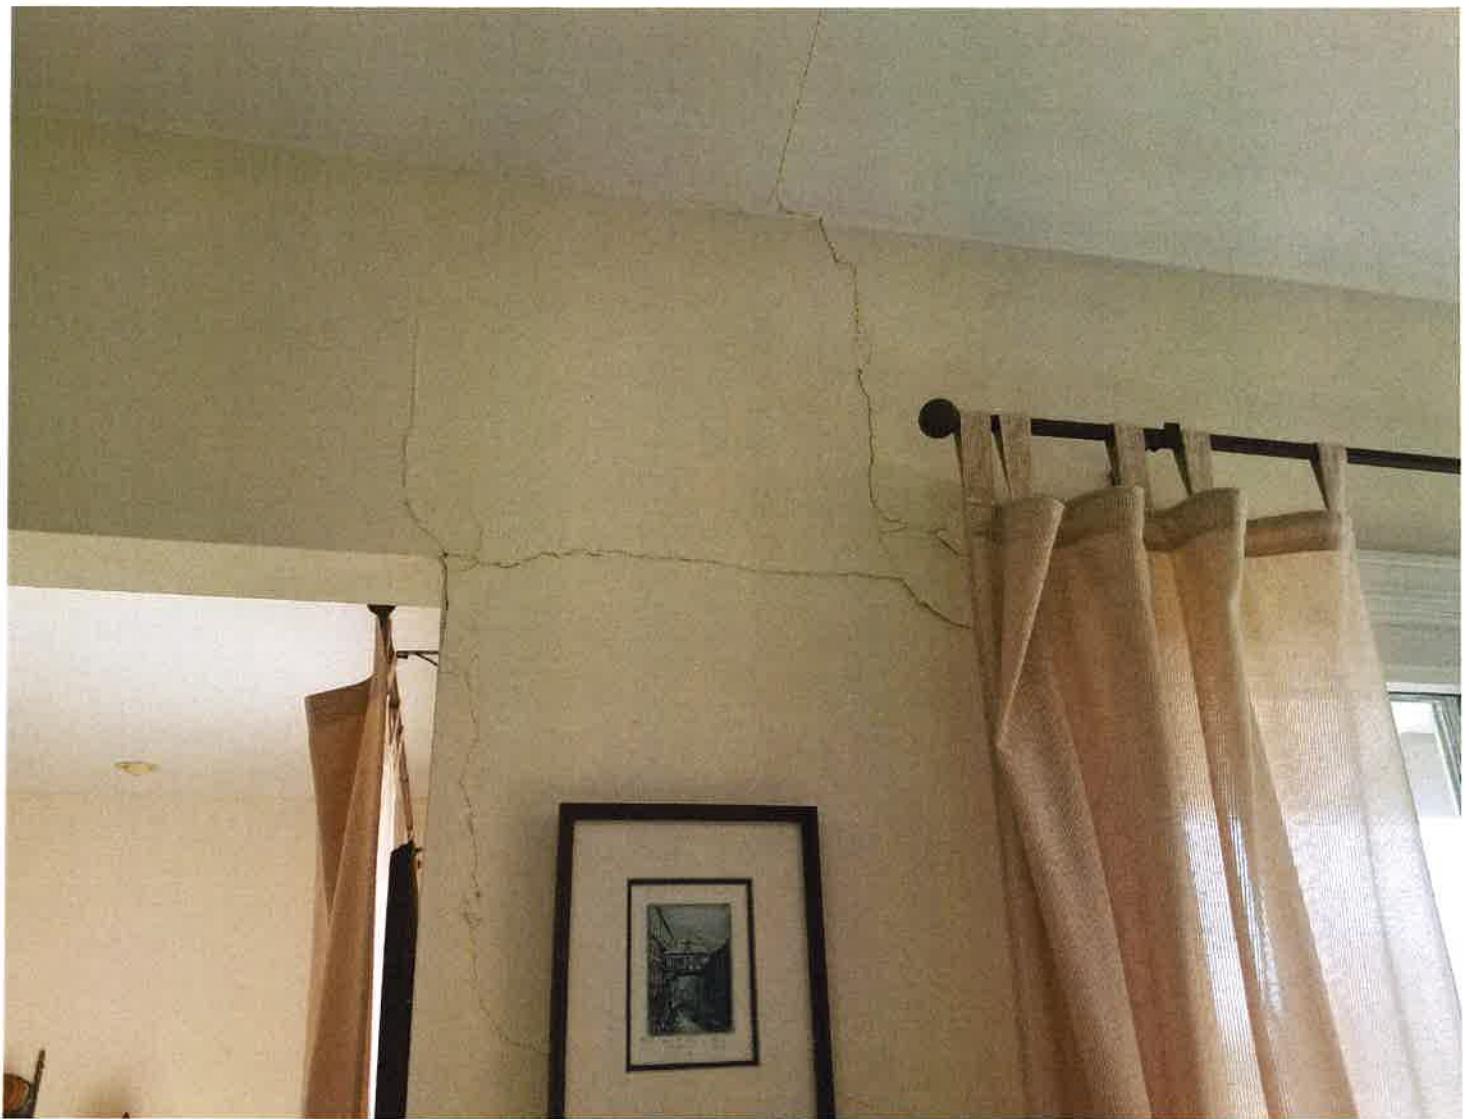
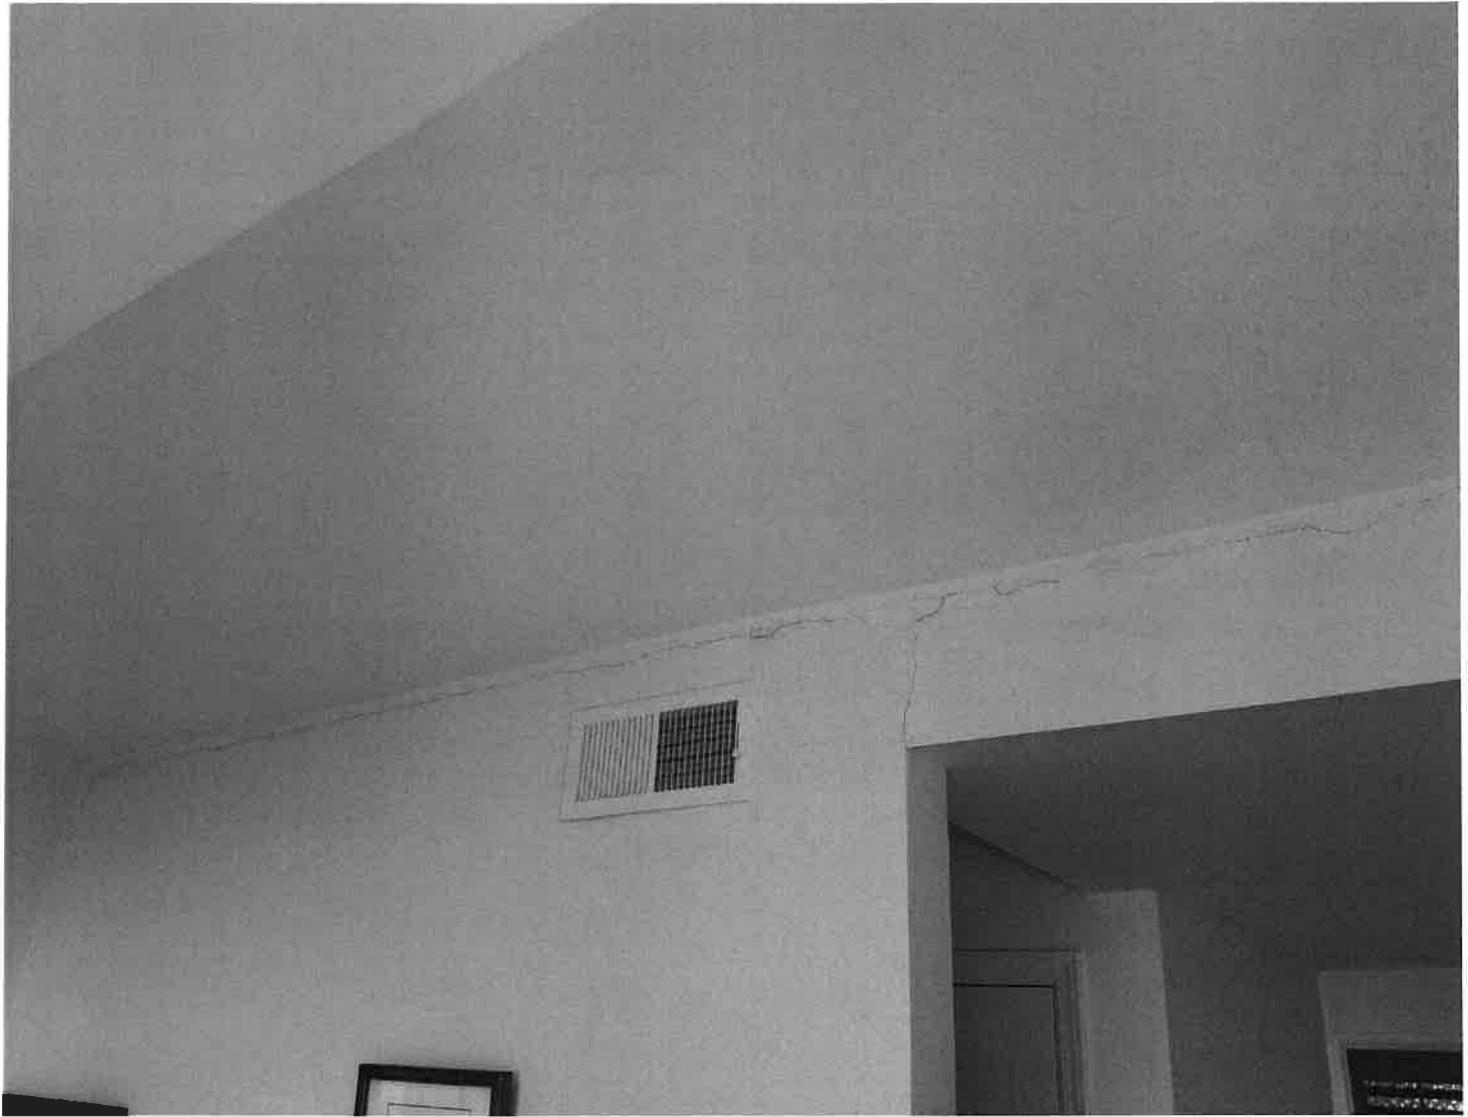
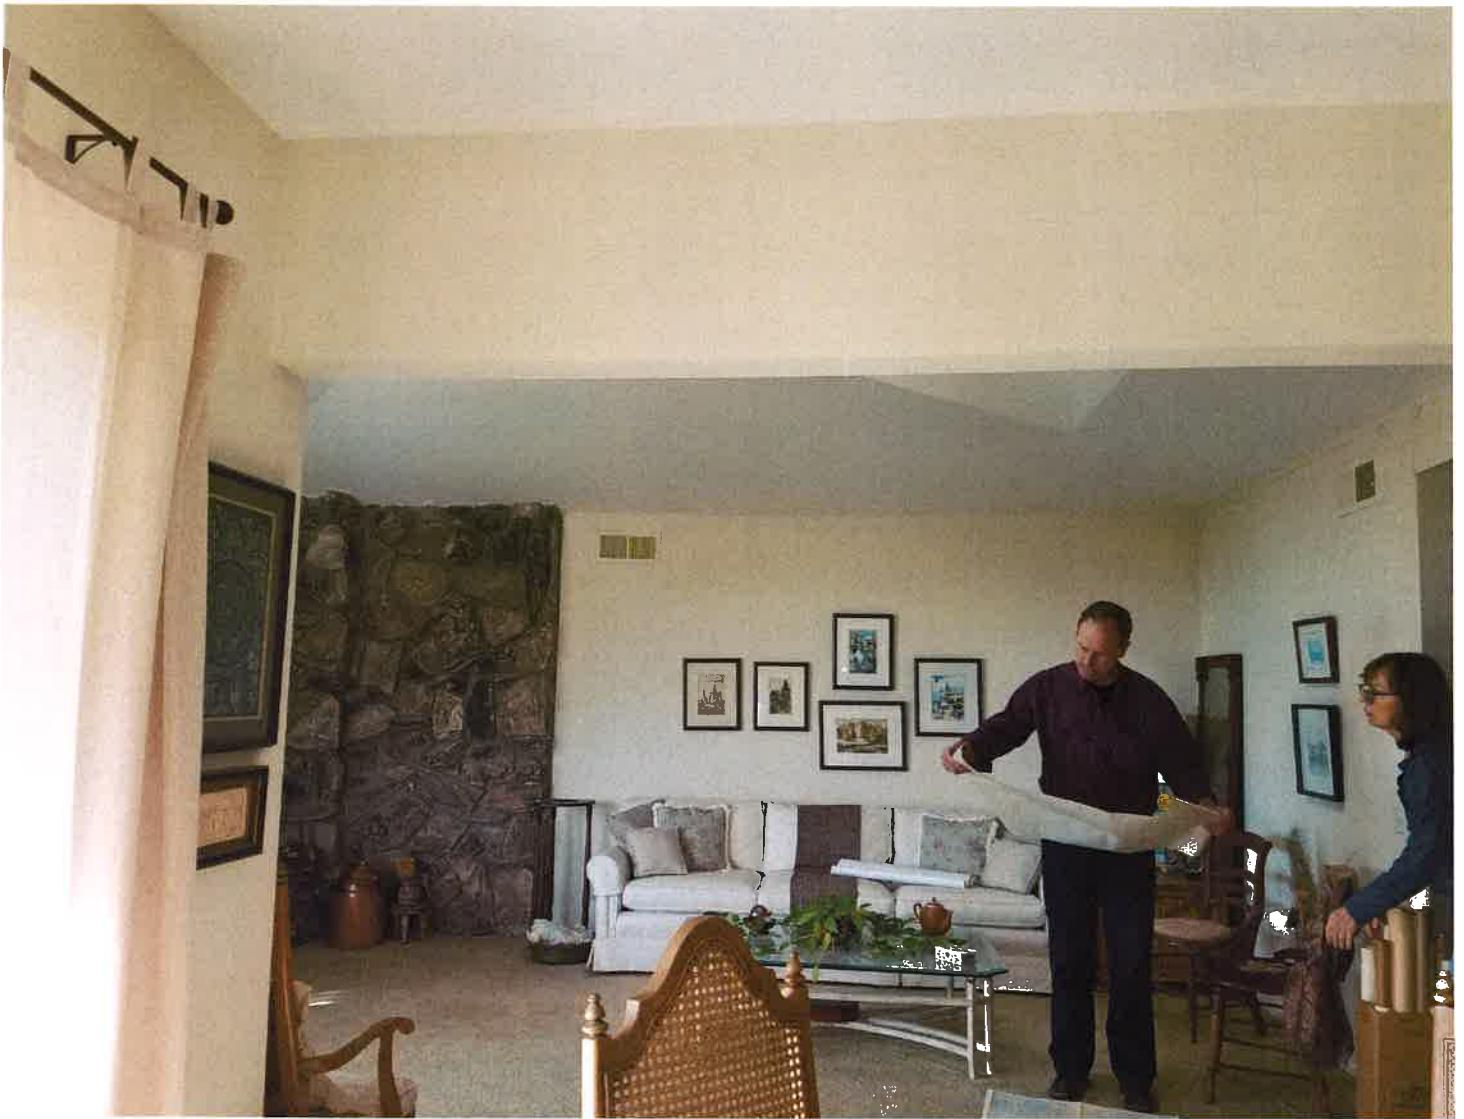
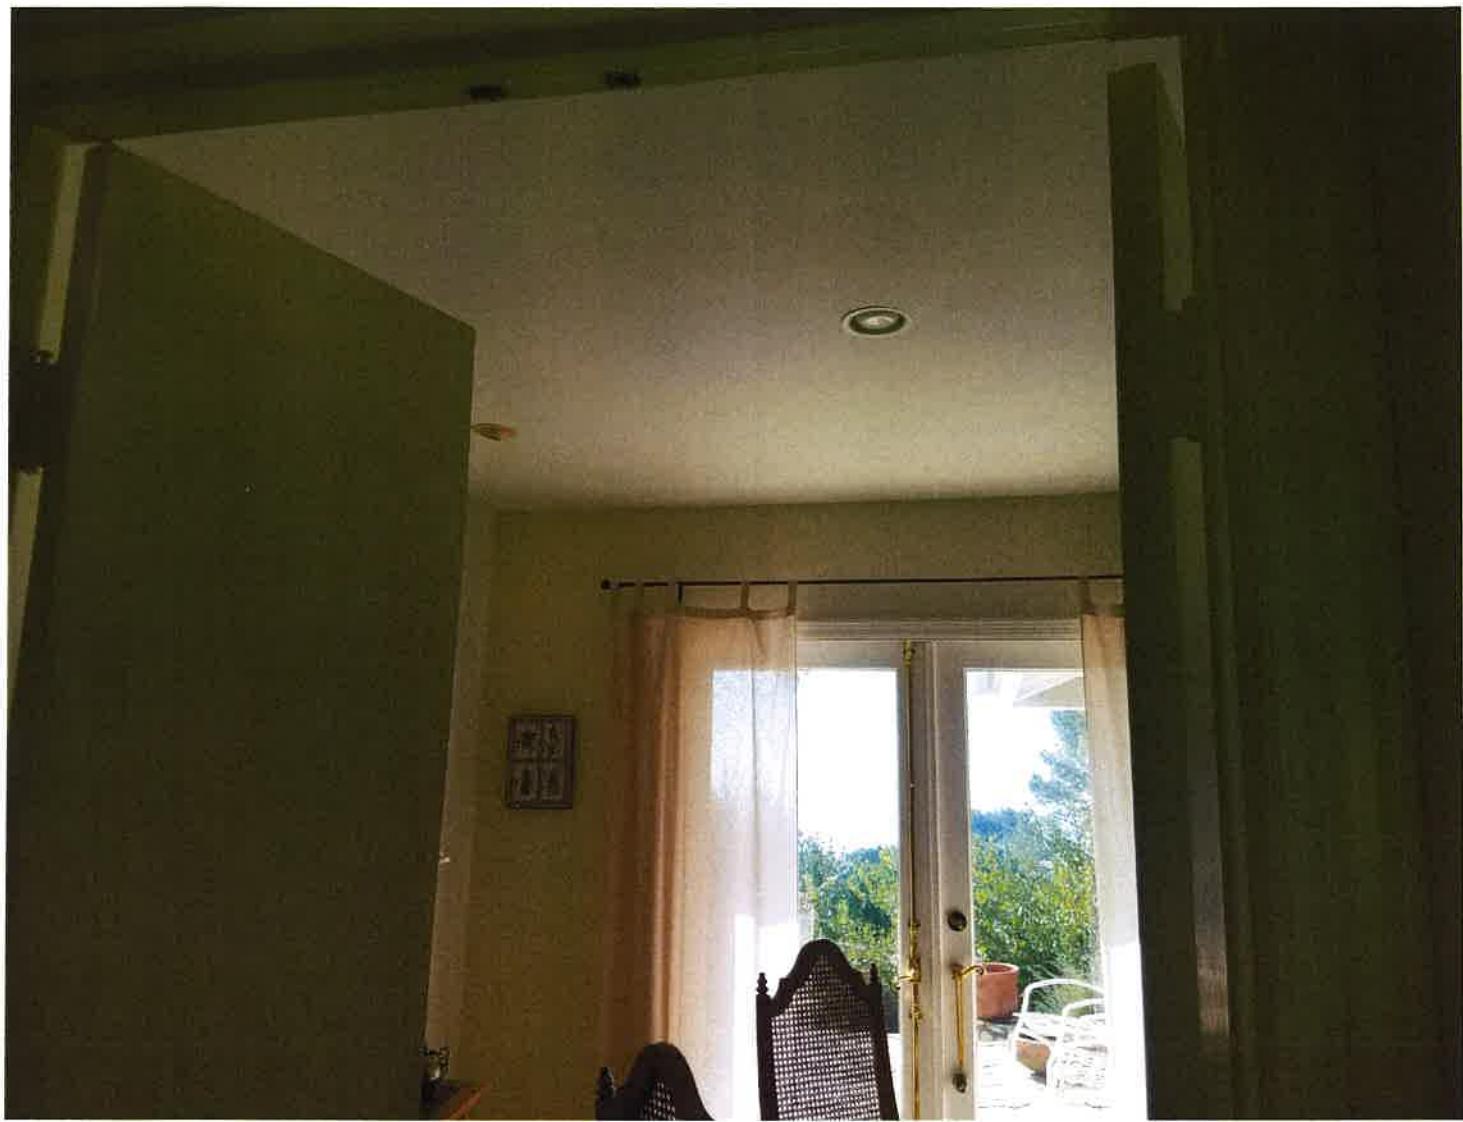
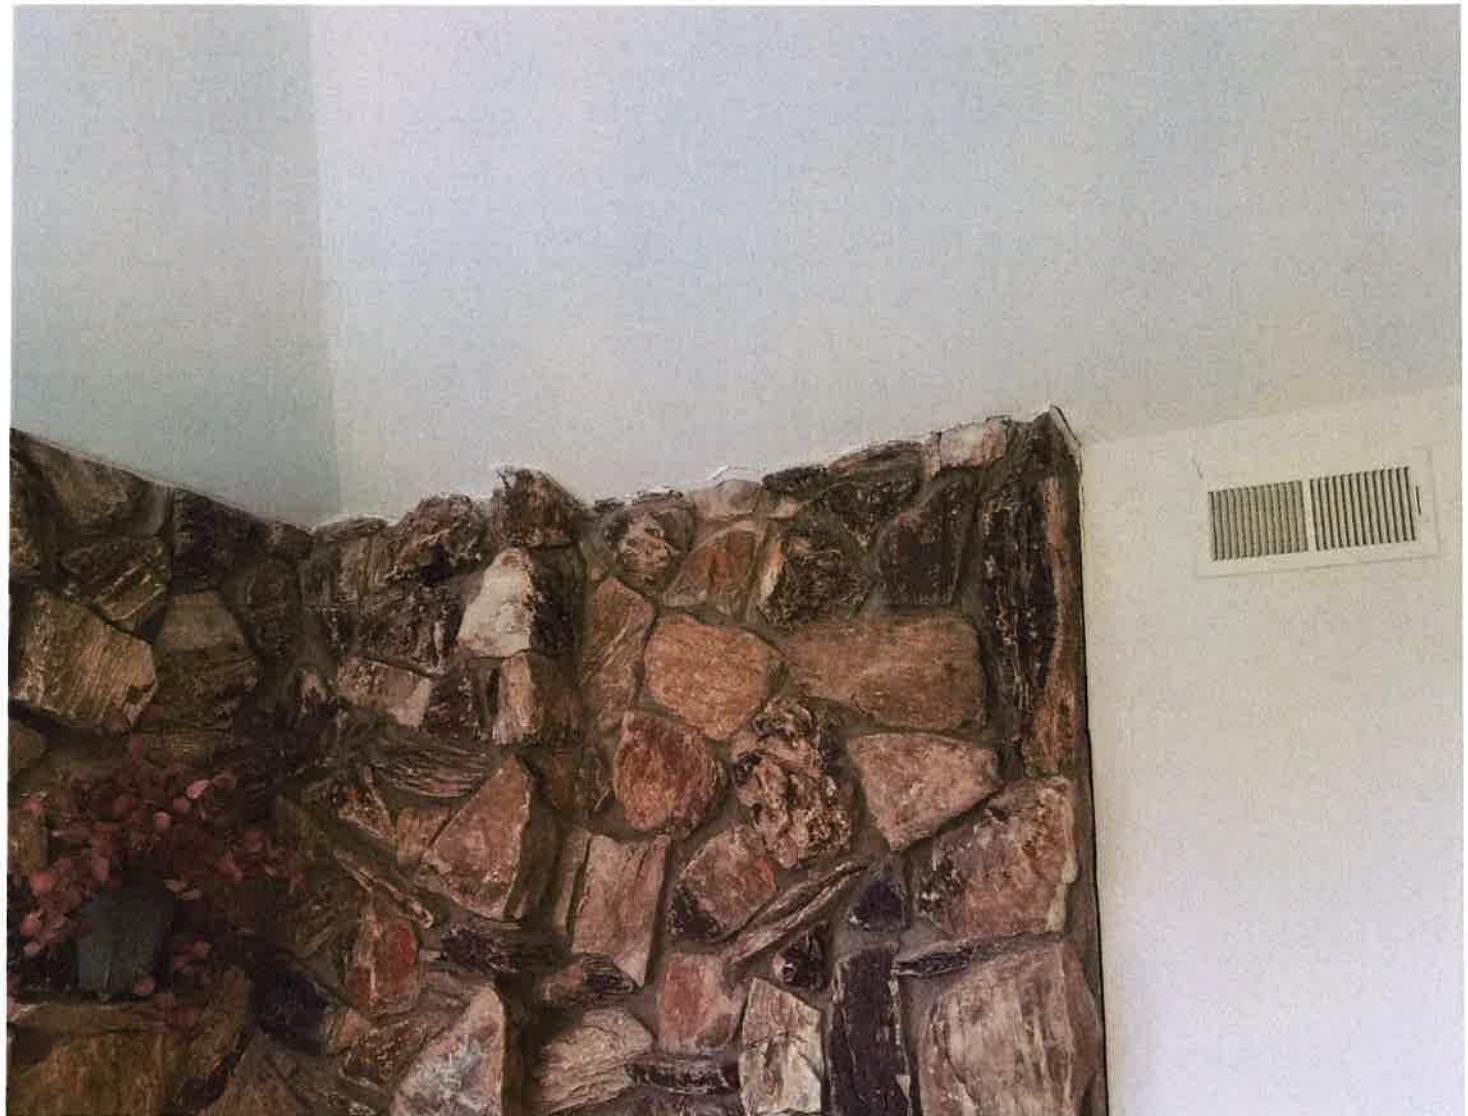
The interior floor surfaces in the family room, dining room and living room felt noticeably tilted downward toward the south exterior walls and we observed numerous interior cracks in these rooms as shown on Photographs 37 – 43.
