F.N. 1-20-0013

Subject: STRUCTURAL EVALUATION OF SINGLE FAMILY RESIDENCE
6347 Tarragon Road, Rancho Palos Verdes, CA 90275

PALOS VERDES ENGINEERING CORPORATION

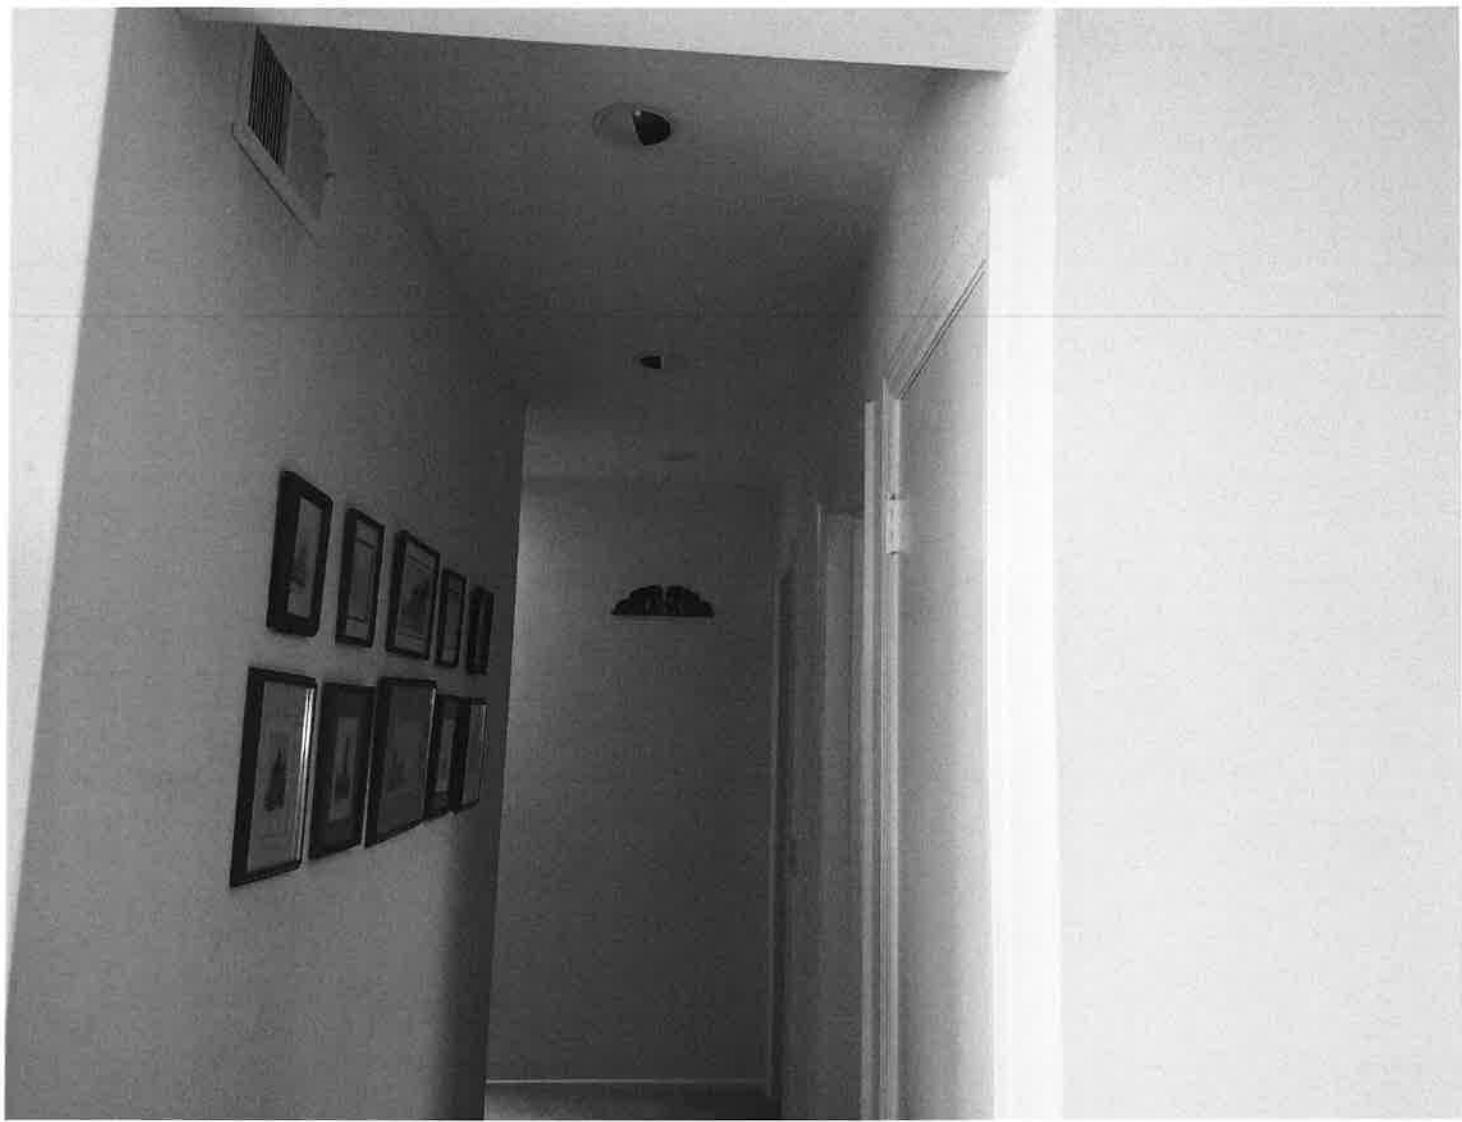
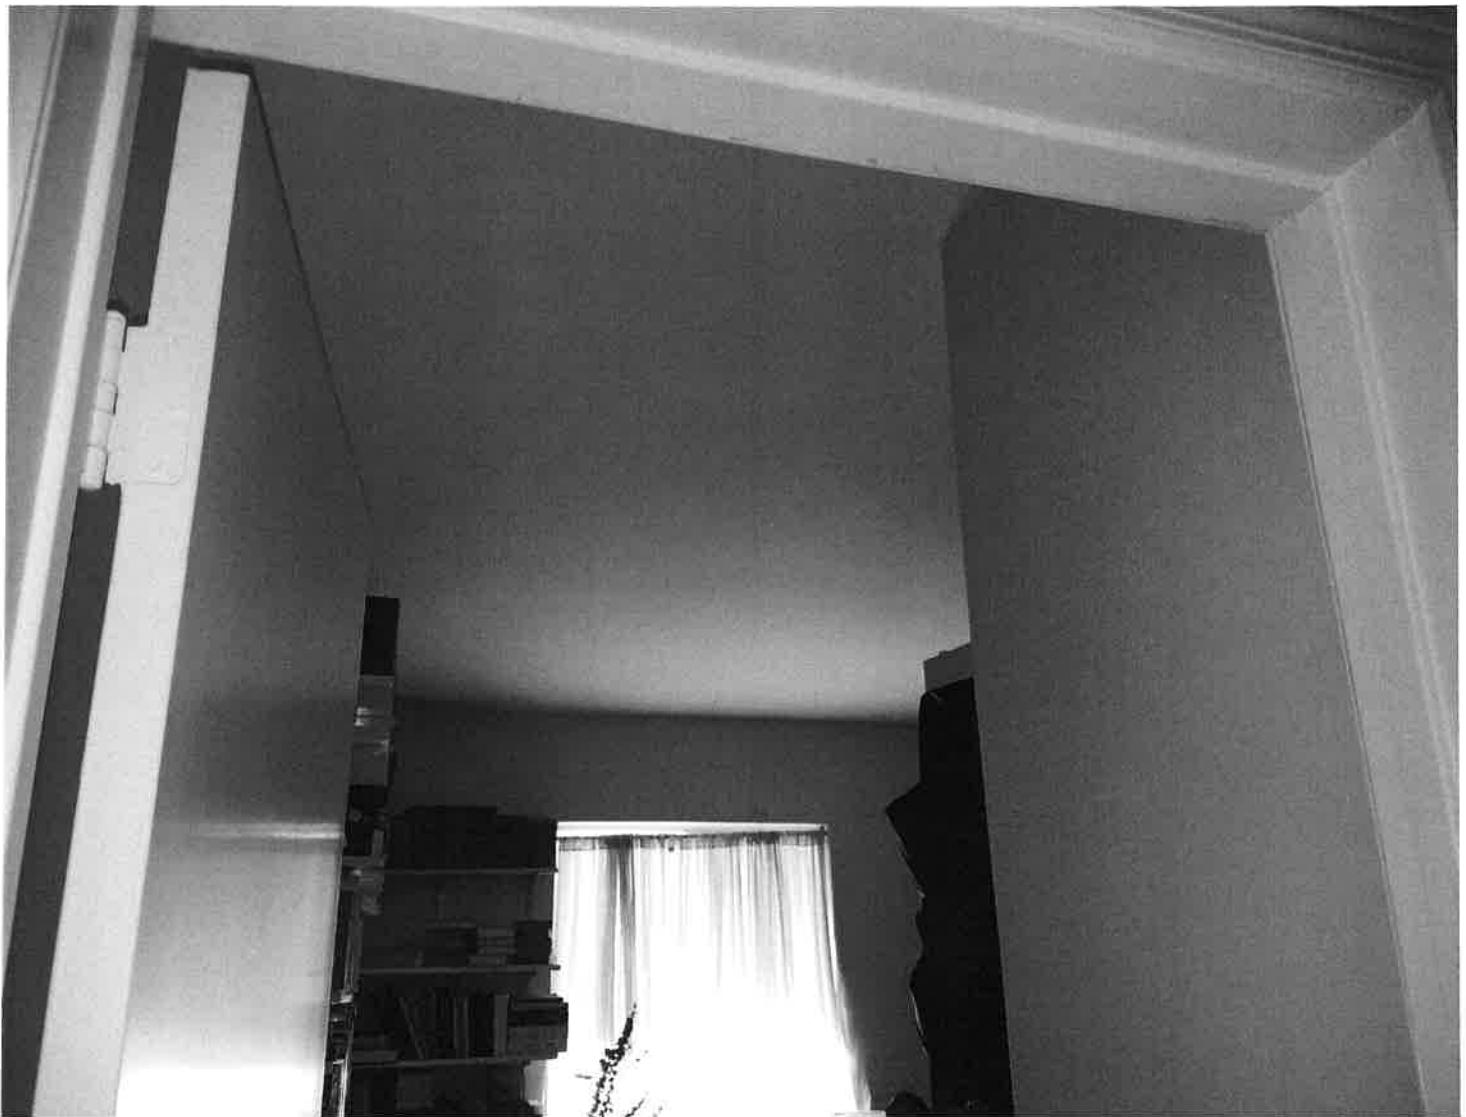
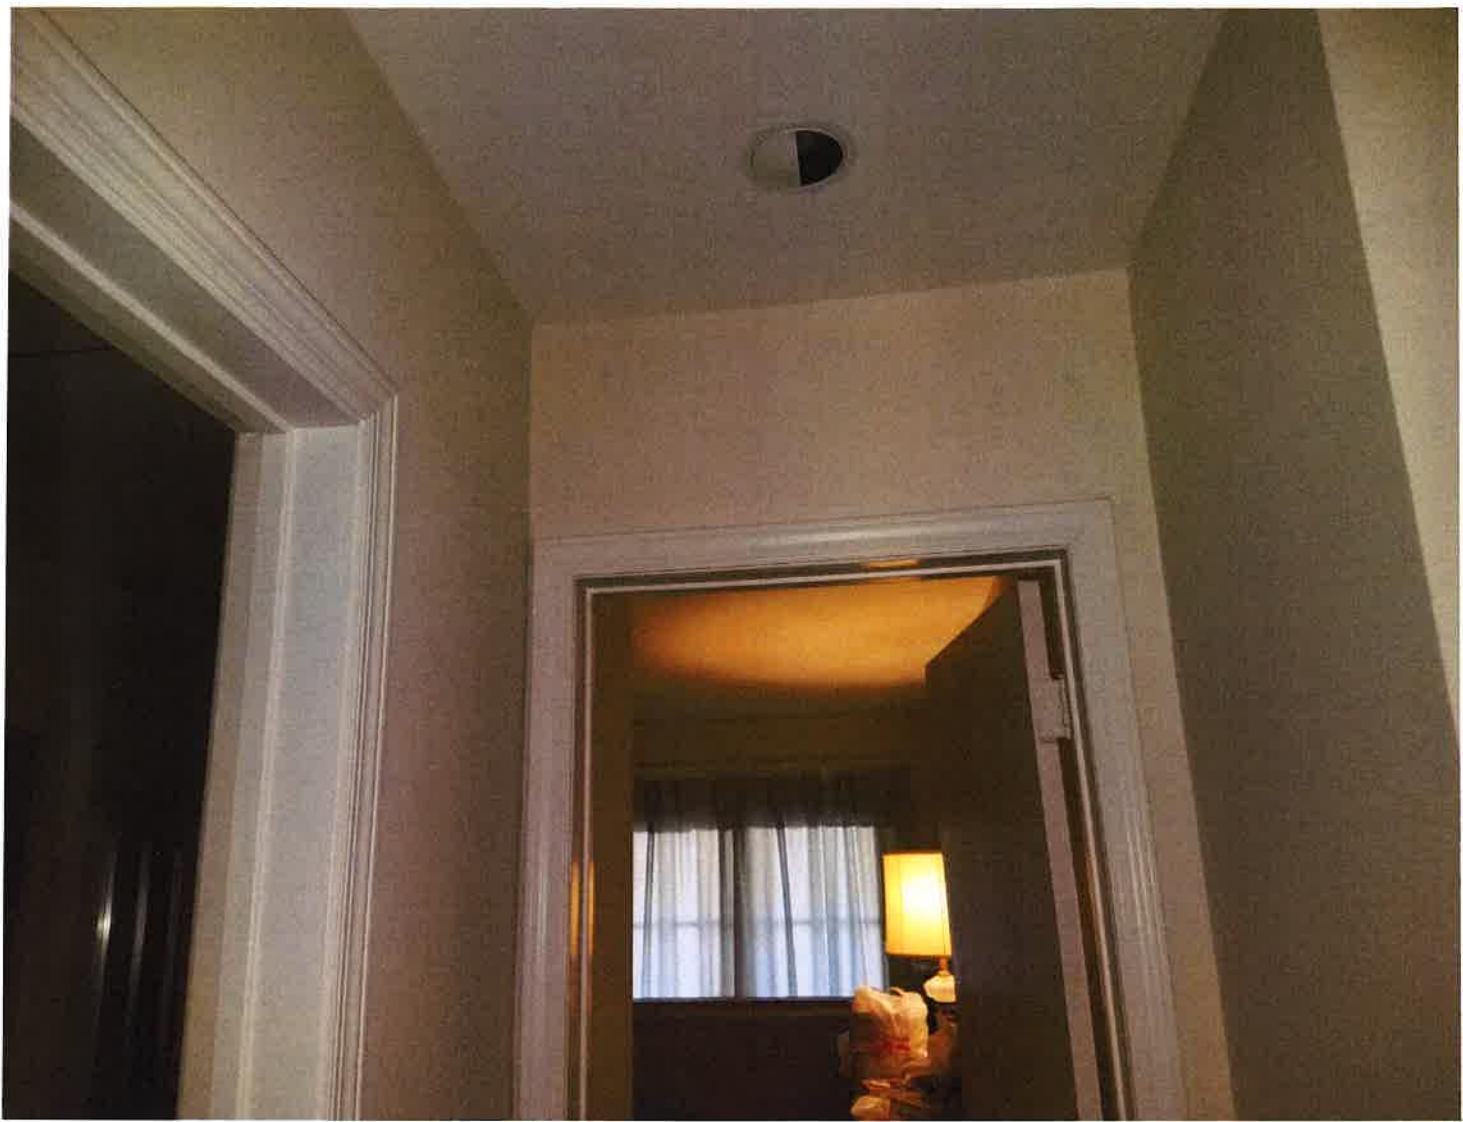
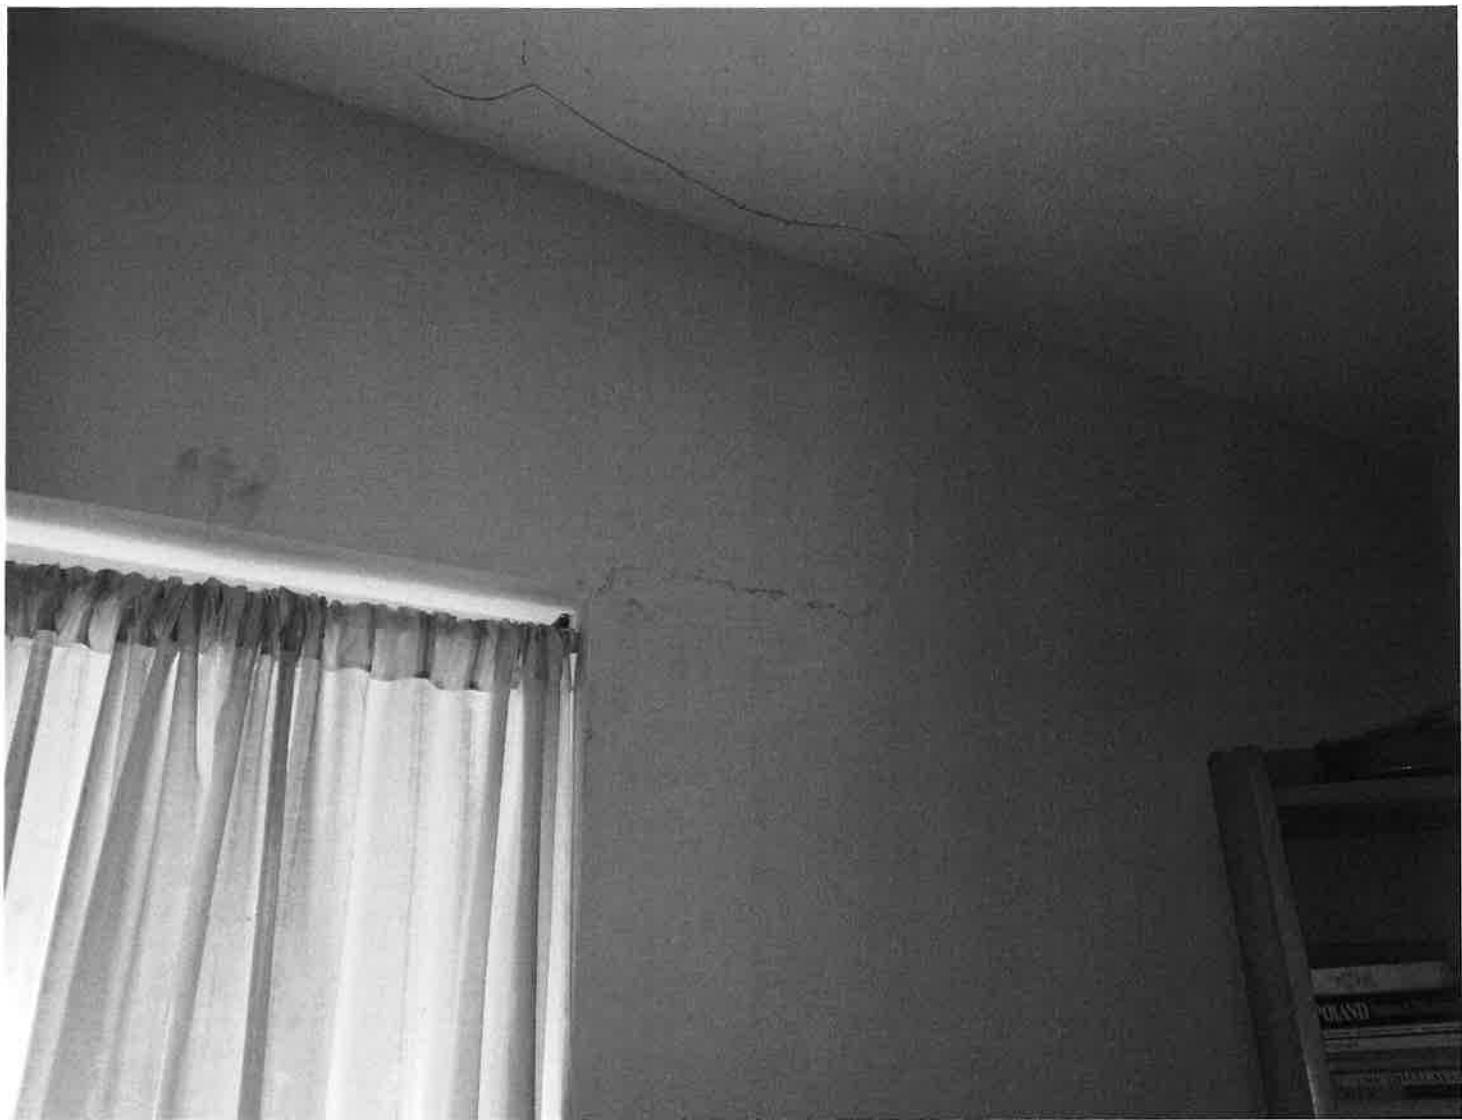
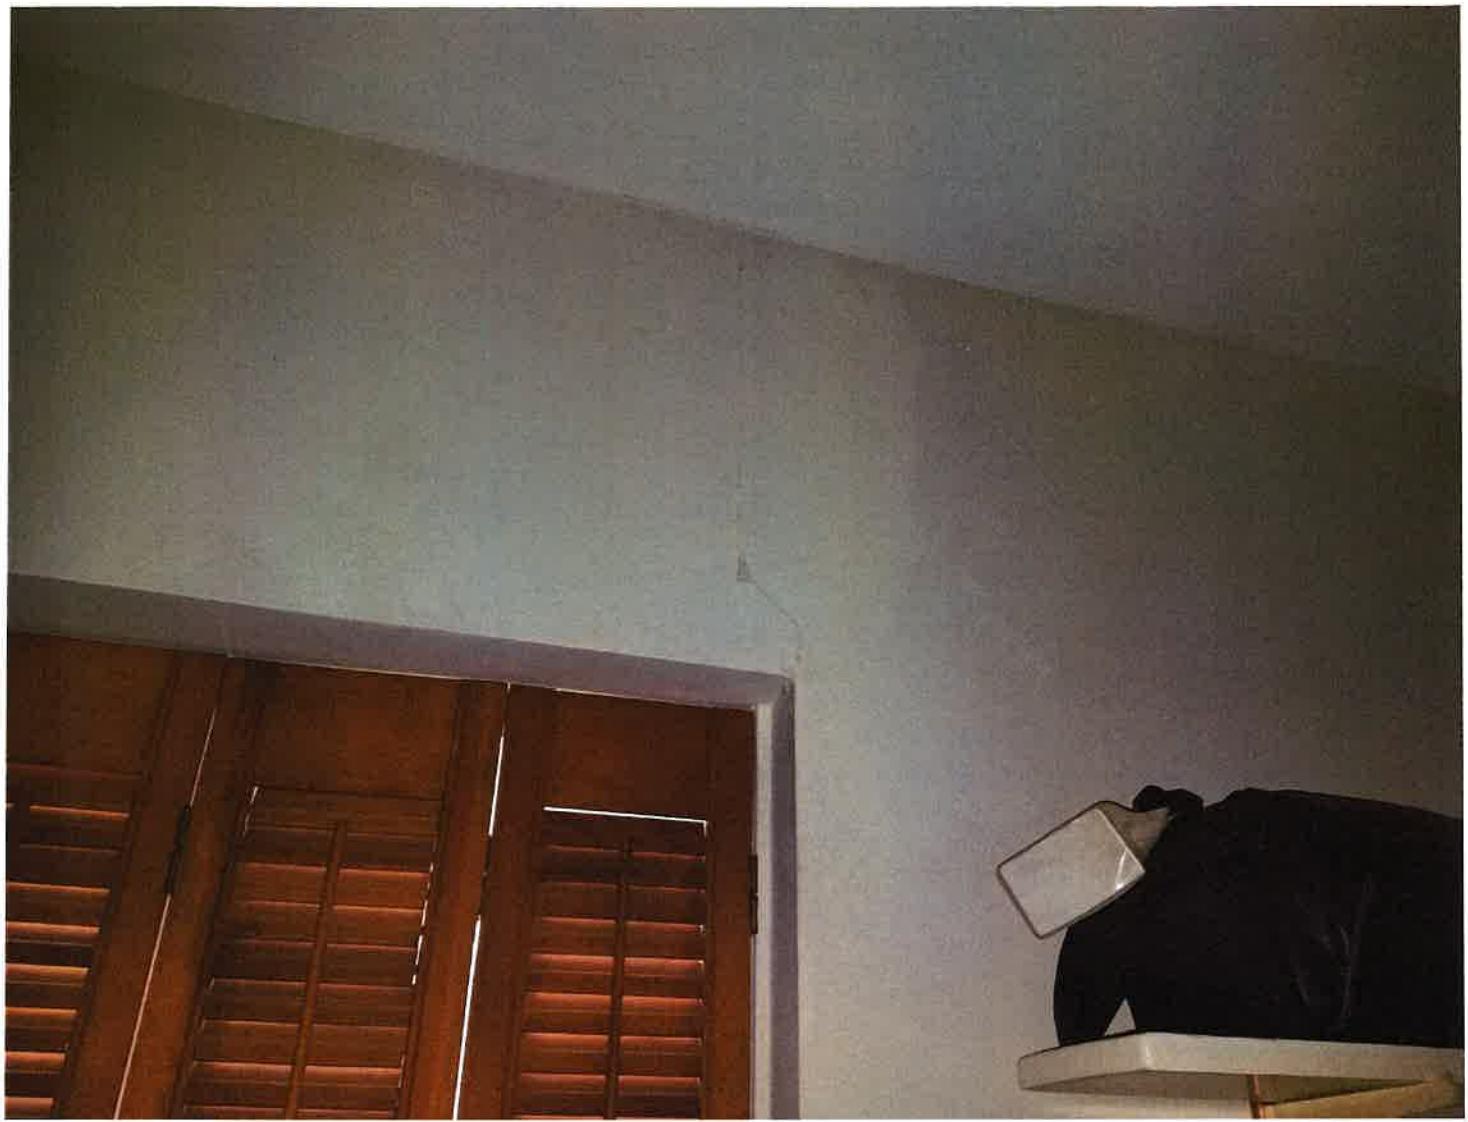
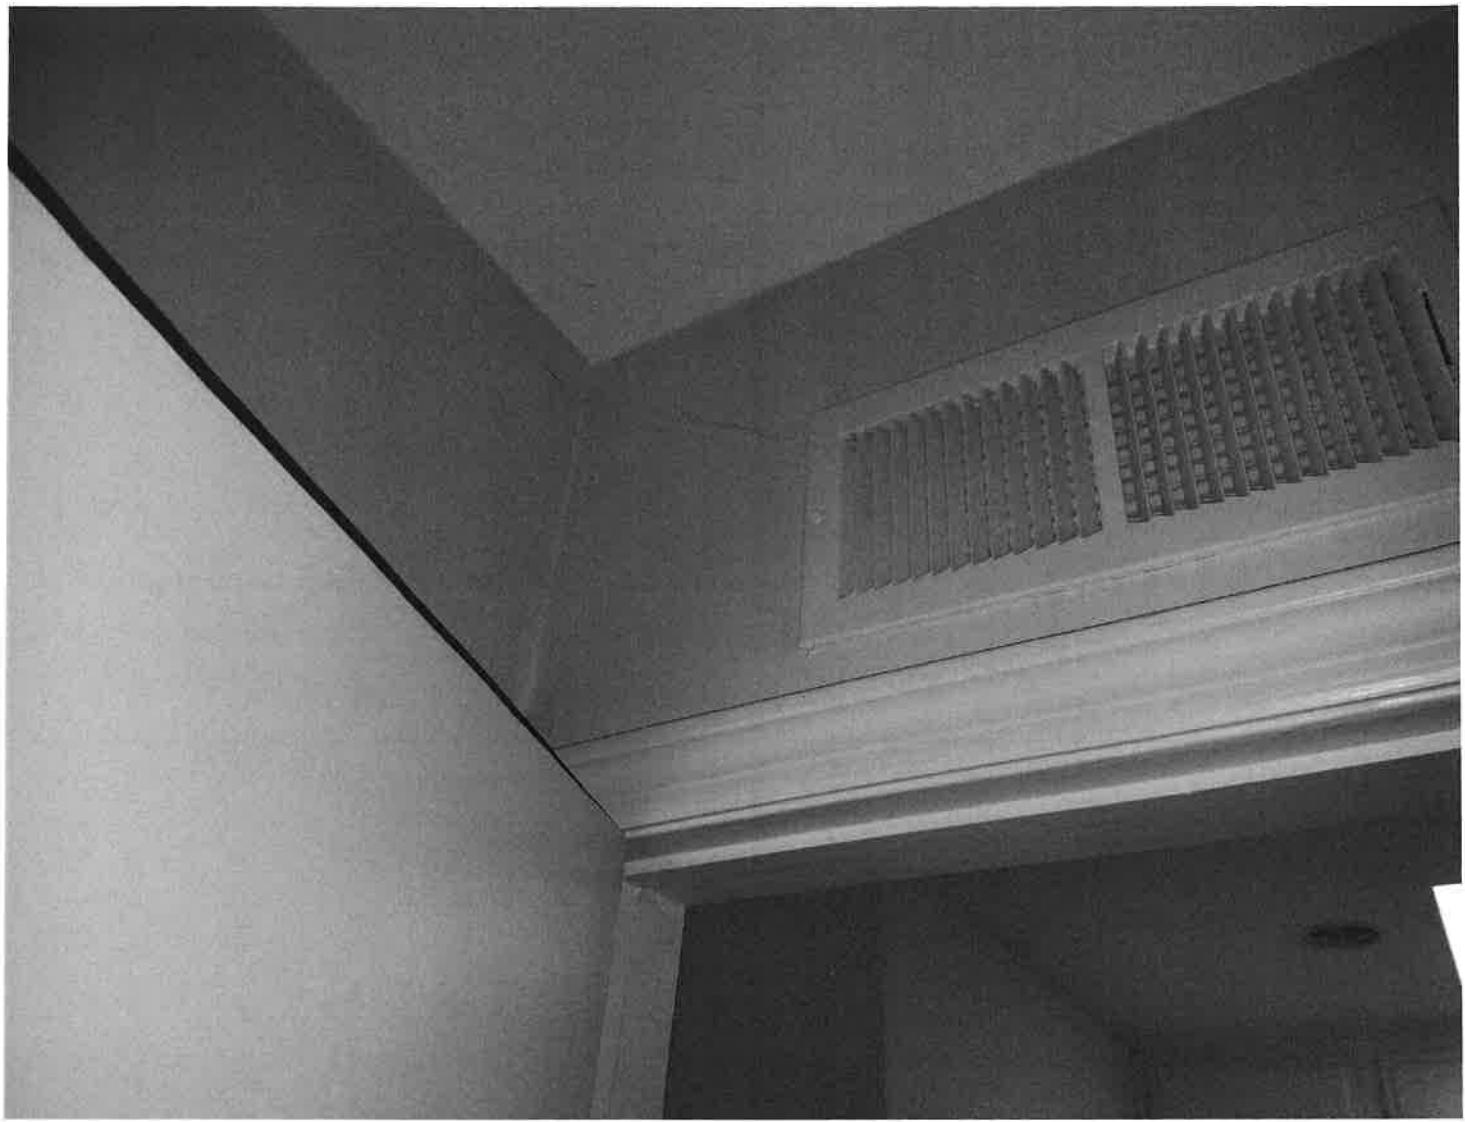
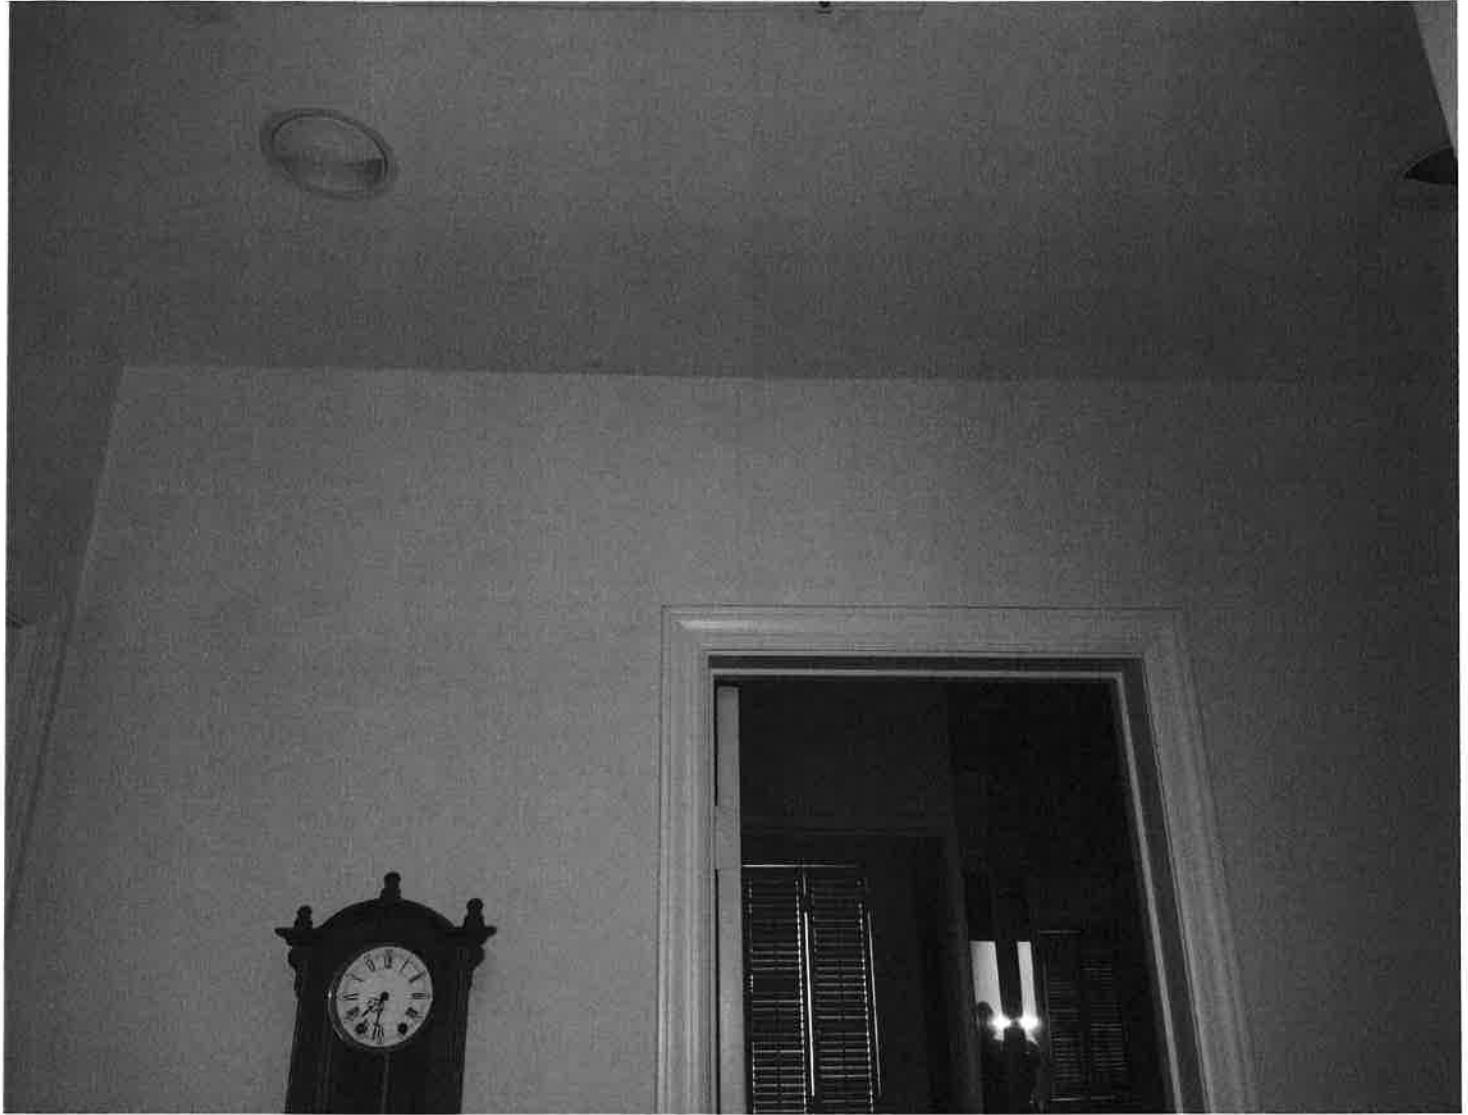
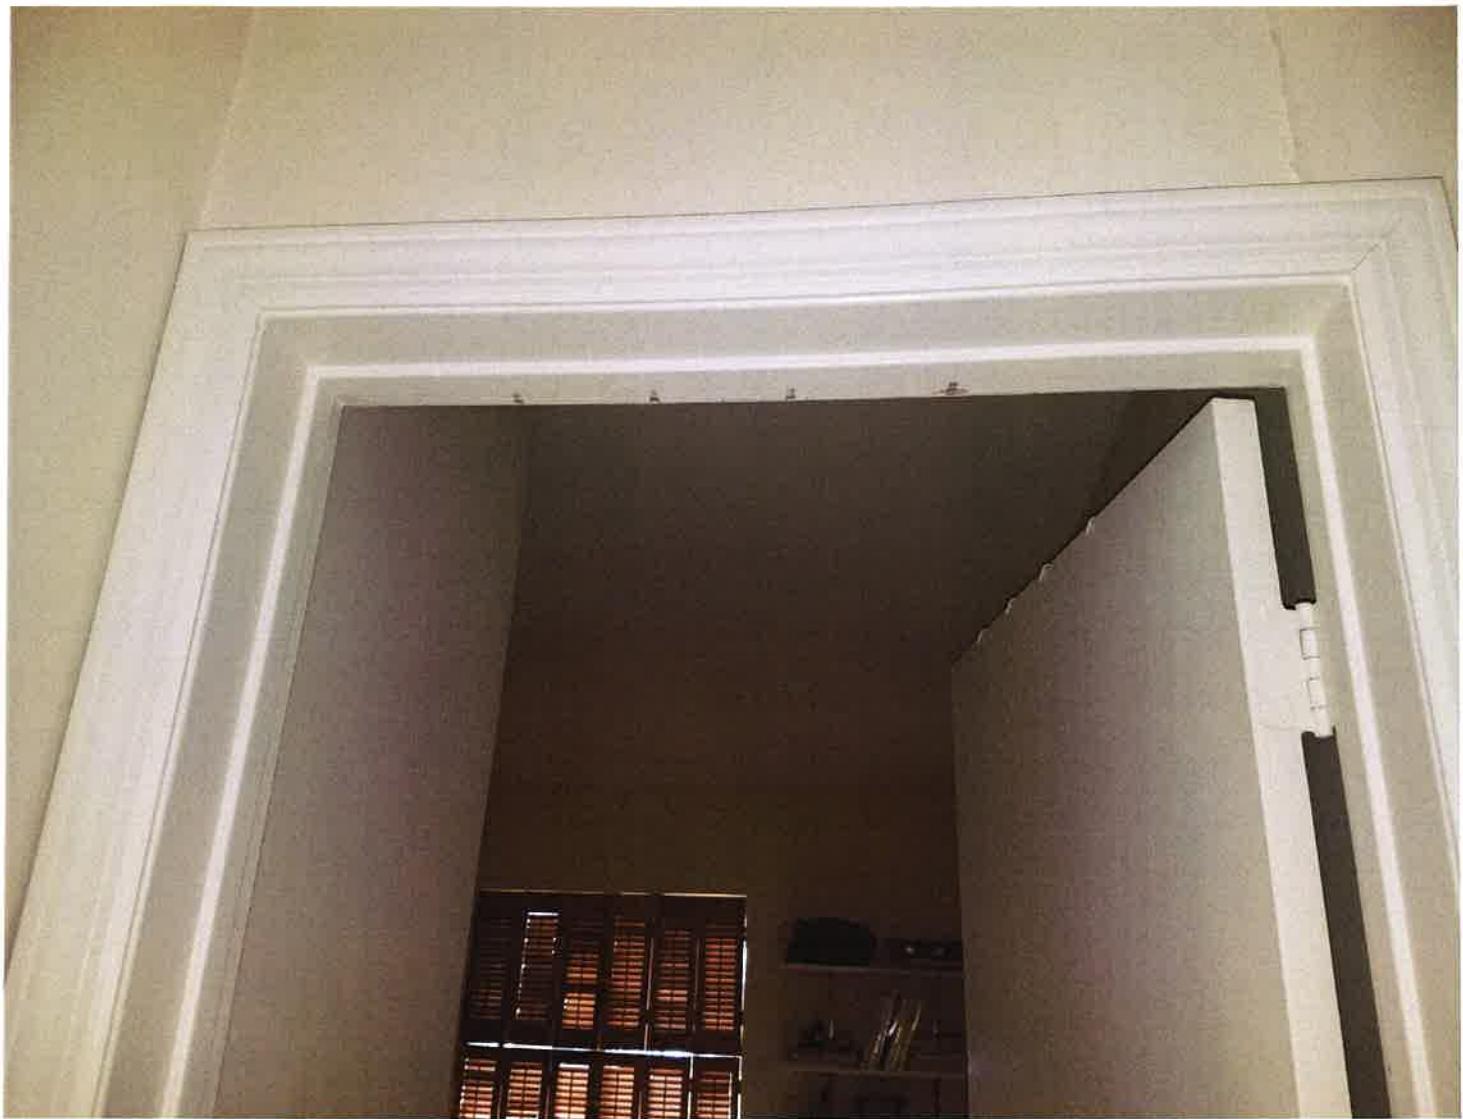
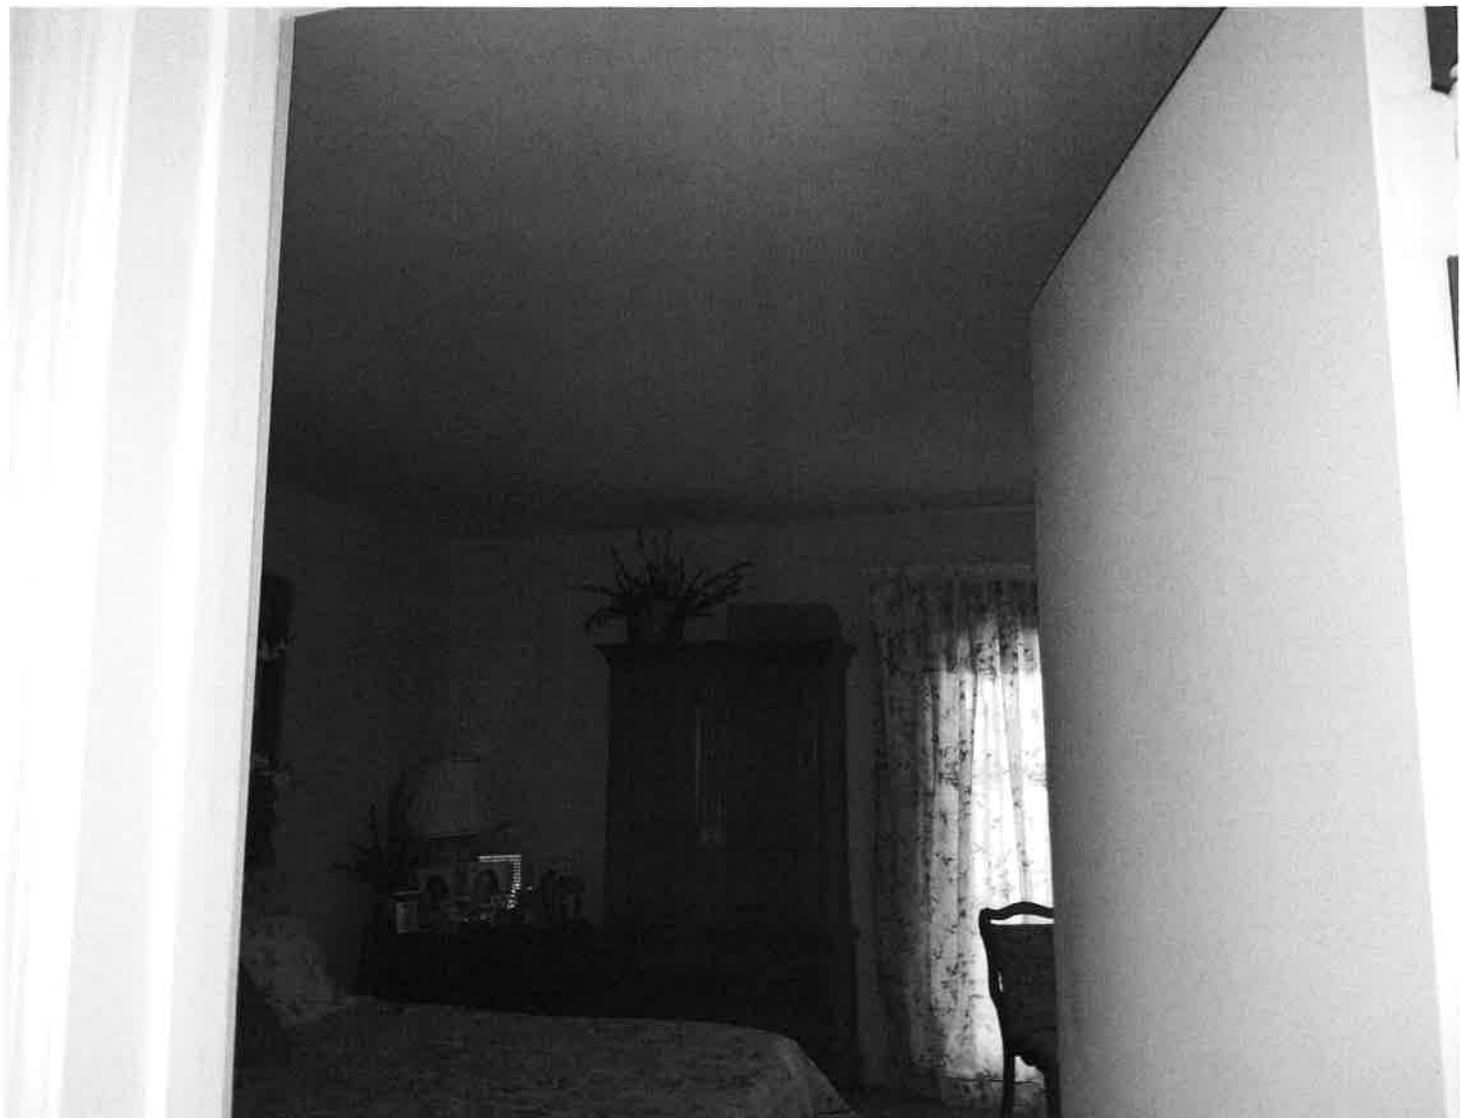
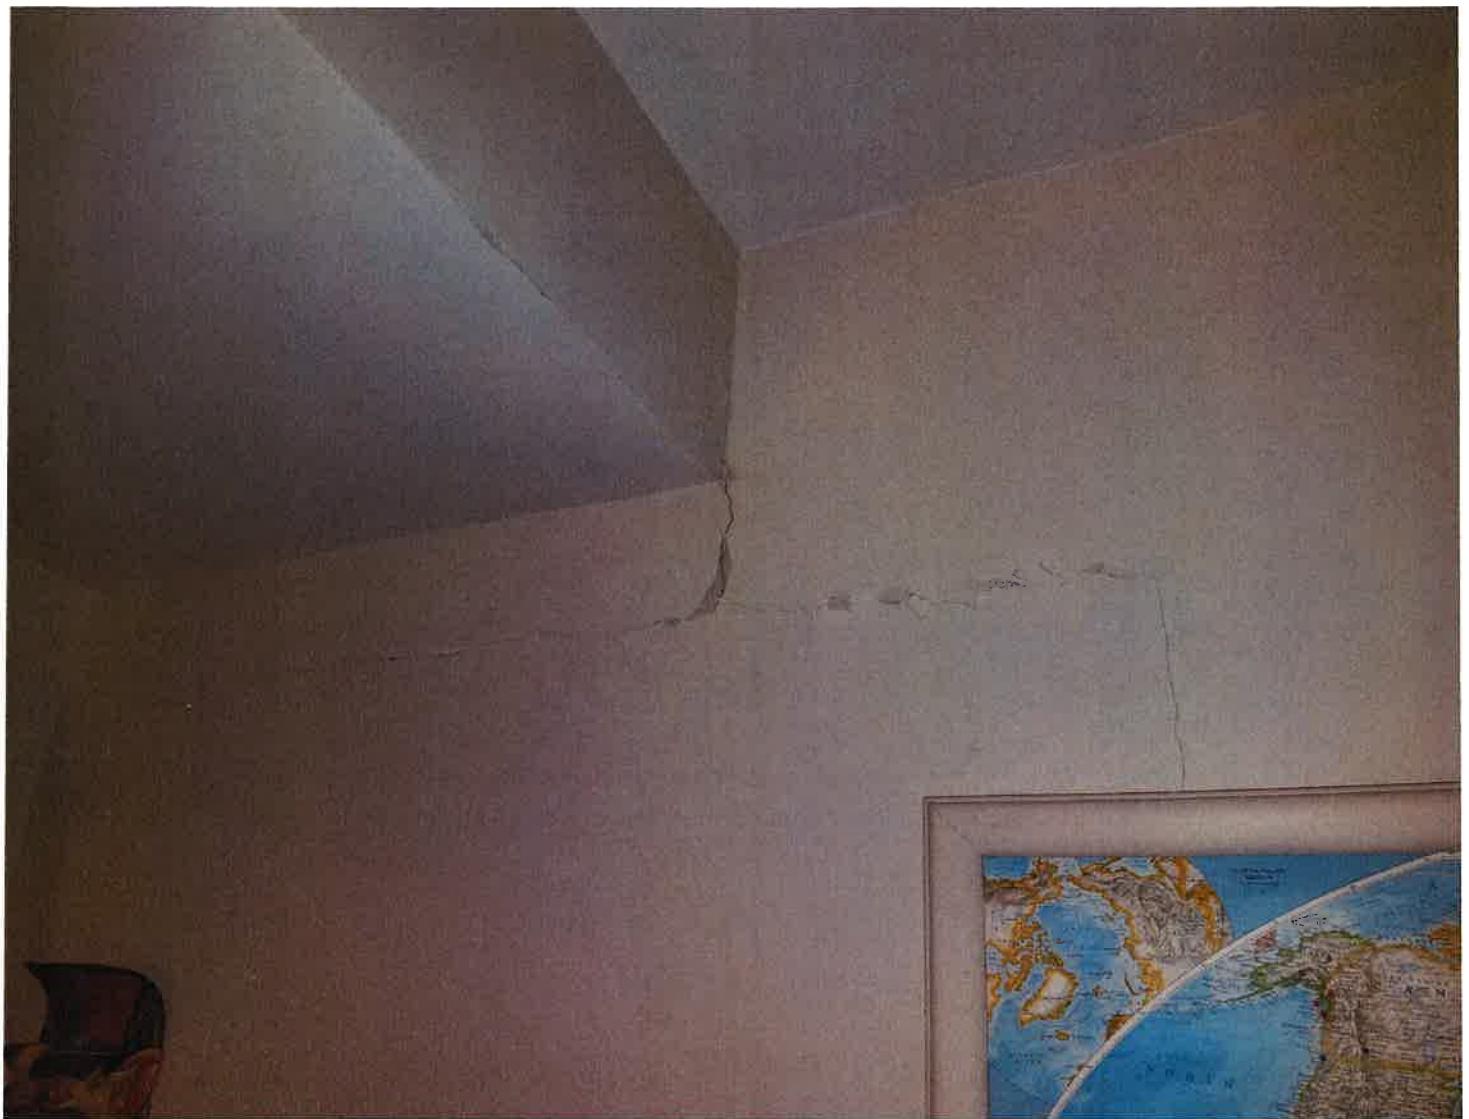
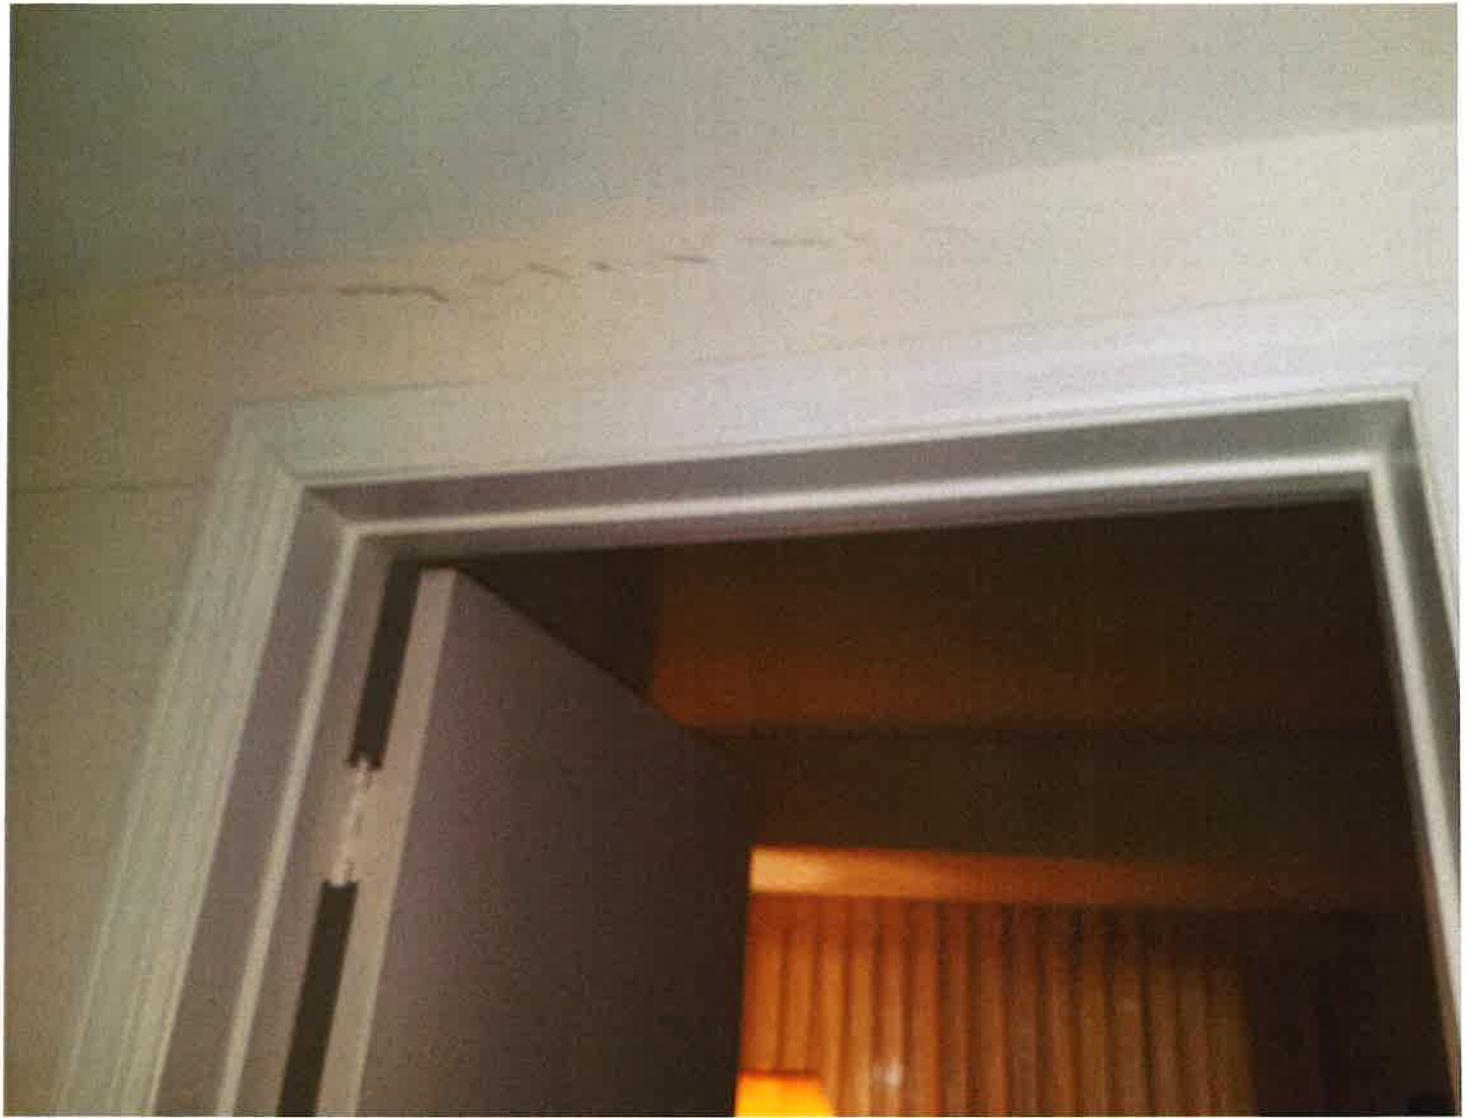
Similar unlevel floor surfaces and interior wall cracks were detected in the bedrooms and bathrooms located at the west end of the home as shown on Photographs 44 – 56.
