F.N. 1-20-0013

Subject: STRUCTURAL EVALUATION OF SINGLE FAMILY RESIDENCE
6347 Tarragon Road, Rancho Palos Verdes, CA 90275

PALOS VERDES ENGINEERING CORPORATION

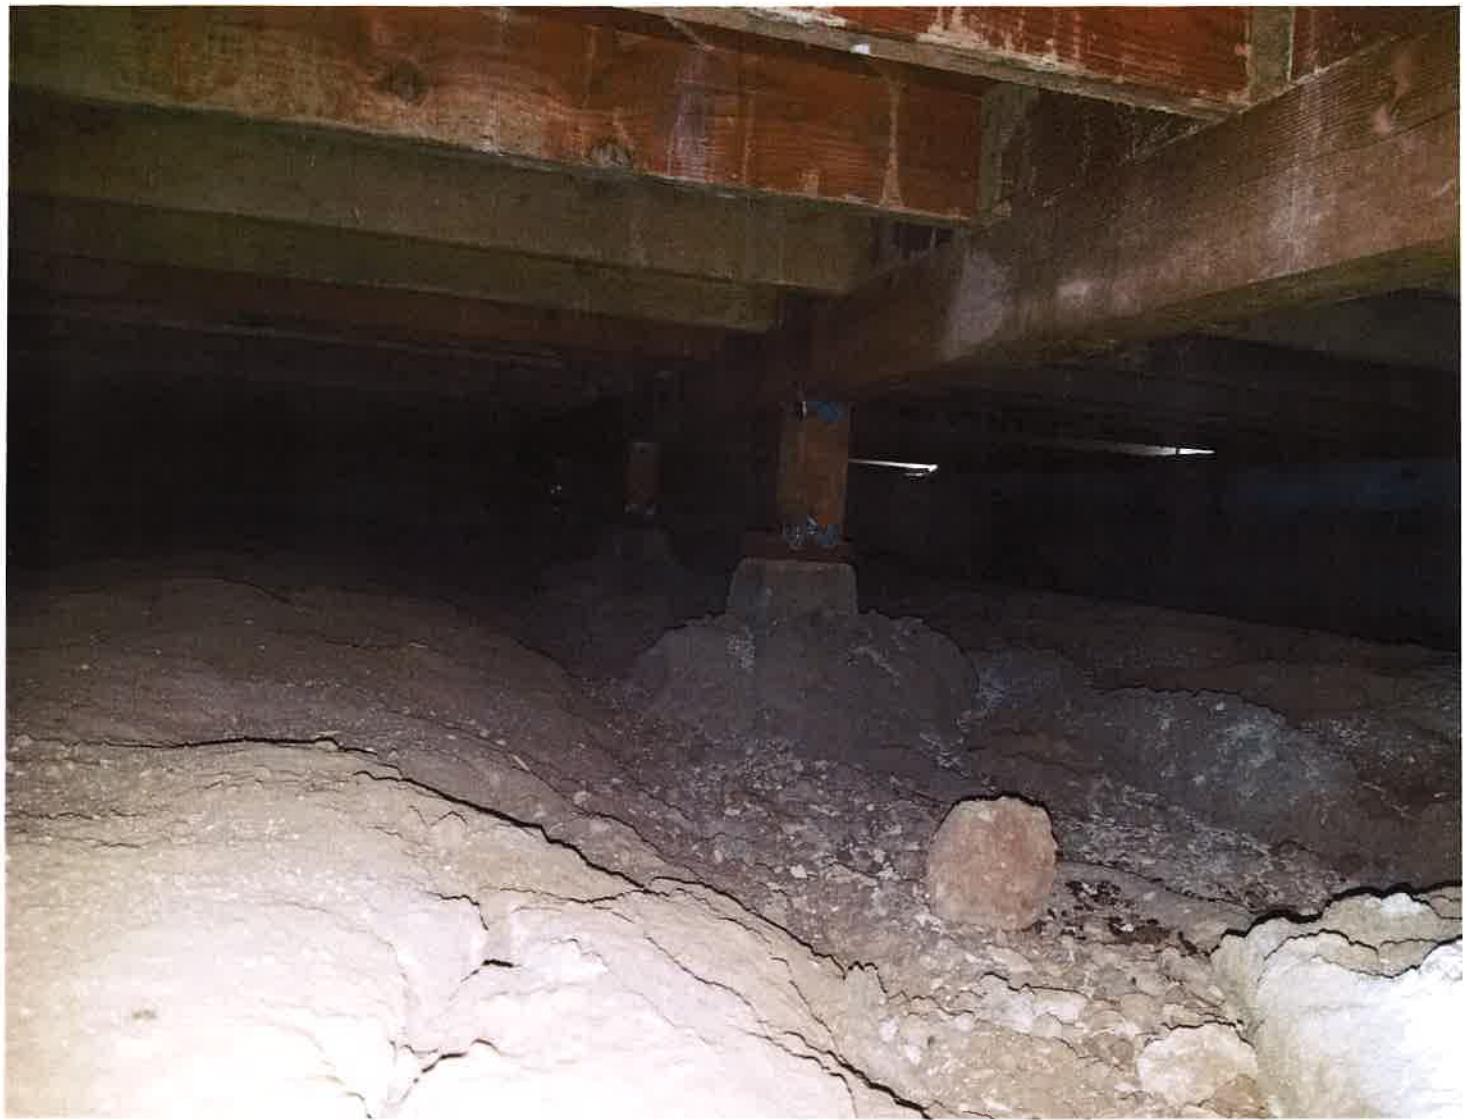
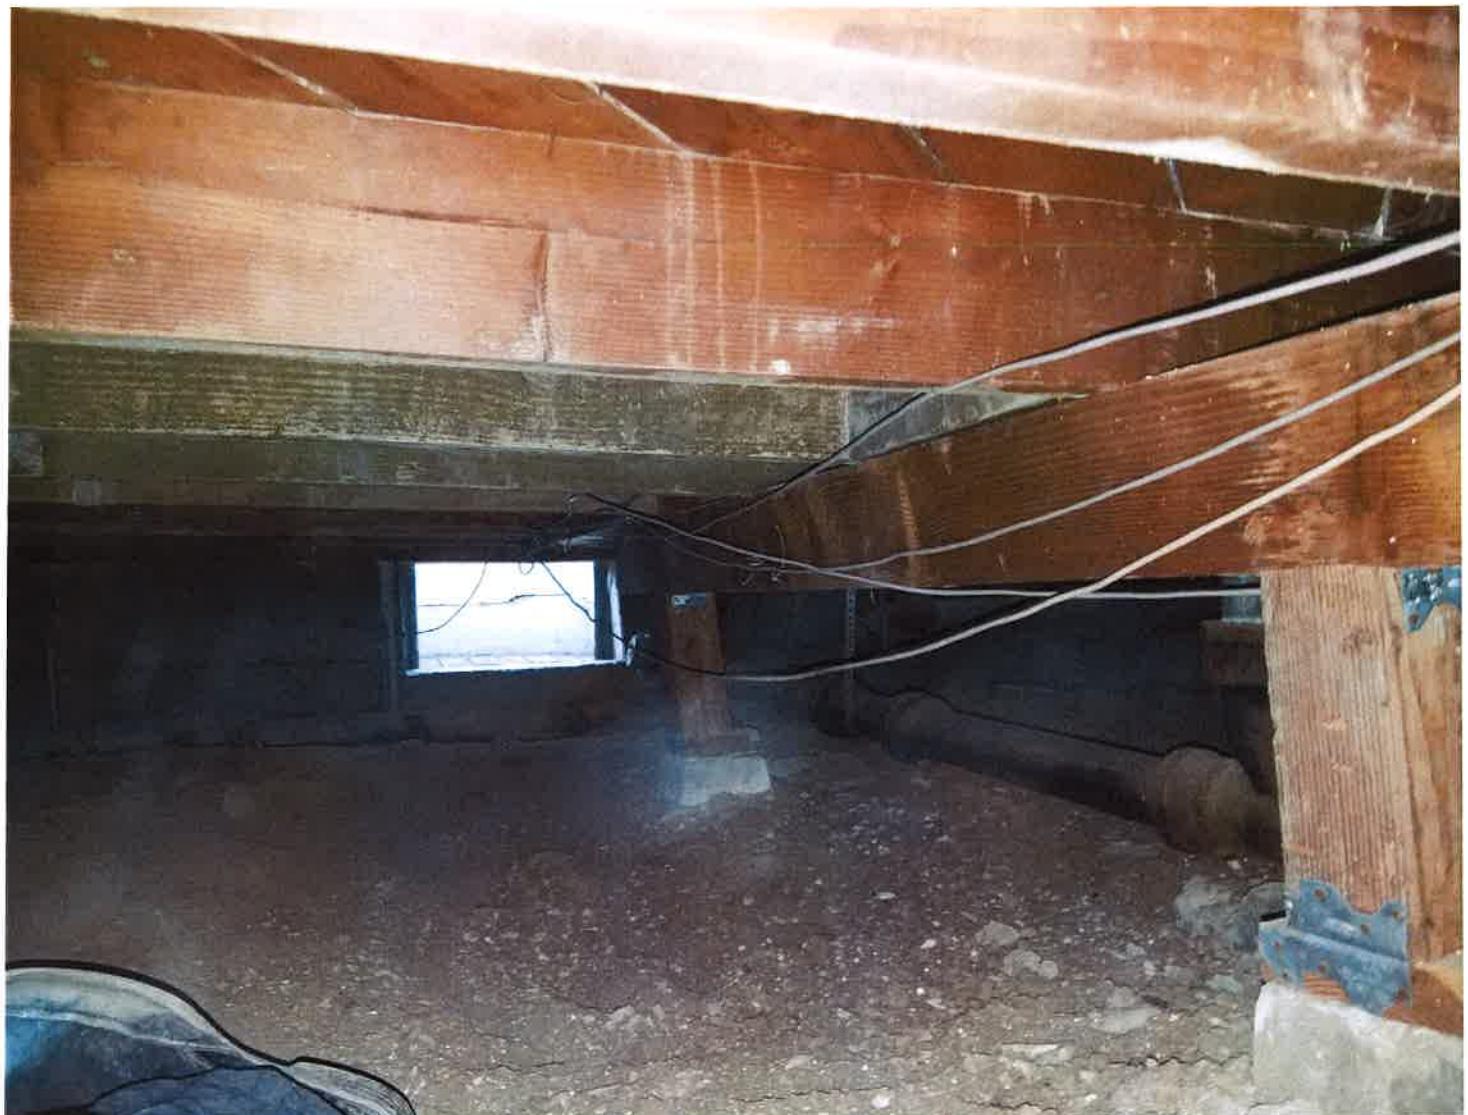
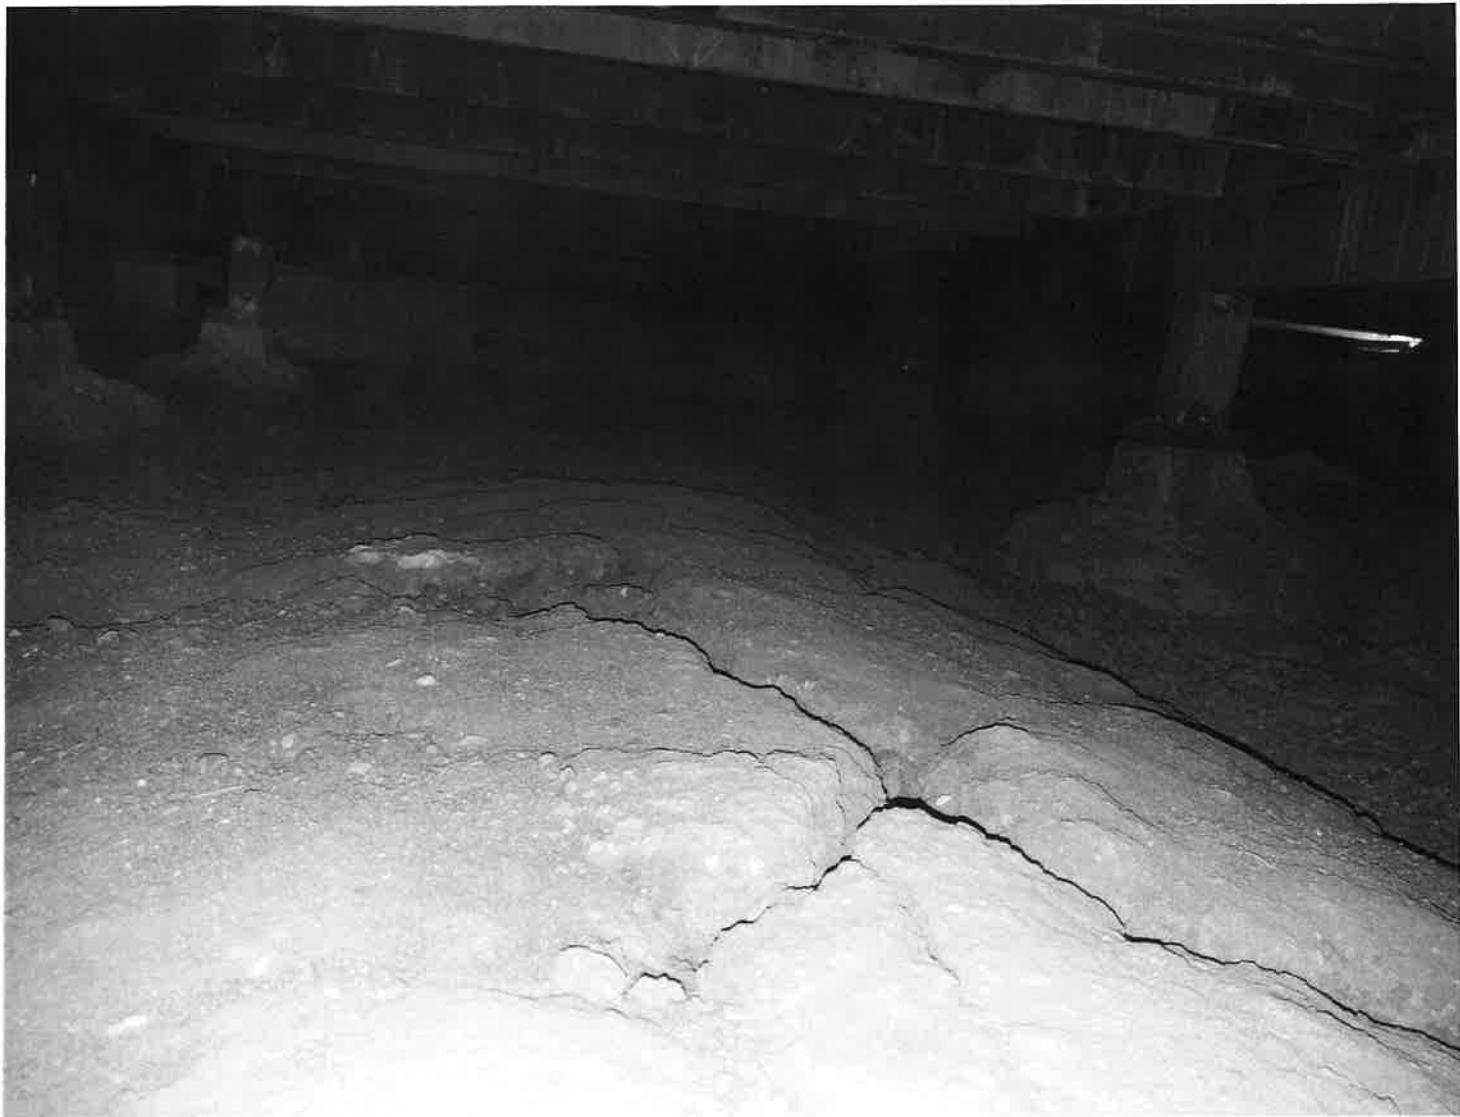
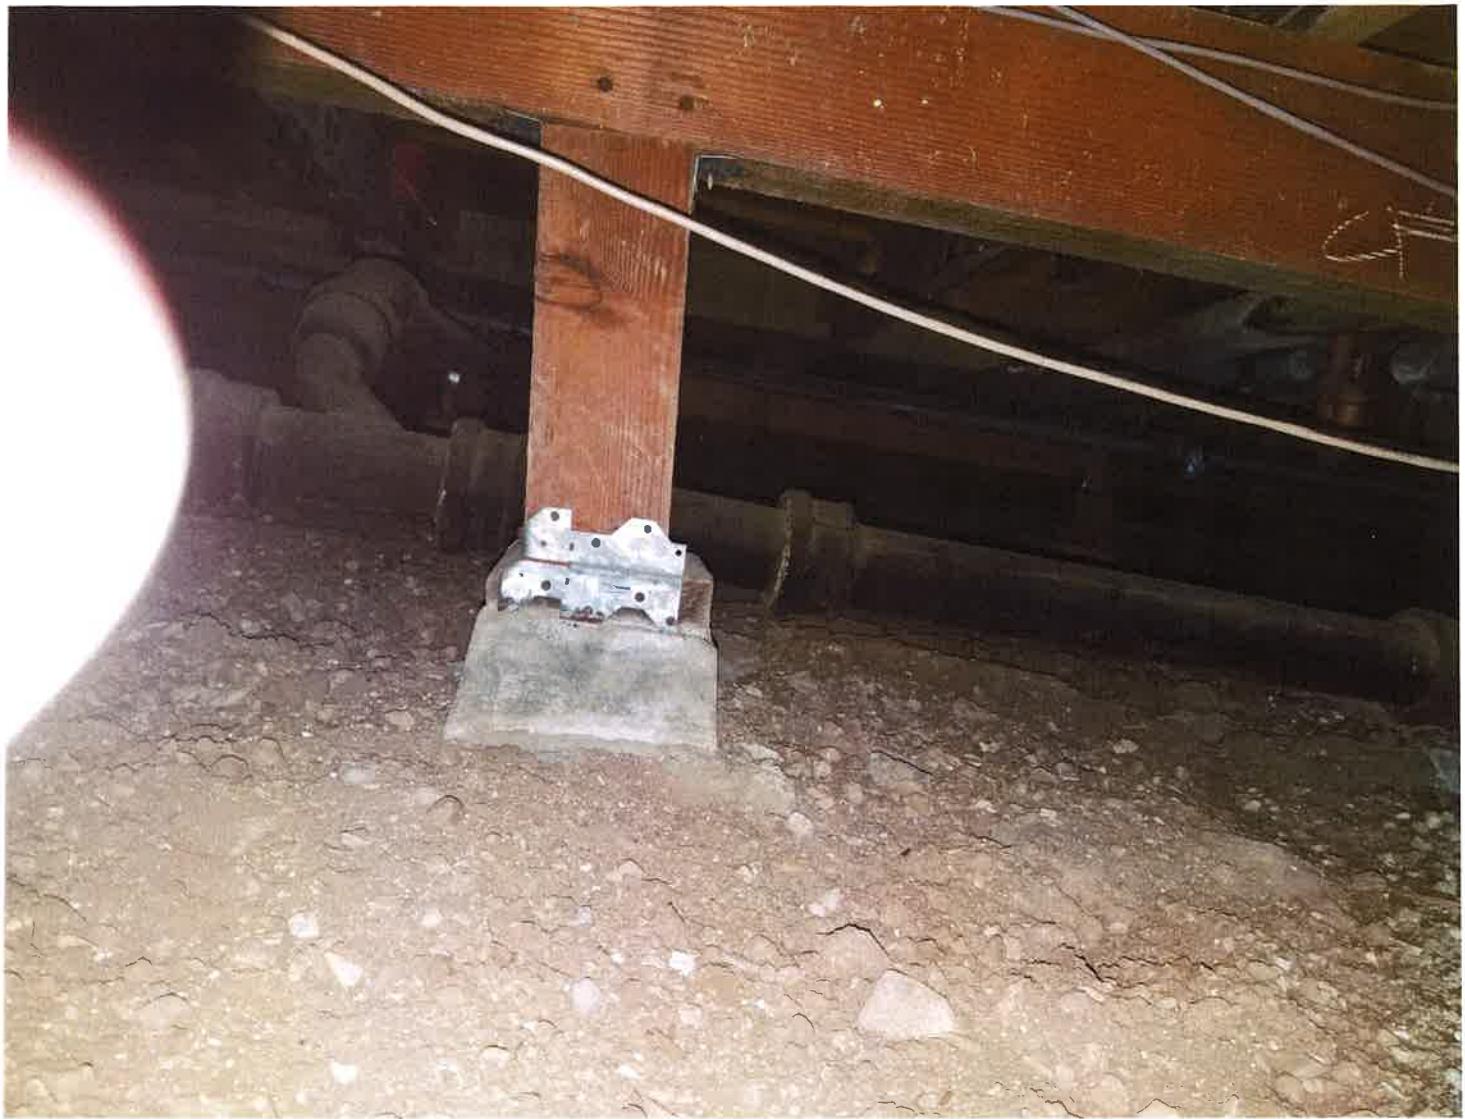
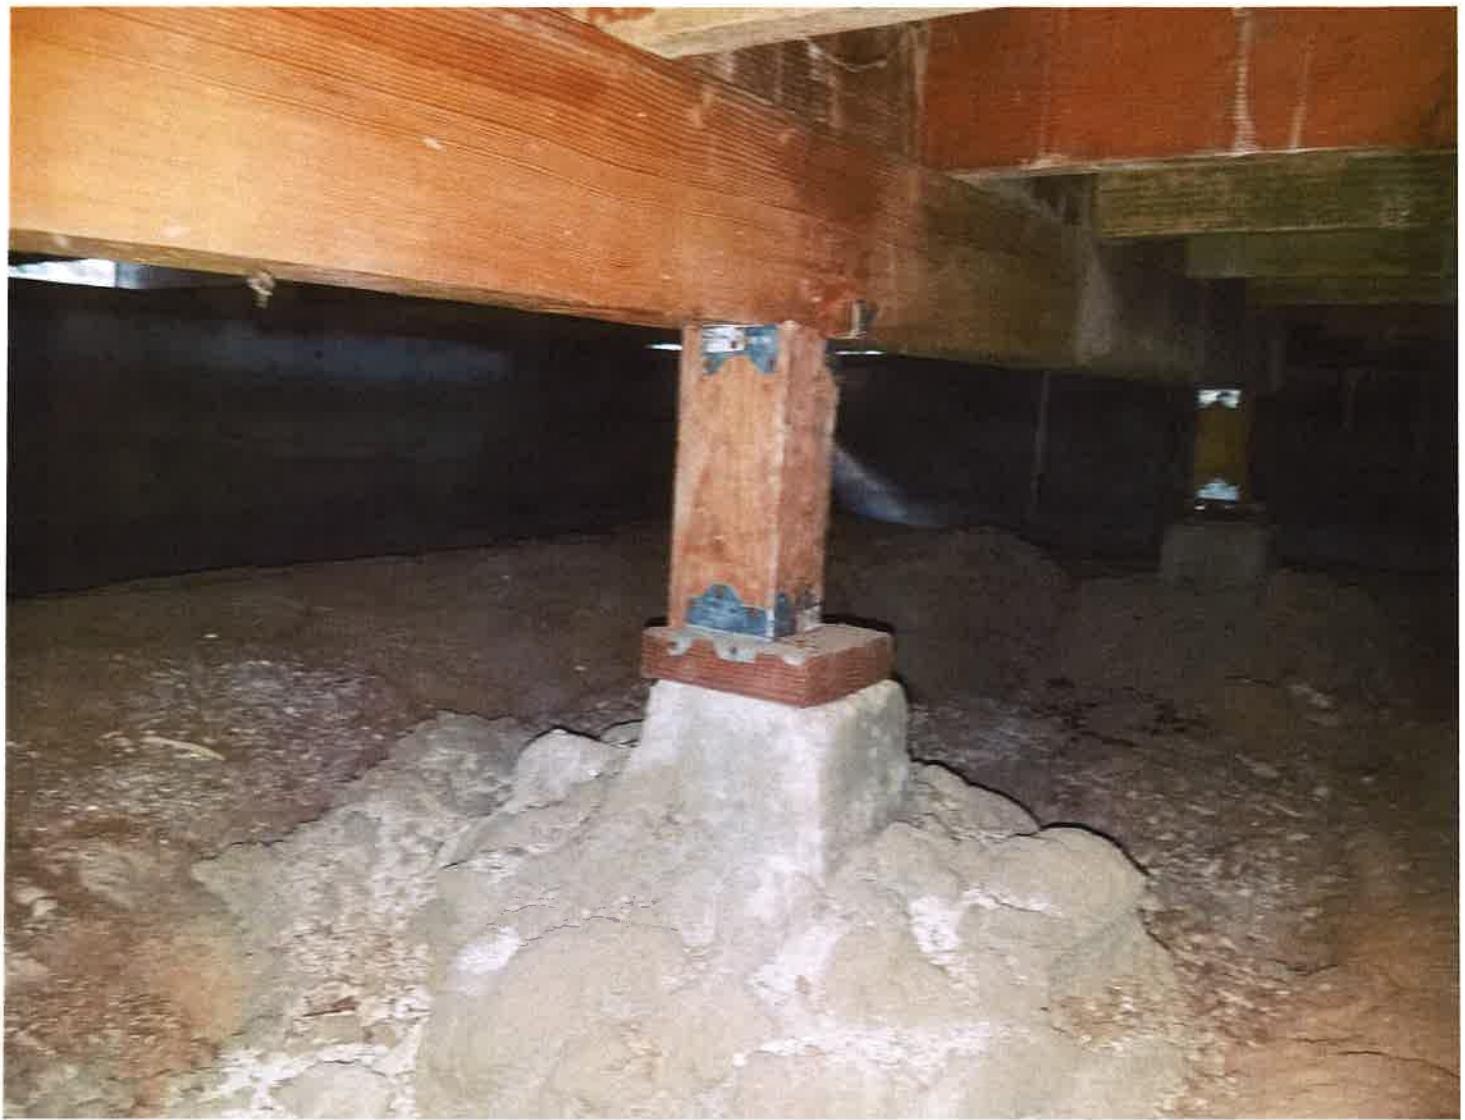
The wood girders and posts were found to be tilted toward the direction of the descending slope as depicted on Photographs 58, 59 & 63 - 65.

There are noticeable dessication cracks in the soil grade as shown on Photographs 63, 66 & 67 which are characteristic of highly expansive soils which have dried following saturated conditions. This phenomena indicates that surface and/or subsurface runoff is directed into the lower elevated underfloor crawlspace during heavy rains.

And as a result of water and its effect on the existing expansive and possibly fill soil, we believe that the building foundations have been affected by both long-term settlement and soil creep influences. The influence of water on the south descending slope triggers lateral movement which can be describe as soil creep. The vertical cracks in the existing footings and the tilted girders and posts in the crawlspace are indicative of the phenomena.

It is our recommendation that a geotechnical engineer be consulted to perform a soils investigation to provide recommendations to stabilize the existing foundations. It is expected that they will also recommend improving the site drainage condition to reduce the amount of runoff that can be directed beneath the residence. A French Drain system should be constructed along the base of the north ascending slope to collect subsurface runoff. This French Drain should have a minimum 5 foot depth and should contain a 6 inch diameter perforated drain line covered in clean gravel and wrapped with a Mirafi filter fabric.

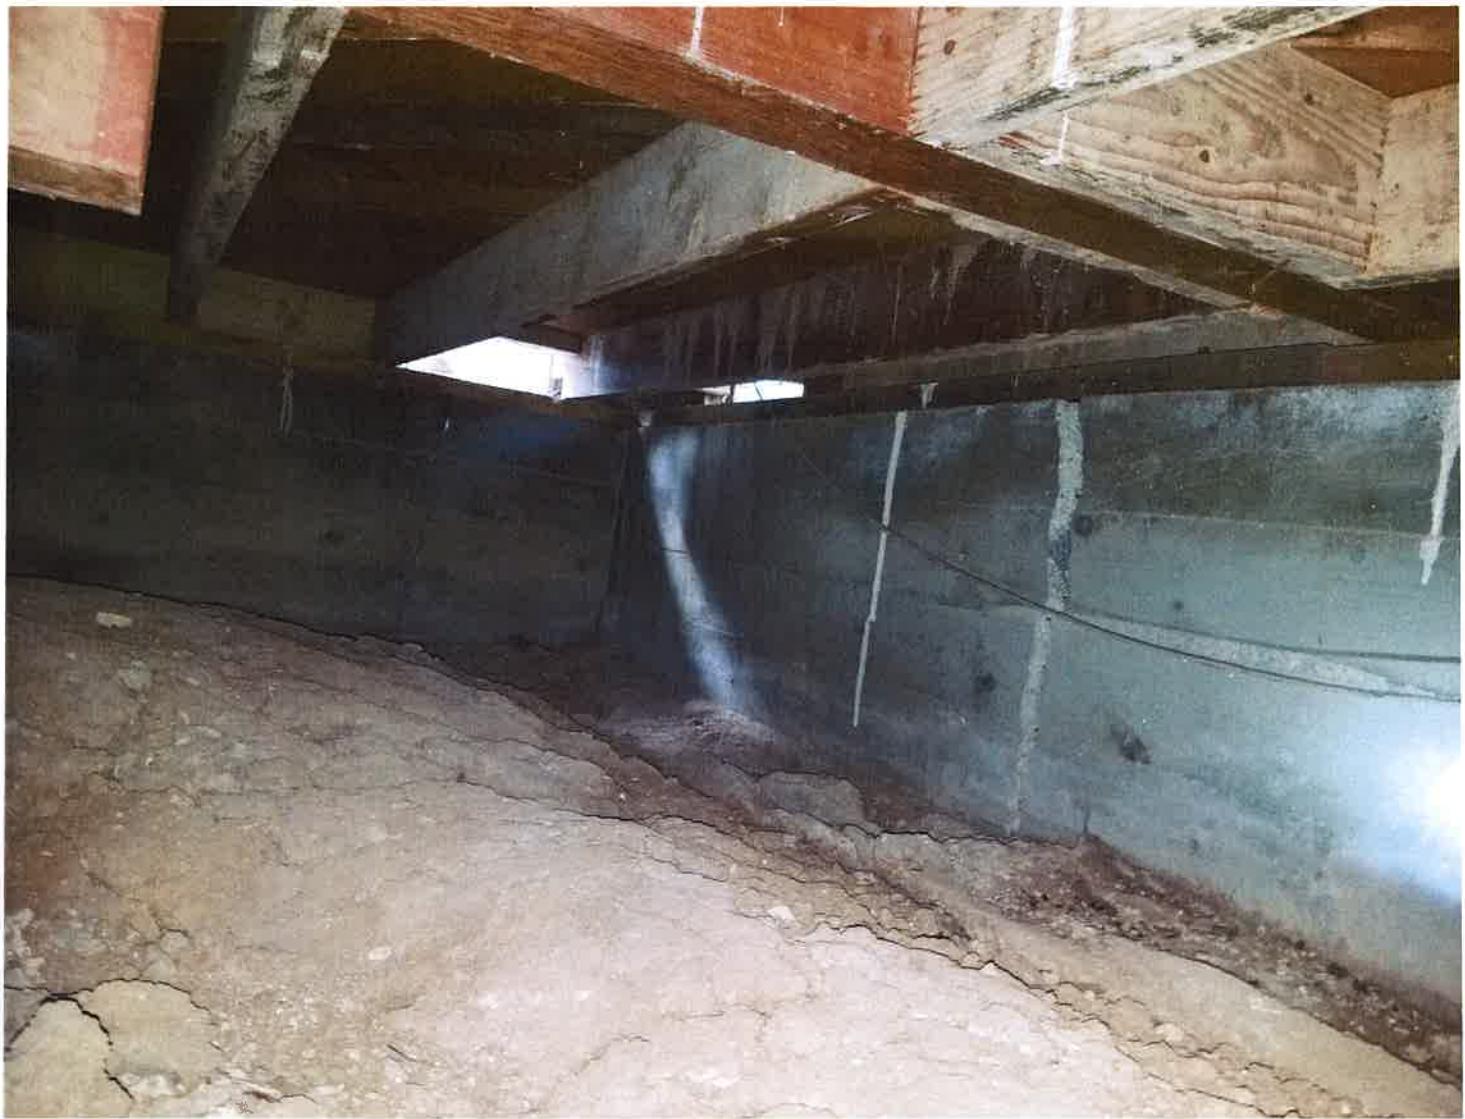
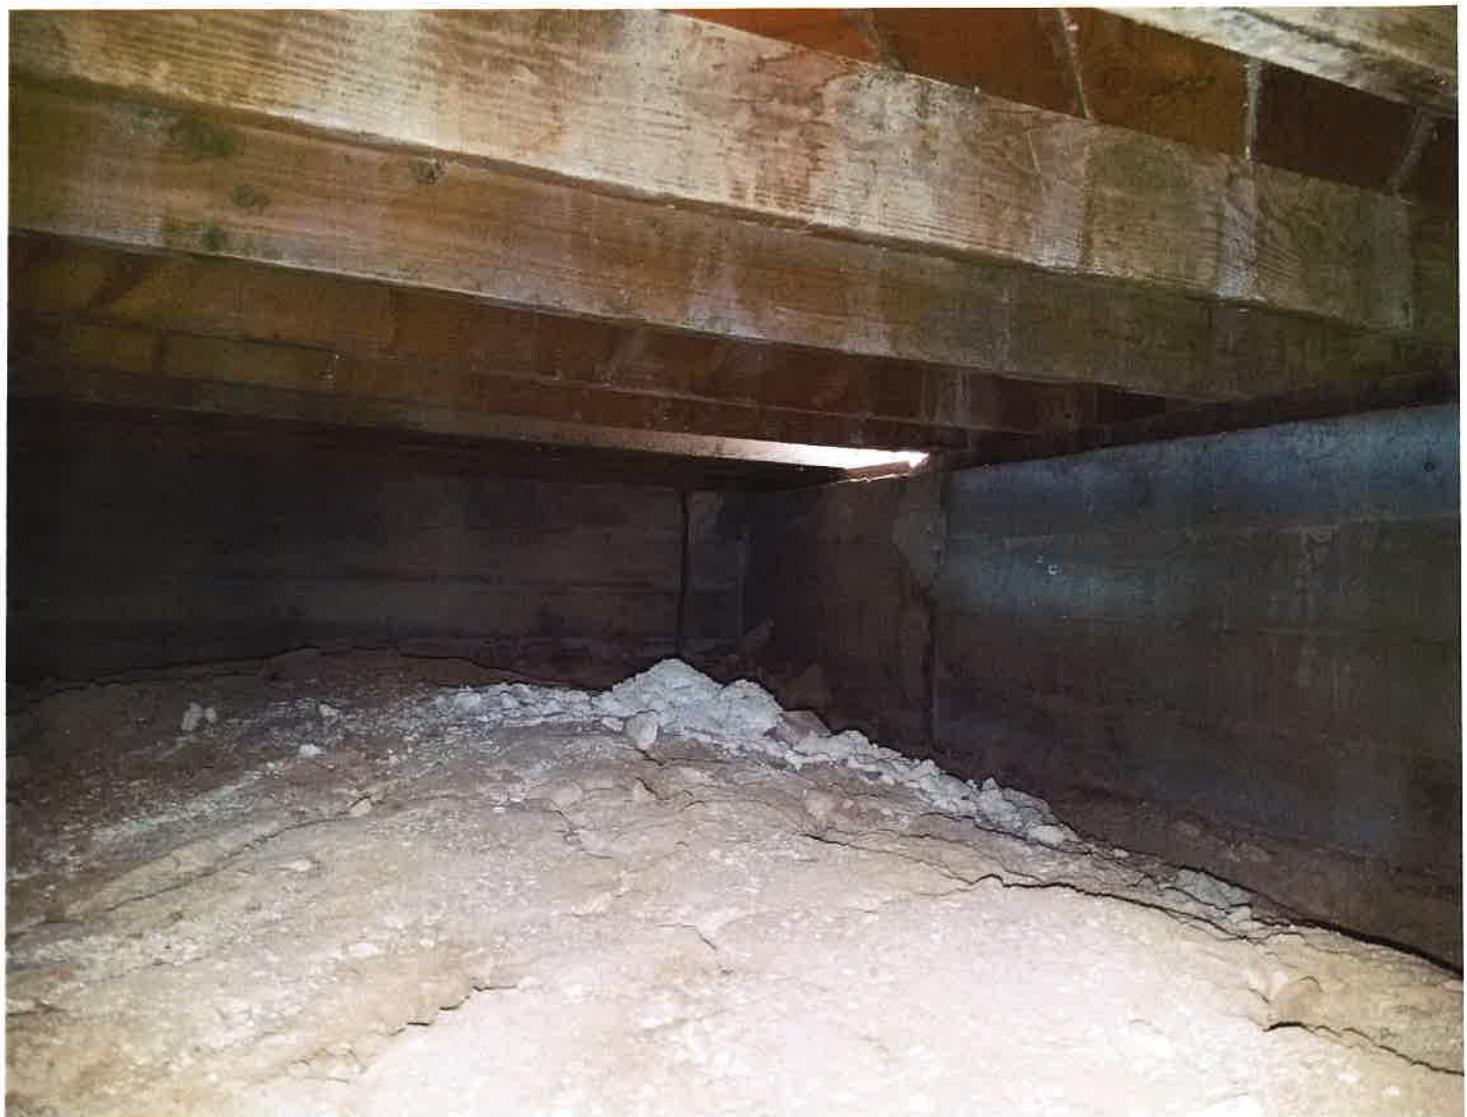
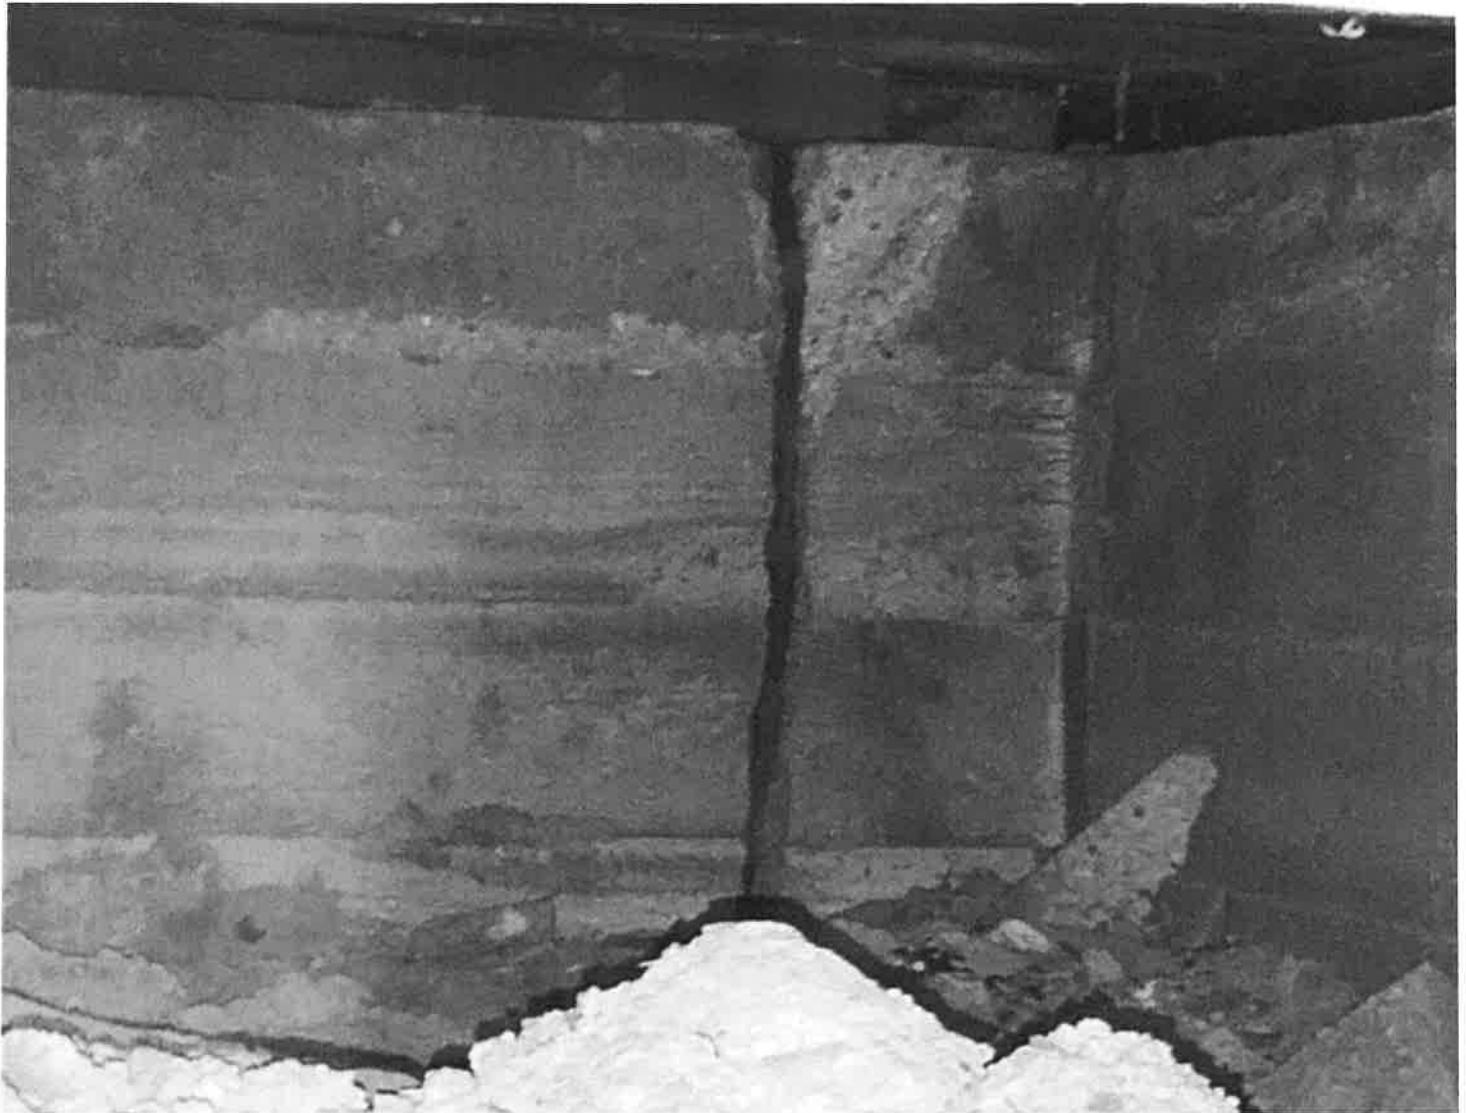
There are wide cracks in the footings that reveal no horizontal rebar as shown on Photographs 60, 67 & 68.

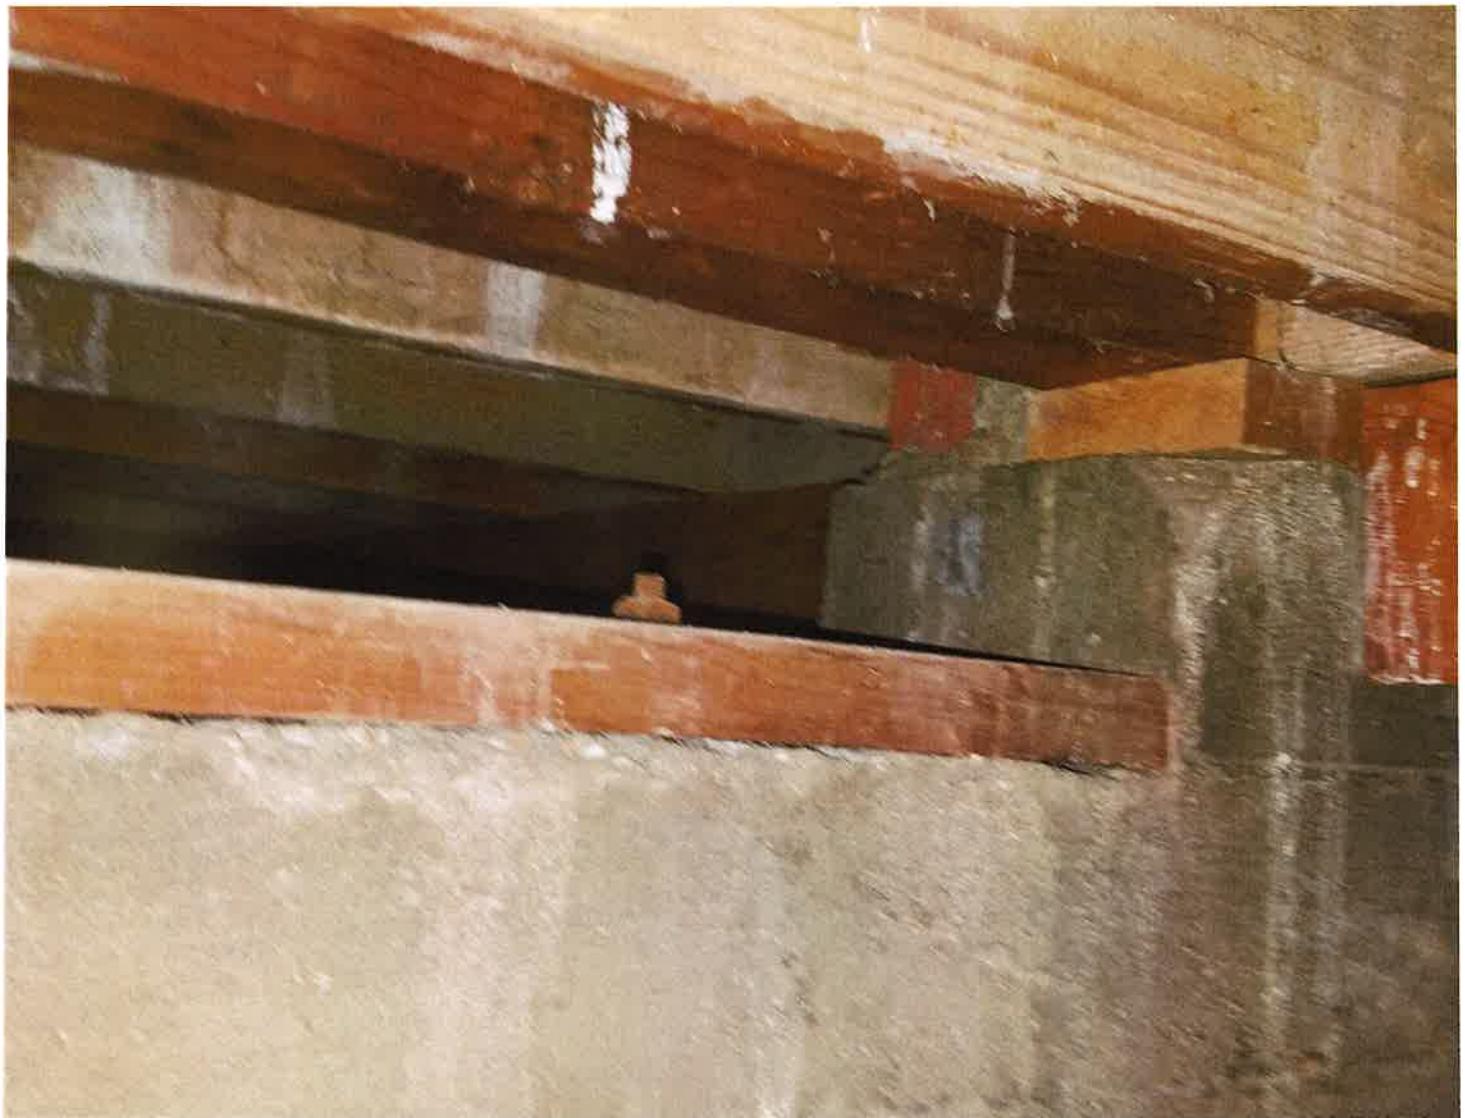
Photograph 69 verifies that the wood mudsill is bolted to the existing concrete foundation.

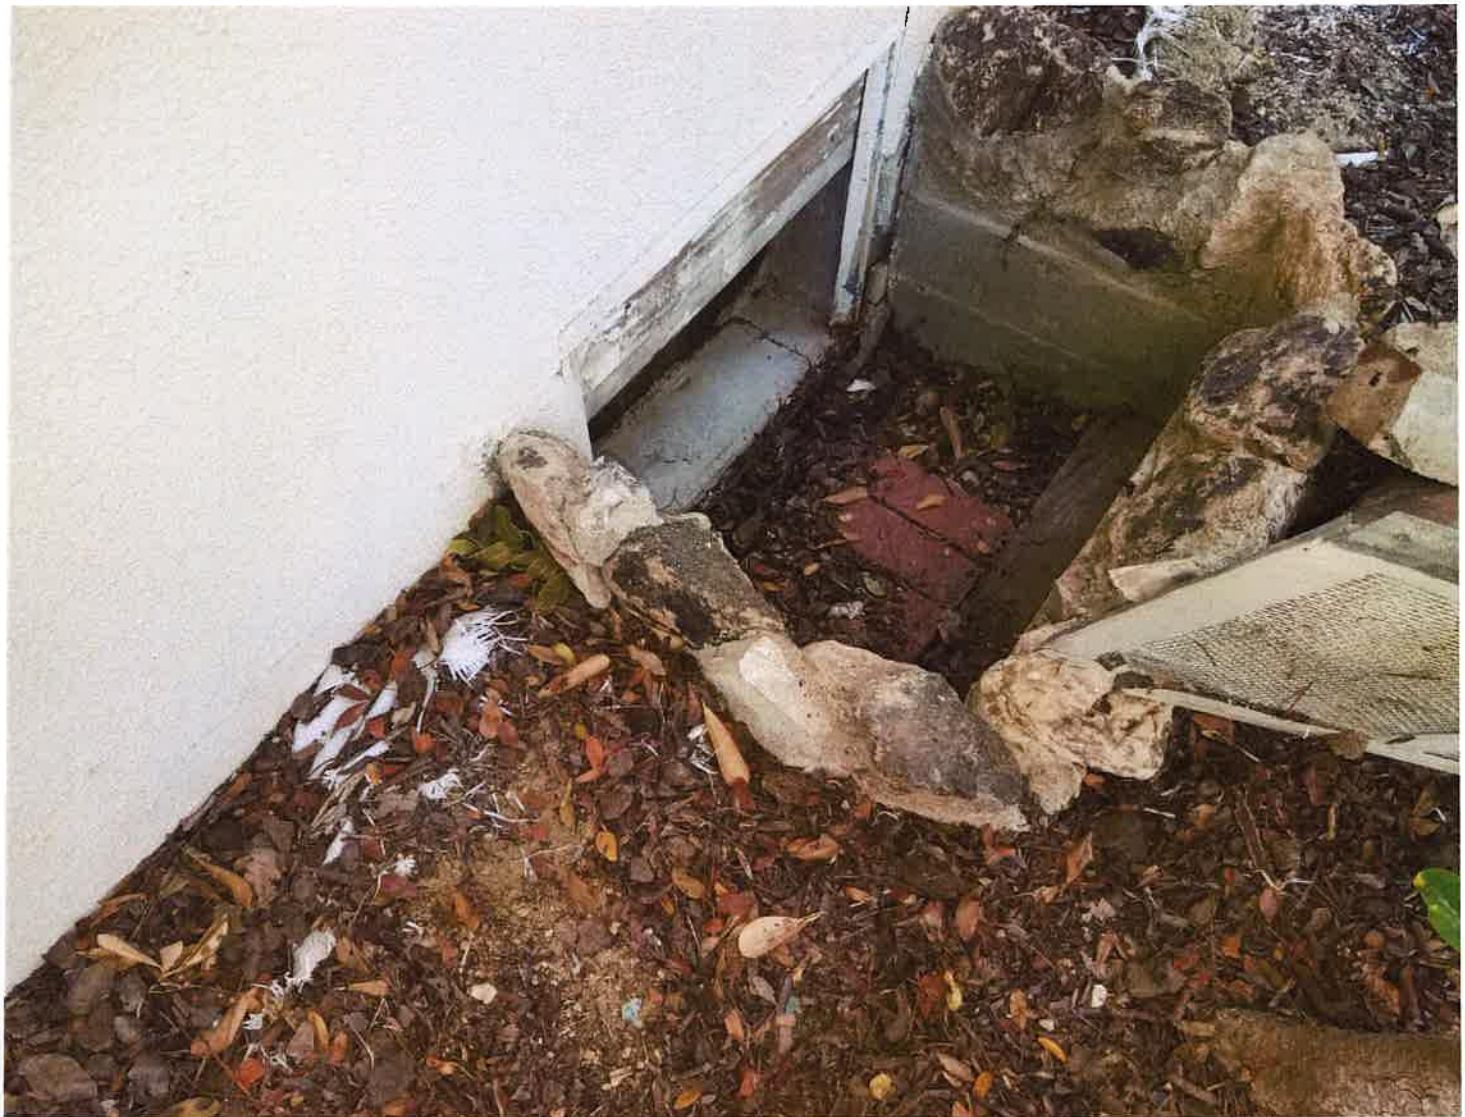
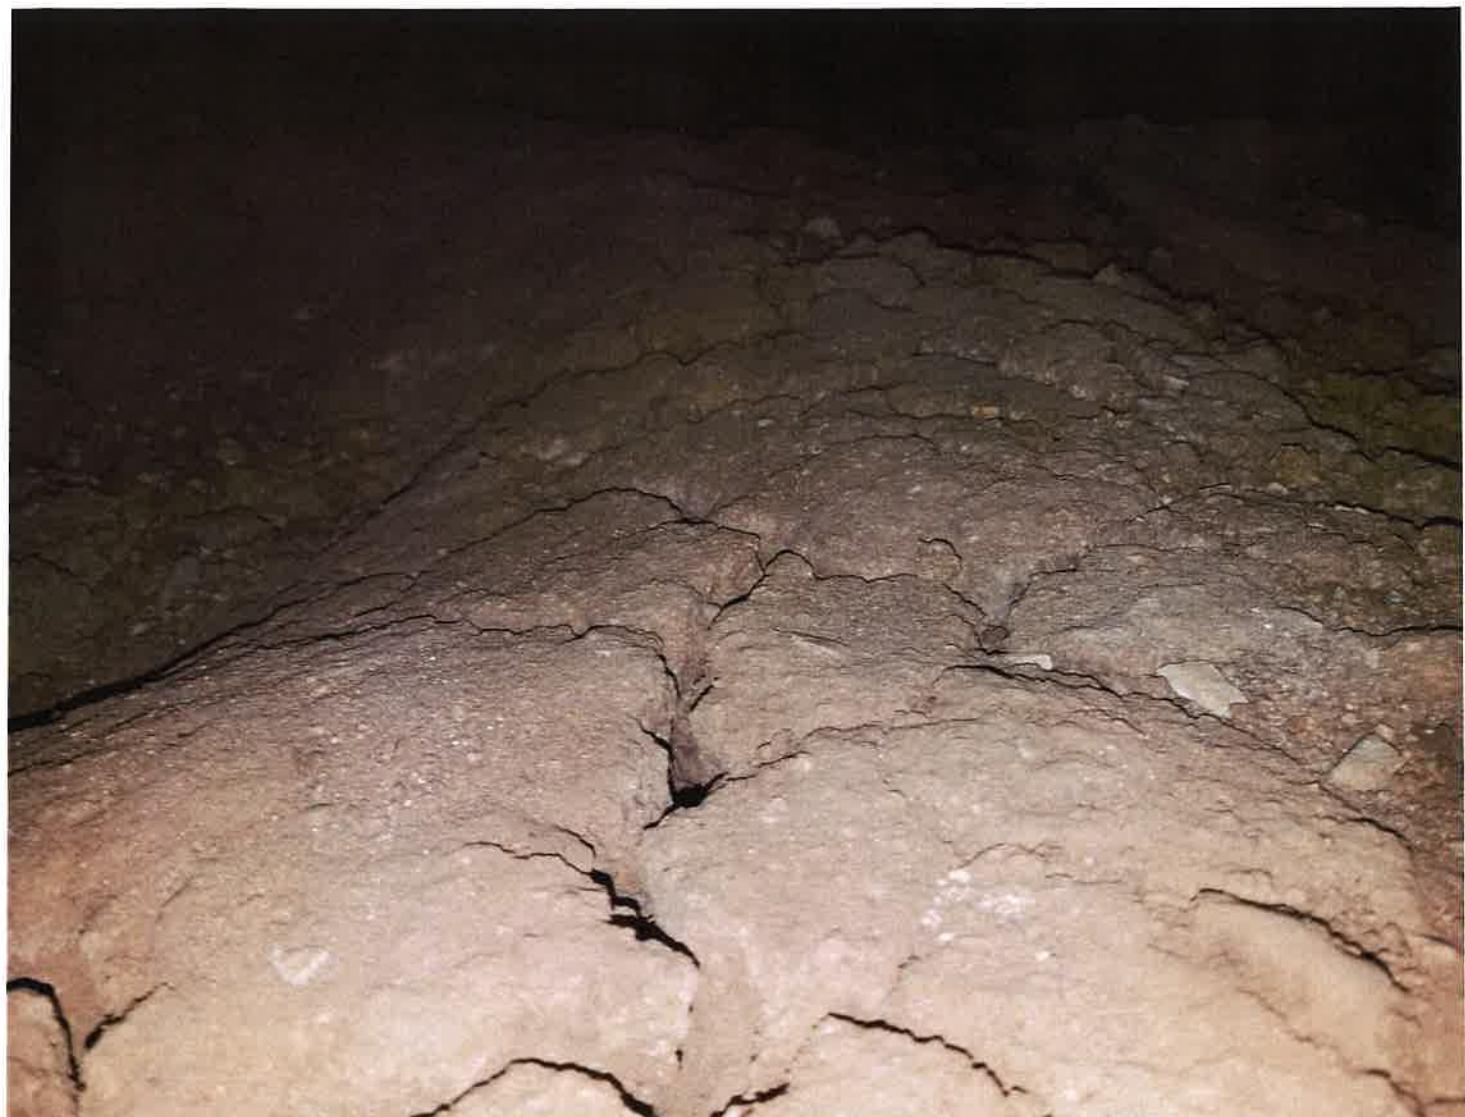
More evidence of large dessication cracks and moist soil was detected in the northerly section of the underfloor crawlspace as shown on Photographs 70 – 72. This section of the underfloor is closest to the ascending hillside.

Subsurface runoff is directed beneath the raised foundation system from the higher elevated areas to the north as indicated by the wide dessication soil cracks and moist soil observed in the underfloor crawlspace. In addition, we noted that there are no area drains in both the hardscape and softscape areas to collect surface runoff and there are an insufficient number of downspouts to collect roof runoff from the eave gutters.
