EQUITY BUILDING INSPECTION

RESIDENTIAL BUILDING INSPECTION

2112 Via Pacheco Palos Verdes Estates, CA 90274

> Sherry Day Kao Charles Day 03/18/2024

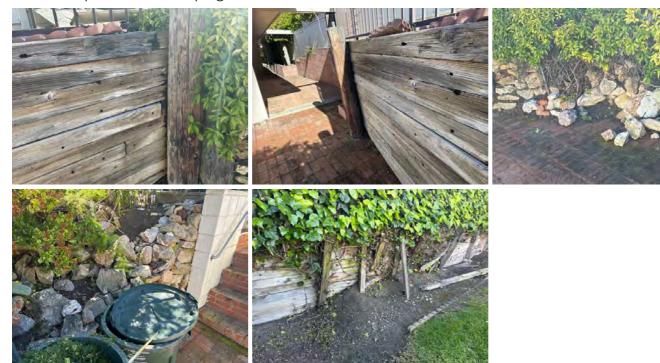
RETAINING WALL - FAILING/LEANING

Areas of the retaining wall appeared to be failing/leaning. I recommend having the wall evaluated and repaired as necessary by a licensed contractor prior to closing.

Contact a qualified landscaping contractor

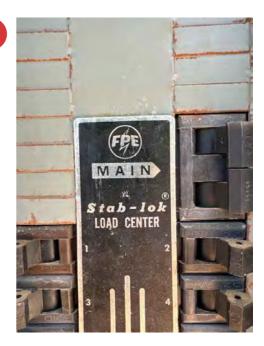
One or more panels were manufactured by the Federal Pacific Electric company (also none as Sylvania brand and Zinsco) and used "Stab-Lok" circuit breakers. Due to the safety issues involved, we do not open these panels. There is evidence that both double and single pole versions of these circuit breakers fail by not tripping when they are supposed to, which in term often leads to breakers overheating and in some cases, electrical fires. Due to evidence of safety issues, it is recommended that a qualified electrician carefully evaluate all Federal Pacific panels and make recommendations. Some insurance companies in the state are not offering property insurance with this manufacturer's panel installed in single family homes that require a 4 point insurance inspection. For more information on the issues with these panels, you can go HERE and HERE

Contact a qualified electrical contractor.

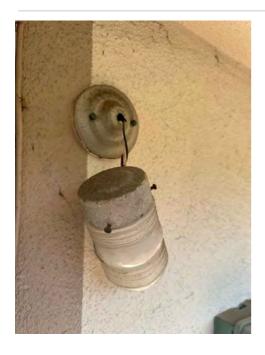
5.12.1 GFCI & AFCI

GFCI PROTECTION NOT INSTALLED

Contact a qualified electrical contractor.

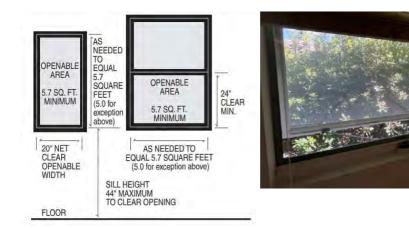
13.4.4 Windows

POOR CONDITION
