Inspection Report

This home inspection report prepared specifically for:

Ronald Nodder
2035 Vista De La Vina
Templeton, CA 93465

Inspection location: 2035 Vista De La Vina
Templeton, CA 93465

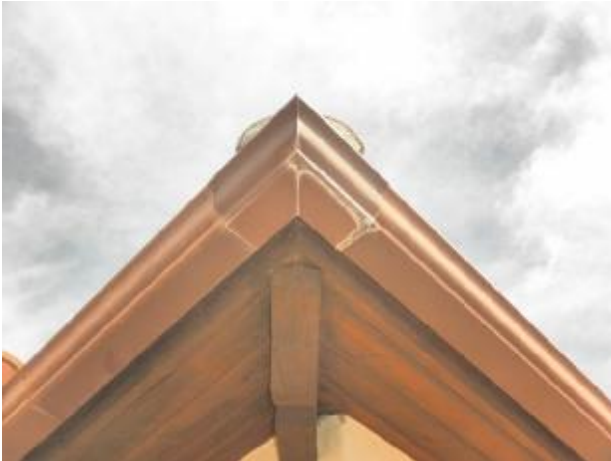
Roof # R

Maintenance Note: The gutter seams are leaking. This can cause moisture damage to the fascia boards. Recommend sealing the gutter seams with Flex Seal as needed.

Some of the gutter seams are leaking.

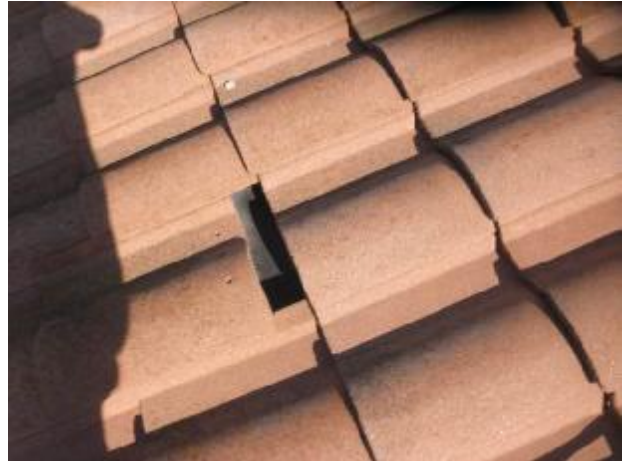
Roof # R

1.) There are two cracked and displaced roof tiles at the west and NW slopes.

Displaced roof tile at the west facing slope.

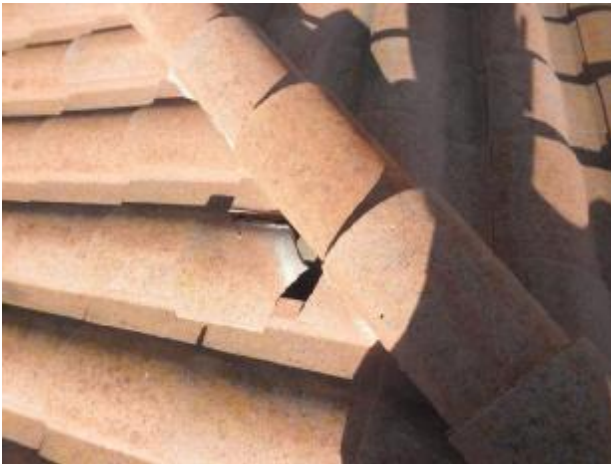
Roof # R

Cracks and displaced roof tile at the NW slope.

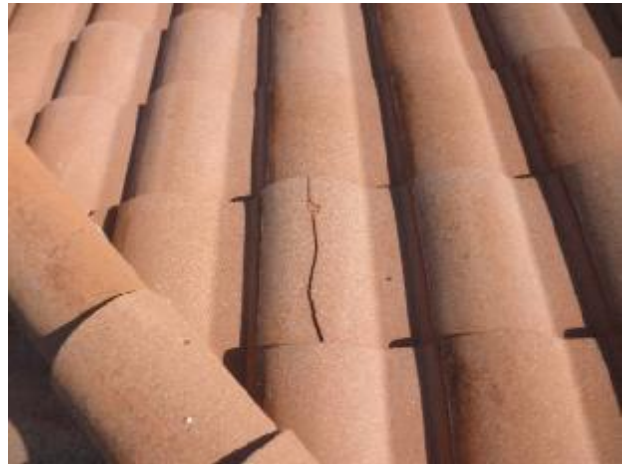
Roof # R

2.) There is one cracked roof tile at the NE facing slope.

Cracked roof tile at the east facing slope.

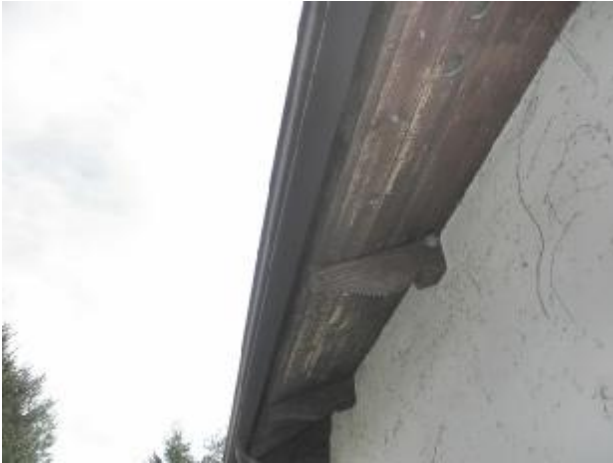
Exterior # EX

The soffit at the NE eave needs to be refinished.

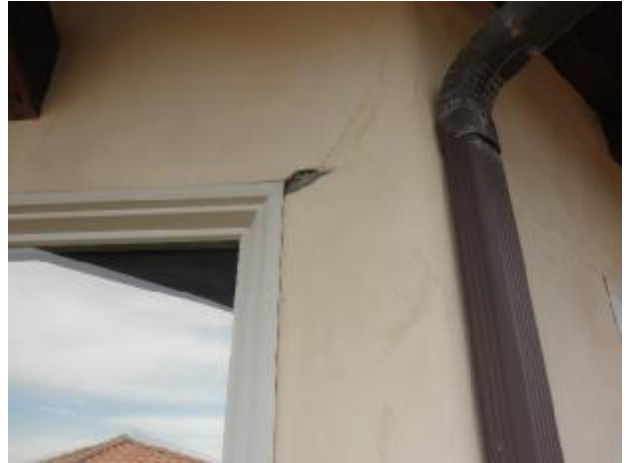
Exterior # EX

Damage to the stucco above the family room window.

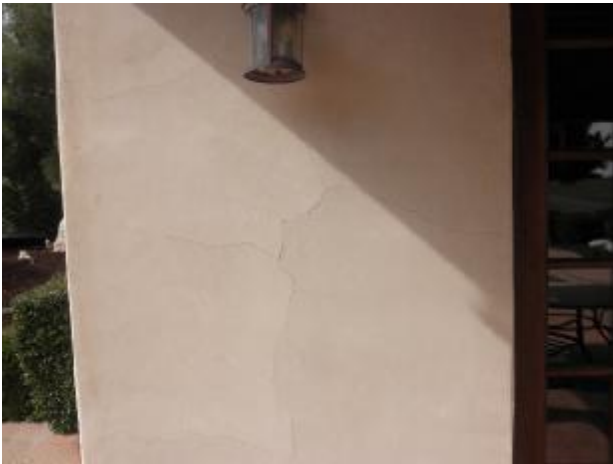
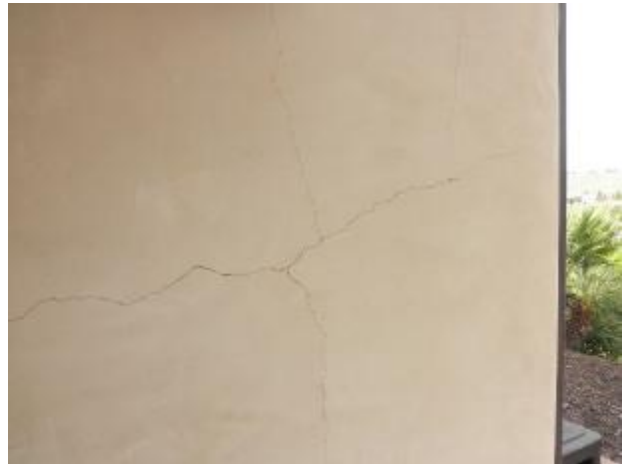
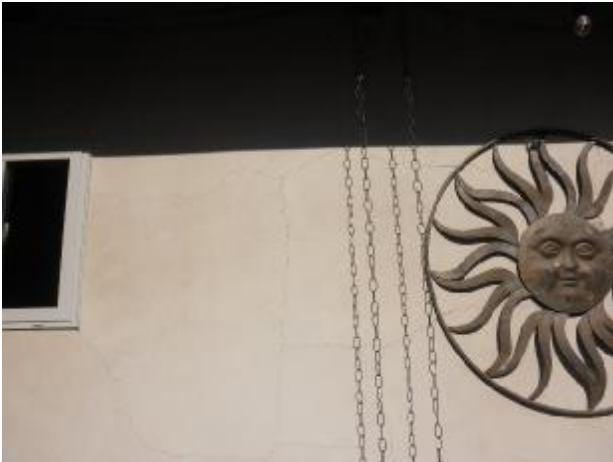
Example of the excessive surface cracking at parts of the plaster walls.

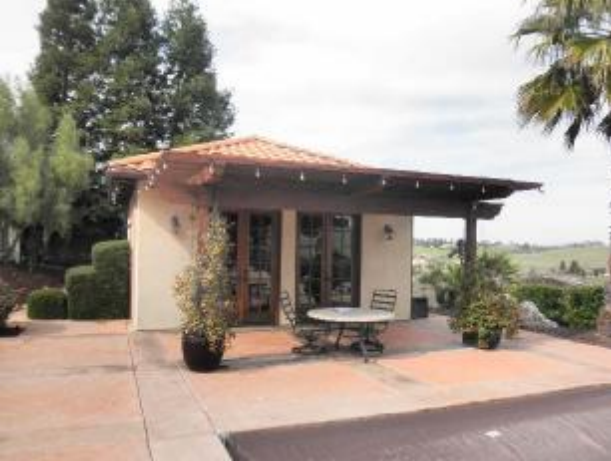
GD

Detached Pool House

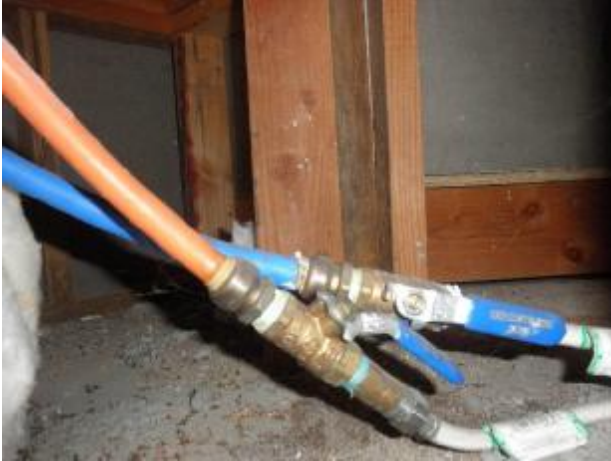
P

- 20 Information Note:** This home has been plumbed with hot and cold water lines that are "Kitec piping". This type of piping was commonly installed between 1995 to 2007. It has had significant defects which has caused flooding of homes. Proper repair requires complete replacement of the water lines. This is recommended to be evaluated by a qualified and licensed Plumbing Contractor prior to close of escrow to determine the full extent of work with repiping the home and the costs associated with this work. (Note: The water lines appear to be primarily in the slab. Recommend cutting out the drywall in the garage directly behind the main water riser to determine fully the type of piping used in the home.)

Example of the Kitec plumbing water lines at the master bath hydrotherapy tub.

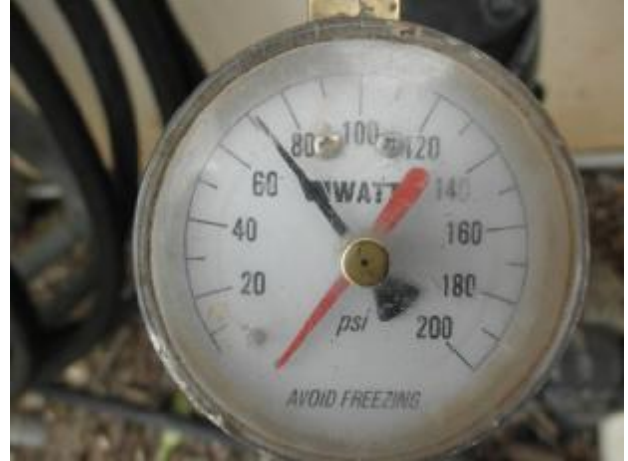
P

The water pressure was measured at 70 psi.

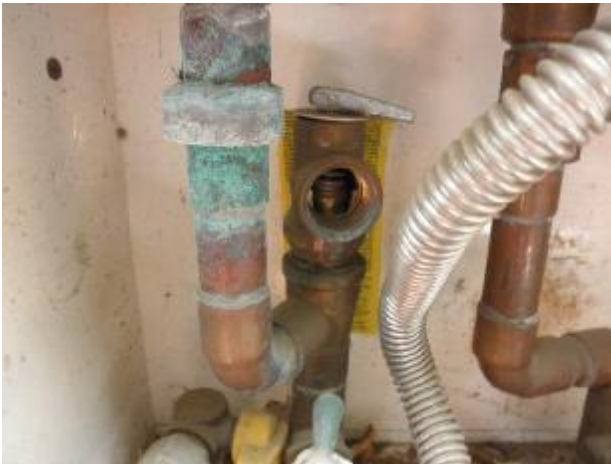
P

Safety Hazard Note: The discharge pipe for the temperature/pressure relief valve on the pool house water heater is missing. This should be installed and plumbed to the exterior of the home.

Missing discharge pipe for the TPR valve on the pool house water heater.

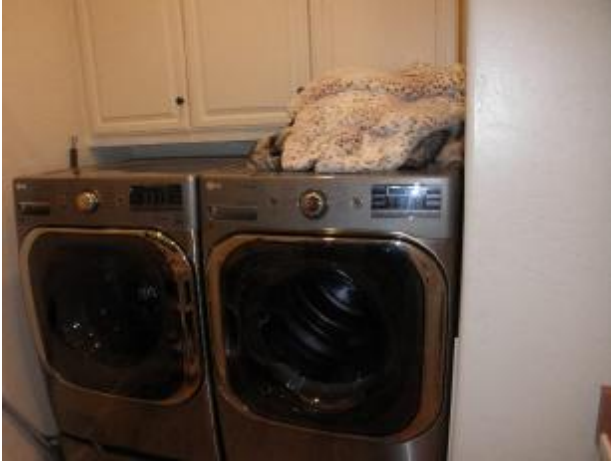
K

Laundry units block access to connections.
