# Inspection Report

**Property Address:**  
11102 Whitebark Ln  
Corona CA 92883

**A New Day Home Inspections**

<b>Property Address</b> 11102 Whitebark Ln Corona CA 92883	<b>Date of Inspection</b> 3/22/2022	<b>Report ID</b> 20220322-11102-Whitebark-Ln
<b>Customer(s)</b> William & Yana Debbaneh	<b>Time of Inspection</b> 01:00 PM	<b>Real Estate Agent</b> Julie Adams Real Broker

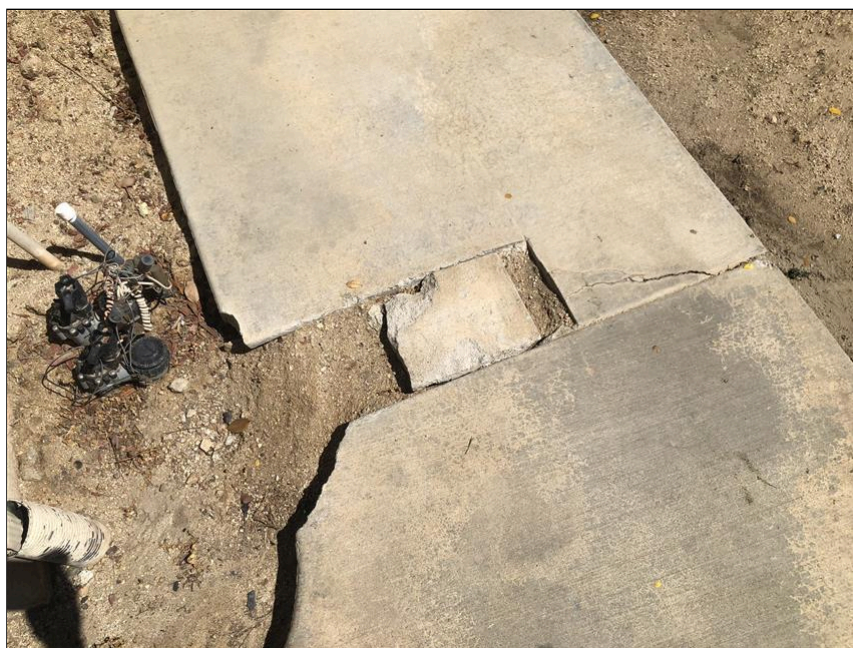
3.3 Item 1(Picture)

➔ Damage to the right side walkway has created trip hazards. The damaged areas should be replaced or repaired as needed.

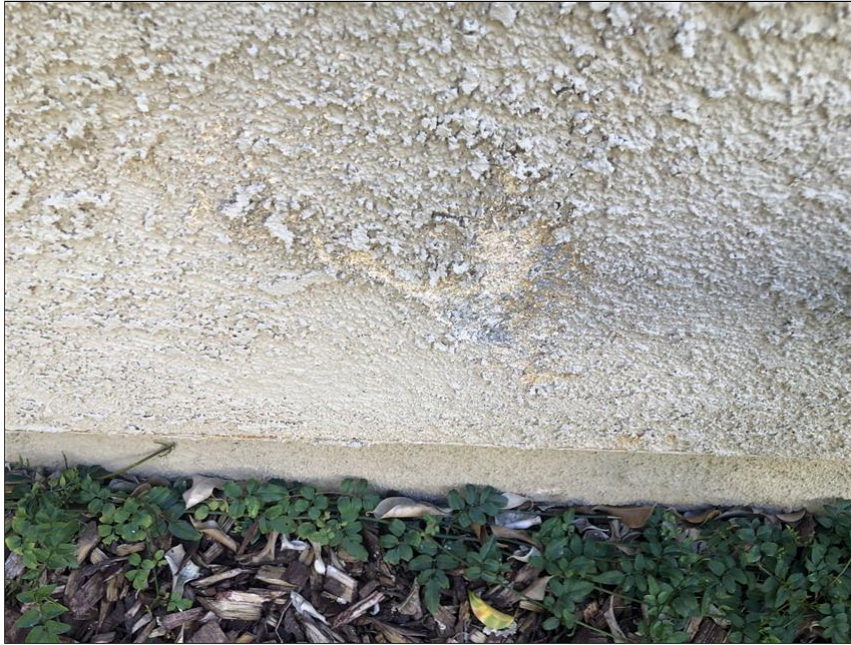
3.7 Item 1(Picture)

- ➡ Sections of the stucco at the front & left side of the building are deteriorated.  
- A qualified plastering technician should evaluate the stucco and make repairs or modifications as necessary.

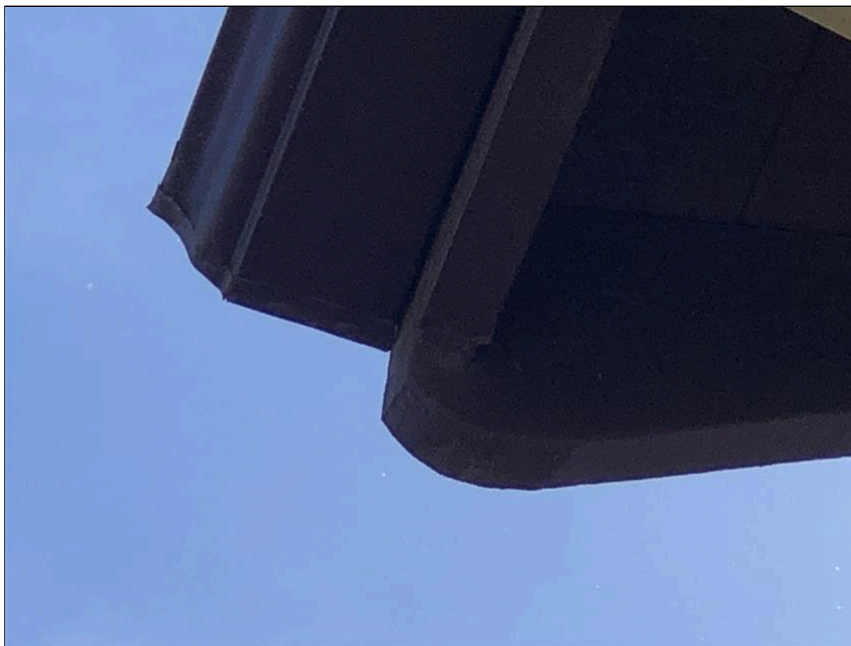
3.8 Item 1(Picture)

- ➔ Conditions associated with wood-destroying organism activity are present in several areas.
- A qualified, licensed pest control operator should evaluate these conditions, and determine what further steps are necessary.
- NOTE: Observations by a building inspector, who is not otherwise specially qualified to inspect for evidence of pests, is not a substitute for inspection by a licensed Pest Inspector or exterminator. This report includes comments on current visible conditions only. ( Rear left side )

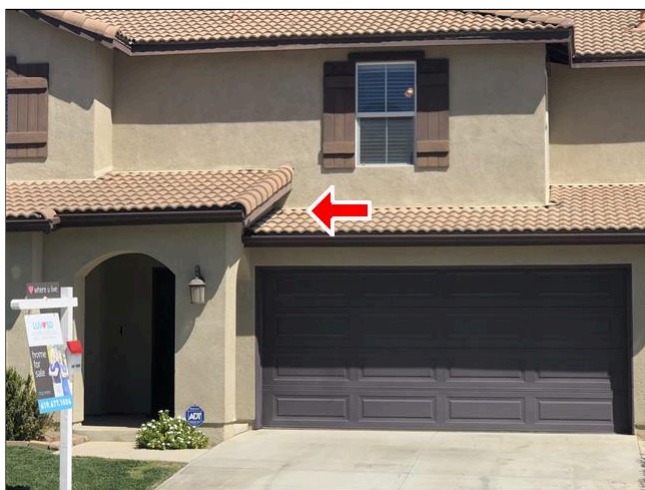
4.2 Item 1(Picture)

➔ (1) Two concrete tiles are cracked and/or broken at the front of the home. A qualified roofing contractor should inspect further and make any needed repairs.

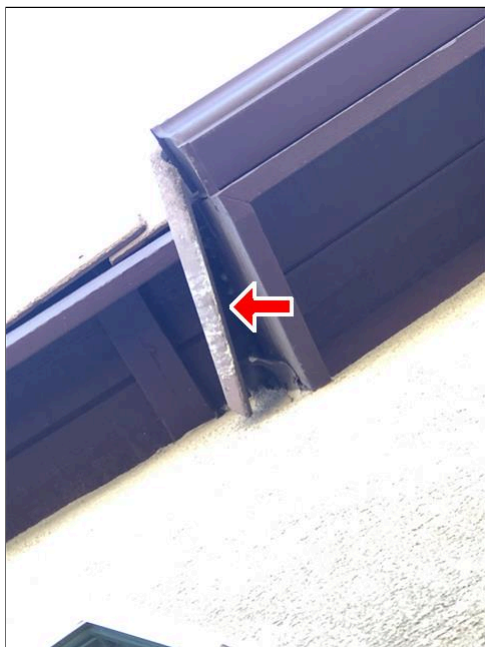
4.2 Item 3(Picture)

(2) The ridge cap at the left front of the home is loose and needs to be secured. A qualified roofer should make this repair.

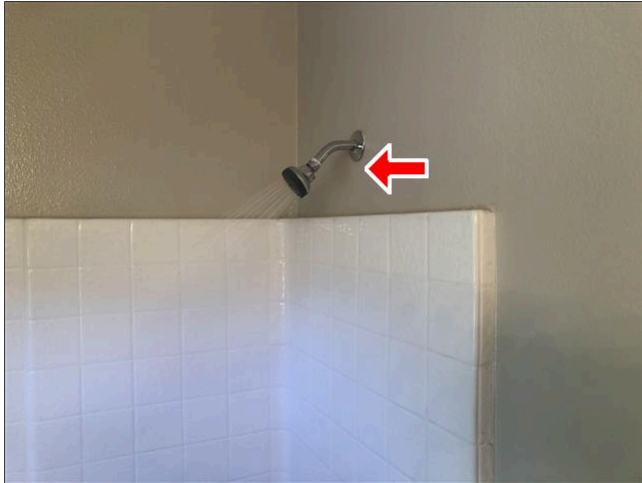
5.4 Item 1(Picture)

➔ The shower head leaks at its base at the hall bathroom. A qualified technician should repair or correct as needed.

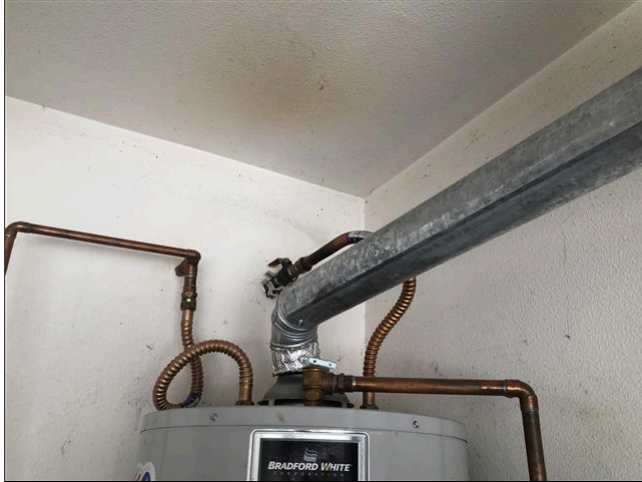
5.8 Item 1(Picture)

➔ This water heater does not have a "Thermal Expansion tank" installed to prevent a possible leak at the

T&P or "Pop-off" valve. Changes in the building standards may require one when a new water heater is installed. This change is not retroactive on older previously installed Gas/LP water heaters. Check with your local building department as to their requirements. There were no leaks or drips at the T&P valve during inspection. If your water heater does begin to drip or leak, then a Thermal Expansion tank may be needed.

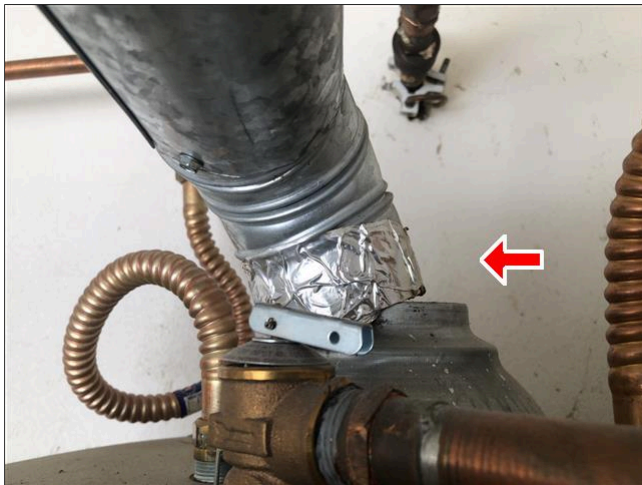
5.10 Item 1(Picture)

➔ The water heater vent is separated allowing the vent gasses to mix with the household air supply. A qualified technician should effect repairs as needed.

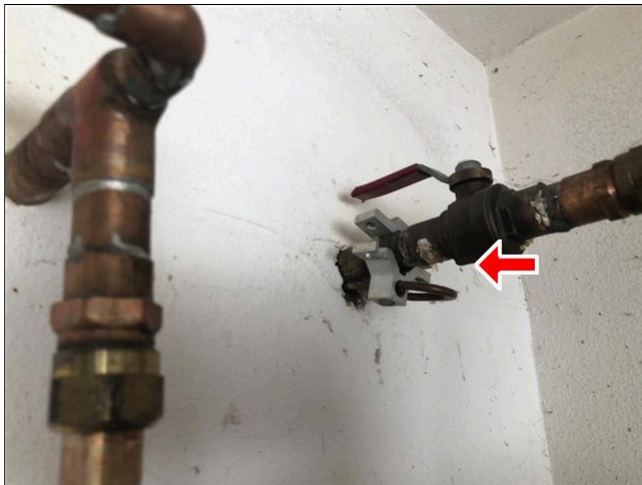
6.3 Item 1(Picture)

- ➔ The connection of the grounding conductor and/or clamp at the grounding source is not secure. A properly connected grounding wire is an important safety feature.  
- Use a licensed electrician to repair the connection.

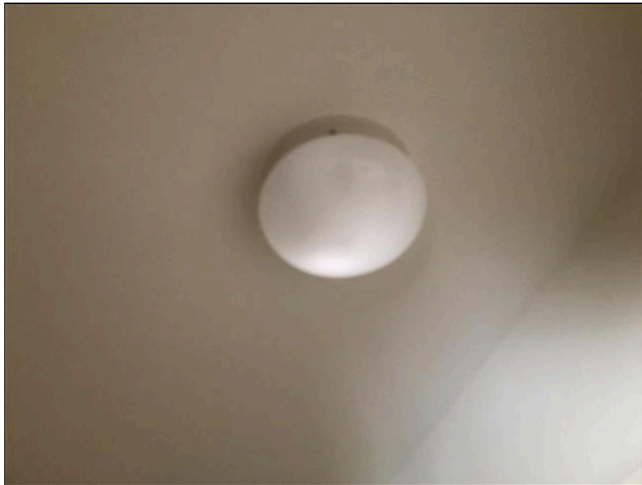
6.10 Item 1(Picture)

- ➡ (1) One or more lights are not functional at the interior. Some bulbs are missing and other bulbs may have burned out. Try replacing the bulbs, and test the fixtures. If a new bulb does not correct the problem, a qualified electrician should make repairs or modifications as necessary.

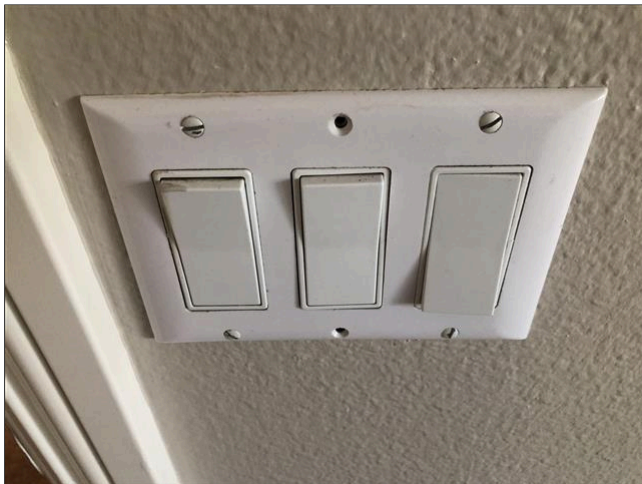
6.10 Item 2(Picture)

- ➡ (2) Two light switched are loose to the wall and are damaged. A qualified technician should make this repair. ( Master bedroom and second floor halfway )

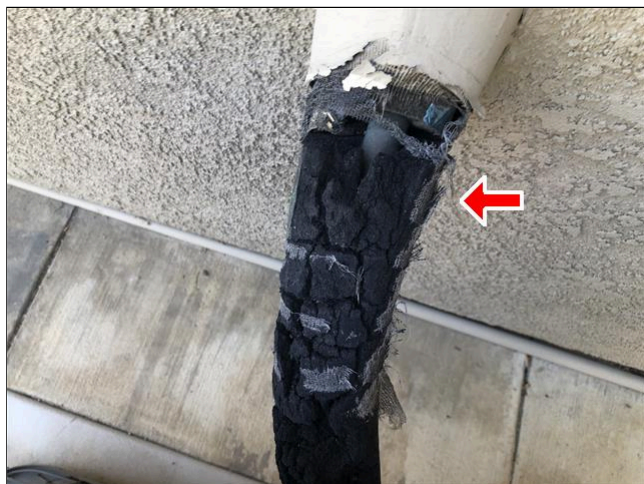
7.12 Item 7(Picture)

➡ (4) The insulation on the suction line is damaged at the exterior. Damaged insulation on a suction line can cause energy loss and condensation. We recommend replacing the damaged insulation.

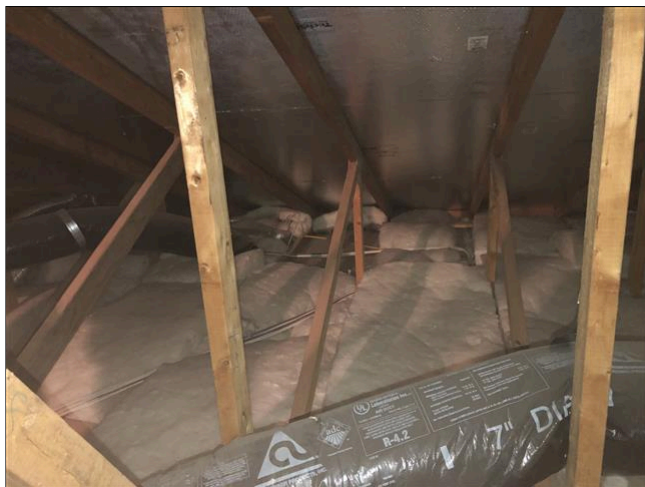
8.4 Item 1(Picture)

Some of the insulation in the attic is missing, or is out of place. Where insulation is missing, new insulation should be installed. Where insulation is out of place, it should be put back into place. A qualified technician should do the work.

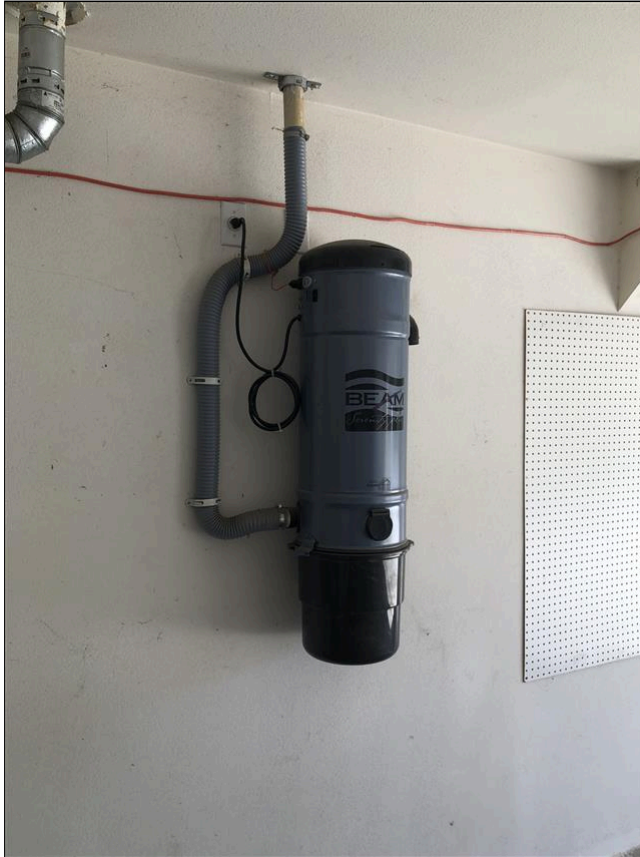
10.0 Item 1(Picture)

➡ The whole house vacuum system was not inspected. We make no claims as to its condition. A technician should service the unit and repair if needed.

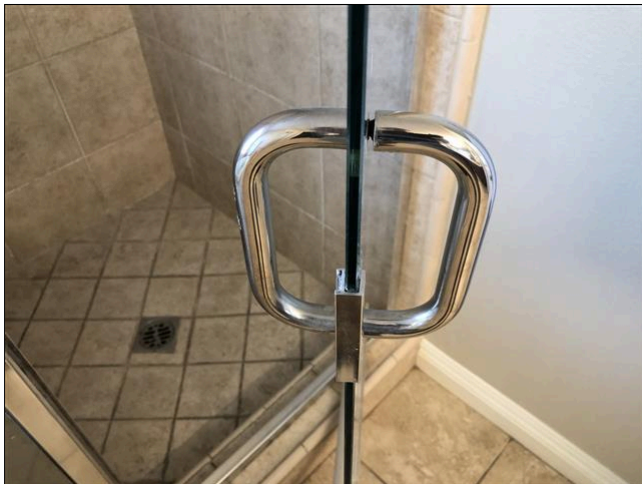
12.6 Item 1(Picture)

The shower door handle is very loose and should be secured. A qualified technician should make this repair. ( Master Bathroom )

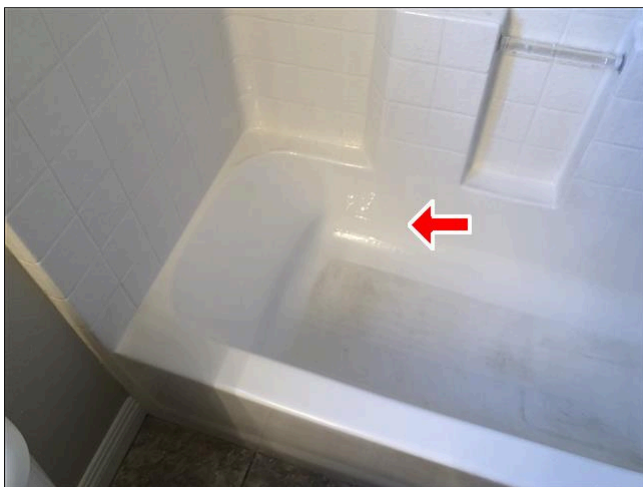
12.10 Item 1(Picture)

➡ The bathtub at the hall bathroom is chipped. A qualified technician should make any needed repairs.

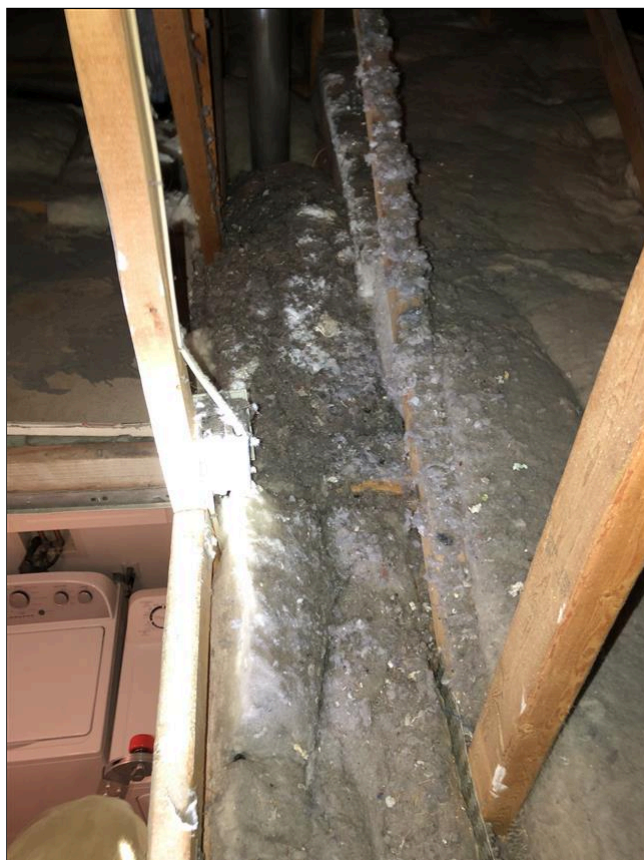
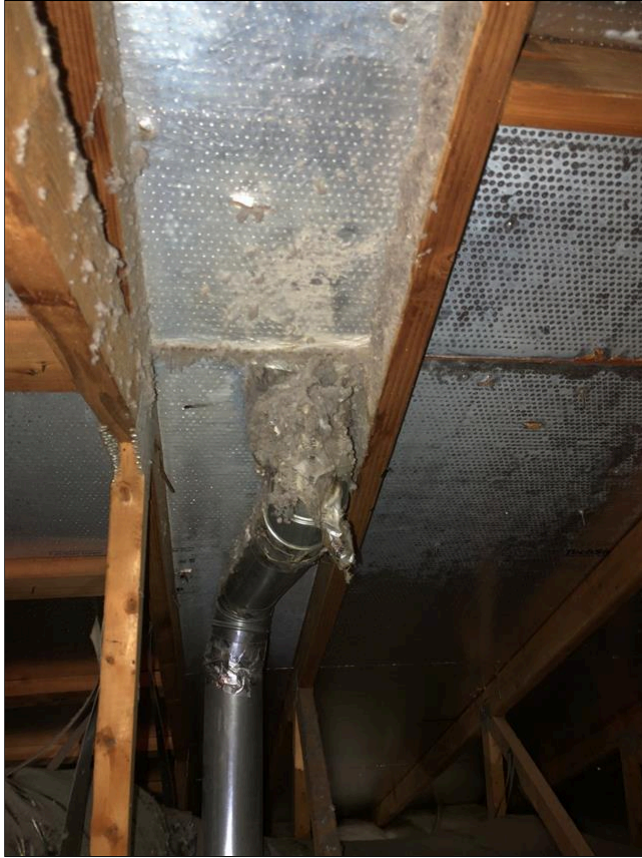
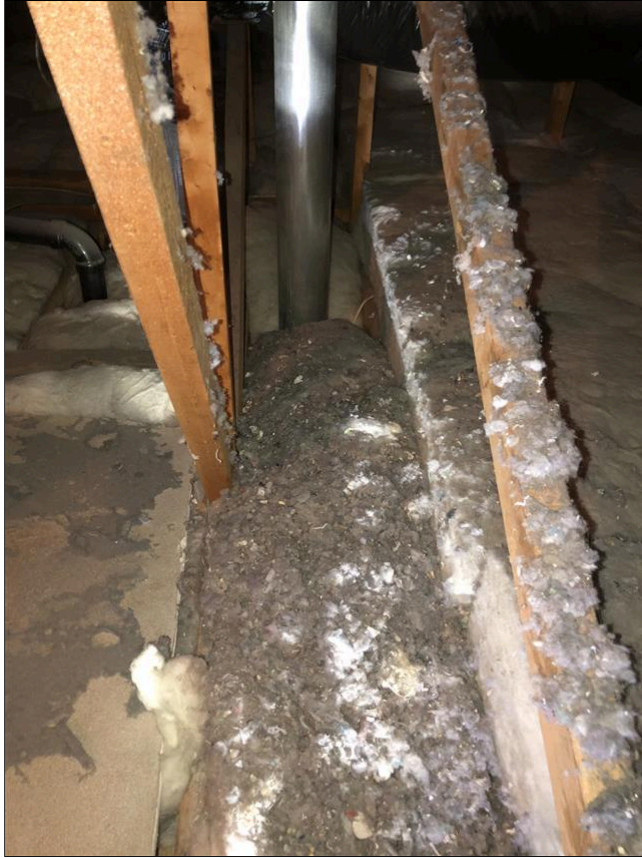
➔ The dryer vent in the attic is loose and is leaking lint in the attic space near the furnaces. This is a significant fire hazard. A qualified technician should fix this leak and clean the lint from the attic space.

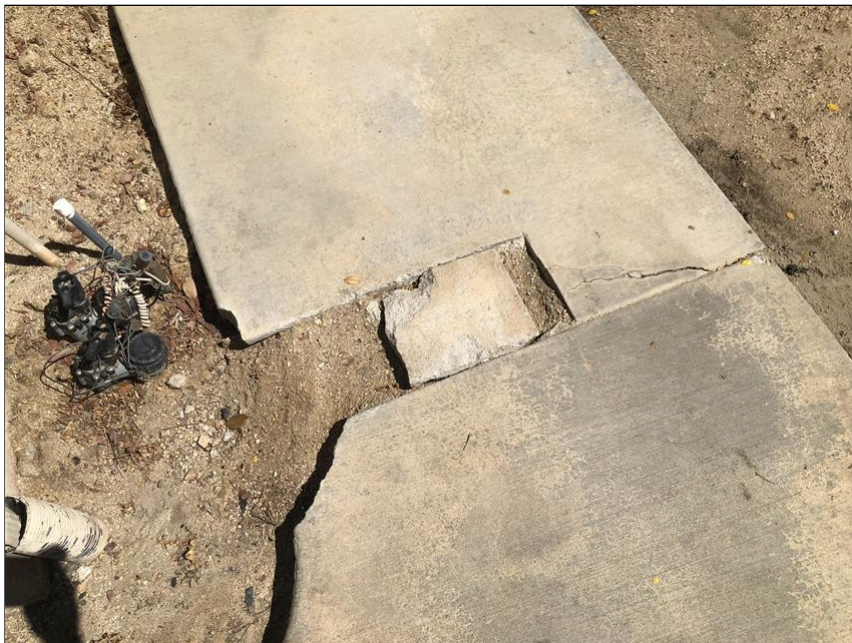
3.3 Item 1(Picture)

- ➔ Damage to the right side walkway has created trip hazards. The damaged areas should be replaced or repaired as needed.

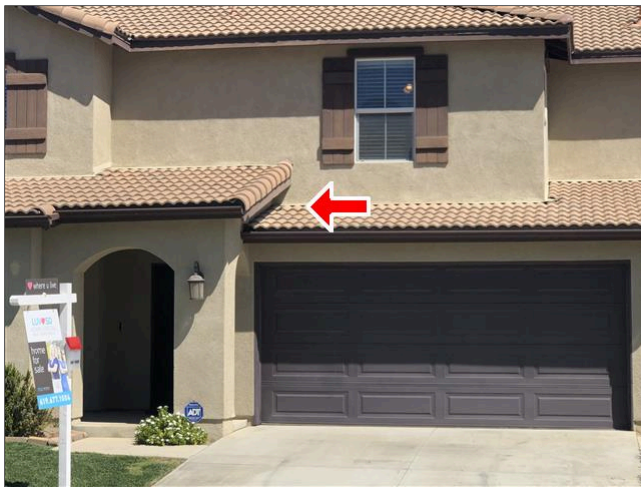
4.2 Item 1(Picture)

➔ (1) Two concrete tiles are cracked and/or broken at the front of the home. A qualified roofing contractor should inspect further and make any needed repairs.

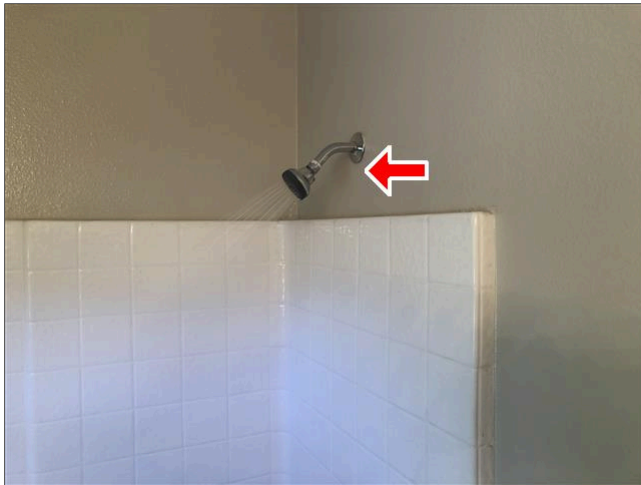
5.4 Item 1(Picture)

- ➔ The shower head leaks at its base at the hall bathroom. A qualified technician should repair or correct as needed.

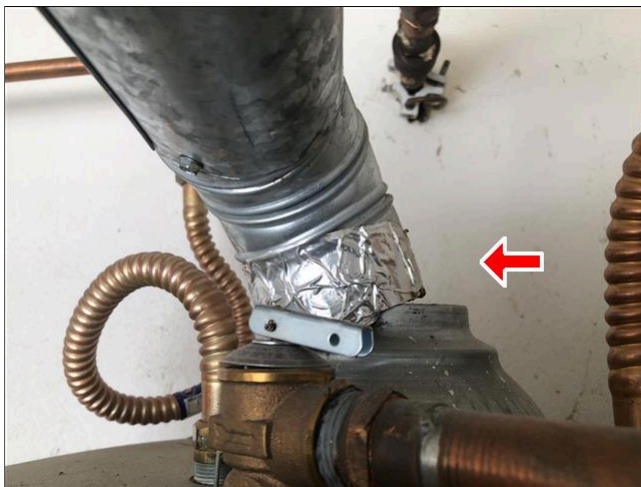
5.10 Item 1(Picture)

- ➔ The water heater vent is separated allowing the vent gasses to mix with the household air supply. A qualified technician should effect repairs as needed.

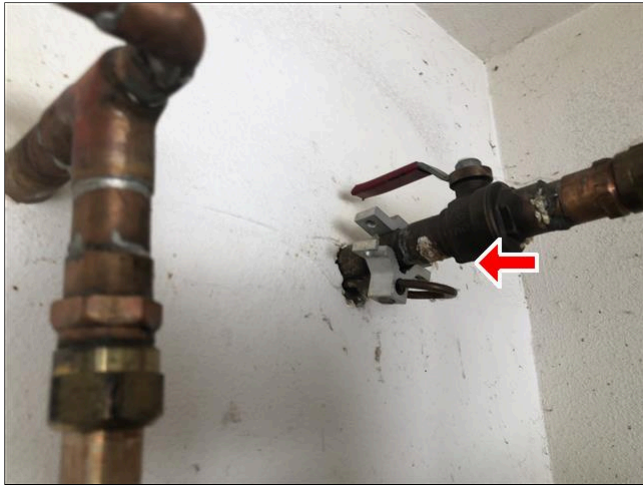
6.3 Item 1(Picture)

- ➔ The connection of the grounding conductor and/or clamp at the grounding source is not secure. A properly connected grounding wire is an important safety feature.  
- Use a licensed electrician to repair the connection.

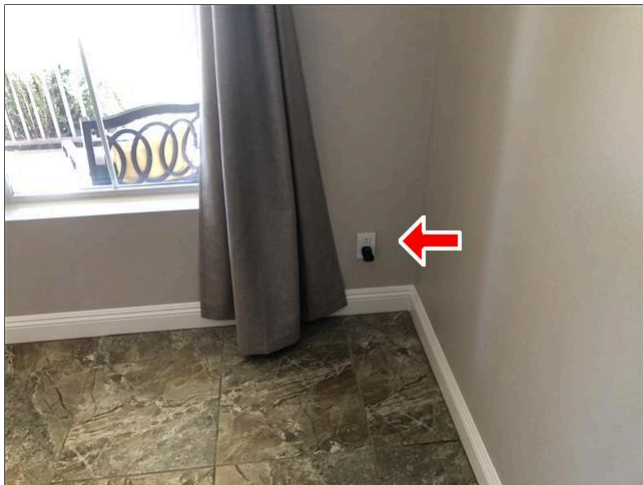
6.10 Item 5(Picture)

➔ (3) One outlet are does not have power at living room. A qualified electrician should make any needed repairs.

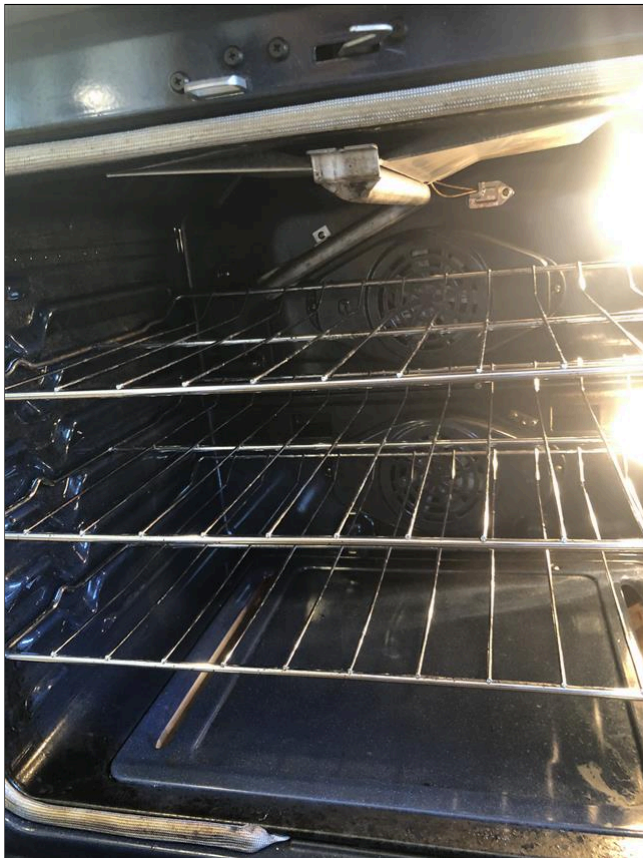
11.3 Item 2(Picture)

- ➔ (2) The convection fans did not work when tested. A qualified technician should repair as needed.

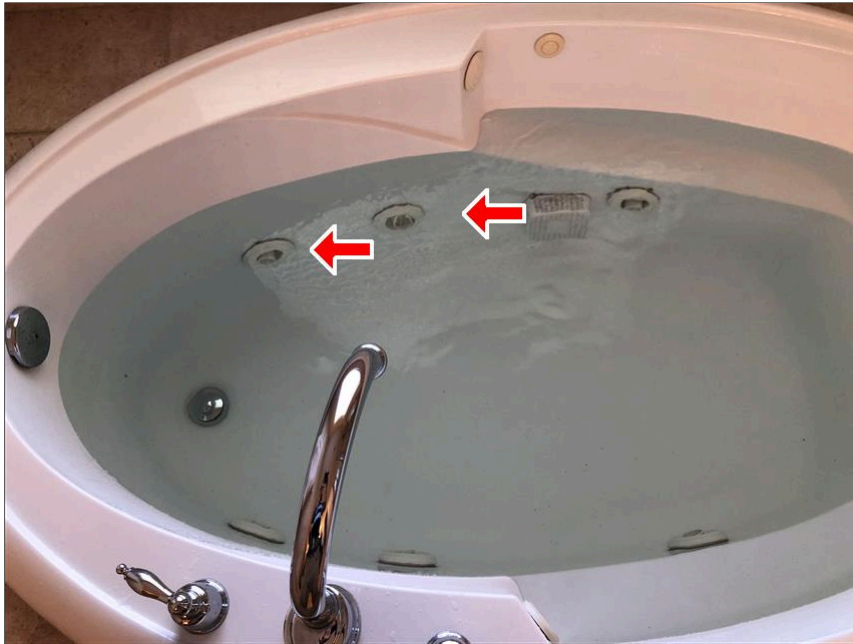
12.11 Item 1(Picture)

- ➔ One or more of the whirlpool tub jets are not functional. A qualified technician should evaluate the system and make repairs or modifications as necessary.

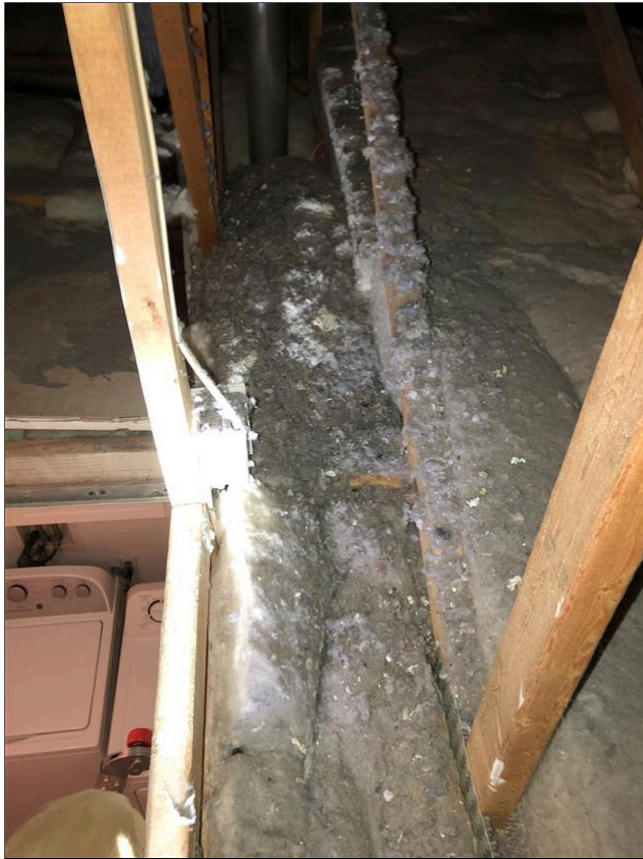
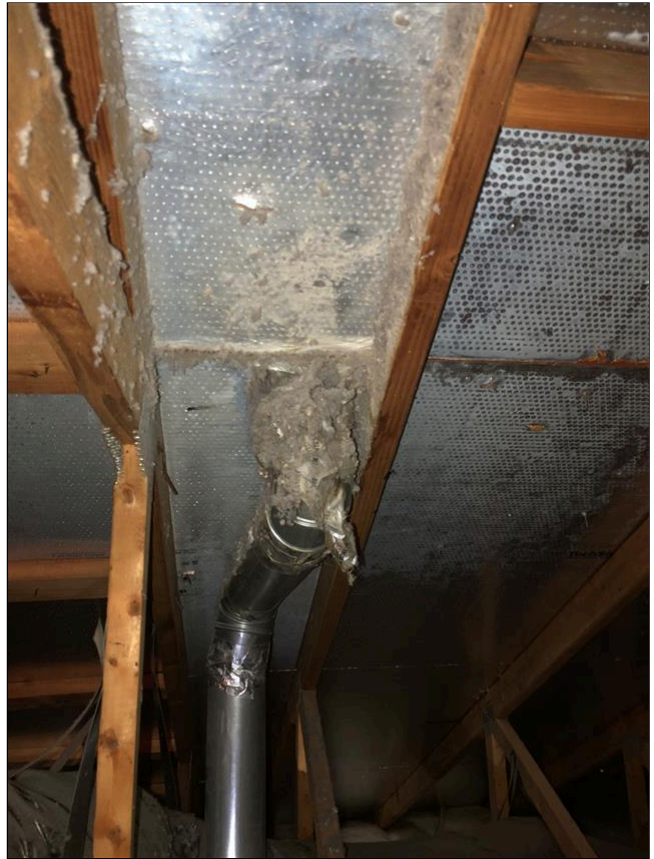
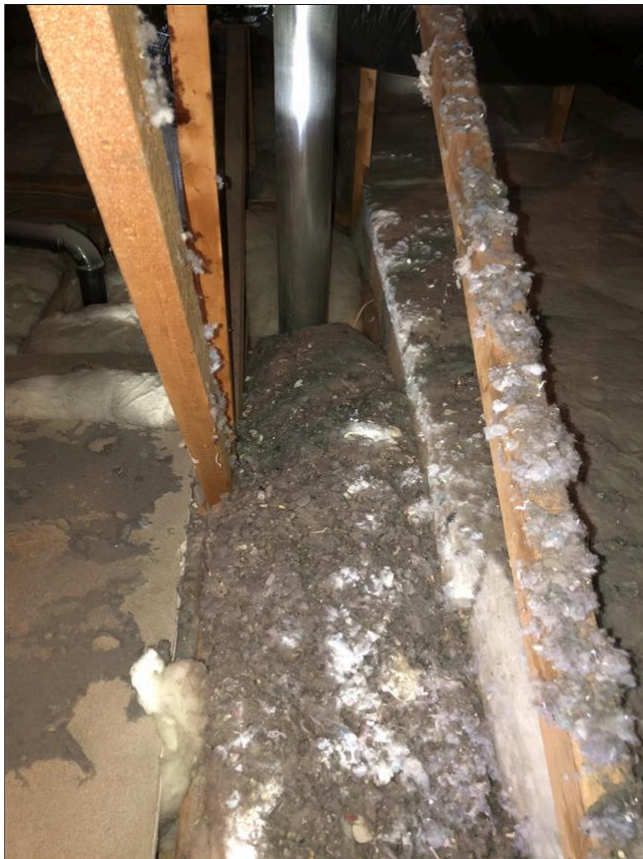
- ➔ The dryer vent in the attic is loose and is leaking lint in the attic space near the furnaces. This is a significant fire hazard. A qualified technician should fix this leak and clean the lint from the attic space.

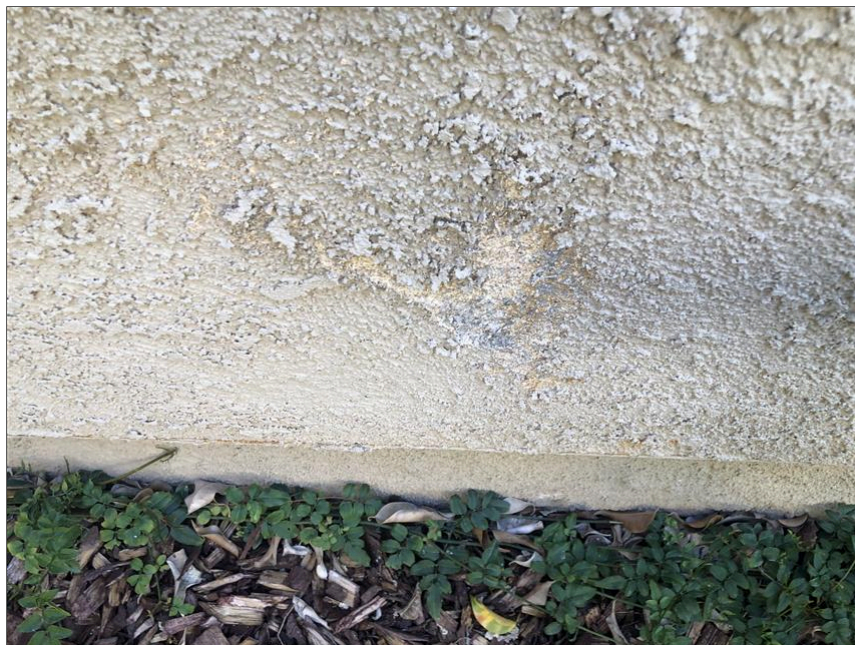
3.7 Item 1(Picture)

Sections of the stucco at the front & left side of the building are deteriorated.  
- A qualified plastering technician should evaluate the stucco and make repairs or modifications as necessary.

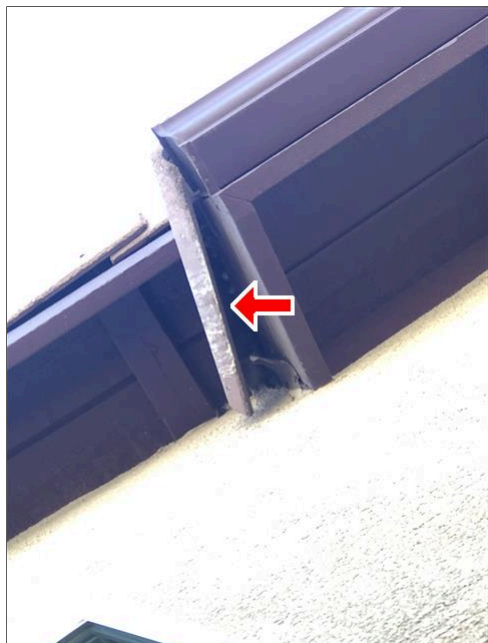
4.2 Item 3(Picture)

(2) The ridge cap at the left front of the home is loose and needs to be secured. A qualified roofer should make this repair.

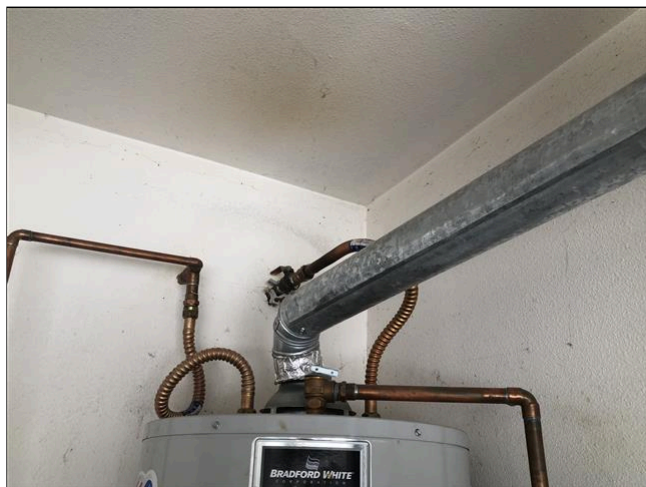
5.8 Item 1(Picture)

This water heater does not have a "Thermal Expansion tank" installed to prevent a possible leak at the T&P or "Pop-off" valve. Changes in the building standards may require one when a new water heater is installed. This change is not retroactive on older previously installed Gas/LP water heaters. Check with your local building department as to their requirements. There were no leaks or drips at the T&P valve during inspection. If your water heater does begin to drip or leak, then a Thermal Expansion tank may be needed.

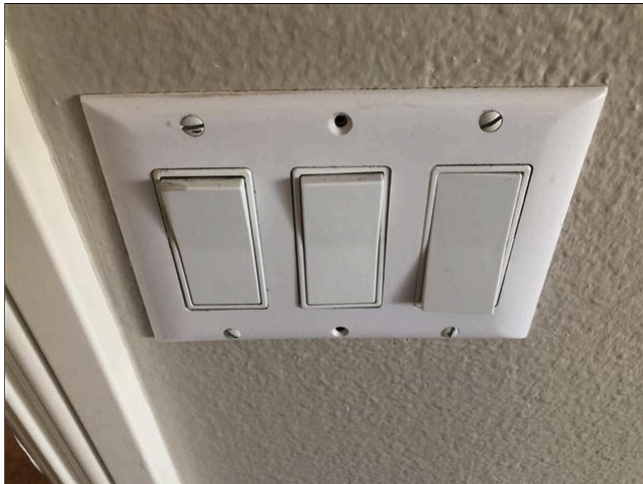
6.10 Item 2(Picture)

(2) Two light switched are loose to the wall and are damaged. A qualified technician should make this repair. ( Master bedroom and second floor halfway )

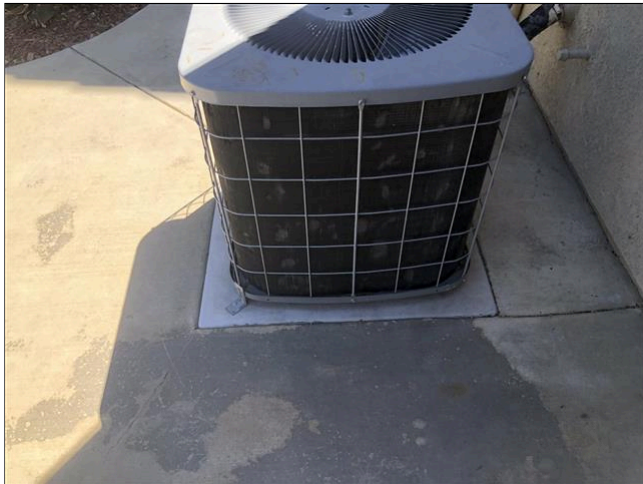
7.12 Item 1(Picture)

- ➔ (1) The cooling fins on the compressor are damaged and degraded. This could shorten the life of the unit. A qualified HVAC contractor should make any needed repairs or modifications. ( both units )

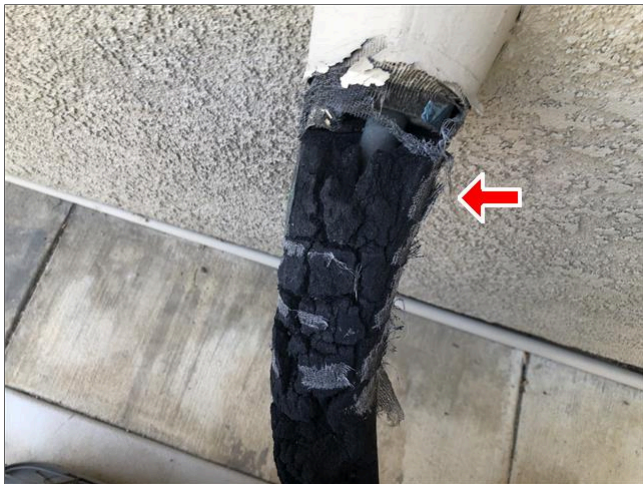
7.12 Item 7(Picture)

➔ (4) The insulation on the suction line is damaged at the exterior. Damaged insulation on a suction line can cause energy loss and condensation. We recommend replacing the damaged insulation.

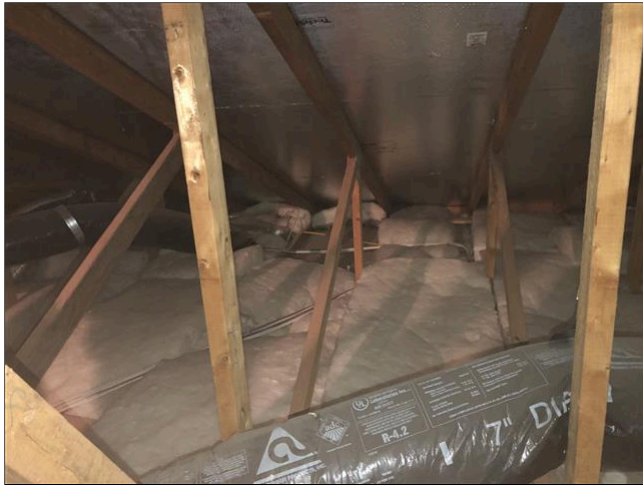
8.4 Item 1(Picture)

Some of the insulation in the attic is missing, or is out of place. Where insulation is missing, new insulation should be installed. Where insulation is out of place, it should be put back into place. A qualified technician should do the work.

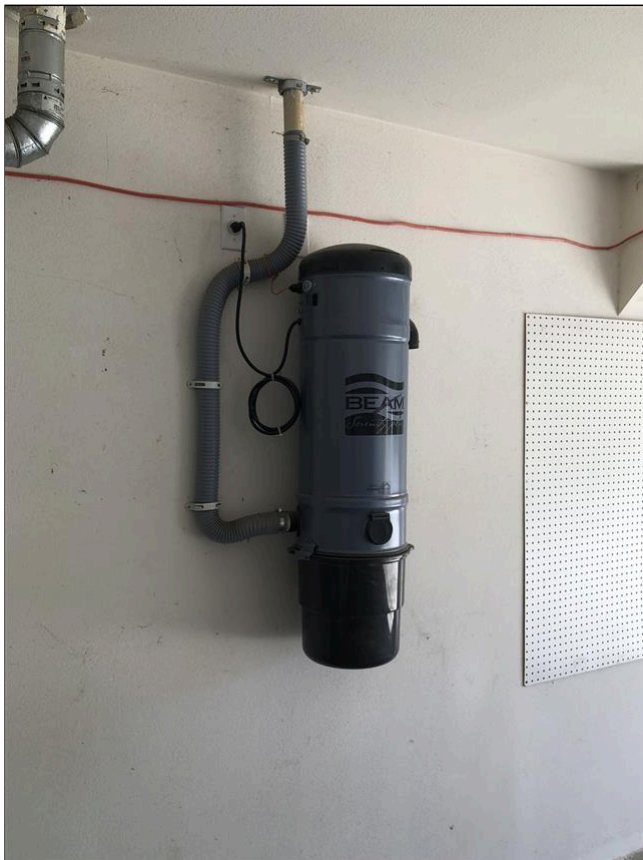
10.0 Item 1(Picture)

- ➔ The whole house vacuum system was not inspected. We make no claims as to its condition. A technician should service the unit and repair if needed.

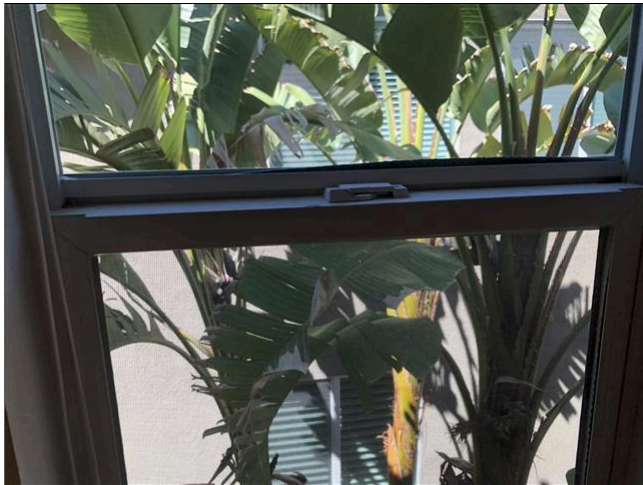
10.4 Item 1(Picture)

(1) The interior insulation for the window in the jack and jill bathroom has become loose. This is a cosmetic issue. A qualified technician should make this repair.

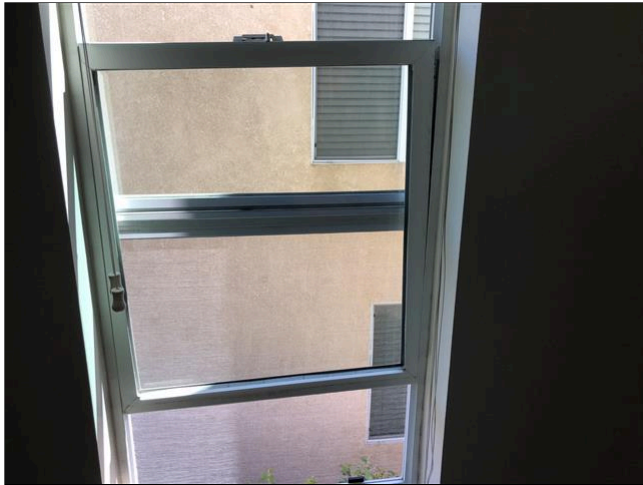
10.4 Item 3(Picture)

(2) One or more windows do not operate smoothly, are difficult to latch or are in need of adjustment. All poorly or non-operating windows and their associated hardware should be cleaned, lubricated, and adjusted for smoother operation. Where needed, essential hardware, such as operator cranks, sash balances and latches should be replaced with compatible components. ( MAster bedroom )

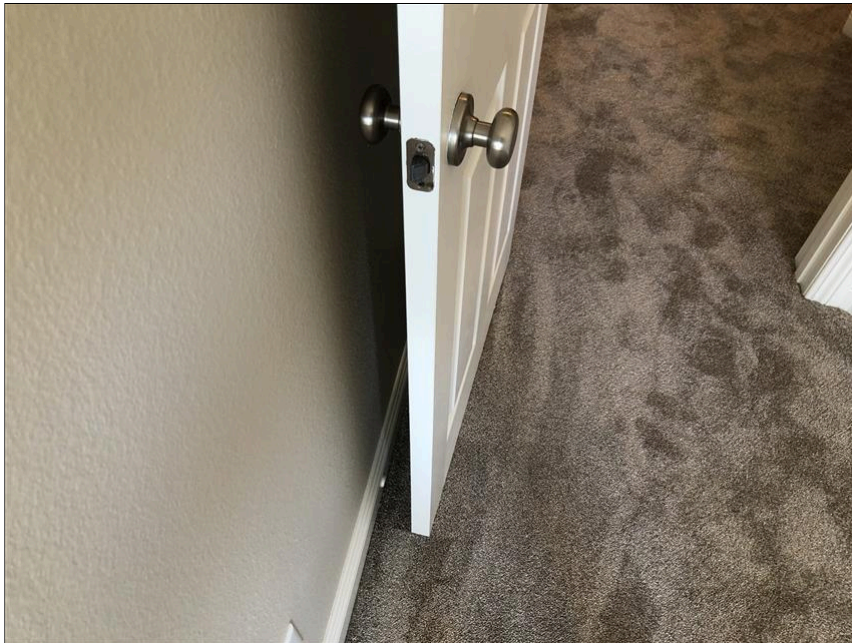
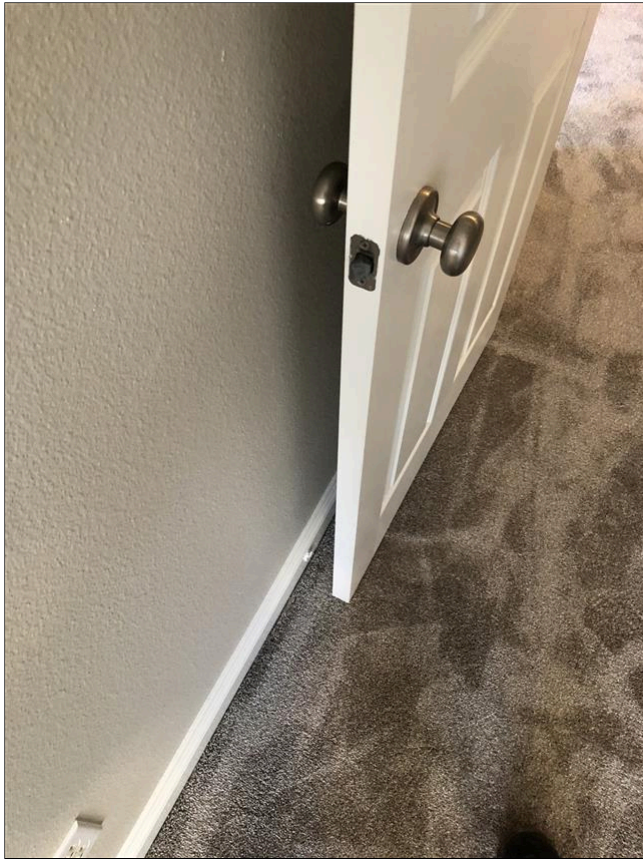
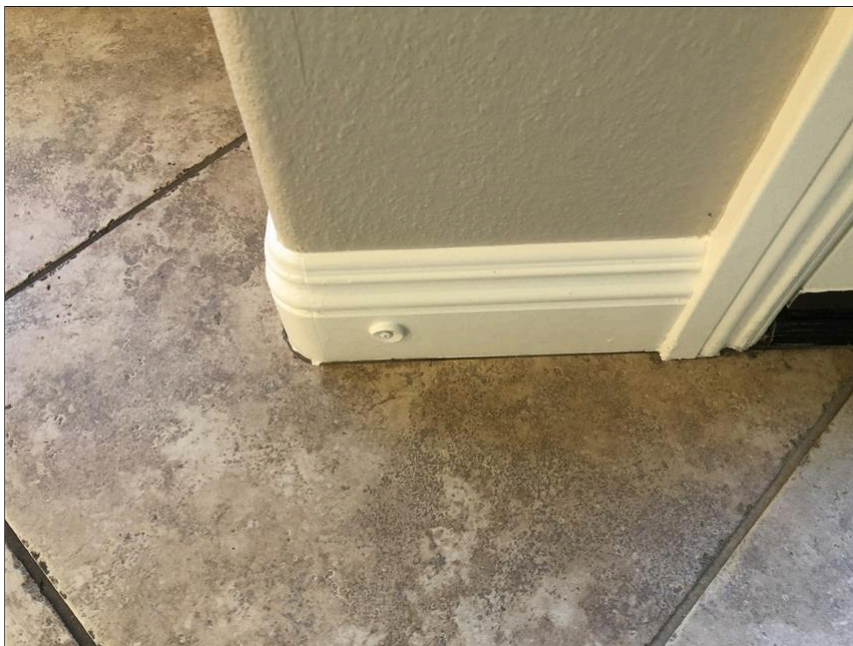
One or more interior doors have no door stop. A stop or bumper should be installed on each door to help prevent damage to the surfaces behind the door.

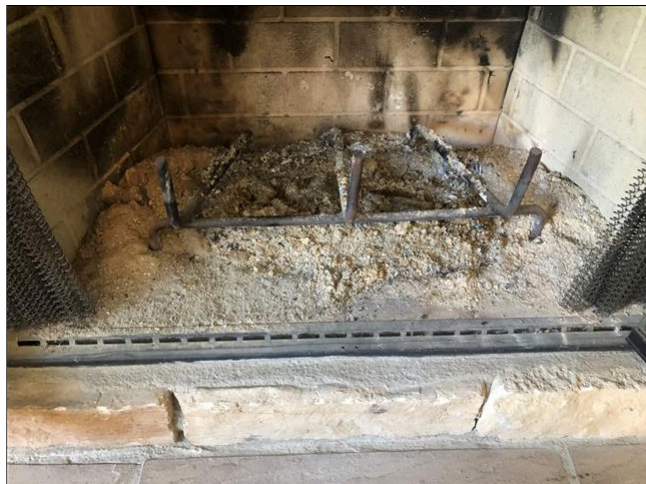
10.11 Item 1(Picture)

➡ The fire box in the family room is filled with ash. This should be cleaned. A qualified technician should make this repair.

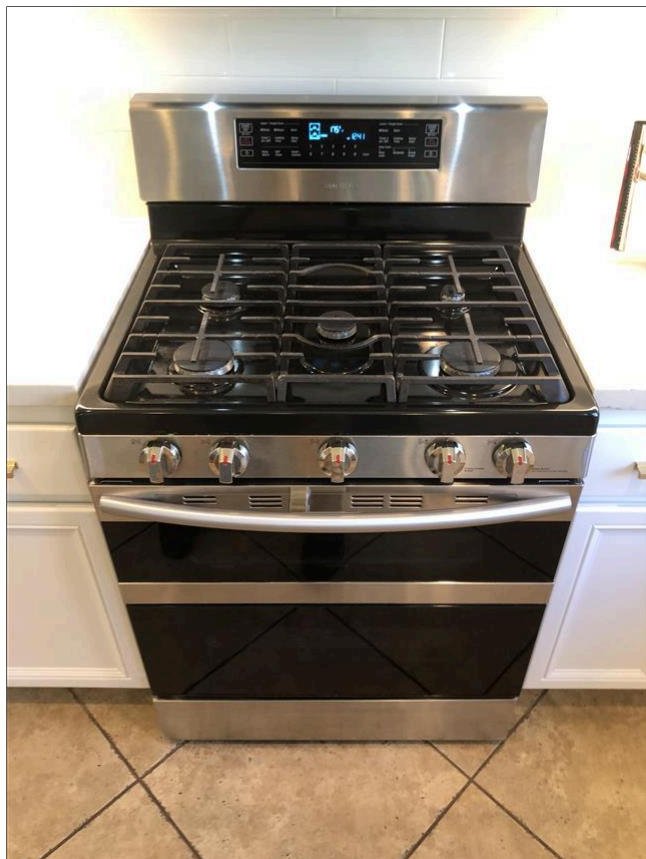
11.3 Item 1(Picture)

➡ (1) Anti-tip hardware is not installed on this range. This is a safety feature that prevents the oven from falling over if a child climbs on the open oven door. Although this safety feature may not have been required when the unit was manufactured or installed, it is needed for safety. We strongly recommend the hardware be installed as a safety upgrade.

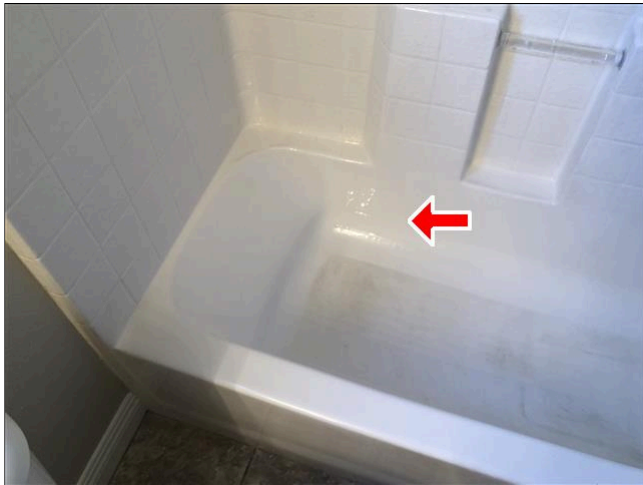
12.10 Item 1(Picture)

➔ The bathtub at the hall bathroom is chipped. A qualified technician should make any needed repairs.
